LISA H. HAMMER, RCA
Horticultural Consultant

December 22, 2020

RE: 5800 North Bay Road
Miami Beach, Florida

As you requested, yesterday I visited the above-referenced property to perform a preliminary tree survey/evaluation. It was reported that there is a prospective buyer of the property who would like to know if there are any existing trees on the site that may prohibit renovation of the property. To accomplish this task, I walked the site and took general notes regarding the existing tree species, quantities, sizes, and conditions, and assessed any potential issues that could impact tree permitting decisions by the City of Miami Beach.

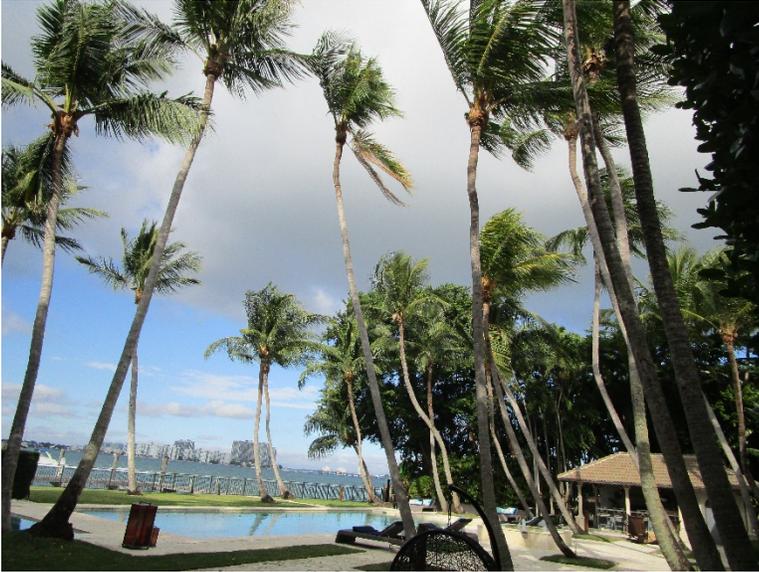
This site has a large number of trees on it and a review of the aerial photos on the Miami-Dade County website shows that there is at least 80% canopy coverage on the lot. The only open areas are over part of the house and north drive area, and the pool deck, even though there are 24 coconut palms (*Cocos nucifera*) and a cluster of Christmas palms (*Adonidia merrillii*) on or near the pool deck.

The pool deck is shown below:

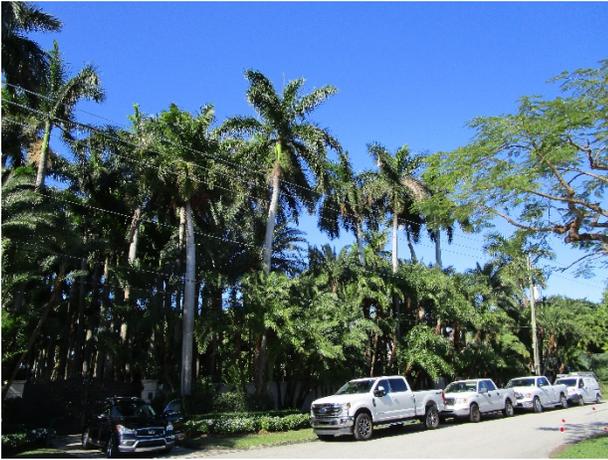
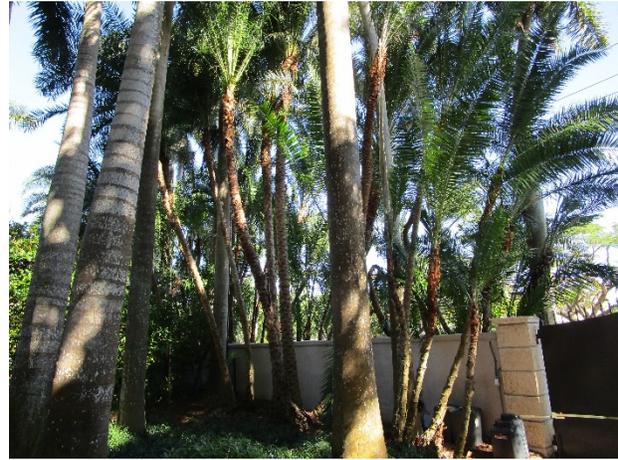
Front Wall Area

There are approximately 28 Senegal date palms (*Phoenix reclinata*) planted on both sides of the front wall and 6 royal palms (*Roystonea regia*) outside the wall. These palms will meet the definition of “specimen trees” due to their trunk sizes. The royal palms are all greater than 12 inches in trunk diameter and if the multiple stems on the Senegal date palms are summed, they will also exceed the minimum size requirements. Consequently, they will be carefully reviewed by city staff. They are good candidates for relocation if there is adequate space on the site.

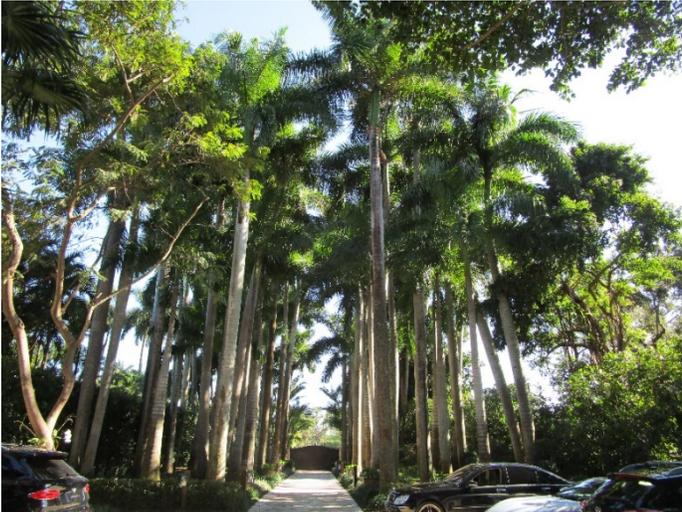
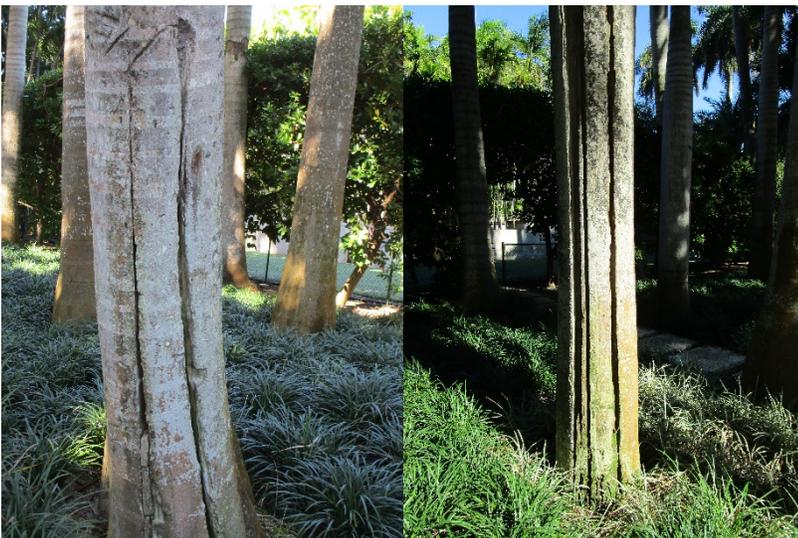
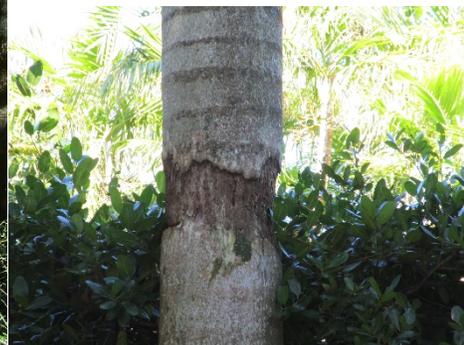
Entry Drive

There are approximately 70 royal palms inside the gate, on either side of the entry drive, virtually all of which are specimen size. Several are damaged. Those which are not damaged could be proposed for relocation, however, there are so many of them, there is not likely enough space on the site. In this case, they could be donated to the city (if they accept them) and relocated off-site, or mitigated.

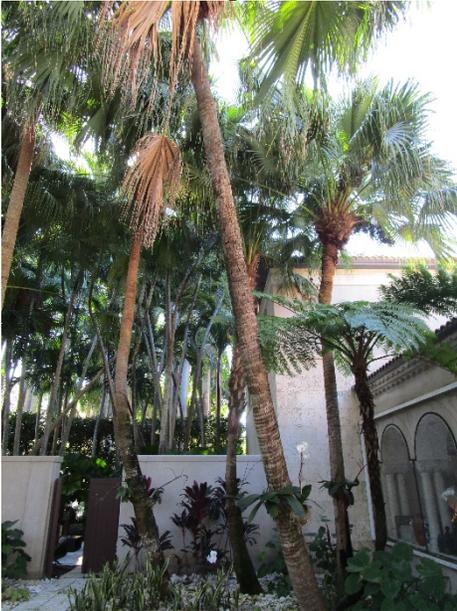
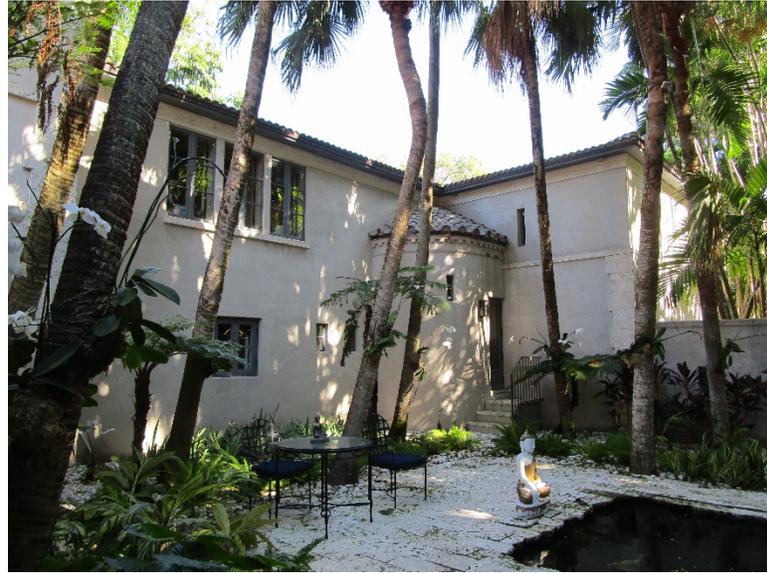
In the courtyard on the east side of the house there are 16 Chinese fan palms (*Livistona chinensis*). These non-native palms could be removed and mitigated, or relocated if necessary.

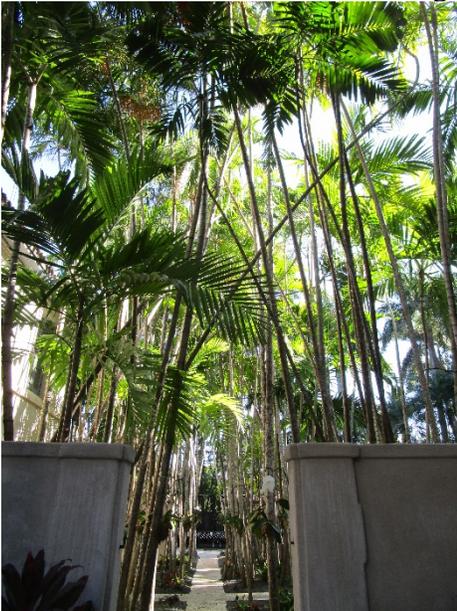
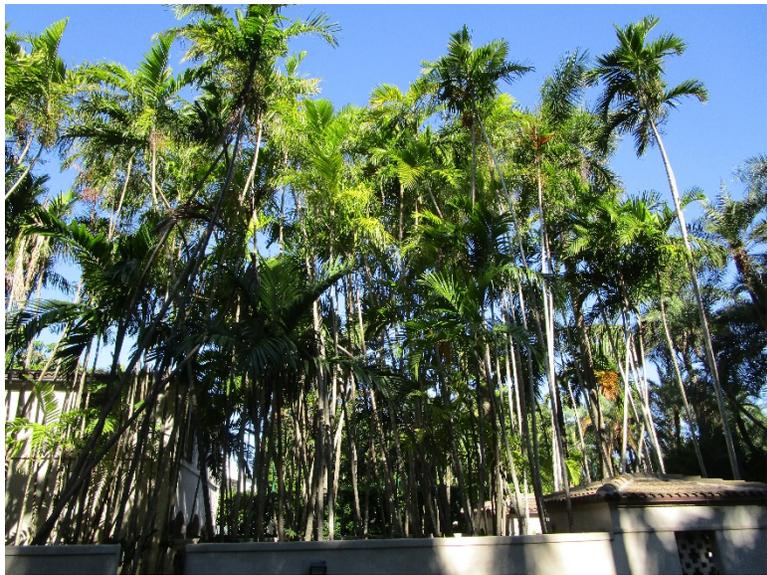
Along the walkway from the courtyard toward the athletic field there are dozens of (possibly one hundred or more?) Christmas palms and solitaire palms (*Ptychosperma elegans*). There are so many of them, most will need to be mitigated.

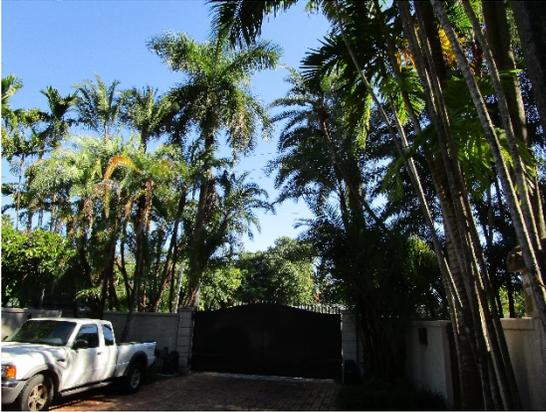
There are also solitaire palms and a few royal palms near the north drive. These could be relocated or mitigated.

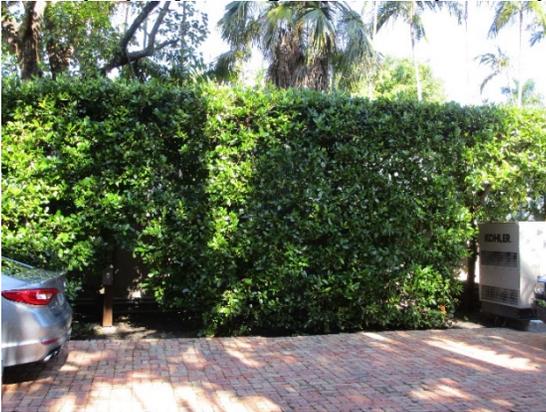
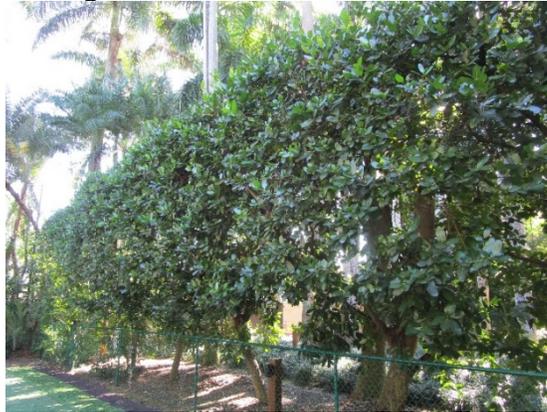
There are Brazilian beautyleaf (*Calophyllum brasiliense*) hedges in several locations on the east side of the property. Hedges are exempt from permitting.

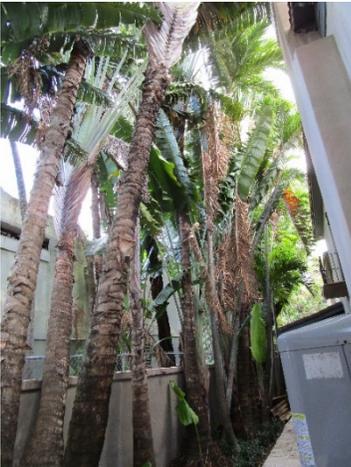
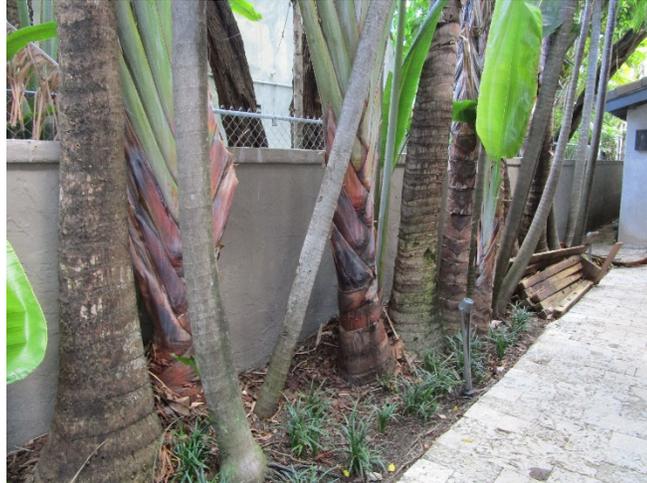
North Side of House

On the north side of the house, adjacent to the perimeter wall, there is a row of traveler's trees (*Ravenala madagascariensis*). They meet the definition of specimen trees but would likely be permitted for removal, provided mitigation is provided. They could be relocated if desired but there could be underground utilities in this location that could be damaged. Their close proximity to the wall may also make it logistically difficult to get them out. They could remain or be mitigated. There are a few Christmas palms in this location as well. They could be retained, removed, or relocated.

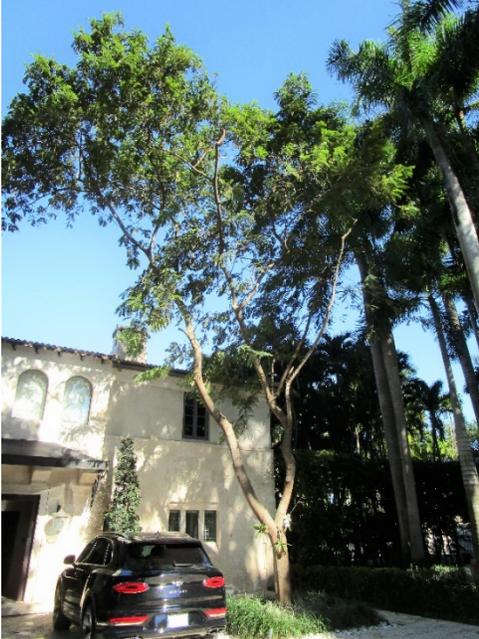
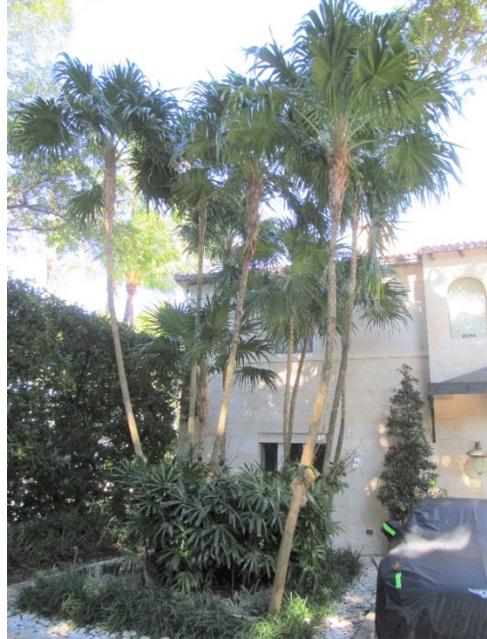
Motorcourt

In the motorcourt there is one cassia tree (*Cassia* sp.) and a cluster of 10 thatch palms (*Thrinax radiata*). The cassia tree measures 12 inches in trunk diameter, just barely meeting the city’s definition of a “specimen tree”. It is in good condition, readily accessible, and a very good candidate for relocation. Therefore, it should not present any major challenges for permitting. The thatch palms are native and therefore, relocation should be considered rather than removal.

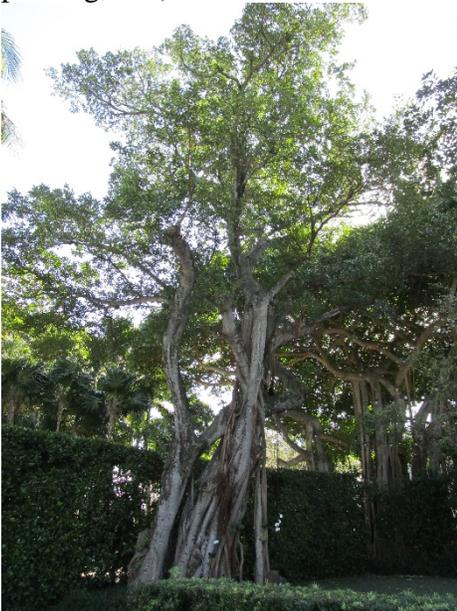
In the backyard, near the southwest corner of the house there is a large specimen native strangler fig tree (*Ficus aurea*). It is most likely within the buildable area but will still be carefully evaluated by city staff if removal, relocation, or severe pruning are proposed. If it is proposed to remain, staff will assess any potential impacts to the tree from the proposed construction (i.e., root damage, canopy pruning, etc.).

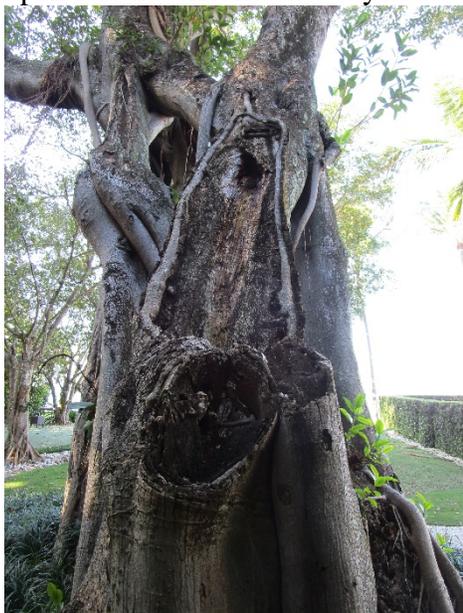
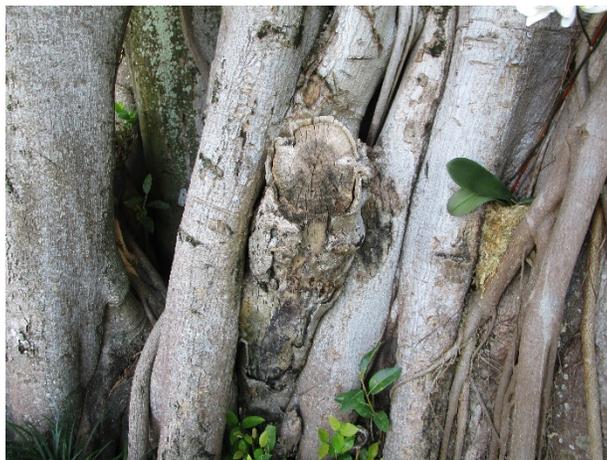
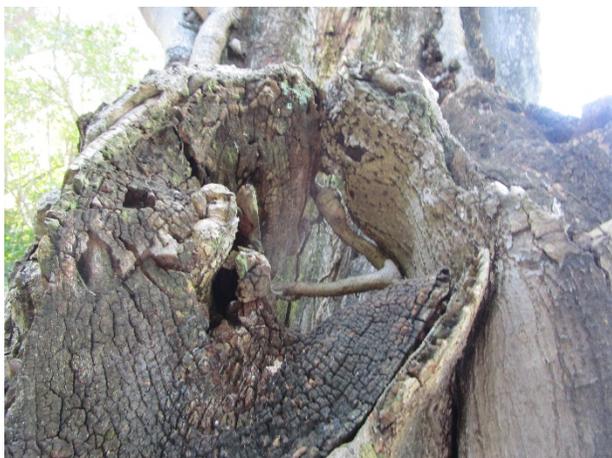
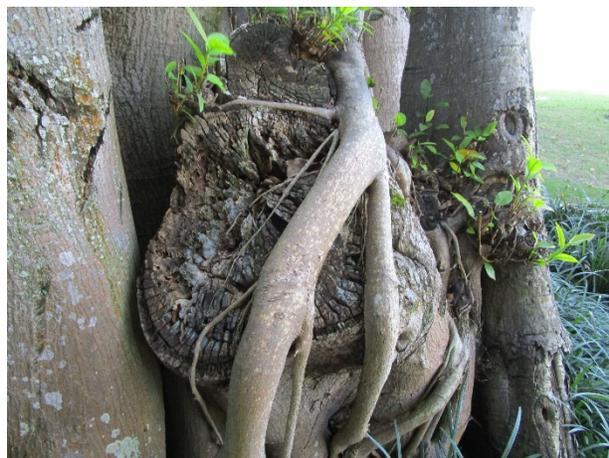
This tree is in fair to poor condition due to previous pruning, storm damage, and subsequent wood decay. Several large limbs or leaders have been removed or ripped off during storms, leaving large open wounds that have decayed.

In my professional opinion, this tree could possibly remain where it is for several more years, but its structure has been compromised and its health is at stake. It is not a good candidate for relocation due to the damage and decay. If it is to remain, you will have to provide a detailed tree protection plan showing protection of its roots, trunks, and canopy. If this tree cannot remain where it is, I would recommend removal. However, you may need to provide more extensive evidence to city staff before they will approve a tree removal permit. If approved, mitigation for this approximately 60-inch diameter tree would likely be about \$20,000.

The greatest challenges to permitting will be the strangler fig by the southwest corner of the house and the lofty fig on the south wall. The strangler fig is damaged and located in the buildable area, therefore, it should be possible to permit its removal; however, city staff will likely require significantly more information before doing so.

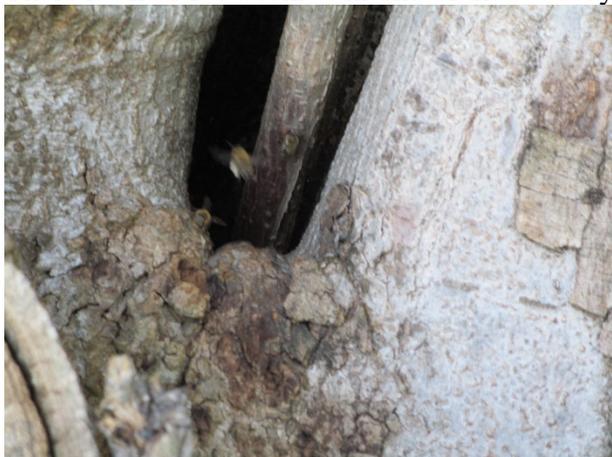
There is an active beehive in one of those decayed areas, suggesting the decay cavity is quite deep.

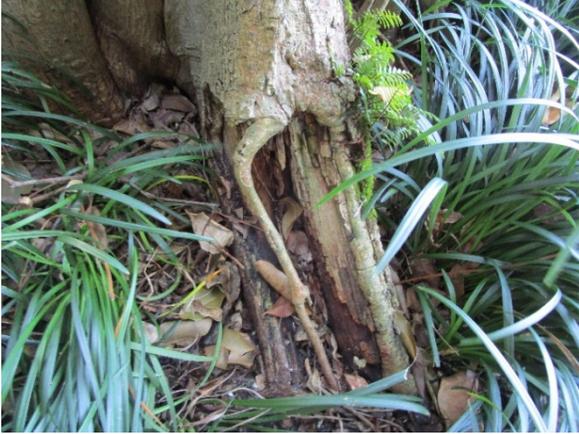
At least one buttress root was damaged and decayed.

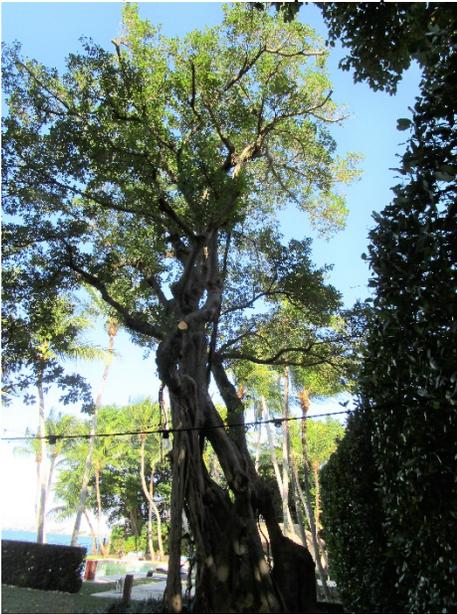
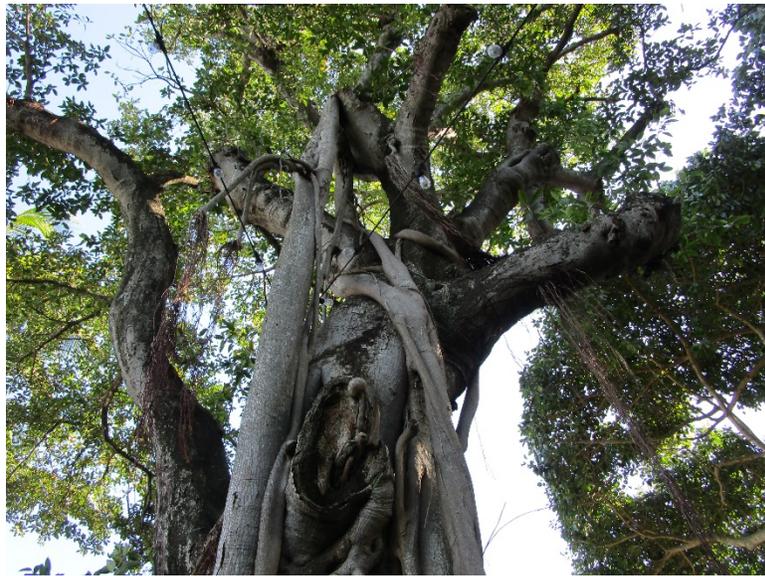
Many of the larger branches have been reduced using heading cuts, which according to industry standards, is an unacceptable pruning practice.

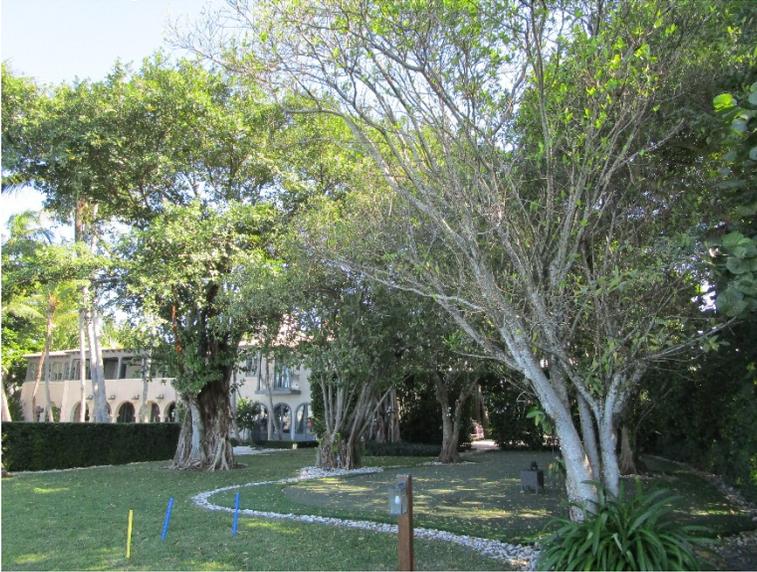
In the southwest corner of the property there are 5 smaller strangler figs. Due to their size and location, I suspect they were relocated to this area from elsewhere on- or off-site. Most have multiple leaders which, if added together, will likely make them “specimen trees”. Therefore, city staff will carefully evaluate them. They are generally in good condition and good candidates for relocation, if city staff will approve. It is possible they would permit some of them for removal, but not a certainty. The largest one shown below, far left, is in good condition and should be proposed to remain or relocate.

Five strangler figs in southwest corner.

The five smaller strangler figs in the southwest corner will likely be carefully reviewed by city staff. Tree removal permits may be difficult to obtain, but probably not impossible. The simplest approach may be to propose that they be retained or relocated elsewhere on-site.

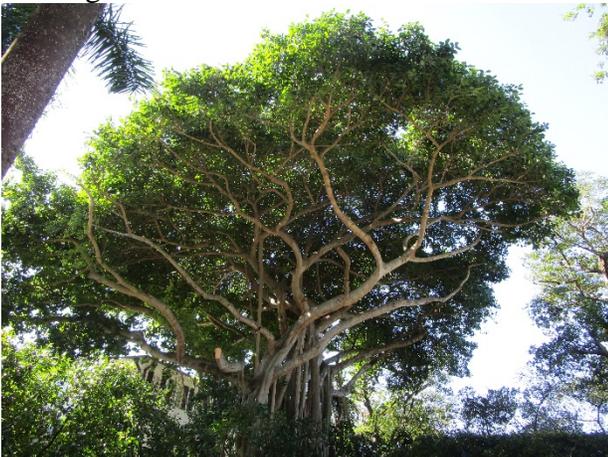
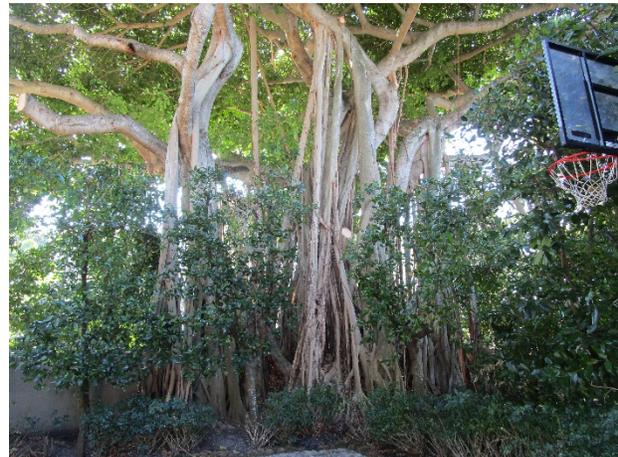
There are several *Ficus* species trees growing near and over the walls along the north and south property lines. The largest of these is on the south side, near the motorcourt. It is a non-native lofty fig (*Ficus altissima*). It is a huge tree in very good condition and providing extensive canopy coverage.

This species is on Miami-Dade County's list of prohibited species but in the City of Miami Beach, it requires a permit like any other tree except, if removed, there is no permit fee. Mitigation is still required and it would be significant (probably \$30,000 to \$40,000). The tree is not within the buildable area and in my opinion, it will be very difficult to obtain a tree removal permit for this tree. There could also be public opposition to its removal. Due to its size and location, it is not a good candidate for relocation. Therefore, I recommend that this tree be retained. This will require limited (none) construction activity within the area beneath its canopy and pruning will be limited to no more than 25% canopy reduction throughout the entire canopy (not just on one side). This tree will be the greatest limitation to renovation/development on this site.

It would likely be very difficult to obtain a tree removal permit for the large lofty fig on the south wall. Therefore, I recommend that it be proposed to remain and protected from any construction activity.

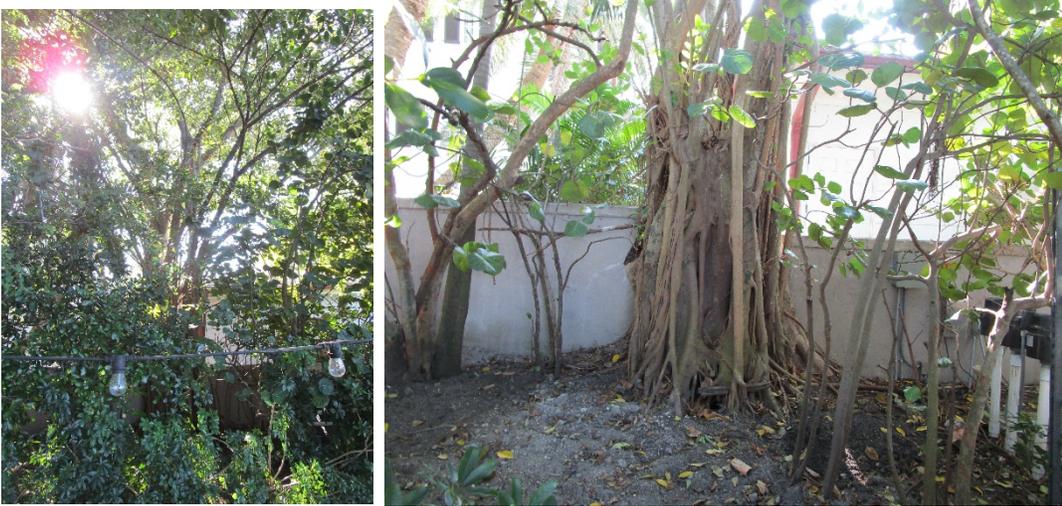
Also along the south wall near the west end is a strangler fig. It is specimen size and in fair condition. It could not be successfully relocated, therefore, retention or removal would be recommended. Since it is native and not within the buildable area, city staff could deny a removal permit, but might issue one with more information. If removed, it would require mitigation (probably about \$12,000 to \$14,000).

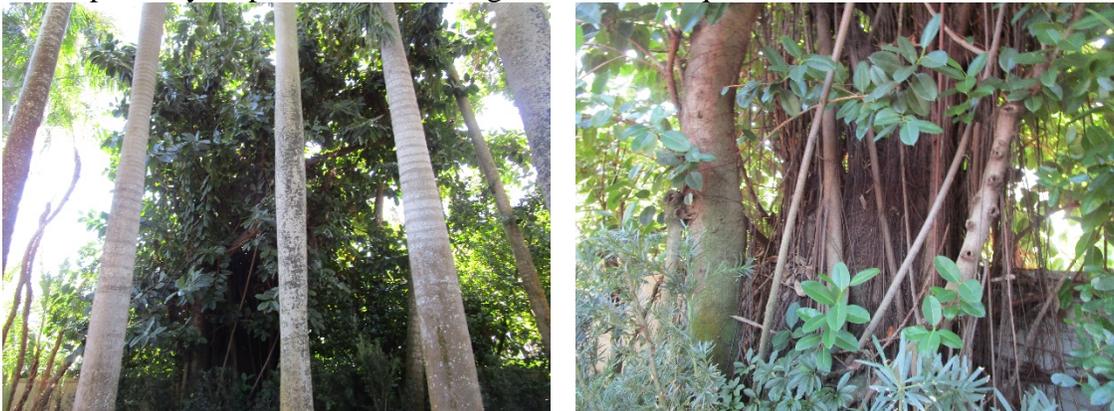
On the east end of the south wall there is a rubber tree (*Ficus elastica*). This is a non-native *Ficus* species of limited value. It cannot be relocated and should either be retained or removed. Removal would probably be permitted, but mitigation will be required.

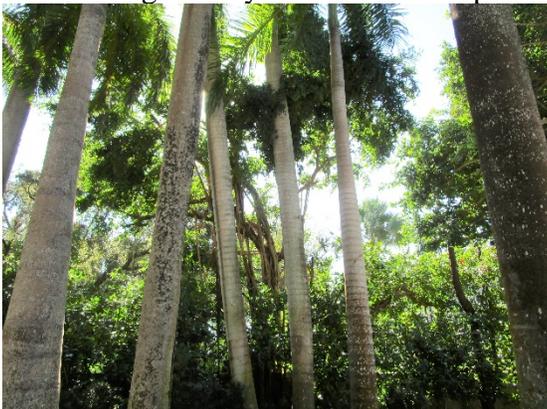
In the mid-section of the south wall there is a fairly small weeping fig (*Ficus benjamina*). It is non-native and generally an undesirable species. It can be removed but mitigation will be required.

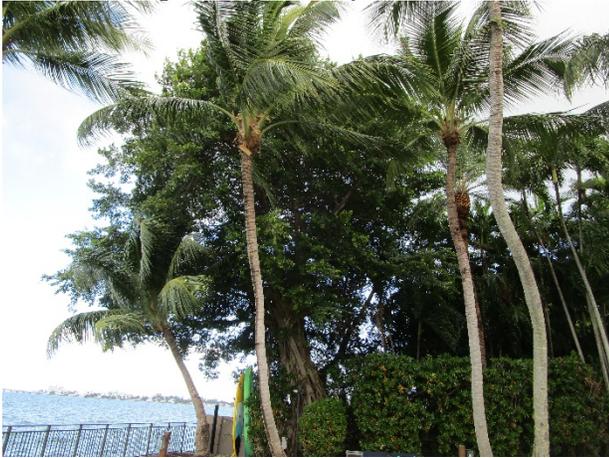
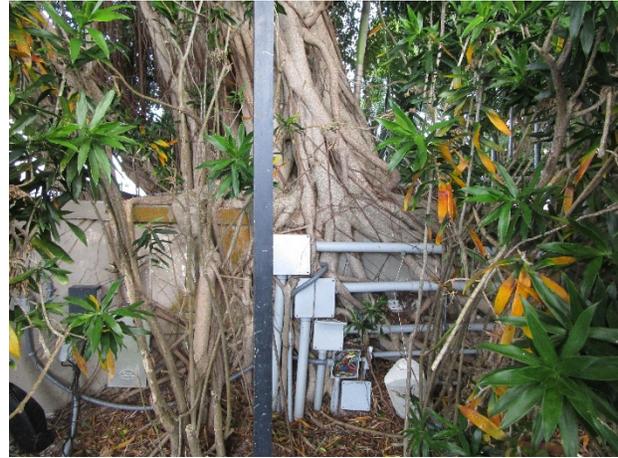
On the north wall, near the west end, there is an Indian laurel (*Ficus microcarpa*). This is a prohibited species for which you might obtain a permit, but may need to provide greater substantiation. It is outside the buildable area and highly visible from the water. Its roots could be adversely impacting the wall and/or the utilities on the wall, which could be a factor in permitting its removal. It is not possible to relocate it. After the lofty fig and the strangler fig near the house, this tree most likely poses the greatest permitting challenge. If it is permitted for removal, mitigation would be required (probably about \$20,000).

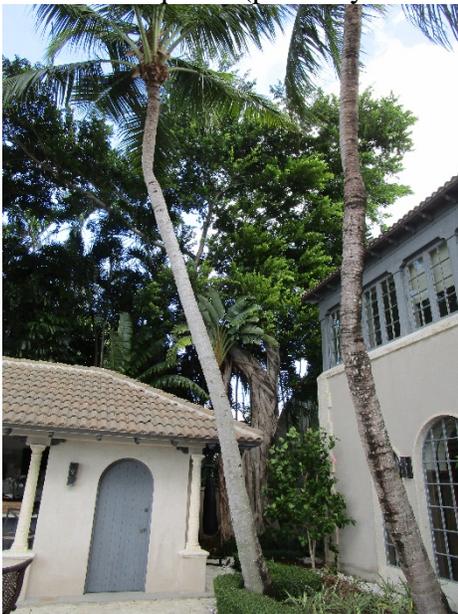
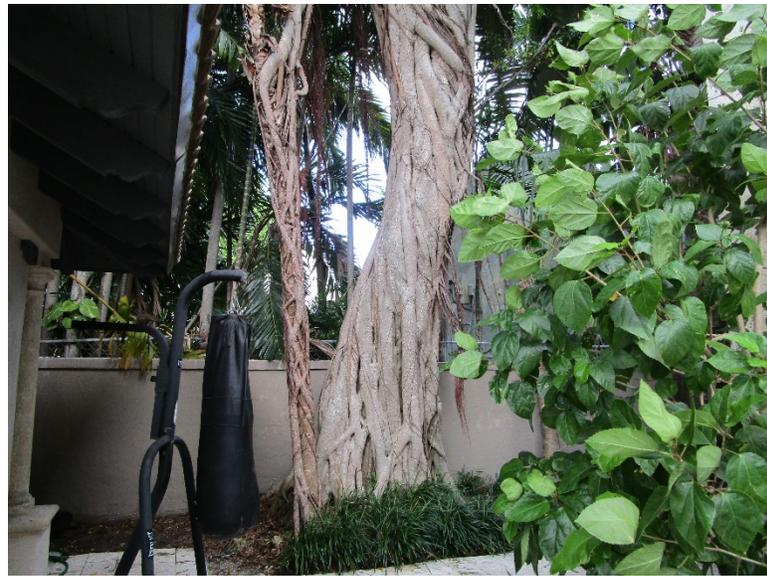
There is another Indian laurel on the north wall, just east of the cabana, outside of the buildable area. It might also be permitted for removal, but greater substantiation may be needed and mitigation would be required (probably about \$14,000 to \$16,000).
