# ***Tree Resource Evaluation for 4000 Alton Road, Miami Beach***

***May 11, 2020***

## **Summary**

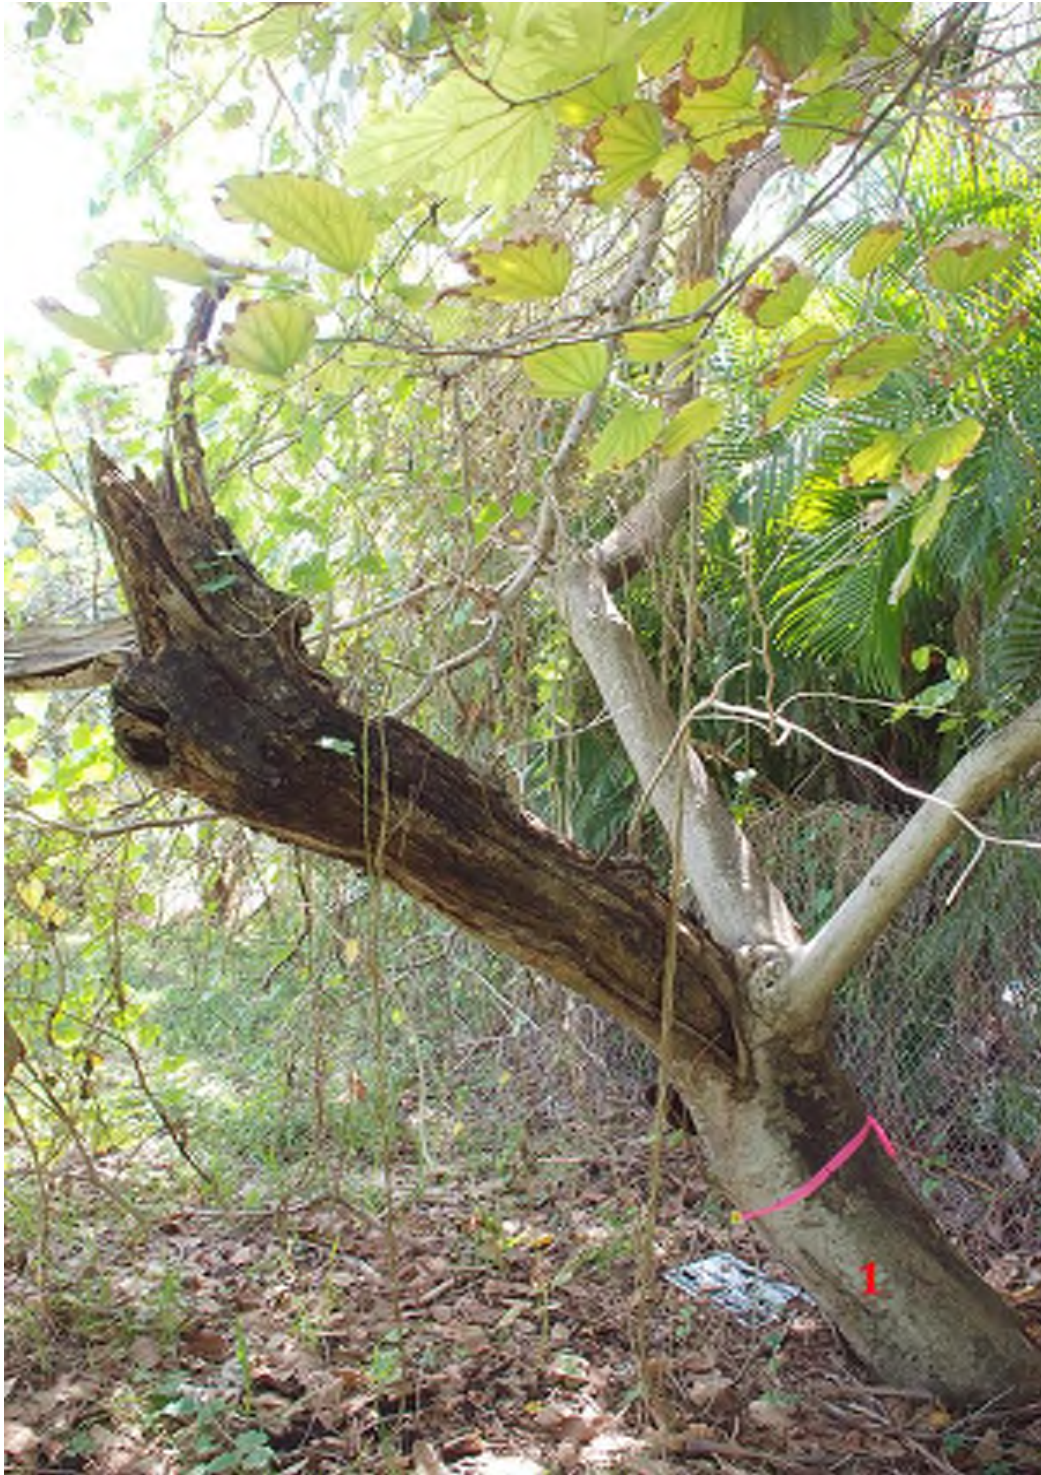
**Photo 1 above is tree 1 with extensive decay.**

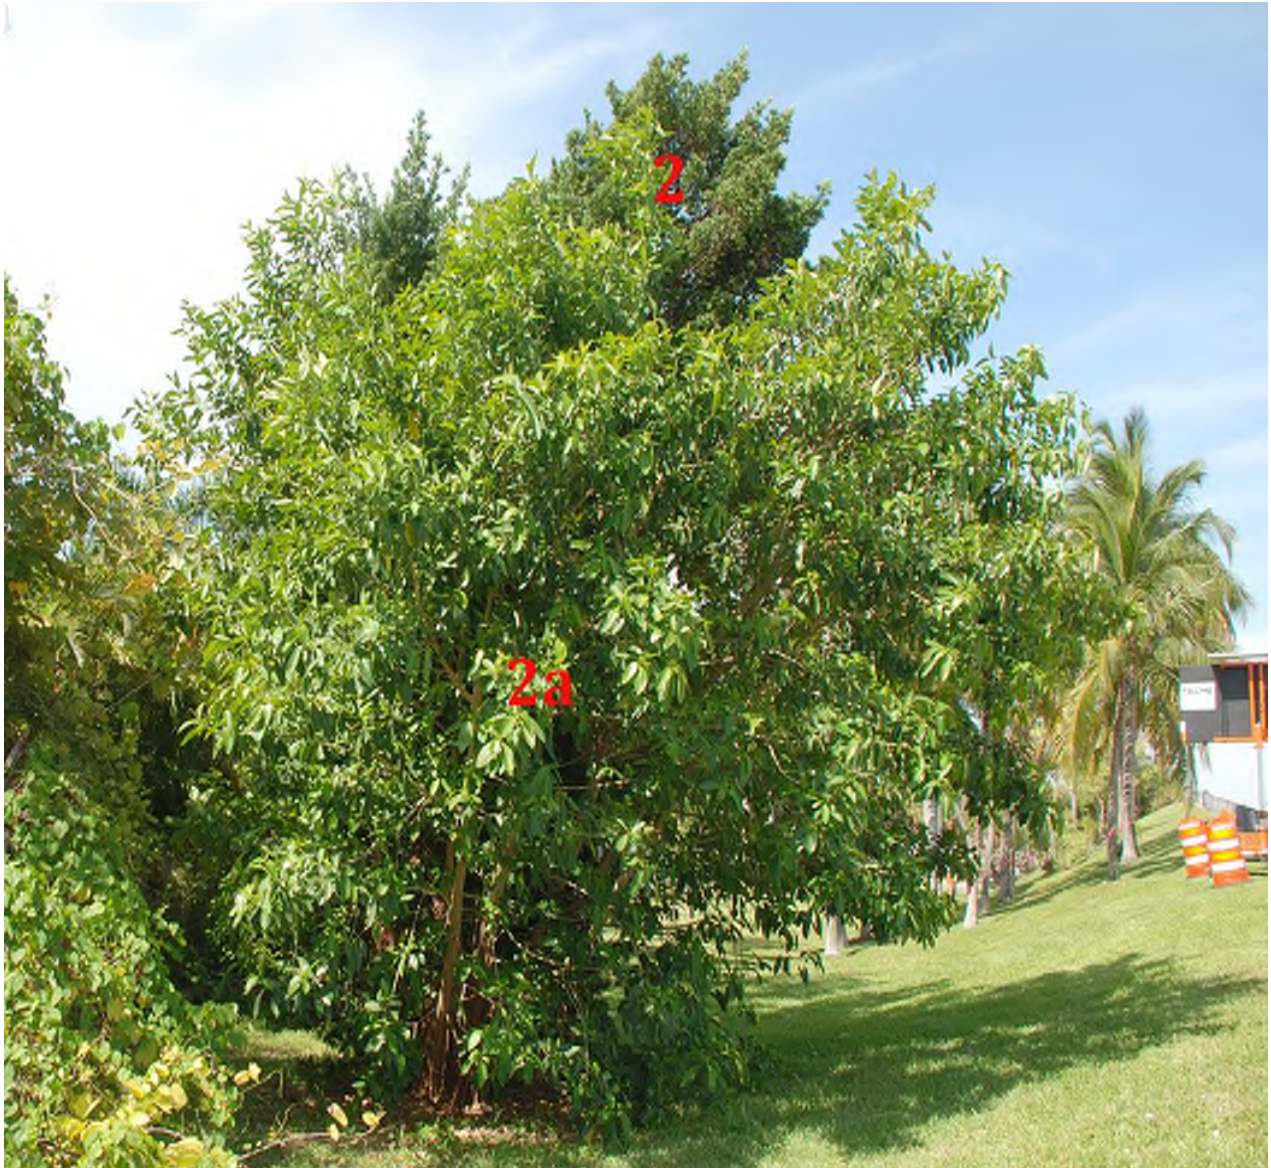
**Photo 2 above is tree 2 that is becoming enveloped by a strangler fig, tree 2a. The “trunks” for tree 2a are not yet self-supporting. If tree 2 was removed, tree 2a would fail.**

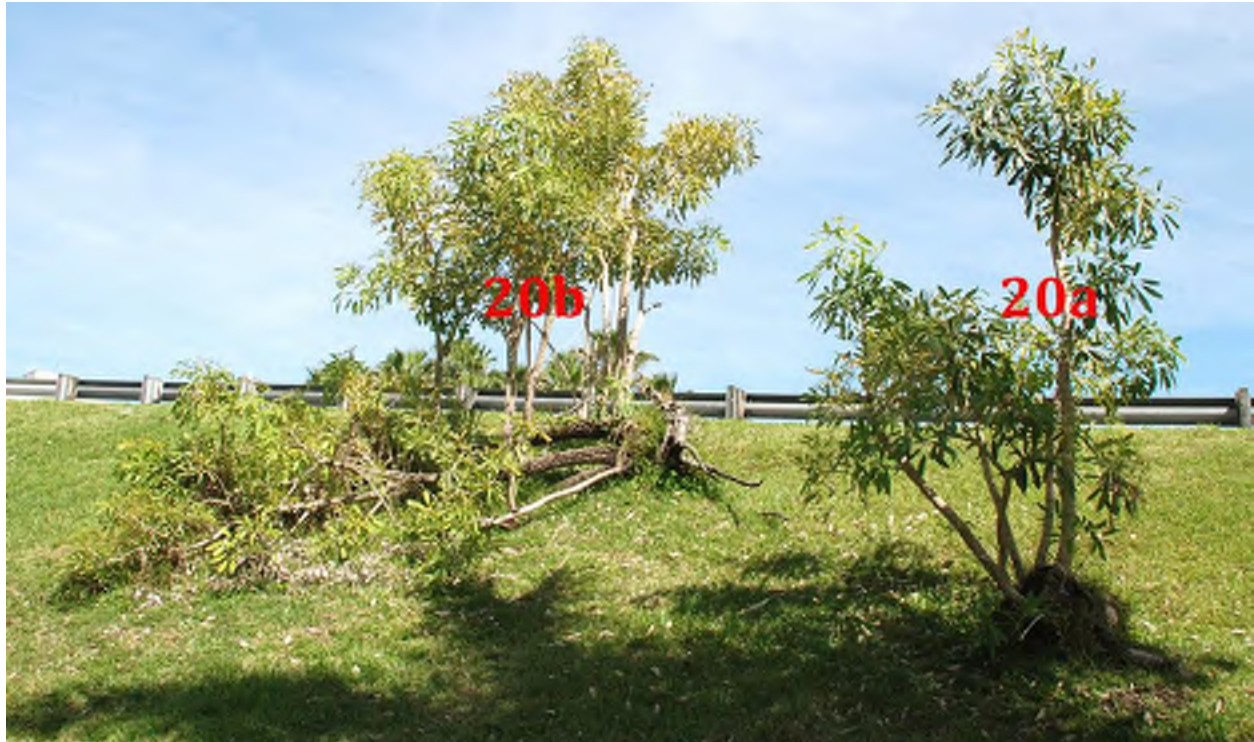
**Photo 9 above is trees 20a & 20b. Both had trunks that previously failed and are now coppicing (producing new trunks).**

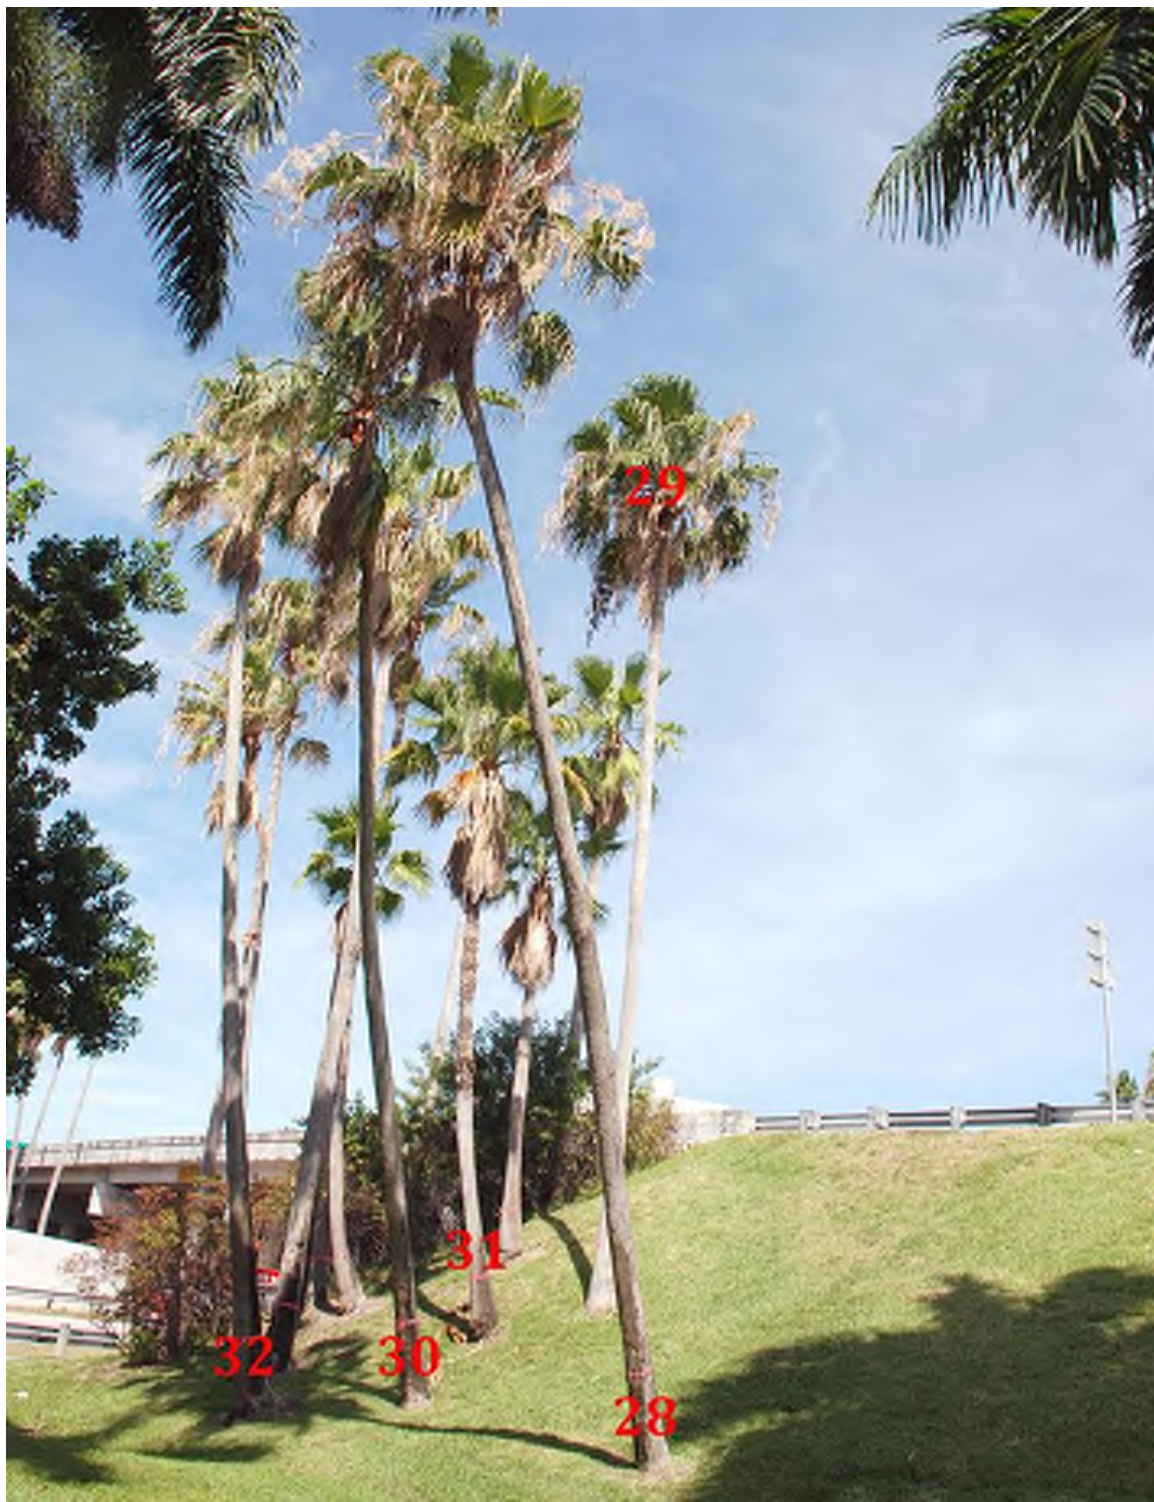
**Photo 16 above is palms 28, 30, 31 & 32. Palms 28 & 30 are rated as moderate due the lean of the trunk.**

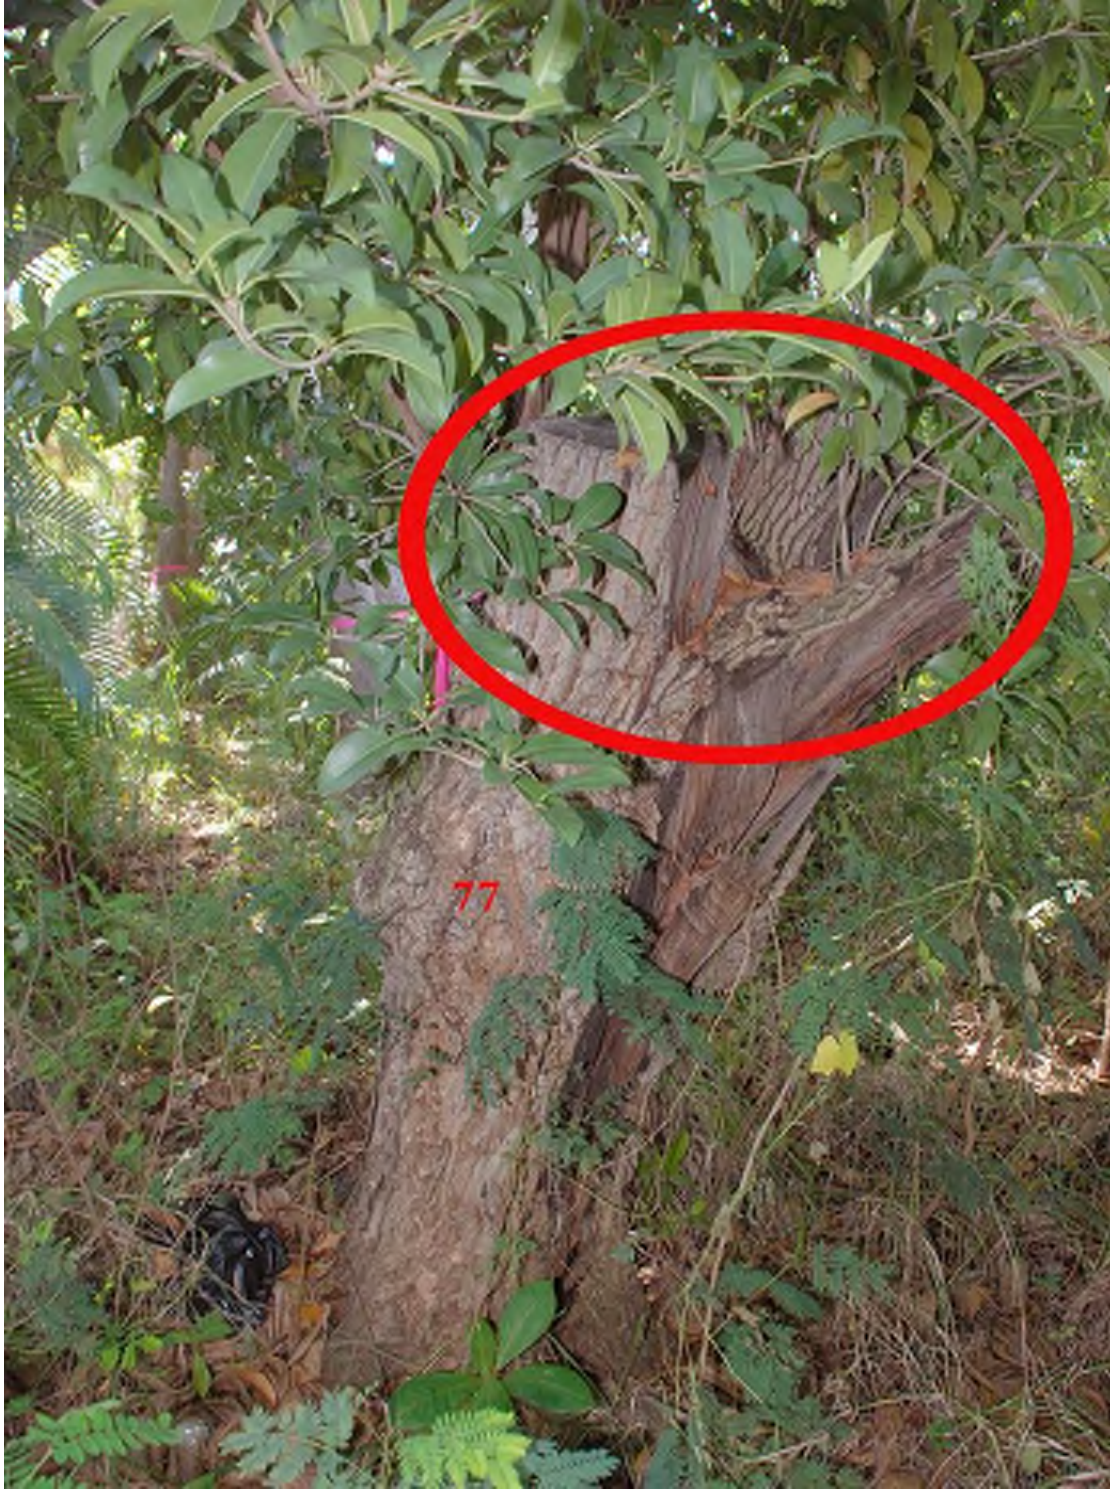
**Photo 46 above is the topped trunk of tree 77 with extensive decay indicated.**

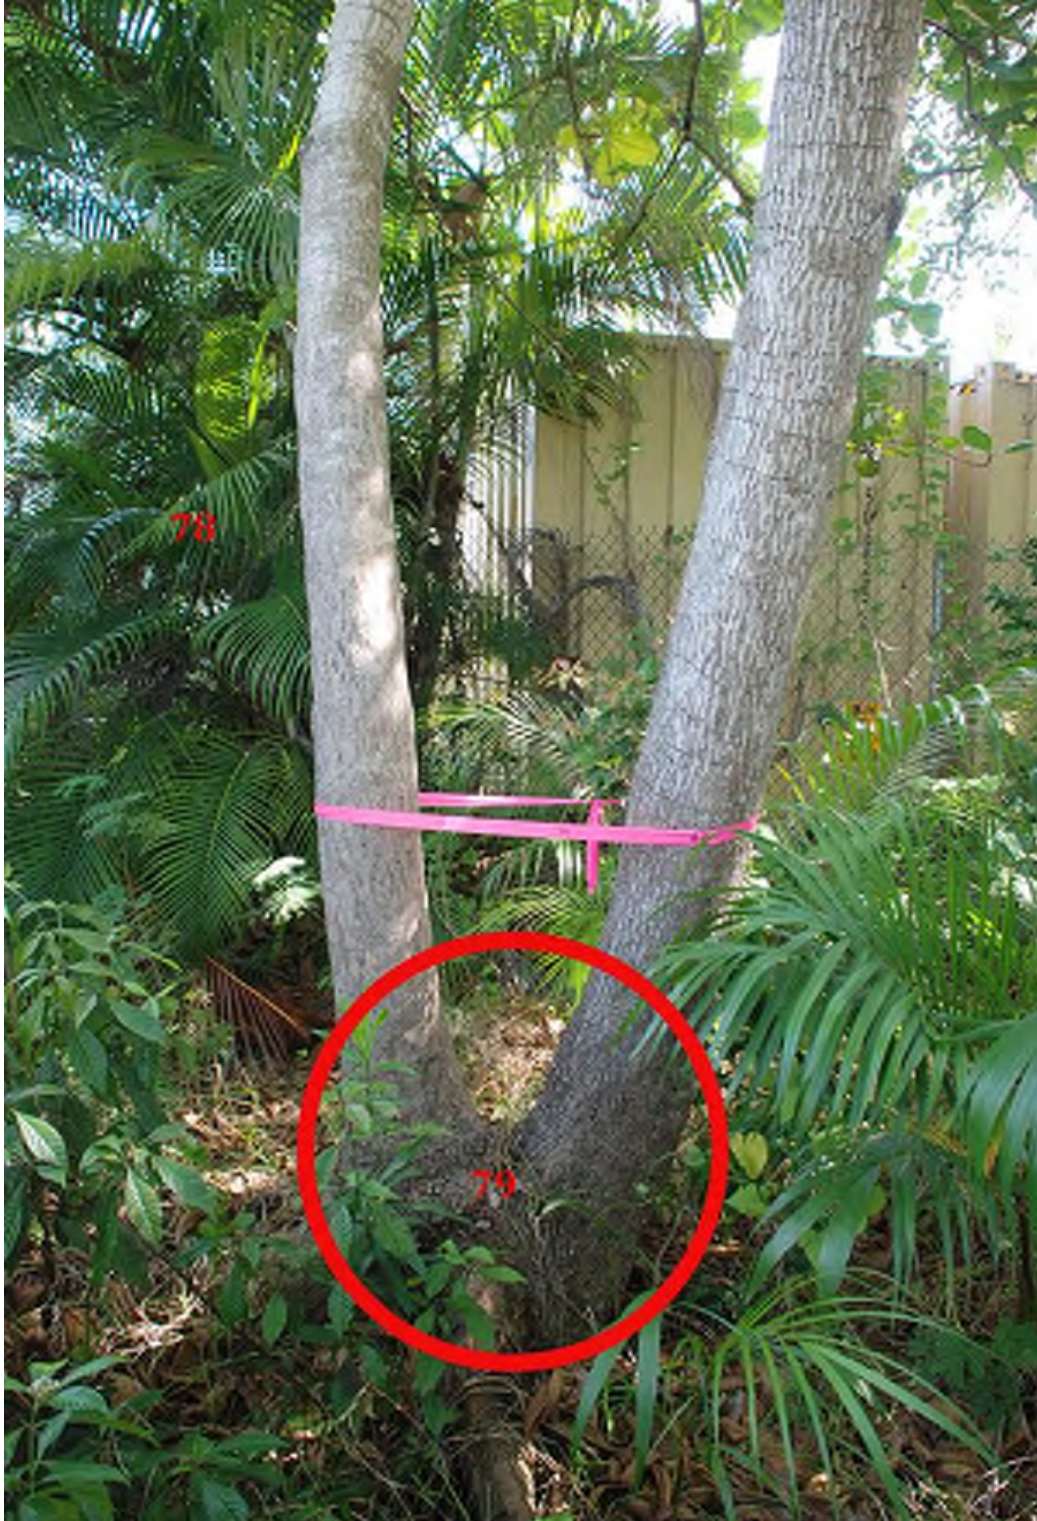
**Photo 47 above is tree 79 with a weak codominant branch/trunk connection.**

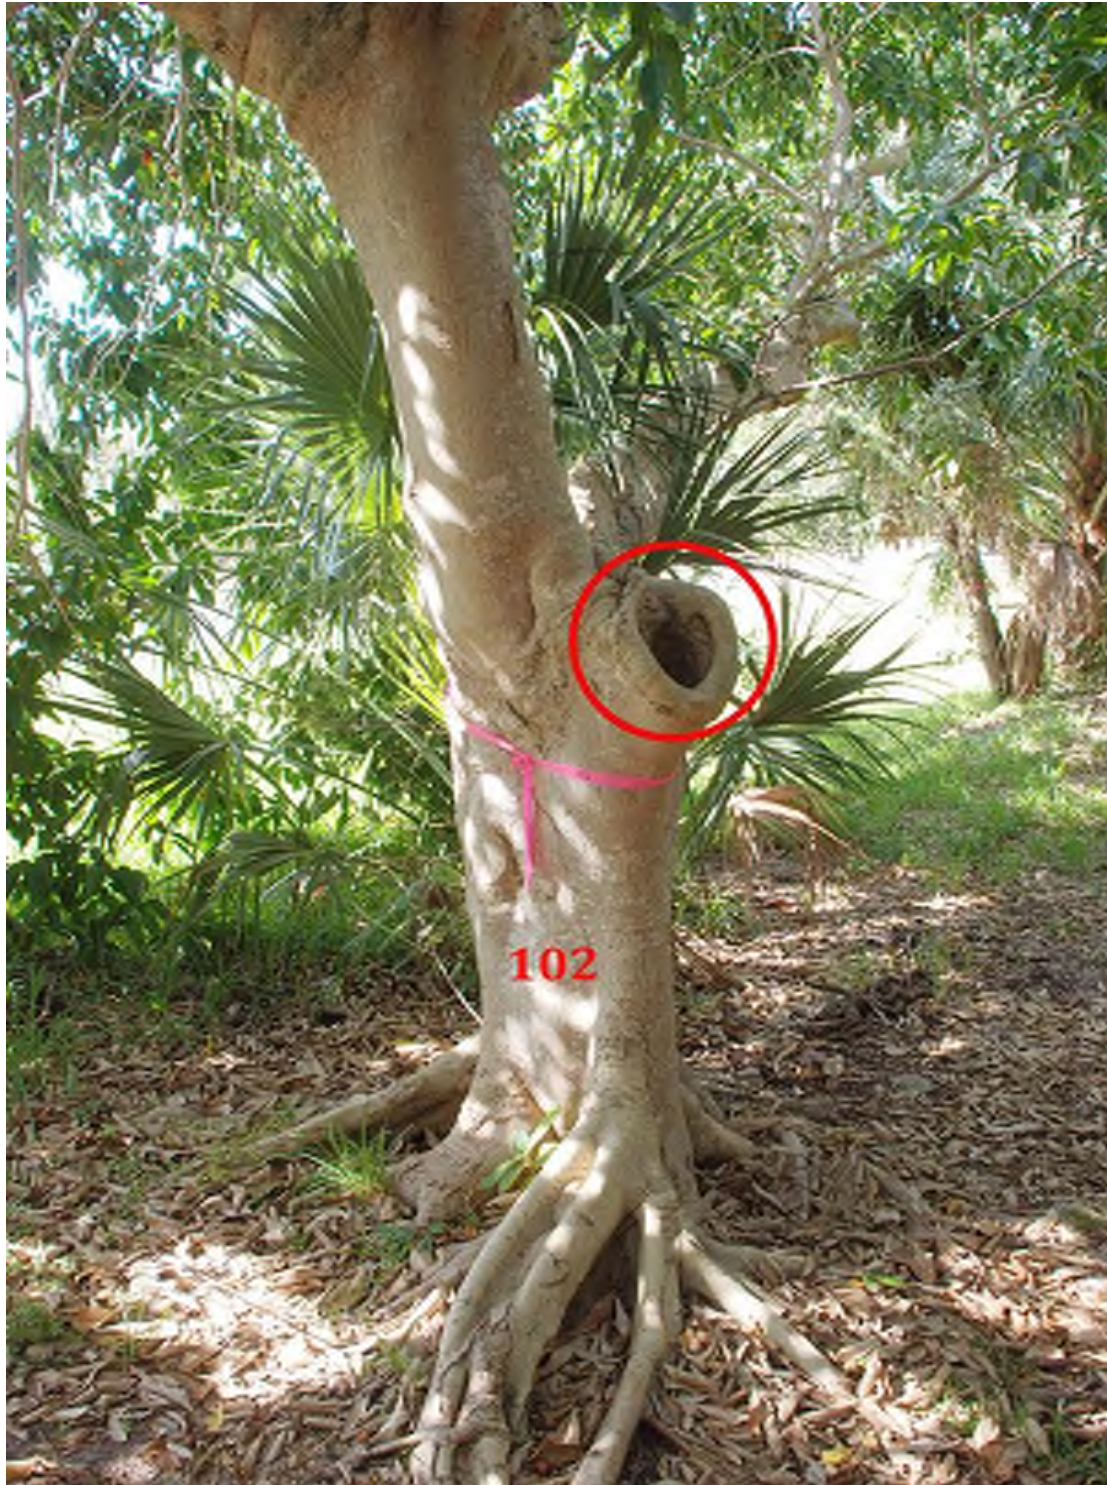
**Photo 62 above is the trunk of tree 102 viewed from the north. There is a cavity indicated however there appears to be no active decay.**

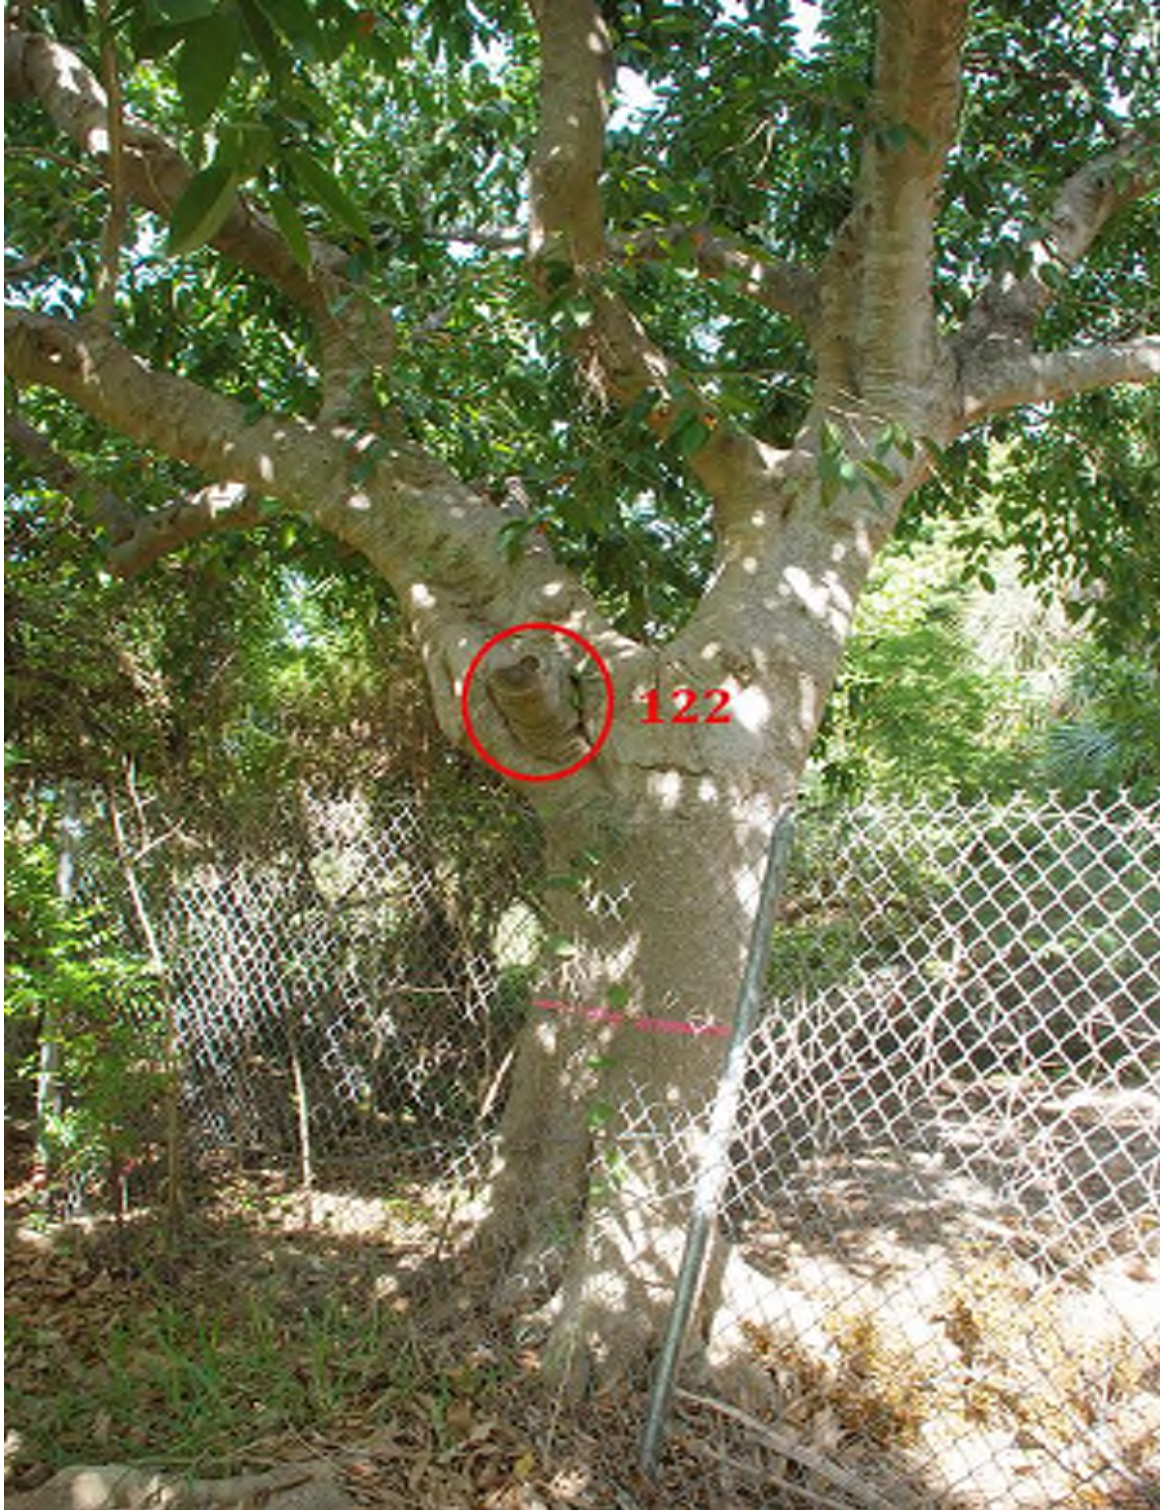
**Photo 73 above is the trunk of tree 122 with an old pruning cut indicated that does not appear to be actively decaying.**

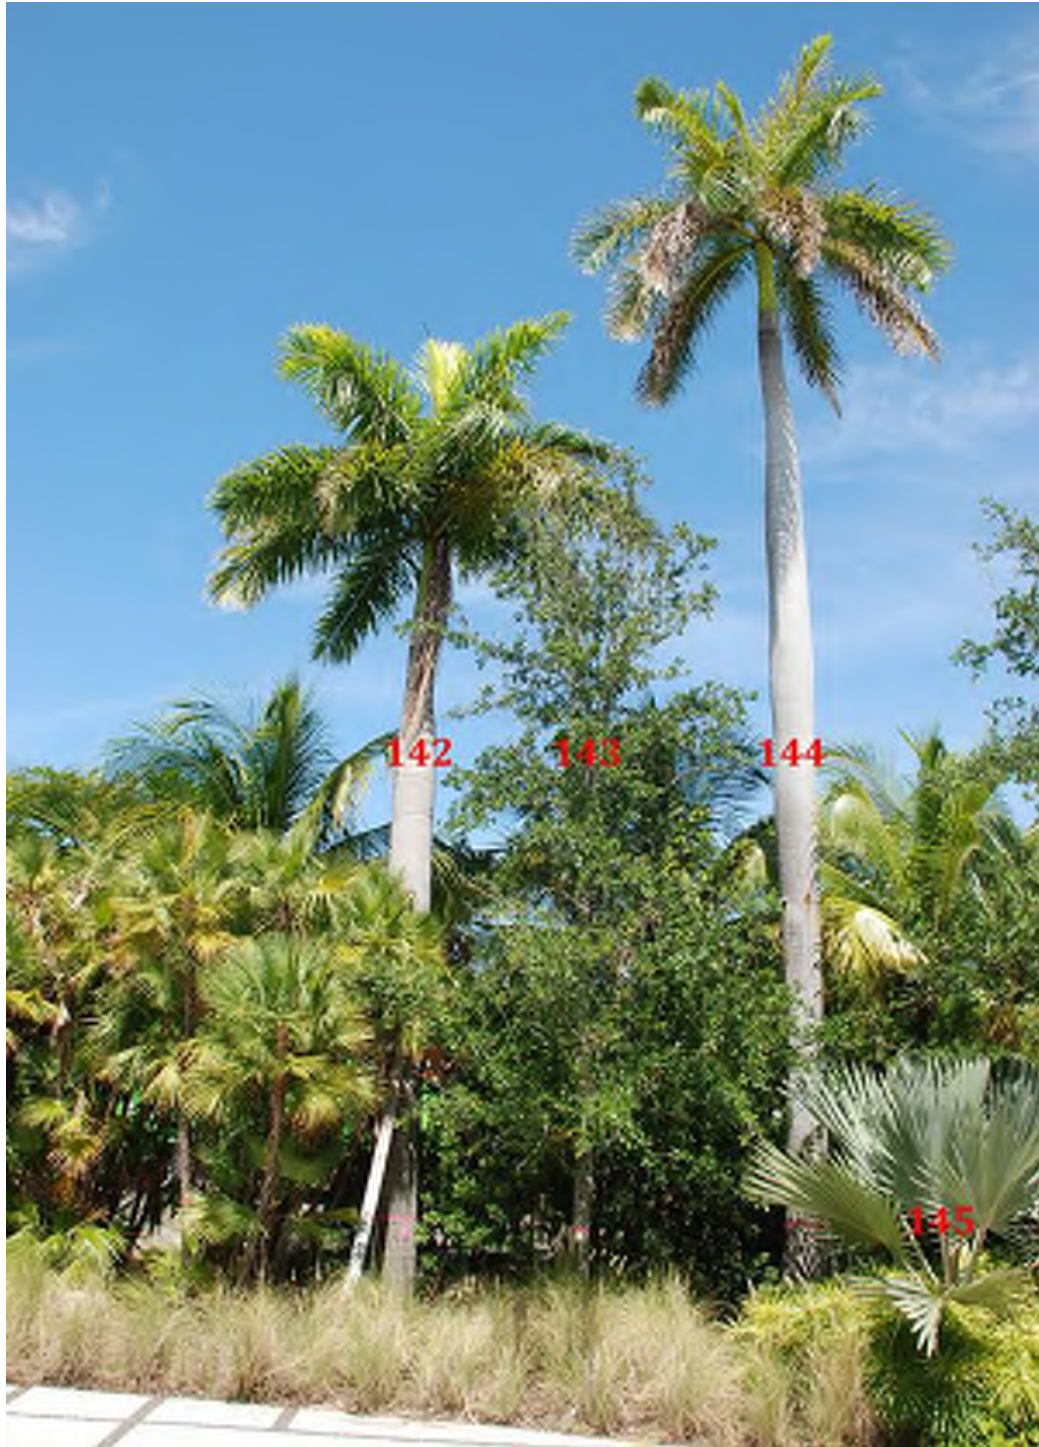
**Photo 78 above is palms 142, 144 & 145 and tree 143. Palm 144 is developing a severe nutrient deficiency.**

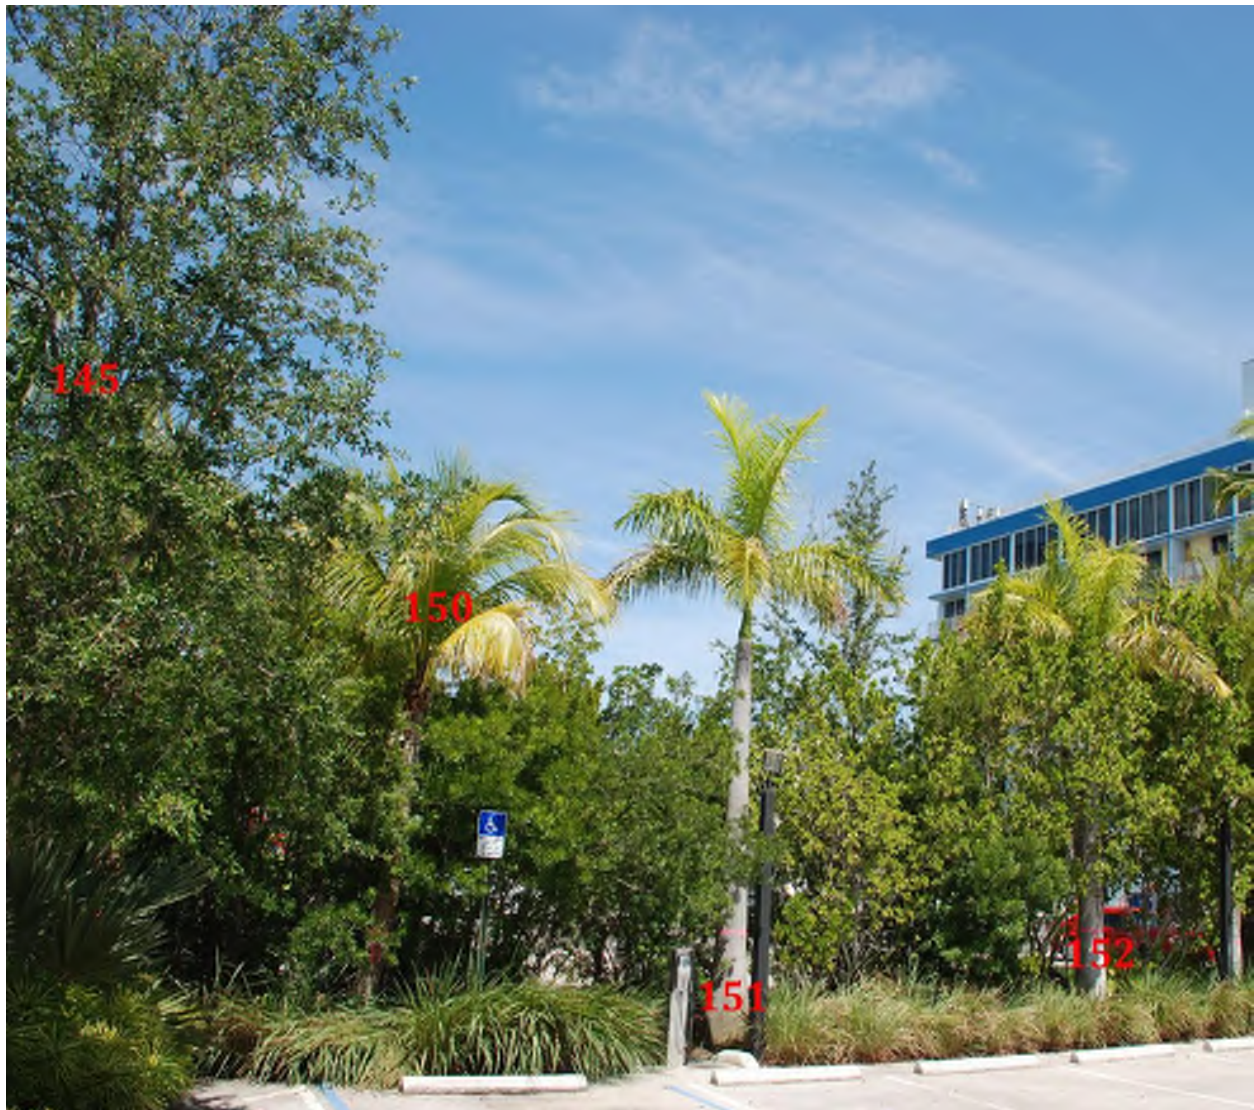
**Photo 80 above is palms 150, 151 & 152 with signs of nutrient deficiencies.**

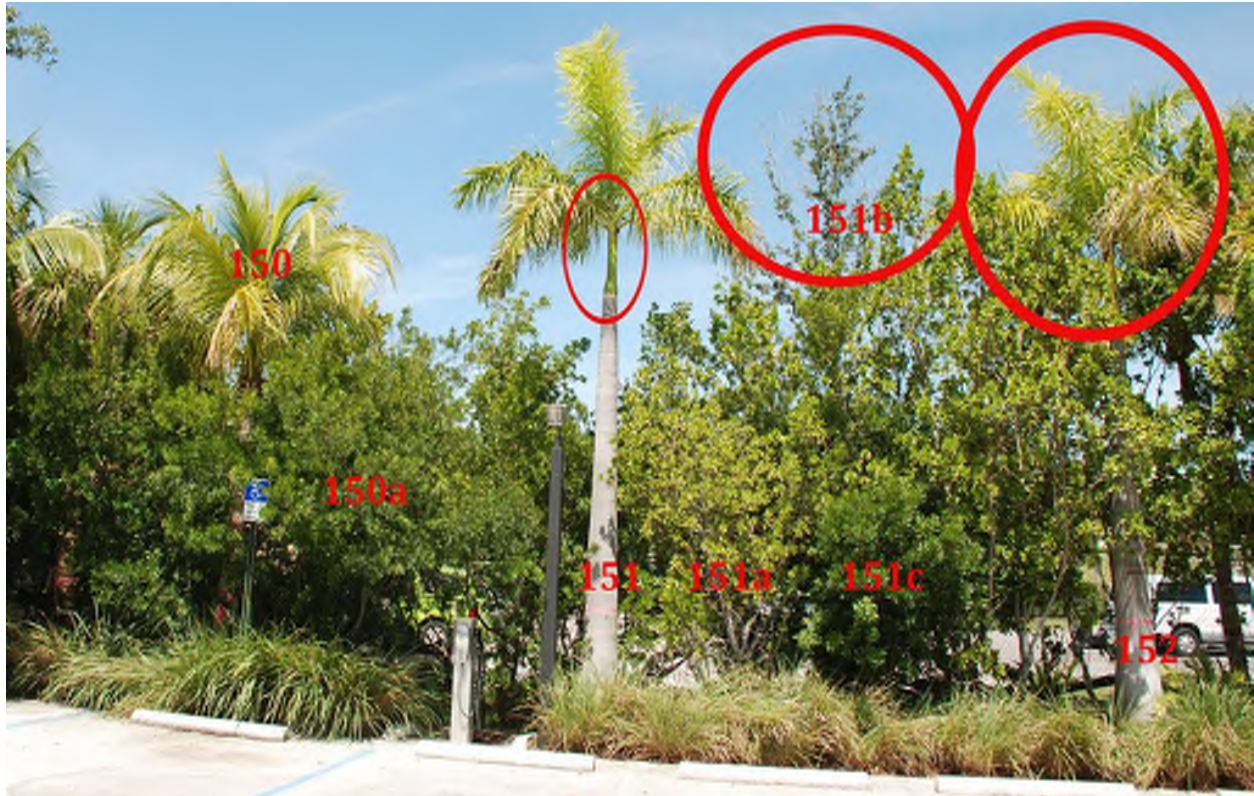
**Photo 81 above is palms 151 & 152 with severe nutrient deficiencies and tree 151b with significant small branch die-back.**

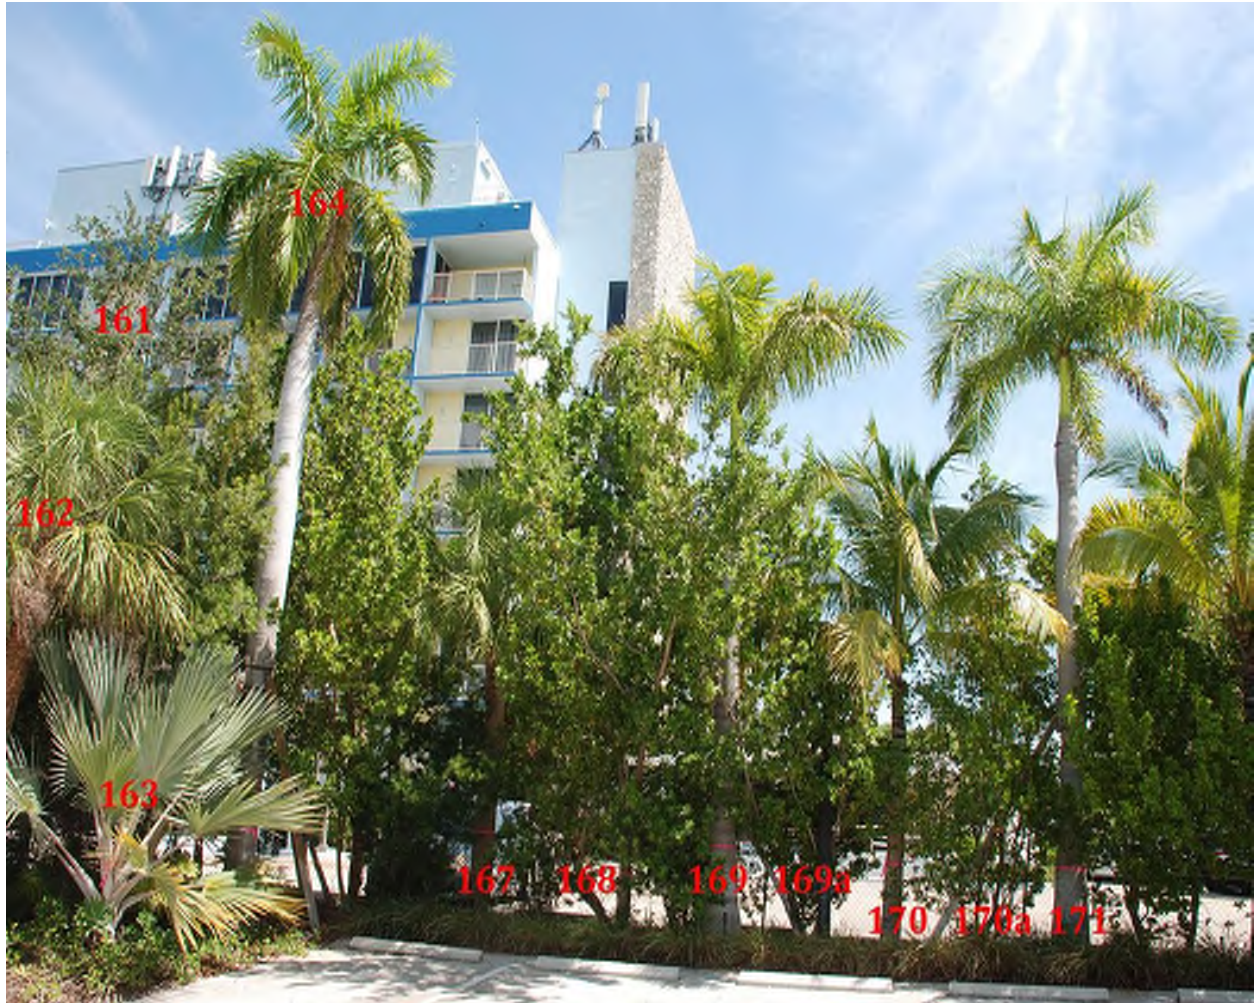
**Photo 84 above is palms 164, 167, 169, 170 & 170 showing signs of nutrient deficiencies.**

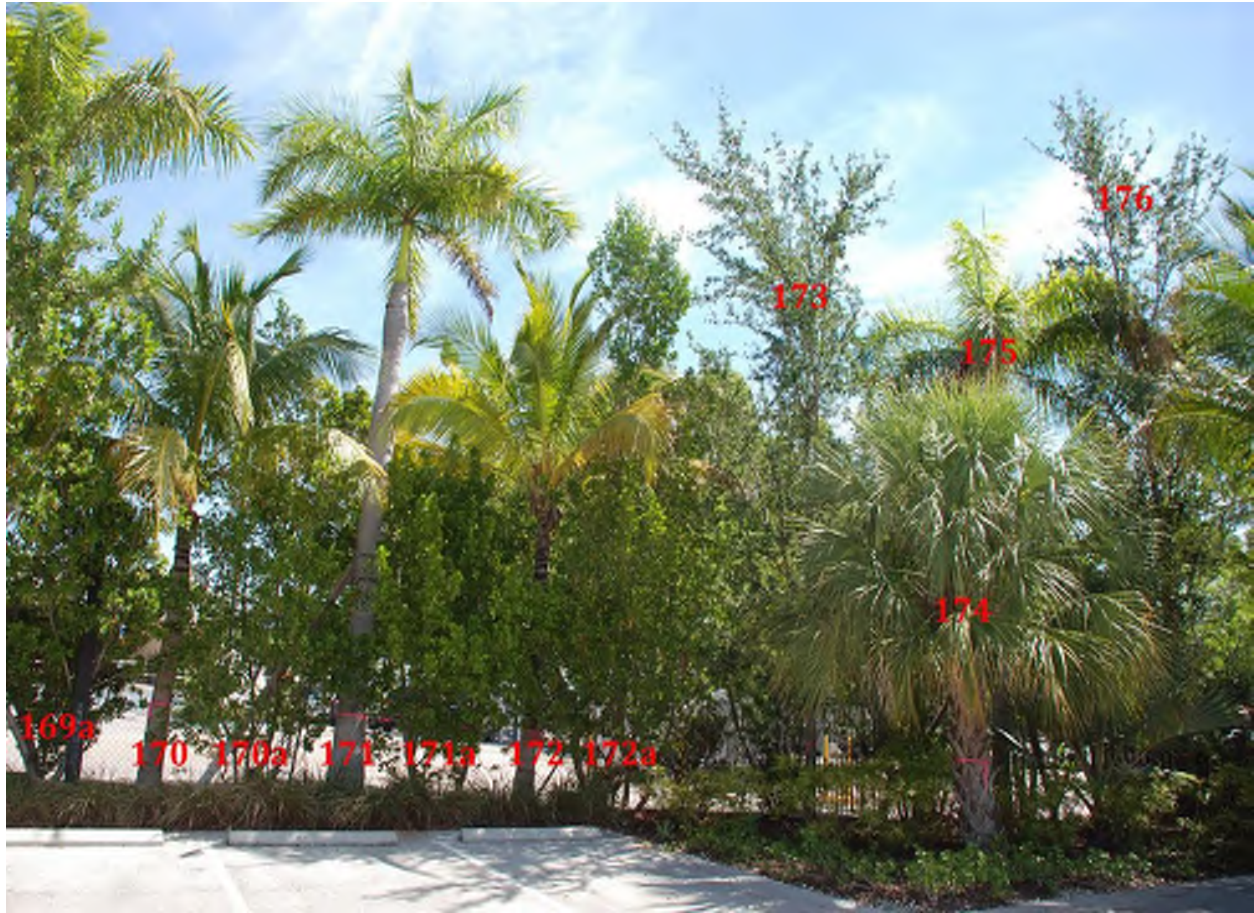
**Photo 85 above is palms 171, 172 & 175 showing signs of severe nutrient deficiencies.**

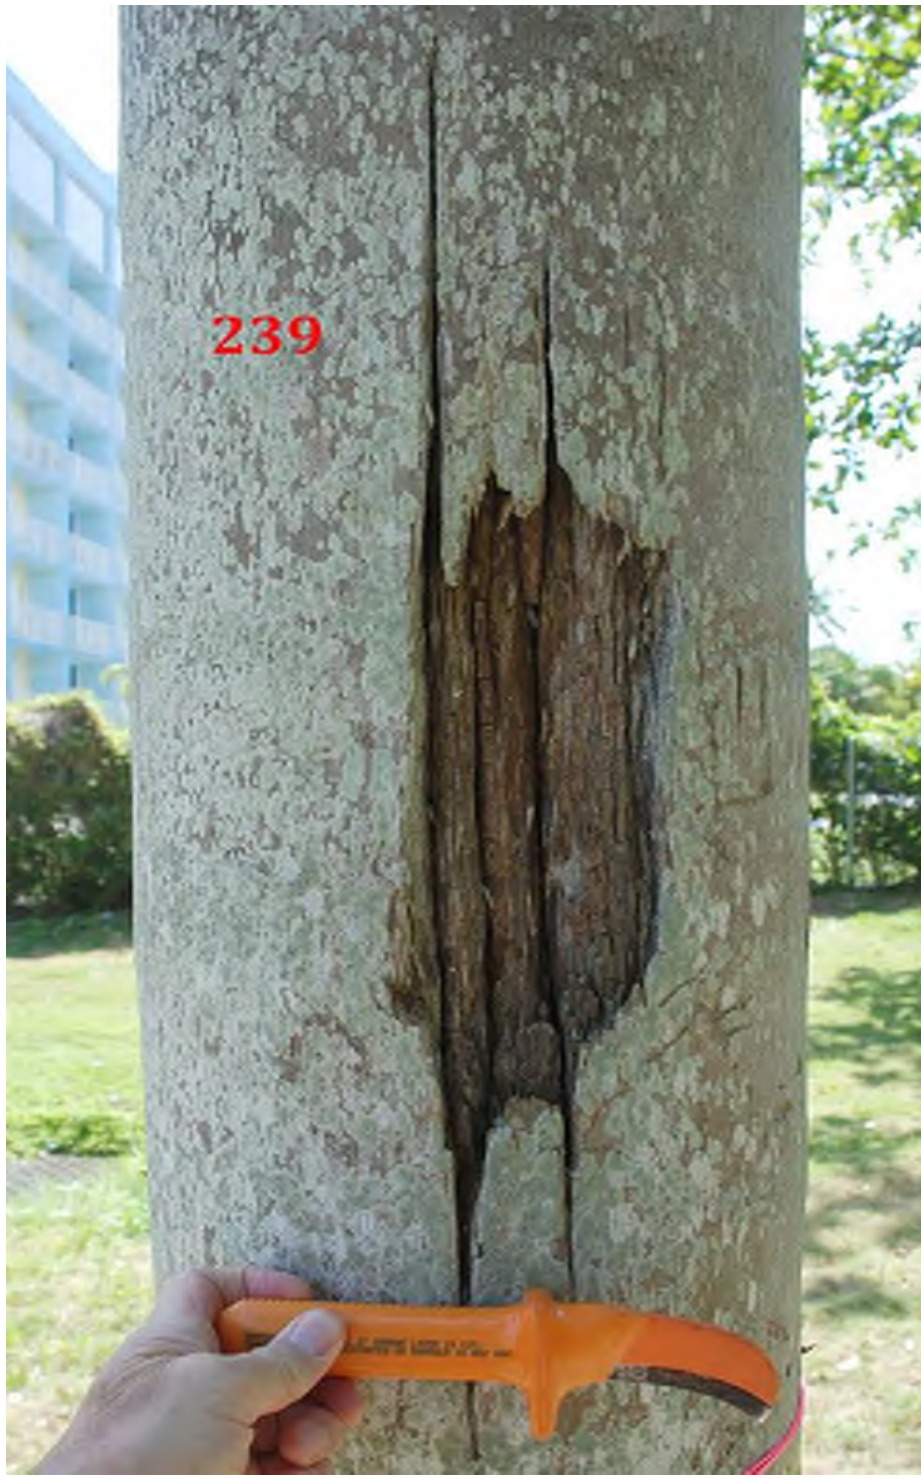
**Photo 134 above is the cracked and damaged trunk of palm 239. This palm should be removed. The orange knife is 7 inches in length.**

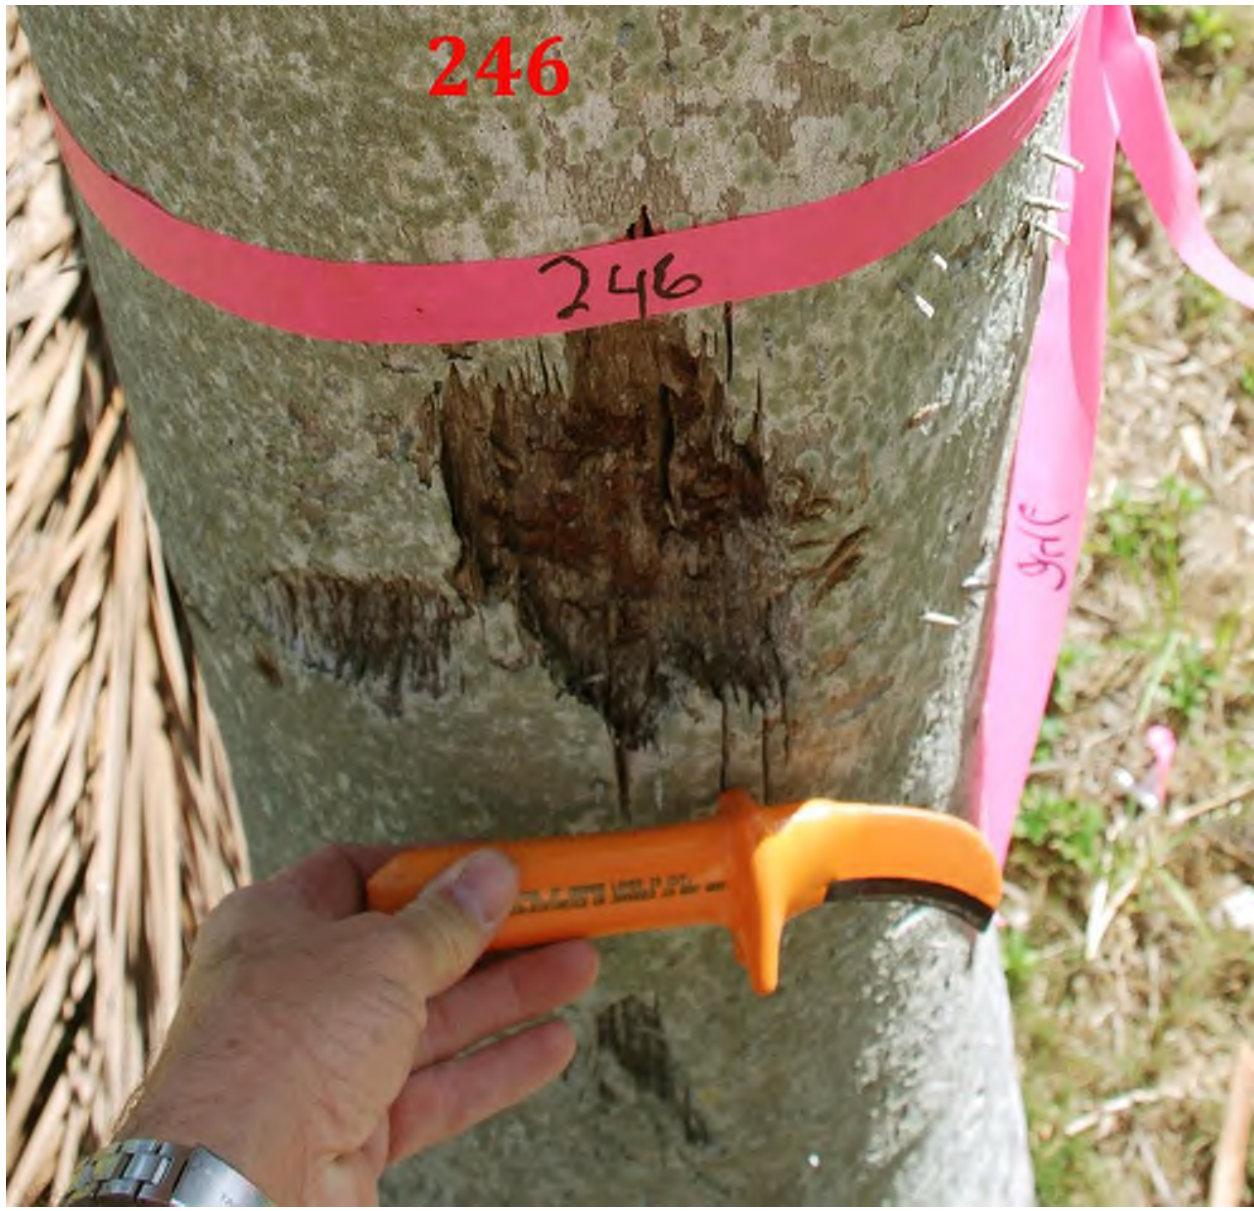
**Photo 137 above is tree 246 with some superficial damage to the pseudobark of the trunks.**
