Arborist report / Tree assessment:

Sept. 2, 2021

7300 Trouville Esplanade. Miami Beach. Fl. 33141

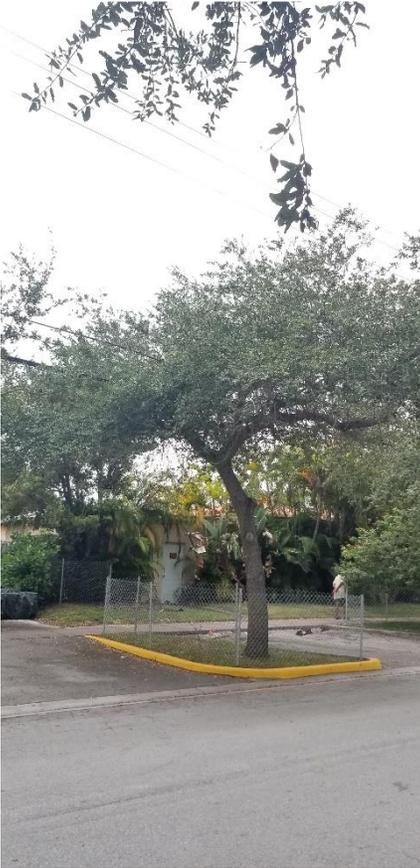
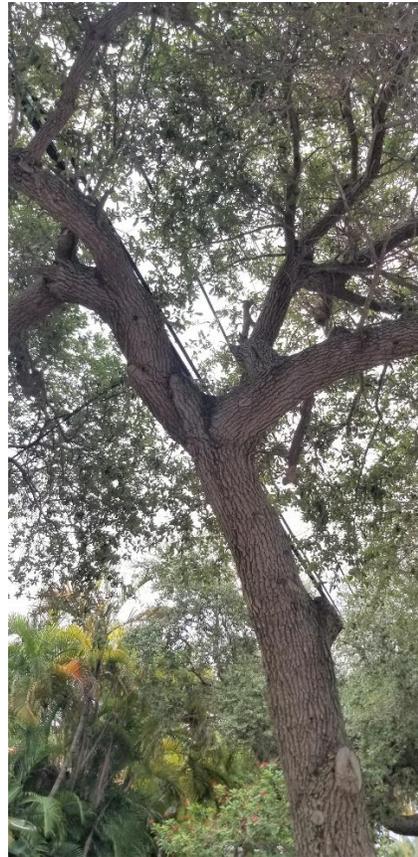
#1- *Quercus virginiana*

Tree #1- Quercus virginiana, pictured in #1, codominant leader, encroaching into power lines, the tree is in fair condition.

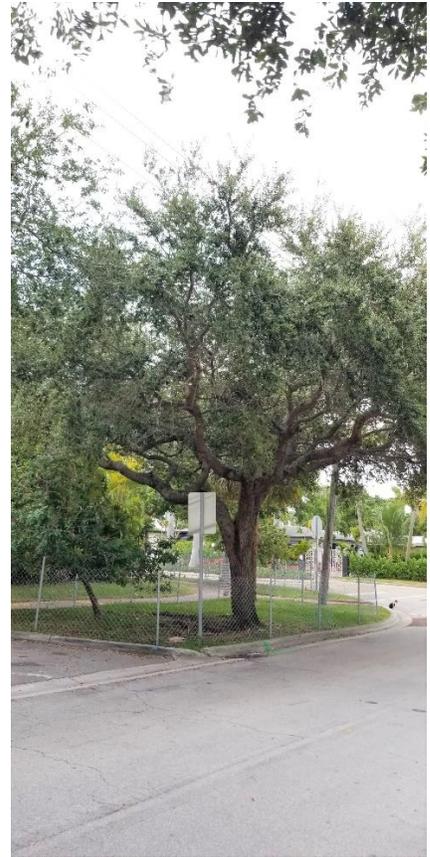
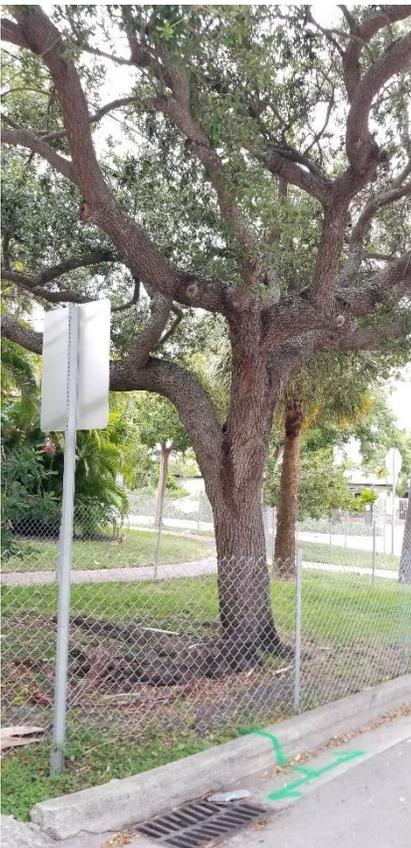
#2- *Quercus virginiana*

Tree #2- Quercus virginiana, pictured in #2, codominant leader, encroaching into power lines, the tree is in fair condition.

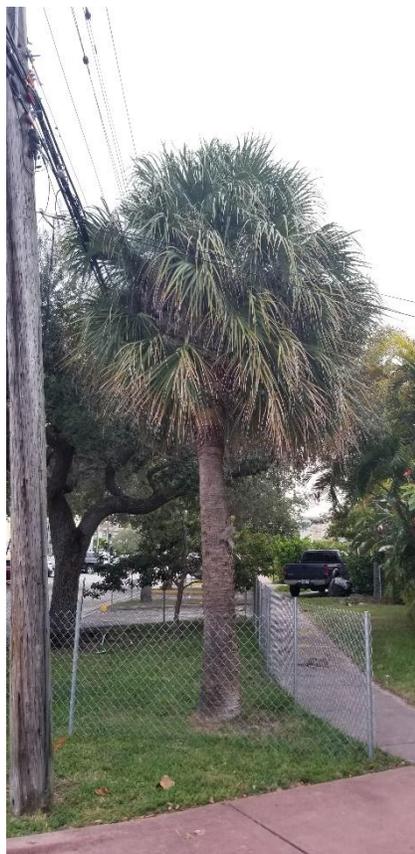
#3- Sable palmetto

Tree #3- Sable palmetto, pictured in #3, encroaching into power lines, the palm is in good condition.

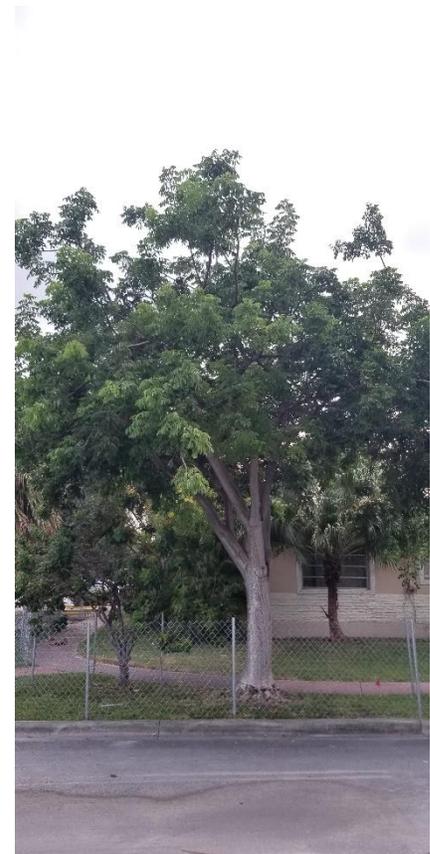
#4- *Bursera simaruba*

Tree #4- Bursera simaruba, pictured in #4, codominant leader, the tree is in good condition.

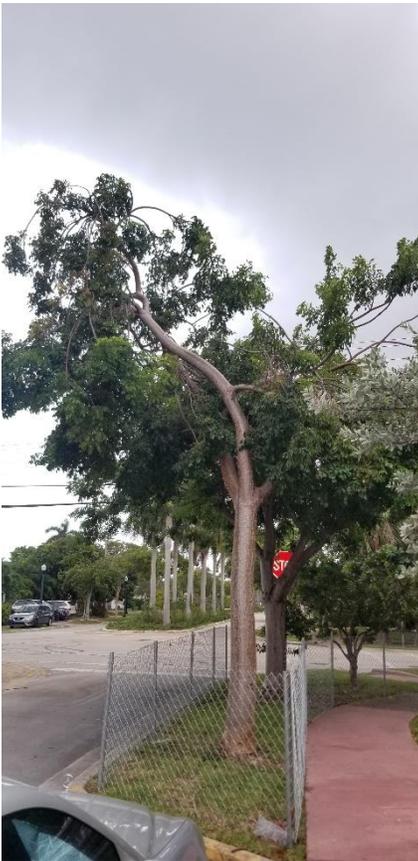
#5- *Bursera simaruba*

Tree #5- Bursera simaruba, pictured in #5, codominant leader, the tree is in good condition.

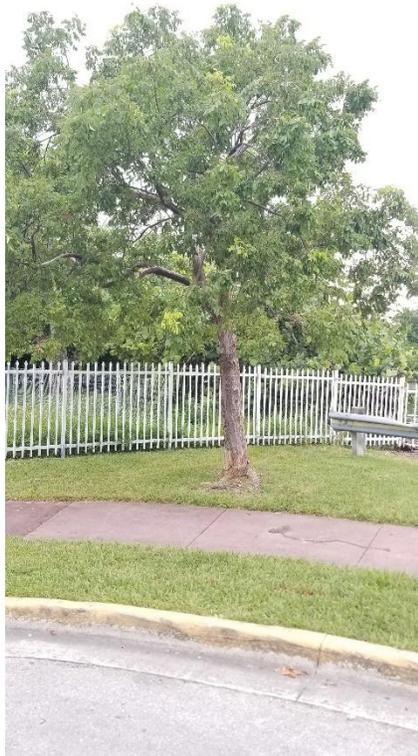
#6- *Bursera simaruba*

Tree #6- Bursera simaruba, pictured in #6, codominant leader, the tree is in good condition.

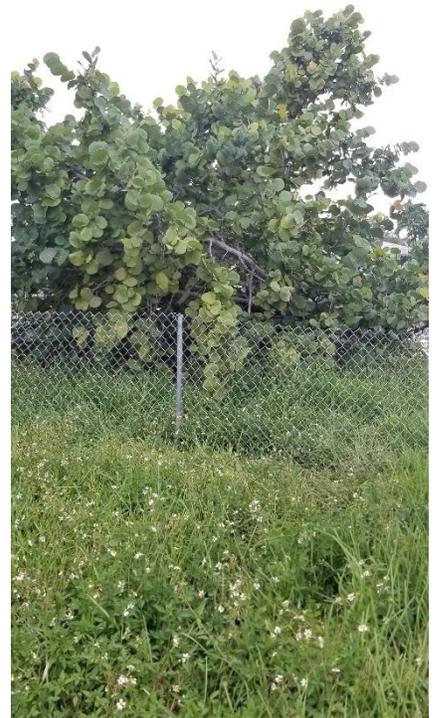
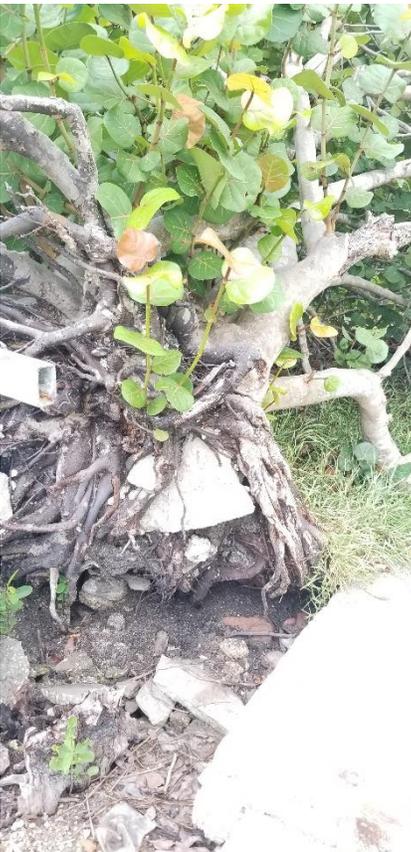
#7- *Coccoloba uvifera*

Tree #7- Coccoloba uvifera, pictured in #7, fallen over, the tree is in poor condition.

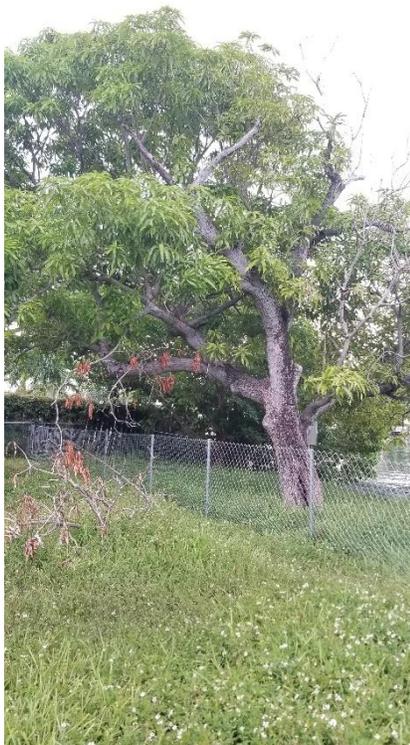
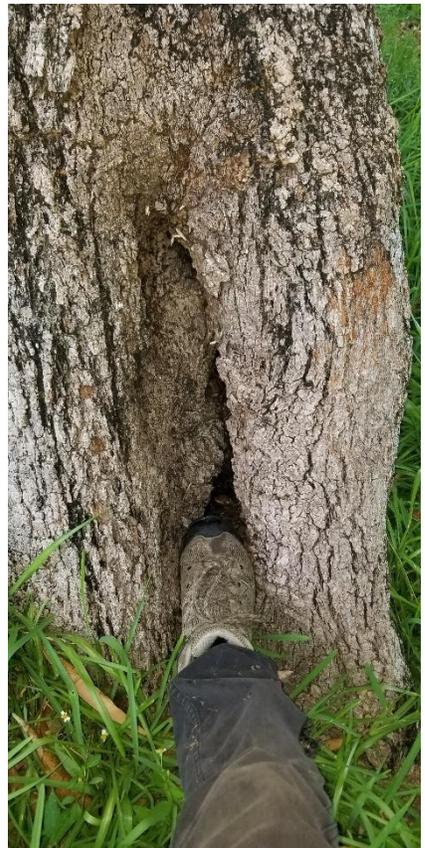
#8- *Mangifera indica*

Tree #8- Mangifera indica, pictured in #8, large cavity at the base, the tree is in fair condition.

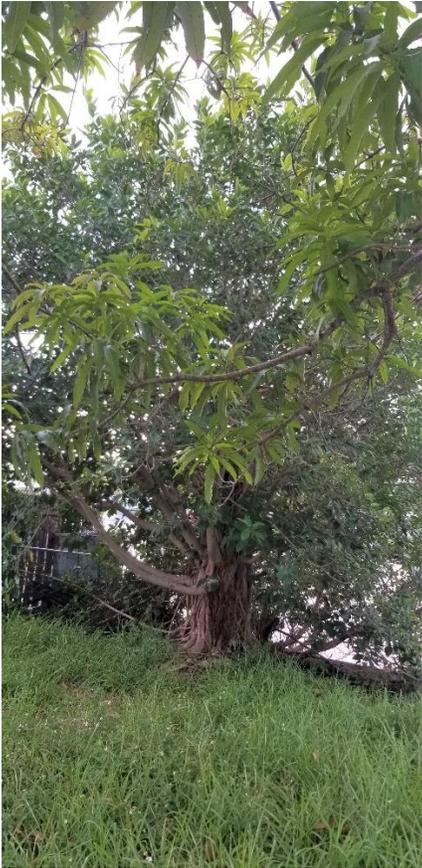
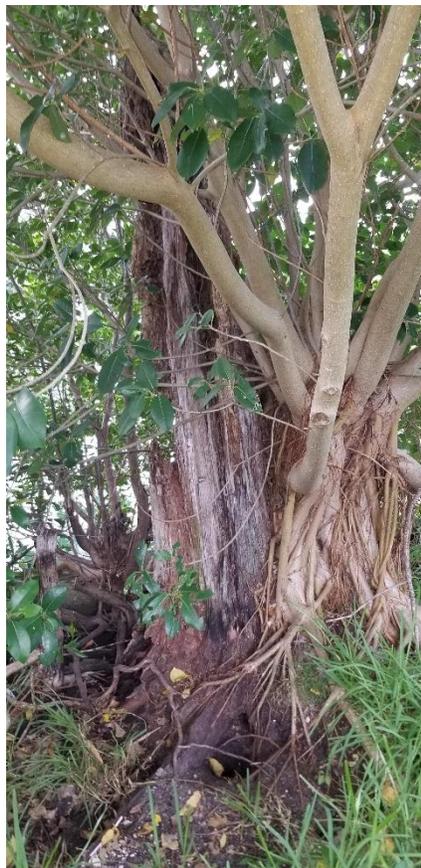
#9- *Ficus aurea*

Tree #9- Ficus aurea, pictured in #9, volunteer growing on and around an old stump, the tree is in good condition.

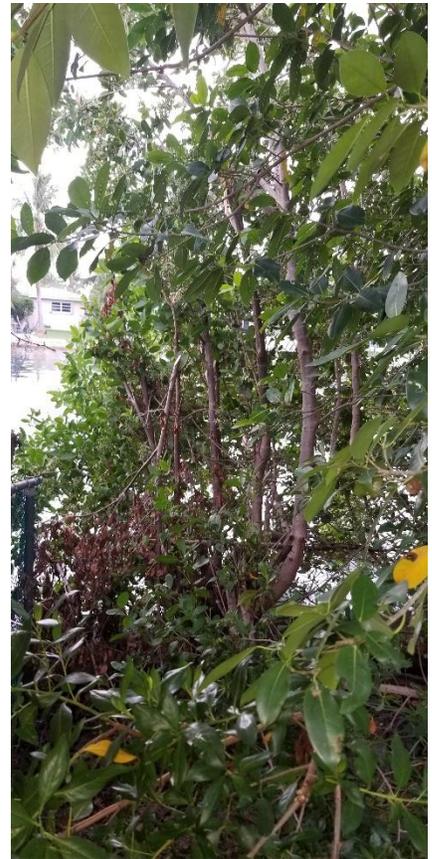
#10- *Laguncularia racemosa*

Tree #10- Laguncularia racemosa, pictured in #10, volunteer, encroached against the sea wall, the tree is in good condition.

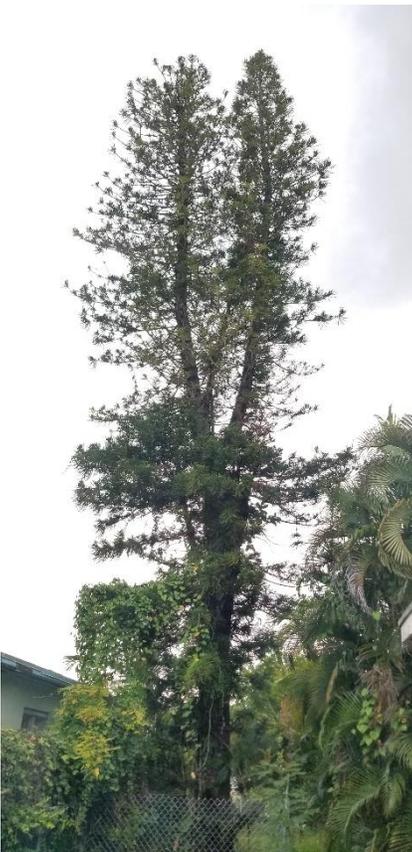
#11- *Araucaria heterophyllus*

Tree #11- Araucaria heterophylla, pictured in #11, (INVASIVE).

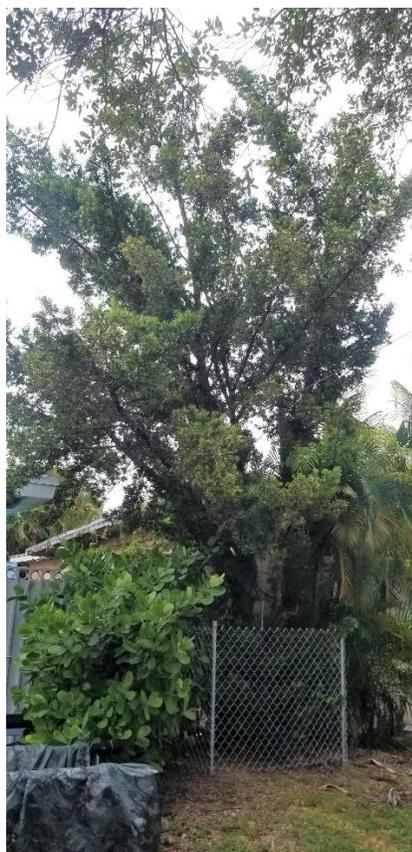
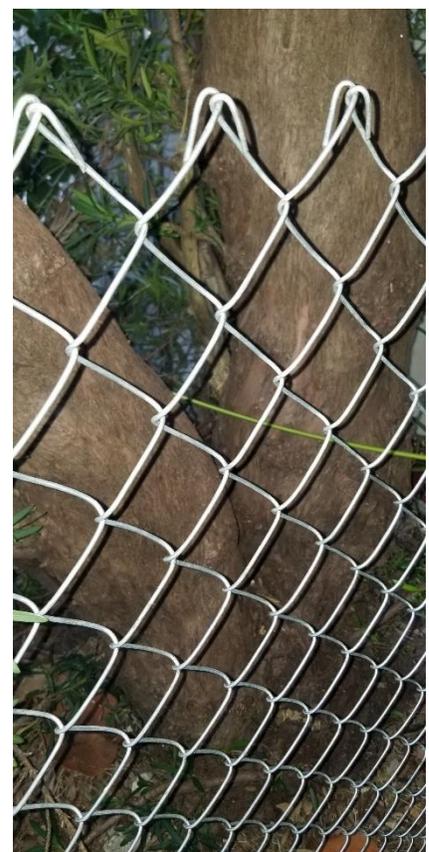
#12- *Podocarpus macrophyllus*

Tree #12- Podocarpus macrophyllus, pictured in #12, codominant leader, the tree is in fair condition.

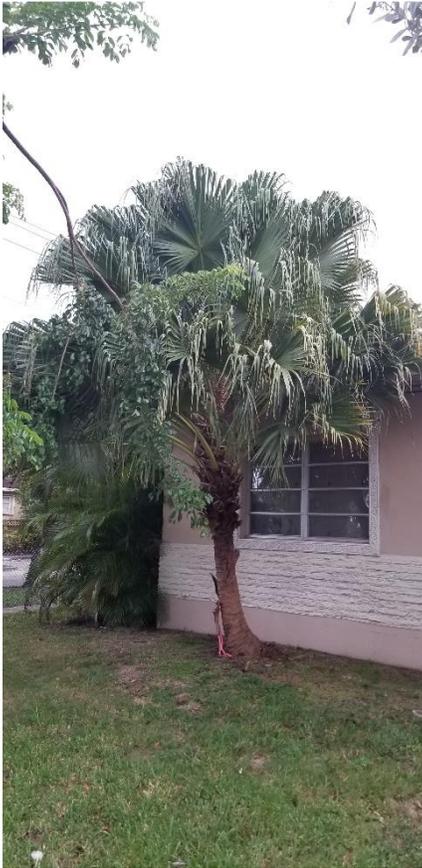
#13- *Livistonia chinensis*

Tree #13- *Livistonia chinensis*, pictured in #13, the palm is in good condition.

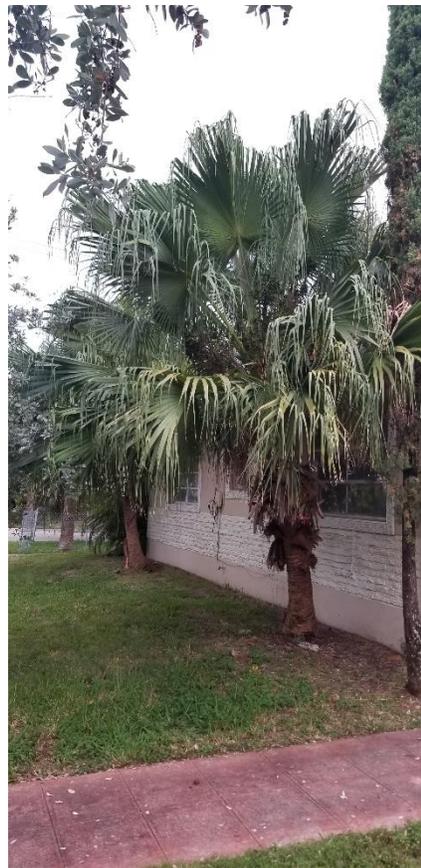
#14- *Livistonia chinensis*

Tree #14- *Livistonia chinensis*, pictured in #14, the palm is in good condition.

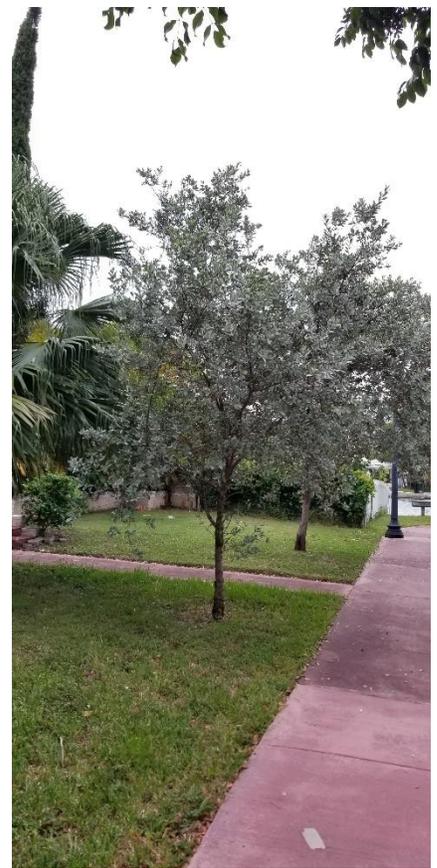
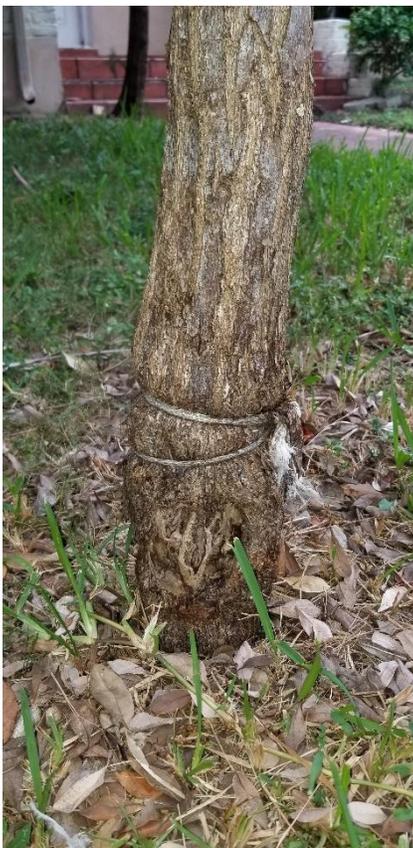
#15- *Conocarpus erectus*

Tree #15- *Conocarpus erectus-sericeus*, pictured in #15, codominant leader, wire embedded at the base, the tree is in good condition.

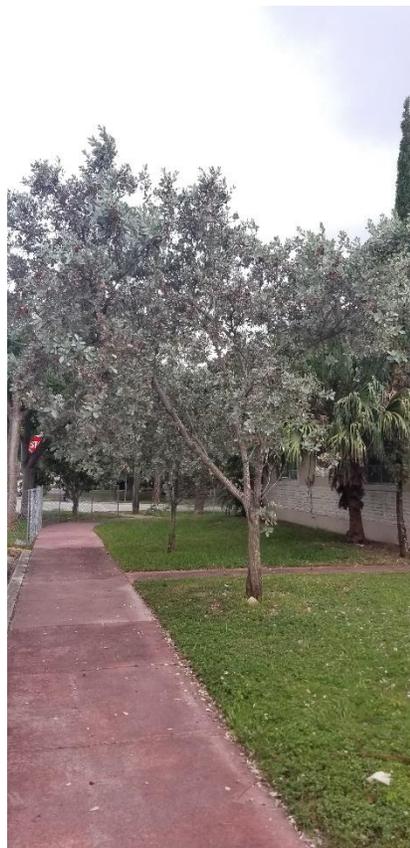
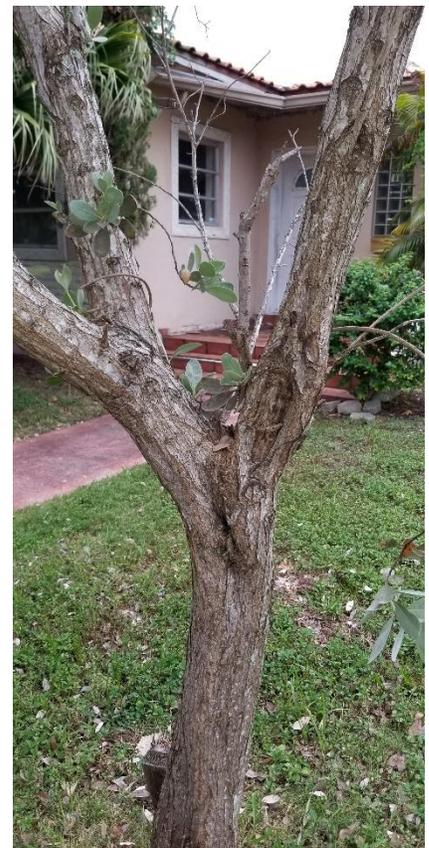
#16- *Conocarpus erectus*

Tree #16- *Conocarpus erectus-sericeus*, pictured in #16, codominant leader, the tree is in good condition.
