Deauville Beach Resort - Structural Condition Assessment
Anesta Consulting File Number: 21-04005
Report Issued December 15, 2021

Structural Condition Assessment

Building: Deauville Beach Resort

Location: 6701 Collins Avenue, Miami Beach, Florida 33141

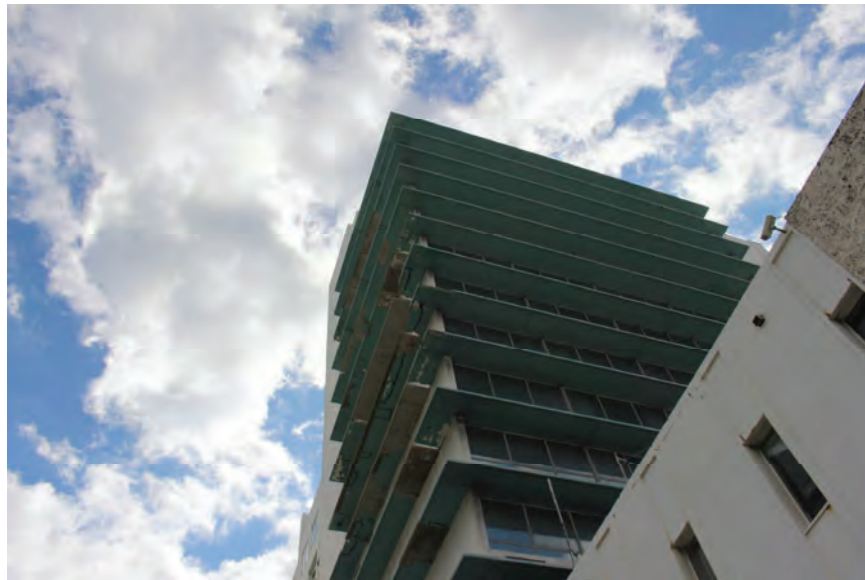
Image 19: View of the exterior condition of the northwest corner of the hotel. Note the unfinished corrosion repairs to the north eyebrows.

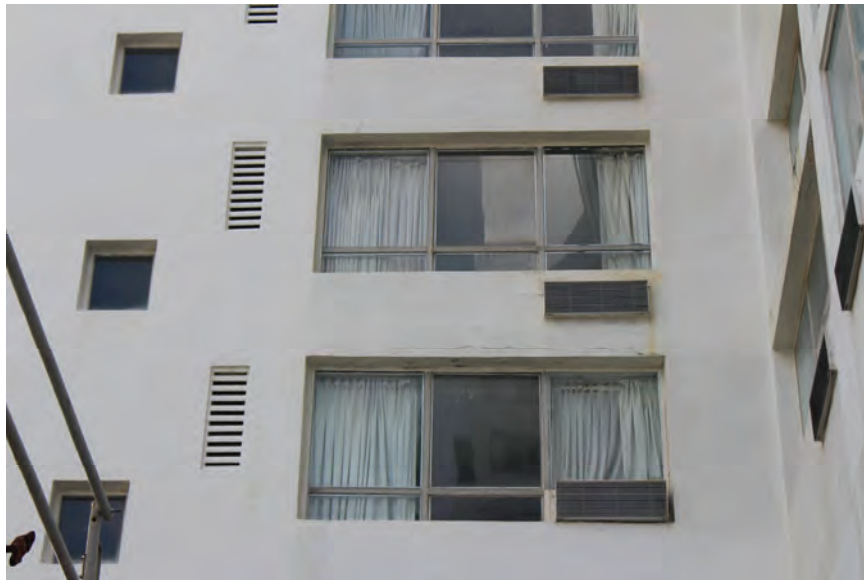
Image 21: View of the apparent beam corrosion along the Hotel windows on the north end of the building.

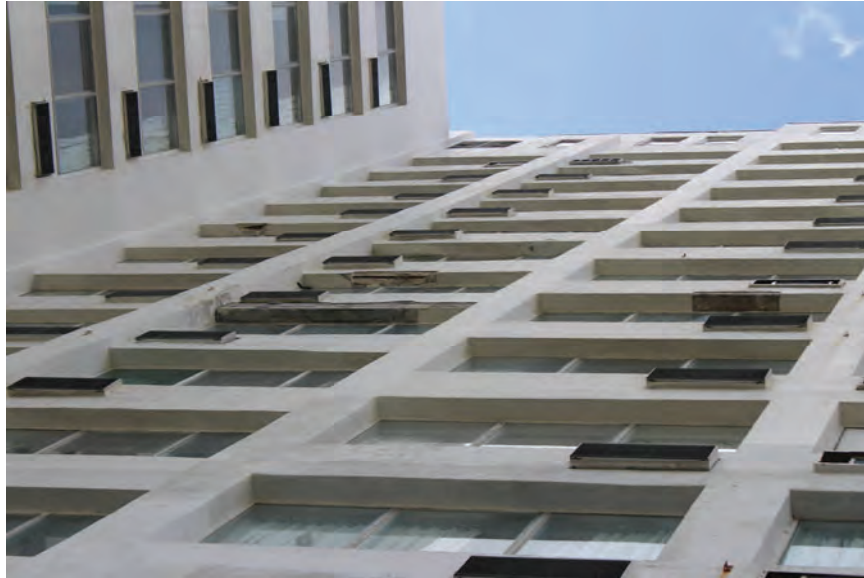
Image 22: View of the apparent beam corrosion and prior repairs along the Hotel windows on the north end of the building.

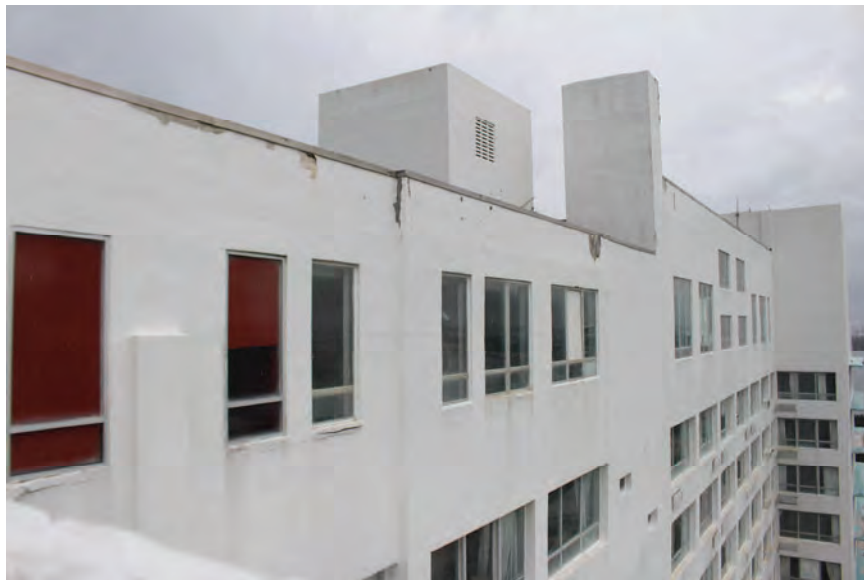
Image 23: View of the apparent beam corrosion and prior repairs on north face of hotel.

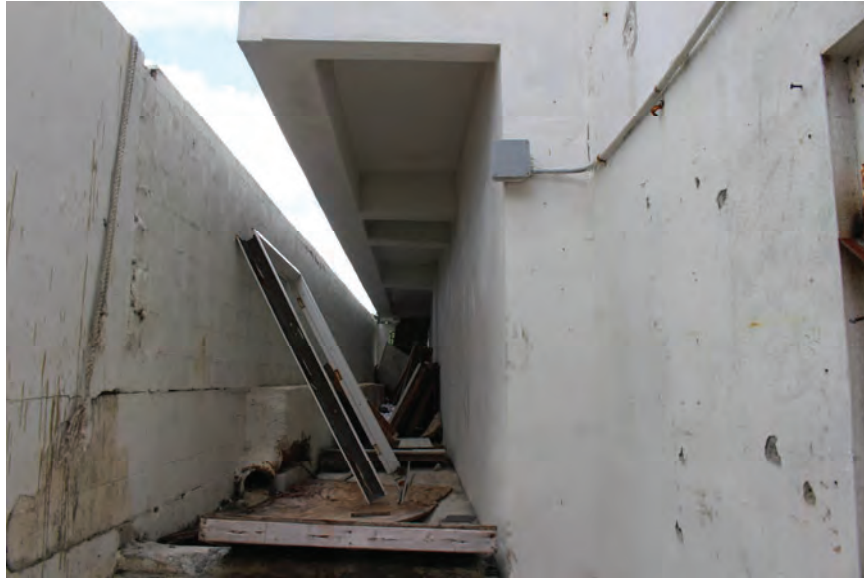
Image 24: Condition of the north end of the east wing of the Hotel. Note that the north wall of the Hotel's east wing was cantilevered off of the main structural frame at the Lobby Level.

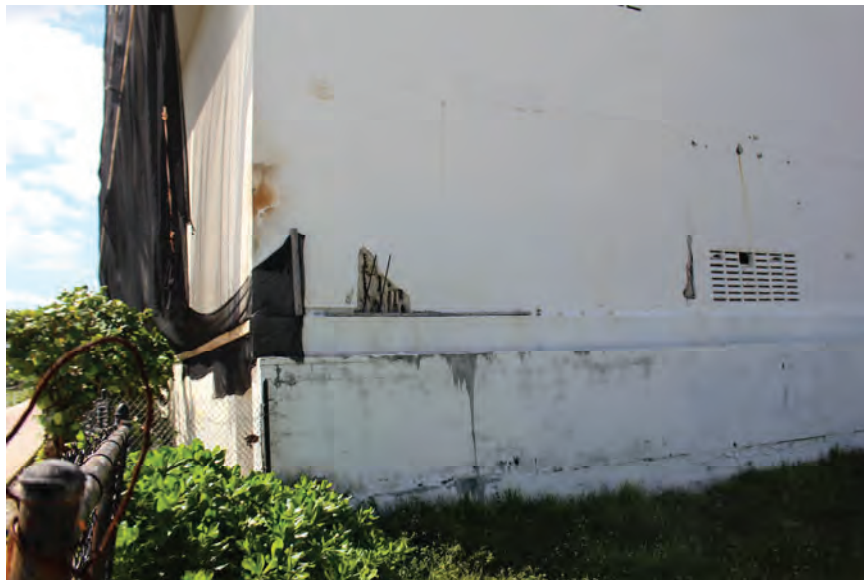
Image 25: Unfinished and open repair areas of structural columns along the Hotel's north face.

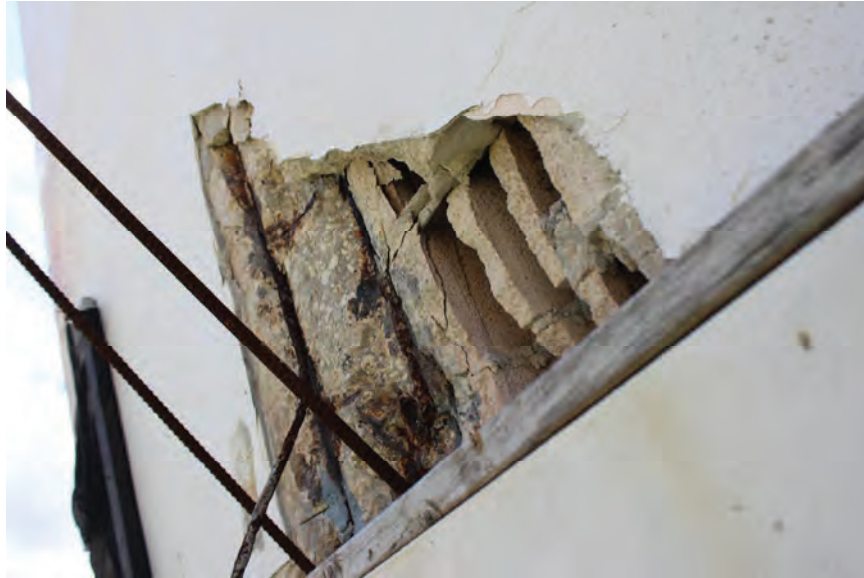
Image 26: Unfinished and open repair area for structural column at east end of the Hotel's north face.

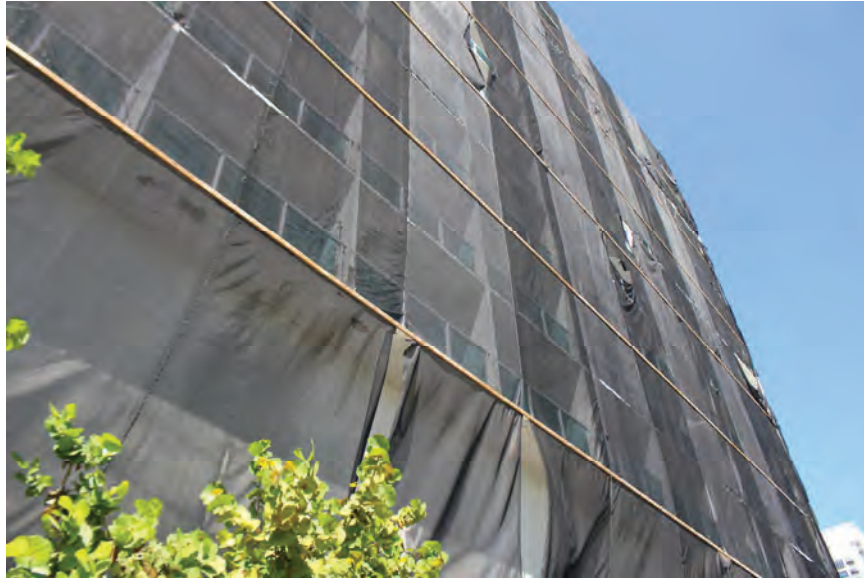
Image 28: Typical Hotel east face balcony and column corrosion.

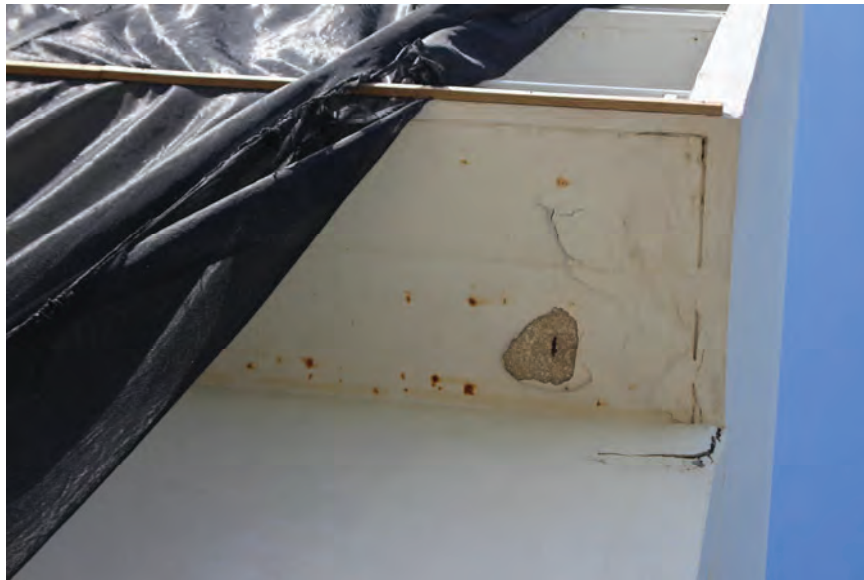
Image 29: Typical Hotel east face balcony and column corrosion.

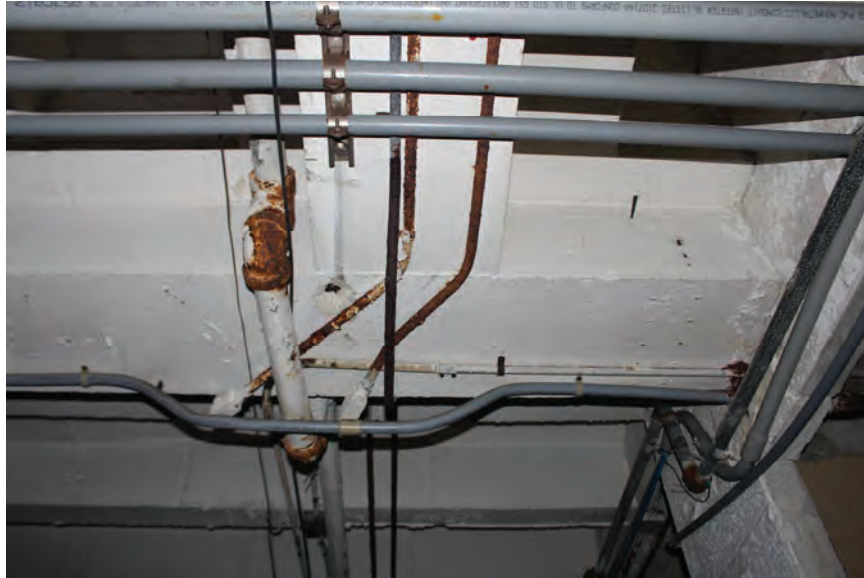
Image 32: View of the condition of a corroded and cracked beam (shear and flexural cracks), located below the exterior radius wall of the east ballroom. (Beam Label 6)

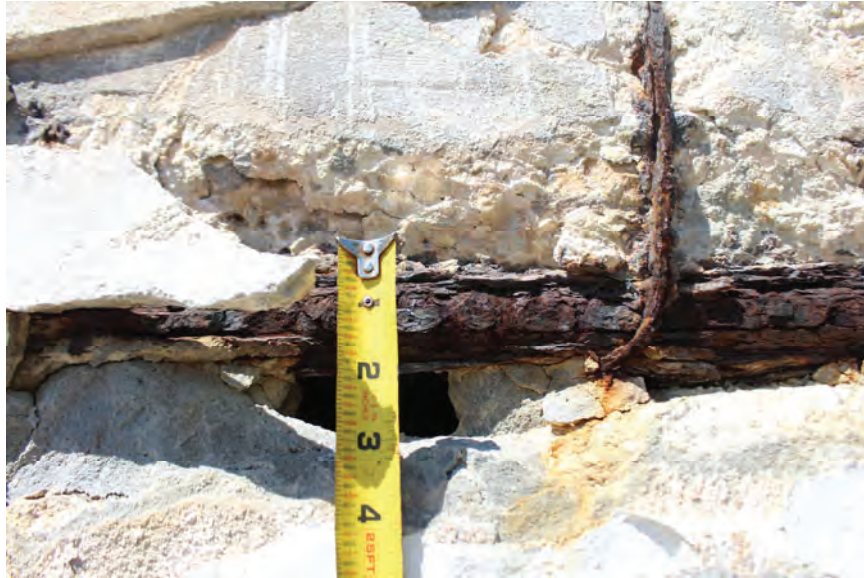
Image 34: View of the loss of steel cross-section within support wall below east ballroom.

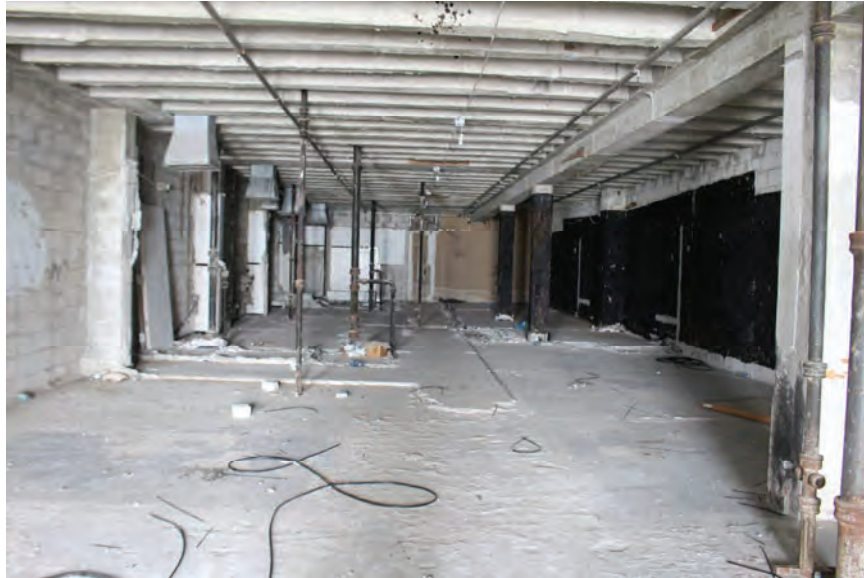
Image 46: Typical condition of concrete frame system at roof level of hotel. Note the size of the beams and columns.

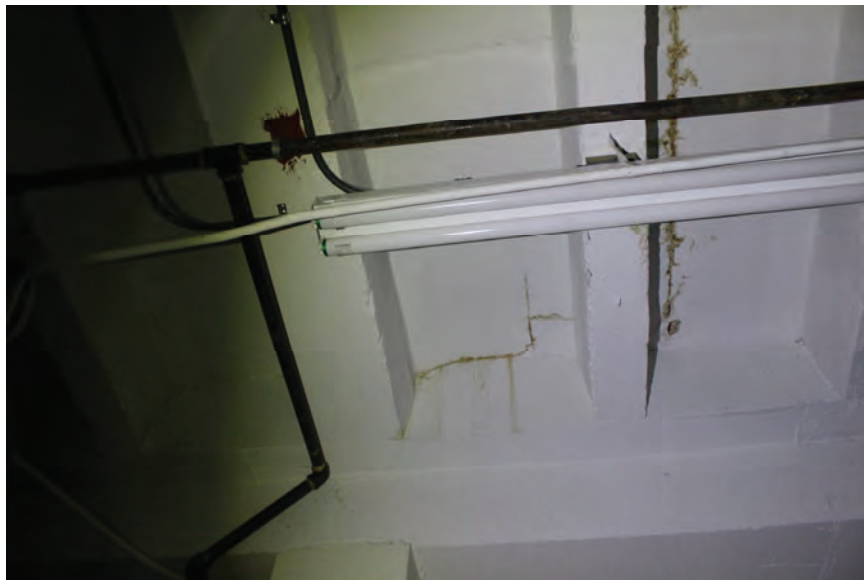
Image 47: Typical propagation of cracks off concrete frame system into adjacent slab (diaphragm) system. Photo shown below main roof level.

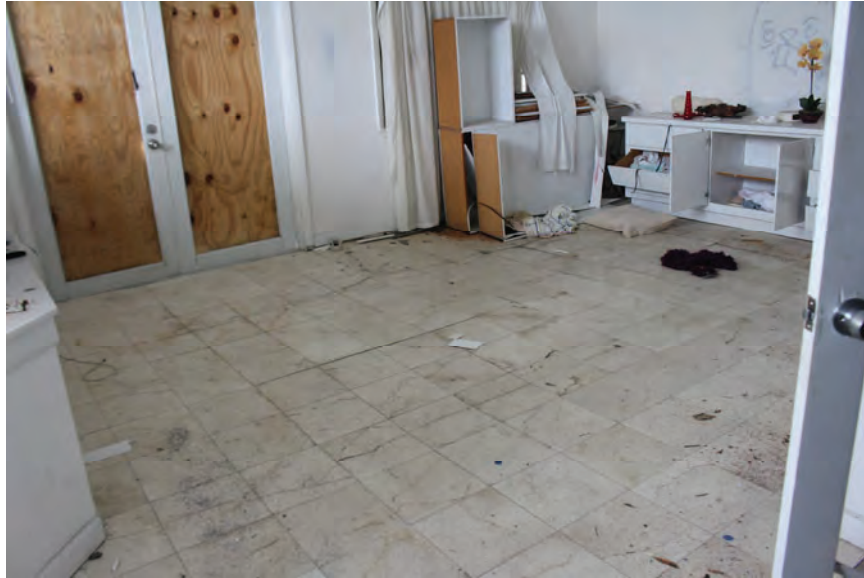
Image 48: Deflection of floor slab at roof level (within Penthouse) at west end of Hotel.

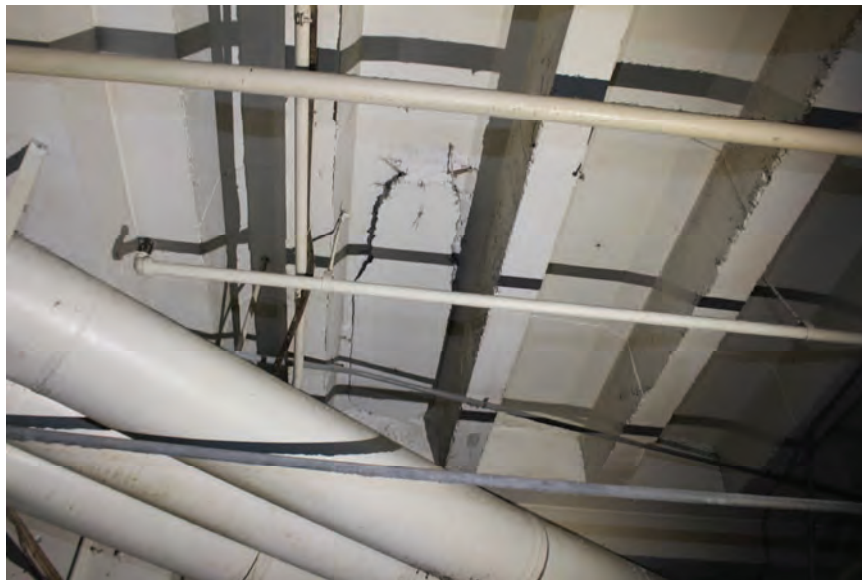
Image 53: Typical condition of slab system from Ground Level, below Hotel. Note corrosion as well as honeycombed concrete.

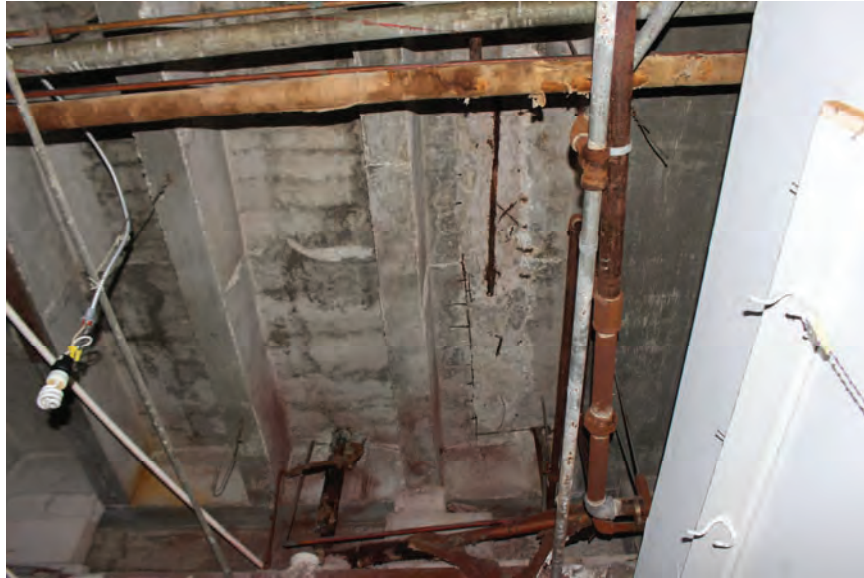
Image 54: Typical condition of slab system from Ground Level, below Hotel. Note corrosion as well as honeycombed concrete.

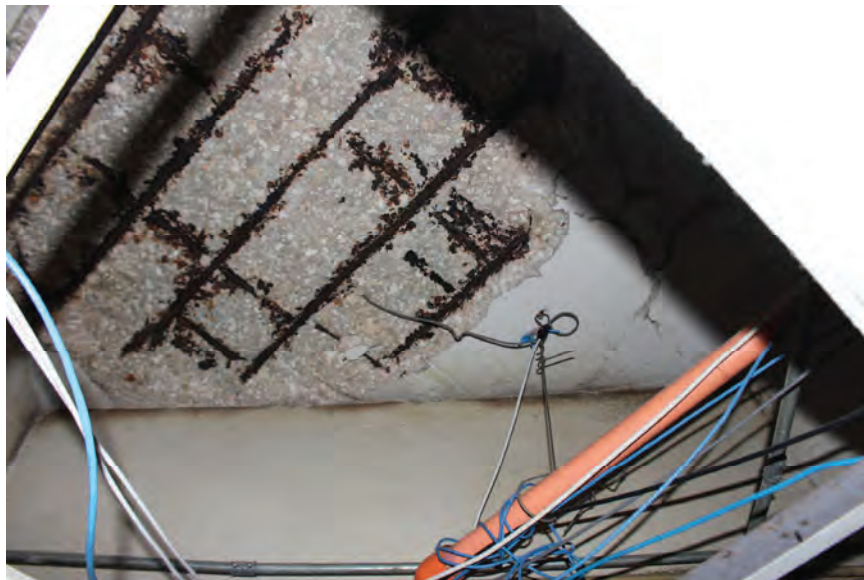
Image 55: Typical condition of corroded slab rebar apparent above Ground, Lobby, and Upper Levels.

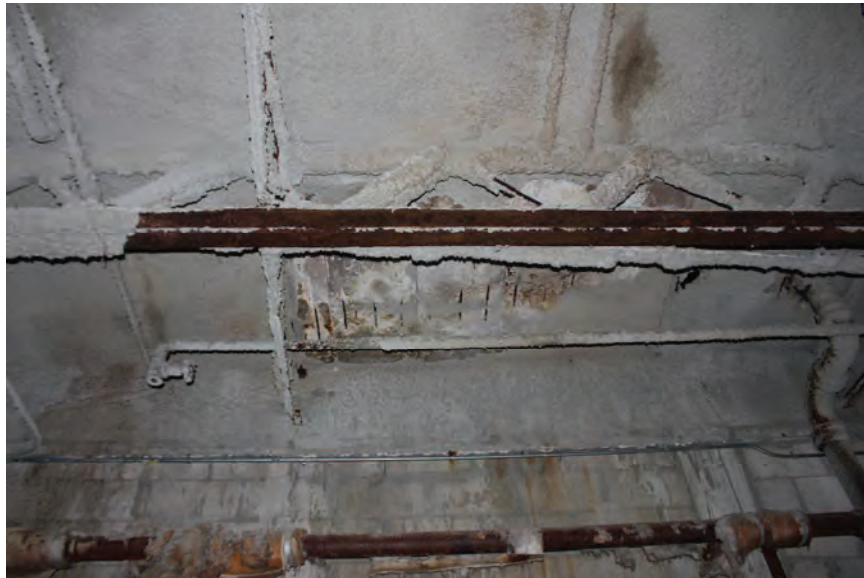
Image 57: Typical condition of corroded plank slab concealed by fireproofing/insulation.

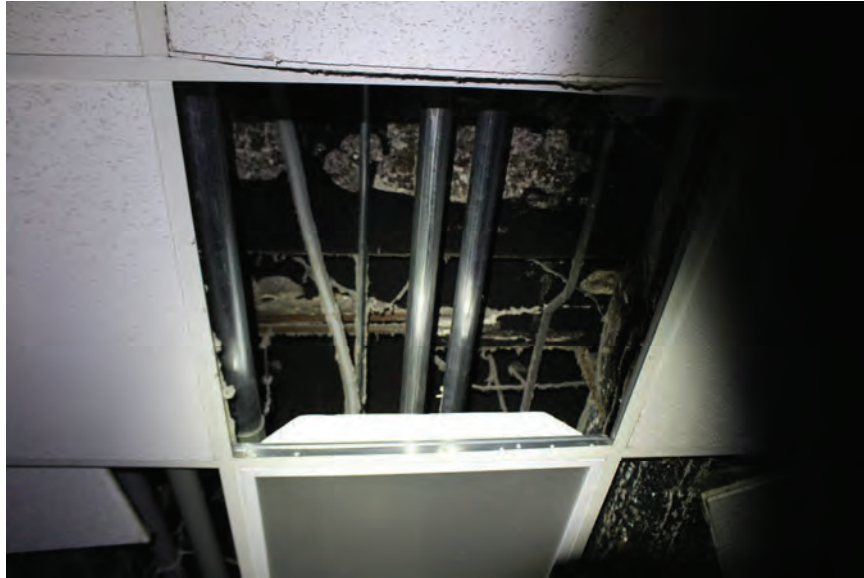
Image 58: Typical condition of 3rd Floor Level (transfer slab). Note spalled, cracked, and deteriorated concrete.

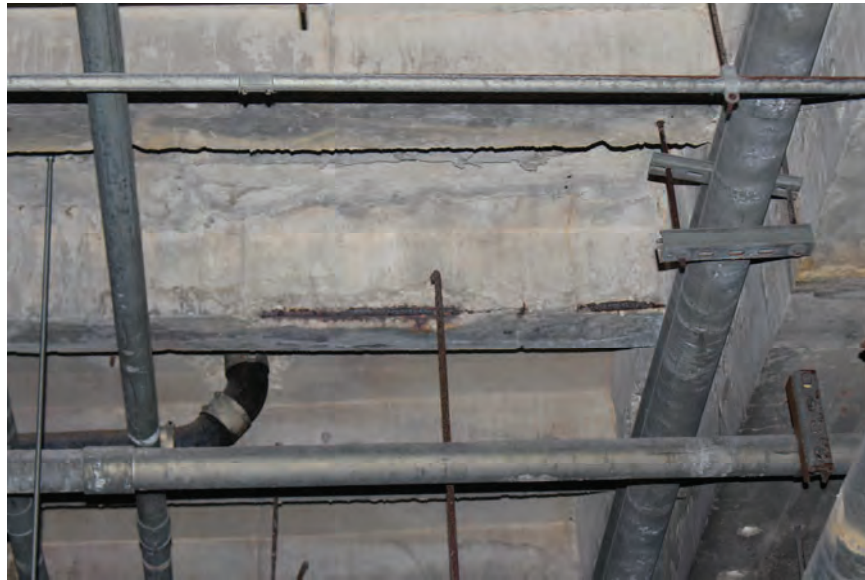
Image 60: Typical condition of joist corrosion.

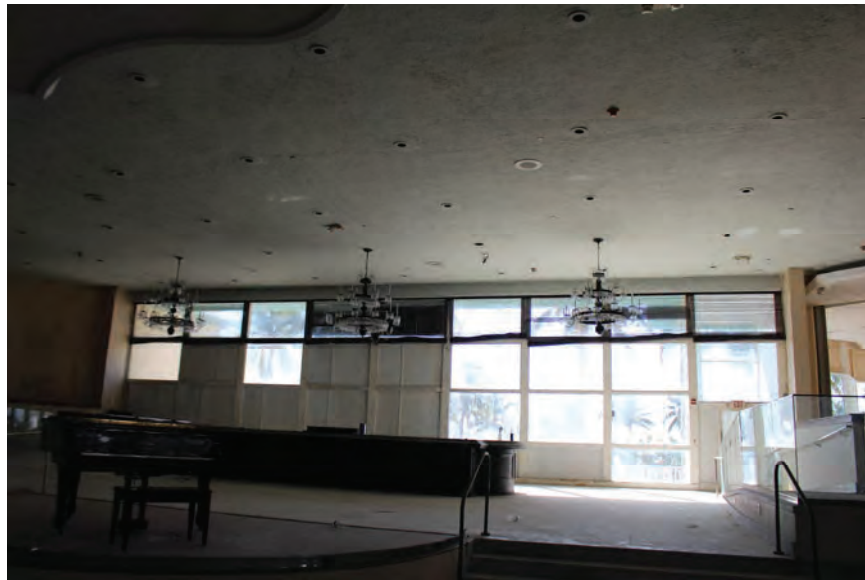
Image 61: Beam corrosion along southeast end of Lobby, above curtain wall. Note that this beam supported the adjacent Lobby roof structure.

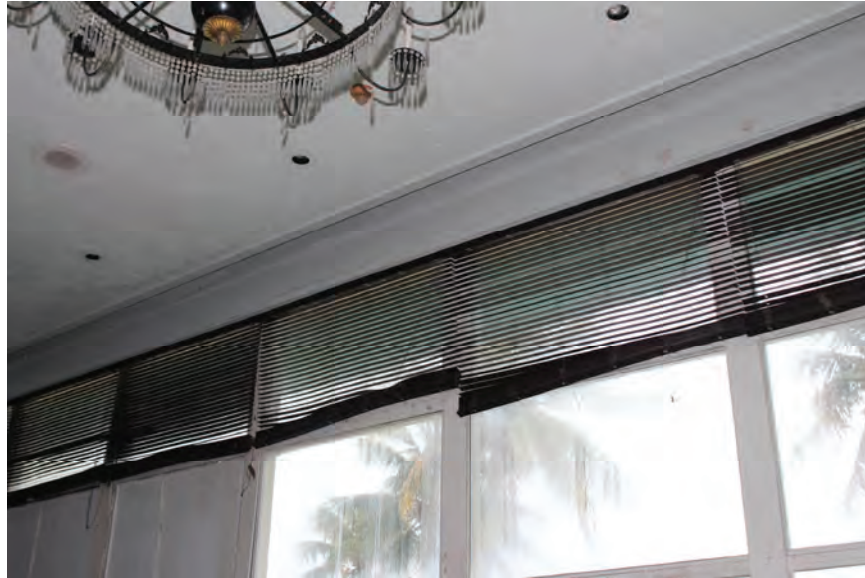
Image 62: Close up view of concrete beam corrosion in previous image.

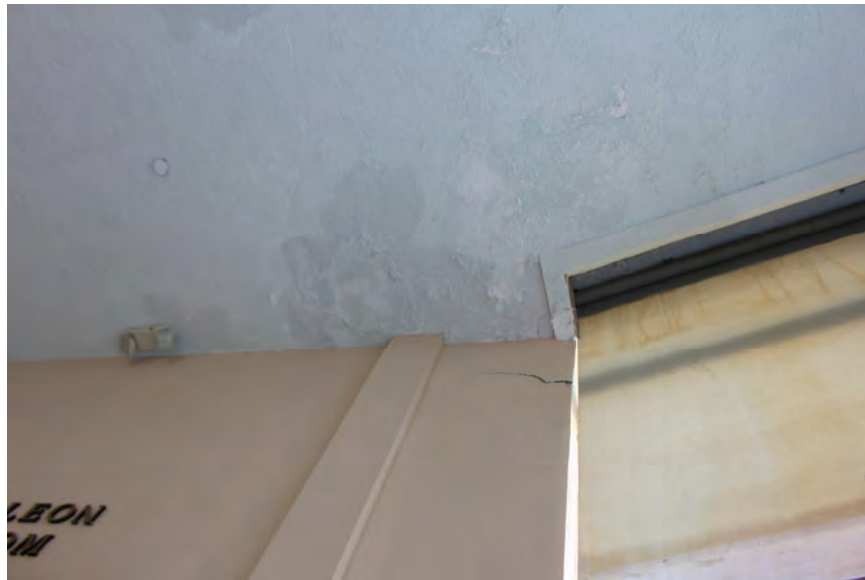
Image 63: Typical concealed corrosion damage with visible distress within Lobby along perimeter walls.

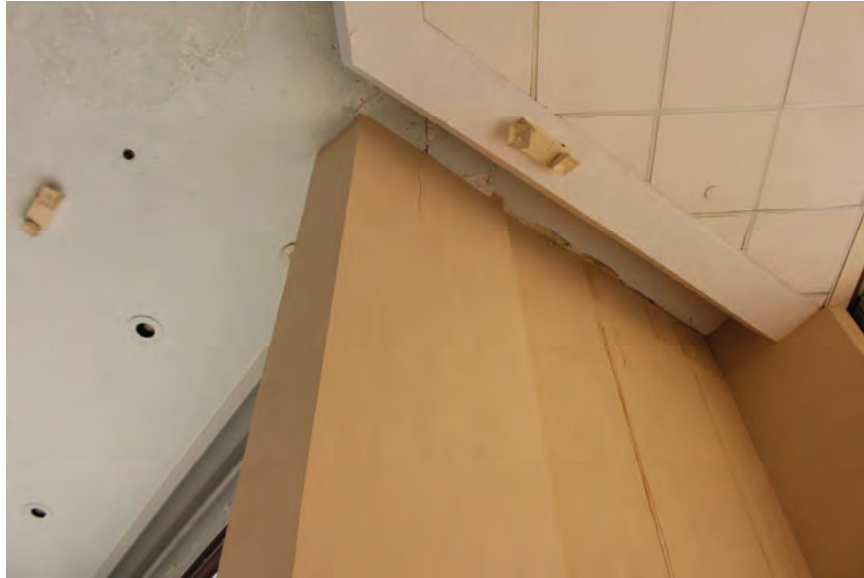
Image 64: Typical concealed corrosion damage with visible distress within Lobby along perimeter walls.

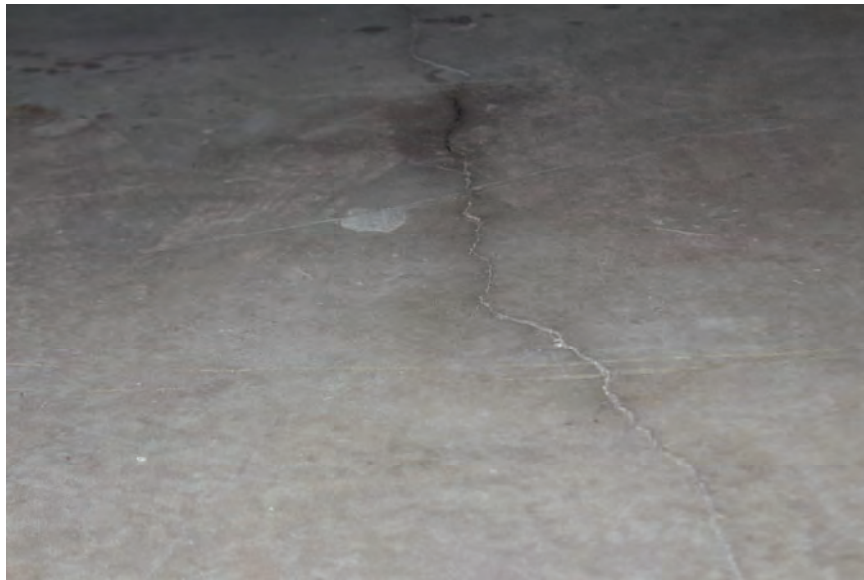
Image 65: Typical crack condition along top of South Ballroom floor slab, along the supporting Ground Level office walls, which was an indication of slab deflection between supports.

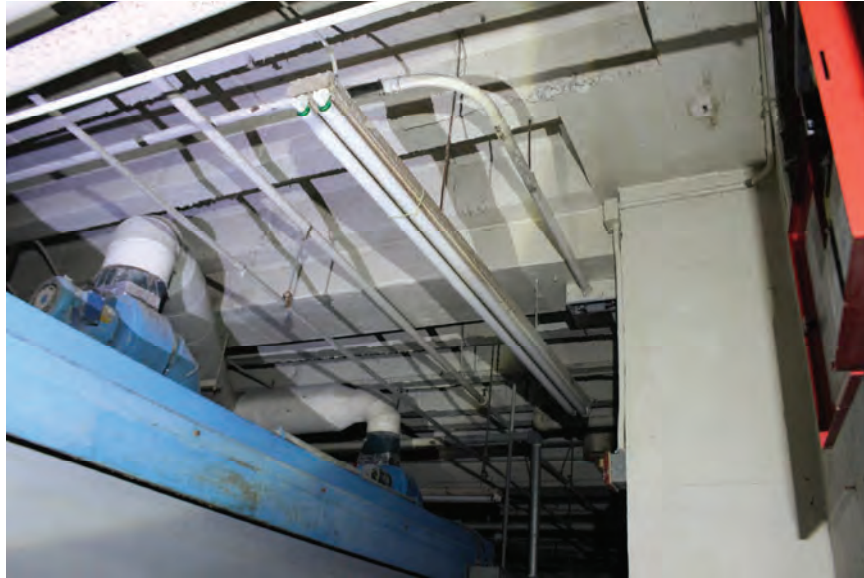
Image 66: Typical condition of honeycombed concrete, apparent during visual inspection.

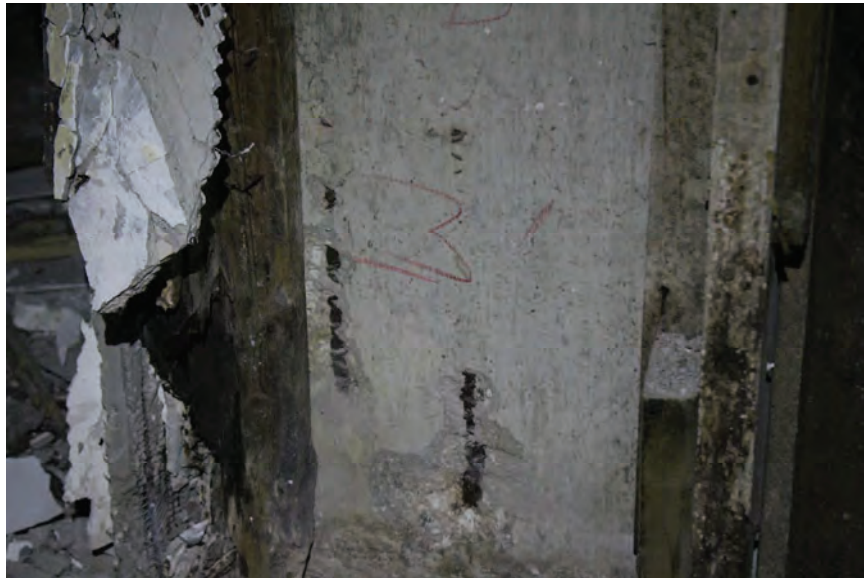
Image 67: Typical condition of column reinforcement with less than 1" of clear cover on Ground Level below South Ballroom, within the interior of the building.

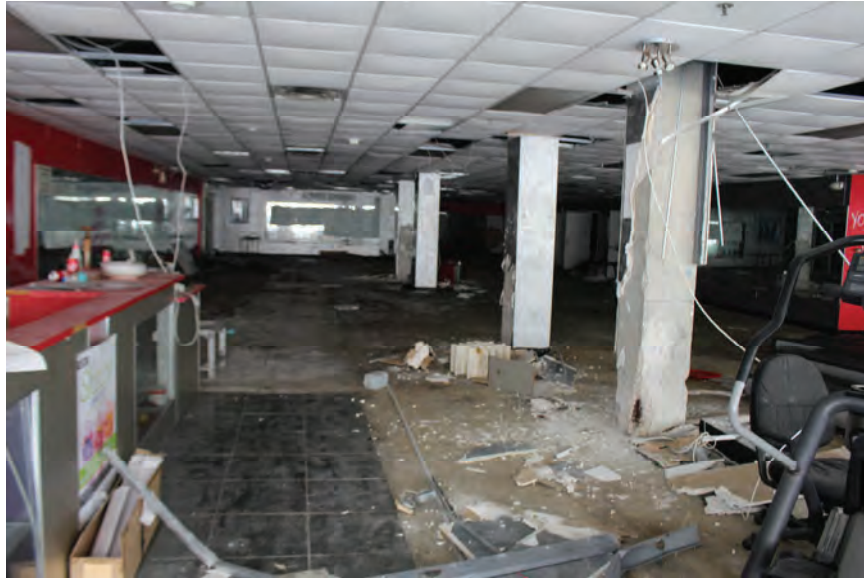
Image 68: Corrosion of interior Ground Level columns, located at south end of building.

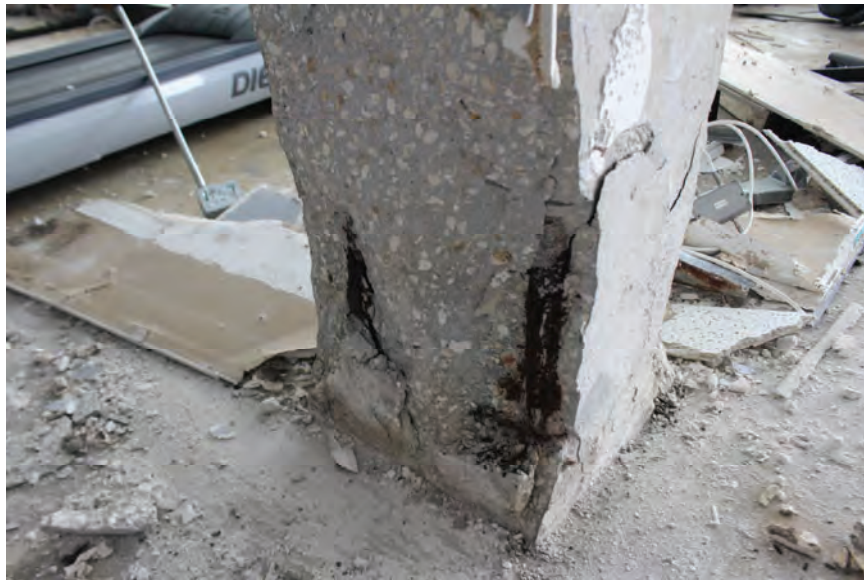
Image 69: Corrosion of interior Ground Level columns, located at south end of building.

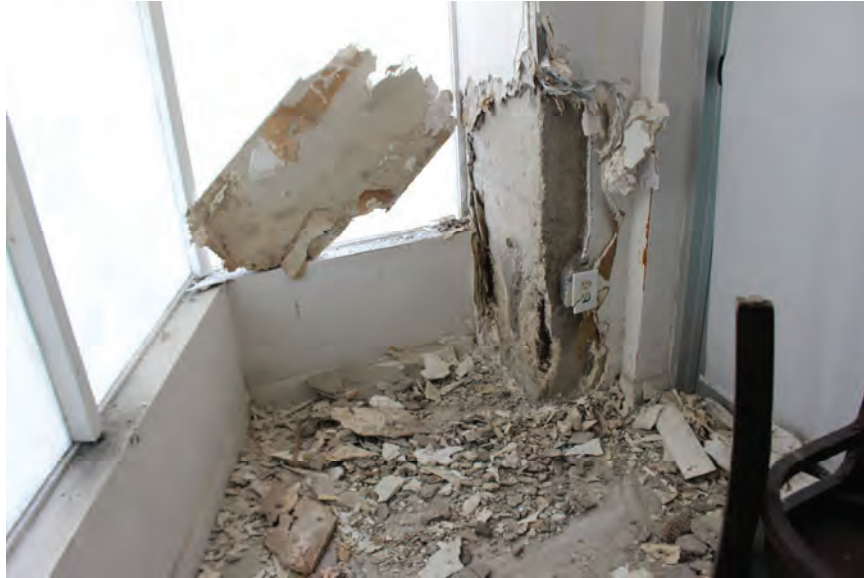
Image 70: Corrosion of perimeter Ground Level columns, located along west face of south end of building.

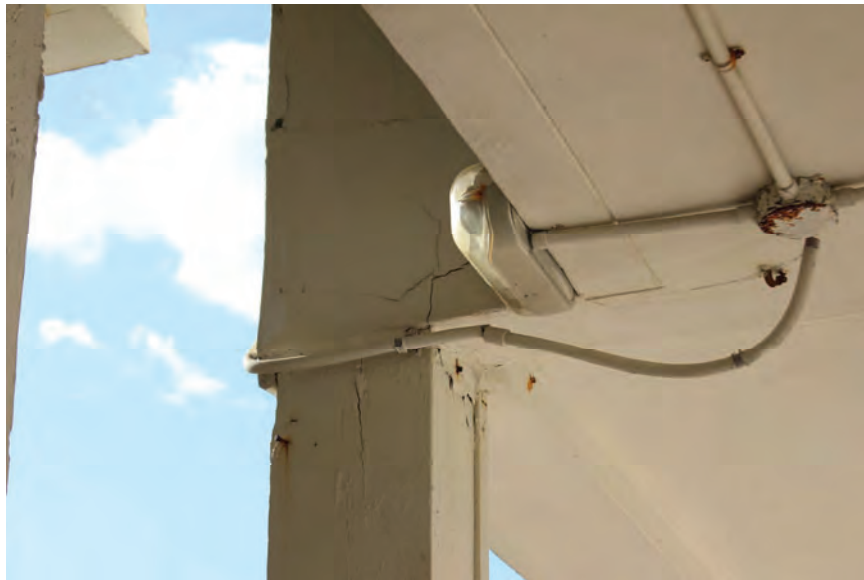
Image 71: Typical exterior corrosion damage along south portion of building.

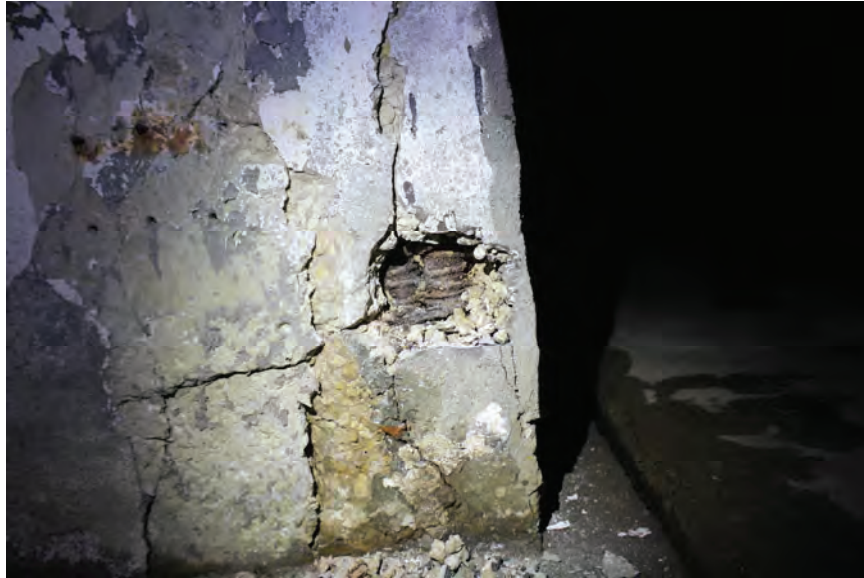
Image 74: Typical condition of Ground Level Hotel frame column closely spaced reinforcement as well as inadequate concrete mix. Note the loose aggregate and little to no cement paste. (Column Label 10)

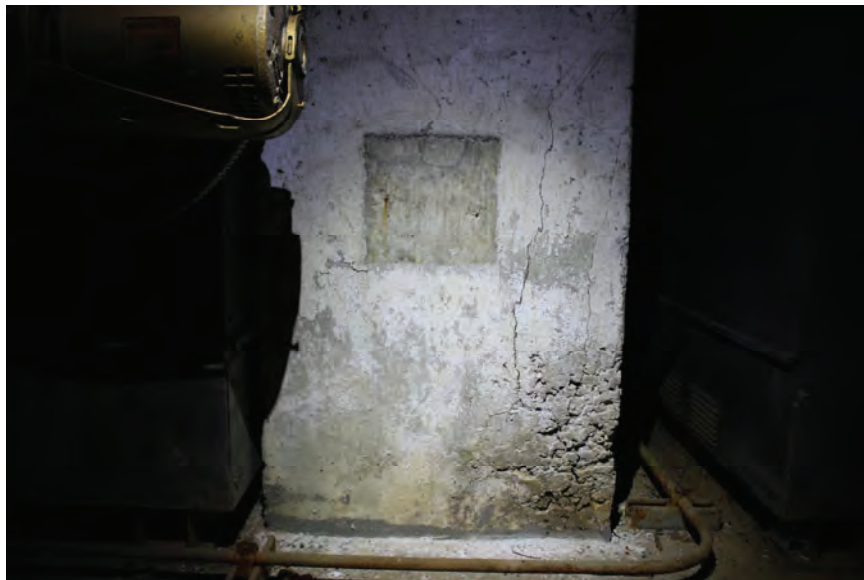
Image 75: Typical condition of Ground Level Hotel frame column with substantial honeycomb. Note corrosion cracks.

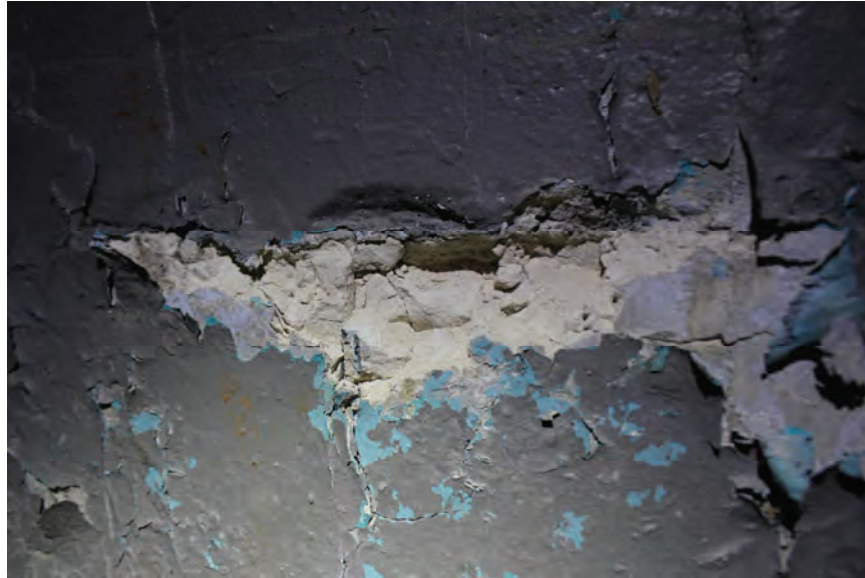
Image 76: Condition of Ground Level Hotel frame column which featured flaked paint. While sounding the column with a hammer, we encountered powder-like concrete at an apparent horizontal joint. (Column Label 12)

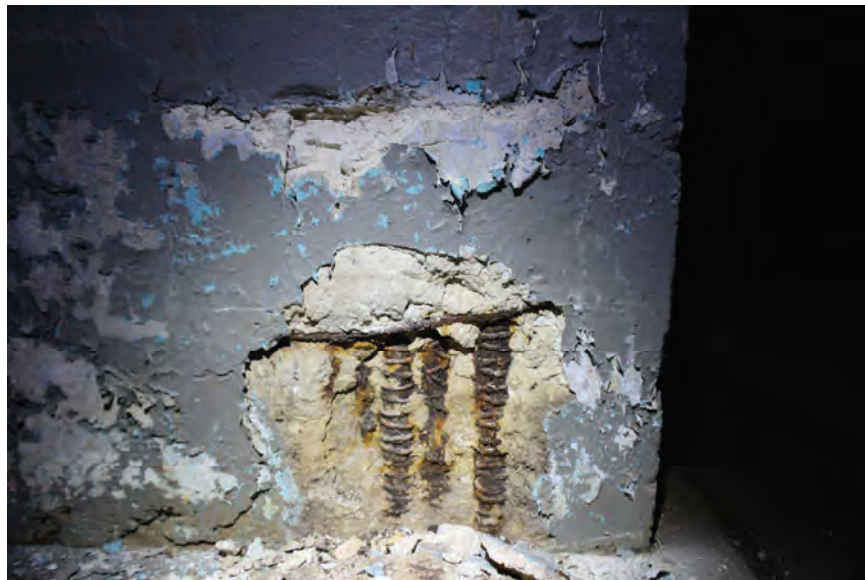
Image 77: Condition of Ground Level Hotel frame column which featured flaked paint and powder-like concrete. While sounding the column with a hammer, a concrete spall detached and revealed severe corrosion, closely spaced rebar, and offset rebar cage (inadequate clear cover). (Column Label 12)

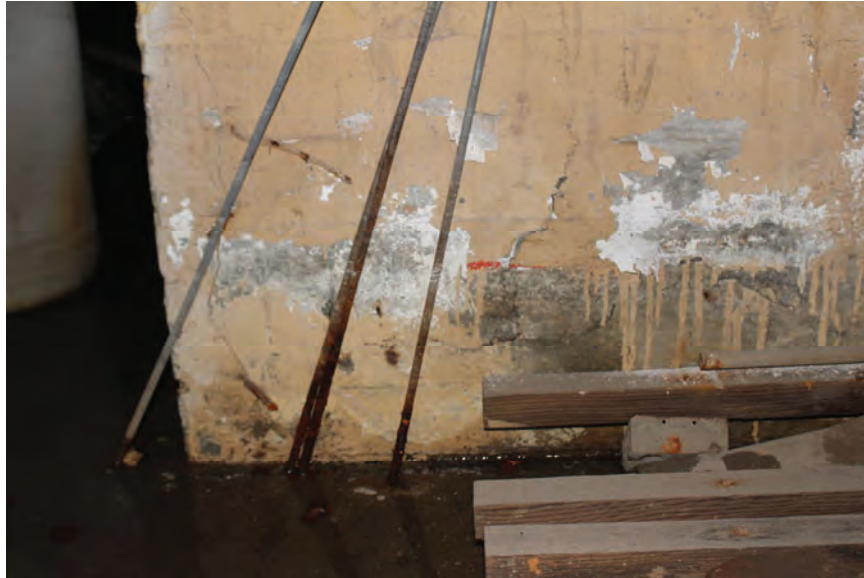
Image 78: Condition of the east end of the main lobby elevator shaft, including a Ground Level hotel frame column. Note the corrosion. (Column label 14)

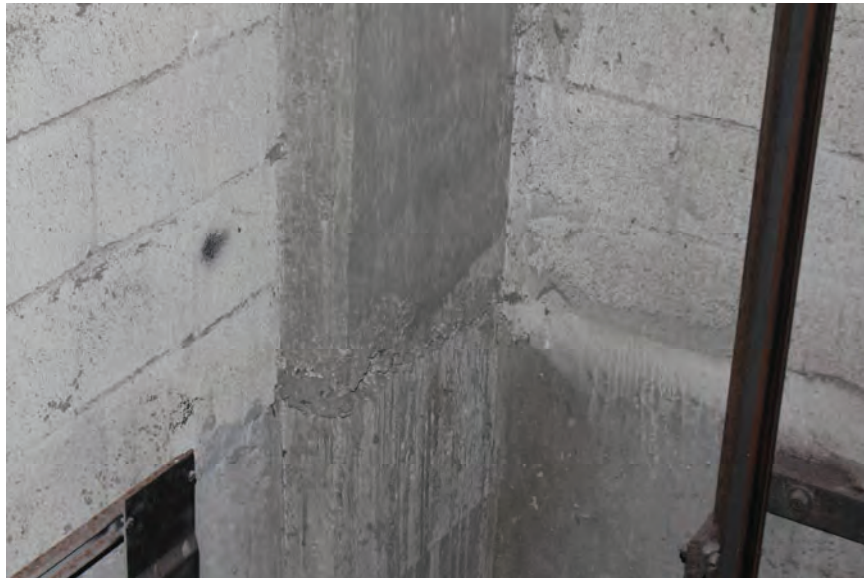
Image 79: Typical condition of the joints within the main lobby elevator shaft's rigid frame system. Note the honeycomb.

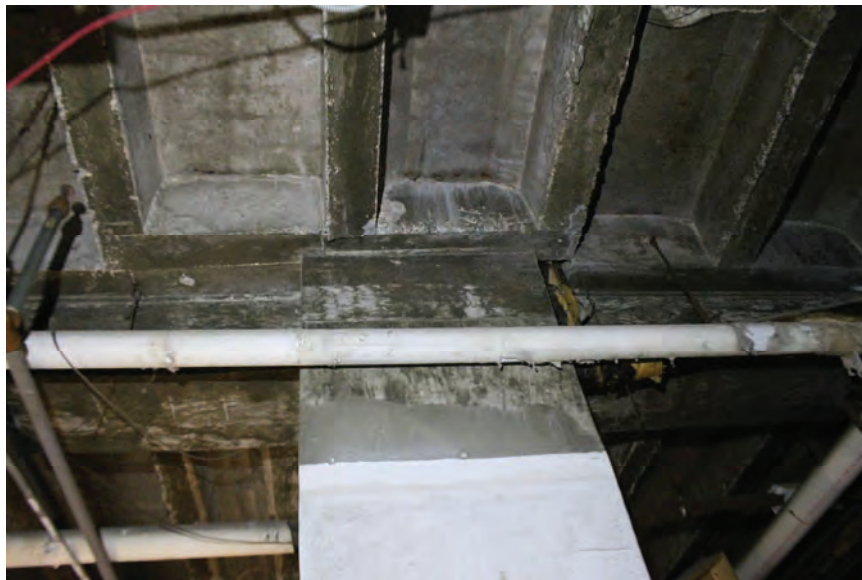
Image 81: Typical condition of congested beam-column Ground Level Hotel frame joint. Note honeycombed concrete. Note the size of the columns and beams (beam spans left to right above column in image)

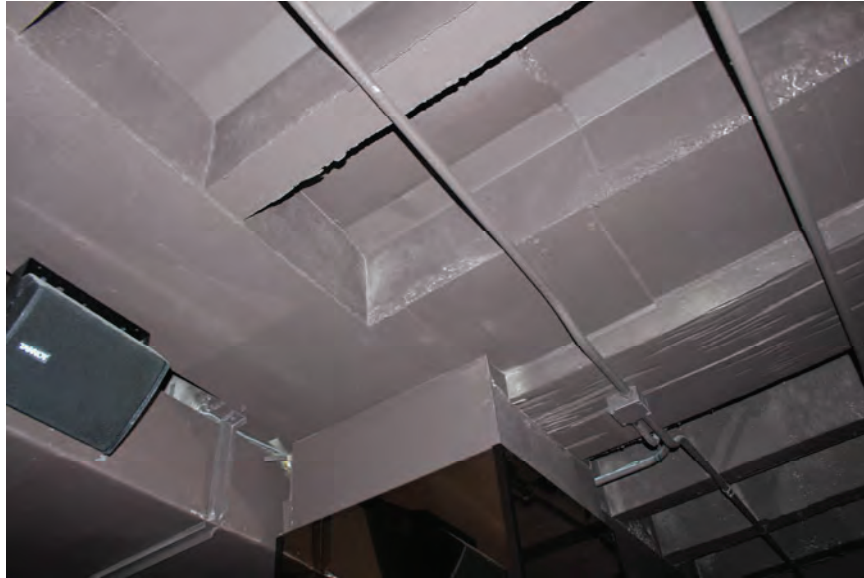
Image 82: Typical condition of congested Lobby Level Hotel frame beam-column joint. Note honeycombed concrete. Note the size of the columns and beams (beam spans upper left to bottom right above column in image)

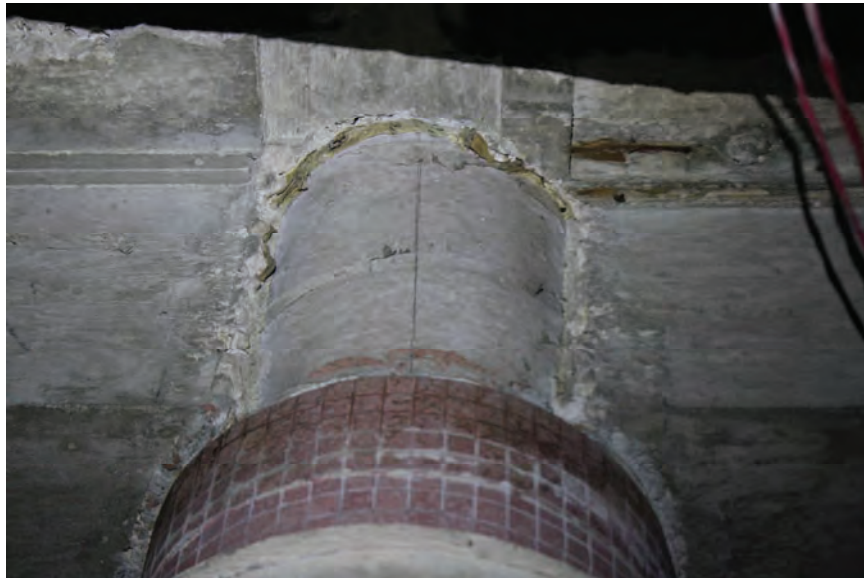
Image 83: Typical condition of sonotube paper within the beam-column joint. Note honeycombed concrete.

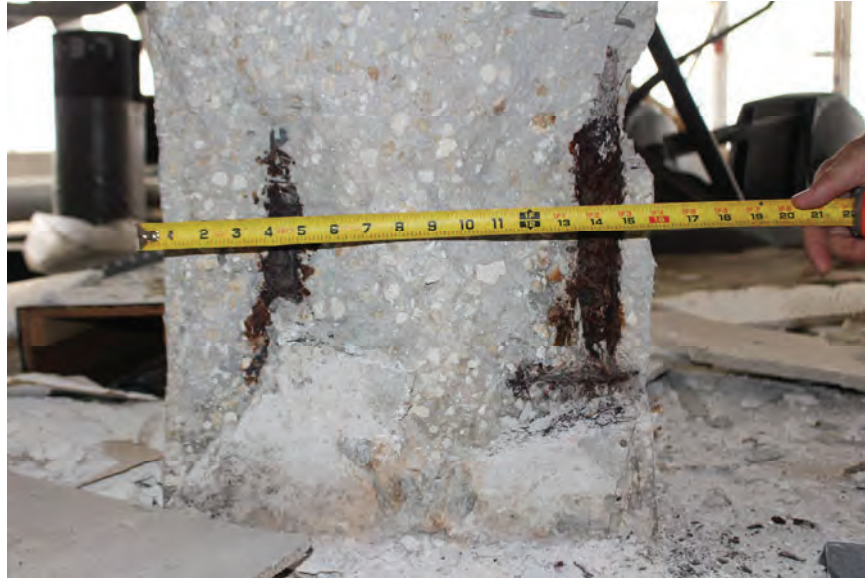
Image 84: Typical condition of offset rebar within column cross-section, affecting clear cover and depth of reinforcement. Note advanced corrosion particular to this column, Label 1.

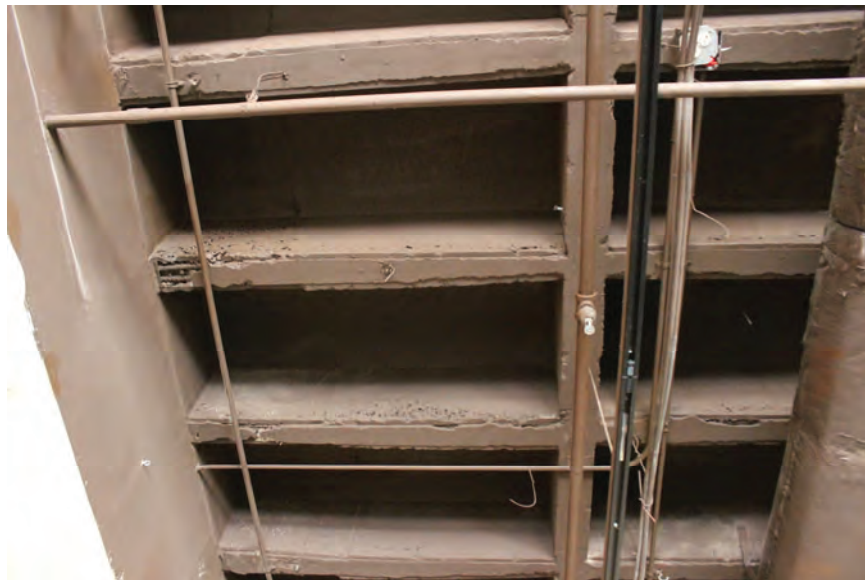
Image 85: Typical condition of sporadic and widespread nature of honeycombed concrete. Note exposed reinforcement.

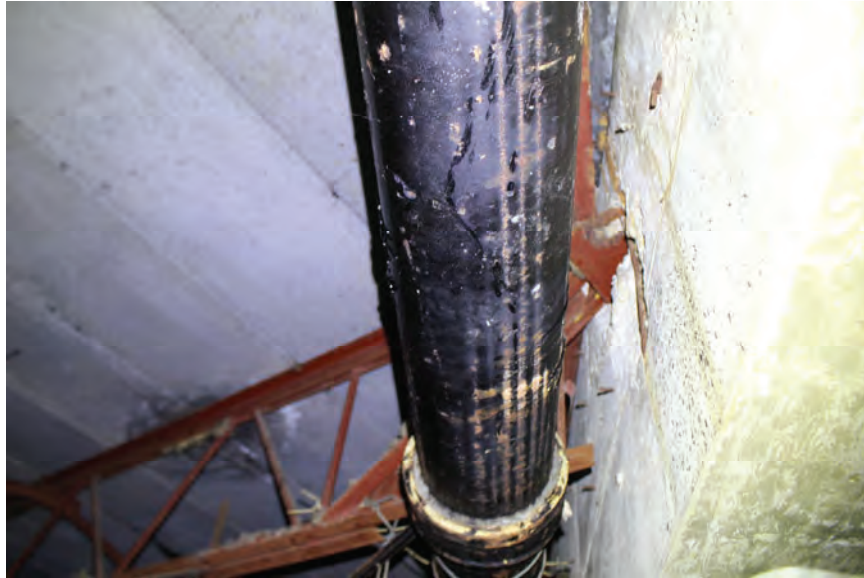
Image 86: Typical honeycomb at steel truss connection to reinforced concrete structural frame. Primarily located above Lobby and Ballrooms. Note corrosion of exposed reinforcement.
