Deauville Beach Resort - Structural Condition Assessment
Anesta Consulting File Number: 21-04005
Report Issued December 15, 2021

Structural Condition Assessment

Building: Deauville Beach Resort

Location: 6701 Collins Avenue, Miami Beach, Florida 33141

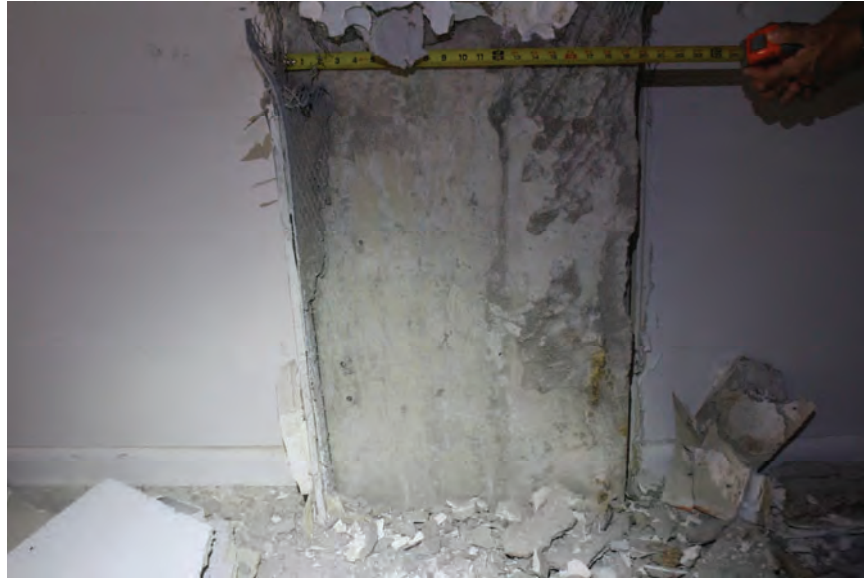
Image 88: Typical vertical joint in column.

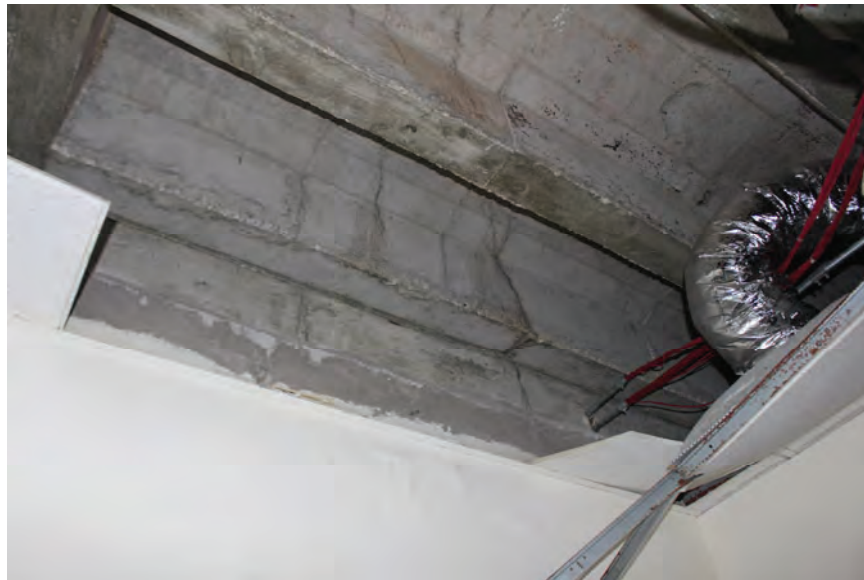
Image 89: Typical condition of slab system cracks which propagated through the joists near hotel perimeter walls in upper floors.

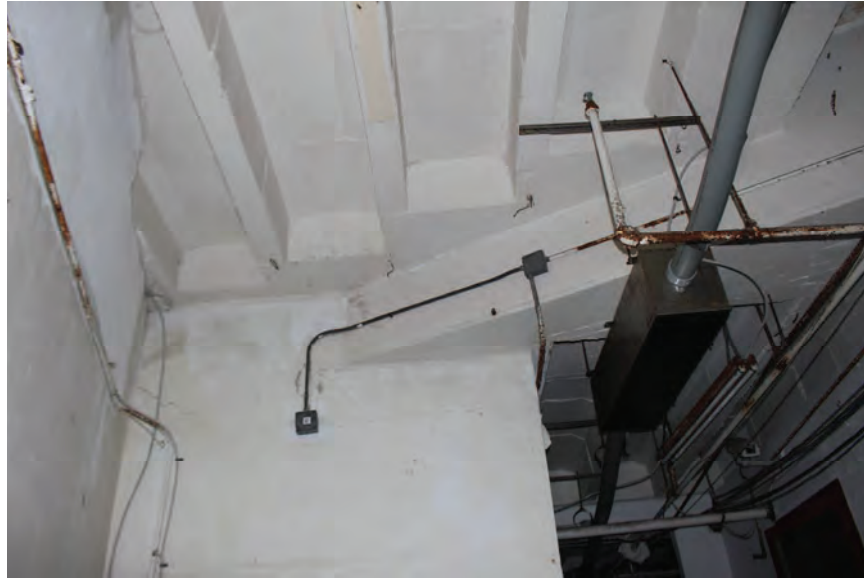
Image 90: Structural crack which transmits through walls, beams, and slabs along the interface between the hotel portion and lobby portion of the building, viewed within the Ground Level. Note that there was no isolation joint between the hotel and lobby portions of the building.

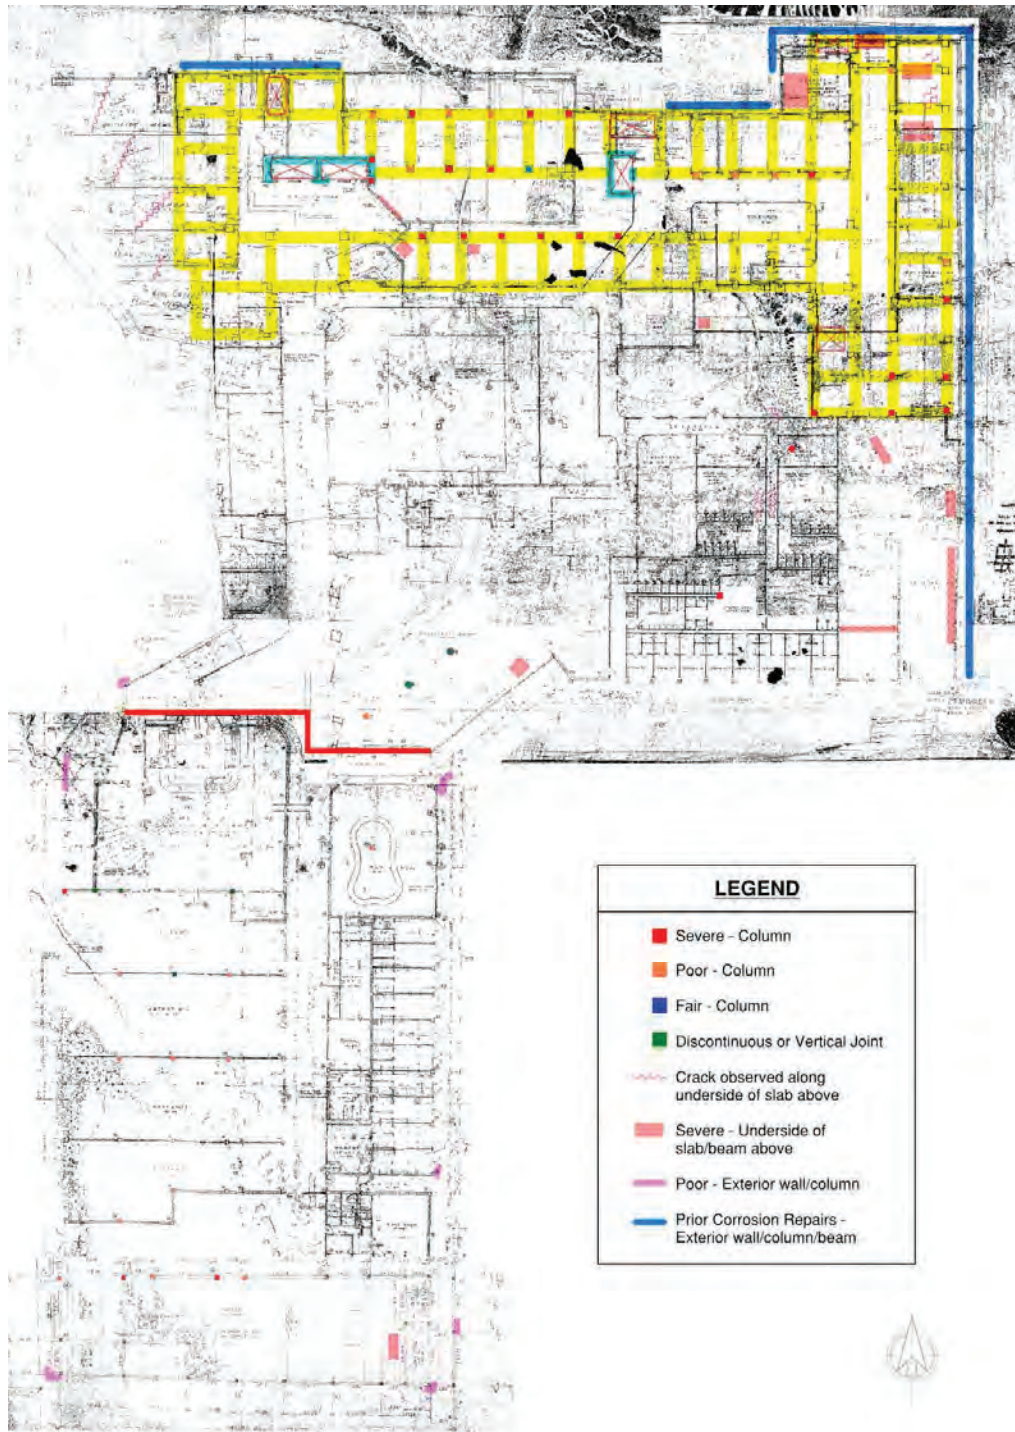
Image 95: Depiction of the Conditions Observed during our Inspections of the Ground Level Columns, 1st Elevated Level and Exterior Walls/Columns/Beams

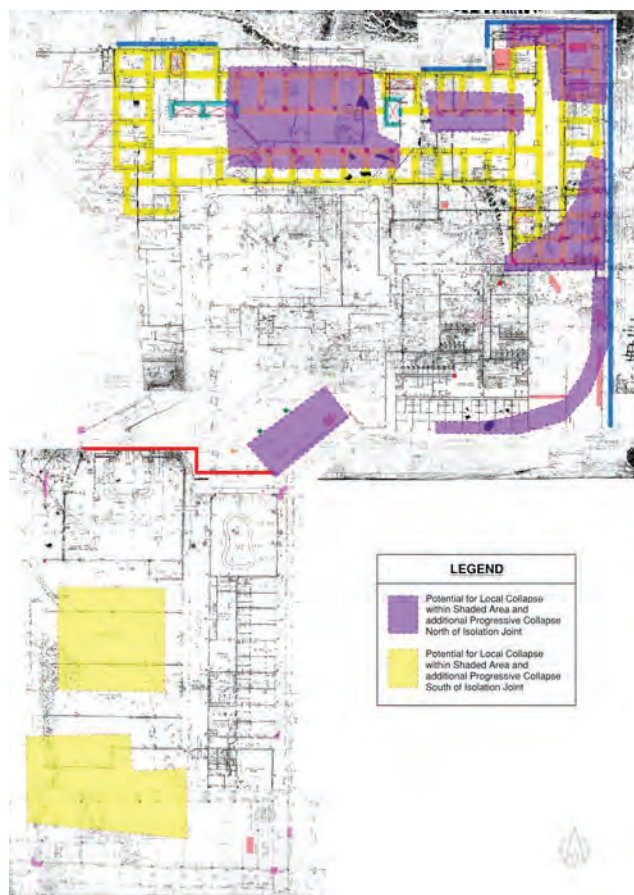
- a. Due to the presence of transfer slabs and the lack of isolation joints, areas of potential localized collapse are likely to cause progressive collapse to the remainder of the adjacent continuous structure either north or south of the isolation joint

Image 126: Potential local collapse and resultant potential progressive collapse locations within the continuous adjacent structure based on our assessment

- c. Based on our assessment as discussed herein, we recommend that the Deauville be demolished in a controlled fashion and in conjunction with additional guidance from a licensed Florida Professional Engineer with experience in the demolition and partial demolition of structures. It is our recommendation that the Deauville be demolished as soon as possible, and completed prior to the start of the 2022 Hurricane Season.
