STRUCTURAL CONDITION ASSESSMENT

JEFFERSON APARTMENTS

542 Jefferson Ave.

February 2, 2022

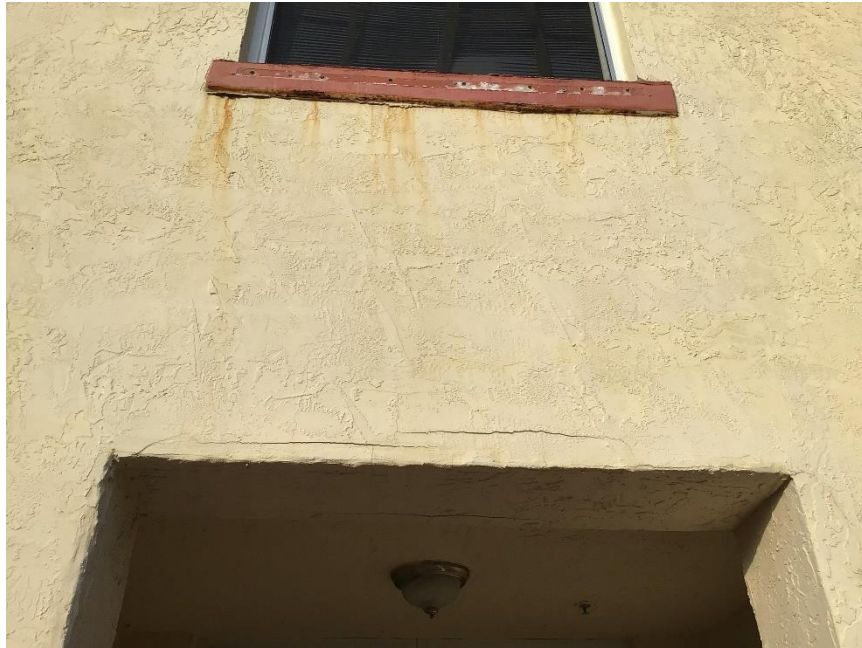
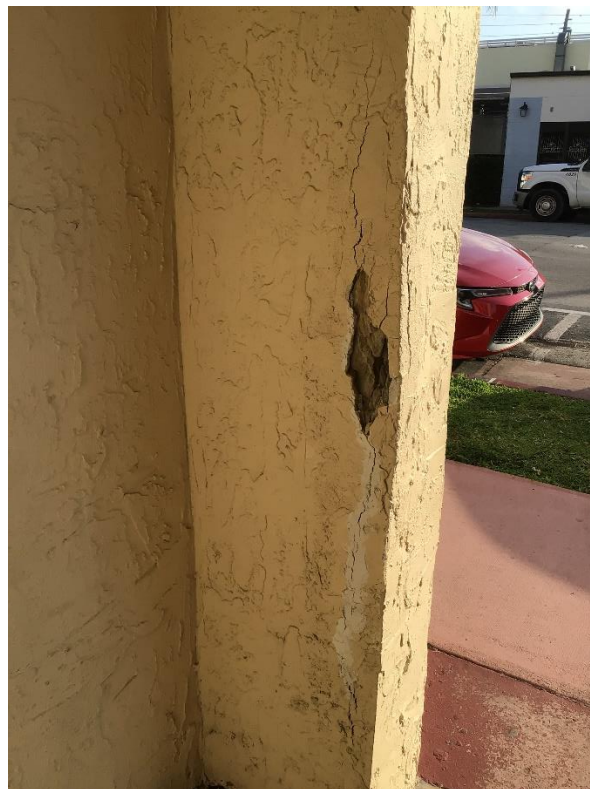
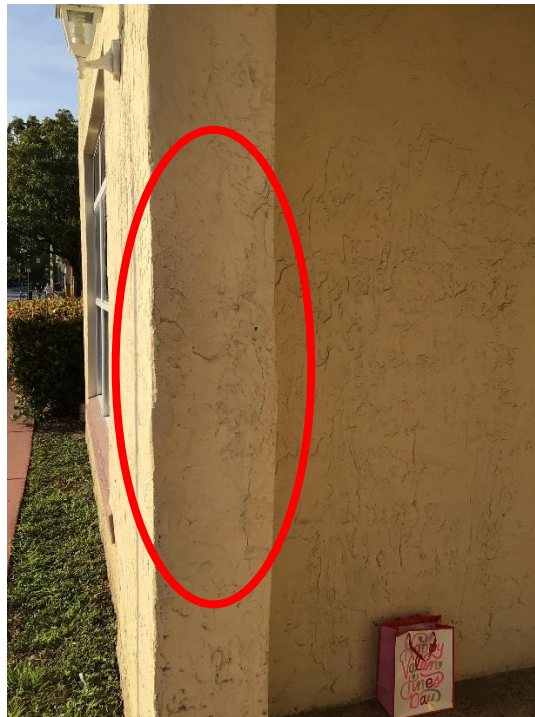
Item	Repair Priority	Item Description	Representative Photos
S-1	Immediate	Delamination & Spall at beam and side walls at entrance.	Photos #1 to #3
S-2	Immediate	Delaminations throughout exterior façade.	Photos #4 to #6
S-3	Immediate	General condition of stucco/façade throughout building.	Photos #7 to #10
S-4	Immediate	General condition of headers and sills around windows. Some sills were observed to have spalled off.	Photos #11 to #13
S-5	5-Years	General roofing condition. Signs of water ponding and bubbles were observed.	Photo #14
S-6	5-Years	General condition of roof top AC units	Photos #15 & #16
S-7	-	Washer and dryer units placed on CMU blocks	Photo #17
S-8	Immediate	Signs of water intrusion in windows at units on east end.	Photo #18
S-9	5-Years	General condition of units.	Photos #19 to 21
S-10	Immediate	Water stains observed at ceiling of electrical meter room.	Photo #22

Concrete Spall/Delamination Repair (with reinforcement): Remove concrete that is not sound (loose, delaminated, etc.) above oxidized (corroded) reinforcement beginning with a ½" deep saw cut perimeter. Use only light, 15 LB electric chipping hammers. Once initial removal is complete, proceed with the undercutting of all exposed oxidized reinforcement providing 1" minimum clearance between exposed reinforcement and sound concrete. Concrete removal shall extend along oxidized reinforcement to a location that is free of bond inhibiting conditions and where reinforcement is well bonded in sound concrete. Repair area shall form a square/rectangular area with 90 degree sides. Interior corners should be rounded to a minimum radius of 1 inch. Feather edges must be avoided.

Oxidized reinforcement shall be sandblasted or mechanically cleaned. Splice reinforcement with equal size bar where section loss of 15-20% occurs. All exposed reinforcement shall be coated with a corrosion inhibitor. Patch area with repair mortar that is suitable for extremely aggressive environments.

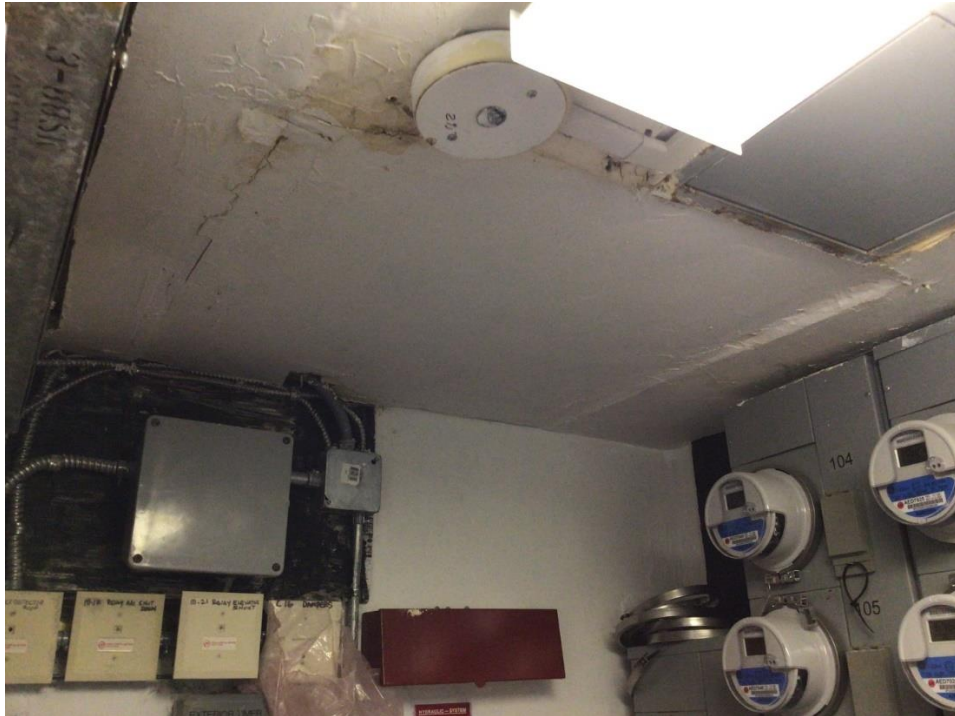
Photograph #22

In some units, sagging in the floor was observed which has resulted in tiles cracking. In the bathrooms, the shower head is not located in the center of the tub. Water stains were observed in the electrical meter room and should be further investigated so the source can be corrected. Areas of ponding were observed at multiple locations on the roof. Stagnant water has the possibility of leaking into the building and causing damage. It is recommended that these areas of the roof be sloped to allow water to runoff and eliminate ponding.
