STRUCTURAL CONDITION ASSESSMENT

**Sabrina Apartments
1551 Pennsylvania Ave.
Miami Beach, FL**

**BCC Engineering, Inc.
Certificate of Authorization No. 7184**

February 4, 2022

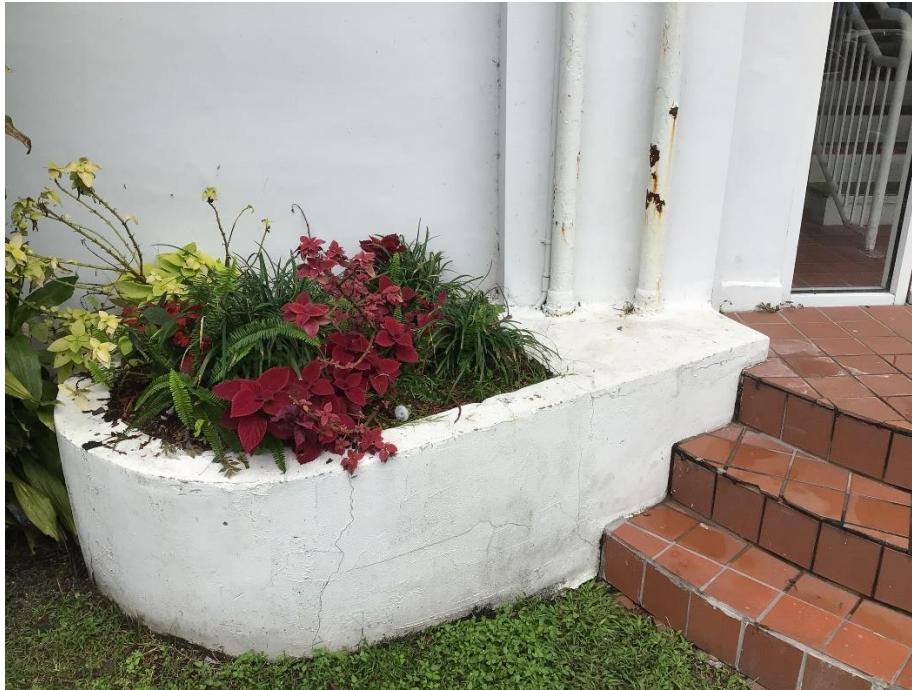
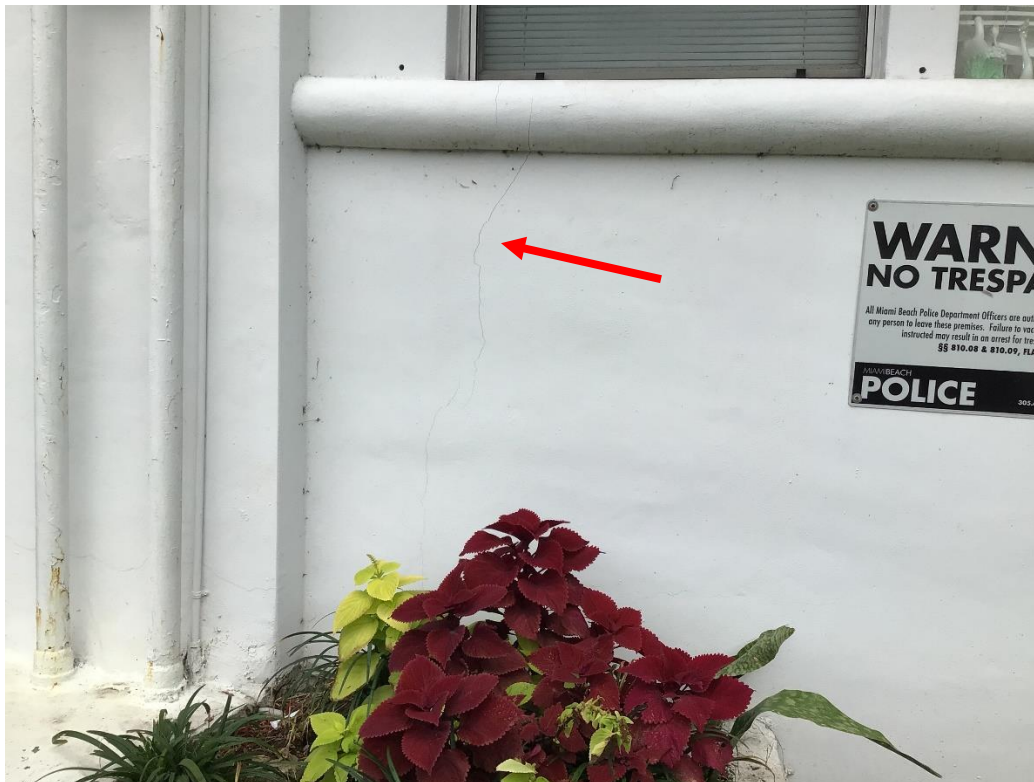
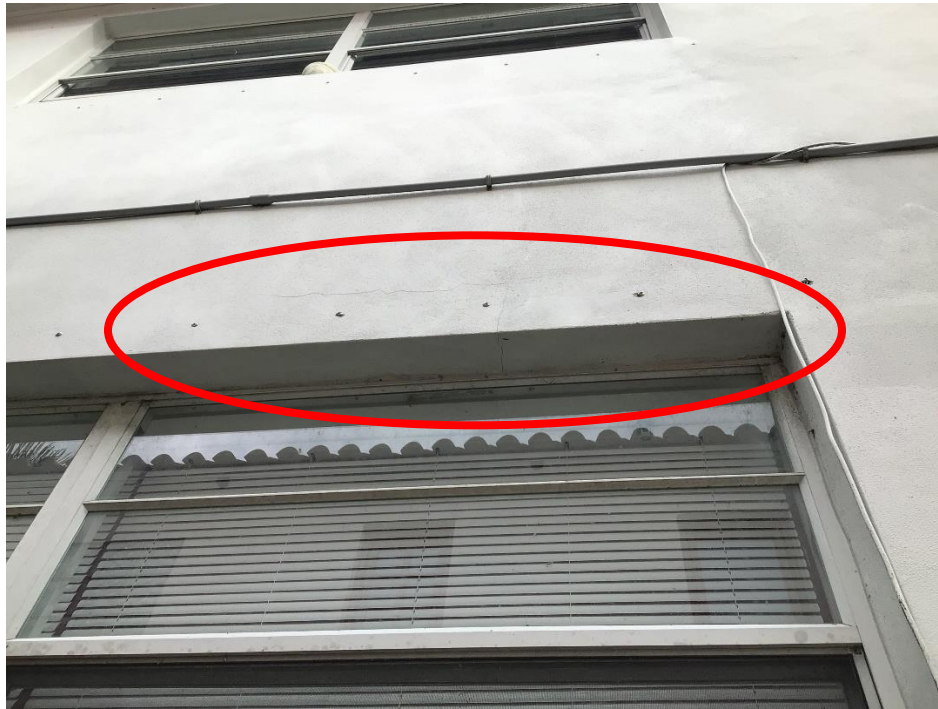
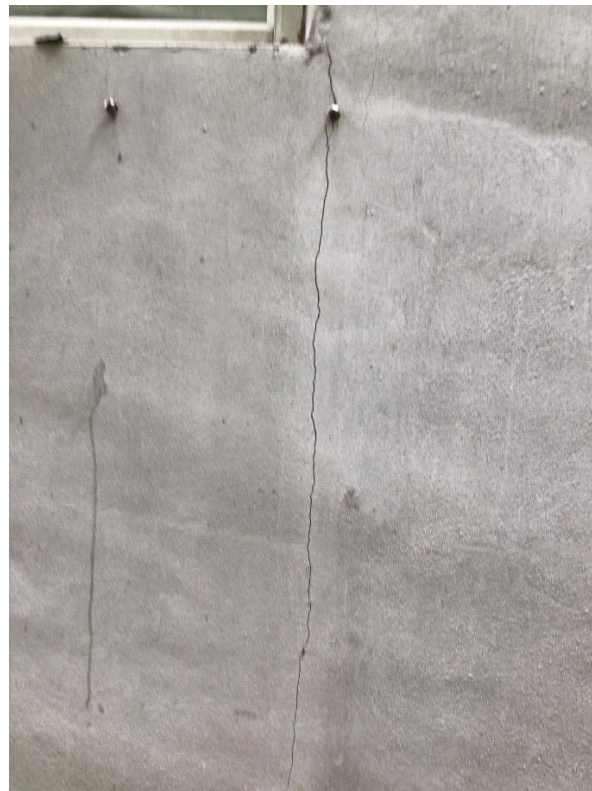
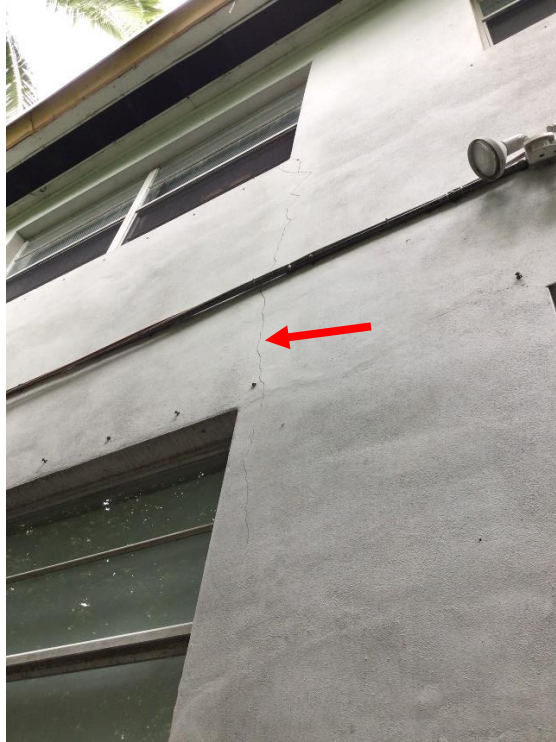
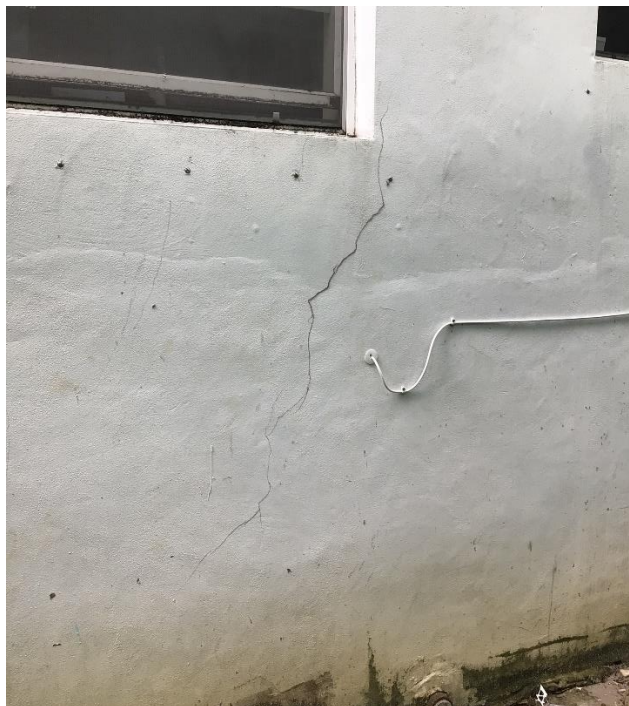
Item	Repair Priority	Item Description	Representative Photos
S-1	5-Years	General condition of stucco/façade throughout building. Cracks observed throughout.	Photos #1 to #6
S-2	5-Years	Door oxidizing.	Photo #7
S-3	5-Years	General condition of roof soffit.	Photo #8
S-4	10-Years	General Condition of roofing	Photos #9 & #10
S-5	5-Years	General condition of units.	Photos #11 to 14

Overall, the structure is in fair condition with some areas of concern. There are cracks and delaminated areas on the building exterior that need to be repaired. The roof overhang soffits have sporadic patchwork and have not been painted leaving the new wood exposed to the elements. The roofing is in good condition and may have been recently replaced. In the interior, the wood floors have signs of wear and tear. Termite damage was also observed throughout the wood floors. At the basement, there are pumps that are constantly running and pumping out water from floor drain. According to building maintenance personnel, the pumps have to be replaced every 2-3 months.

Given the age of the building and corrosive environment, spalls/delaminations are expected and do not pose an immediate unsafe condition. If left unresolved, however, these areas will worsen increasing the damaged area requiring repair and creating an unsafe condition. Delaminated portions of the structure will eventually spall off and fall to the ground. If left untreated, cracks can become spalls and delaminations. As water seeps into the unsealed cracks, the reinforcement corrodes which expands and loosens the concrete.

- Hire a pest control company to tent the structure.
- Stucco and repaint the exterior of the building.
