STRUCTURAL CONDITION ASSESSMENT

**VILLA MATTI APARTMENTS
221 28th Street
Miami Beach, FL**

**BCC Engineering, LLC
Certificate of Authorization No. 7184**

February 1, 2022

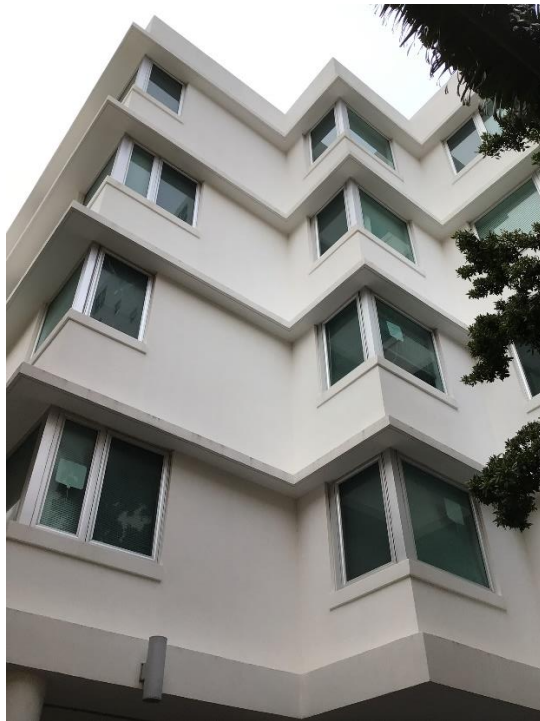
Photograph #1

Item	Repair Priority	Item Description	Representative Photos
S-1	10-Years	General condition of façade. No observable deficiencies were observed.	Photo #1
S-2	10-Years	General condition of meter room. No observable deficiencies were observed.	Photo #2
S-3	10-Years	General condition of RTU frames and roofing. No observable deficiencies were observed.	Photo #3
S-4	10-Years	General condition of a typical unit. No observable deficiencies were observed.	Photos #4 to #5
S-5	Immediate	ADA lift is not functional.	Photo #6

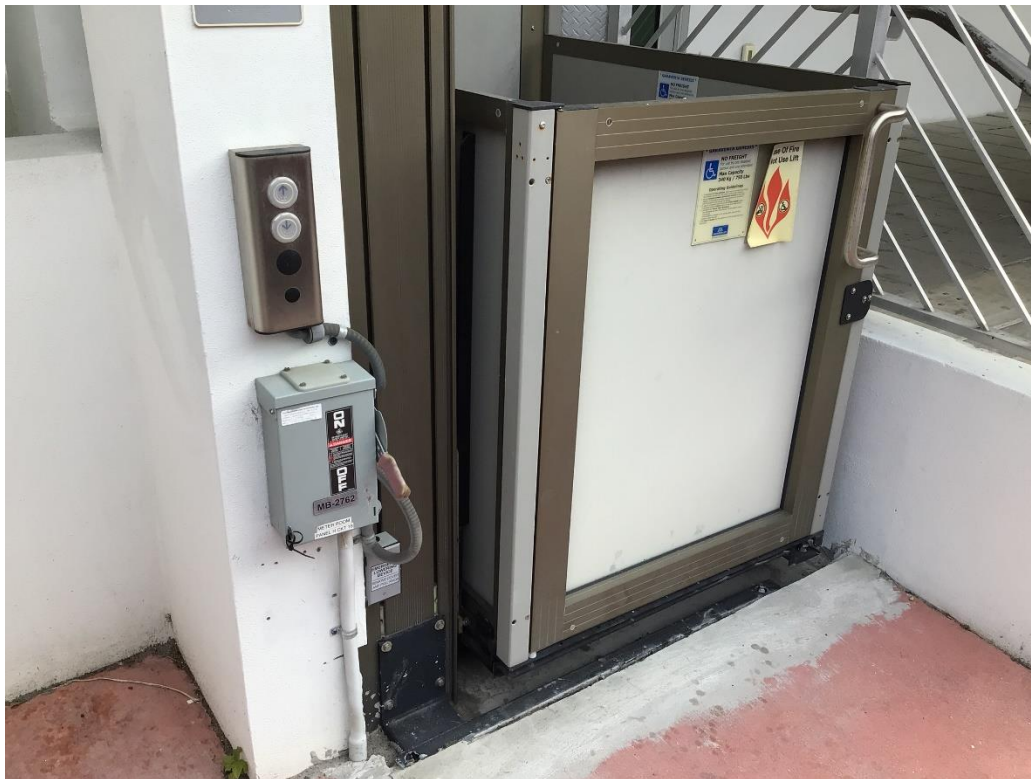
Photograph #6

Overall, the structure is in good condition with some isolated areas requiring attention. These areas pertain to an ADA lift which is not functional. To gain access to the lobby, individuals who require the use of a lift need to traverse through the parking lot and around the building.

- Retain a certified contractor to repair ADA lift.

Opinion of Probable Cost of Immediate Repairs			
Item Description	Unit Cost	Unit	Cost
ADA Lift Repair	\$5,000	1	\$5,000
Subtotal			\$5,000
General Conditions (10% of Construction Cost)			\$500
General Requirements (15% Contractor O&P)			\$825
10% Contingency			\$633
Total			\$6,958
