STRUCTURAL CONDITION ASSESSMENT

**Fernwood Apartments
935 Pennsylvania Ave.
Miami Beach, FL**

**BCC Engineering, Inc.
Certificate of Authorization No. 7184**

February 4, 2022

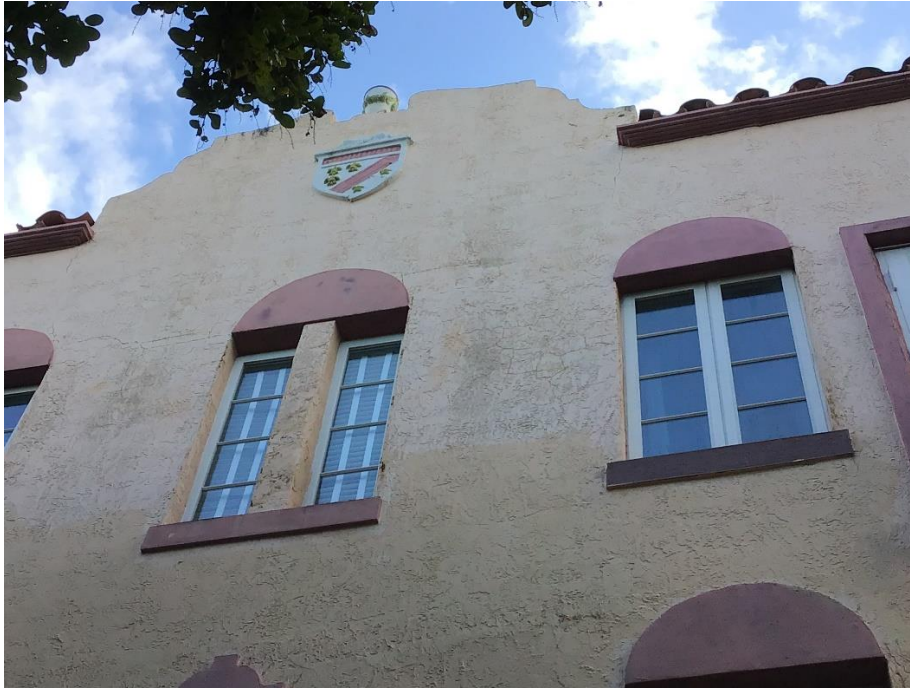
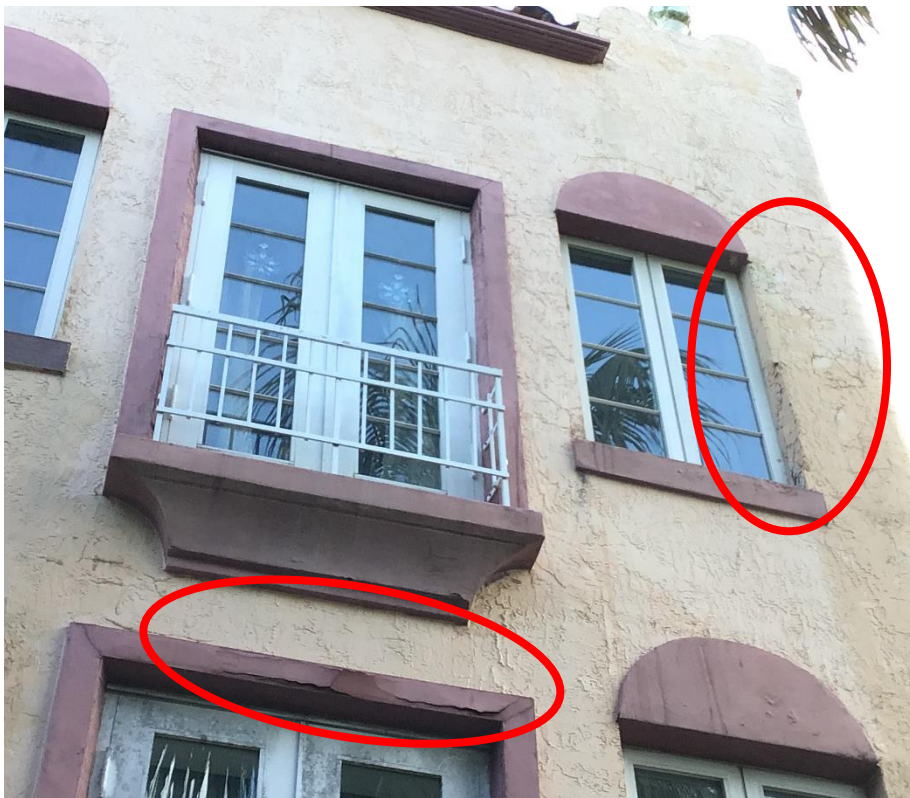
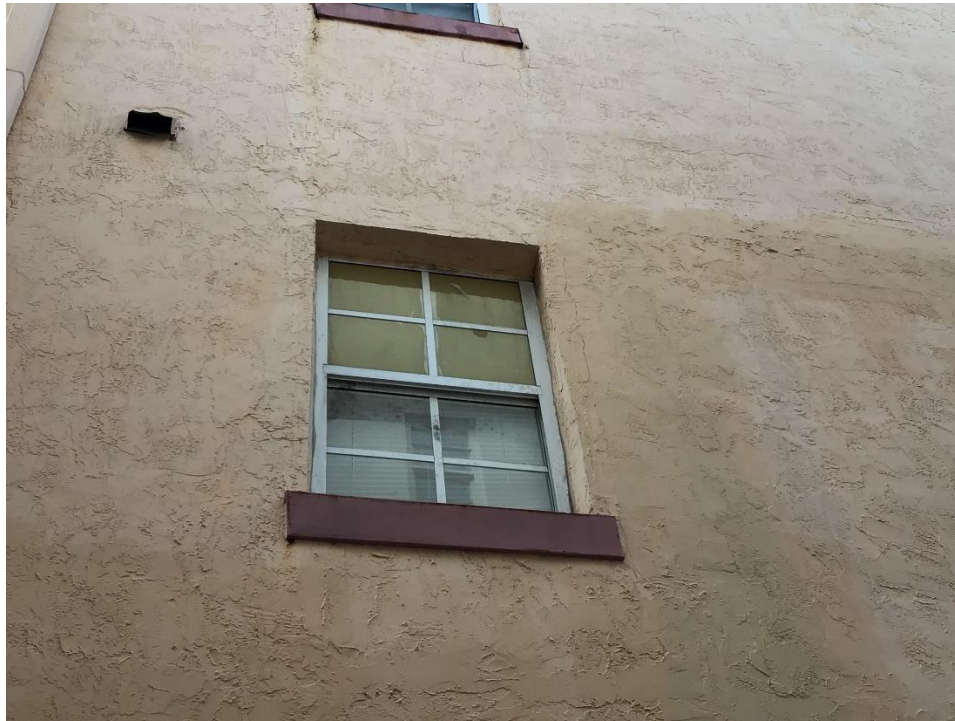
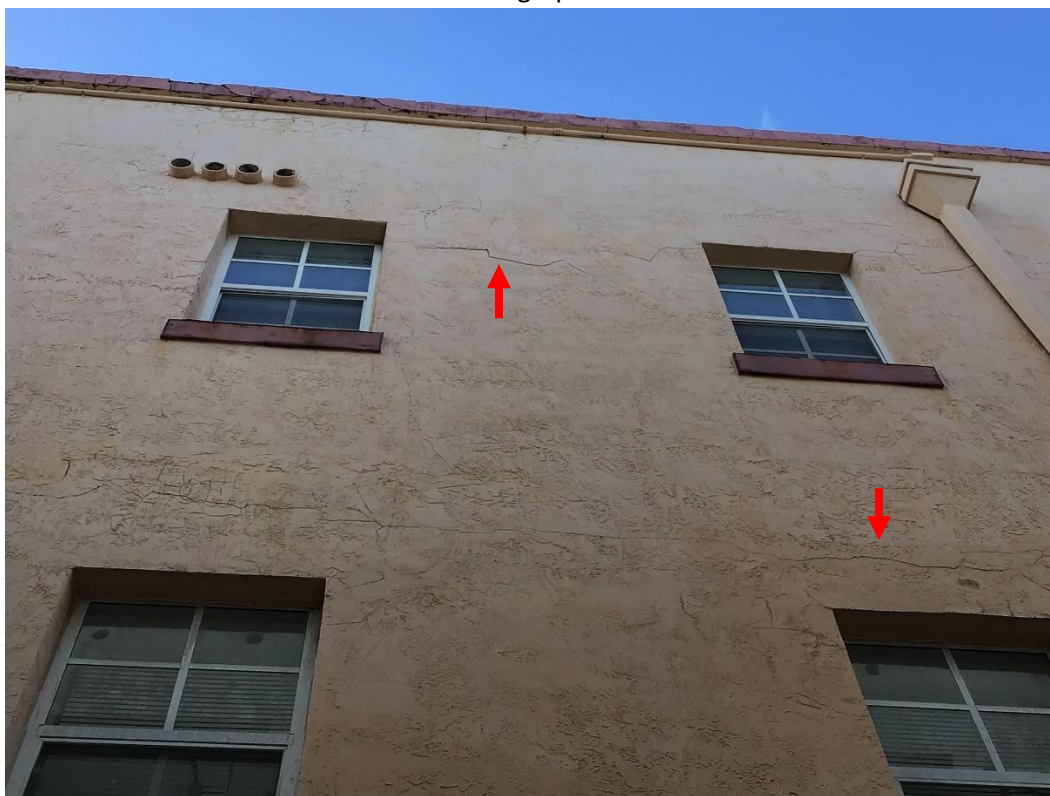
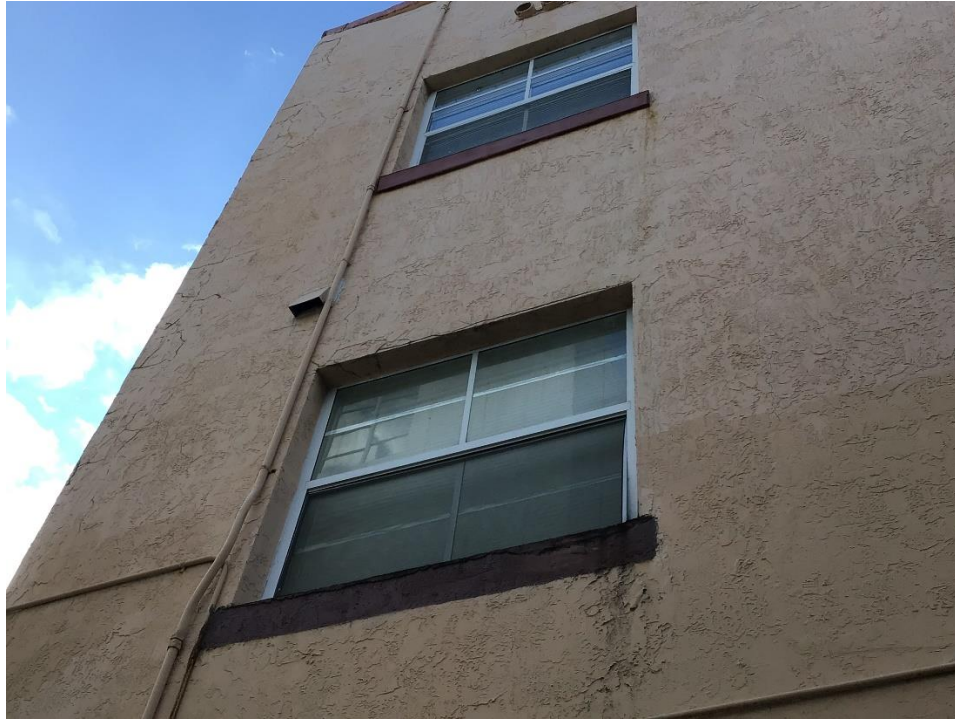
| Item | Repair Priority | Item Description | Representative Photos |
|---|---|---|---|
| S-1 | Immediate | General condition of stucco/façade throughout building. Cracks and delaminations observed throughout. | Photos #1 to #5 |

Overall, the structure is in fair condition with several areas of concern. There are cracks and delaminated areas on the building exterior that need to be repaired. On the east stair, delaminations at the third floor landing were observed on the walls. At the ground floor, the stair is shored due to damage caused by concrete spalls/delaminations. Stair access is limited due to the shoring leaving the building with one means of egress.

Given the age of the building and corrosive environment, spalls/delaminations are expected and do not pose an immediate unsafe condition. If left unresolved, however, these areas will worsen increasing the damaged area requiring repair and creating an unsafe condition. Delaminated portions of the structure will eventually spall off and fall to the ground. If left untreated, cracks can become spalls and delaminations. As water seeps into the unsealed cracks, the reinforcement corrodes which expands and loosens the concrete.

- Replace broken window.
- Repair/Replace roof top AC units.
- Stucco and repaint the exterior of the building.
- Concrete Repair:

Epoxy Injection: Cracks that are in sound concrete (do not have corrosion stains, sound hollow when struck with a hammer indicating delamination, etc.) and have a crack width between 0.005 and 0.25 inches may be injected with an epoxy resin. Prior to epoxy injection, cracks being repaired shall be cleaned to remove any loose debris and organic material.

Concrete Spall/Delamination Repair (without reinforcement): Concrete that is not sound (loose, delaminated, etc.) shall be removed and the sound concrete surface shall be cleaned of any debris and organic material. The area being repaired shall be saw cut to a minimum depth of 1-1/2 inches and form a square/rectangular area with 90 degree sides. Interior corners should be rounded to a minimum radius of 1 inch. Feather edges must be avoided. The area receiving new concrete shall be roughened/keyed in order to provide adequate bond. A bonding agent may be provided in addition for added bond or as a substitute to roughening the concrete surface. Once the area has been prepped, patch with repair mortar that is suitable for extremely aggressive environments.

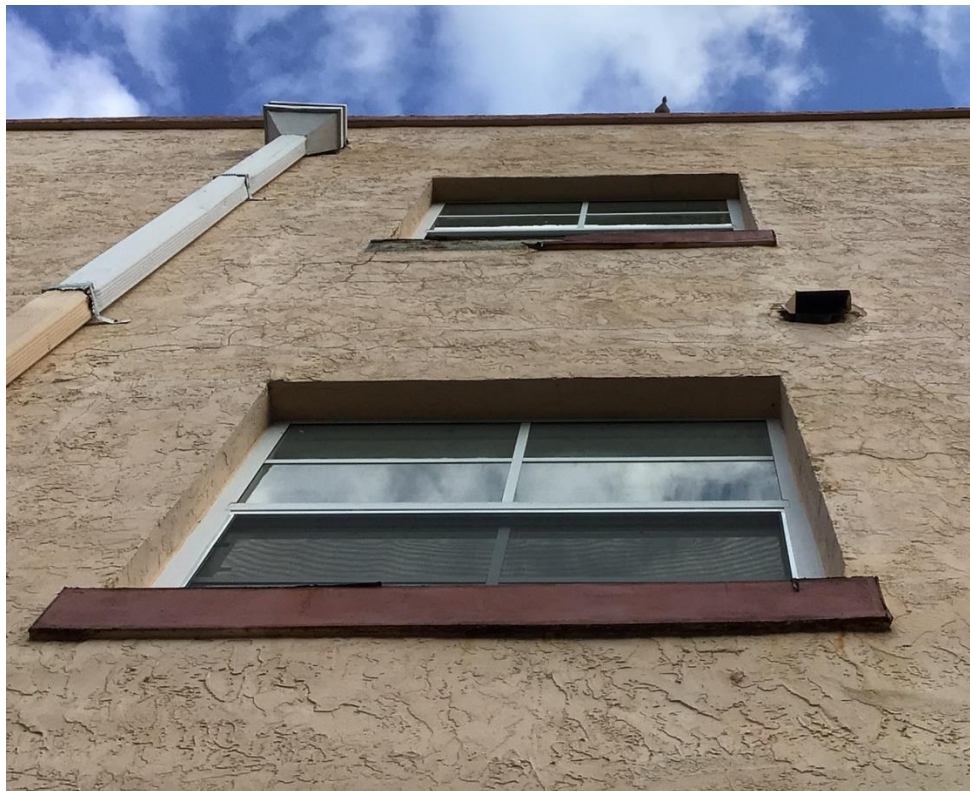
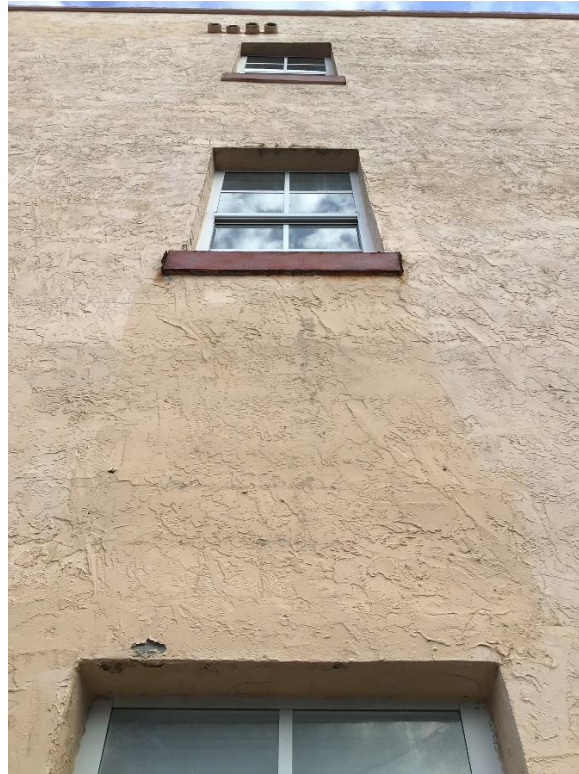
| Item | Repair Priority | Item Description | Representative Photos |
|---|---|---|---|
| S-2 | Immediate | General condition of stucco/façade throughout building. Some sills were observed to have spalled off. | Photos #6 to #7 |

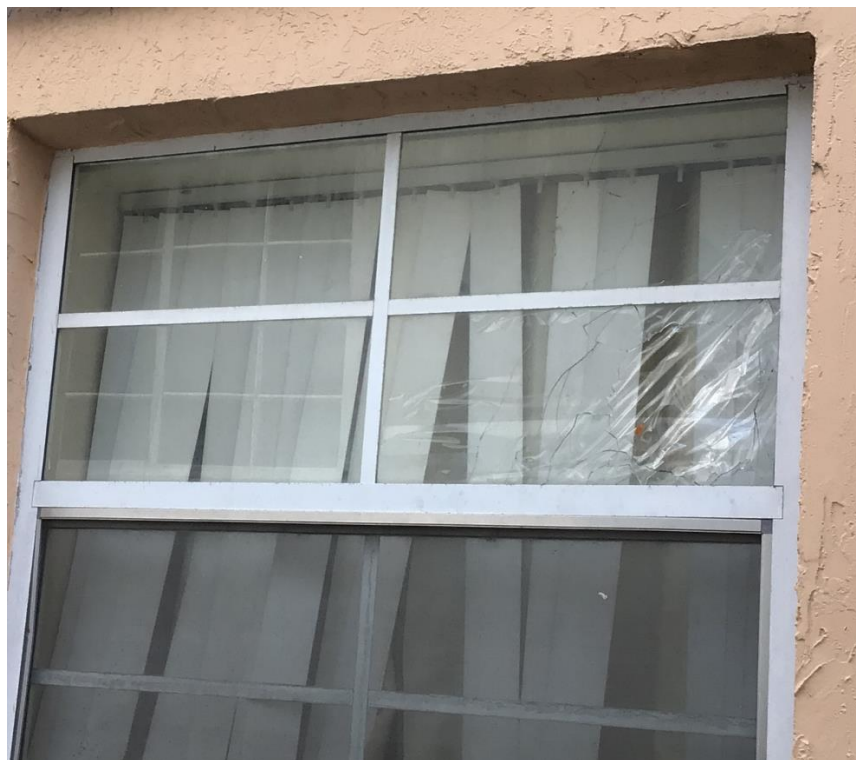
Photograph #8

| Item | Repair Priority | Item Description | Representative Photos |
|---|---|---|---|
| S-3 | Immediate | Broken window. | Photo #8 |

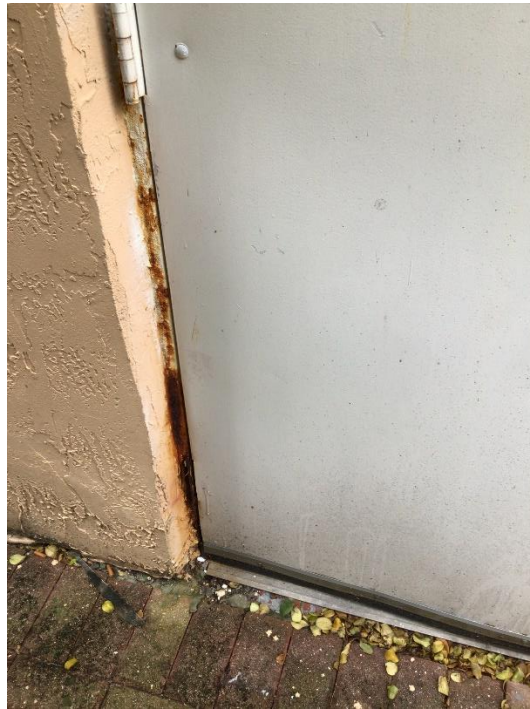
Photograph #9

| Item | Repair Priority | Item Description | Representative Photos |
|---|---|---|---|
| S-4 | 5-Years | Door frame oxidizing. | Photo #9 |

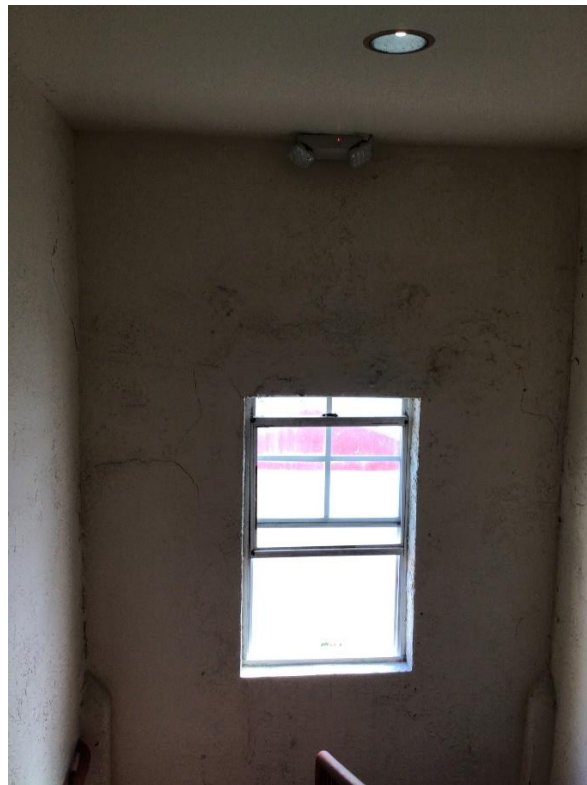
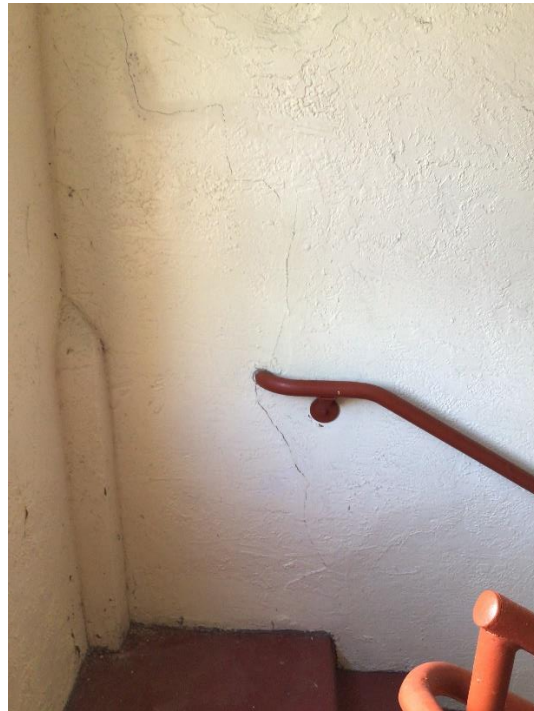
| Item | Repair Priority | Item Description | Representative Photos |
|---|---|---|---|
| S-5 | Immediate | Spalls/Delaminations on exterior wall of east stair. | Photos #10 & #11 |

Concrete Spall/Delamination Repair (with reinforcement): Remove concrete that is not sound (loose, delaminated, etc.) above oxidized (corroded) reinforcement beginning with a 1/2" deep saw cut perimeter. Use only light, 15 LB electric chipping hammers. Once initial removal is complete, proceed with the undercutting of all exposed oxidized reinforcement providing 1" minimum clearance between exposed reinforcement and sound concrete. Concrete removal shall extend along oxidized reinforcement to a location that is free of bond inhibiting

Oxidized reinforcement shall be sandblasted or mechanically cleaned. Splice reinforcement with equal size bar where section loss of 15-20% occurs. All exposed reinforcement shall be coated with a corrosion inhibitor. Patch area with repair mortar that is suitable for extremely aggressive environments.

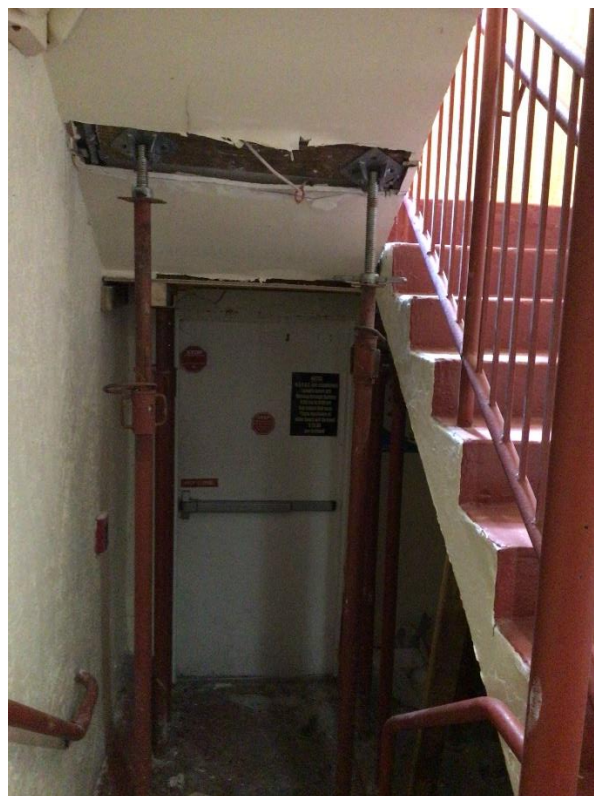
Photograph #12

| Item | Repair Priority | Item Description | Representative Photos |
|---|---|---|---|
| S-6 | Immediate | East stair shored due to concrete spalls. | Photo #12 |

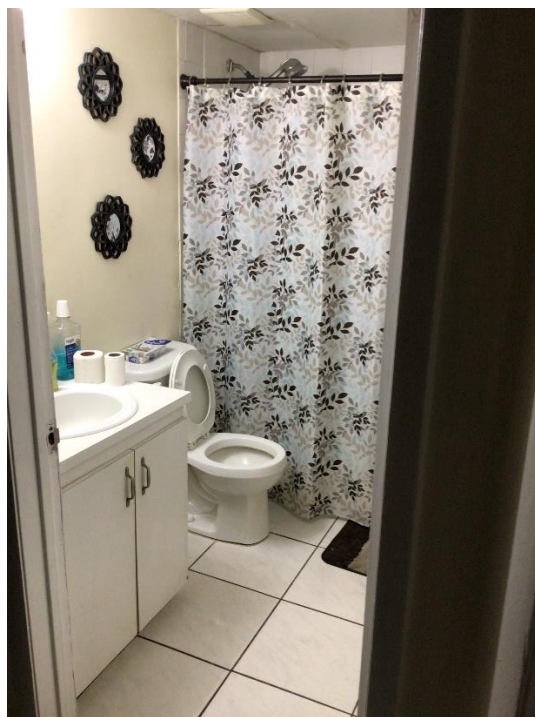
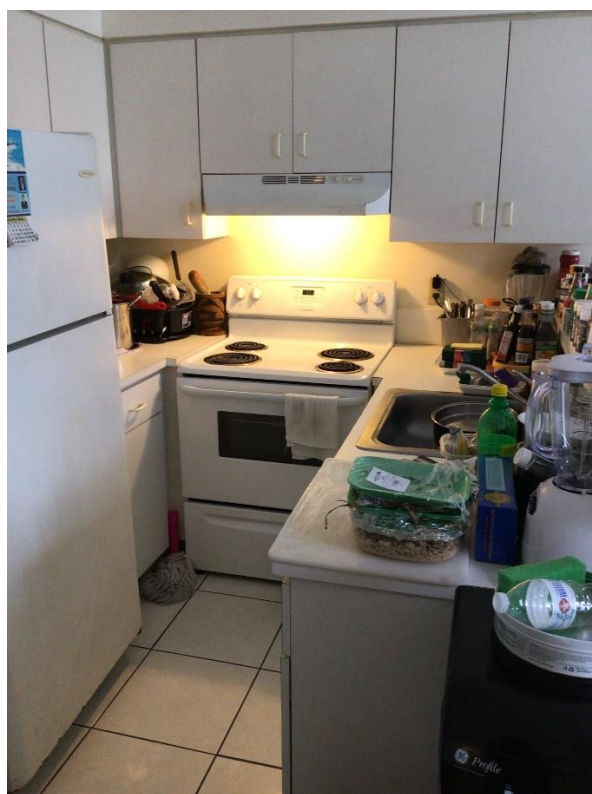
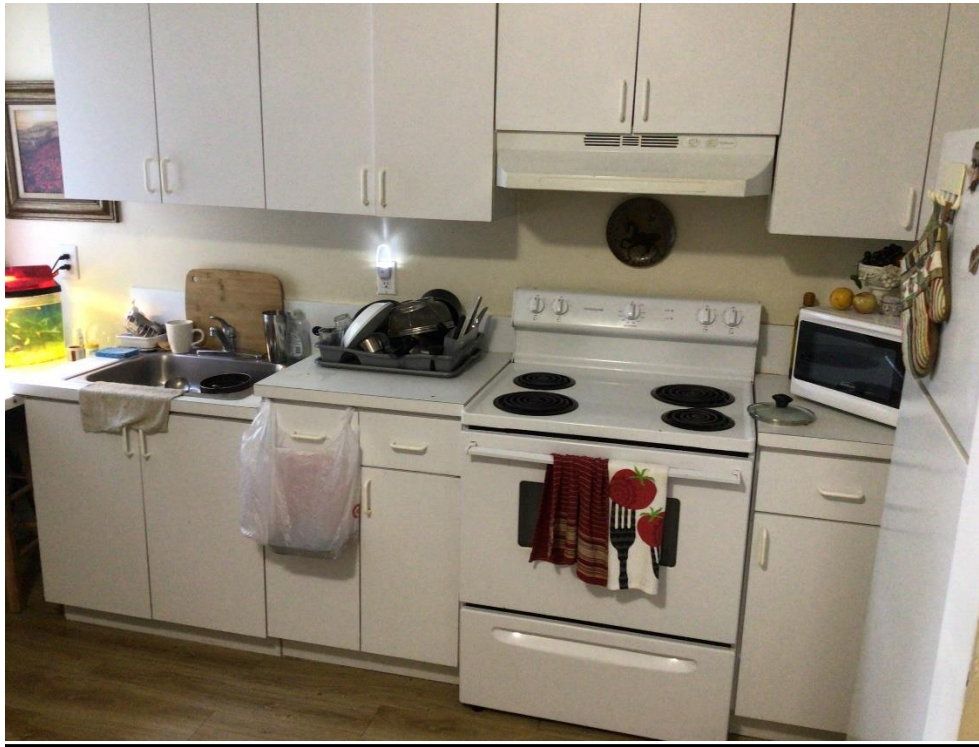
| Item | Repair Priority | Item Description | Representative Photos |
|---|---|---|---|
| S-7 | 5-Years | General condition of units. | Photos #13 to 15 |

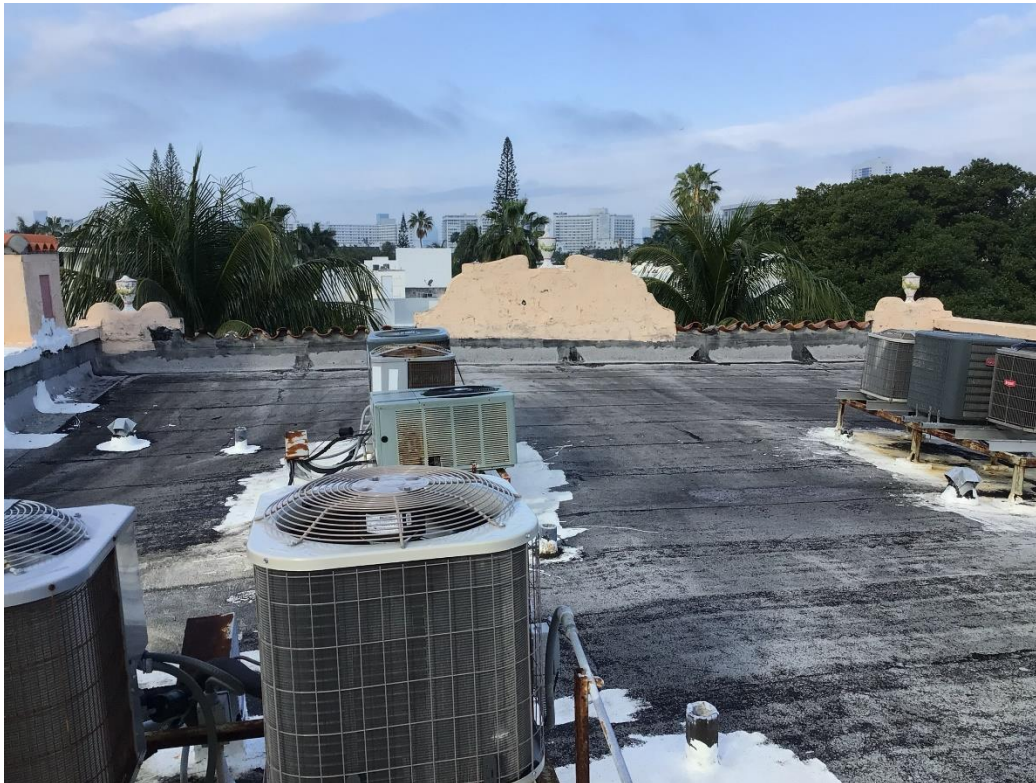
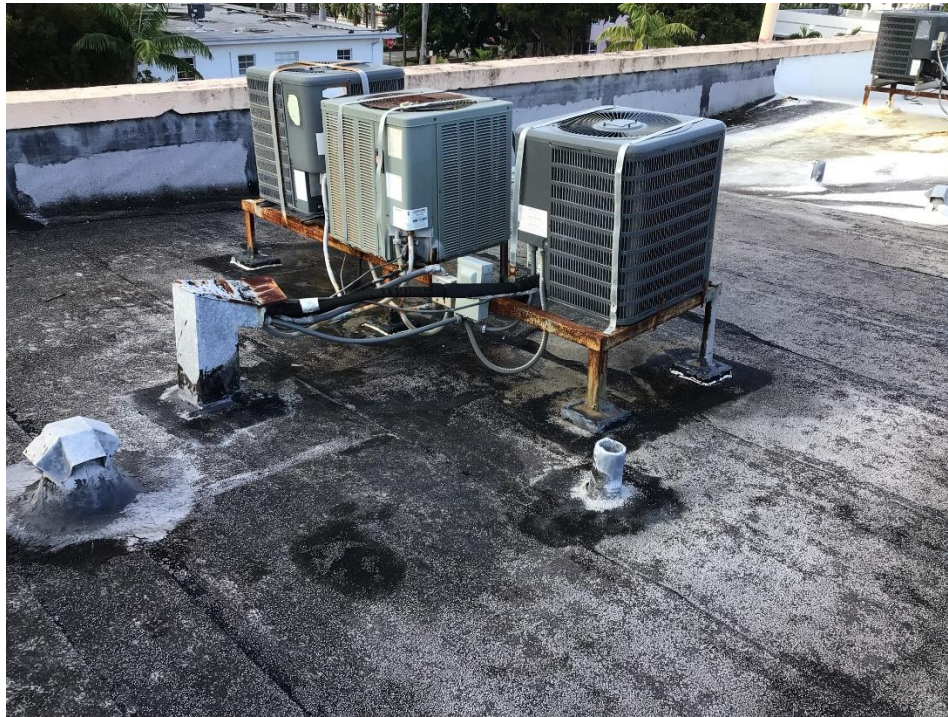
| Item | Repair Priority | Item Description | Representative Photos |
|---|---|---|---|
| S-8 | 5-Years | General condition of roofing and roof top AC units. | Photos #16 to #17 |

Corrosion was observed on the AC stands at the roof. The roofing has patchwork throughout the entire work. Some bubbles in the roofing membrane were observed. Water ponding at the center of the roof was observed due to minimal sloping of the roofing.

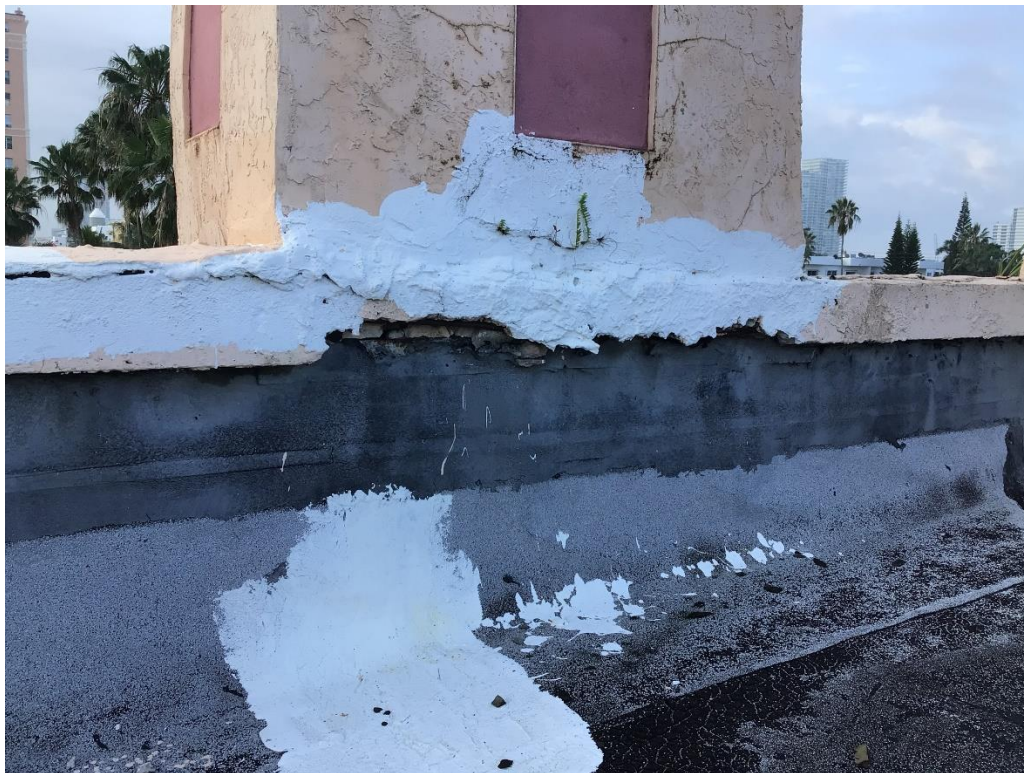
Photograph #18

| Item | Repair Priority | Item Description | Representative Photos |
|---|---|---|---|
| S-9 | 5-Years | General condition of stucco and roofing along perimeter. | Photo #18 |
