CHECKLIST ITEM I & K SITE AND SURROUNDING PHOTOS

NOTES: THE PROJECT IS LOCATED AT 301 OCEAN DRIVE, MIAMI BEACH, FL

PROJECT: 301 Ocean Drive_SOBE

CHECKLIST ITEM H SITE PHOTOS

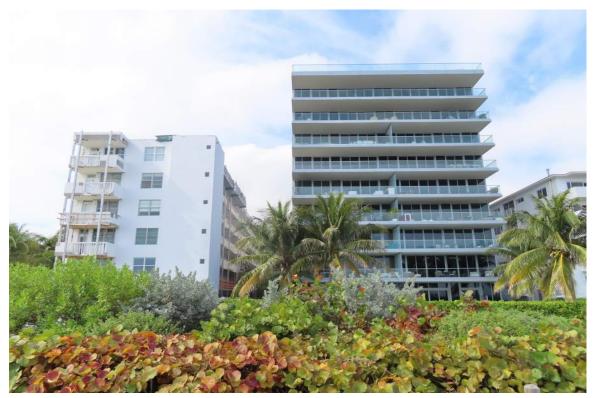
Figure 1: East face of 301 Ocean Drive (left) and 321 Ocean Drive (right).

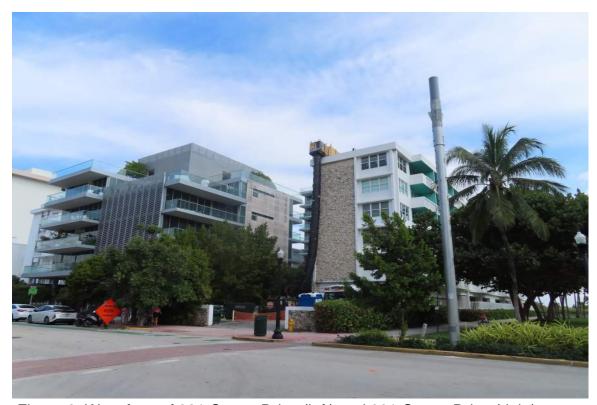
Figure 2: West face of 321 Ocean Drive (left) and 301 Ocean Drive (right).

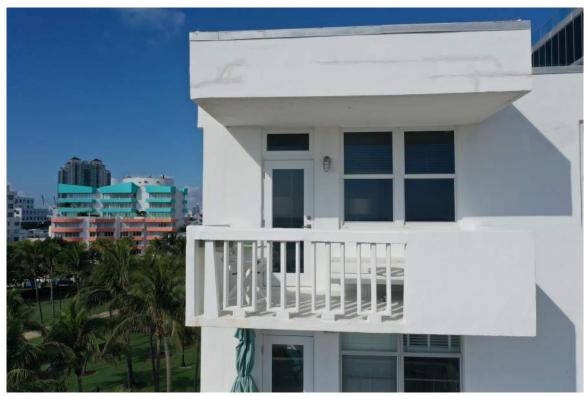
Figure 1: East balcony at 6th floor with existing precast decorative railing.

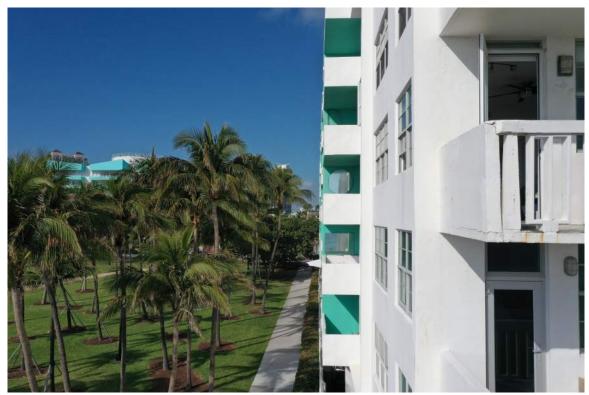
Figure 2: Existing South and East balconies.

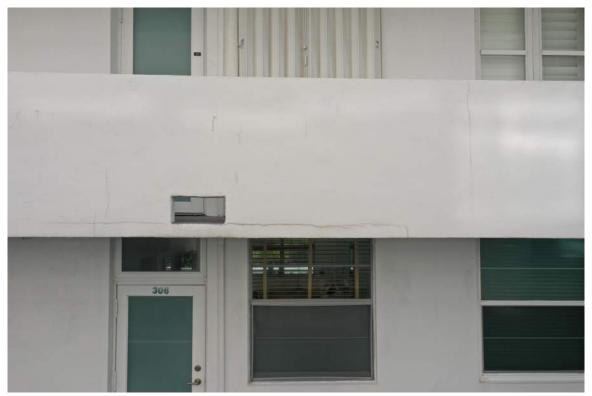
Figure 3: Existing North catwalks with signs of cracking and deterioration.

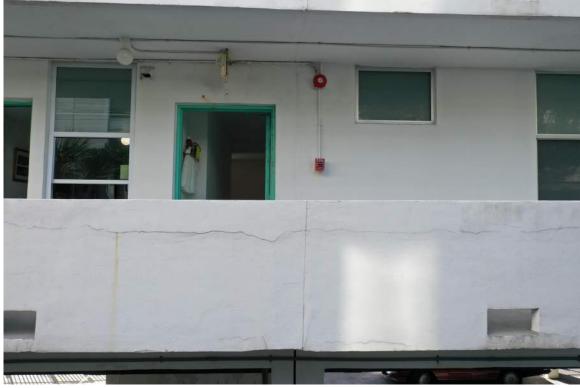
Figure 4: Existing North catwalks with signs of cracking and deterioration.

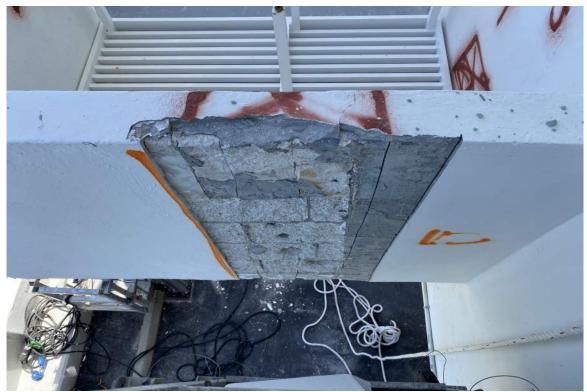
Figure 5: Condition of existing masonry walls at East balcony.

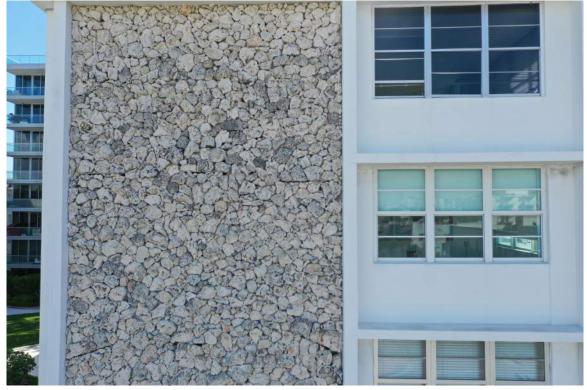
Figure 6: General view of West elevation.

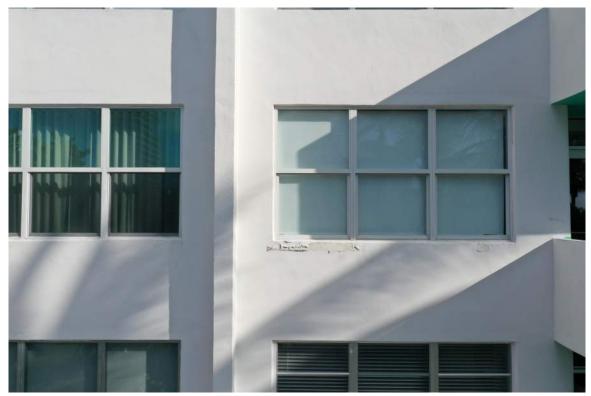
Figure 7: Photo taken at Level 2 along south building face.

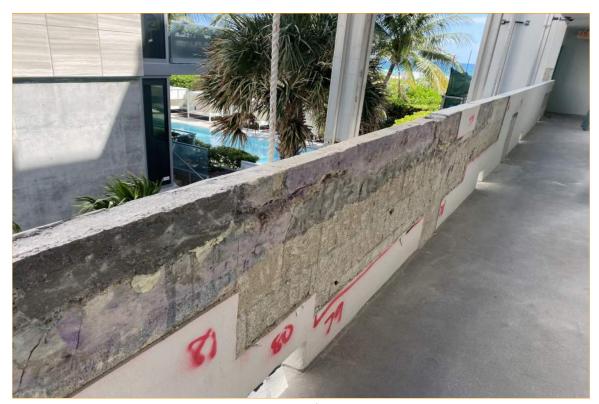
Figure 8: Existing deteriorated condition of masonry wall at North catwalks.

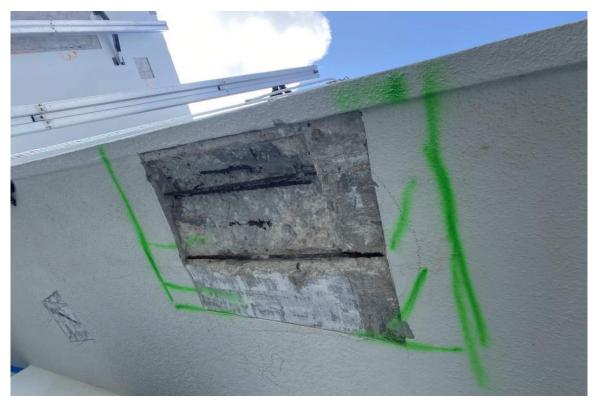
Figure 9: Probing performed on underside of concrete slab at North catwalk revealing extent of deterioration and previous repairs.
