## A-012 Exploratory Photos

5757 La Gorce, Miami Beach FL  
Design Review Board Final Submittal

File # DRB22-0824

## A-013 Exploratory Photos

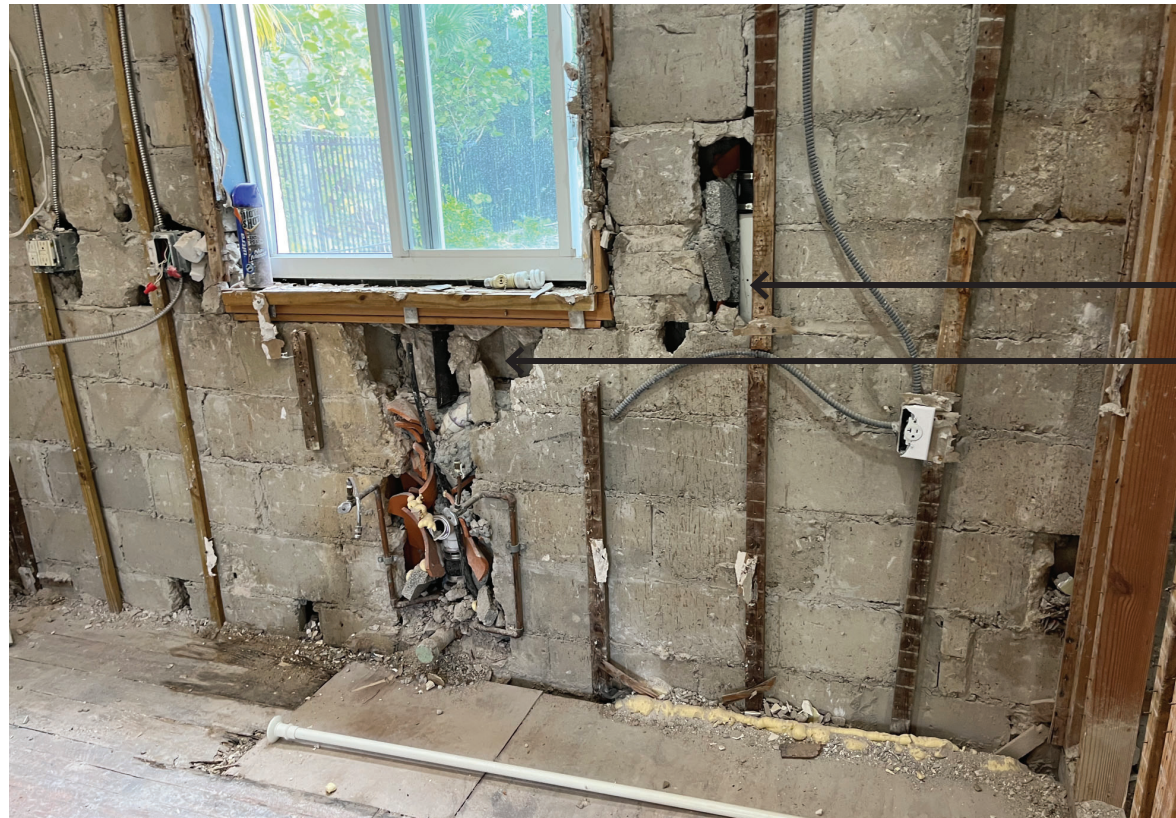
OPENINGS  
IMPROPERLY  
FILLED

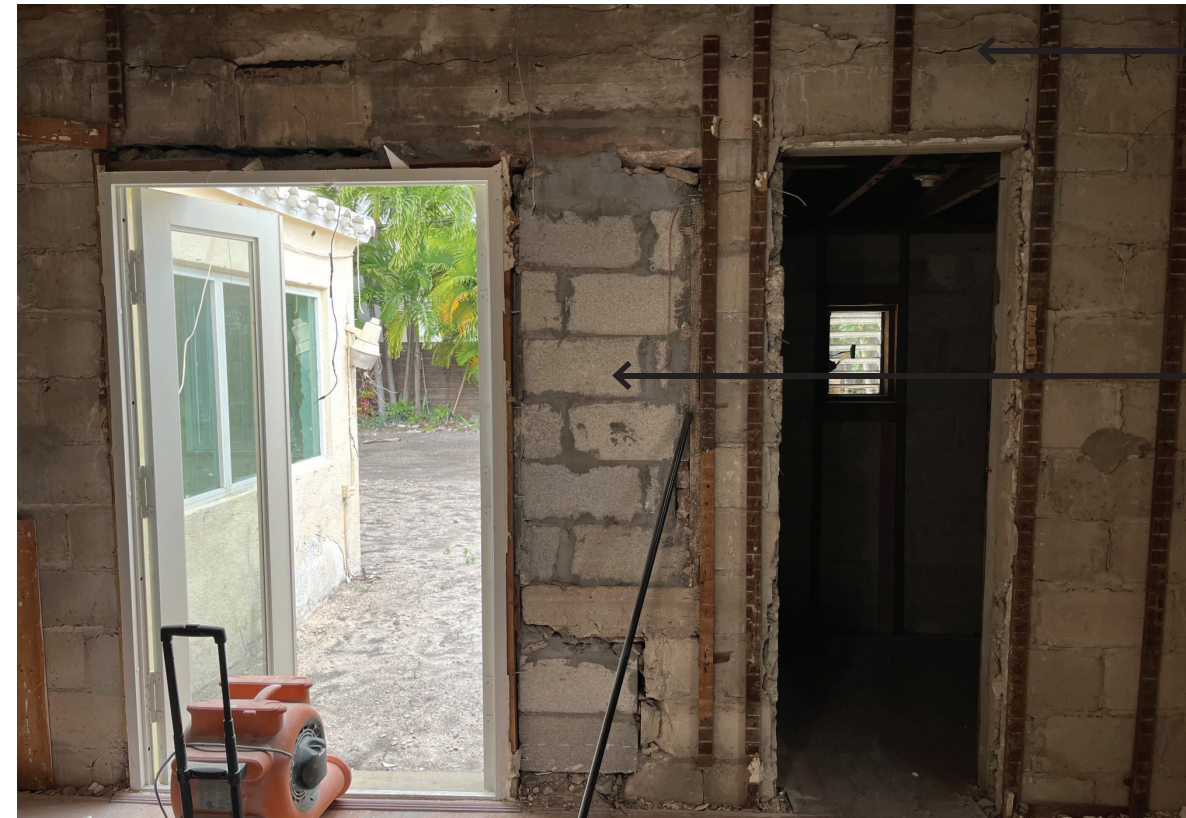
EXTENSIVE SPALLING  
AT UPPER AND LOWER  
REBAR OF TIE BEAM.  
REBAR FULLY EXPOSED  
AND DETERIORATED

OPENINGS  
IMPROPERLY  
FILLED

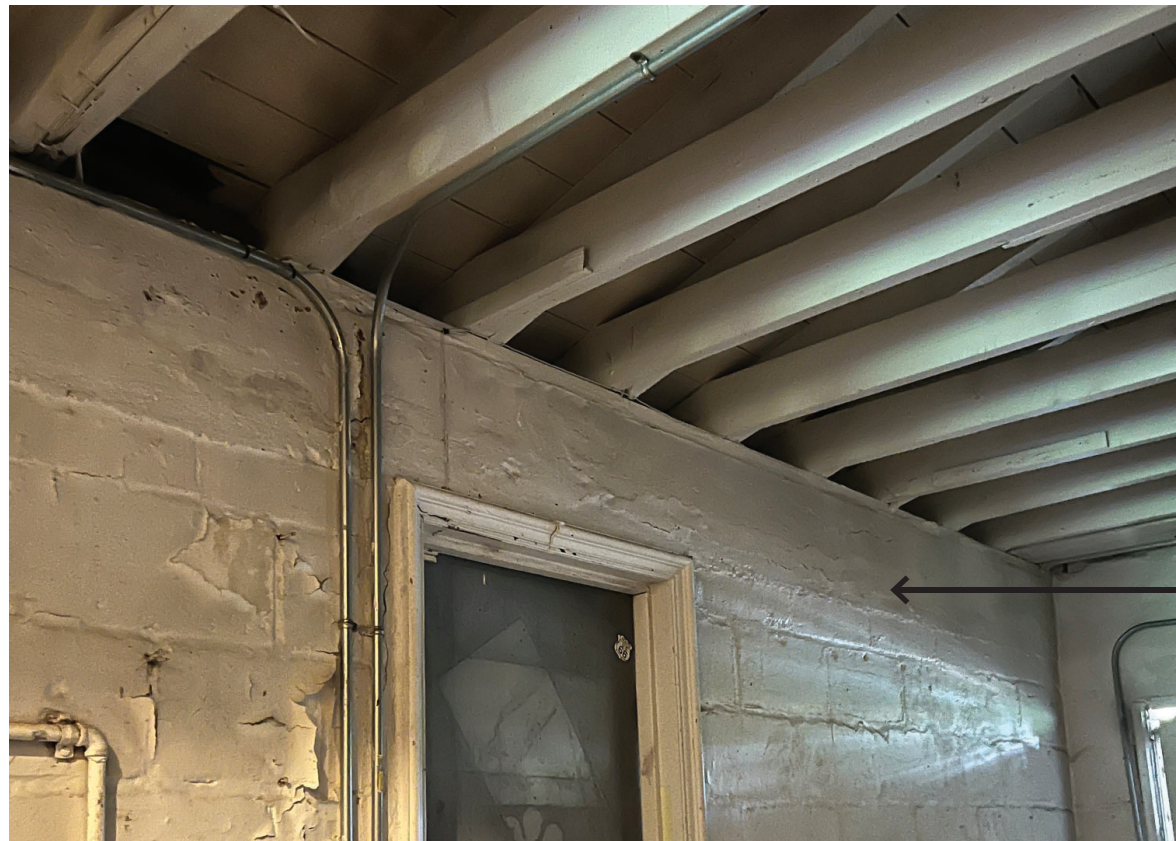
EVIDENCE OF  
SPALLING

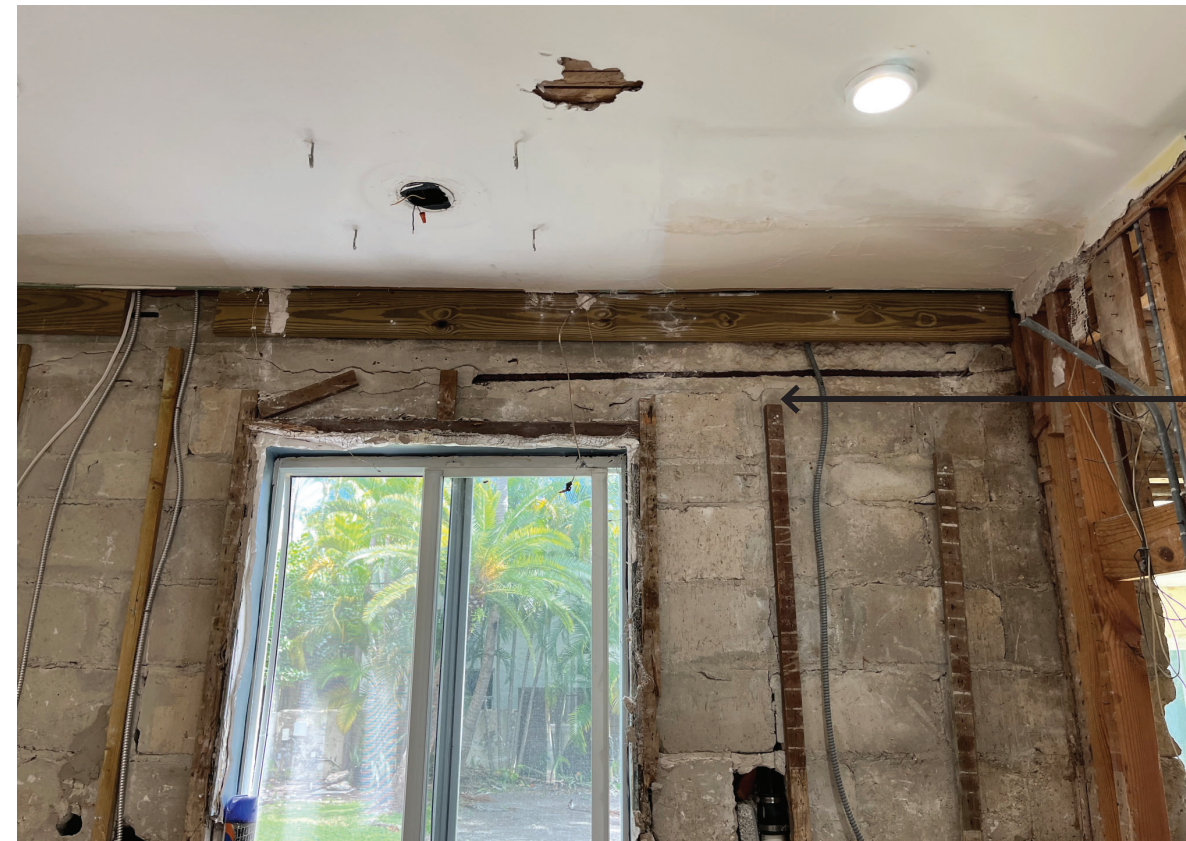
EXTENSIVE SPALLING  
AT UPPER AND LOWER  
REBAR OF TIE BEAM.  
REBAR FULLY EXPOSED  
AND DETERIORATED

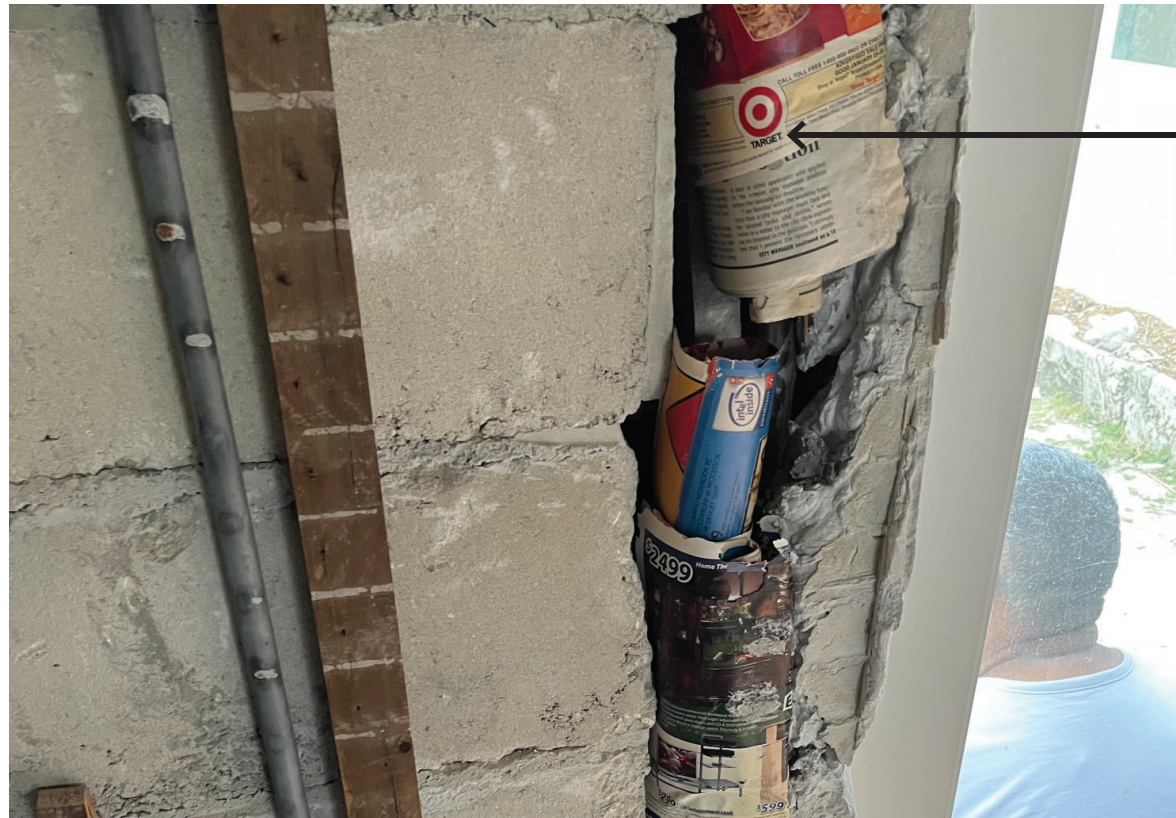
DOORS IMPROPERLY  
INSTALLED, NO TIE  
COLUMNS, NO BLOCK

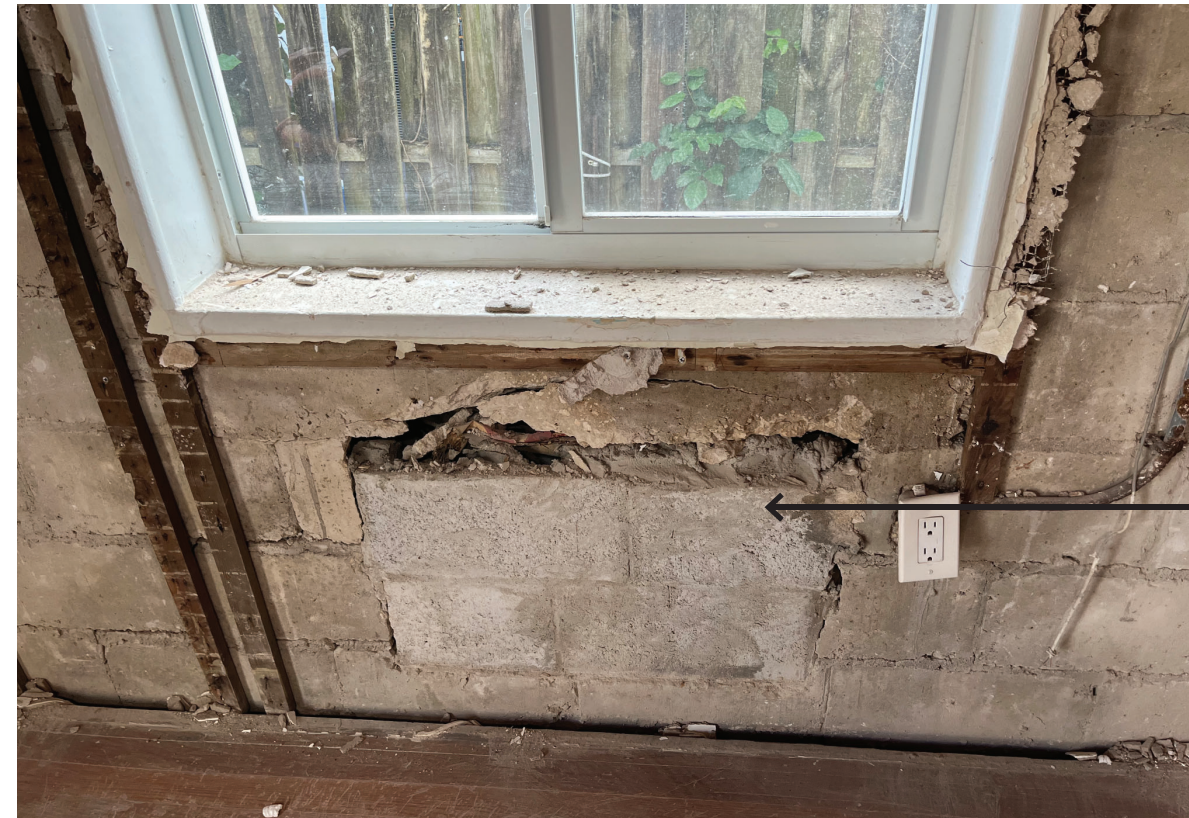
OPENINGS  
IMPROPERLY FILLED

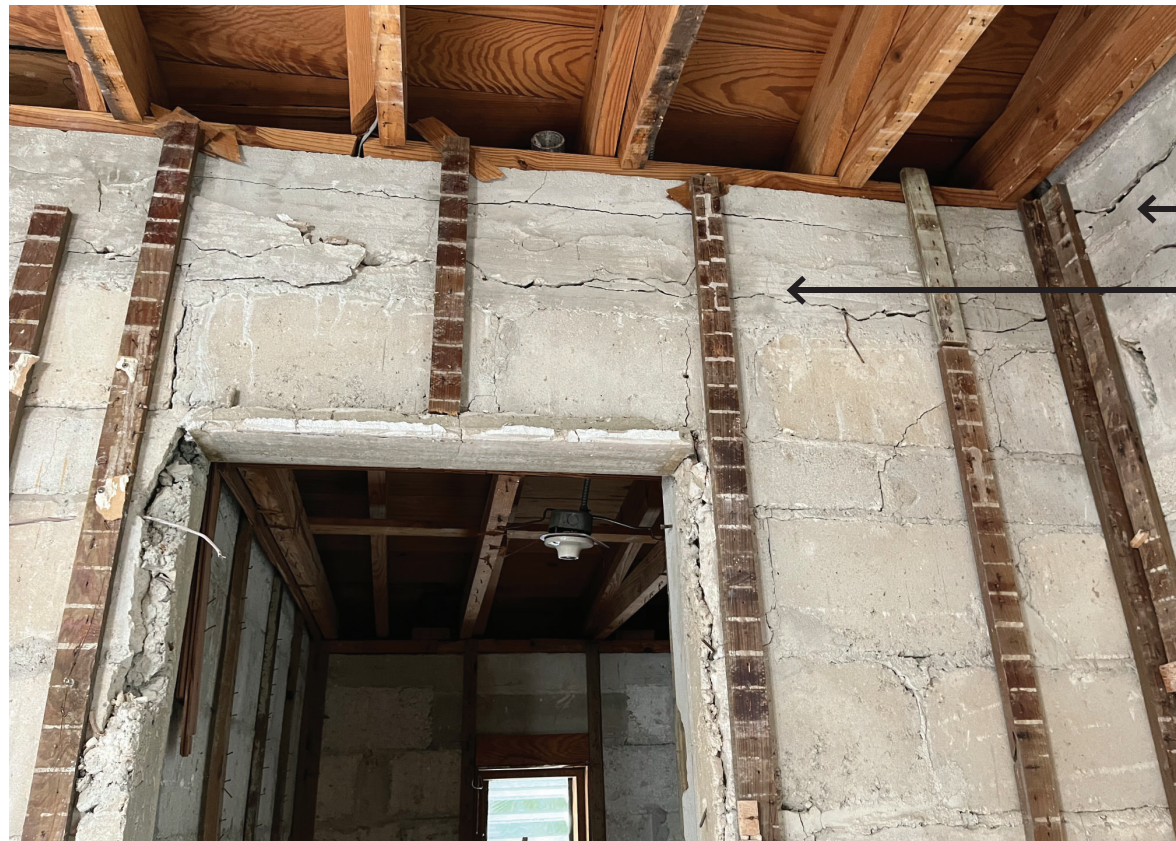
EXTENSIVE SPALLING  
AT UPPER AND LOWER  
REBAR OF TIE BEAM

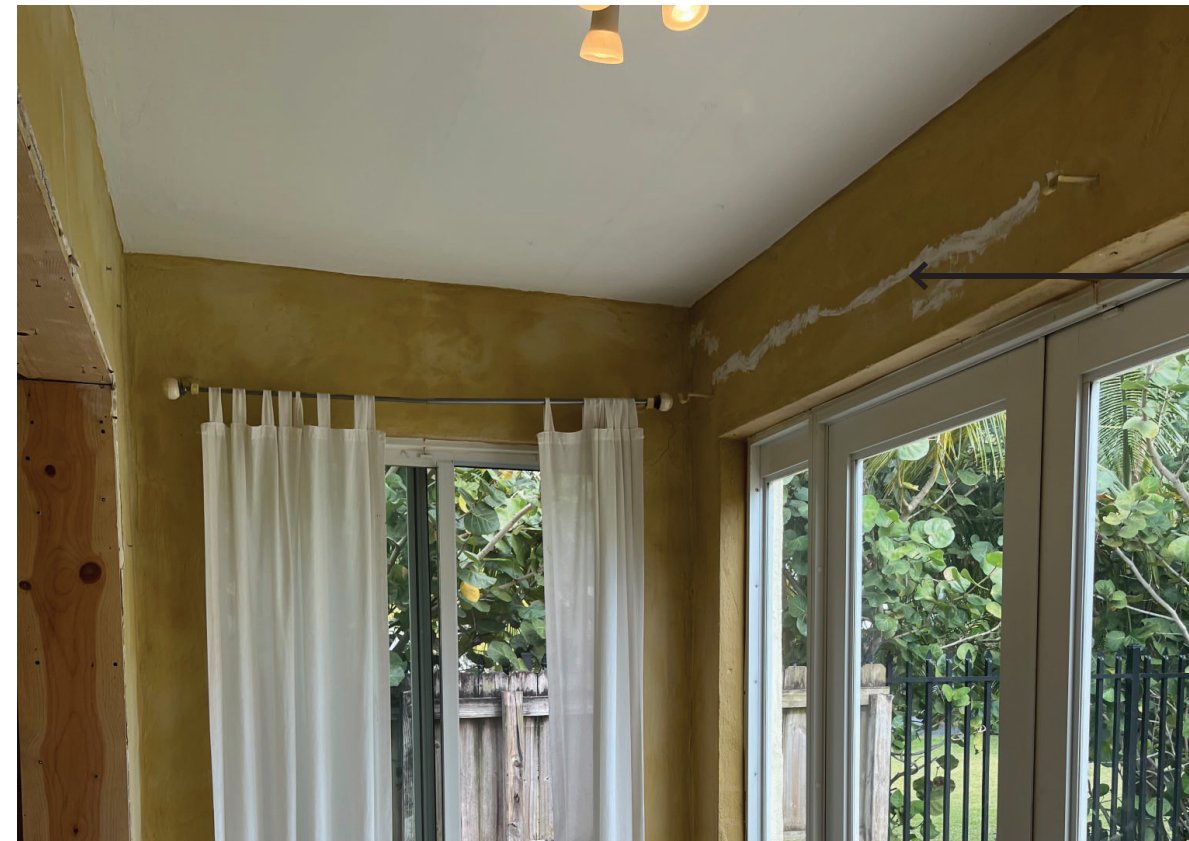
EVIDENCE OF  
SPALLING
