RE: **DRB22-0824** – Letter of Intent – Design Review of Proposed
Comprehensive Landscaping located at 5757 La Gorce Drive,
Miami Beach, Florida

STRUCTURAL CONDITION ASSESSMENT
5757 La Gorce Dr
Miami Beach, Florida.

STRUCTURAL CONDITION ASSESSMENT for
5757 La Gorce Dr
Miami Beach, Florida

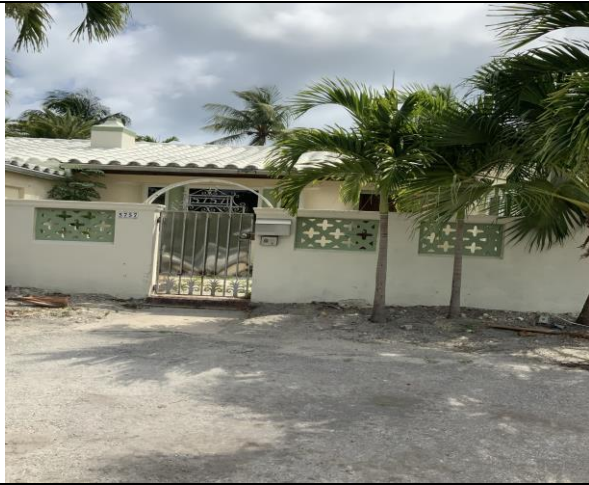
Front Elevation of the Building

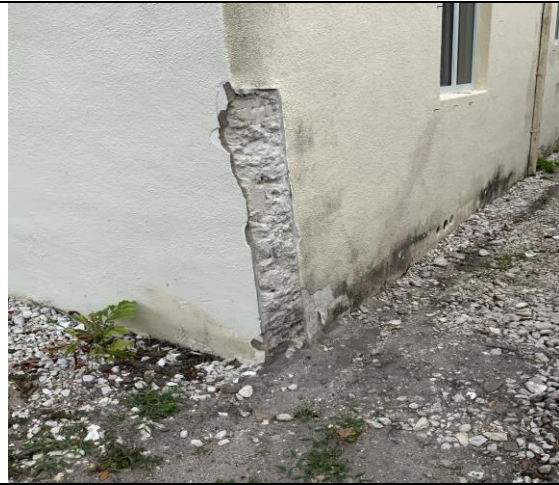
Delaminated Stucco and Spalling Concrete

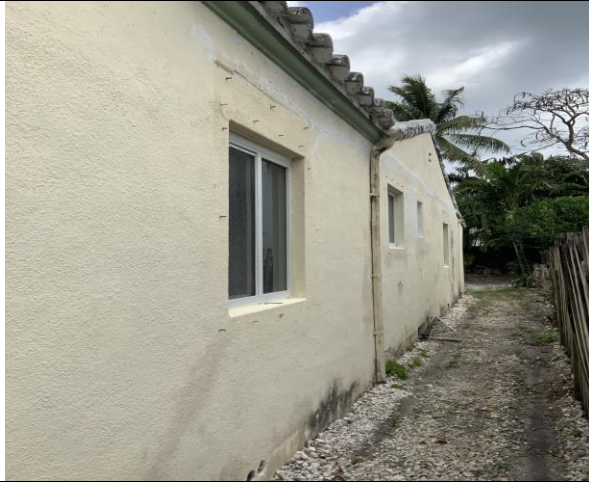
Side View of the External Walls

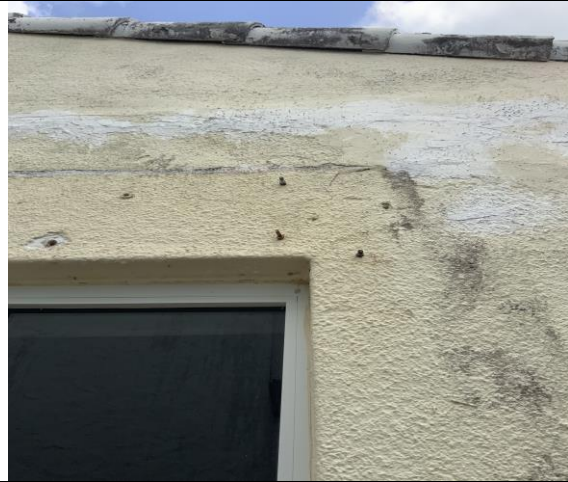
Masonry members; which comprise the exterior walls of the building, the external face seems to be in fair condition for the most part because stucco has been applied to cover the spalling and the cracks, however the inside face of the external walls tells us another story, it is really in bad shape both from severe cracking as well as severe concrete spalling on all the concrete elements inside the wall. There are several hairline and more severe cracks in the masonry that are attributed to age, exposure to the elements, and settlement of the shallow foundations. As well as major cracks, spalling & deterioration on other areas of the building.

Delaminated Stucco on External Walls

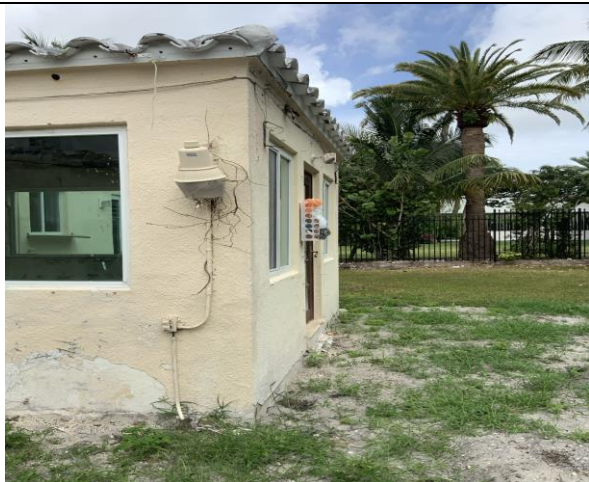
Delaminated Stucco and loose Electrical Connections

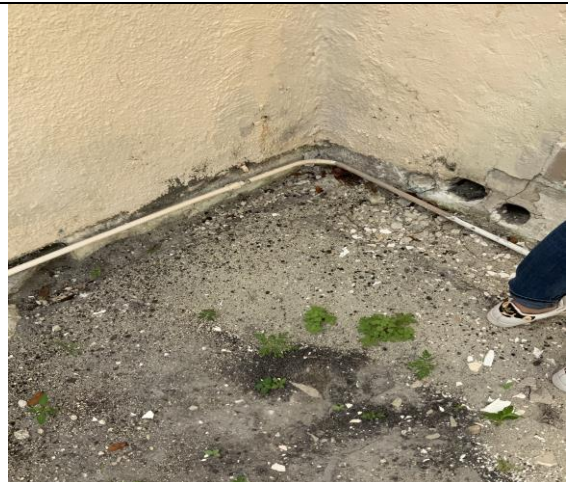
Deterioration at the Base of the Wall

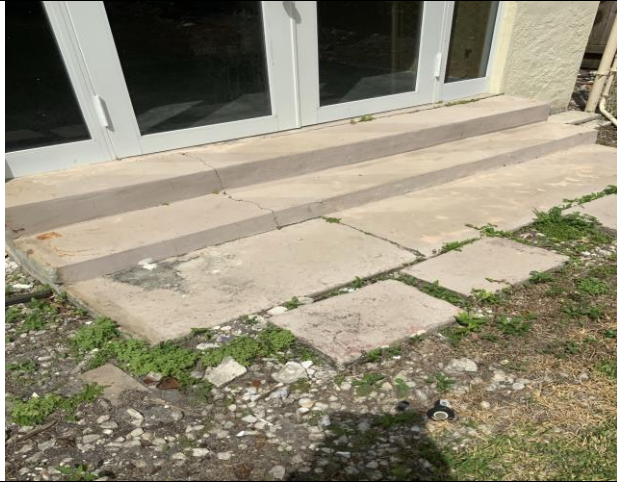
Cracks and loose Entrance Steps

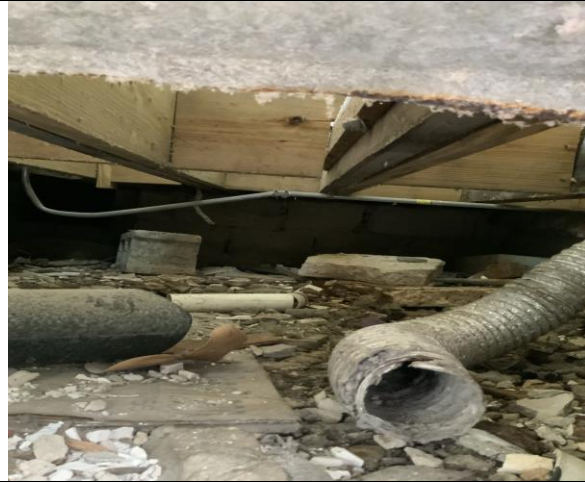
Crawl Space in poor condition due to Termites

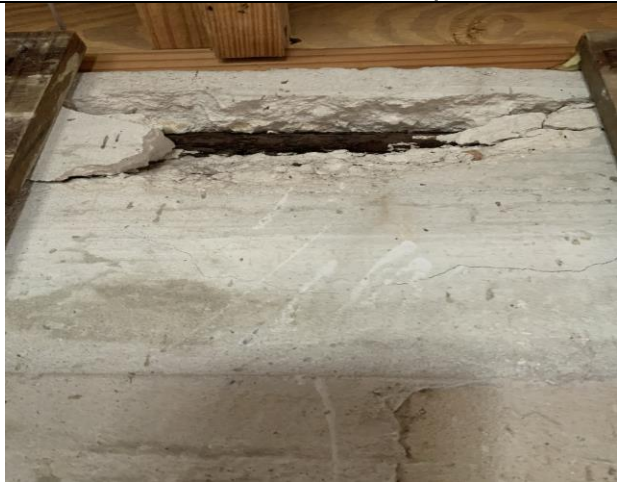
Spalling Concrete @ the Beam

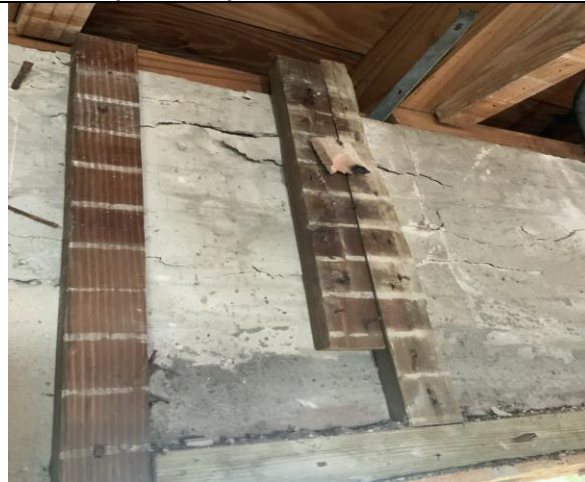
Spalling Concrete at top & bottom of Wall

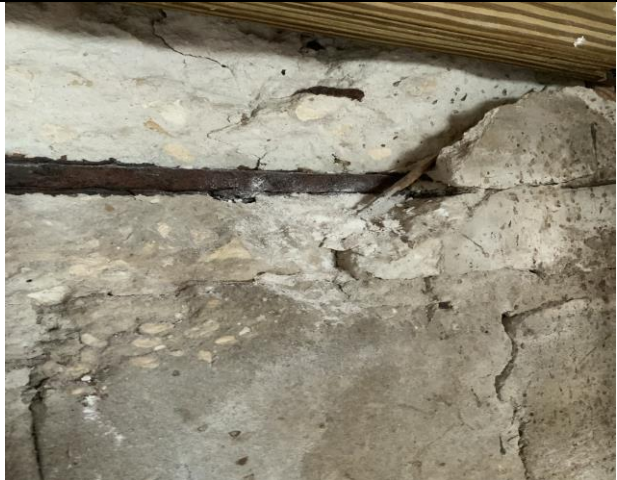
Excessive Concrete Spalling at the Beam

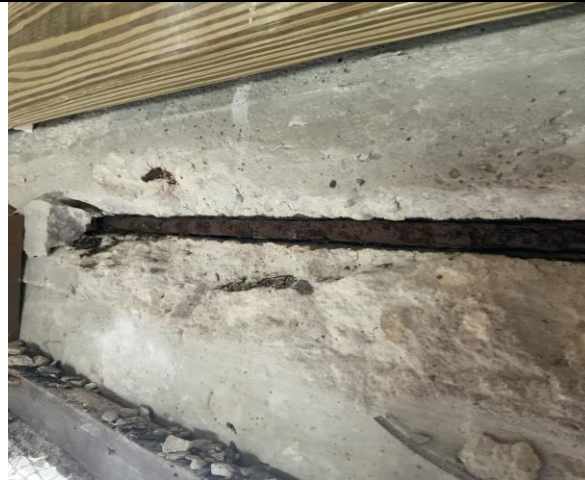
Excessive Concrete Spalling and Rebar Rusting

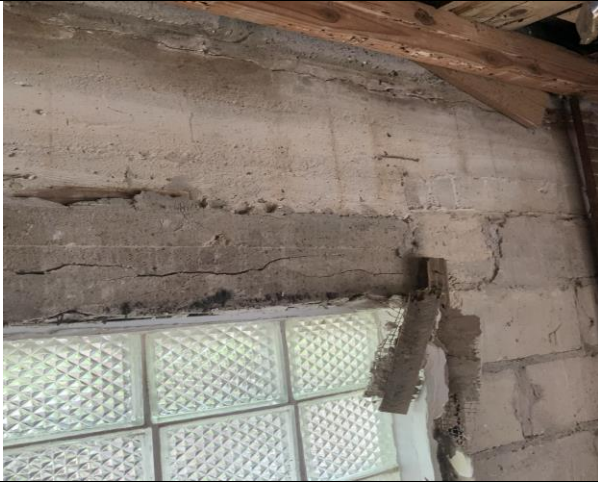
Cold Joints and excessive cracking and spalling

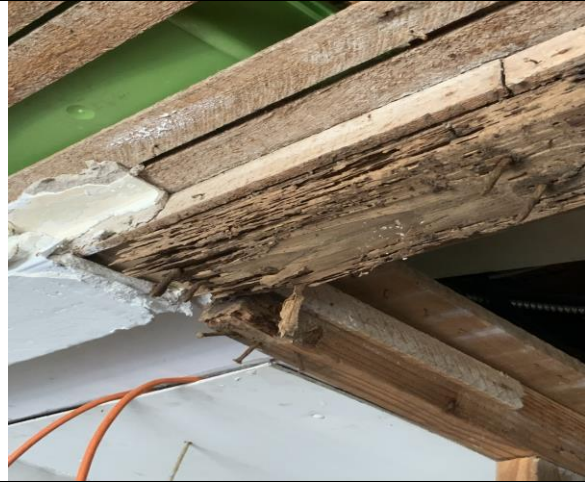
Wood members; The roof of the structure has failed in multiple locations, and the termite damages have caused severe and extensive damage to all the wood members of the building (please see photos). There is rot damage of wood, that

Wood Joists attacked by Termites

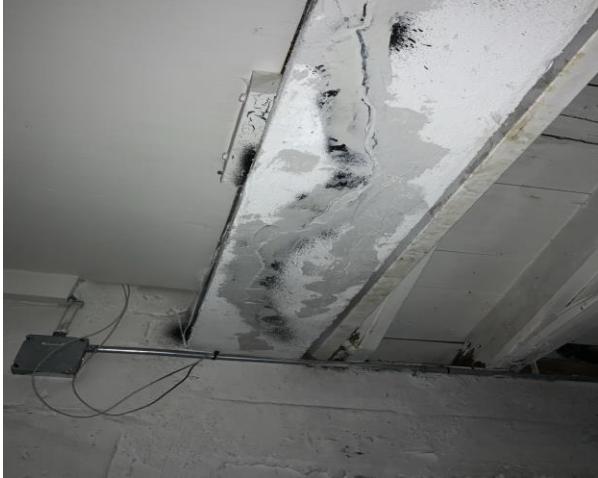
Excessive Beam Cracking and Spalling

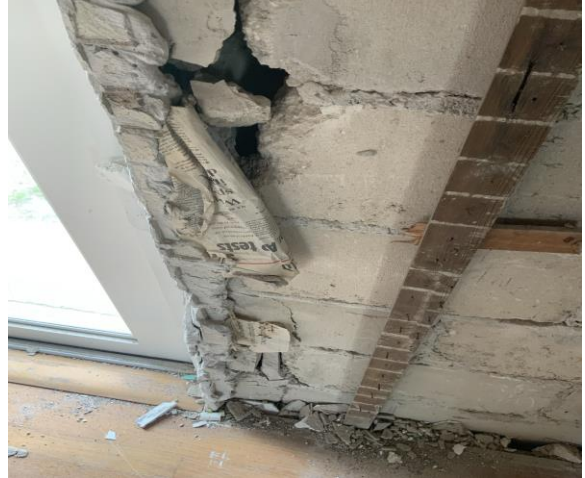
Interior Spalled Door Jam

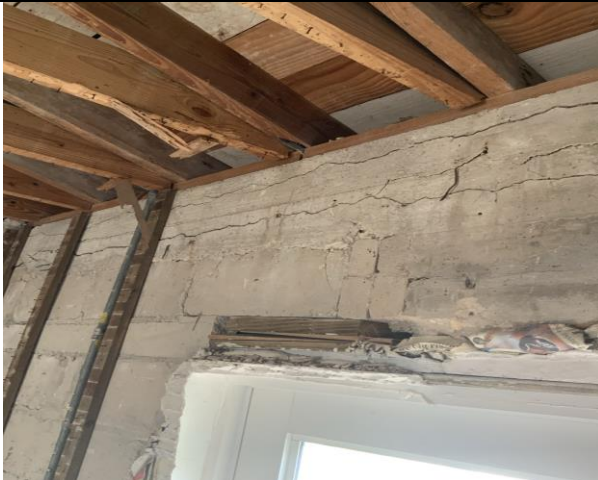
Excessive concrete spalling and wood Joist damage

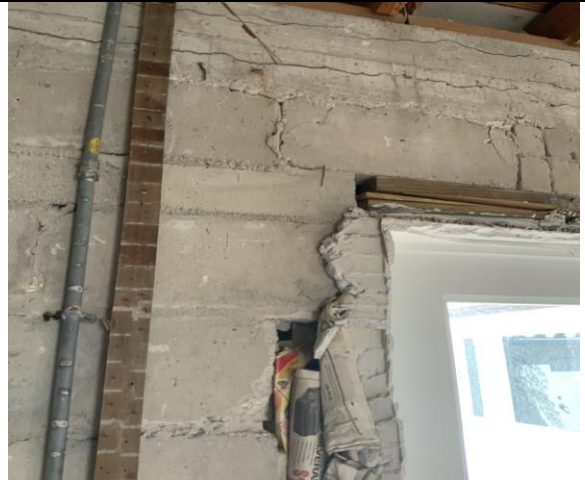
Severe Cracking, Concrete Spalling and wooden planks in the wrong place

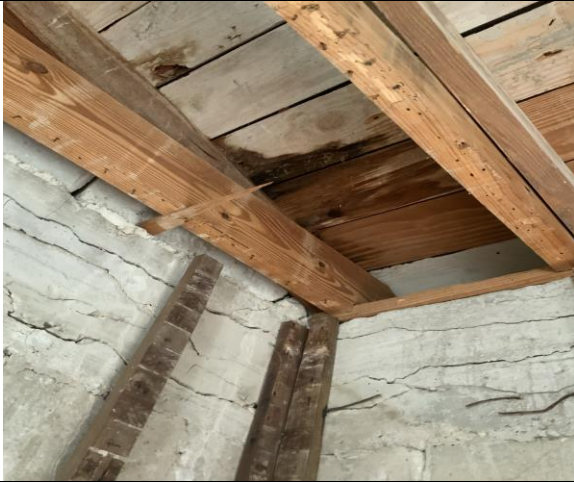
Internal Severe Wall Cracking

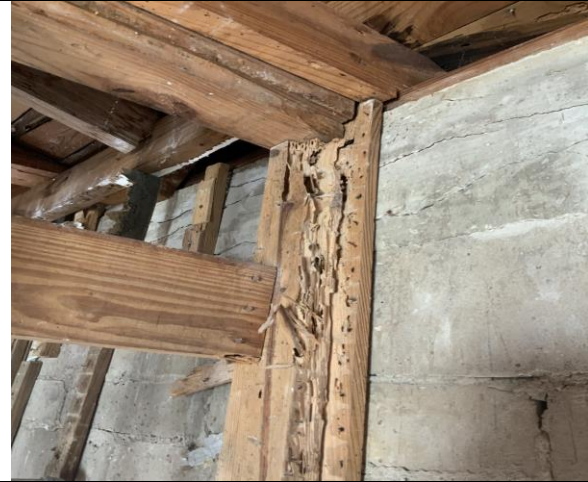
Severe Termite Attack at the wooden Joists
