26 April 2021

**Lot #9 Block 19 on Marseille Dr - Arborist Report**  
**Miami Beach, Fl. 33141-3608**  
**Folio: 02-3210-010-0050**

**Lot #9 - Block 19, Marseille Dr.  
Miami Beach, Florida 33141  
Arborist Report**

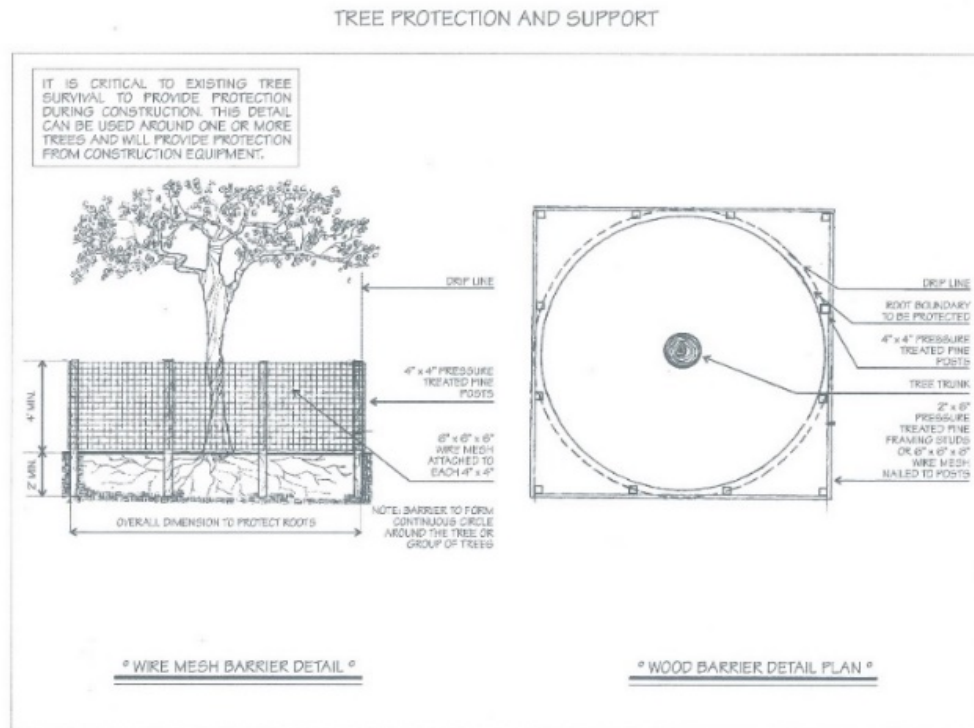
## Tree Protection Detail

Root and trunk protection features have not been established on this lot. The palms that are to remain will require installation of protective features for upcoming activity where machines are expected to travel through the areas adjacent to the palms.

1. Approved tree protection zone barriers shall be constructed to the above diagram specifications unless approved otherwise. Refer to the Miami-Dade County landscape manual.
2. Human traffic, if required within protected root zones, shall be routed on designated mulched paths.
3. Staging areas, material storage and ingress/egress should occur outside any tree protection zone.
4. The canopies of adjacent property trees were inspected and will not be affected by proposed construction.
5. If tree protective measures cannot be constructed in accordance with the above, a reasonable alternative must be proposed by the agent and approved by City of Miami Environmental Resource Department.
