Arborist Report

205 E San Marino Drive
Miami Beach

2/27/2020

Property Location -
205 E San Marino Drive
Miami Beach, FL 33139

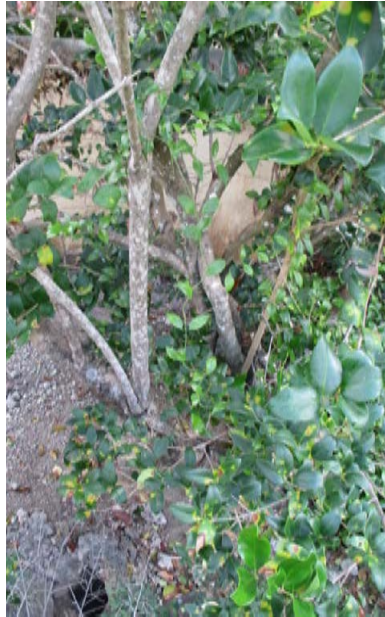
Tree #1 is a Japanese Privet located in the front swale along E San Marino Drive. It is multi-trunked. It is in fair condition - the tree has been shaped and one limb is experiencing dieback (circled in red). There is a foliar spot disease on the leaves.

This tree has not been incorporated into the landscape plan and will therefore be removed.

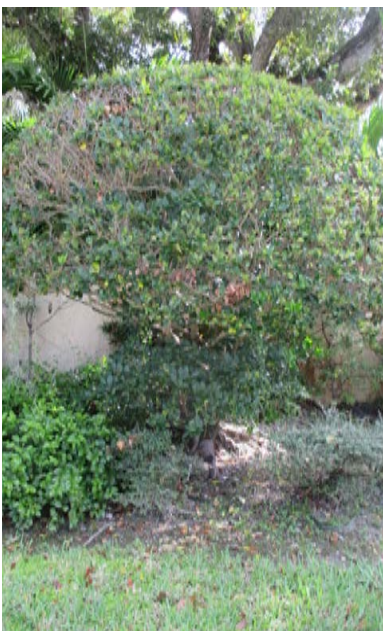
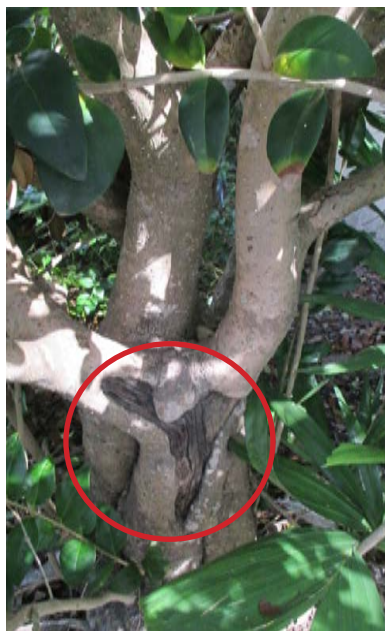
Tree #2 is a Japanese Privet located in the front swale along E San Marino Drive. It is double-trunked. It is in fair condition - the tree has been shaped and there is a wound on one of the trunks (circled in red). There is a foliar spot disease on the leaves.

This tree has not been incorporated into the landscape plan and will therefore be removed.

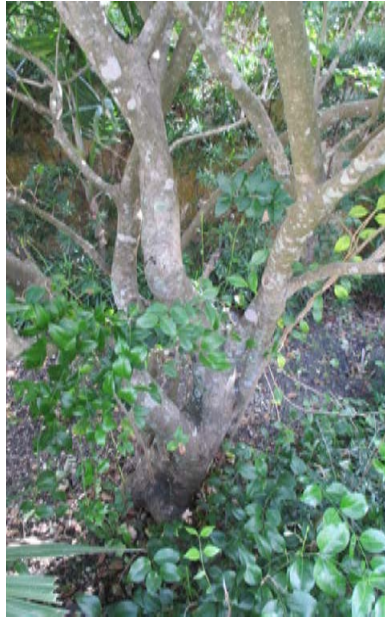
Tree #3 is a Japanese Privet located in the front swale along E San Marino Drive. It is multi-trunked. It is in fair condition and the tree has been shaped. There is a foliar spot disease on the leaves. This tree has not been incorporated into the landscape plan and will therefore be removed.

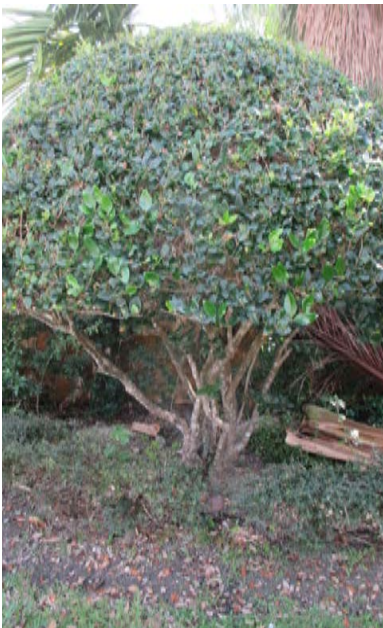
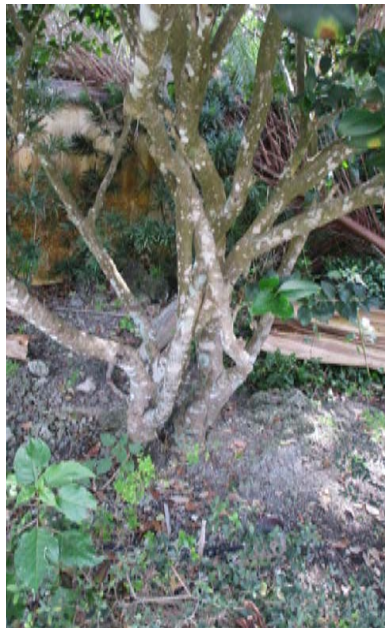
Tree #4 is a Japanese Privet located in the front swale along E San Marino Drive. It is multi-trunked. It is in fair condition and the tree has been shaped. There is a foliar spot disease on the leaves. This tree has not been incorporated into the landscape plan and will therefore be removed.

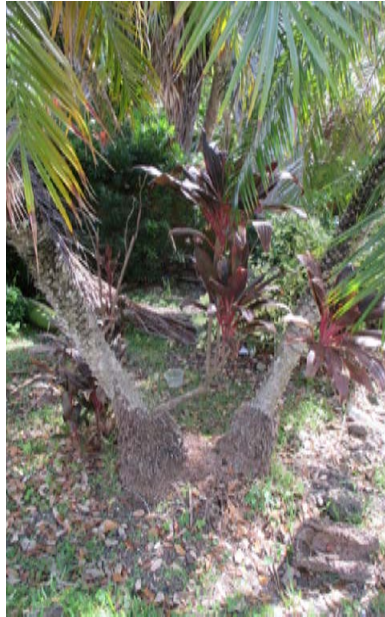
Tree #5 is a double Pygmy Date Palm located in the front swale along E San Marino Drive. Overhead wires are present. This tree is in fair condition with lower dead fronds and some yellow fronds. This tree has not been incorporated into the landscape plan and will therefore be removed.

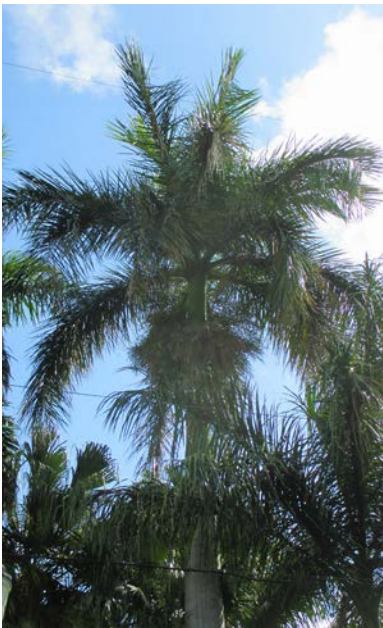
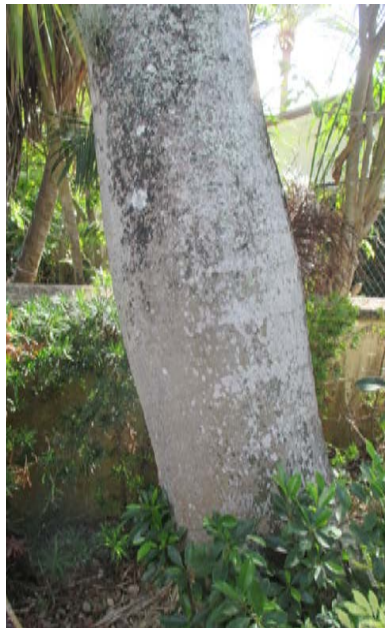
Tree #6 is a Royal Palm located in the front swale along E San Marino Drive. It is in good condition with a full, healthy green canopy.

This tree is to remain, and protective barriers shall be placed at the dripline, in this case, 10ft from the tree trunk. Barriers shall be installed prior to the start of construction and demolition, and shall remain in place until development is completed and until the department authorizes their removal. Barriers shall be a minimum of 4ft high, and shall be constructed of continuous chain link fence with metal posts at 8ft spacing, or of 2x4 posts with three equally spaced 2x4 rails. Posts may be shifted to avoid roots. No materials shall be placed or disposed of within the TPZ. Natural grade shall be maintained within the TPZ.

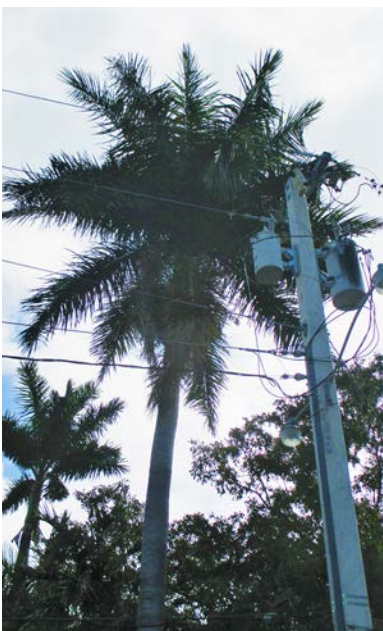
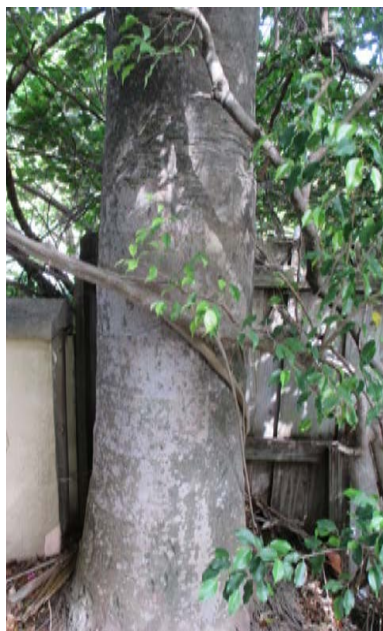
Tree #8 is a Royal Palm located in the front northwest corner of the property. It is in good condition with a full, healthy green canopy.

This tree is to remain, and protective barriers shall be placed at the dripline, in this case, 10ft from the tree trunk. Barriers shall be installed prior to the start of construction and demolition, and shall remain in place until development is completed and until the department authorizes their removal. Barriers shall be a minimum of 4ft high, and shall be constructed of continuous chain link fence with metal posts at 8ft spacing, or of 2x4 posts with three equally spaced 2x4 rails. Posts may be shifted to avoid roots. No materials shall be placed or disposed of within the TPZ. Natural grade shall be maintained within the TPZ.

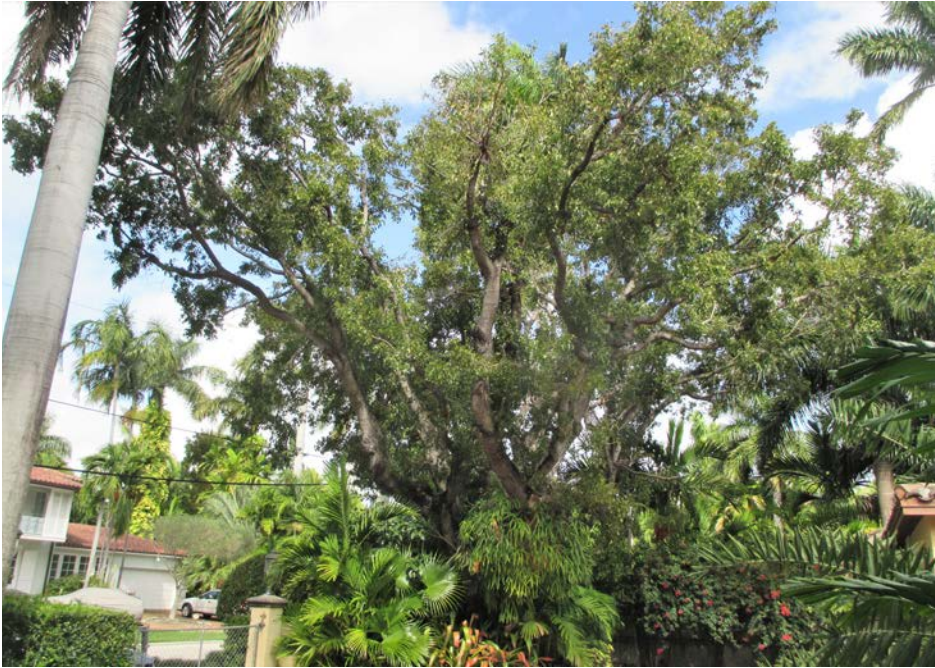
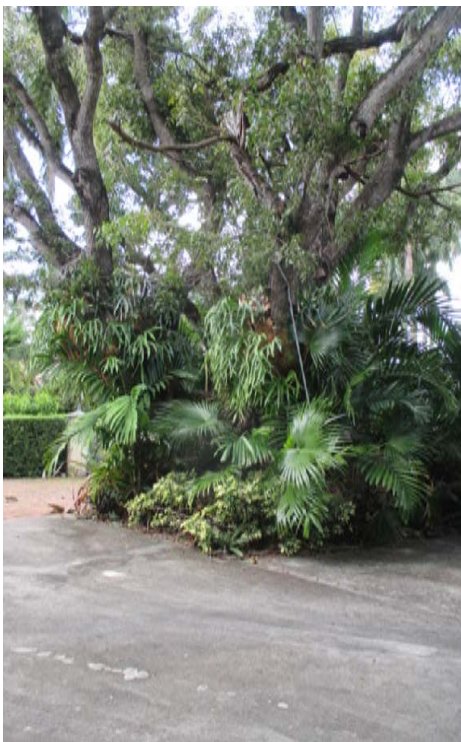
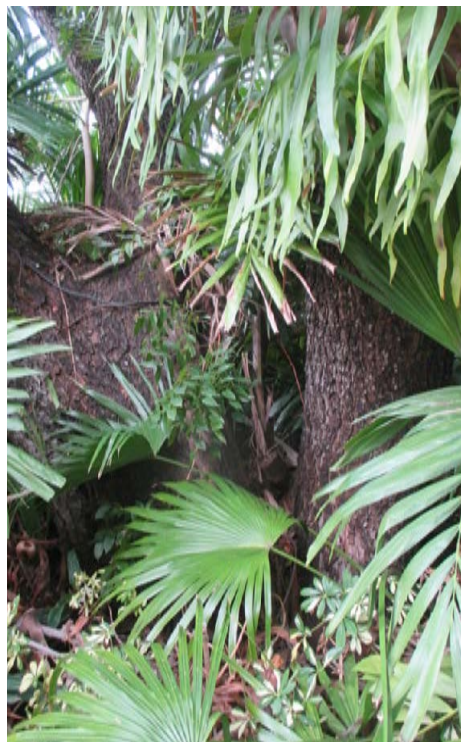
Tree #9 is a large Mahogany located at the front of the property. It is composed of two large trunks and has a wide-spreading canopy. The tree appears to be low in vigor as there are a number of old pruning cuts with little or no woundwood formation and decay has developed at these cut locations. Staghorn ferns on the main limbs and dense vegetation around the base of the tree may be obscuring potential defects. Prune to remove deadwood including two broken limbs hanging in the canopy. Concrete is at the base of the tree on two sides, beginning 4ft and 5ft away from the trunk. Care should be taken to not injure any tree roots when the concrete is removed.

This tree is to remain, and protective barriers shall be placed at the dripline, in this case, 25ft from the tree trunk. Barriers shall be installed prior to the start of construction and demolition, and shall remain in place until development is completed and until the department authorizes their removal. Barriers shall be a minimum of 4ft high, and shall be constructed of continuous chain link fence with metal posts at 8ft spacing, or of 2x4 posts with three equally spaced 2x4 rails. Posts may be shifted to avoid roots. No materials shall be placed or disposed of within the TPZ. Natural grade shall be maintained within the TPZ. This tree should be monitored on a periodic basis for health and structural integrity.

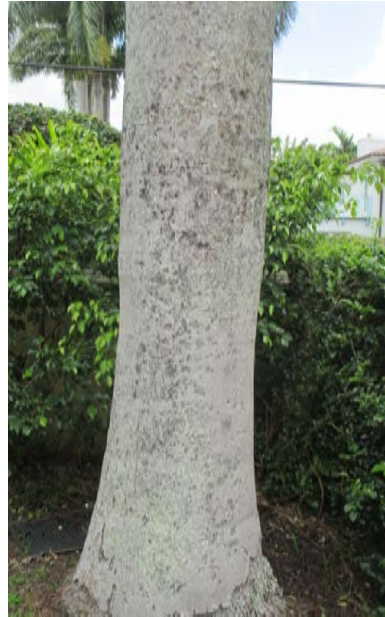
Tree #10 is a Royal Palm located at the front of the property. It is in good condition with a full, healthy green canopy. Some trunk pencilling is occurring. This tree has not been incorporated into the landscape plan and will therefore be removed.

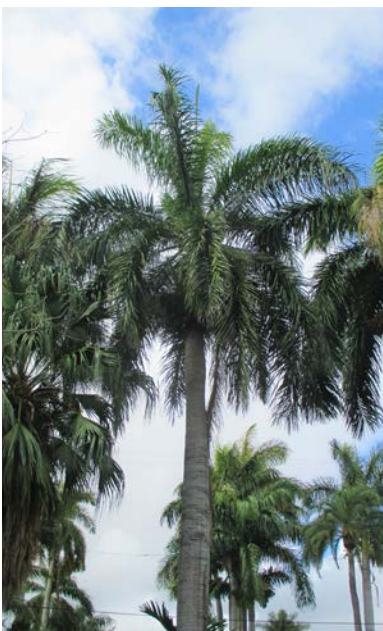
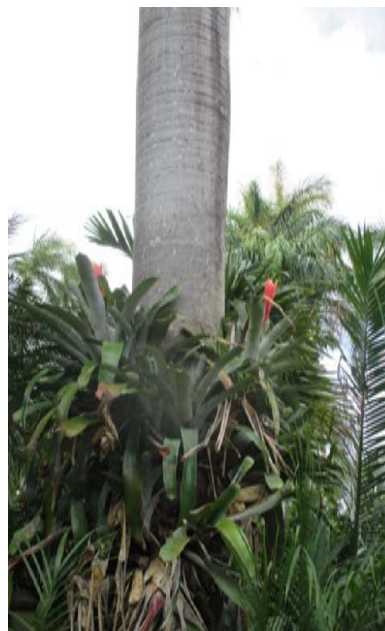
Tree #11 is a Royal Palm located at the front of the property. It is in good condition with a full, healthy green canopy. Some trunk pencilling is occurring. This tree has not been incorporated into the landscape plan and will therefore be removed.

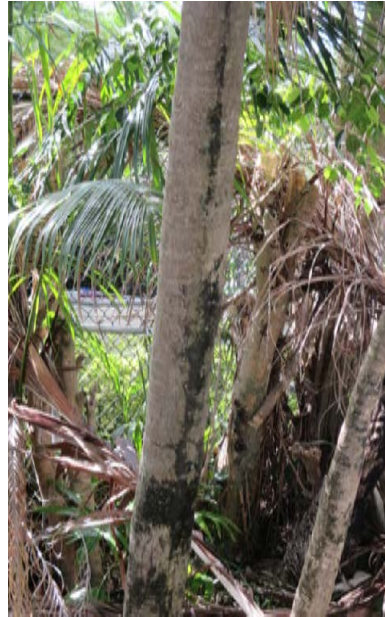
Tree #12 is a Thatch Palm located in the front southwest corner of the property. It is in fair condition and is competing with nearby vegetation. This tree has not been incorporated into the landscape plan and will therefore be removed.

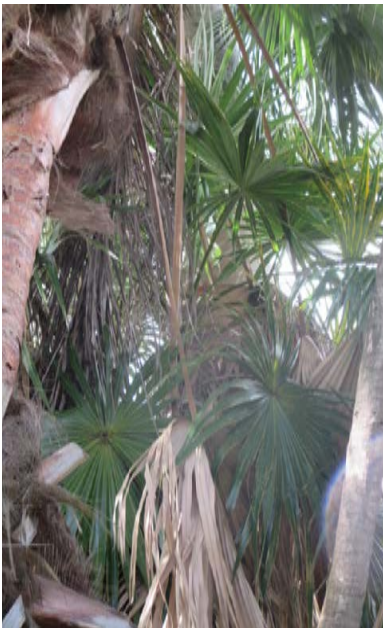
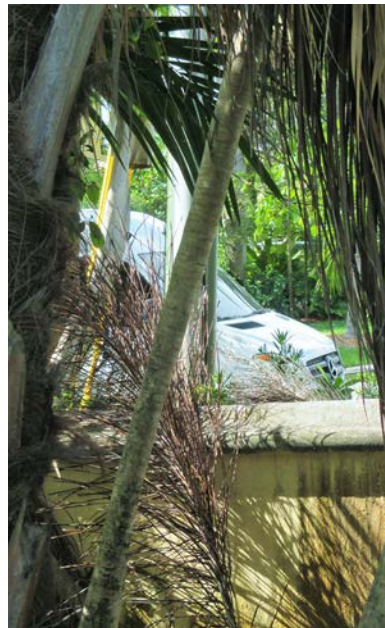
Tree #13 is a Thatch Palm located in the front southwest corner of the property. It is in fair condition and is competing with nearby vegetation. This tree has not been incorporated into the landscape plan and will therefore be removed.

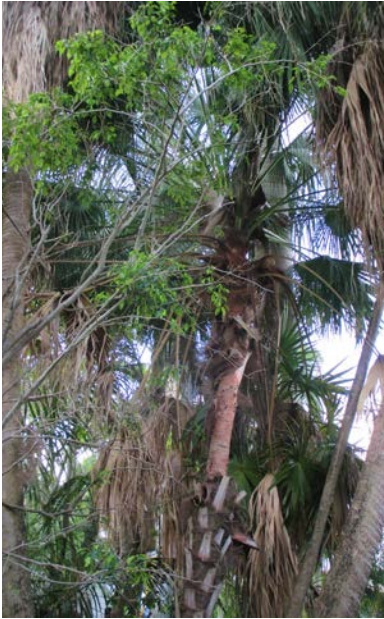
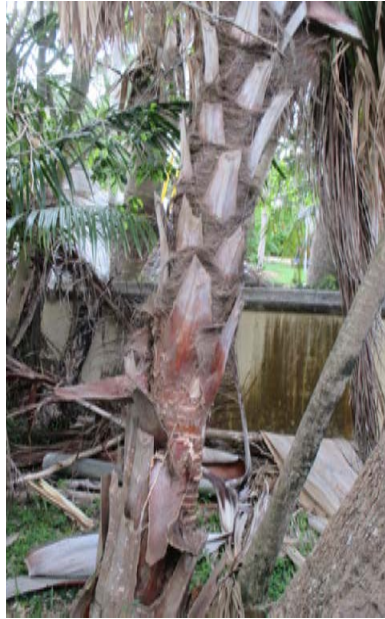
Tree #14 is a Chinese Fan Palm located in the front southwest corner of the property. It is in fair condition and is competing with nearby vegetation. This tree has not been incorporated into the landscape plan and will therefore be removed.

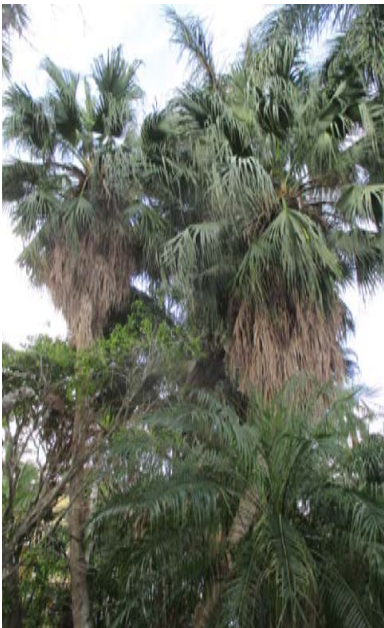
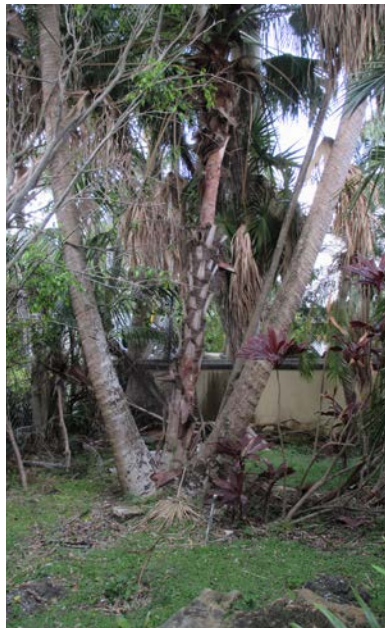
Tree #15 is a double Chinese Fan Palm located in the front southwest corner of the property. It is in good condition with a dense, green canopy. This tree has not been incorporated into the landscape plan and will therefore be removed.

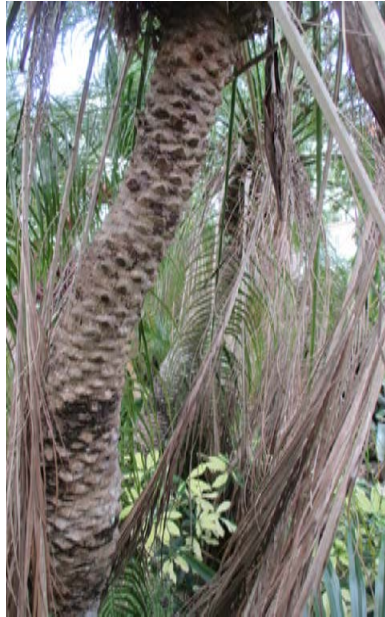
Tree #16 is a double Pygmy Date Palm located in the front southwest corner of the property. It is in fair condition with a canopy on the thinner side and lower dead fronds are present. This tree has not been incorporated into the landscape plan and will therefore be removed.

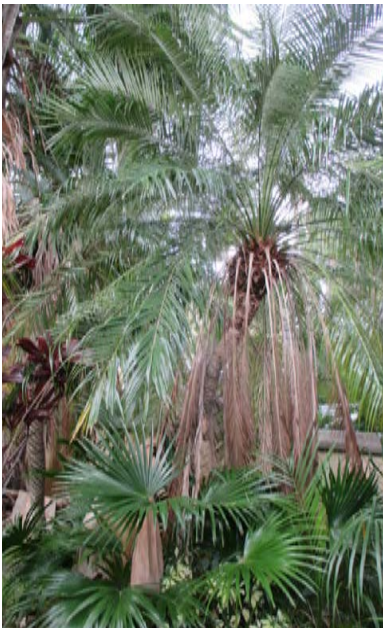
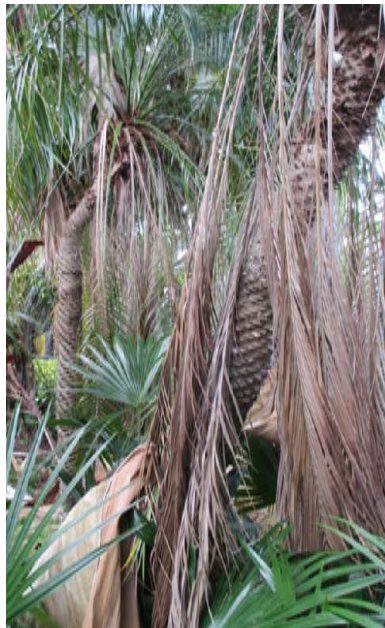
Tree #17 is a double Pygmy Date Palm located in the front southwest corner of the property. It is in fair condition with a canopy on the thinner side and lower dead fronds are present. This tree has not been incorporated into the landscape plan and will therefore be removed.

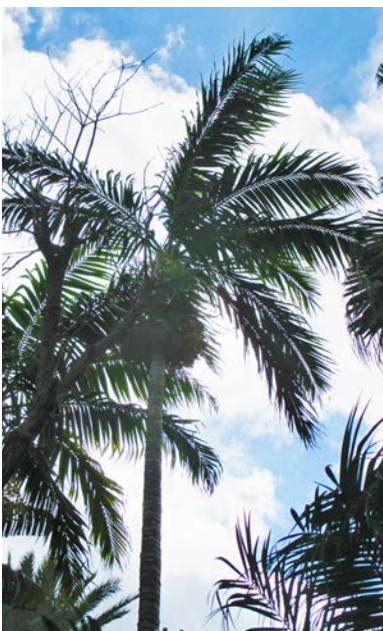
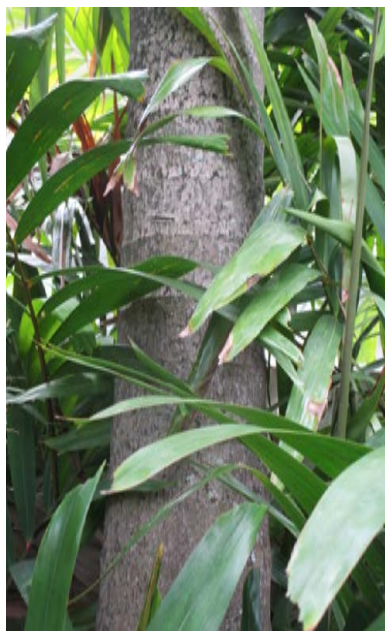
Tree #19 is a Montgomery Palm located on the front southern side of the property. It is in good condition with a healthy, green canopy.

This tree has not been incorporated into the landscape plan and will therefore be removed.

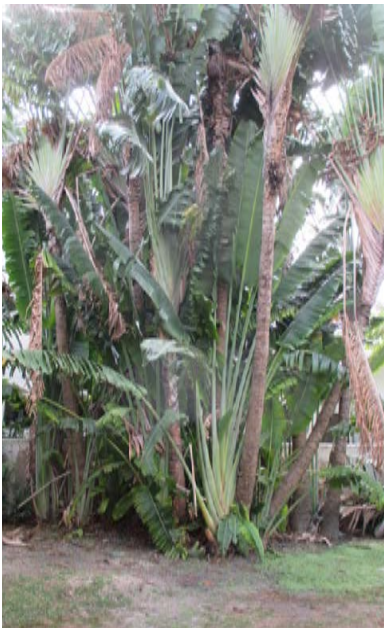
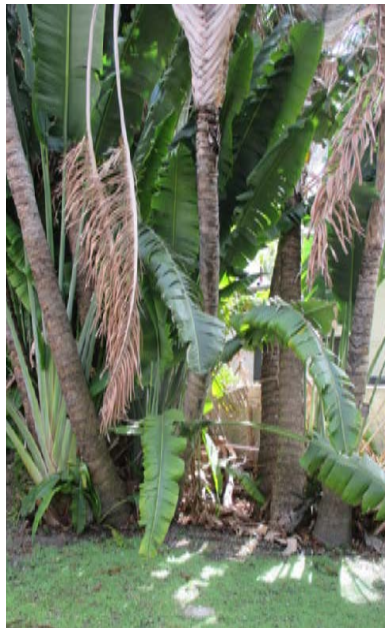
Trees #21 - 33 is a large Travelers Palm cluster located on the south side of the front yard. It is in fair condition with some tattered fronds and lower dead fronds. This tree has not been incorporated into the landscape plan and will therefore be removed.

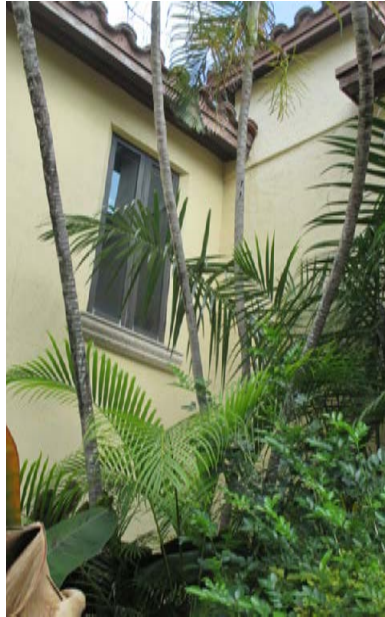
Tree #39 is an Areca Palm cluster located at the front of the house. It is in poor condition - the canopy is thin and the foliage is necrotic and chlorotic. This tree has not been incorporated into the landscape plan and will therefore be removed.

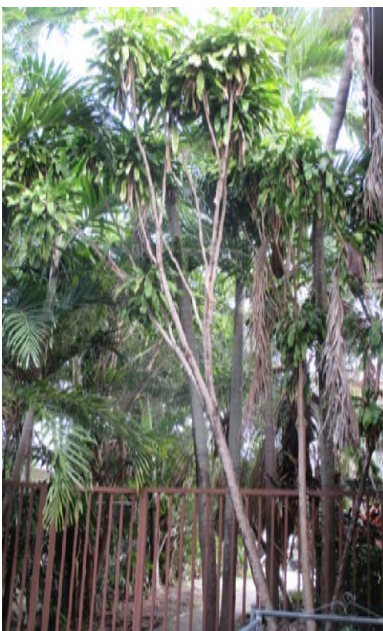
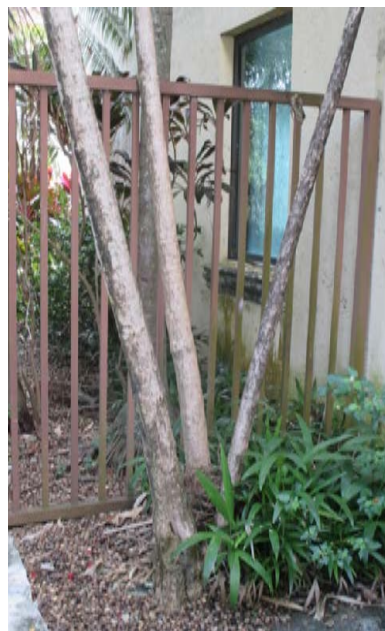
Tree #52 is a Dracaena located on the north side of the existing house. This plant is in poor condition with chlorotic foliage.

This plant has not been incorporated into the landscape plan and will therefore be removed.

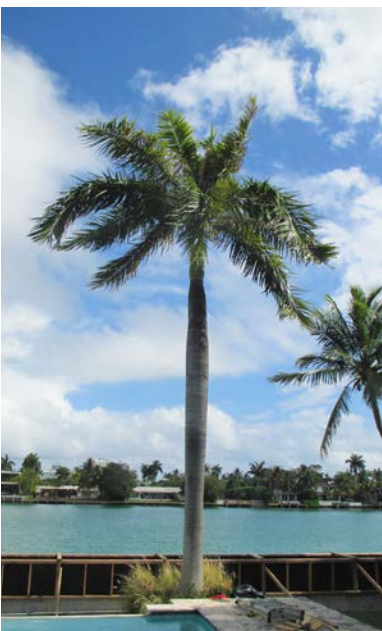
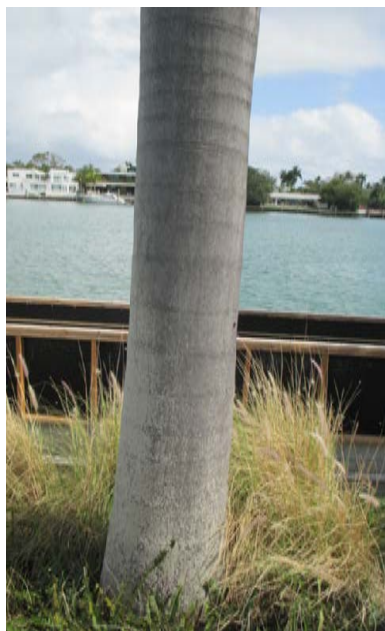
Tree #62 is a Royal Palm located at the rear of the property. It is in fair condition with a trunk that is pencilling and a canopy on the smaller side that has some foliage that is chlorotic and frizzled. This tree has not been incorporated into the landscape plan and will therefore be removed.

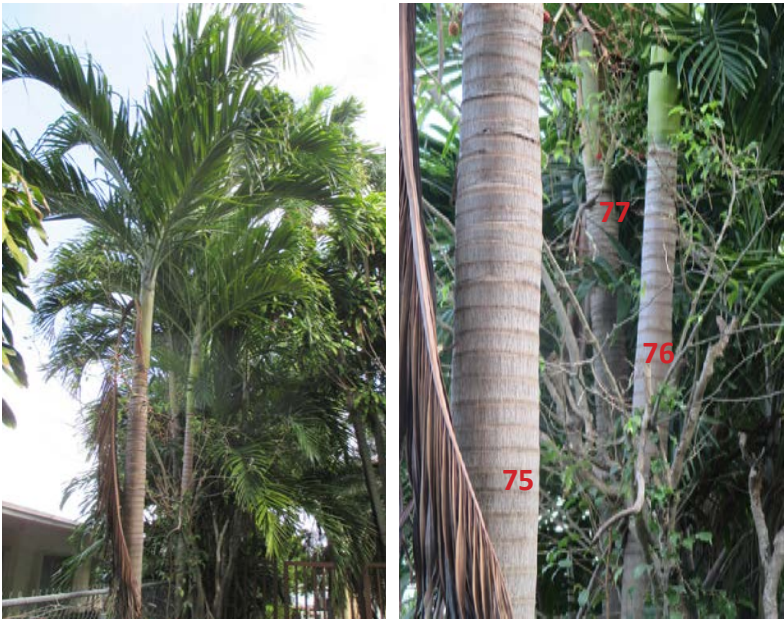
Trees #75 - 77 are three Christmas Palms located to the north of the existing house. They are in fair condition with yellow spotting on the foliage. These trees have not been incorporated into the landscape plan and will therefore be removed.
