June 9, 2022

**Certified Arborist Assessment
1311 15 Terrace, Miami Beach, Florida
NLE Project No. 14822003**

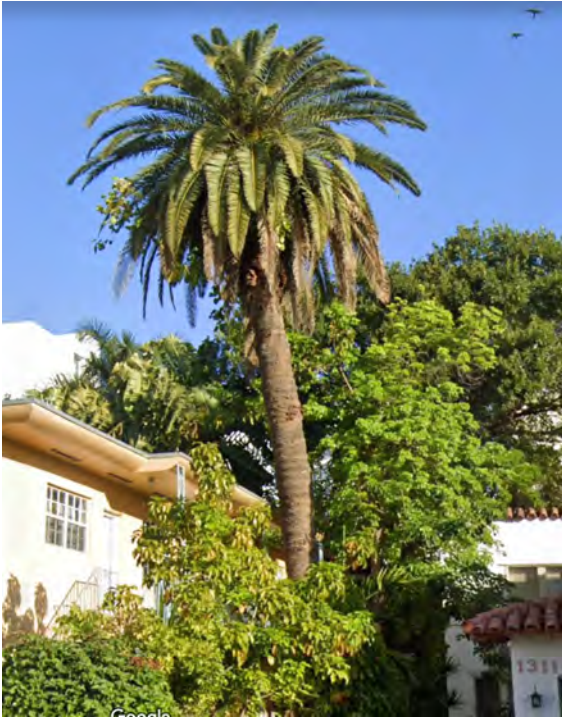
Tree 1 Canary Island date palm
(*Phoenix canariensis*)
29 inch DBH, Fair condition
55 foot height, 20 foot spread

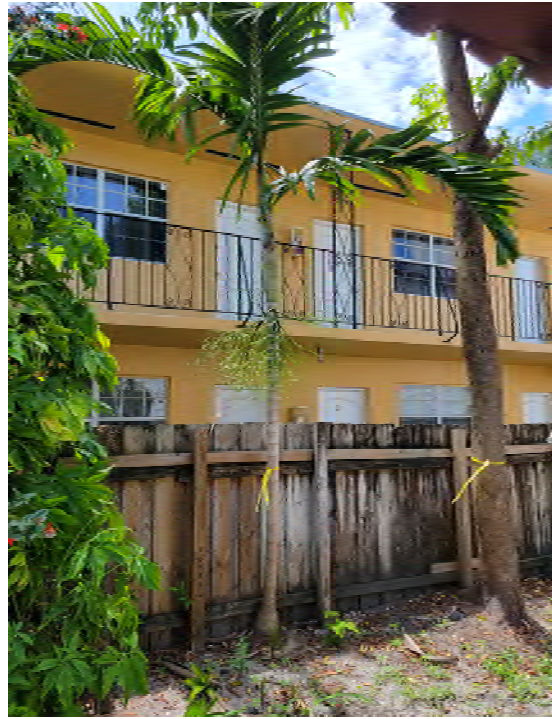
Tree 2 solitaire palm
(*Ptychosperma elegans*)
4 inch DBH Good condition
18 foot height, 8 foot spread

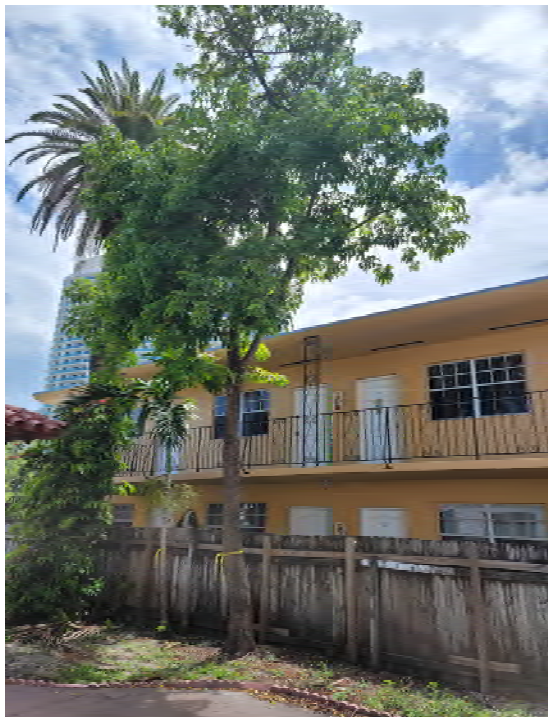
Tree 3 bishopwood
(*Bischofia javanica*)
12 inch DBH, Fair condition
45 foot height, 25 foot spread

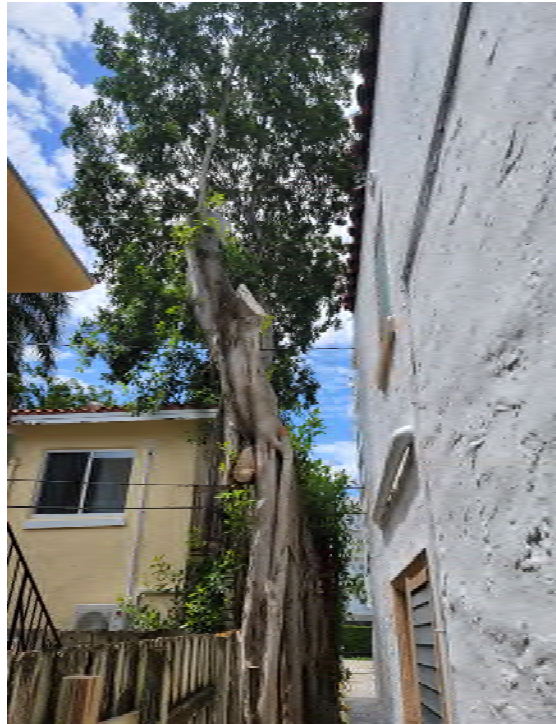
Tree 4 strangler fig
(*Ficus aurea*)
72 inch DBH Fair condition
60 foot height, 40 foot spread

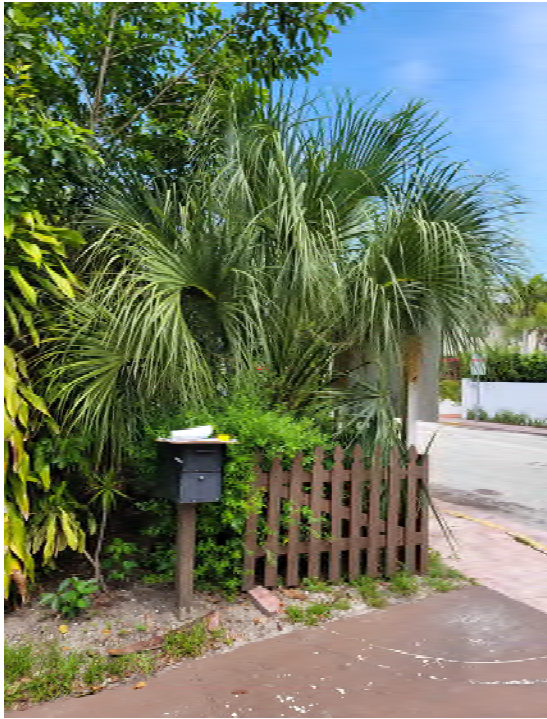
Tree 5 sabal palm
(Sabal palmetto)
10 inch DBH, Good condition
12 foot height, 12 foot spread

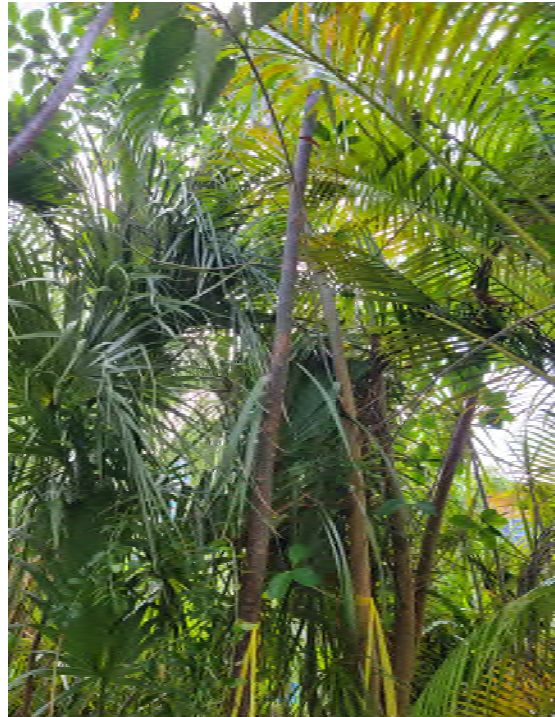
Tree 6 gumbo limbo
(Bursera simaruba)
3 inch DBH Fair condition
16 foot height, 8 foot spread

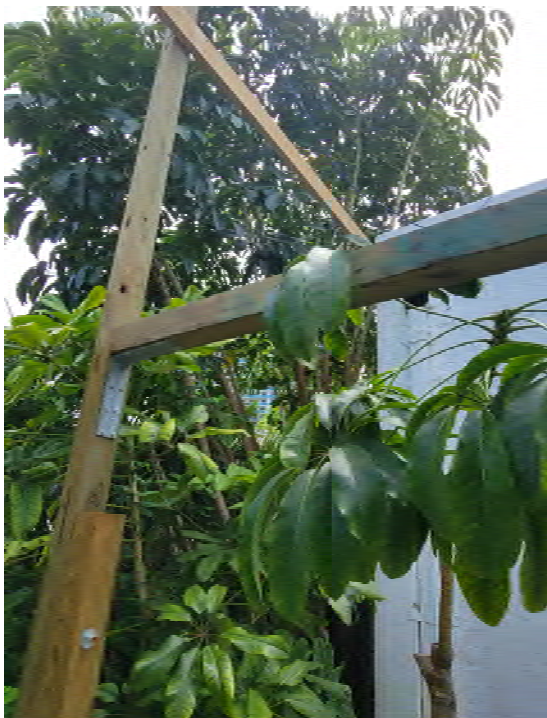
Tree 7 umbrella tree
(Schefflera actinophylla)
28 inch DBH, Fair condition
25 foot height, 25 foot spread

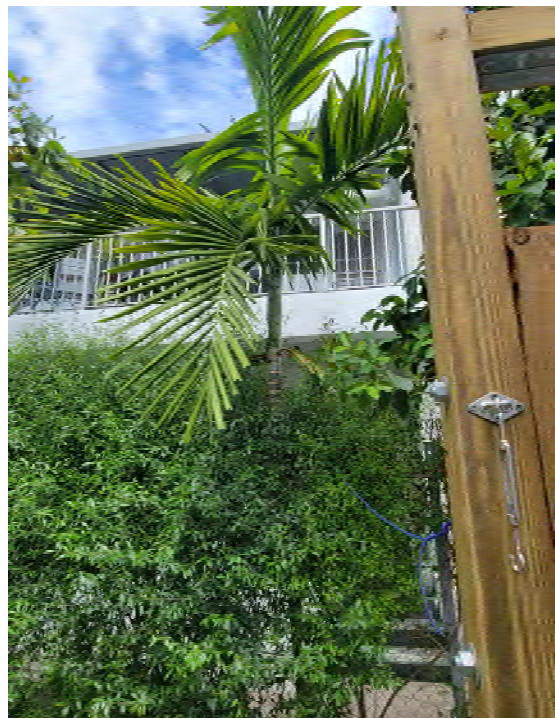
Tree 8 solitaire palm
(Ptychosperma elegans)
4 inch DBH Good condition
16 foot height, 12 foot spread

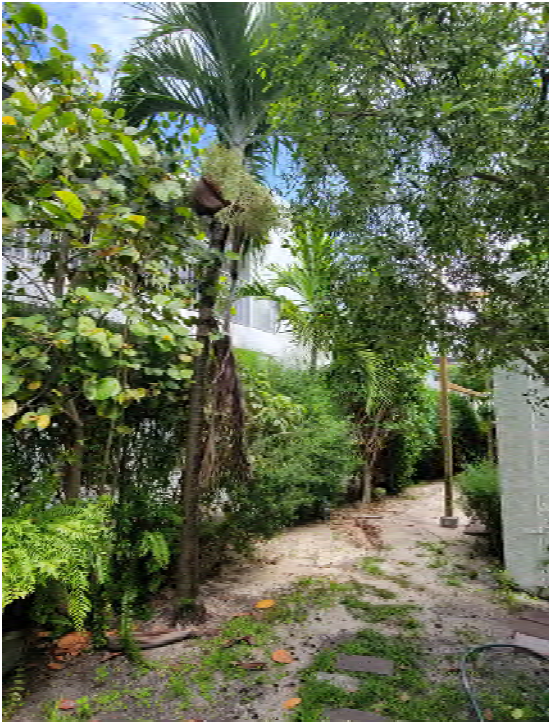
Tree 9 Christmas palm
(*Adonidia merrellii*)
6 inch DBH, Good condition
20 foot height, 12 foot spread

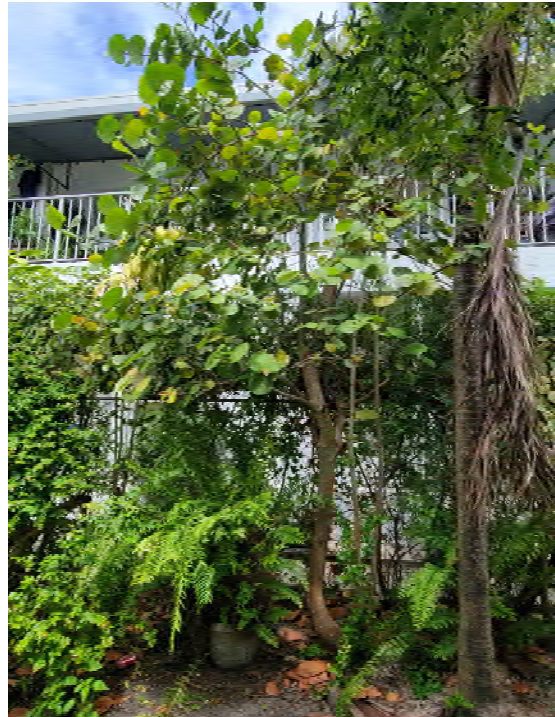
Tree 10 seagrape
(*Coccoloba uvifera*)
5 inch DBH Fair condition
20 foot height, 12 foot spread

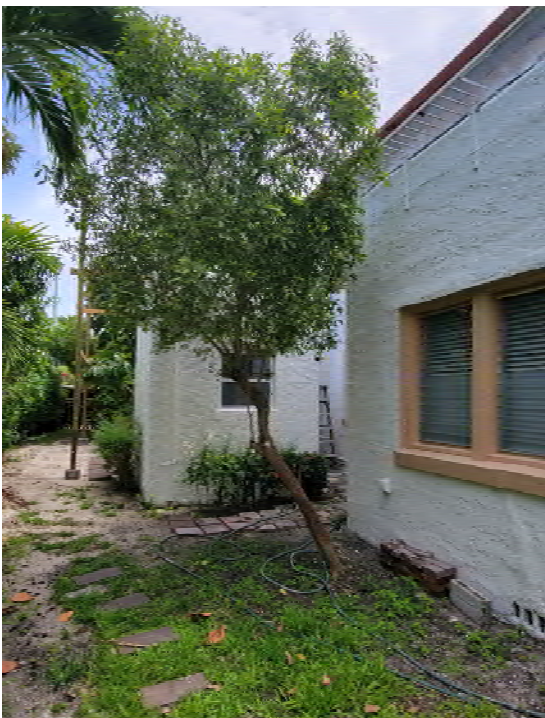
Tree 11 pink trumpet tree
(*Tabebuia heterophylla*)
6 inch DBH, Fair condition
18 foot height, 12 foot spread

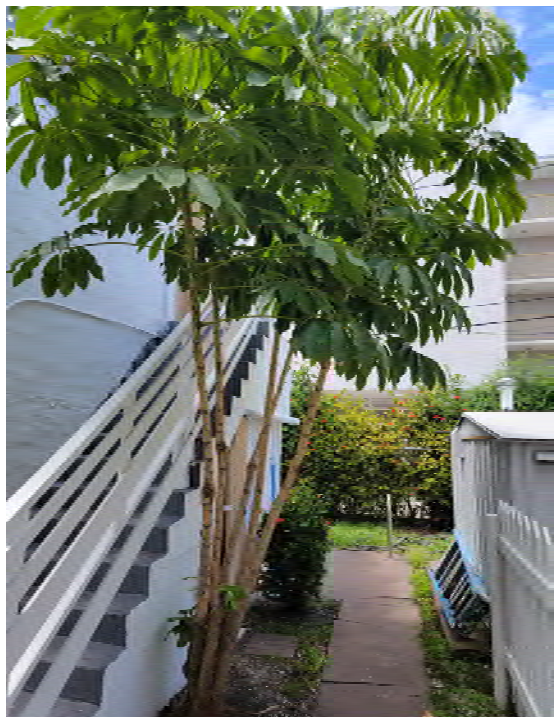
Tree 12 umbrella tree
(*Schefflera actinophylla*)
10 inch DBH Fair condition
16 foot height, 16 foot spread

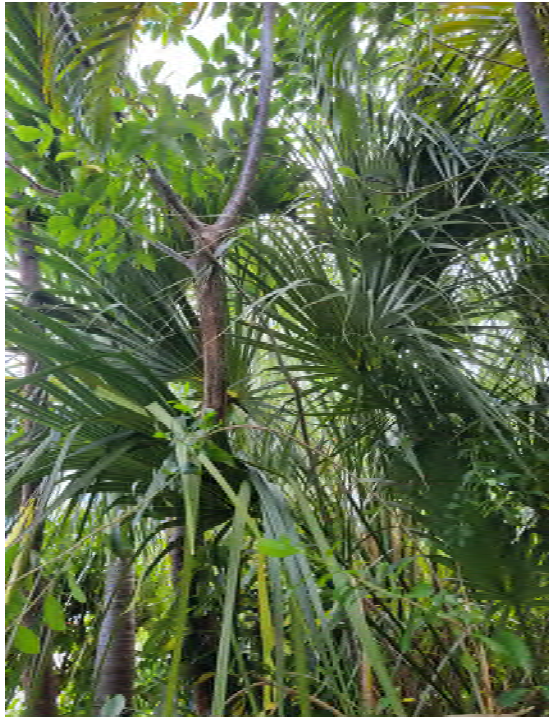
Tree 13 gumbo limbo
(*Bursera simaruba*)
3 inch DBH, Fair condition
16 foot height, 12 foot spread

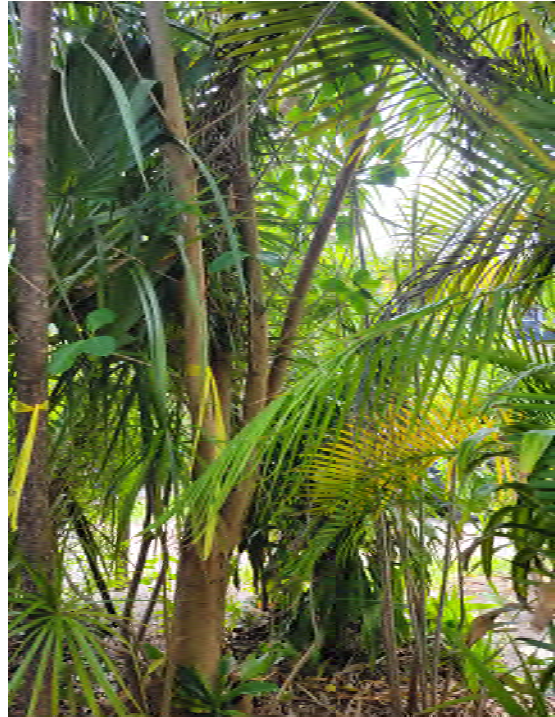
Tree 14 strangler fig
(*Ficus aurea*)
11 inch DBH Fair condition
20 foot height, 16 foot spread

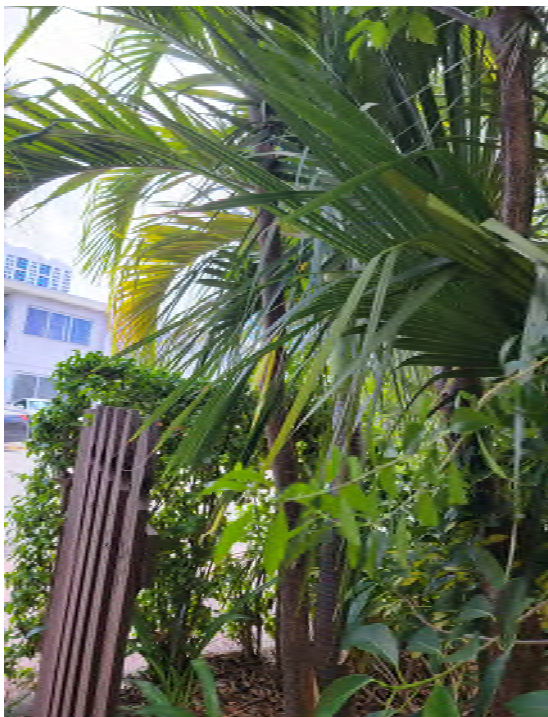
Tree 15 gumbo limbo
(*Bursera simaruba*)
3 inch DBH, Good condition
18 foot height, 12 foot spread

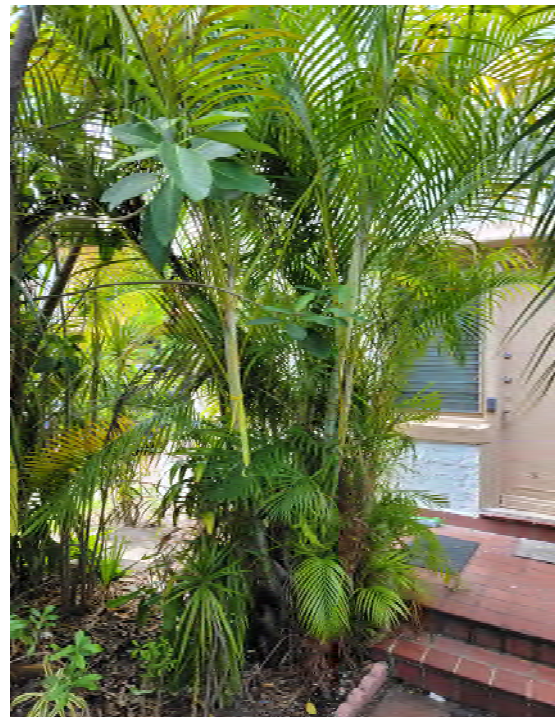
Tree 16 areca palm
(*Dypsis lutescens*)
cluster inch DBH Good condition
15 foot height, 15 foot spread

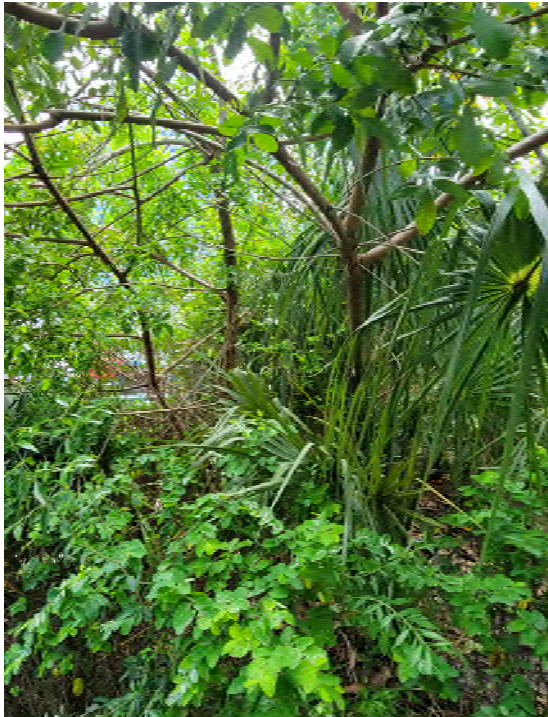
Tree 17 Brazilian pepper
(*Schinus terebinthifolius*)
10 inch DBH, Fair condition
20 foot height, 12 foot spread

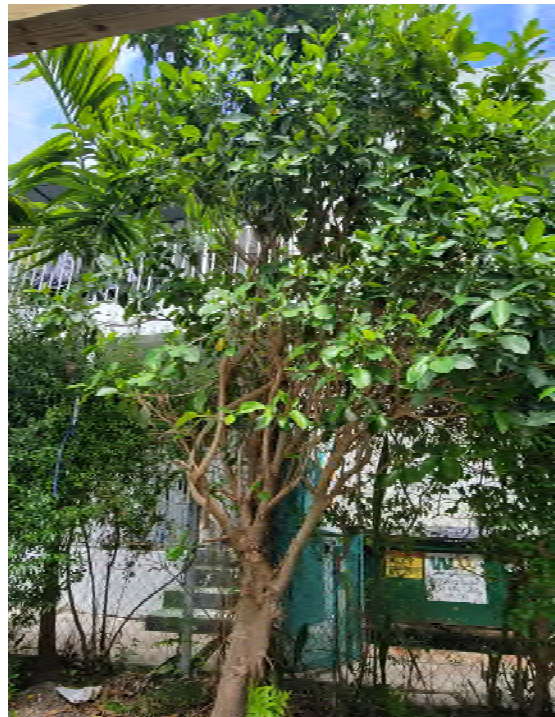
Tree 18 strangler fig
(*Ficus aurea*)
15 inch DBH Good condition
20 foot height, 15 foot spread

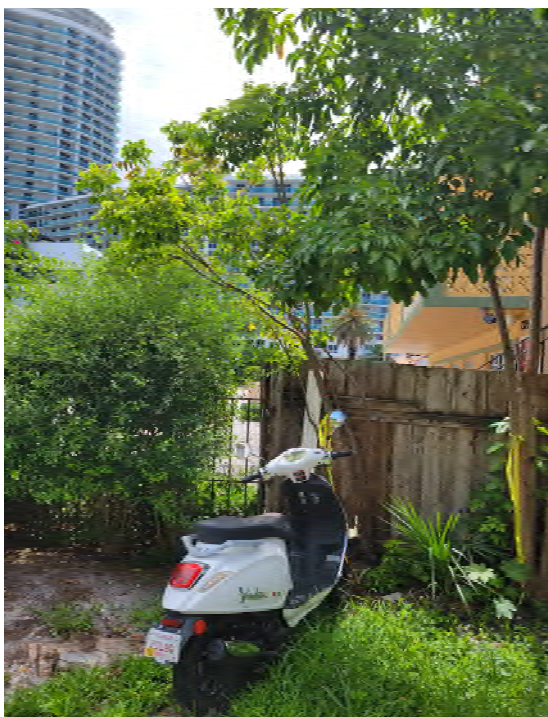
Tree 19 gumbo limbo
(*Bursera simaruba*)
7 inch DBH, Fair condition
5 foot height, 8 foot spread

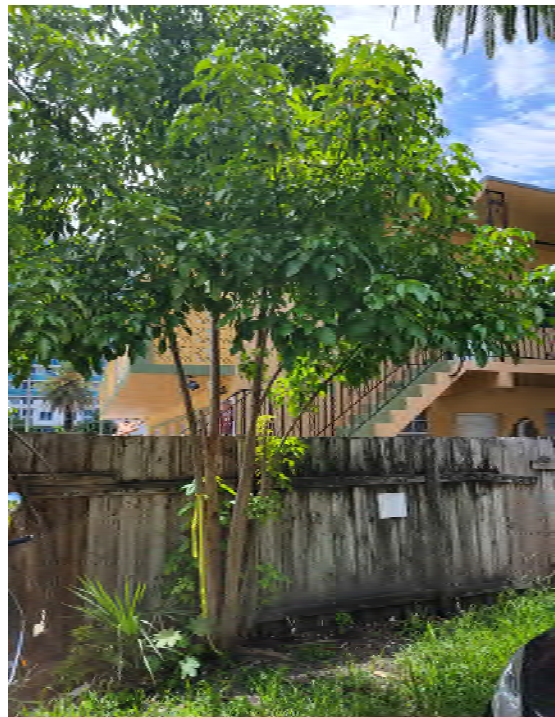
Tree 20 bishopwood
(*Bischofia javanica*)
15 inch DBH Fair condition
20 foot height, 12 foot spread
