Arborist Report

2130 Verdun Dr
Miami Beach, FL 33141

08/04/2022

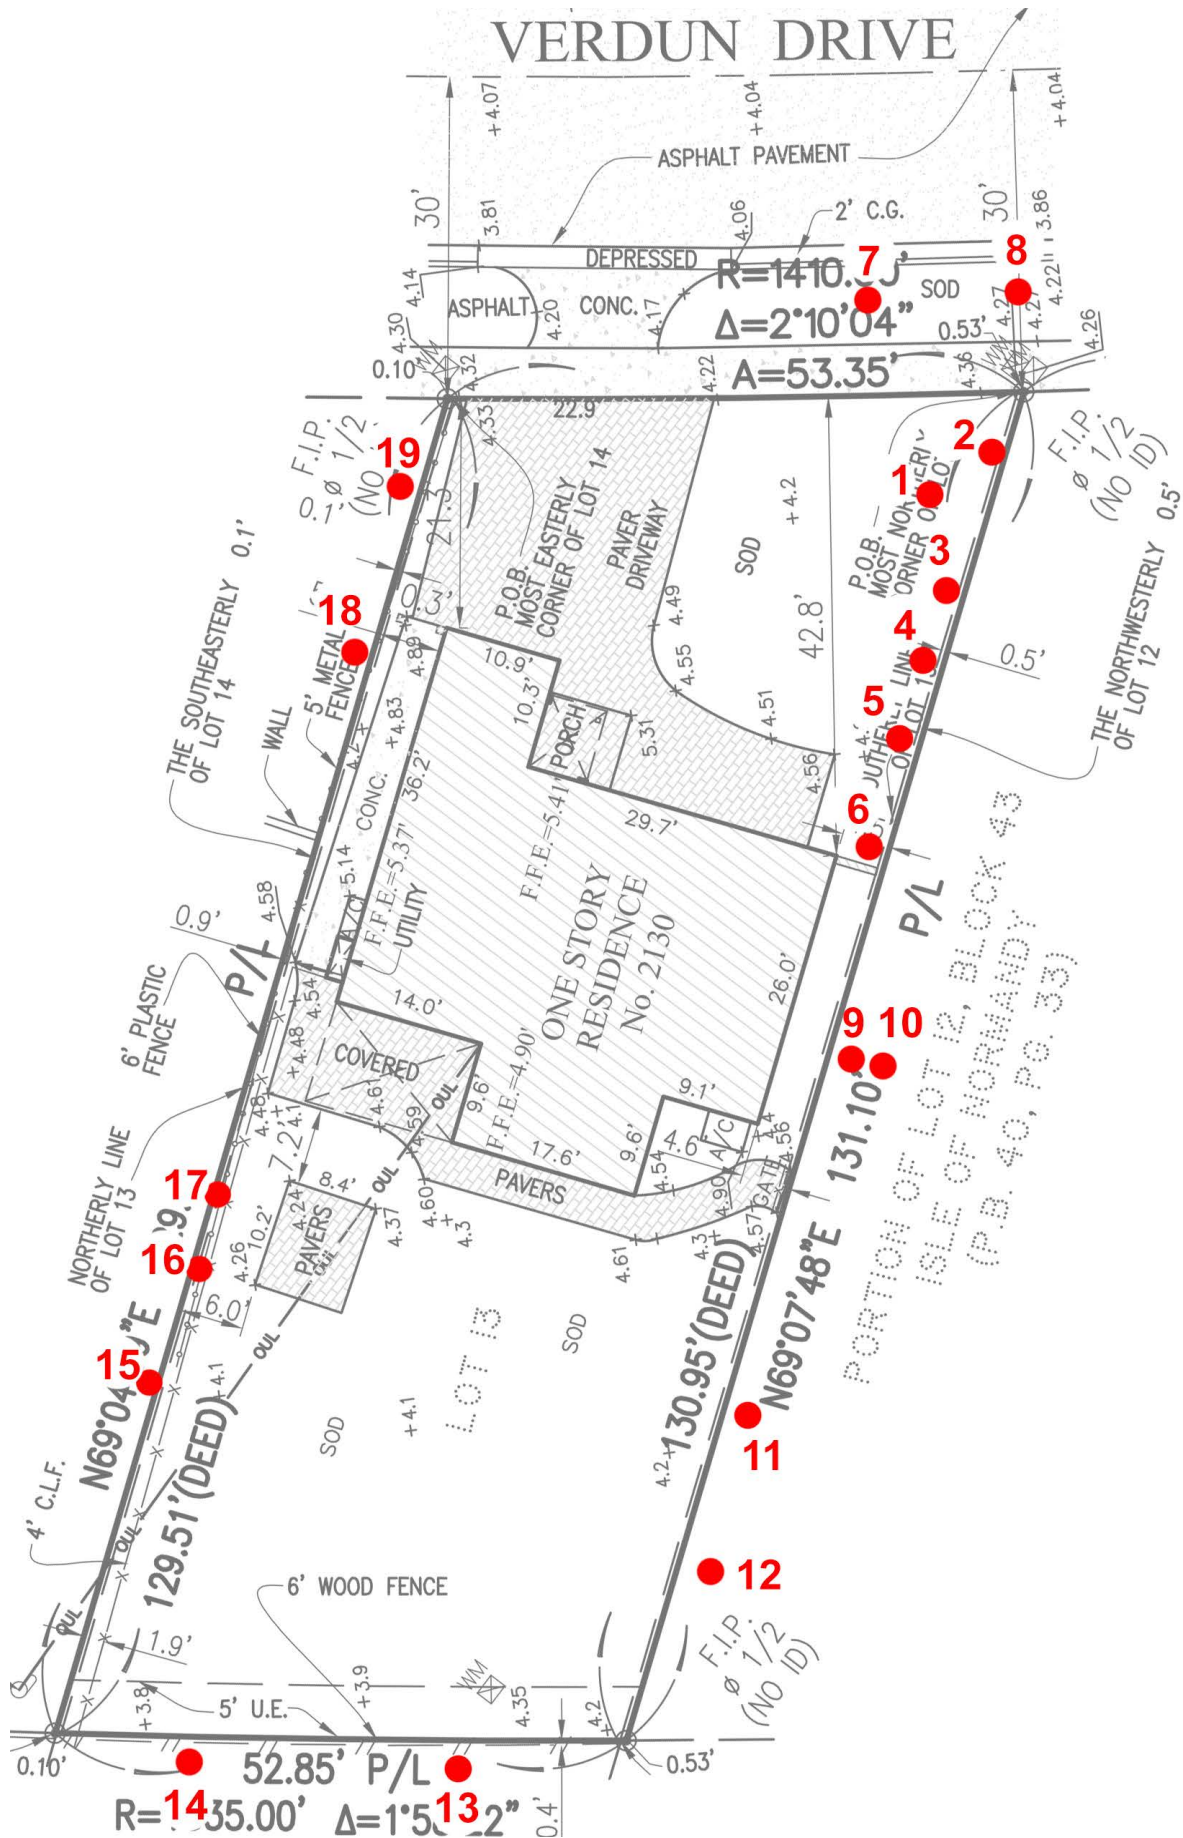
Tree Survey
(Not to scale)

EXISTING TREE INVENTORY AND EVALUATION TABLE									
#	BOTANICAL NAME	COMMON NAME	DBH	HT	SP	DISPOSITION	CONDITION	TPZ	NOTES / REMARKS
1	<i>Cocos nucifera</i>	Coconut Palm	9 "	20 '	16 '	Remove	Fair	4'	Minor trunk injuries, reduced vigor
2	<i>Dypsis lutescens</i>	Areca Palm	Multi	16 '	14 '	Remove	Fair	5'	Overgrown, nutrient deficiency
3	<i>Dypsis lutescens</i>	Areca Palm	Multi	16 '	14 '	Remove	Fair	5'	Overgrown, nutrient deficiency
4	<i>Dypsis lutescens</i>	Areca Palm	Multi	16 '	14 '	Remove	Fair	5'	Overgrown, nutrient deficiency
5	<i>Dypsis lutescens</i>	Areca Palm	Multi	16 '	14 '	Remove	Fair	5'	Overgrown, nutrient deficiency
6	<i>Sabal palmetto</i>	Sabal Palm	15 "	14 '	14 '	Remove	Good	5'	Minor trunk injuries, good vigor
STREET TREES									
7	<i>Lysiloma latisiquum</i>	Wild Tamarind	12 "	18 '	26 '	Remain	Fair	10'	Exposed surface roots, number of breakage wounds
8	<i>Lysiloma latisiquum</i>	Wild Tamarind	13 "	20 '	32 '	Remain	Fair	10'	Exposed surface roots, number of breakage wounds

NEIGHBORING TREES									
9	<i>Sabal palmetto</i>	Sabal Palm	15 "	14 '	14 '	N/A	Poor	5'	Poor structure, affected by tree #10
10	<i>Ficus aurea</i>	Strangler Fig	36 "	26 '	40 '	N/A	Fair	24'	Leaning towards south, too close to structure
11	<i>Sabal palmetto</i>	Sabal Palm	12 "	14 '	14 '	N/A	Good	5'	Good condition healthy in appearance
12	<i>Sabal palmetto</i>	Sabal Palm	15 "	18 '	14 '	N/A	Good	5'	Good condition healthy in appearance
13	<i>Veitchia merrillii</i>	Christmas Palm	Multi	16 '	28 '	N/A	Fair	7'	Cluster, overhanging the property line
14	<i>Ficus benjamina</i>	Weeping Fig	N/A	28 '	36 '	N/A	Fair	15'	Number of utility clearance pruning cuts
15	<i>Sabal palmetto</i>	Sabal Palm	N/A	12 '	14 '	N/A	Fair	5'	Good condition healthy in appearance
16	<i>Dypsis lutescens</i>	Areca Palm	Multi	12 '	14 '	N/A	Fair	5'	Overgrown, nutrient deficiency
17	<i>Dypsis lutescens</i>	Areca Palm	Multi	12 '	14 '	N/A	Fair	5'	Overgrown, nutrient deficiency

18	<i>Quercus virginiana</i>	Southern Live Oak	6 "	16 '	12 '	N/A	Fair	5'	Poor structure, reduced vigor
19	<i>Quercus virginiana</i>	Southern Live Oak	6 "	12 '	14 '	N/A	Fair	5'	Poor structure, reduced vigor
