GENERAL ASSESSMENT REPORT

EXISTING STRUCTURAL SYSTEMS

803 2ND STREET MIAMI BEACH, FLORIDA

APRIL 5, 2021

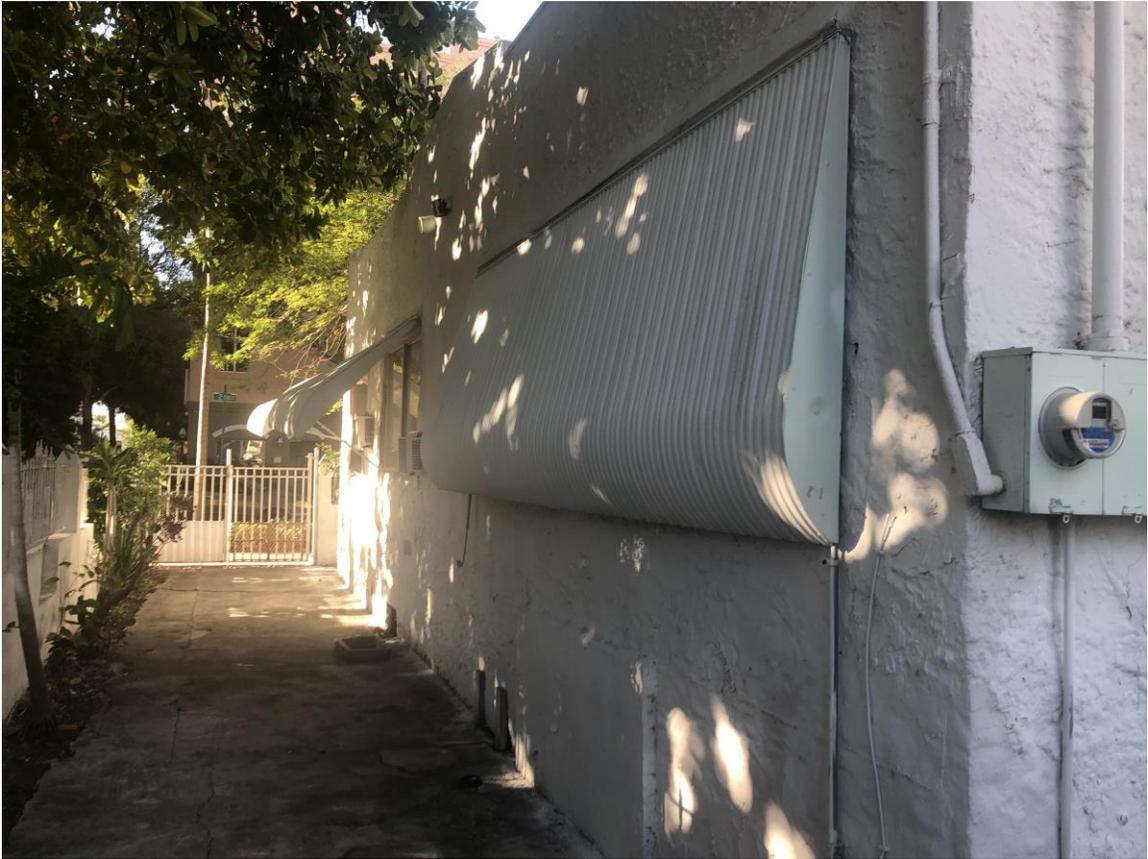
PHOTOGRAPH NO. 5

11. There are aluminum awnings over the windows on the front (south side) and east side of the building. The hold-open rods and fasteners are in generally poor condition and missing in some locations, making the awnings unsafe. The tops

of the awnings are not well sealed to the wall, and stucco immediately above them is generally cracked. Refer to Photographs Nos. 1, 2, 5, 7, 8, 21, and 24. It appears that there were awnings previously existing at some windows on the north and west sides of the building, but currently all that remains are the top tracks. Refer to Photographs Nos. 31 and 36.

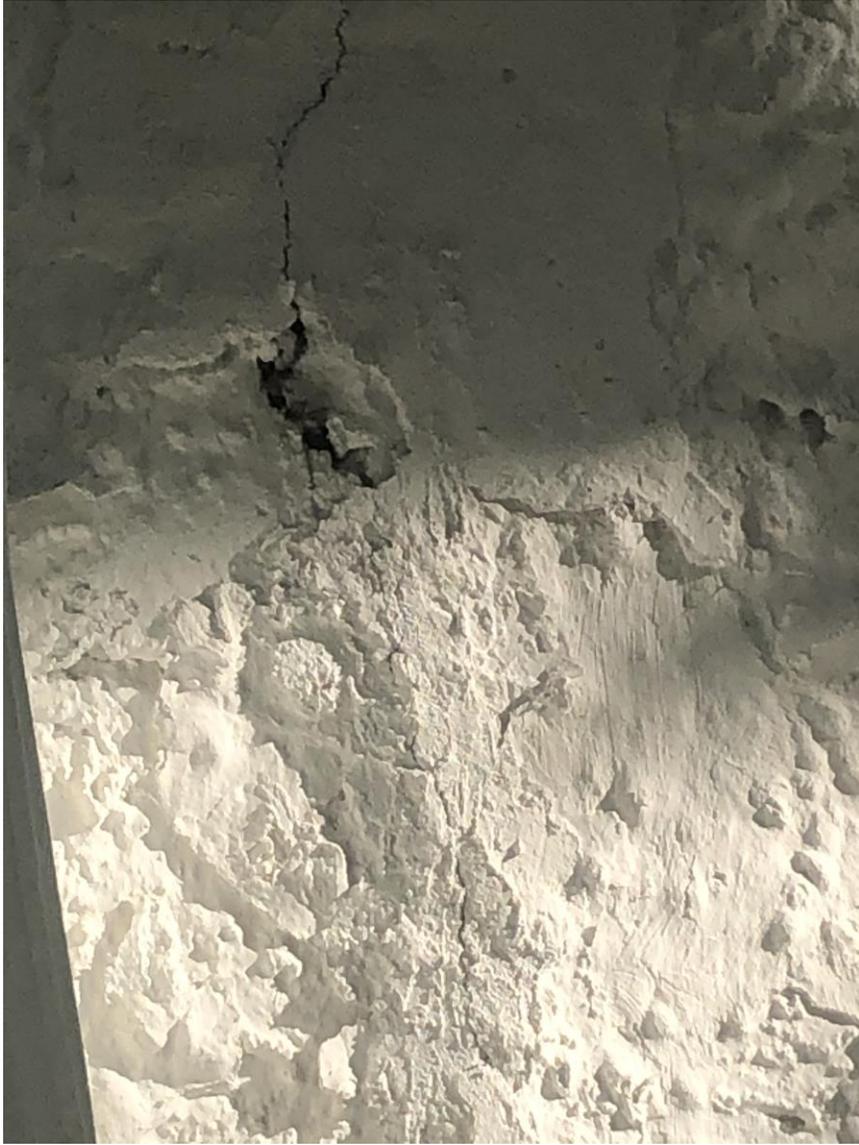
PHOTOGRAPH NO. 9

7. There is a hive of live bees inside the wall cavity at the east end of the south wall. The bees enter and leave through a hole in the exterior stucco. Refer to Photograph No. 9.

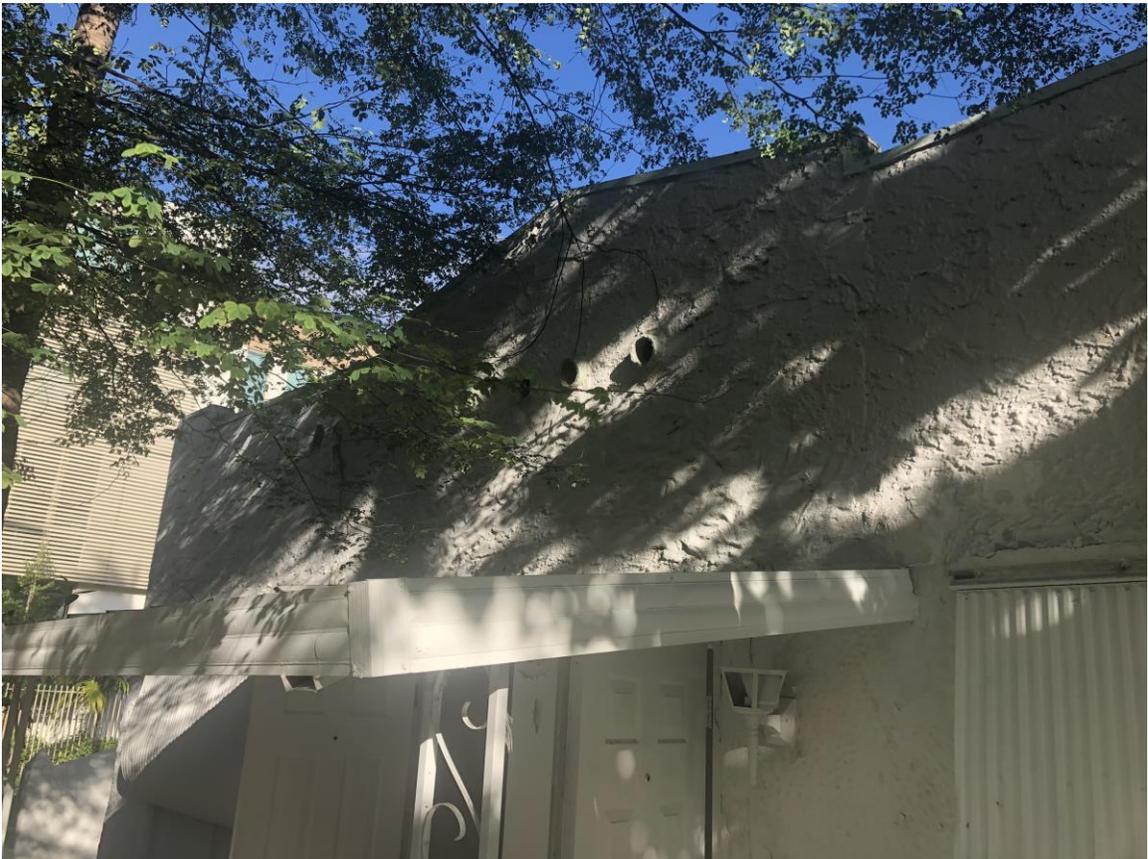
PHOTOGRAPH NO. 15

6. The gutter of the aluminum canopy above the front entrances is clogged with debris, and there are plants growing in it. Refer to Photograph No. 15.

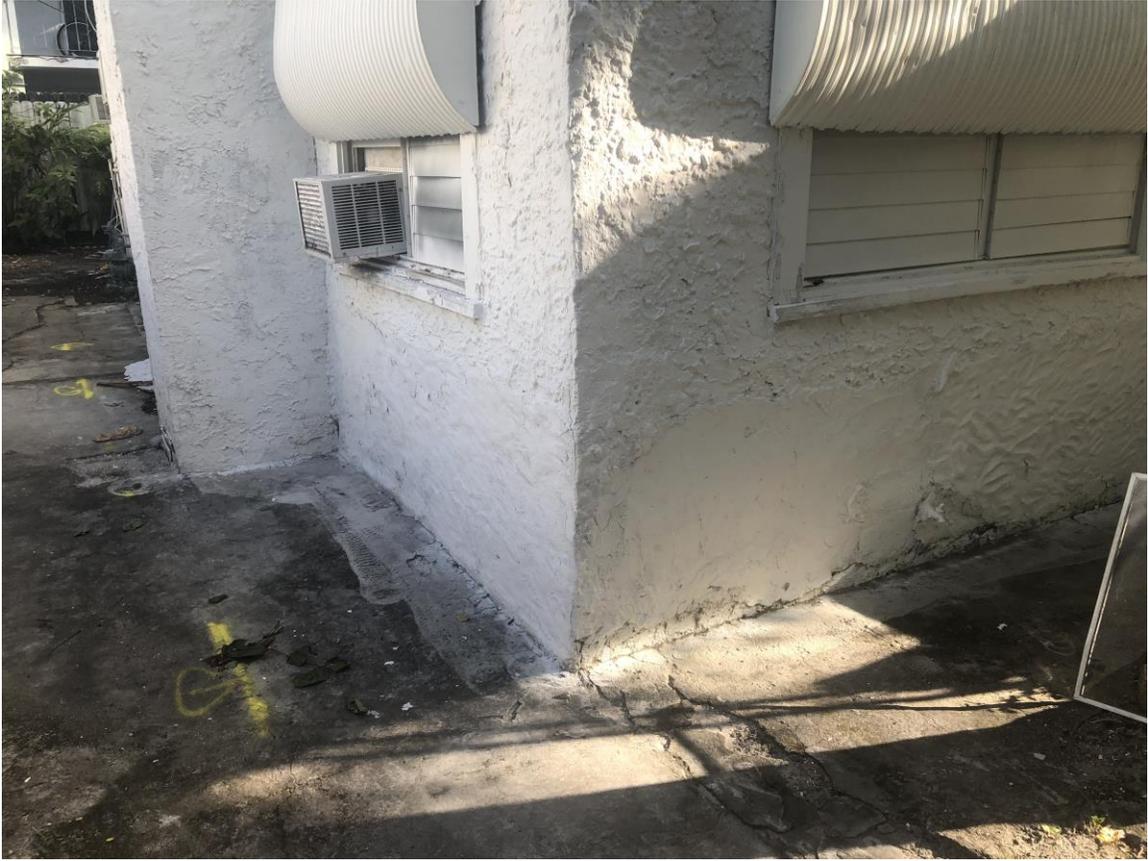
PHOTOGRAPH NO. 21

1. Most of the exterior stucco has been replaced, with almost all of the stucco below the window-sill level having been replaced. The replacements have apparently occurred at a number of different times. The replacement areas are of obviously different textures (some very crudely applied). Some of the patches appear to have been extended over adjacent areas of stucco without proper surface preparation, resulting in areas of delamination. Refer to Photographs Nos. 6, 10 through 14, 17, 19 through 22, 26, 30, 31, 33, 34, 36, 39, 58, 59, 60, 64, 75 and 77.

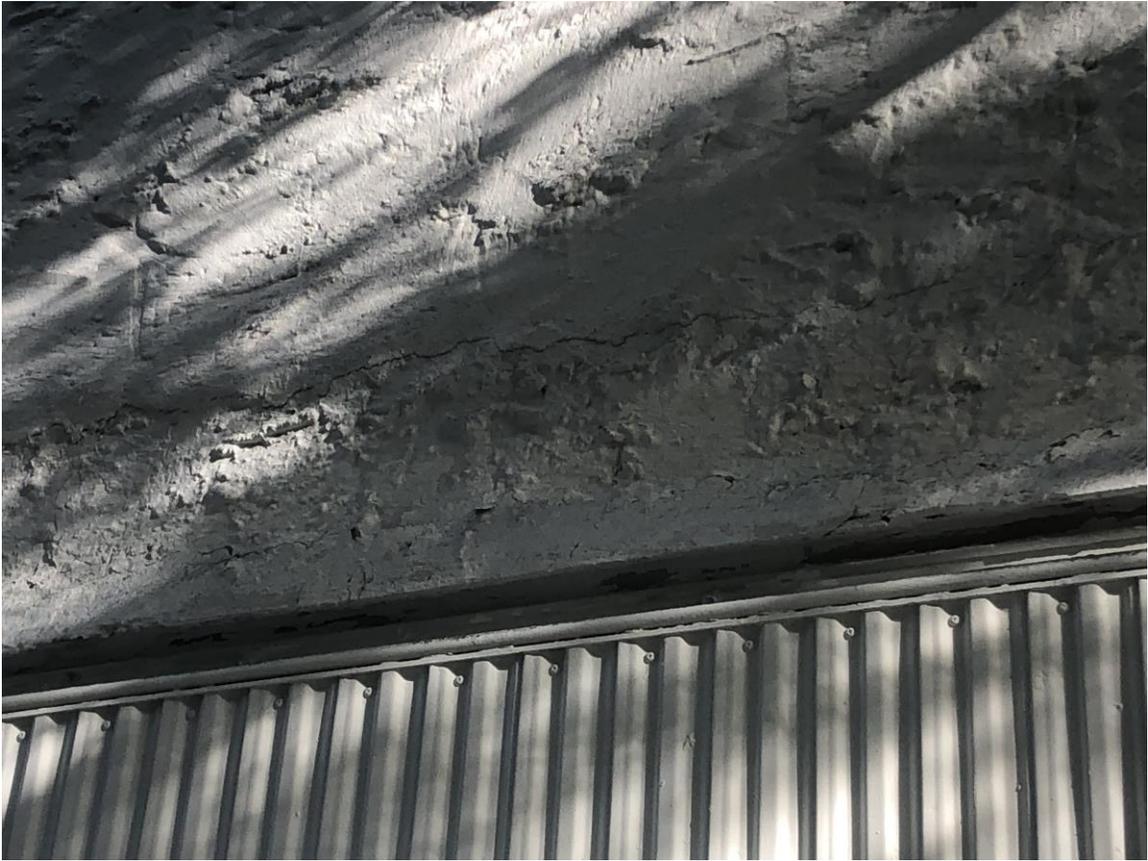
PHOTOGRAPH NO. 24

2. There are numerous exterior stucco cracks and numerous holes in the exterior stucco. With the stucco on wood lath and no vapor or moisture barrier, each of these cracks and holes is a source of water intrusion to the structural wood framing behind. Refer to Photographs Nos. 7, 8, 9, 12, 13, 14, 16, 18, 22, 23, 24, 26 through 30, 35, 36, 37, 45, 46, 49, 59, 65 and 68.

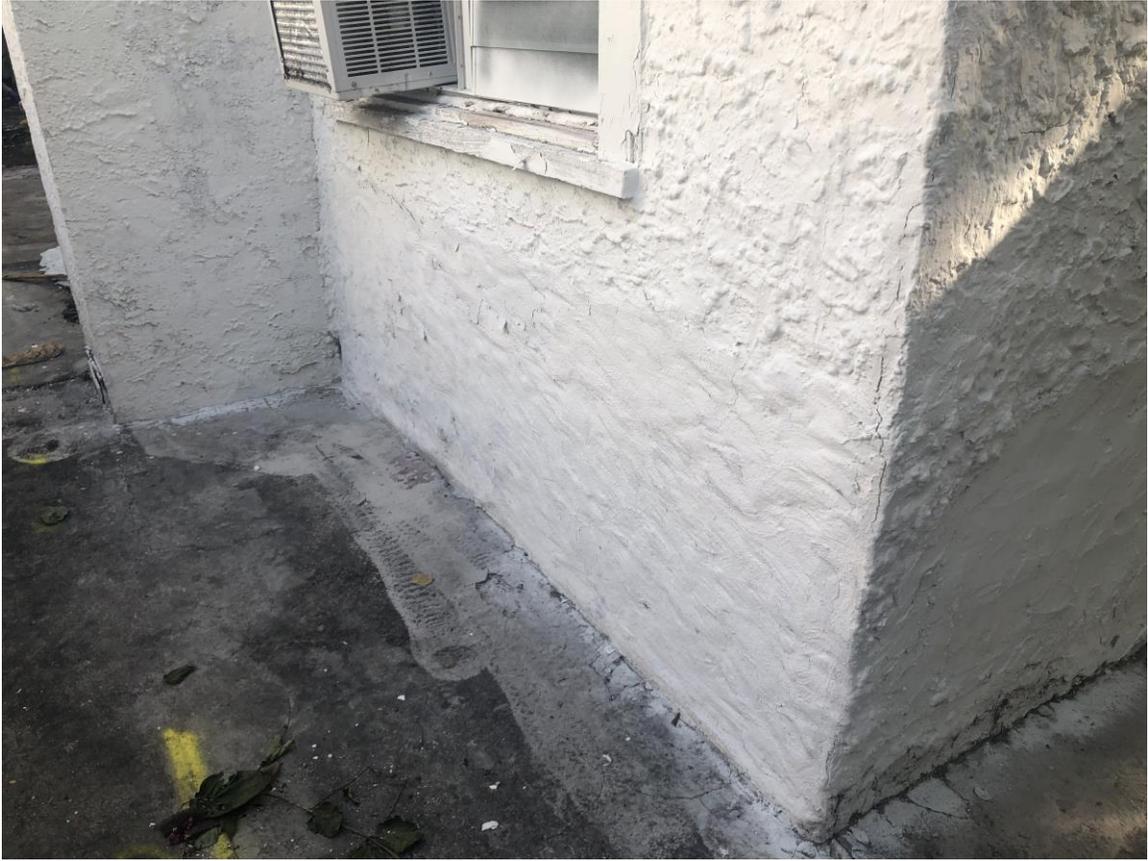
PHOTOGRAPH NO. 26

5. On the east side of the building, there are three window A/C units. Refer to Photographs Nos. 6, 26, 31, 32, 35 and 42. Again, there are numerous gaps that allow water to enter. These units are also not appropriately wind and debris resistant and leave the opened/modified windows less wind and debris resistant.

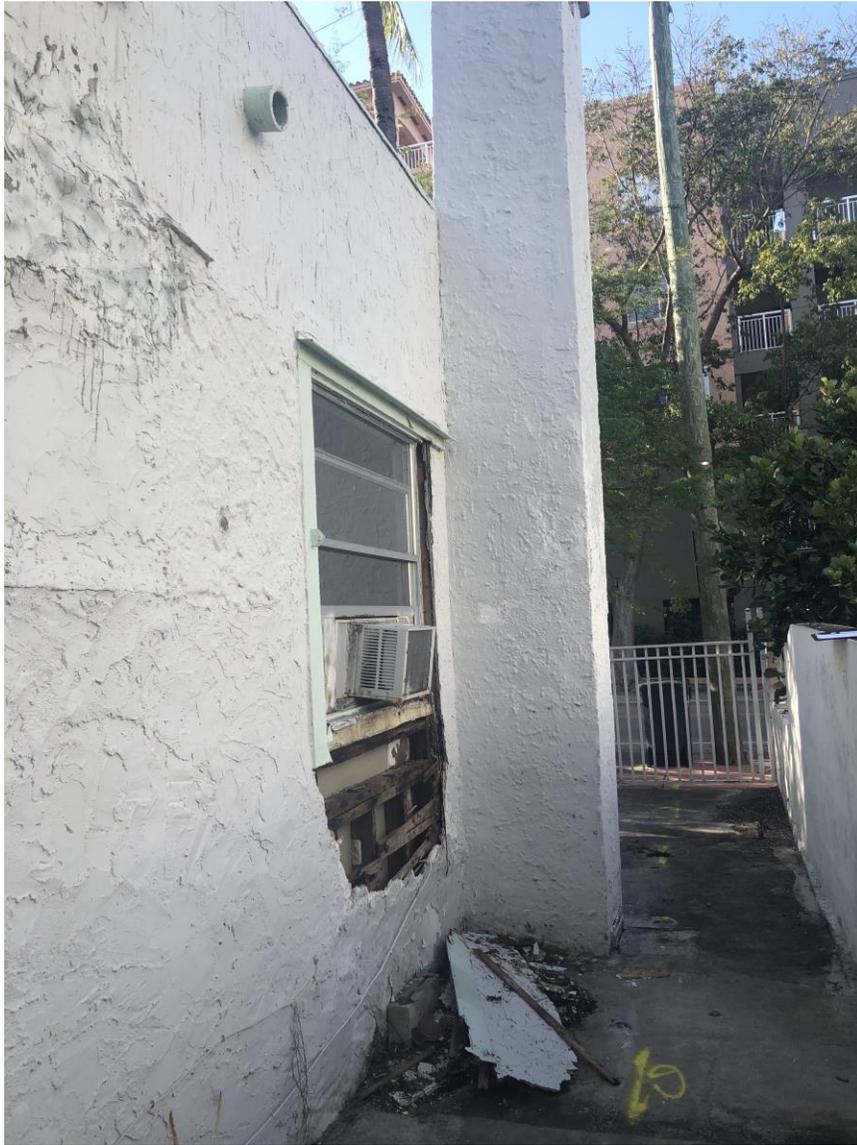
PHOTOGRAPH NO. 32

3. On the west side of the building, there are two locations of significant loss of exterior stucco. Refer to Photographs Nos. 31, 32, 33, 36, 40, 41, 42, 47 and 48. Both of these locations have exposed the wood lath and structural wood members (wall studs and the bearing plate, floor sheathing and floor joists below) to significant water intrusion. The exposed wall framing in the larger opening is

8. None of the existing windows are original to the building. Most of the windows are single-hung aluminum (some painted white, others exposed aluminum), but one window is a slider, and the windows in the southwest room are jalousie. Most of the windows and their seals and caulking are in poor condition. None of the windows have an impact resistance rating. Refer to Photographs Nos. 4, 25, 31, 32, 34, 35, 38, 42, 68, 76, 78, 83 and 93.

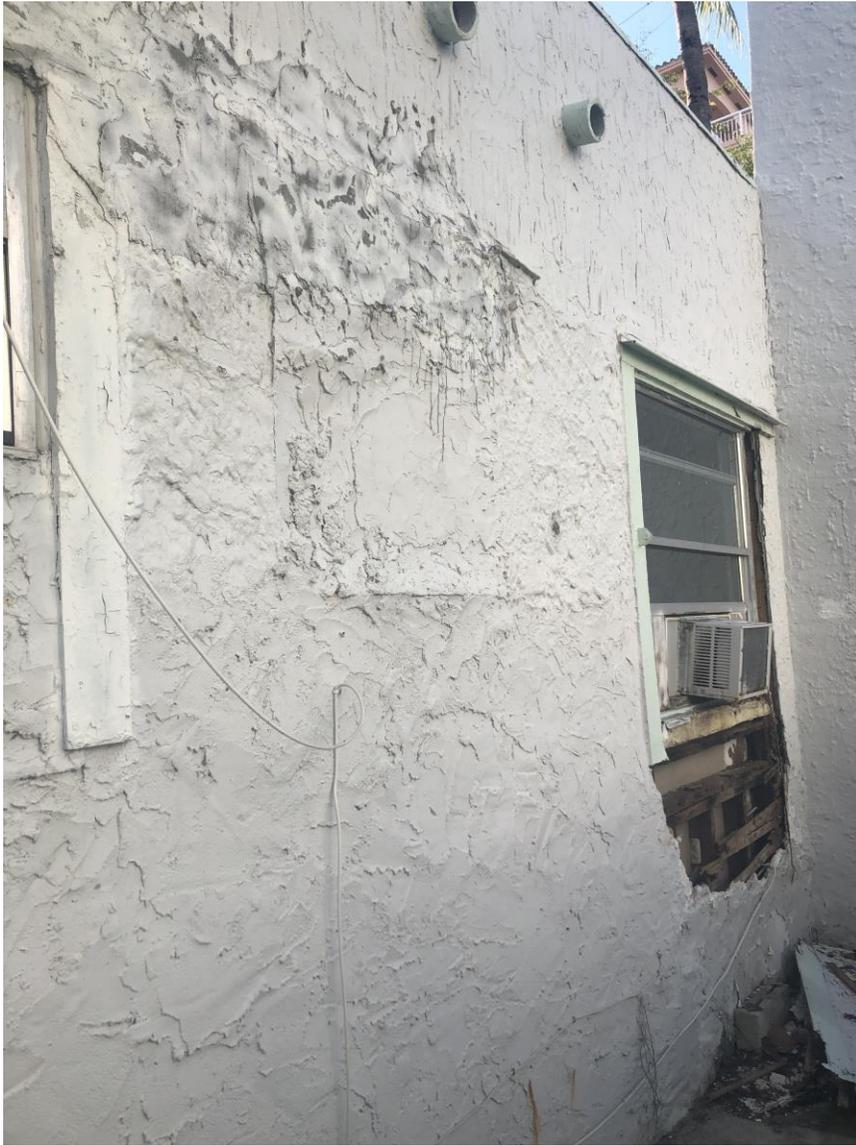
PHOTOGRAPH NO. 33

3. The inaccessible attic space is vented by only three small pipe vents on the front of the building and two small pipe vents on the two sides. Refer to Photographs Nos. 15, 33 and 74. These vents do not provide the area of venting long-required by the building codes.

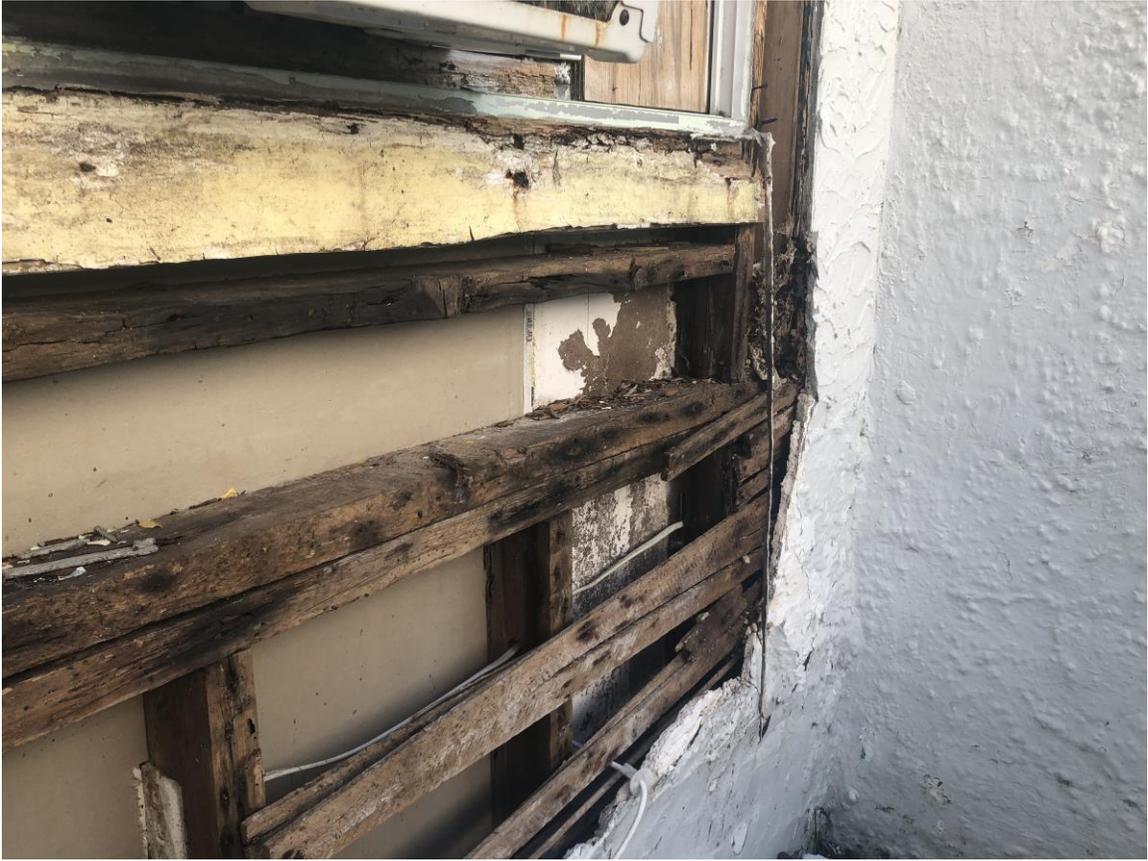
PHOTOGRAPH NO. 41

visibly rotted. Other presently concealed members below the opening are also likely rotted.

6. A number of the exterior window openings have been modified. Refer to Photographs Nos. 34, 41 and 42. The sills of the two front (south side) windows are at different elevations, the sills of the two rear (north side) windows are also at different elevations, and the sills on the east side are at different elevations. It is likely that the structural framing and cladding for these modified openings is inadequate.

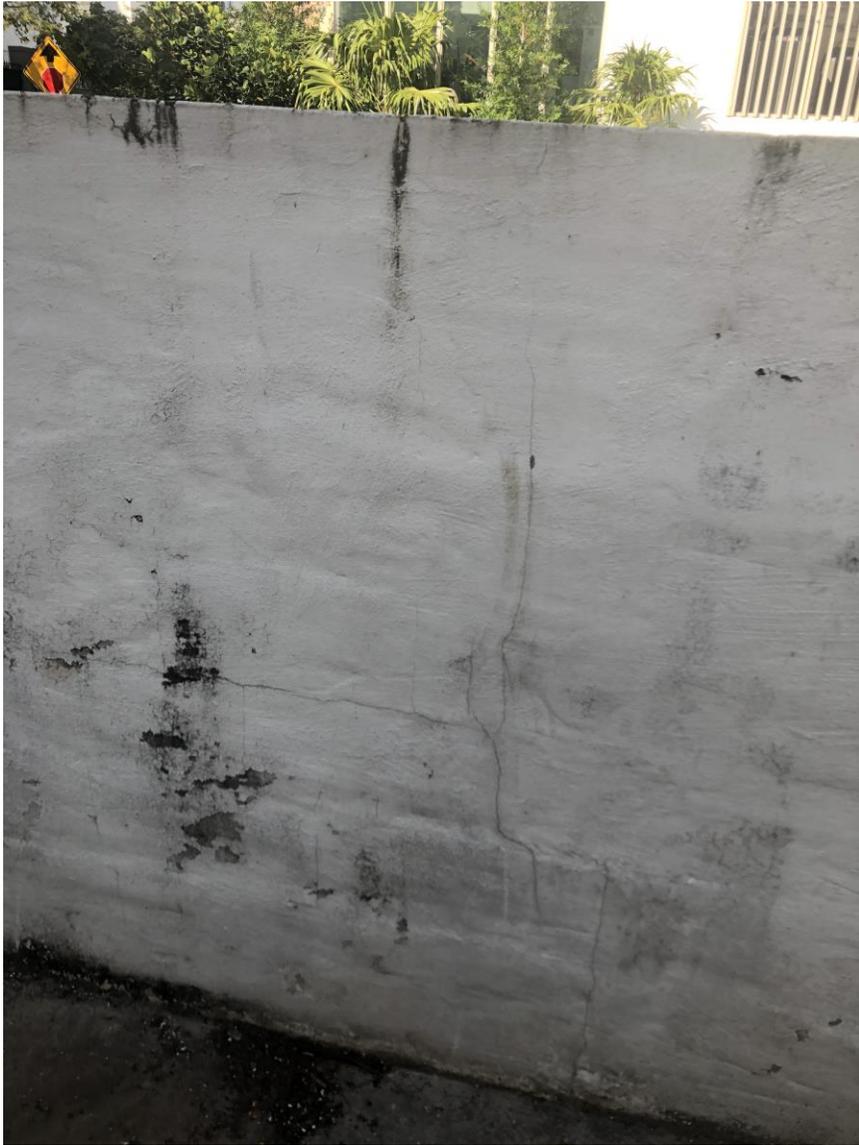
PHOTOGRAPH NO. 53

1. The masonry fence on the west property line is approximately 5 to 6 feet high. The writer used a metal detector on a sample area of the fence and did not find any reinforcing steel (vertical or horizontal). On the top surface of the fence, the tops of grout filled concrete clock cells are visible (no concrete tie beam or cap).

There are several cracks in this fence. There is one particularly wide crack near the middle of its length. No reinforcement was visible in the crack. Refer to Photographs Nos. 50 through 54. The narrower cracks are likely primarily due to material shrinkage, and the wider crack is likely due to some soil settlement as well as material shrinkage. This fence lacks appropriate strength for its height.

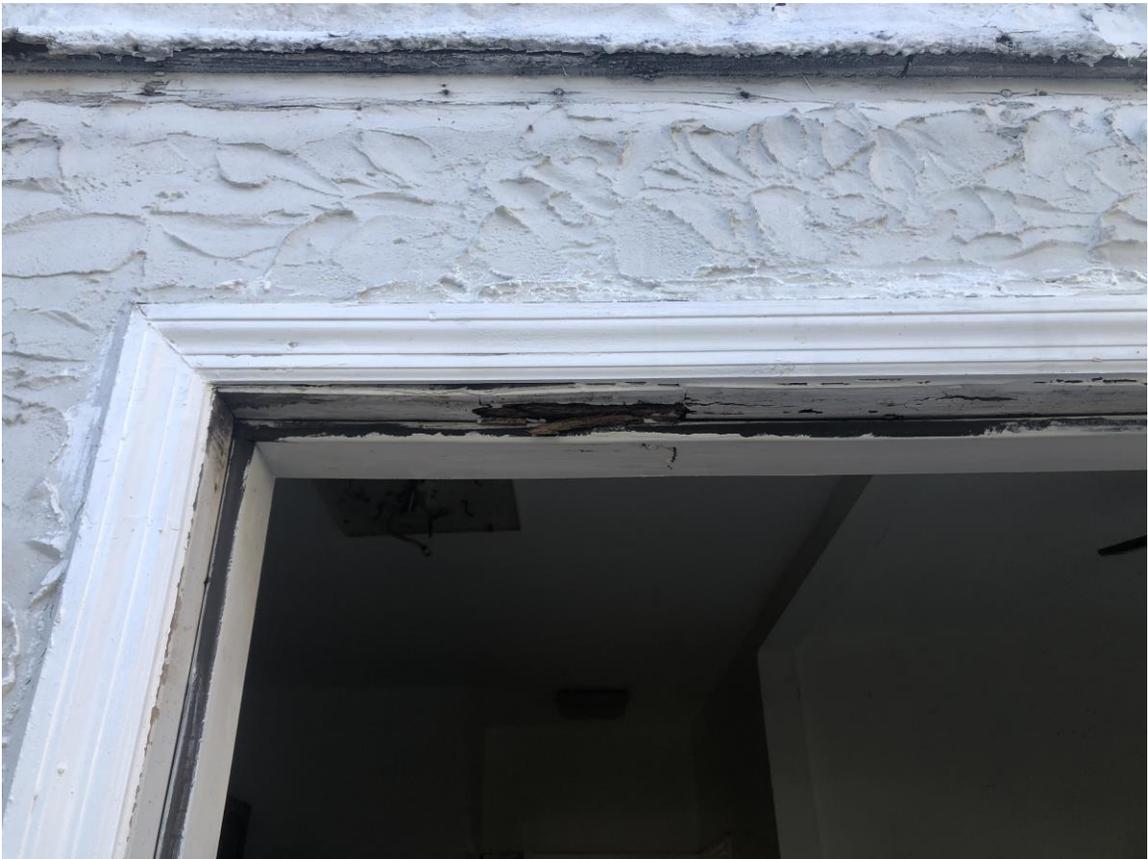
PHOTOGRAPH NO. 62

9. None of the doors are original to the building. All of the doors are hollow metal with wood frames. The wood frames and wood stiles of the two rear doors are rotted. One of the rear doors has a window, while the other does not. Refer to Photographs Nos. 4, 15, 58, 62, 63, 64, 66 and 67.

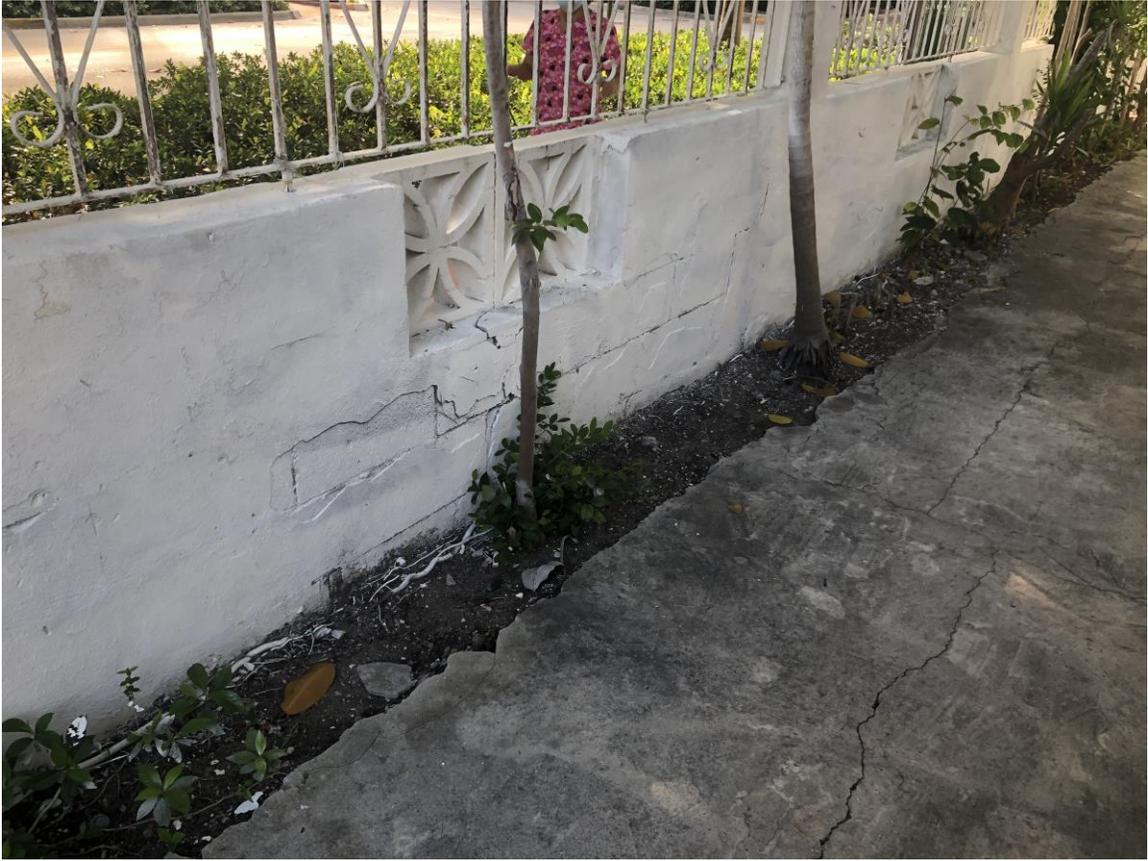
PHOTOGRAPH NO. 70

2. The masonry/metal fences along the east and south property lines also have numerous cracks and areas of missing stucco. Portions of the south perimeter fence are leaning outward. The leaning is likely due to soil settlement. Refer to Photographs Nos. 1, 2, 3, 55, 56, 57, 70, 71 and 72. This fence lacks appropriate strength for its height.

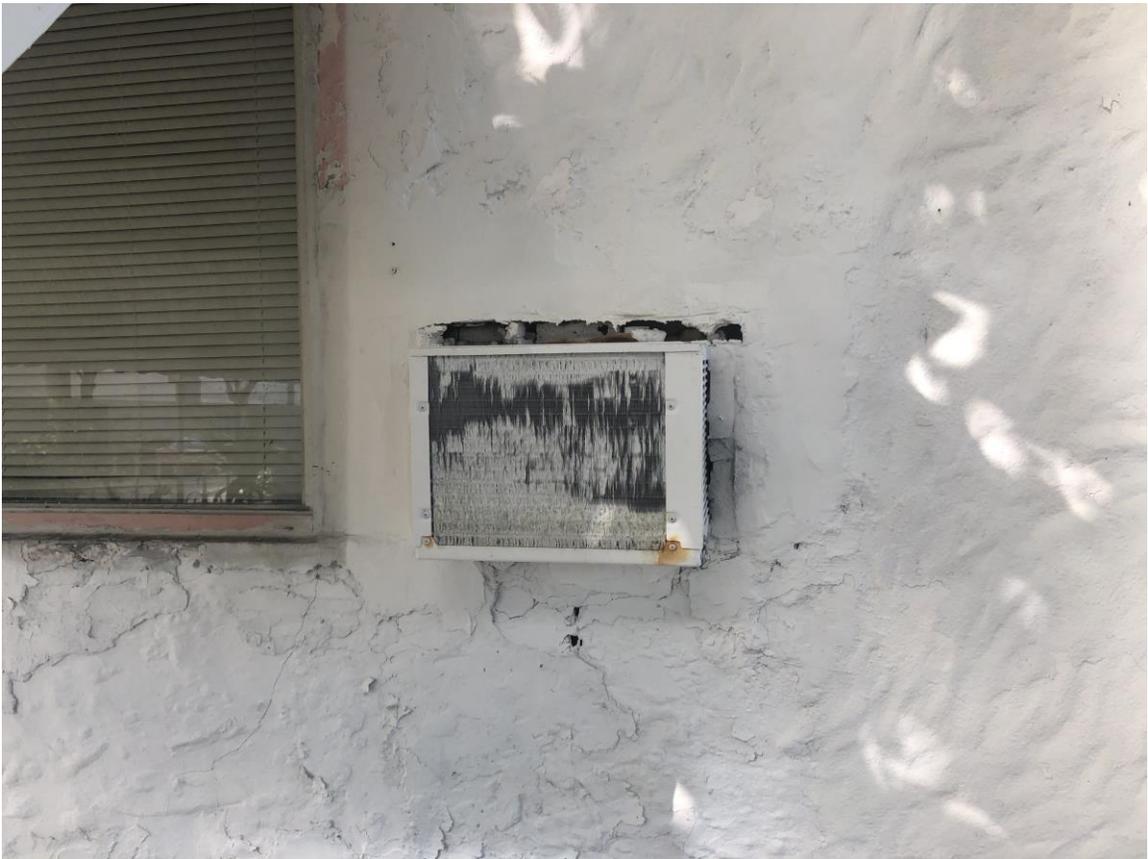
PHOTOGRAPH NO. 76

4. There are three through-wall air-conditioning units on the east wall of the building. Each of these units has significant gaps around their perimeters. Refer to Photographs Nos. 74, 76, 78 and 81. These gaps allow water to enter the wall cavities, which is likely causing rot of the concealed wood structural members of the wall and floor.

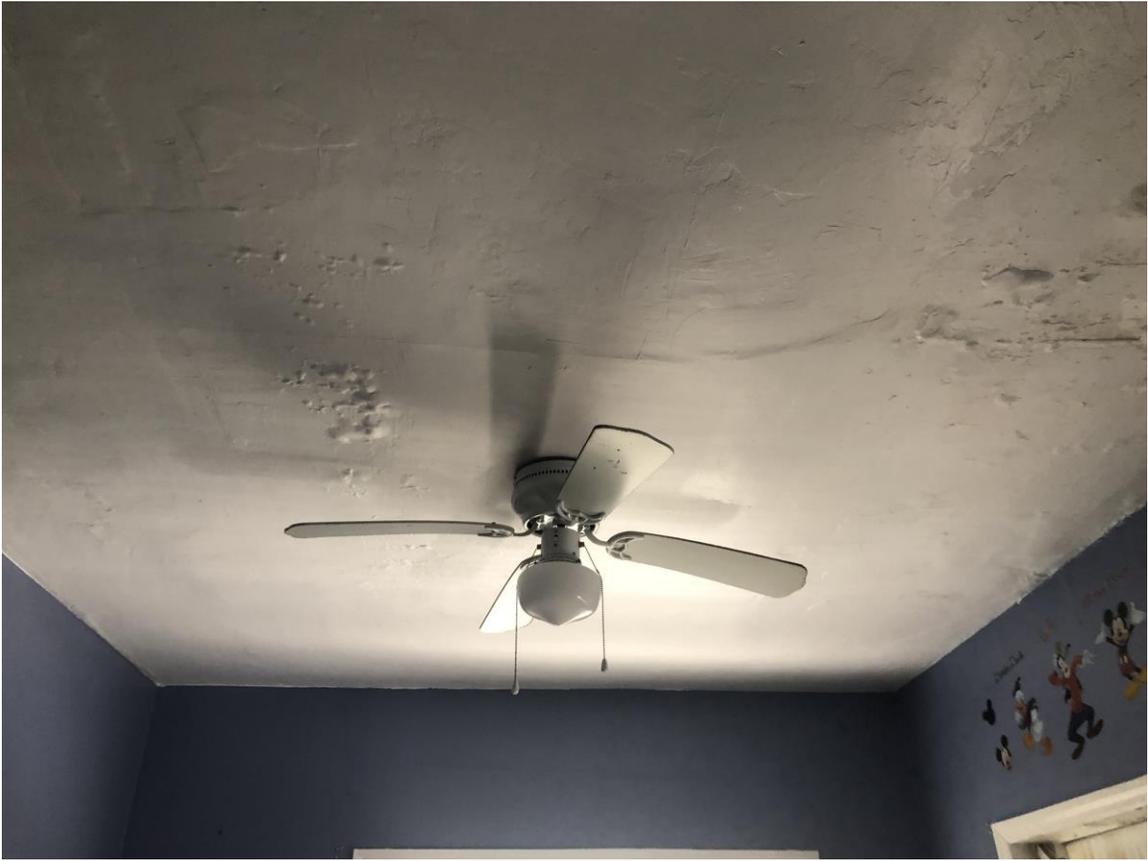
PHOTOGRAPH NO. 84

4. There are signs of current or previous roof leaks on the interior of the southeast room. Refer to Photographs Nos. 84, 85, and 86.
5. The presently existing roofing is old, worn and cracked. Refer to Photographs Nos. 94 and 95.

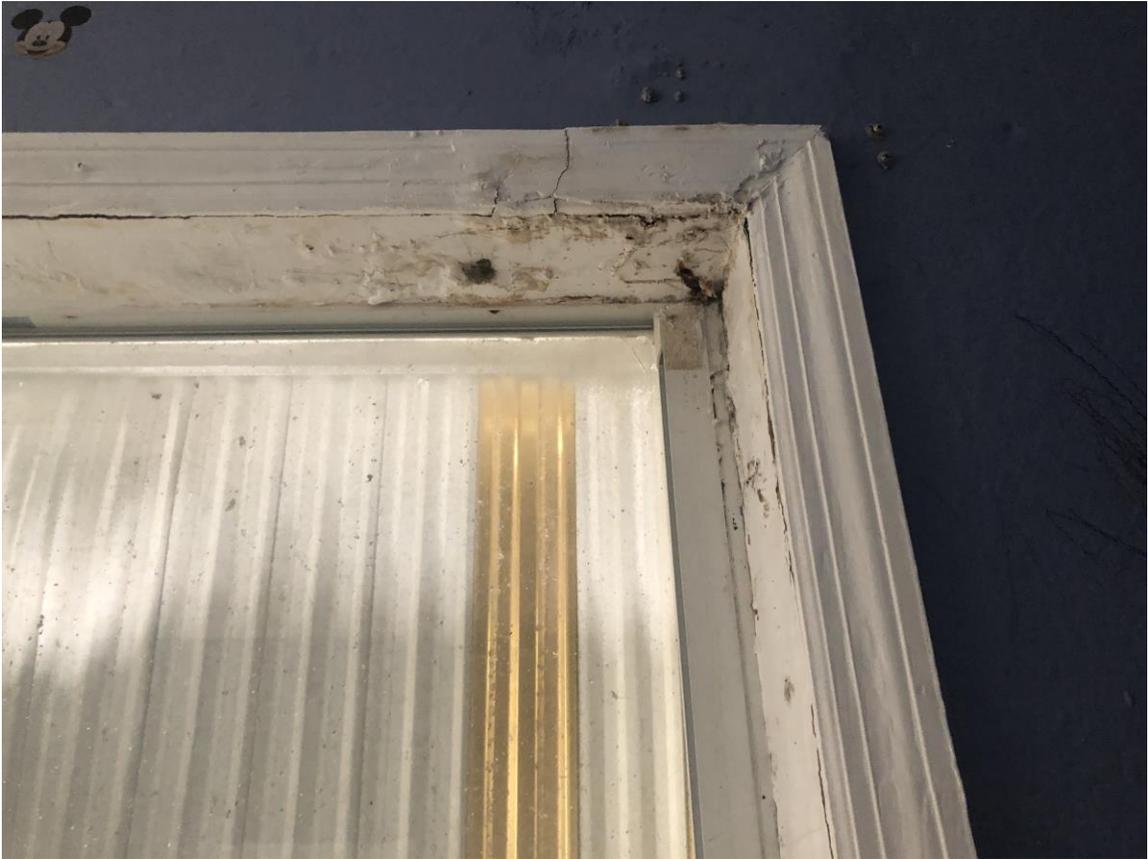
PHOTOGRAPH NO. 85

10. Some of the present windows were set in previously existing wood frames. At other windows, the previous casements/frames were removed, and stucco was patched in around them. Some windows have both conditions. Most of the exposed wood casements//frames are rotted. Refer to Photographs Nos. 22, 25, 26, 31 through 36, 38, 43, 44, 58, 61 and 78. Interior window casements are also stained and rotted in some locations. Refer to Photographs Nos. 85, 86 and 87.

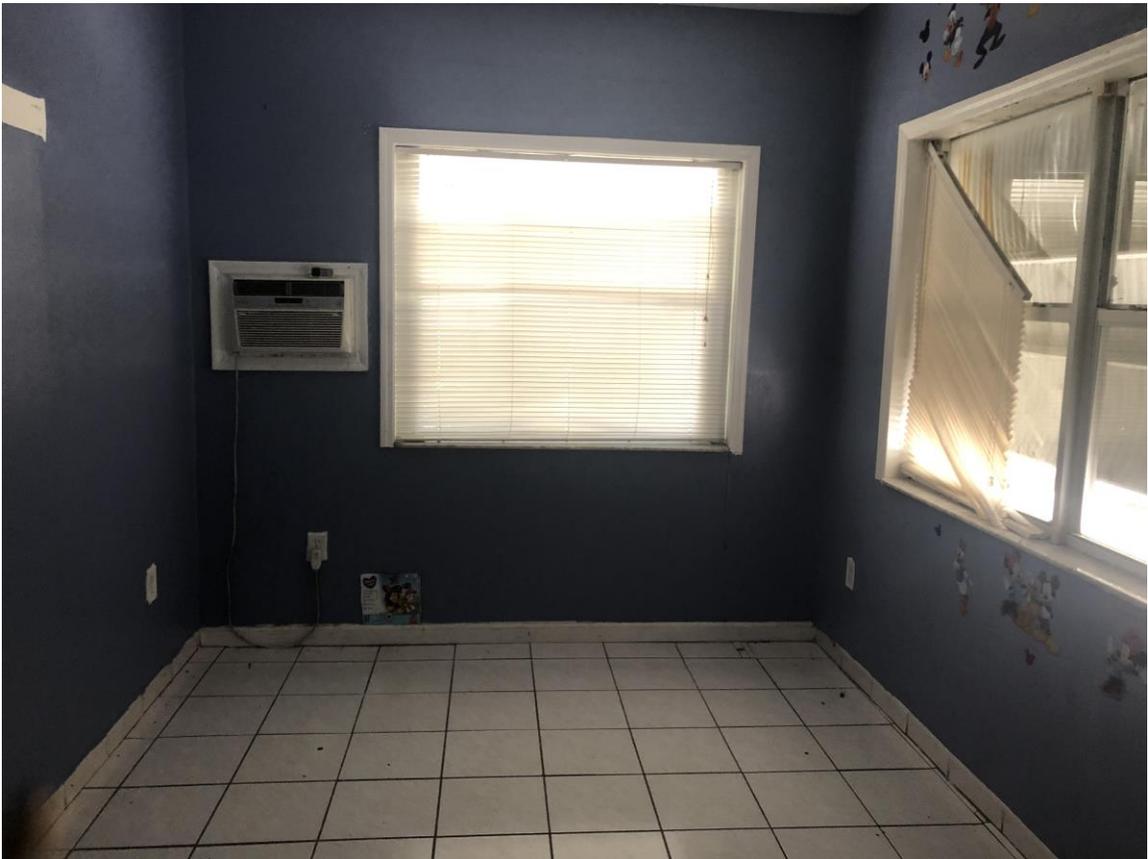
PHOTOGRAPH NO. 88

1. In general, all of the wood-framed floors deflect and vibrate under foot.
2. The floors are uneven in a number of locations. This may indicate inherent weakness, deterioration, long-term deformation and or soil settlements. Refer to Photographs Nos. 88, 89, 91, 92 and 93.

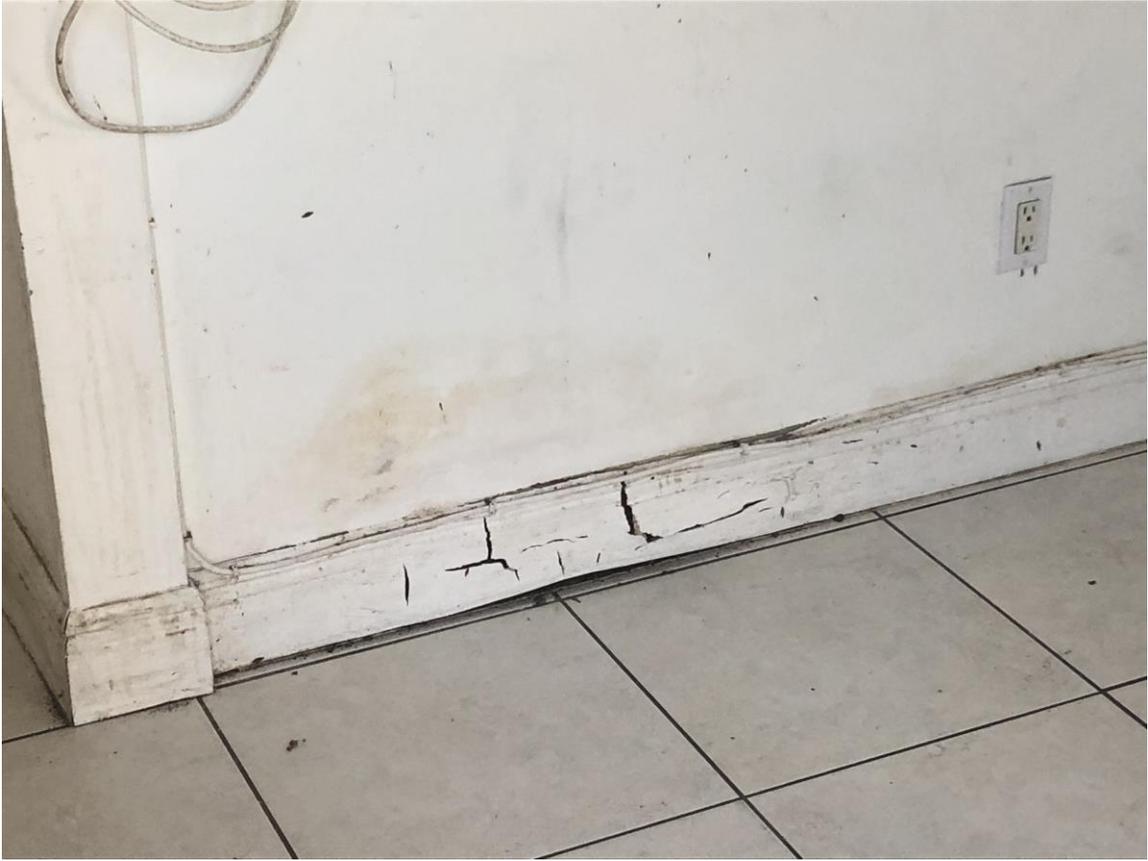
PHOTOGRAPH NO. 91

3. The baseboard in the kitchen of the western unit is significantly rotted, along with staining of the wall above and deflection of the floor below. Refer to Photograph No. 91. The bathroom plumbing is on the other side of this wall. This indicates previous or current leaks in the pipes which have most likely damaged the partition framing and bearing plate, floor sheathing and floor joists.

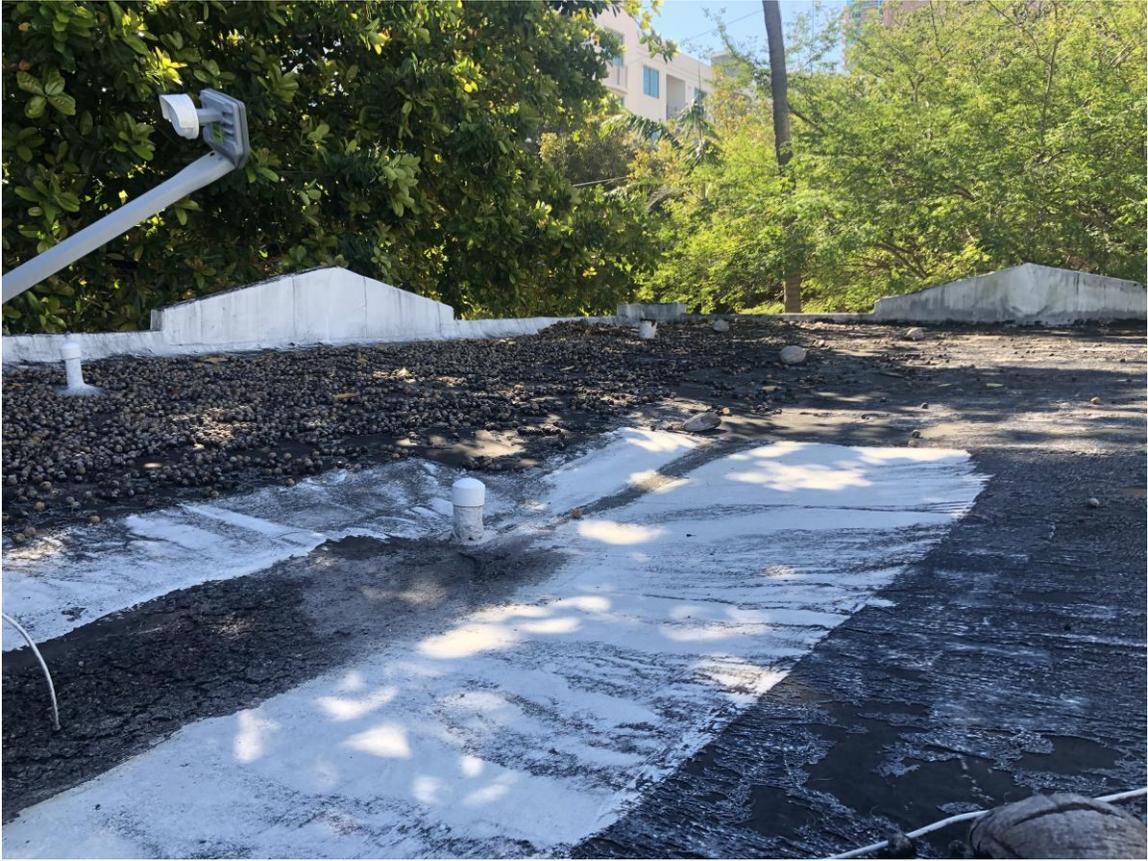
PHOTOGRAPH NO. 94

1. There is only one roof scupper (through the rear parapet) for the entire roof, and there is no overflow scupper/drain. Refer to Photographs Nos. 58, 94 and 95.

2. The adjacent tall trees have deposited, and will continue to deposit, a considerable amount of debris on the roof. Such debris could easily clog the one scupper, causing a back-up of water on the roof, which could overload portions of the roof structure. Refer to Photographs Nos. 58, 94 and 95.

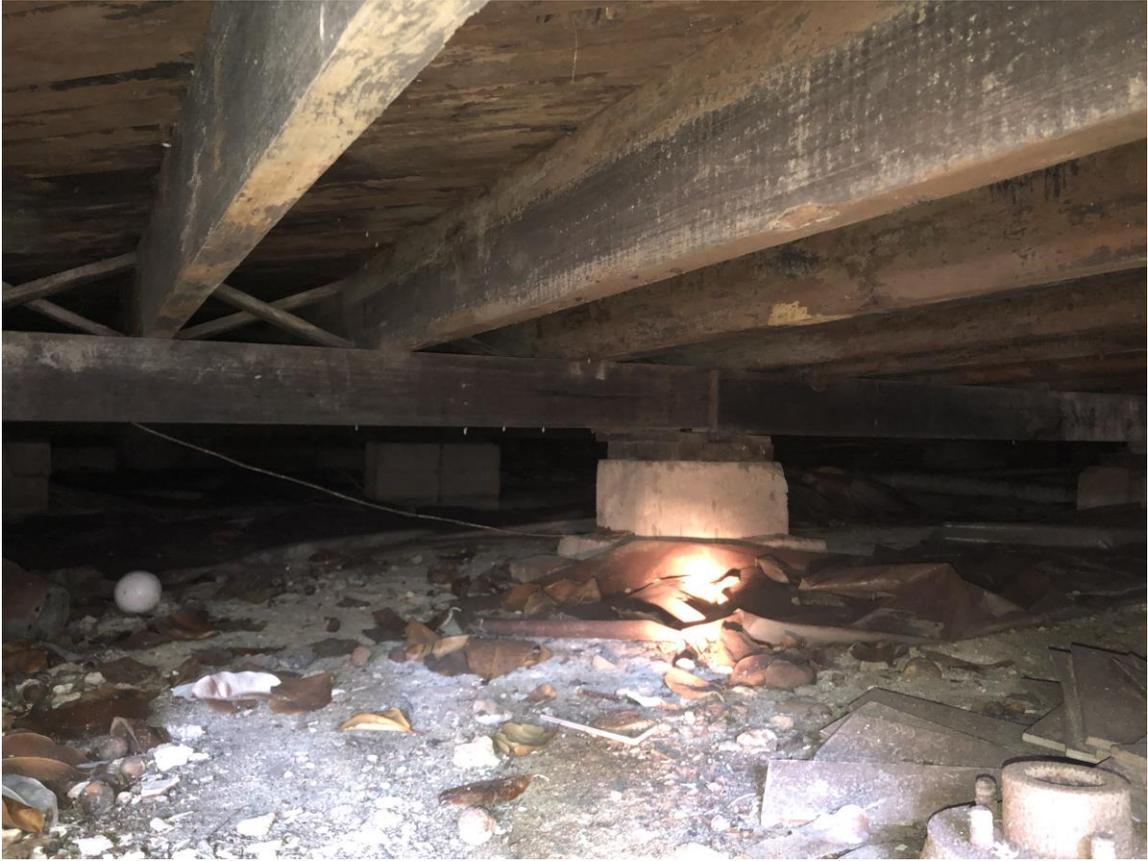
PHOTOGRAPH NO. 96

4. There is a lack of ventilation for the crawl space. There are no vents on the north and south sides. There were two vents on the west side, but they have been covered and/or blocked (refer to Photograph No. 100). There were two vents on the east side of the building, but one has long been boarded over (refer to Photograph No. 74). This lack of ventilation can lead to excessive moisture that can support the growth of fungi that cause rot. Yellow and white powders observed on several of the wood floor members are likely such fungi. Refer to Photograph No. 96.

5. In the area under the floor that was visible, there is insect damage in some of the wood joists and sheathing. Refer to Photographs Nos. 96, 97 and 98.
