ALVEY TREE CONSULTING LLC

## Arborist Report

1420 22nd Street

Miami Beach

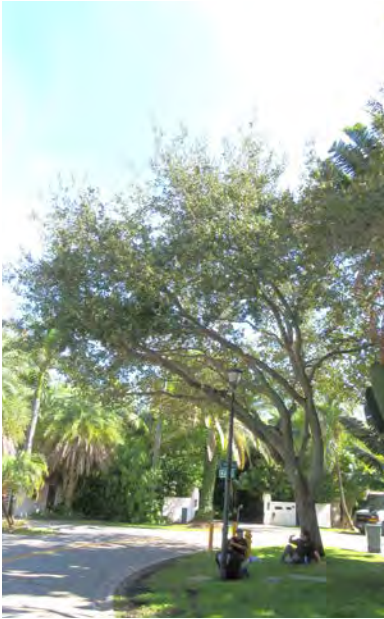
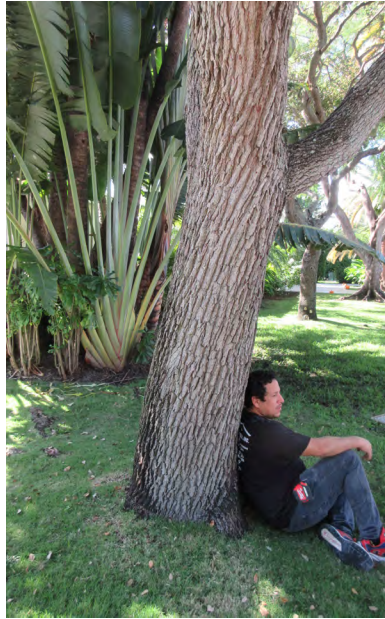
## Tree #1

**Condition -**  
GOOD

Tree #1 is a Live Oak street tree located at the corner of Lake Avenue and 22nd Street. It is in good condition. Old pruning cuts are closing over well. Little deadwood is present. There are some large surface roots. Prune to increase clearance over the street.

**Disposition -**  
REMAIN - 20FT RADIUS TPZ

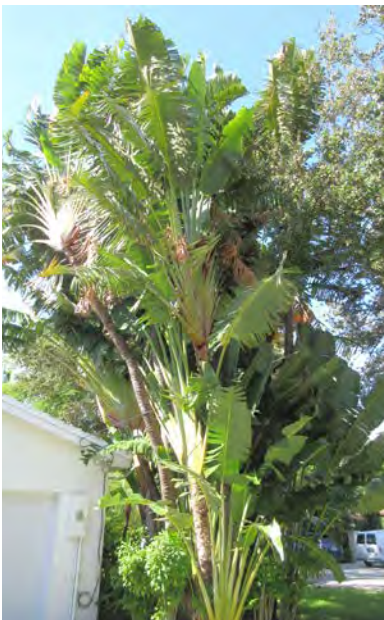
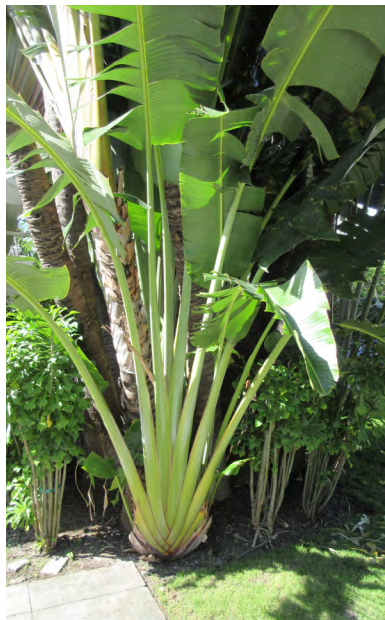
## Tree #2

Tree #2 is a Traveler's Palm cluster located at the northeast corner of the house. It is in good condition with some tattered fronds. This tree has not been incorporated into the landscape plan and will therefore be removed.

**Disposition -**  
REMOVE

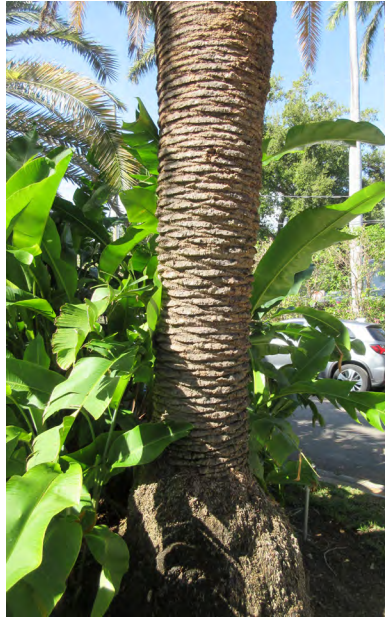
## Tree #5

Tree #5 is a Canary Island Date Palm street tree located along 22nd Street. It is in good condition. There is some yellowing on the fronds.

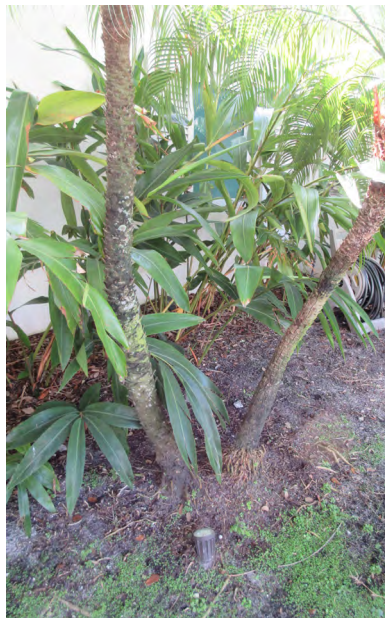
## Tree #6

Tree #6 is a double Pygmy Date Palm located at the front of the house. It is in fair condition with yellow fronds. This tree has not been incorporated into the landscape plan and will therefore be removed.

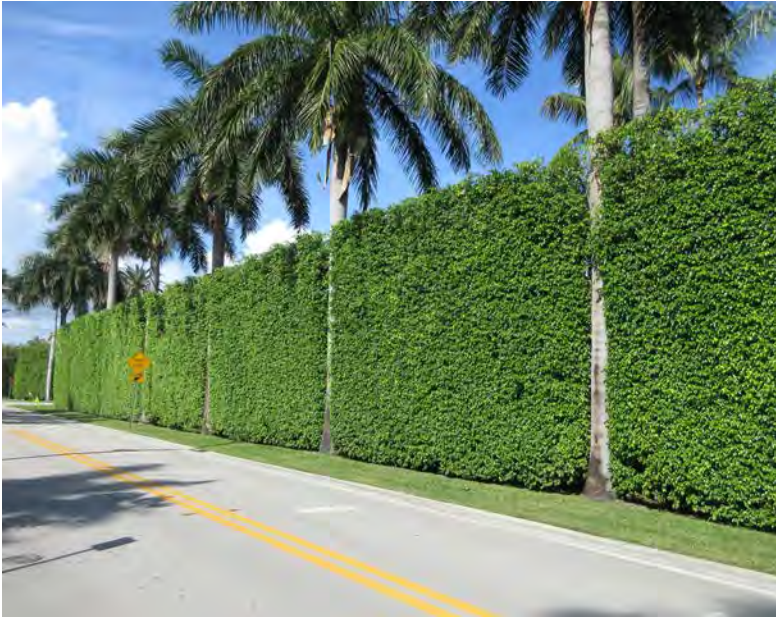
## Tree #7,8, 25, 26

Tree #7,8, 25, 26 is a Weeping Ficus hedge that wraps around the majority of the property. It is in good condition with dense, healthy green foliage. The hedge has been routinely trimmed.

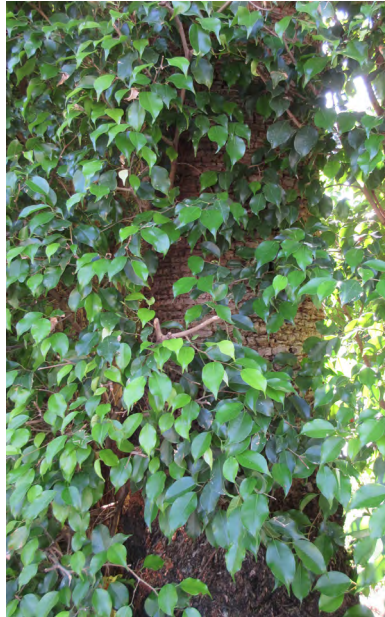
## Tree #10

Tree #10 is a Canary Island Date Palm street tree located along 22nd Street. It is in good condition with some off-color fronds.

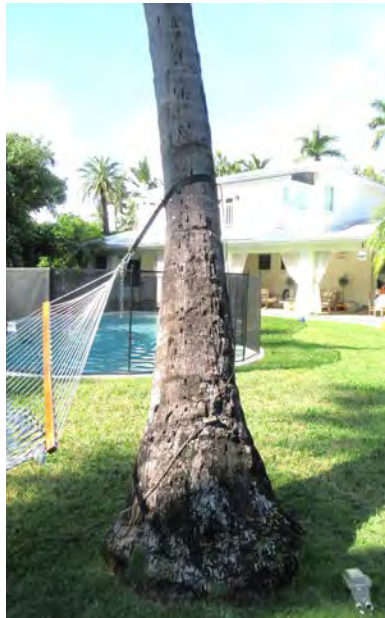
## Tree #19

Tree #19 is a Coconut Palm located in the backyard. It is in good condition. There are some climbing spike injuries to the trunk. This tree has not been incorporated into the landscape plan and will therefore be removed.

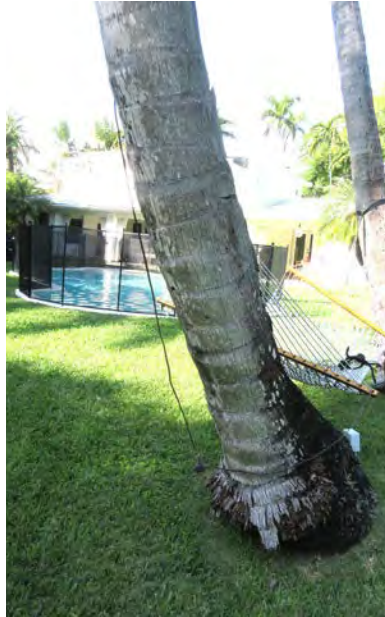
## Tree #20

Tree #20 is a Coconut Palm located in the backyard. It is in fair condition. There are some climbing spike injuries to the trunk and the trunk is pencilling. This tree has not been incorporated into the landscape plan and will therefore be removed.

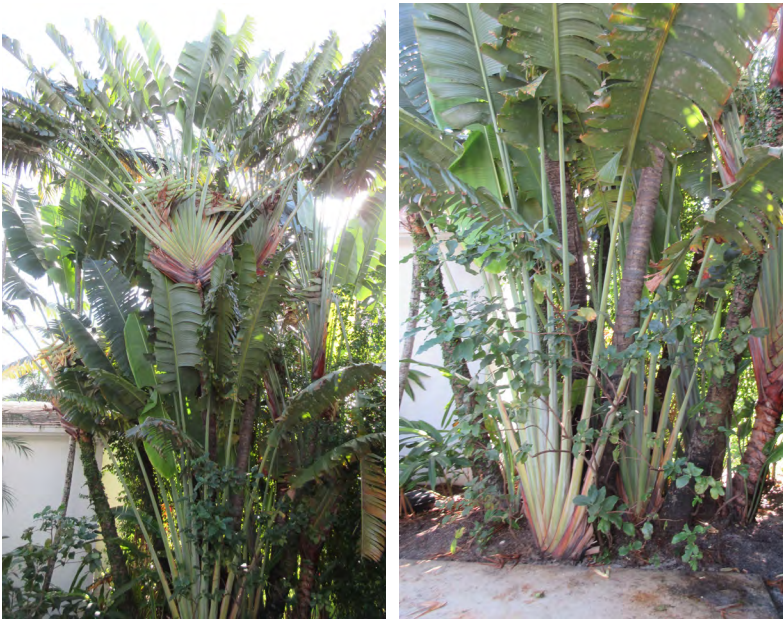
Tree #22, 32 is one Traveler’s Palm cluster located at the northwest corner of the house. It is in fair condition with tattered fronds and some pest issues. This tree has not been incorporated into the landscape plan and will therefore be removed.

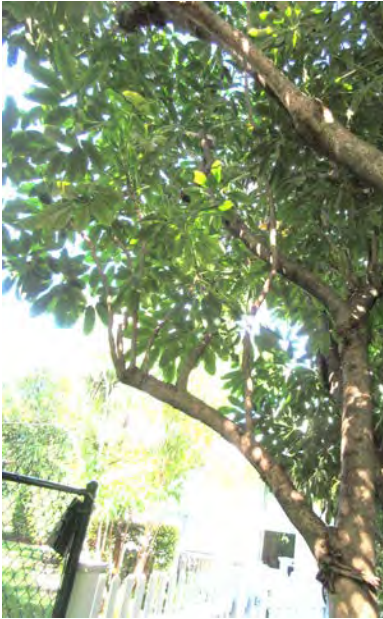
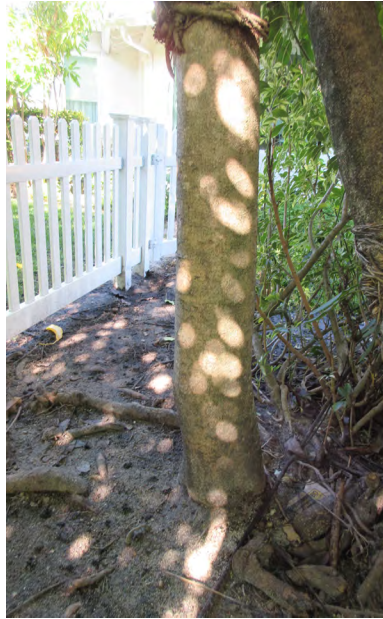
Tree #28 is an Umbrella Tree located in the backyard. It is in fair condition and is competing with the nearby trees. This species is highly invasive in South Florida and this tree will therefore need to be removed.

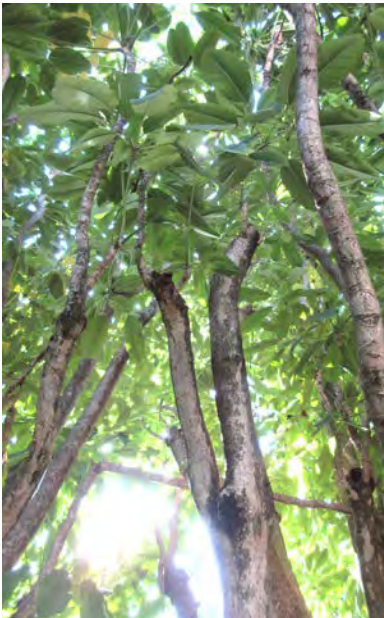
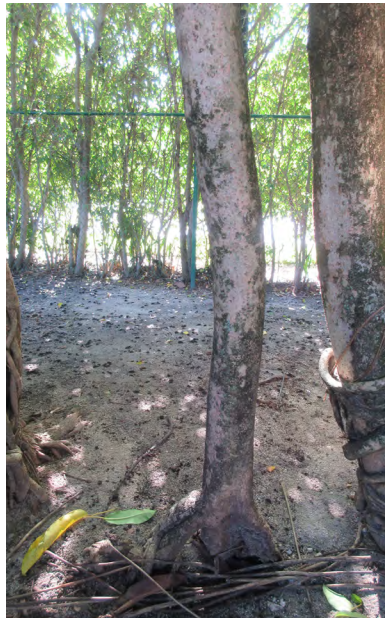
## Tree #31

Tree #31 is an Umbrella Tree located in the backyard. It is in poor condition and is competing with the nearby trees. The tree has been hattracked and there is little canopy remaining. This species is highly invasive in South Florida and this tree will therefore need to be removed.

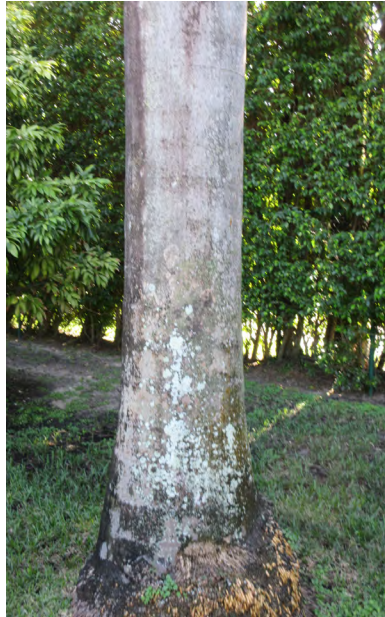
## Tree #33

Tree #33 is a Royal Palm located in the backyard. It is in fair condition with a pencilling trunk.

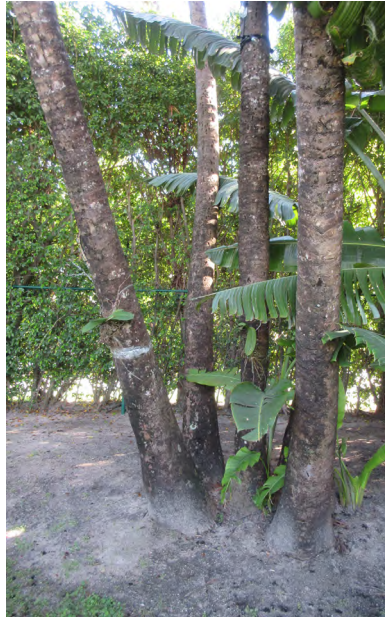
## Tree #41-43

Tree #41-43 is one Traveler's Palm cluster located in the southeast corner of the backyard. It is in fair condition with a small canopy, climbing spike injuries, and lower dead fronds.

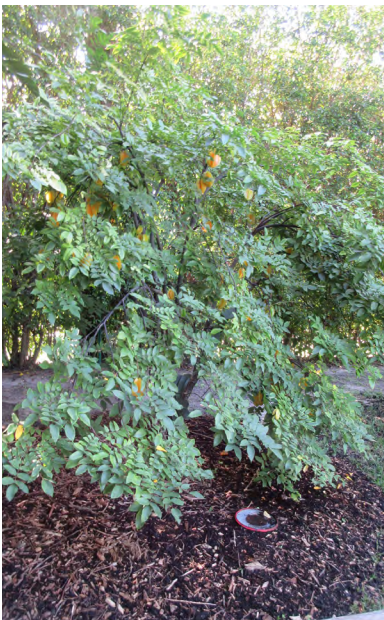
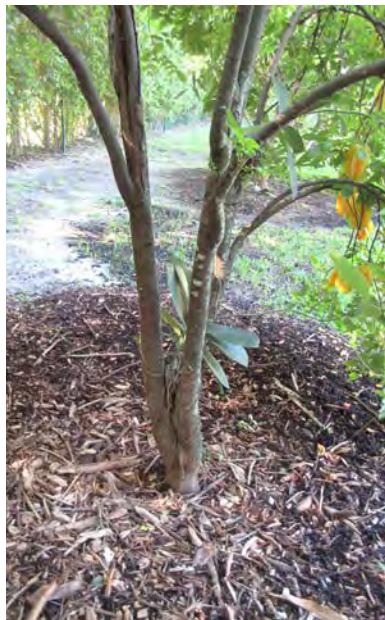
## Tree #44

Tree #44 is a Star Fruit tree located in the southeast corner of the backyard. It is in good condition with many fruits. The trunk divides into two with included bark.

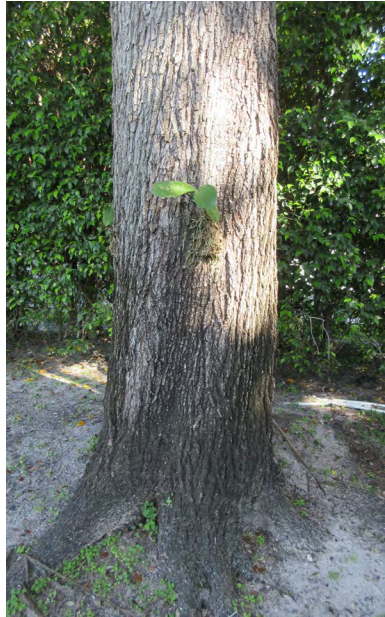
## Tree #45

Tree #45 is a Live Oak street tree located along Lake Avenue. It is located 3.5ft west of the chainlink fence. The tree is in good condition with good vigor. There is one old cavity on the trunk with decay and wetwood that has nearly closed over. Little deadwood is present.

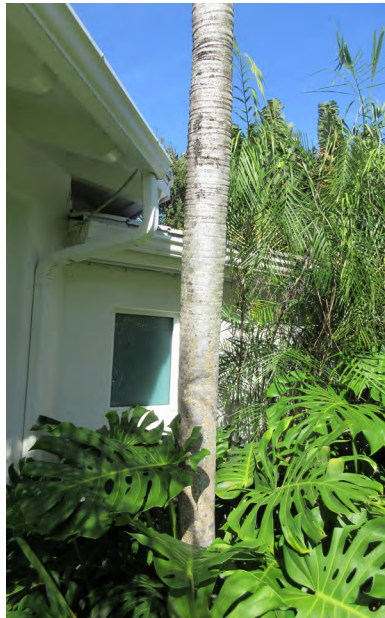
## Tree #48

Tree #48 is a Christmas Palm located at the rear of the house. It is in fair condition with a pencilling trunk. This tree has not been incorporated into the landscape plan and will therefore be removed.

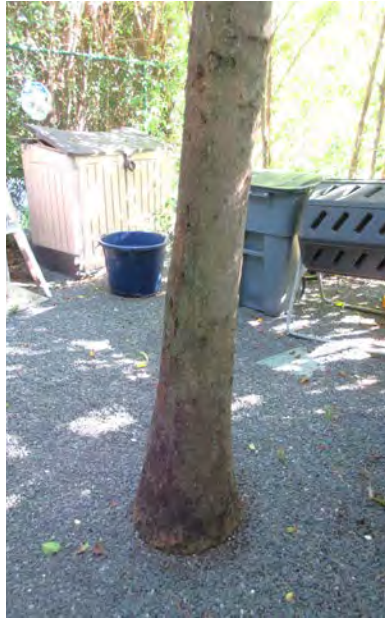
## Tree #55

Tree #55 is a Chinese Fan Palm located on the east side of the property. It is in fair condition with leaf skeletonizer damage and yellowing of the fronds.

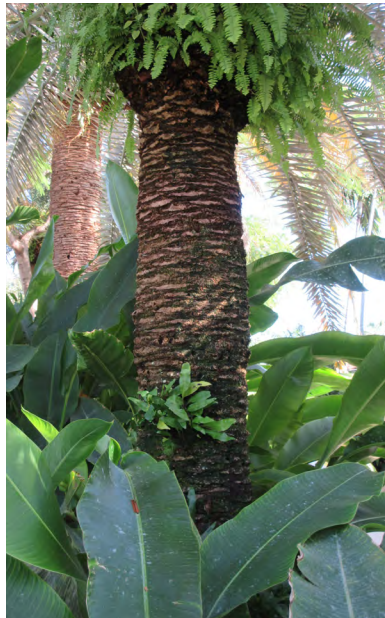
## Tree #56

Tree #56 is a Canary Island Date Palm street tree located along 22nd Street. It is in good condition. The foliage is off-color and there may be a pest issue.

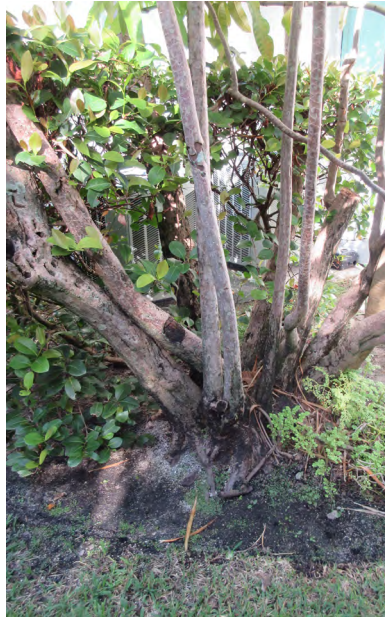
## Tree #61

Tree #61 is a Dragon Tree located at the rear southwest corner of the house. It is multi-trunked and in poor condition. The canopy is thin and there is decay in some of the trunks.

This tree has not been incorporated into the landscape plan and will therefore be removed.

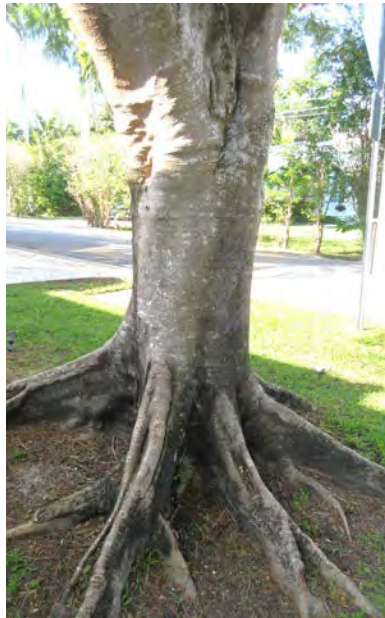
Tree #62 is a Royal Poinciana located at the front of the property. It is in good condition and has a wide-spreading canopy. Little deadwood is present. There are large surface roots. There are old burls present, formed from heading cuts. There is a large cavity on one of the main limbs with decay that is closing over.

Prune to maintain clearance over the street.

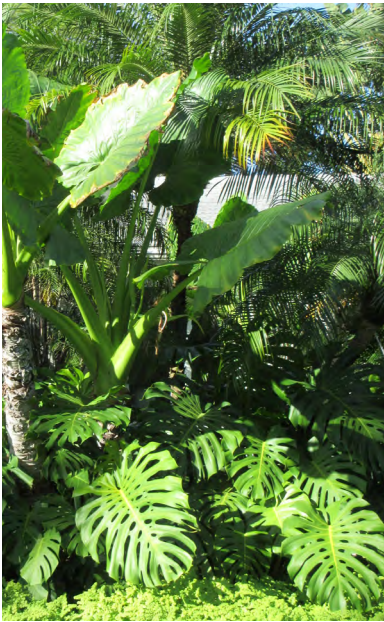
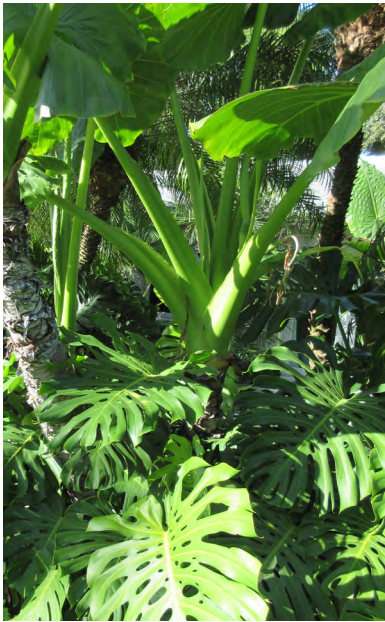
Tree #68 is an Elephant Ear located at the rear of the house. It is in fair condition with some marginal necrosis. This plant has not been incorporated into the landscape plan and will therefore be removed.

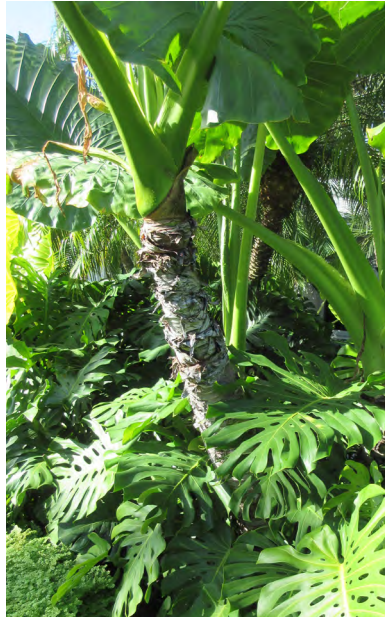
Tree #69 is an Elephant Ear located at the rear of the house. It is in fair condition with some marginal necrosis. This plant has not been incorporated into the landscape plan and will therefore be removed.

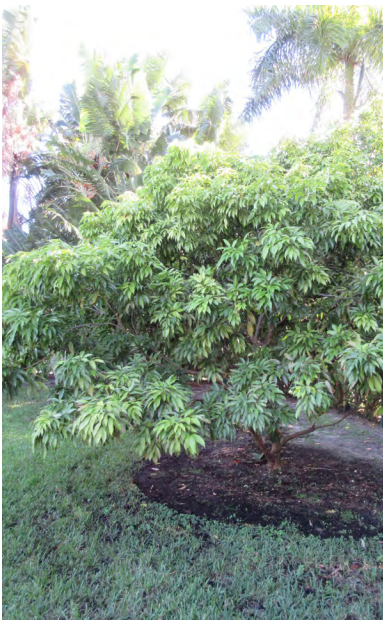
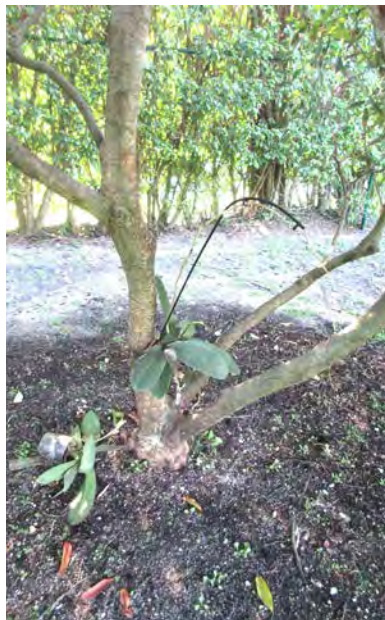
Tree #70 is a Lychee located in the backyard. It is in fair condition with a dense canopy and some chlorosis. This tree has not been incorporated into the landscape plan and will therefore be removed.
