Building Services Report

January 25, 2023

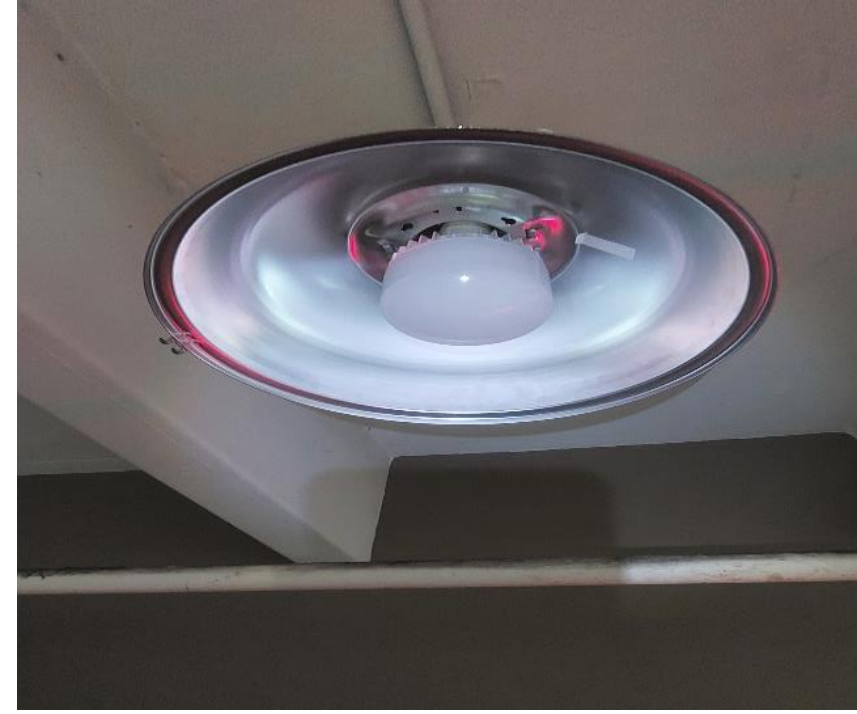
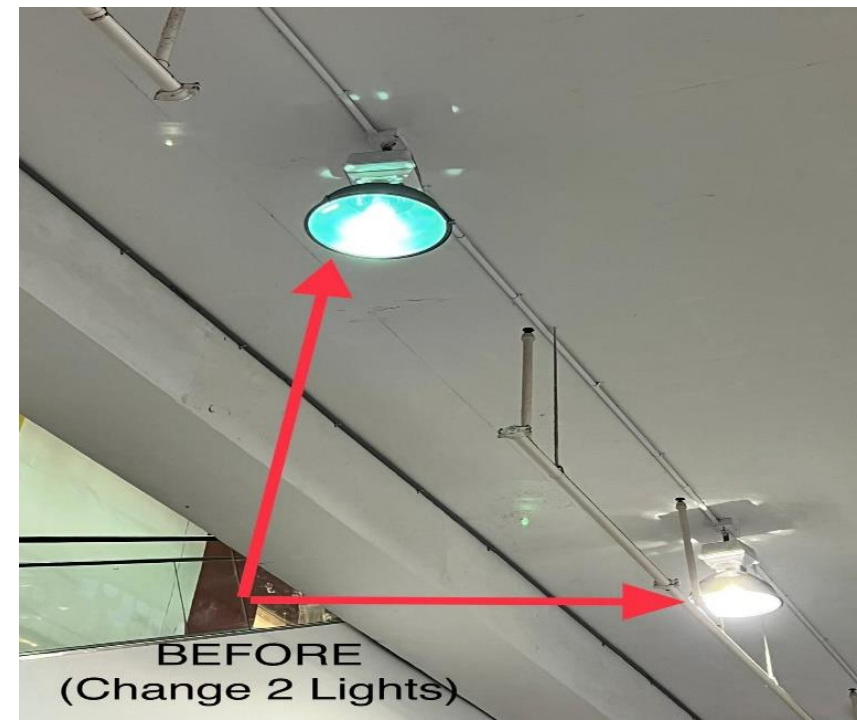
BEFORE
(Change 2 Lights)

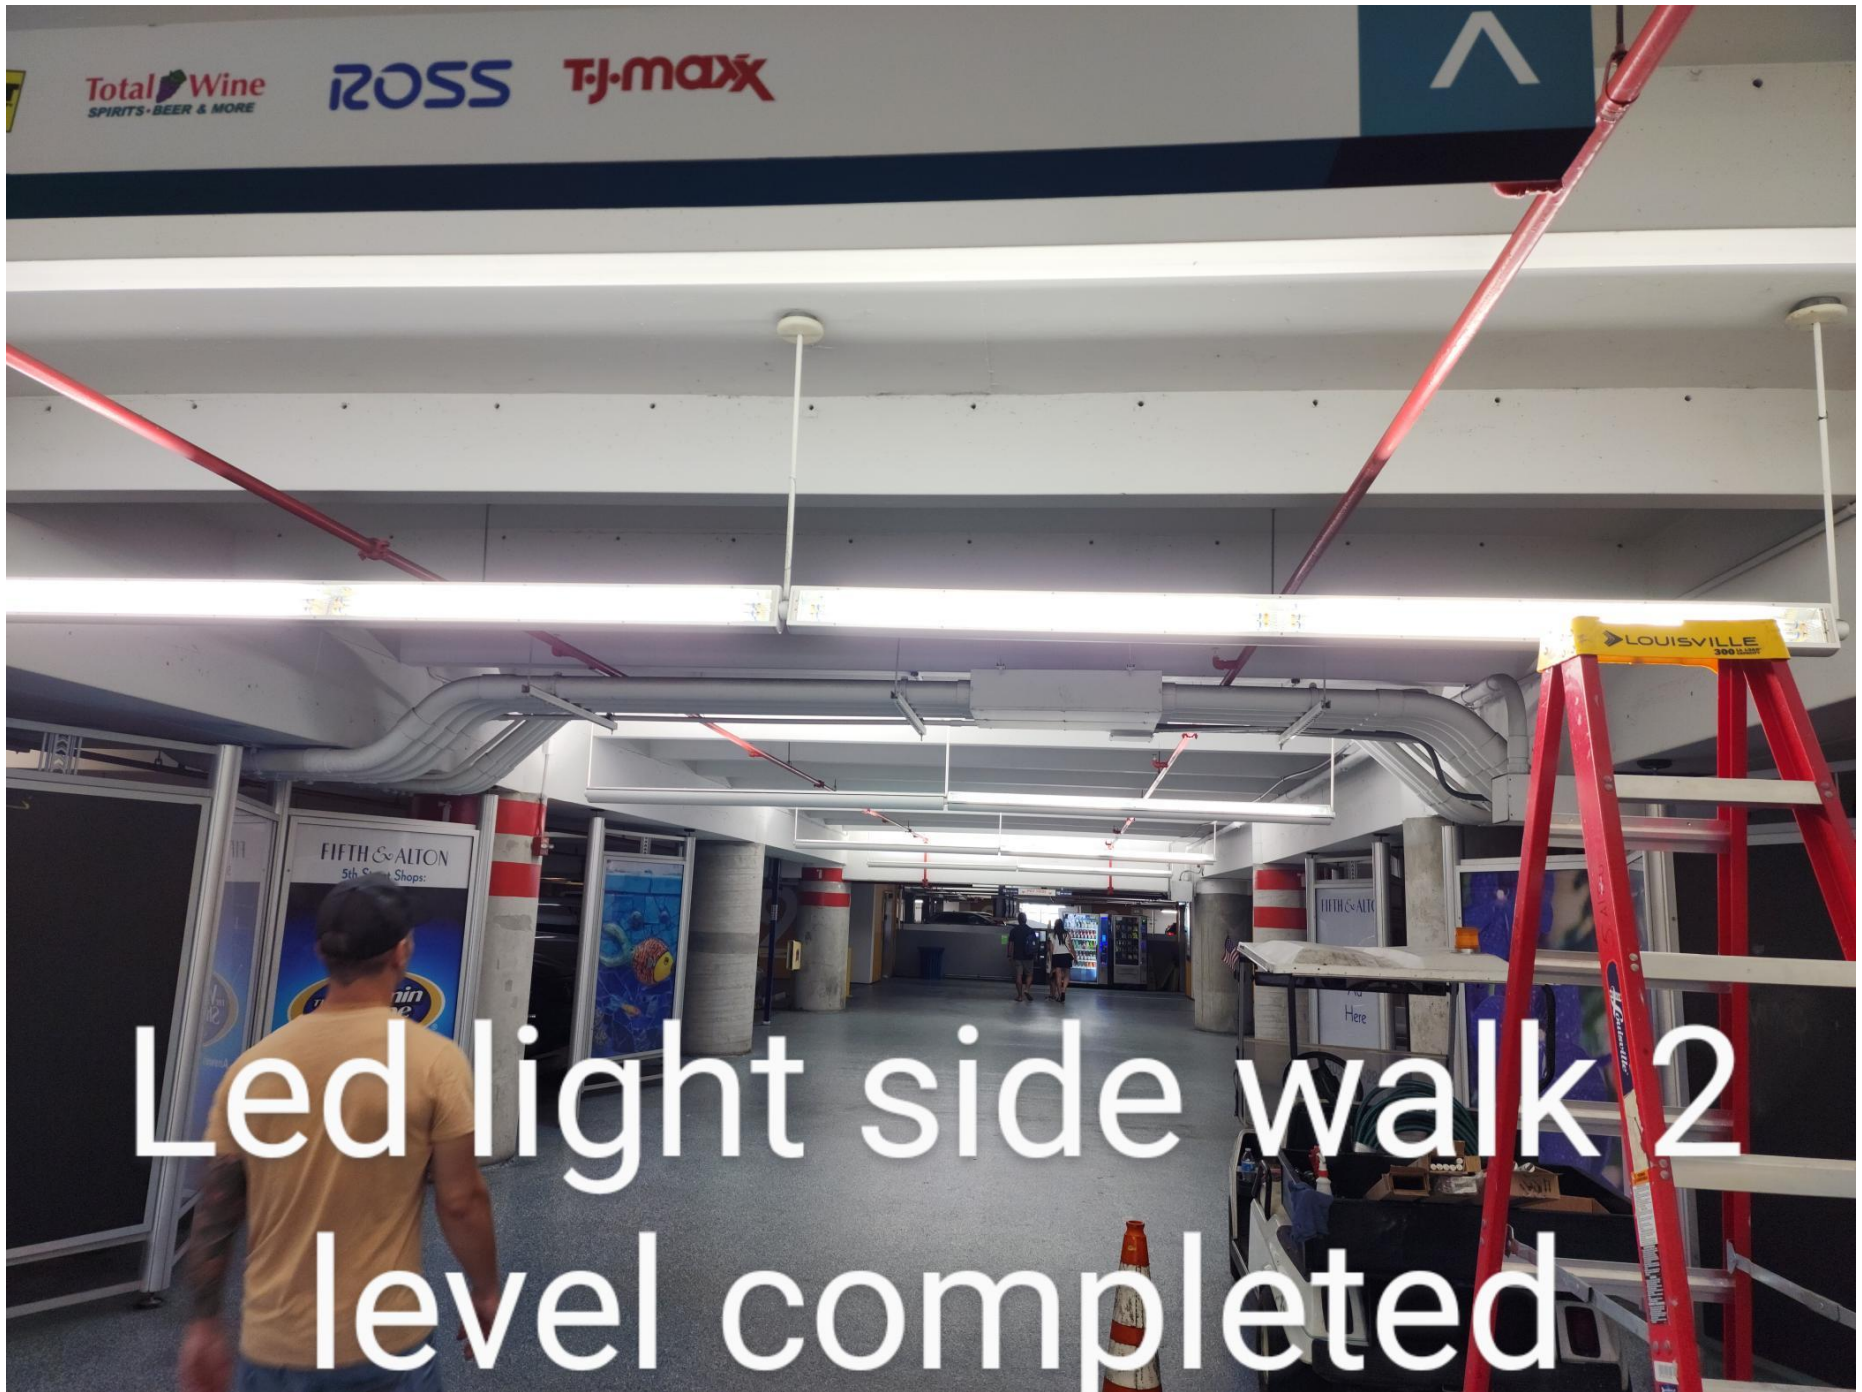
Led light side walk 2
level completed
