INTERIM Treatment REPORT I
Jackson Stewart's *Apollo Mural*
Conservation of the Mosaic

September 14, 2022

Jack Stewart's Apollo is a 92-foot-long mosaic mural originally installed on the historic Miami Beach Versailles Hotel. This artwork was removed upon the demolition of the hotel and has remained in storage since 2014. Both times that RLA assessed the mural, it was stored in an empty lot at 285 NW 71st Street, Miami, FL 33150.

This interim report outlines the work completed for the conservation of the Apollo Mosaic commencing in April 2022 through August 19th, 2022. This work has included an inventory, relocating the mosaic, testing methodologies for treatment, initial cleaning, and review of the artwork by a structural engineer.

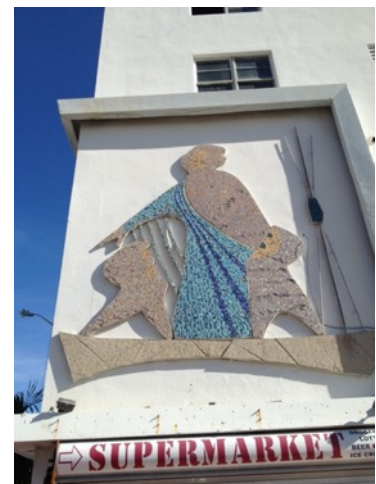
Detail of mural at its original location in 2012. Loss of tesserae already visible. Retrieved from Flickr.

Historical photographs recovered during an online search, show that at in least panels #17, #18, #19 and #20, originally located in the wall in 32nd Street, tile loss was visible since at least 2012.

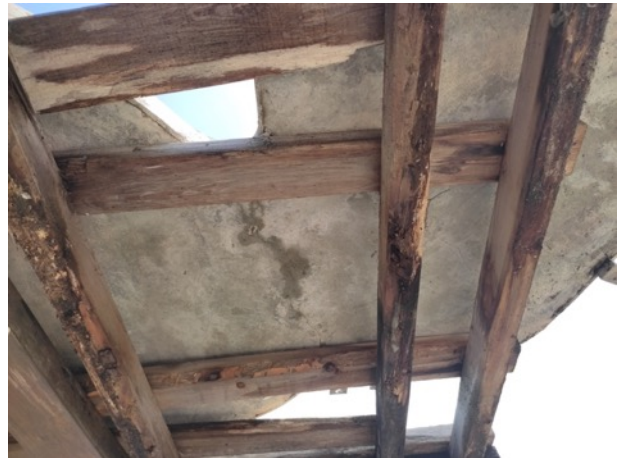
Detail of water infiltration at crack on the back of panel #17 **during** relocation.

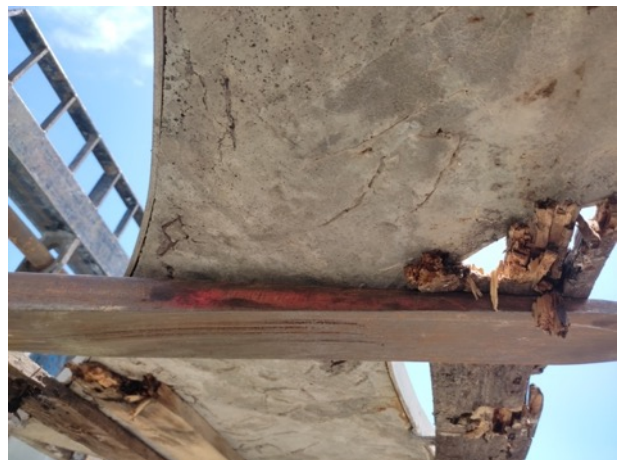
Detail of cracks, distinguishing marks and exposed wire mesh on the back of panel #18 **during** relocation.

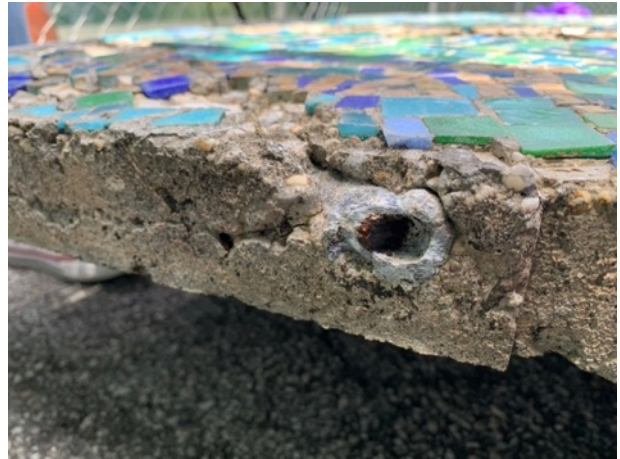
In panel #1, an exposed aluminum tube with internal ferrous support was excavated. The iron was extensively corroded (almost all the way through the rod) and the force of expansion caused the aluminum tube to crack and also expand outwards. The expansion resulted in cracking of the concrete and dislodged embedded tiles. Though the embedded support structure is visible on this panel, it is assumed that this is happening elsewhere, likely due to trapped moisture and galvanic corrosion. As a result, there is extensive tesserae loss throughout most panels anywhere that there is an internal aluminum support bar. This was found to be the case at least in the other two excavated panels #4 and #18. Though the internal mesh is corroded, it does not appear to be causing similar cracking and tesserae loss. However, if it is meant to provide added rigidity to the panels within their backless aluminum frames, this may be compromised based on the extent of the corrosion.

Detail of aluminum tube and corroded ferrous bar exposed due to the detachment of the aluminum frame at panel #1.

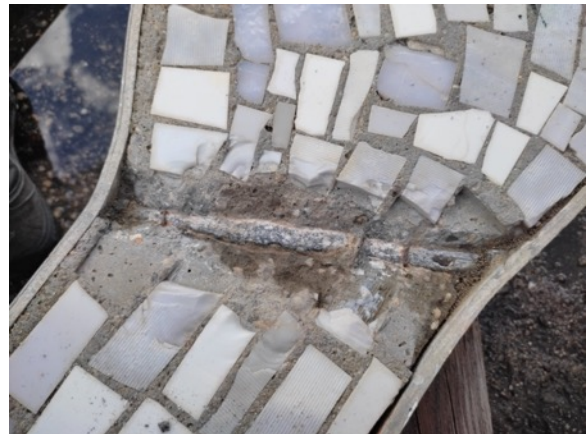
Detail of excavated aluminum tube showing internal corroded ferrous bar, and corroded wires (supposedly attached to mesh) at panel #4.

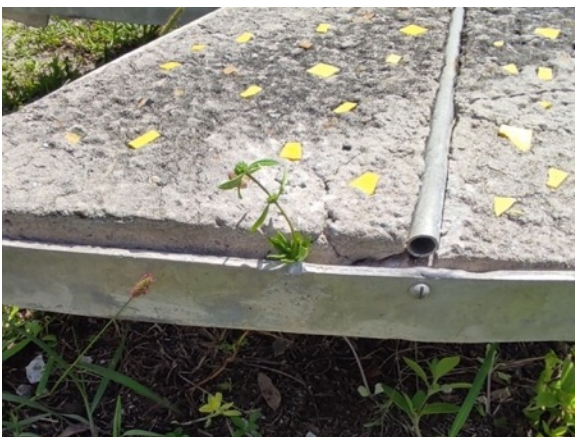
For panels that make up the "ground" elements, the mesh appears to be closer to the surface within the concrete. In these panels, it is not evident what the mesh/lath is attached to within the assembly. The same aluminum tubes that are embedded in the panels that compose the figures, have been set at surface level, merely embedded in the concrete, and do not appear to have internal ferrous rods. It is not clear if there is another set of support rods embedded in these panels in addition to those set at the surface.

Detail of hollow, superficial aluminum decorative tube on 'ground' panel.

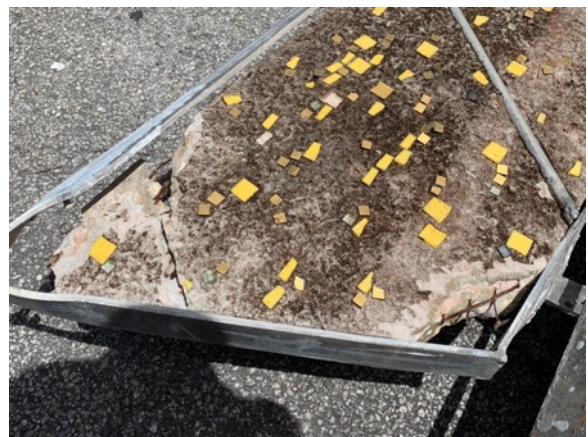
At both the figurative and ground panels, areas of exposed and excavated mesh/lath exhibit corrosion over all surfaces. The individual panels themselves are no more than about 4" or less deep. The recommended depth of any embedded ferrous support is a minimum of 2" from the surface to help mitigate corrosion as a result of concrete carbonation. One can assume that the concrete has carbonated to the depth of all the panel reinforcements and has facilitated corrosion of these elements.

Detail of exposed aluminum tube, cracks, concrete loss and exposed corroded wire mesh on 'ground' panel **during** excavation.

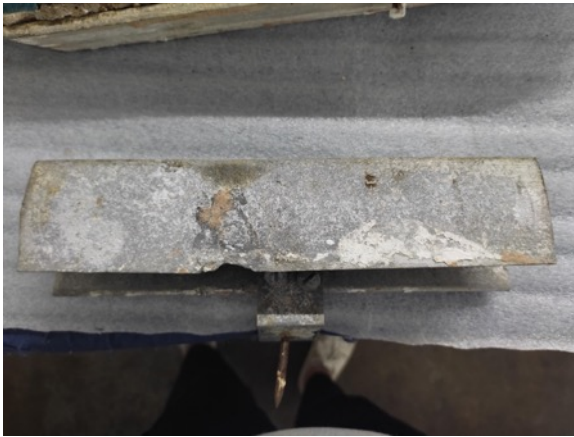
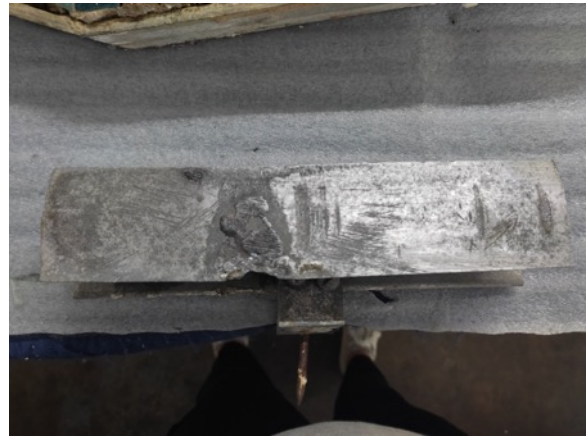
The surface of the aluminum frames is covered in dust, paint splashes of different colors, and is corroded. Some appear to have been coated with silver paint. Cleaning tests were performed in the studio with solvents and aqueous solutions. Acetone was effective to remove the paint and a solution of distilled water with Orvus applied with Scotch Brite was effective in reducing the dirt and corrosion. A metal scraper was necessary in some areas to remove heavy paint deposits.

Detail of aluminum edge **before** mechanical and wet cleaning test.

Detail of aluminum edge **after** mechanical and wet cleaning test.
