November 4, 2023

Certified Arborist Assessment
719 W 51st Street, Miami Beach, Florida
NLE Project No. 14823006

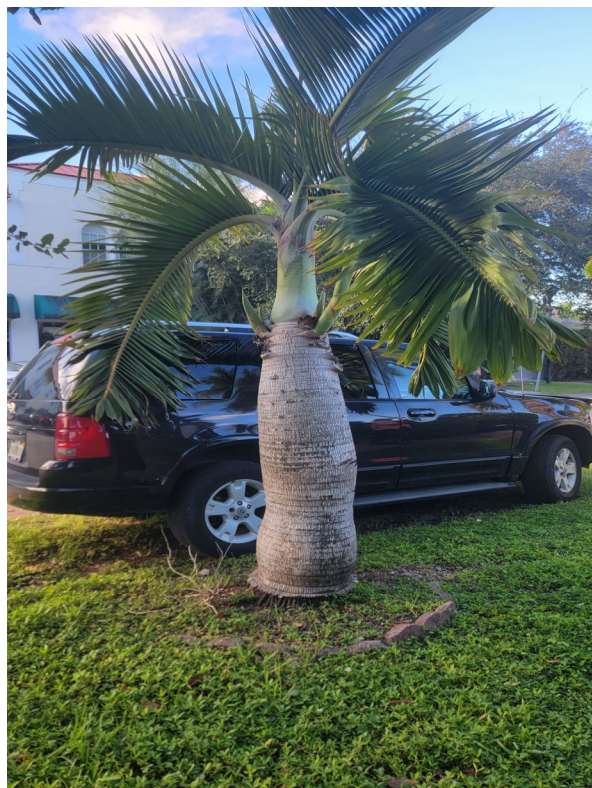
Tree 1 spindle palm
(*Hyophorbe verschaffeltii*)
14 inch DBH, Fair condition
11 foot height, 9 foot spread

size below regulatory threshold

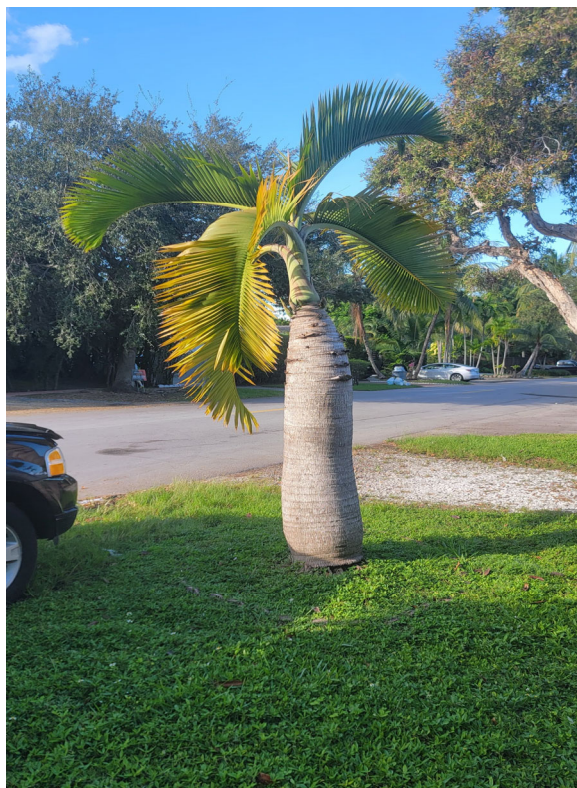
Tree 2 spindle palm
(*Hyophorbe verschaffeltii*)
12 inch DBH Fair condition
11 foot height, 9 foot spread

size below regulatory threshold

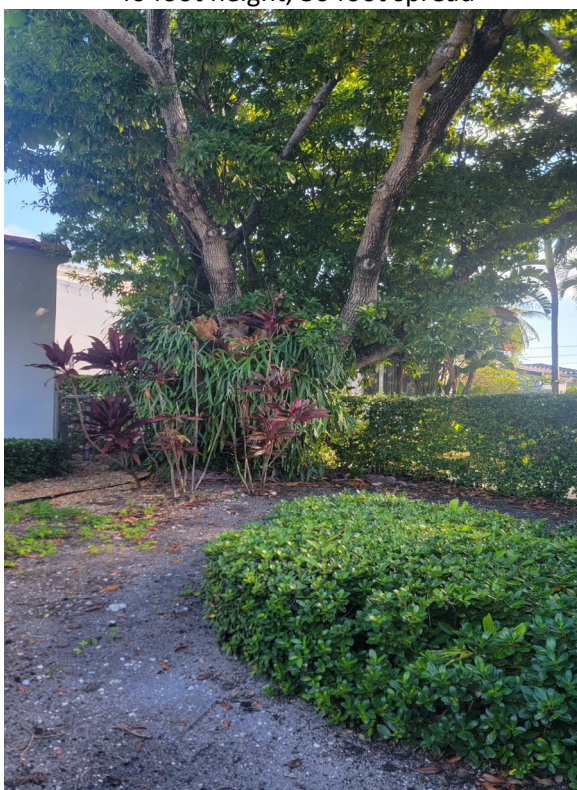
Tree 3 sapodilla
(*Manikara zapota*)
26 inch DBH, Fair condition
40 foot height, 30 foot spread

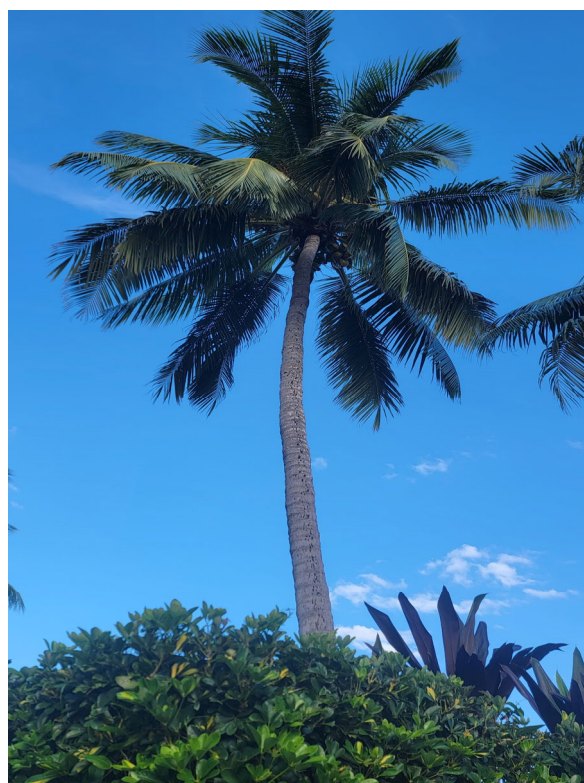
Tree 4 coconut palm
(*Cocos nucifera*)
10 inch DBH Good condition
40 foot height, 18 foot spread

30'C.T.

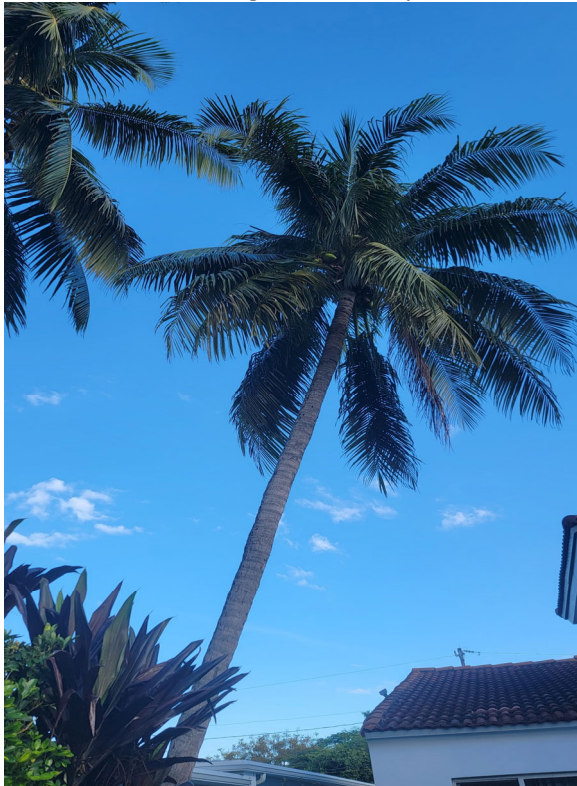
Tree 5 coconut palm
(*Cocos nucifera*)
10 inch DBH, Good condition
35 foot height, 18 foot spread

24'C.T.

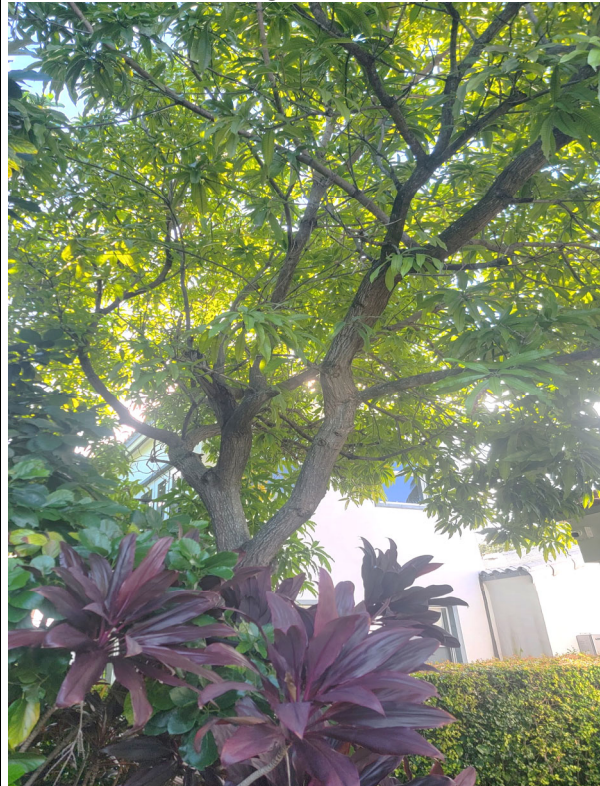
Tree 6 mango
(*Mangifera indica*)
10 inch DBH Fair condition
30 foot height, 30 foot spread

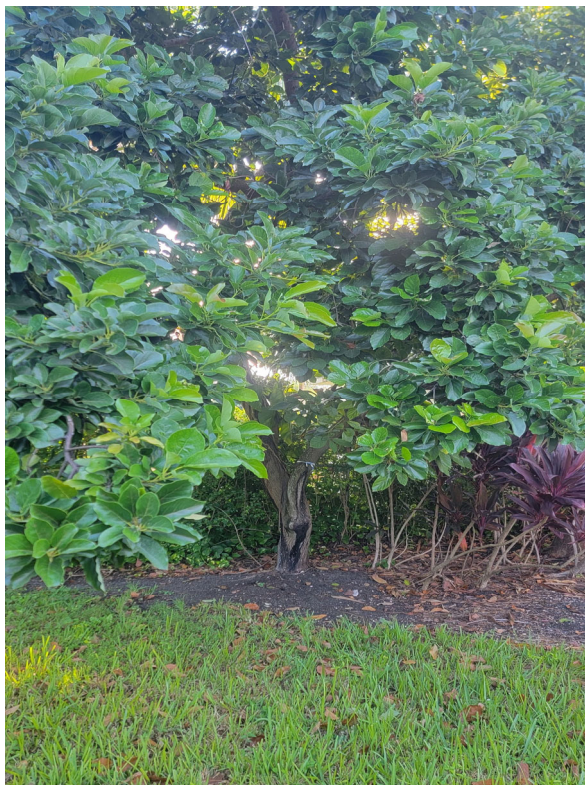
Tree 7 avocado
(*Persea americana*)
12 inch DBH, Fair condition
35 foot height, 35 foot spread

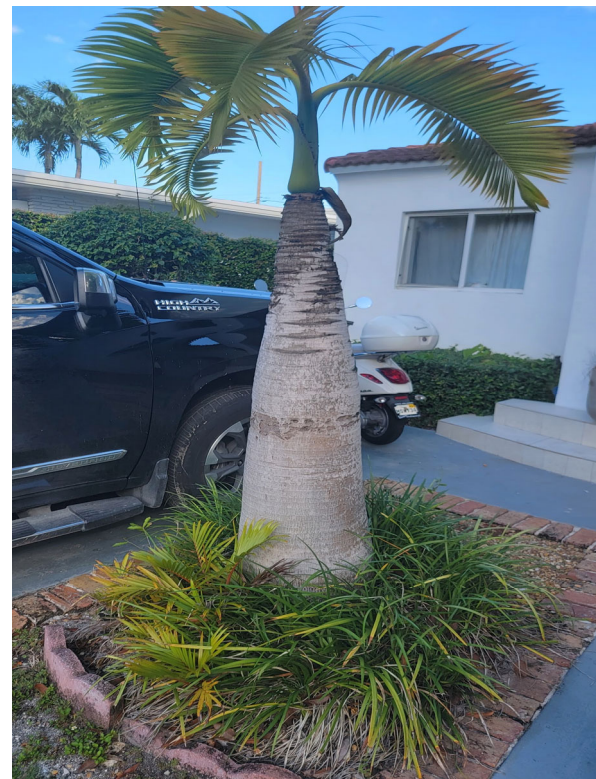
Tree 8 spindle palm
(*Hyophorbe verschaffeltii*)
12 inch DBH Poor condition
8 foot height, 4 foot spread

size below regulatory threshold
