Arborist Report

1901 Alton Road

Miami Beach

9/13/2023

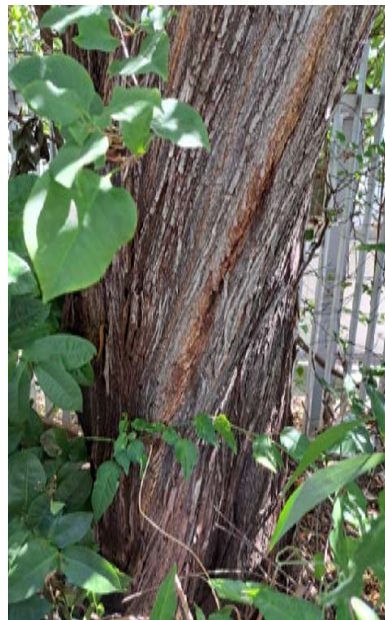
Tree #10 is an Earleaf Acacia located on the northeast side of the property. It is in poor condition. There is limited rooting space. The secondary leader has died. The tree has low vigor and extensive dieback. Prune to remove the deadwood as soon as possible since it is over the parking lot. This species is highly invasive in South Florida and this tree will therefore need to be removed.

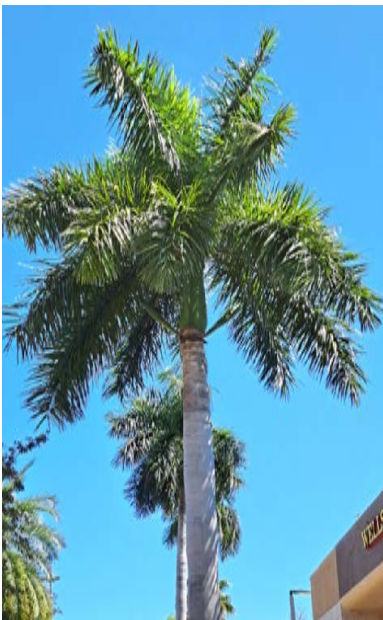
Tree #24 is a Royal Palm located on the western side of the property. It is in good condition with healthy green fronds.

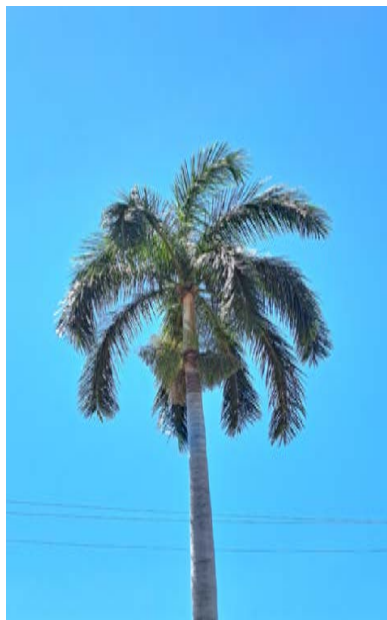
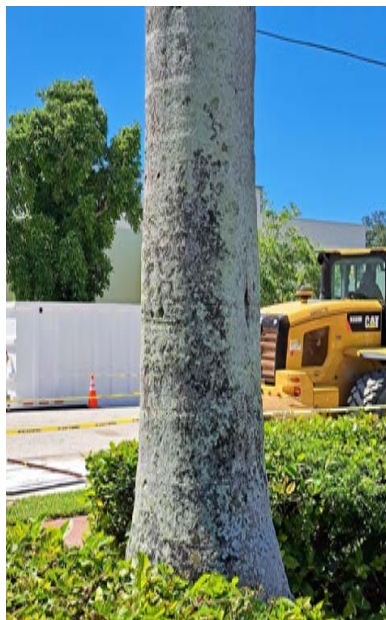
Tree #33 is a Royal Palm located on the south side of the property. It is in good condition. Overhead wires are nearby.
