# Biscayne Environmental, Inc.

RE: 421 E. San Marino Drive, Miami Beach  
Evaluation of Existing Tree Resources  
BEI Project No. 2017-11

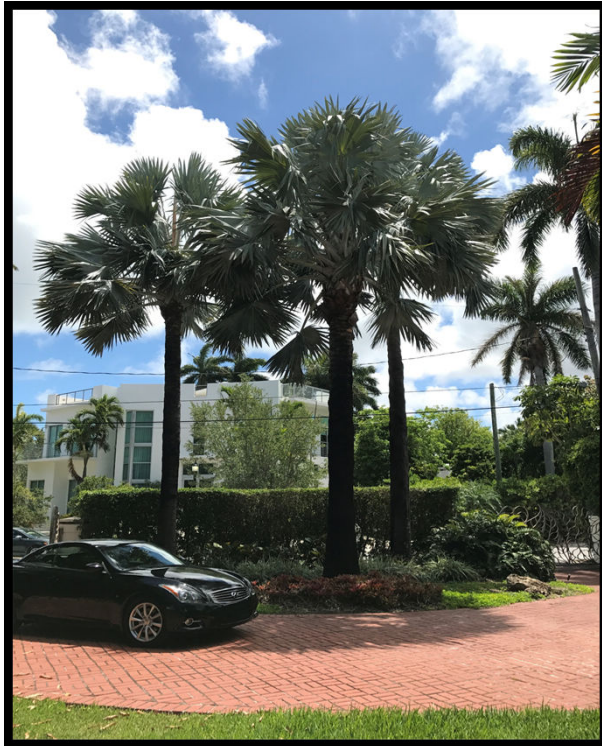
**Photo 1** Bismarck palms in center of circular driveway.

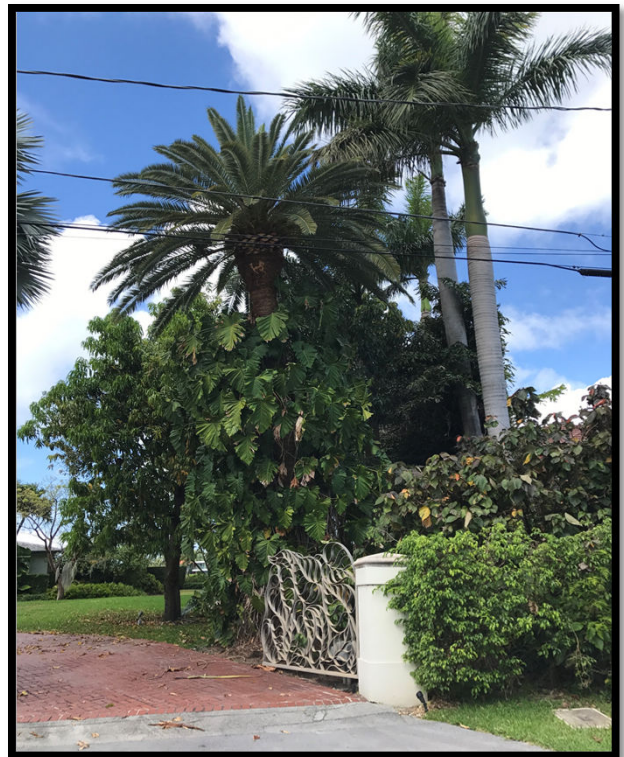
**Photo 2** Canary Island date palm at southwest corner of property.

Because of their location along the north property line, the royal palms should be able to remain in place. All of the other palms could either remain in place (Canary Island date palm in particular), or be relocated on-site, or replaced by other desirable trees. The bottlebrush at the southeast corner of the property by the seawall should be removed and the 2 garcinia trees at the entrance of the house could either be removed or replaced.

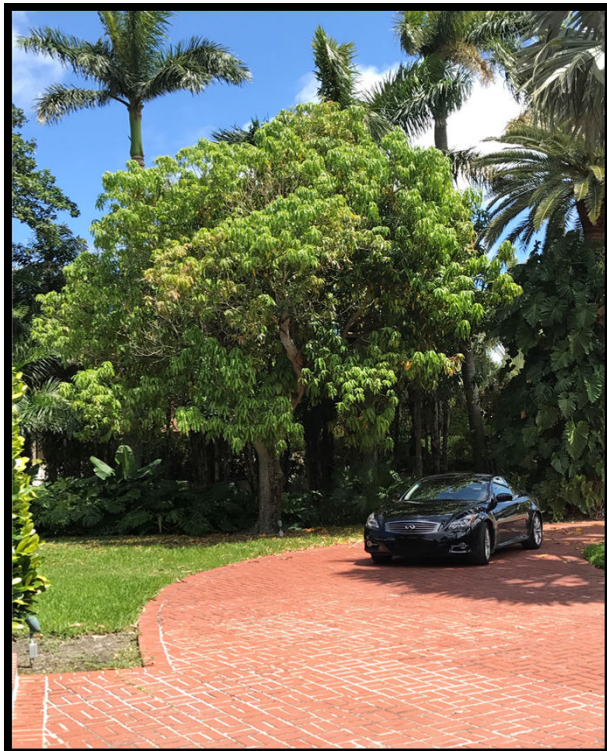
**Photo 3** Mango tree at southwest corner of property.

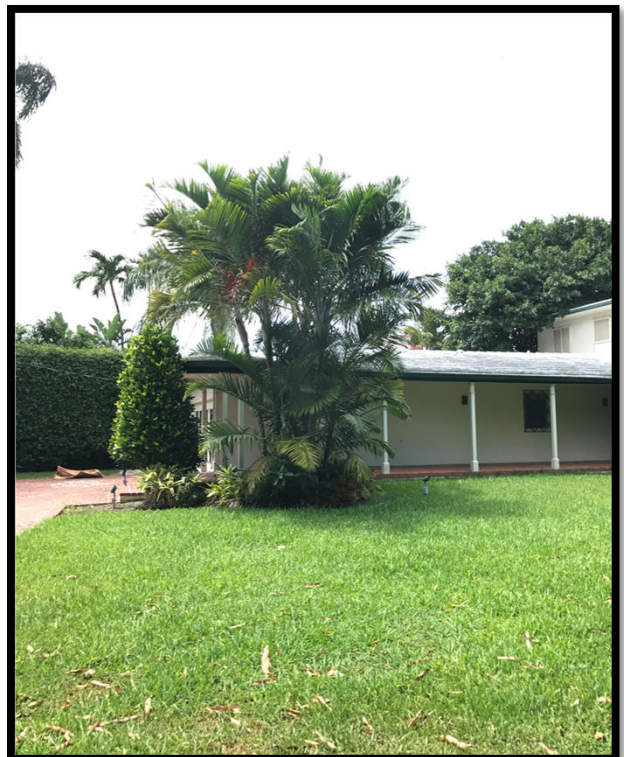
**Photo 4** Cabada cluster at front entryway of house.

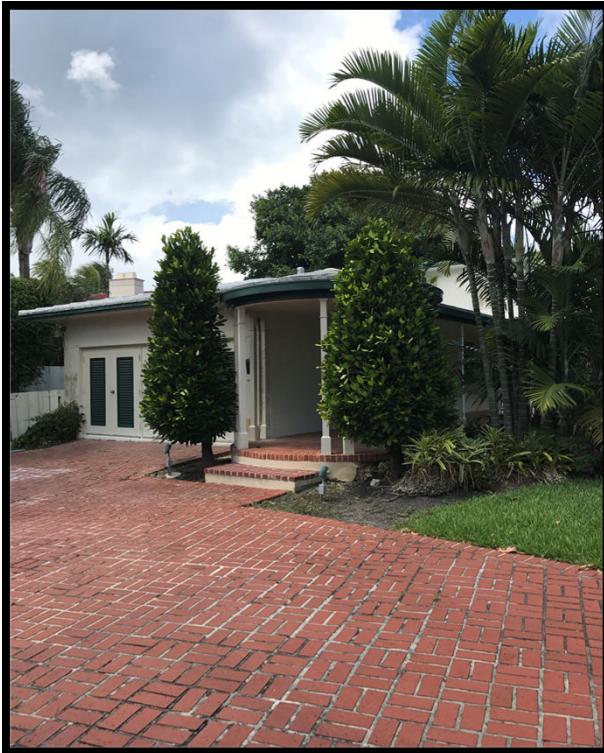
**Photo 5** Garcinas at front entrance of house.

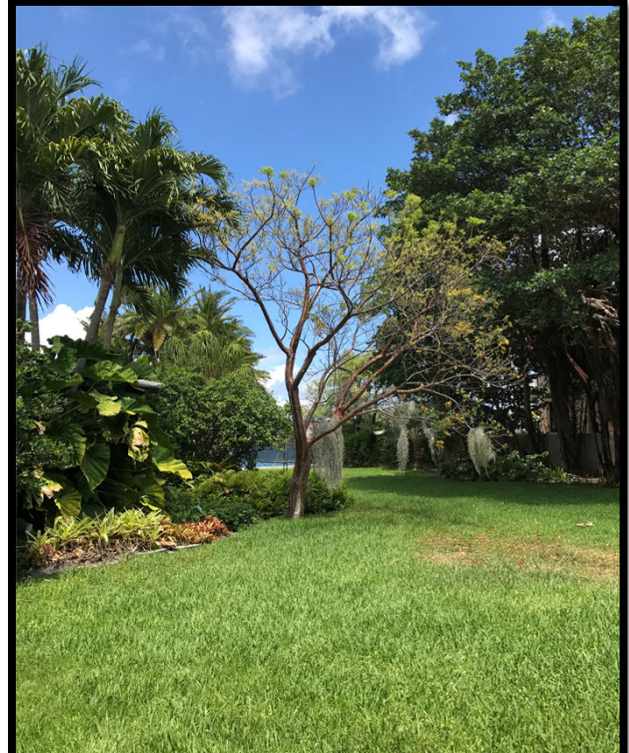
**Photo 6** Gumbo limbo in front yard.

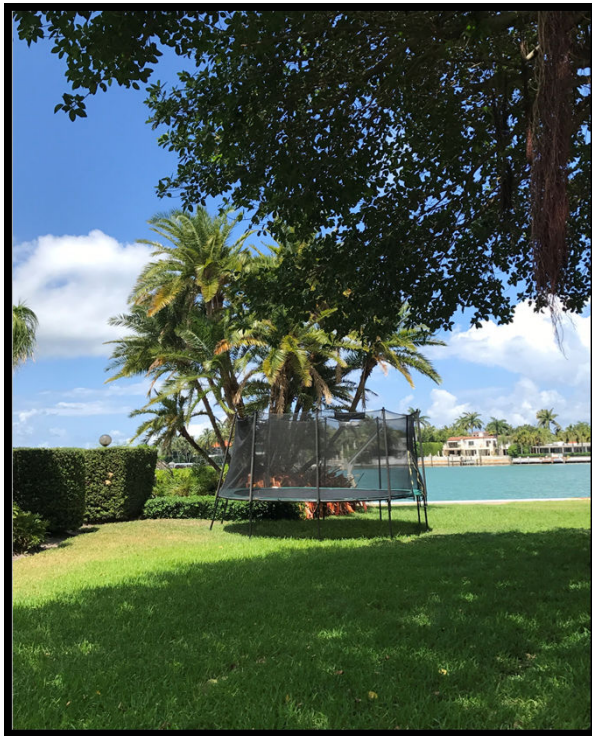
**Photo 7** Reclining date palm cluster in side yard.

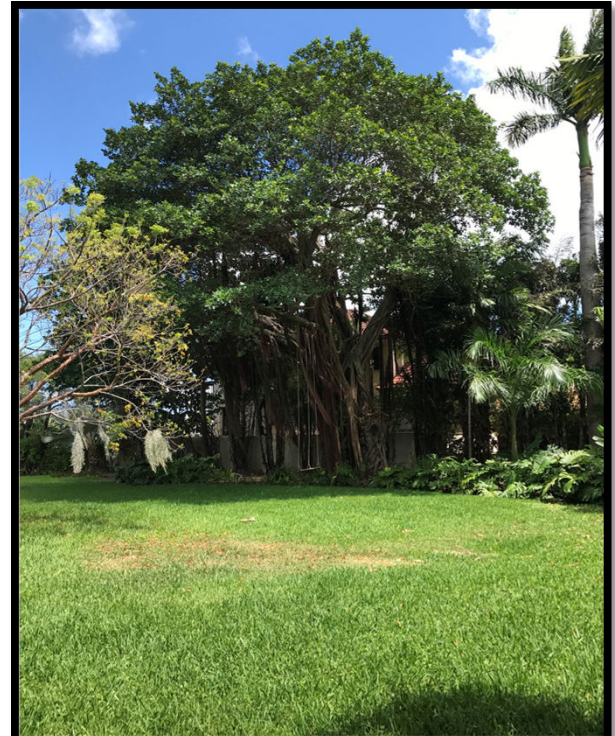
Except for the large strangler fig on the south property line and the banyan tree along the north property line, the trees have been generally well maintained and are in good condition. The large ficus tree has a number of rotten trunks and structural damage to major canopy branches from prior storm damage and recent pruning that occurred (see attached photographs). Therefore, it is recommended that this strangler fig be removed and replaced with desirable native shade trees. The banyan tree on the north property line is growing in a very limited area between the two houses which has resulted in the canopy being cut back significantly (see attached photographs). The banyan tree also shows evidence of previous storm damage and the root system is running along the surface due to its close proximity to a CBS wall and the house. For these reasons, the banyan tree should be removed.

**Photo 8** Strangler fig along south property line.

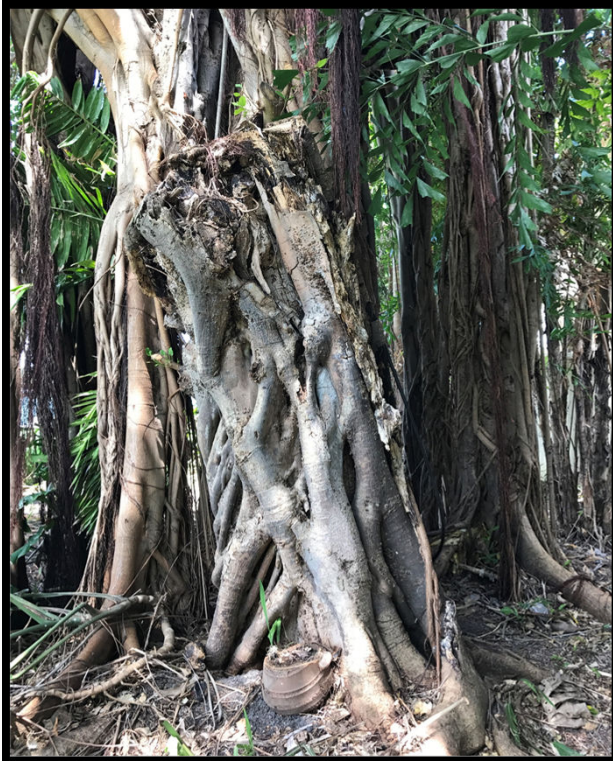
**Photo 9** Rotten trunk on west face of strangler fig.

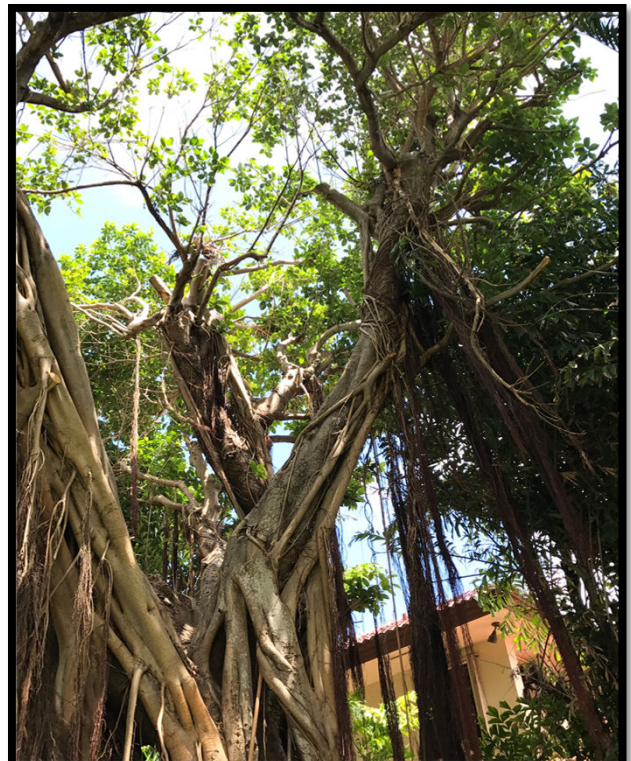
**Photo 10** Structural damage to canopy branches of strangler fig.

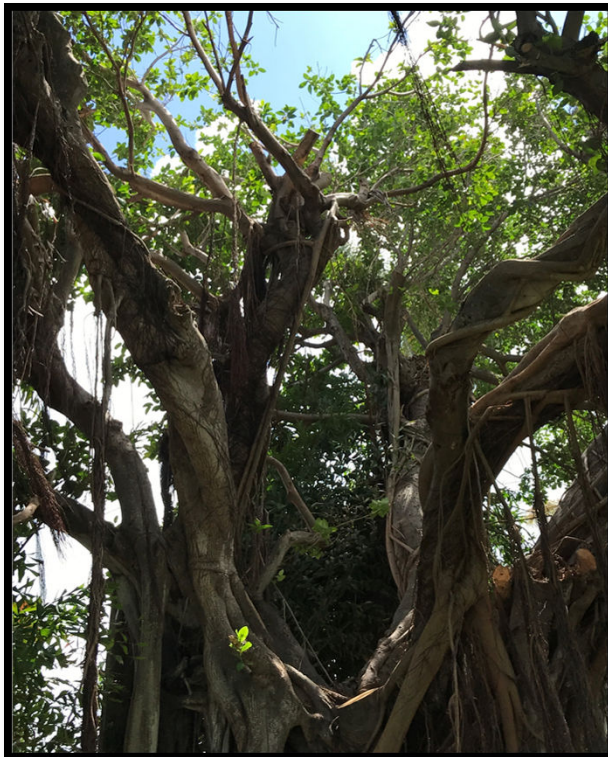
**Photo 11** Close-up of structural branch damage.

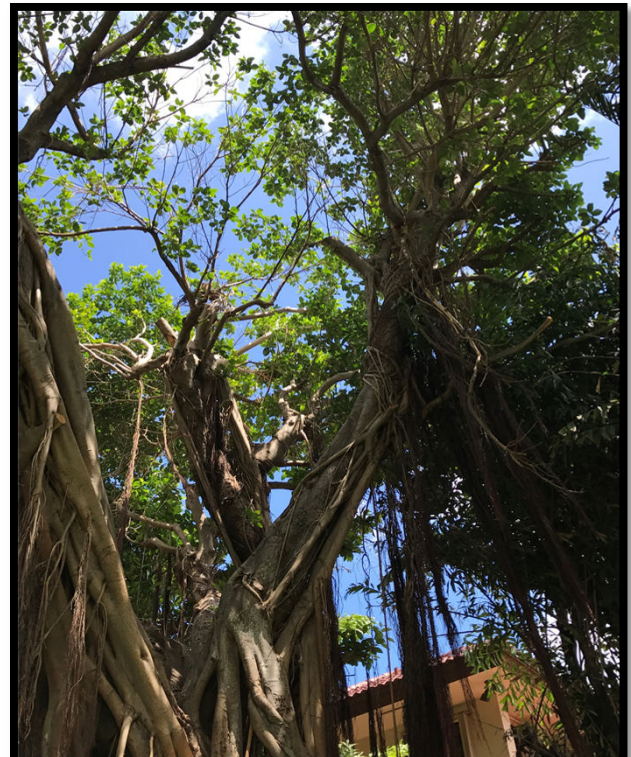
**Photo 12** Branch cluster on right half of photo resulting from storm damage regrowth.

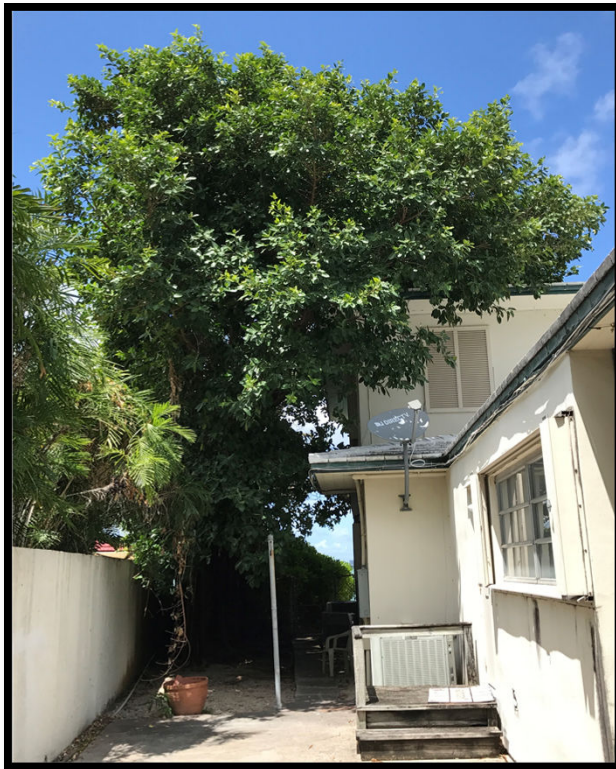
**Photo 13** Banyan tree along north property line growing in confined space.

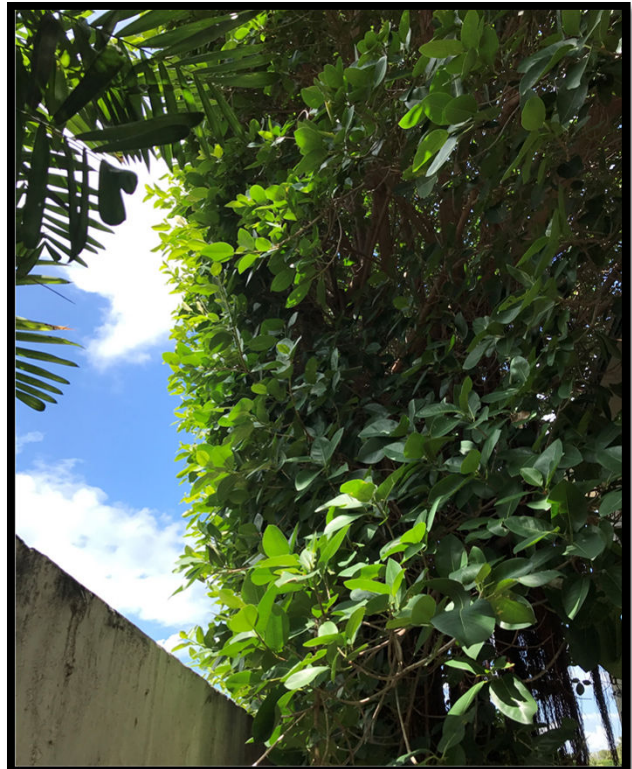
**Photo 14** Close-up of banyan canopy showing shaving off of canopy on north side.

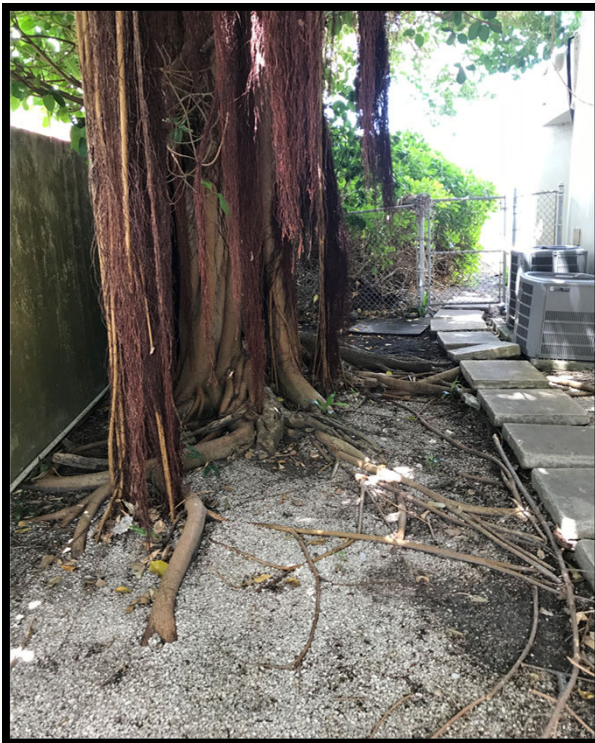
**Photo 15** Exposed roots of banyan tree.

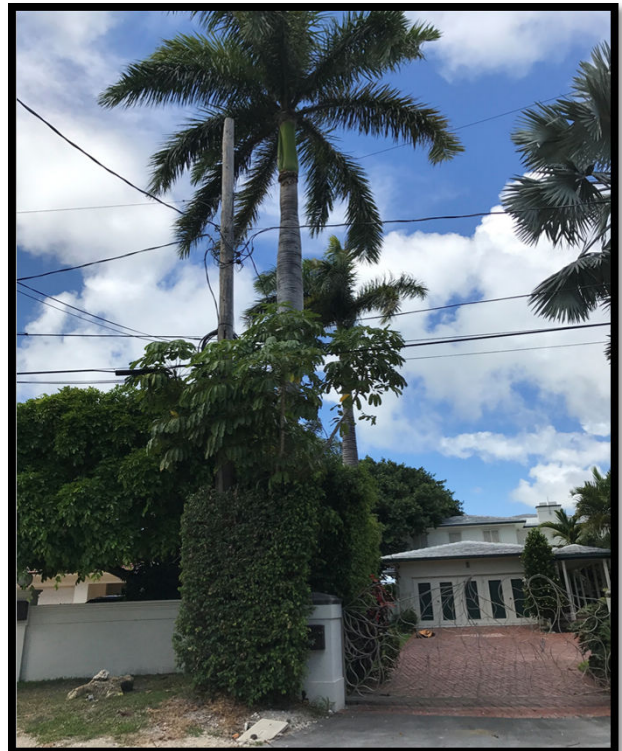
**Photo 16** Royal palms along north property line.
