**GENERAL ASSESSMENT REPORT**

**EXISTING LOG CABIN  
8128 COLLINS AVENUE  
MIAMI BEACH, FLORIDA**

**SEPTEMBER 1, 2017**

PREPARED BY:  
**DOUGLAS WOOD ASSOCIATES, INC.**

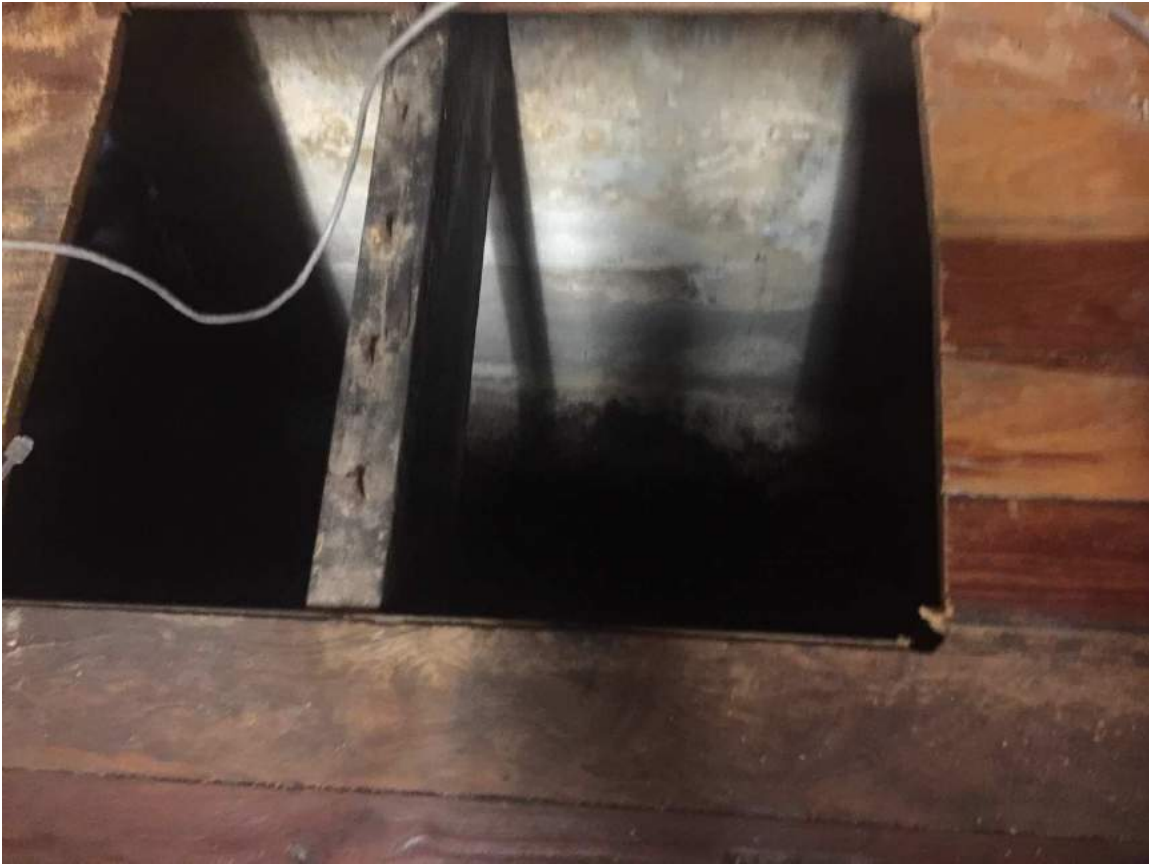
**PHOTOGRAPH NO. 1**

- 2) Inside south side closet of southwest room (original bedroom) (Refer to Photograph No. 1), and
  - 3) North side (back side) of existing fireplace (in existing restroom) (Refer to Photograph No. 2).
- Also, as requested by Douglas Wood Associates, City personnel excavated the soil outside the southwest corner of the cabin (Refer to Photograph No. 3) to reveal the existing concrete stemwall).

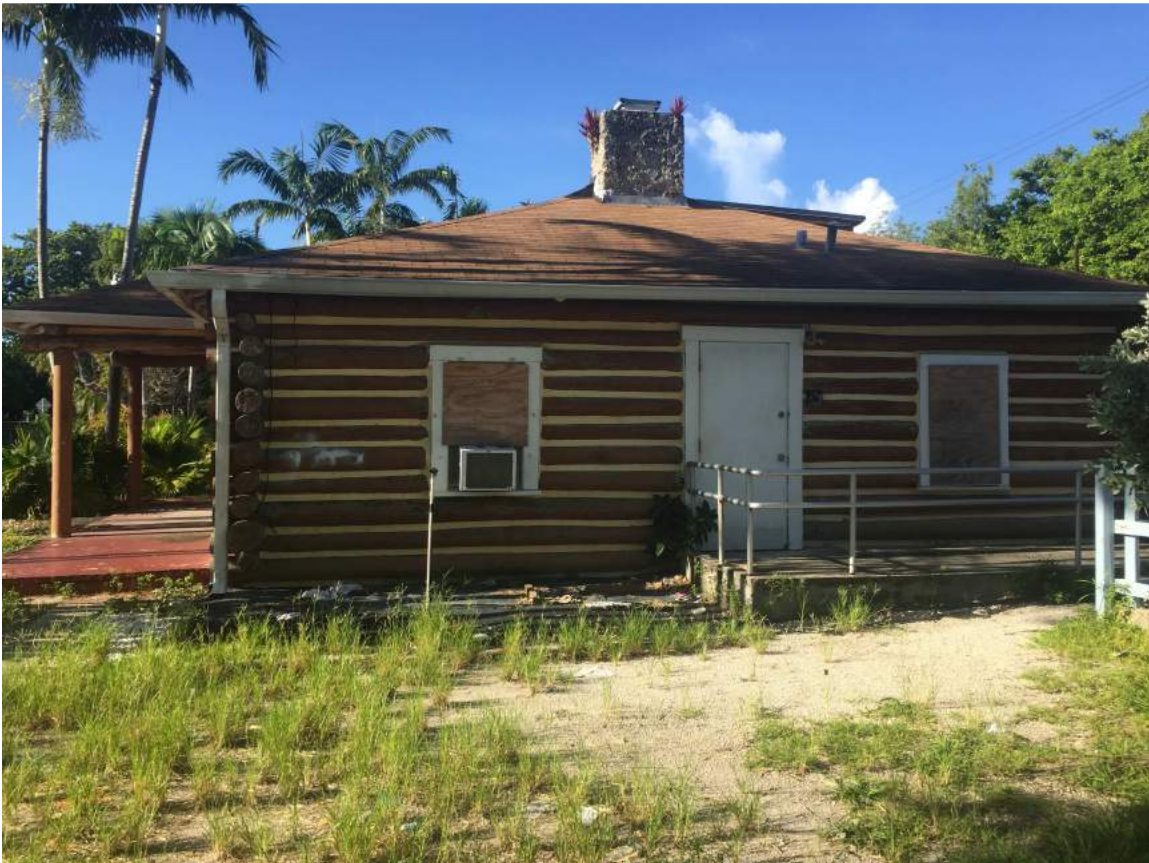
**PHOTOGRAPH NO. 8**

- 1) The entire north wall (Refer to Photograph No. 8) and approximately 2 to 3 foot returns at the east and west walls appear to be constructed of pressure-treated logs. It appears that these areas were entirely reconstructed at some point in time. Where the replacement logs meet the original logs in the east and west walls, the logs are butted to each other (often with mortar or chinking to fill and seal the joints) (Refer to Photographs Nos. 38 and 39). The lack of continuity in these logs results in a lack of structural capacity relative to lateral wind pressures.

- 2) The later pressure-treated logs exhibit weathering, splitting and some areas of minor rot.
- 3) The uppermost log in the north (replaced) wall, was installed in segments (rather than continuous). Again, this arrangement lacks structural capacity relative to wind pressures.

In our opinion, most of the logs in the exterior walls would need to be replaced. Due to the extent of deterioration, it does not appear to be reasonably feasible to repair the exterior logs. Epoxy products intended for wood repair could be considered, but again, the general extent of repairs, the depth of repairs and the volume of repair appear to be too great. Even if such repair materials were used for portions of the exterior logs, the repair areas would, of course, lack the color, texture and grain of the wood. The exterior would need to be completely repainted. The paint and lack of texture in the patches would likely be esthetically unacceptable for a "historical" restoration. Given these conditions and limitations, it is our opinion that the exterior log walls need to be reconstructed using new materials.

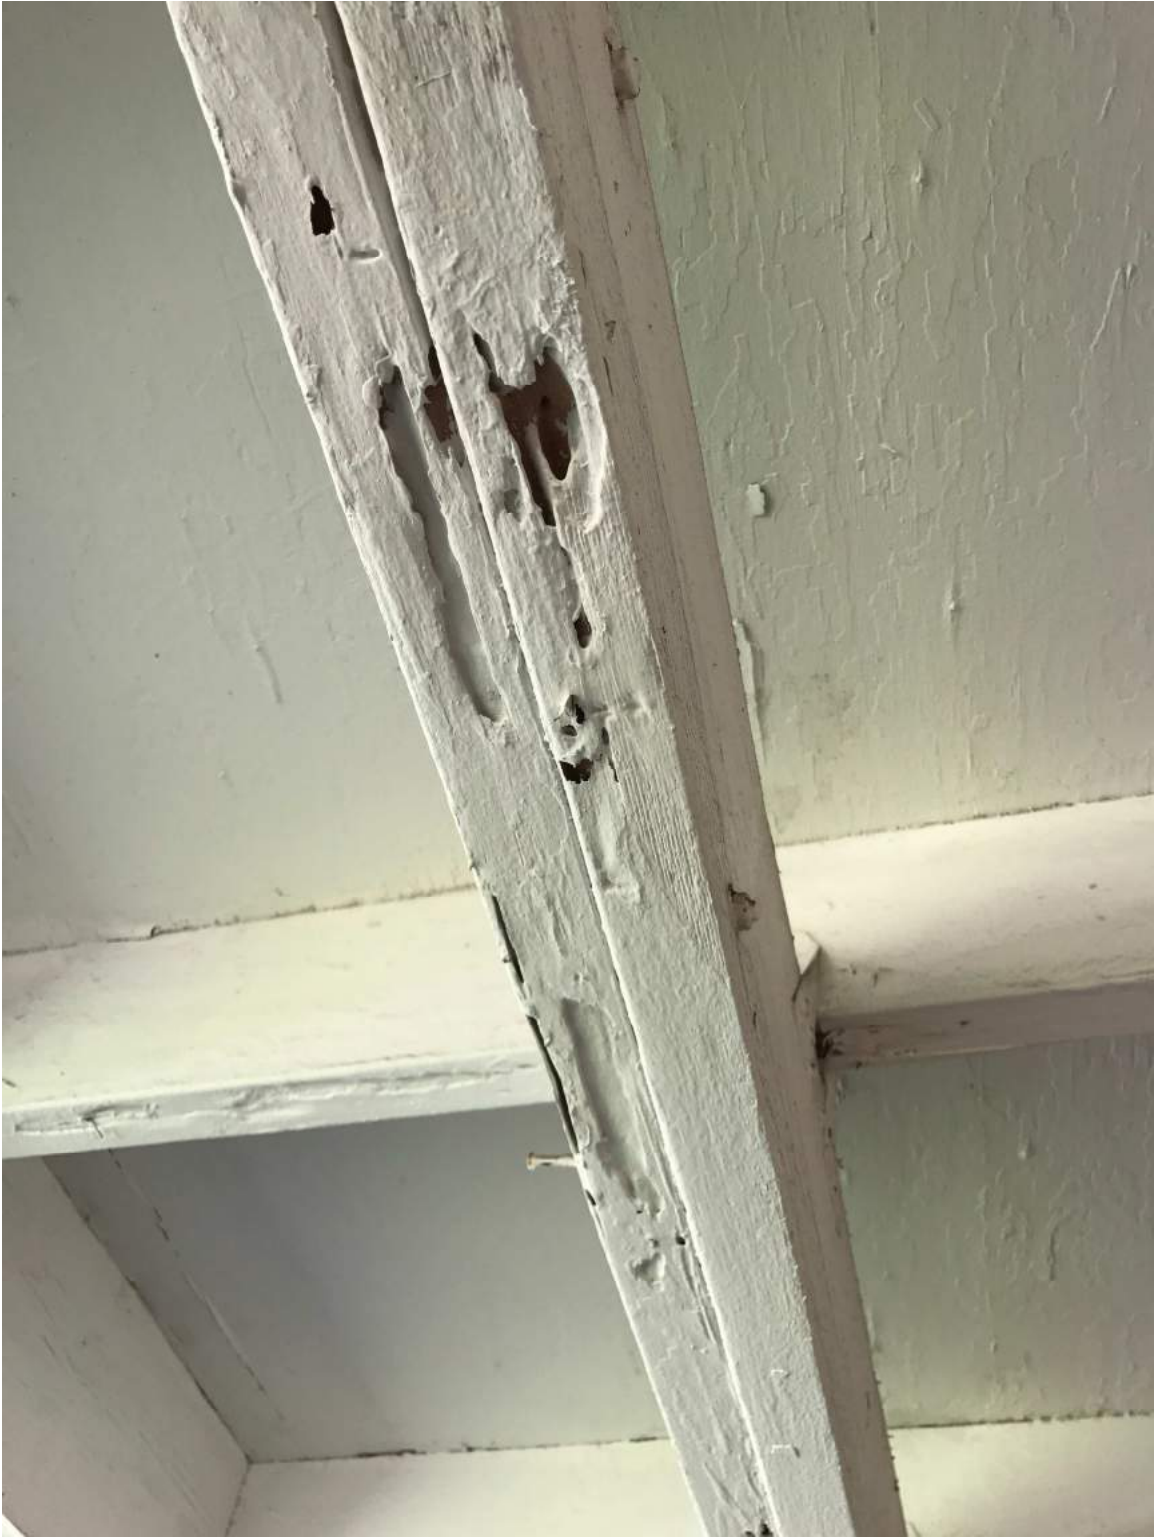
**PHOTOGRAPH NO. 18**

- 3) Numerous locations of the eave sheathing boards exhibit insect damage (Refer to Photograph No. 32).
- 4) There is significant insect damage and/or rot in the rafters and beam of the rear porch (Refer to Photographs Nos. 18, 19, 20, 35 and 36).

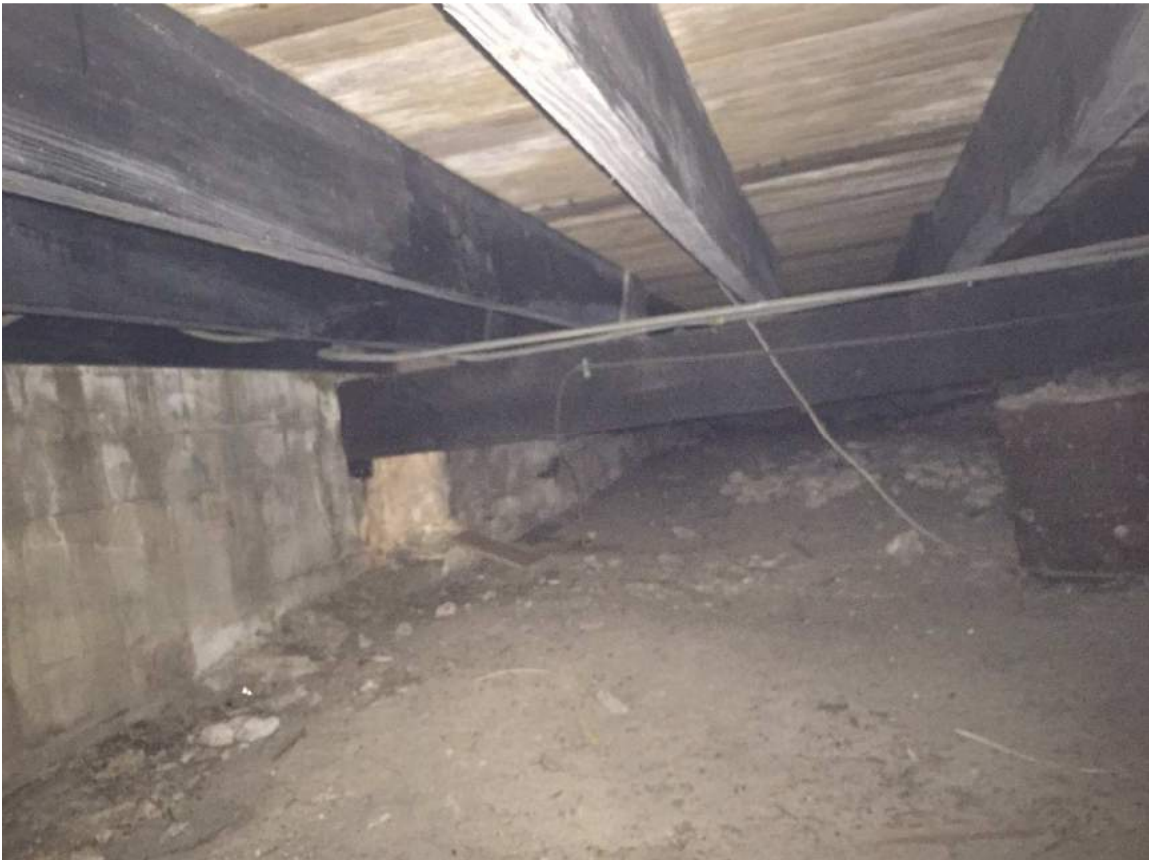
**PHOTOGRAPH NO. 27**

The primary foundations consist of concrete stemwalls founded on continuous concrete wall footings under the perimeter log bearing walls (Refer to Photograph No. 27). The depth of the footing varies somewhat (i.e., it is sloped).

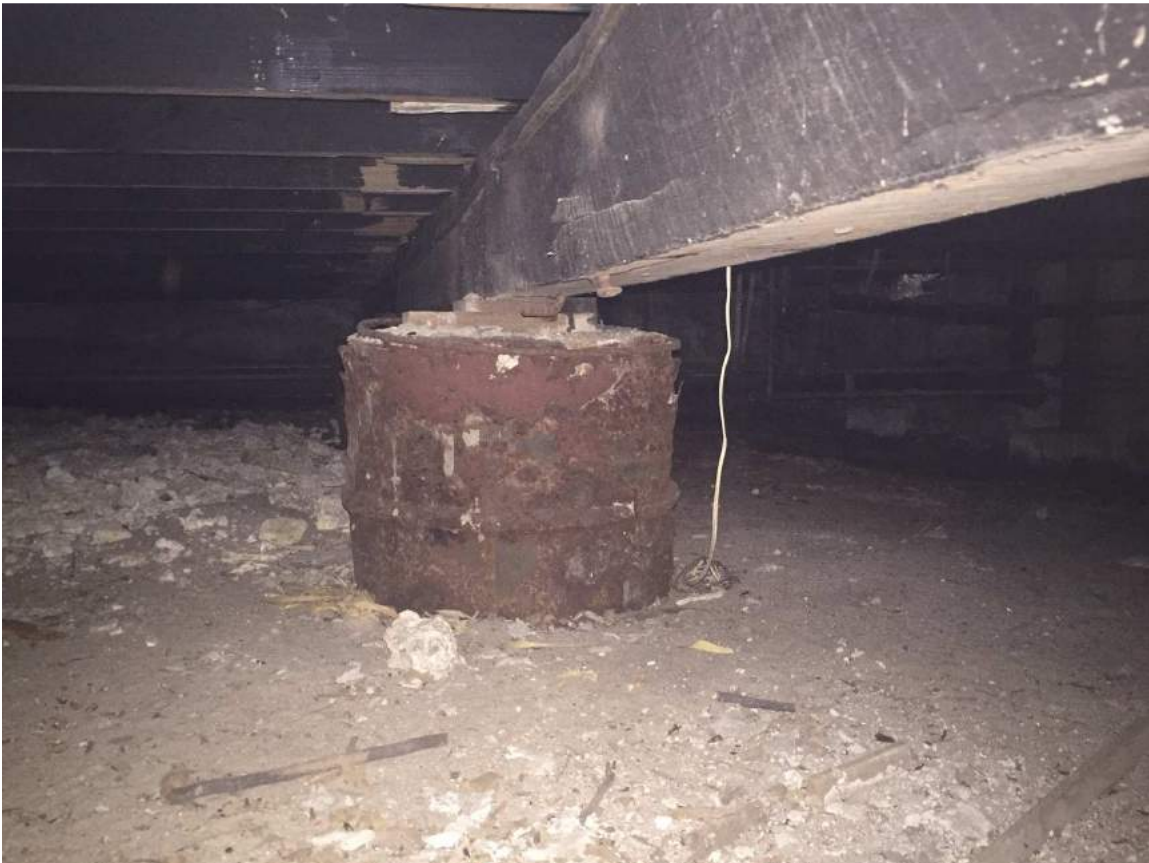
**PHOTOGRAPH NO. 29**

- 1) Some of the floor sheathing and joist segments under the north side restroom (north side of fireplace) have been replaced. The joist splices do not appear to be adequate (Refer to Photograph No. 60).
- 2) There are no provisions for ventilation of the crawl space. Ventilation is a Building Code requirement.
- 3) Where the floor joists bear on the exterior concrete stemwalls, most only bear approximately 1-½" to 2" on to the wall. This is generally an inadequate bearing length. The wood members bear directly on the concrete. In many locations, the joists were set on shims at the stemwall. Many of these shims are loose or have already fallen.
- 4) Where the floor beams bear on the interior concrete piers, they are generally set on unsecured wood blocks or shims (Refer to Photograph No. 29).

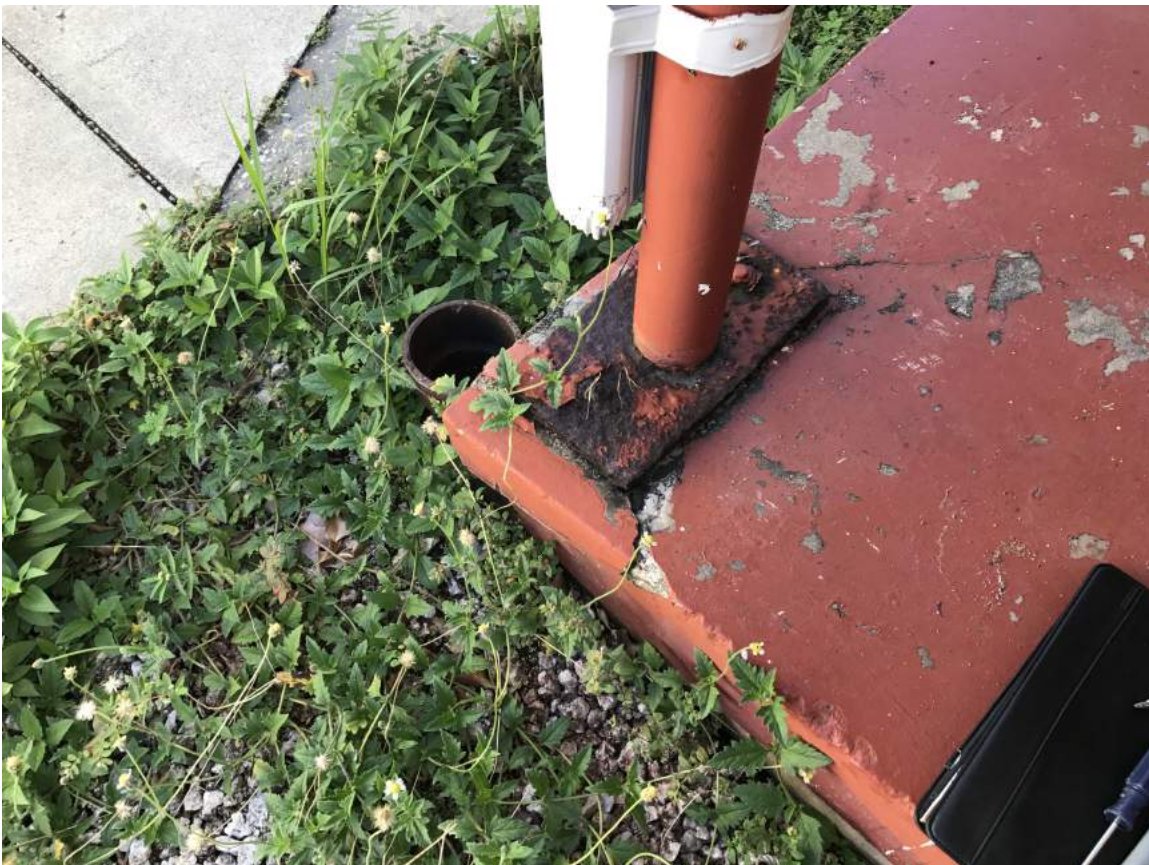
**PHOTOGRAPH NO. 31**

- 1) The concrete slab at the northern pipe column of the rear porch is cracked (Refer to Photograph No. 31).

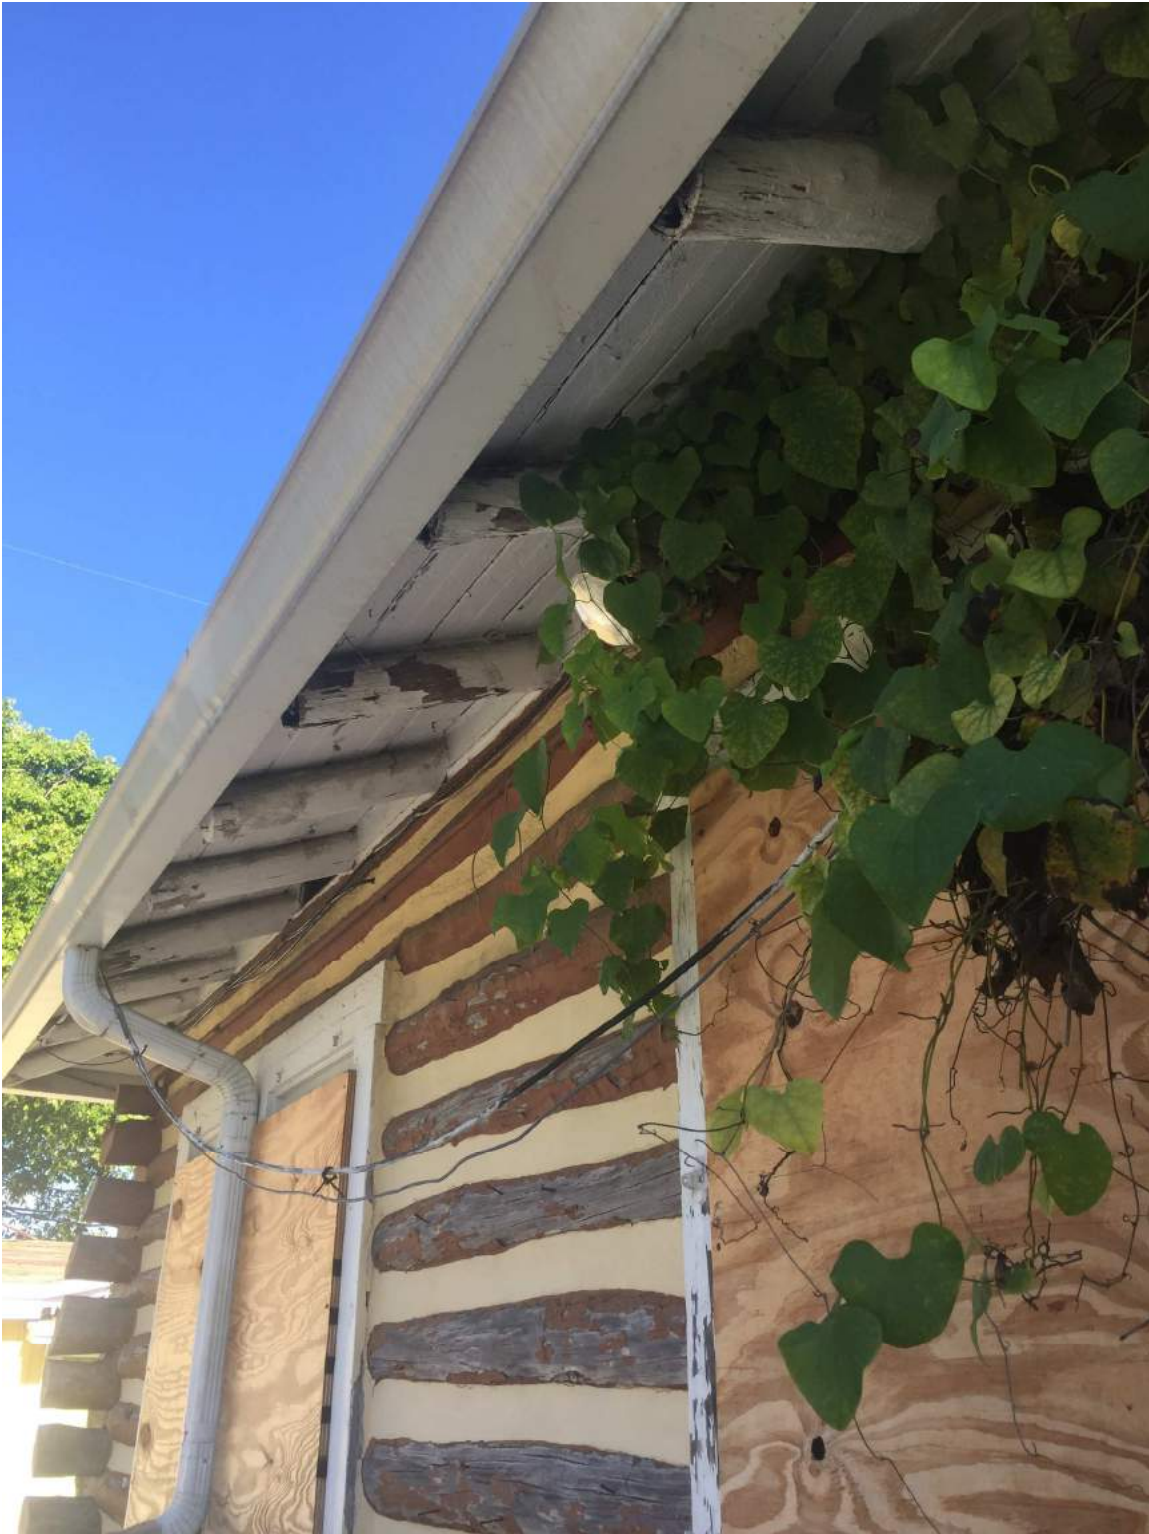
**PHOTOGRAPH NO. 32**

- 2) Many of the exposed small-diameter log eave rafters have significant amounts of rot, insect damage or both (Refer to Photographs Nos. 32, 33 and 34). Many of these eave rafters appear to butt against the fascia. We assume that these eave rafters have been replaced at some time. Continuity with the interior rafters is not apparent at this time. Without continuity, they do not support the eave.
