**GENERAL ASSESSMENT REPORT**

**EXISTING LOG CABIN  
8128 COLLINS AVENUE  
MIAMI BEACH, FLORIDA**

**SEPTEMBER 1, 2017**

PREPARED BY:  
**DOUGLAS WOOD ASSOCIATES, INC.**

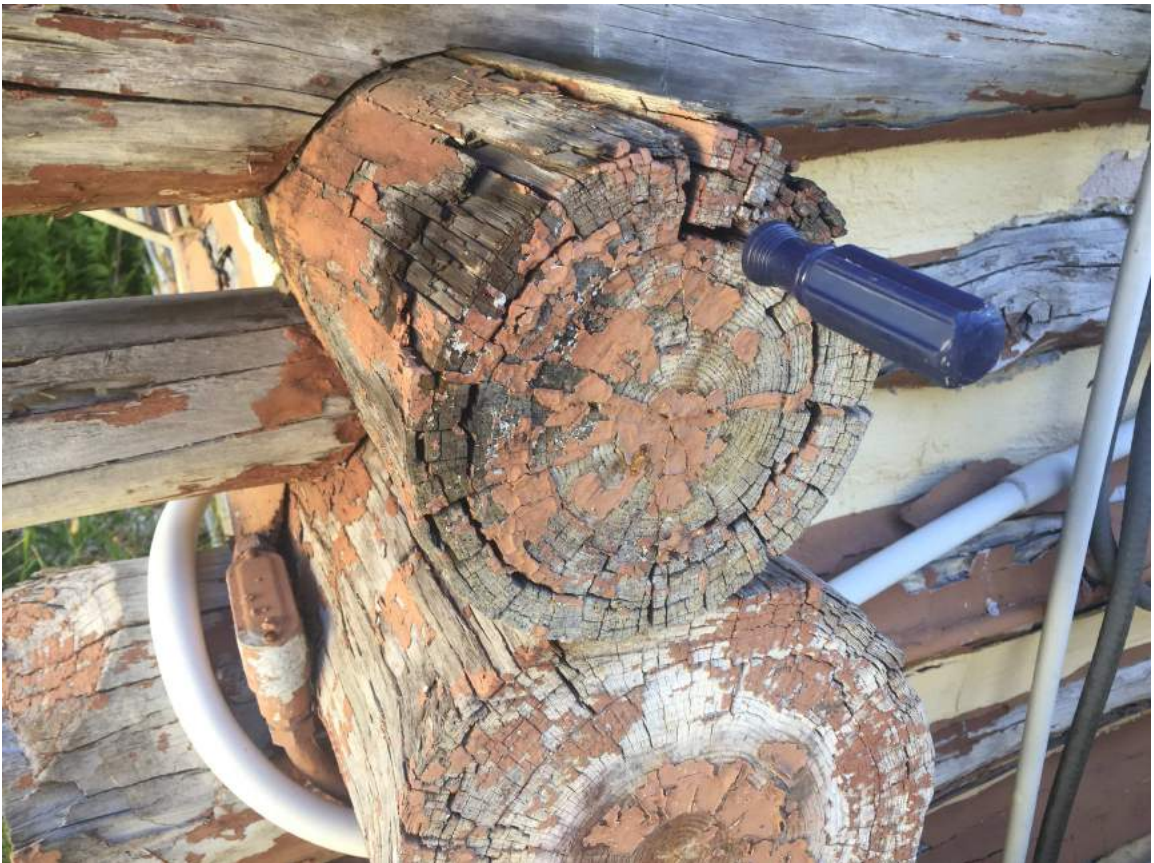
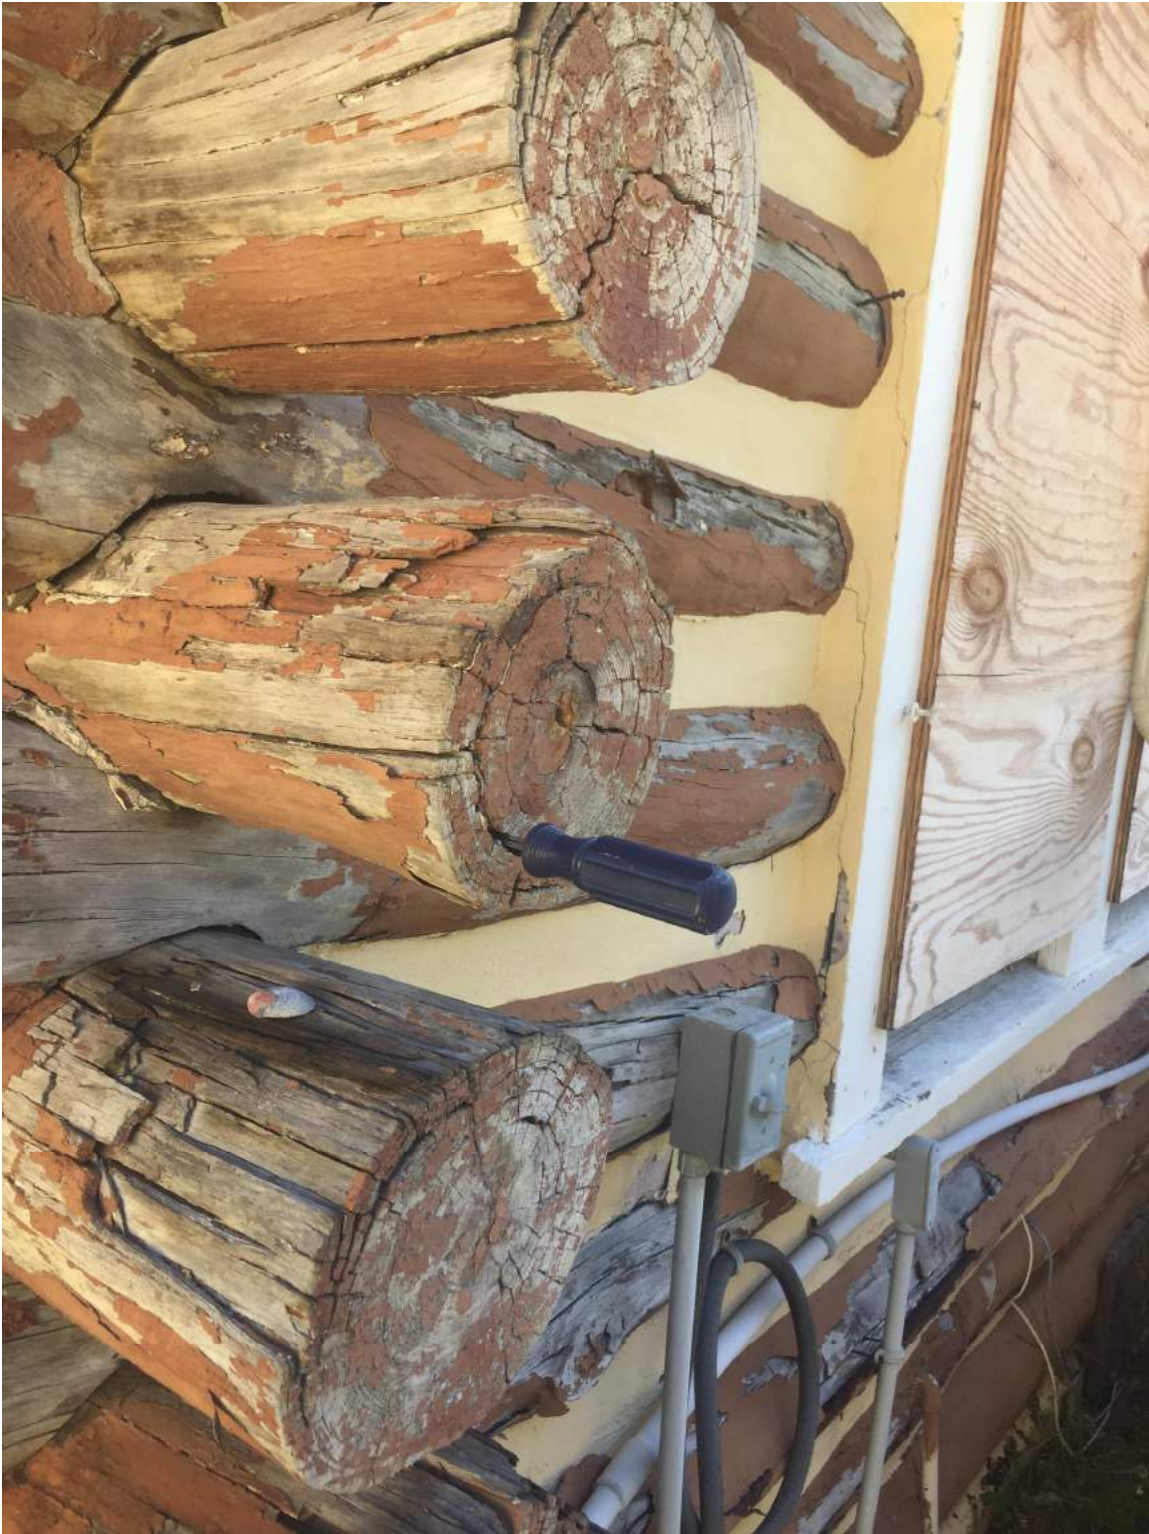
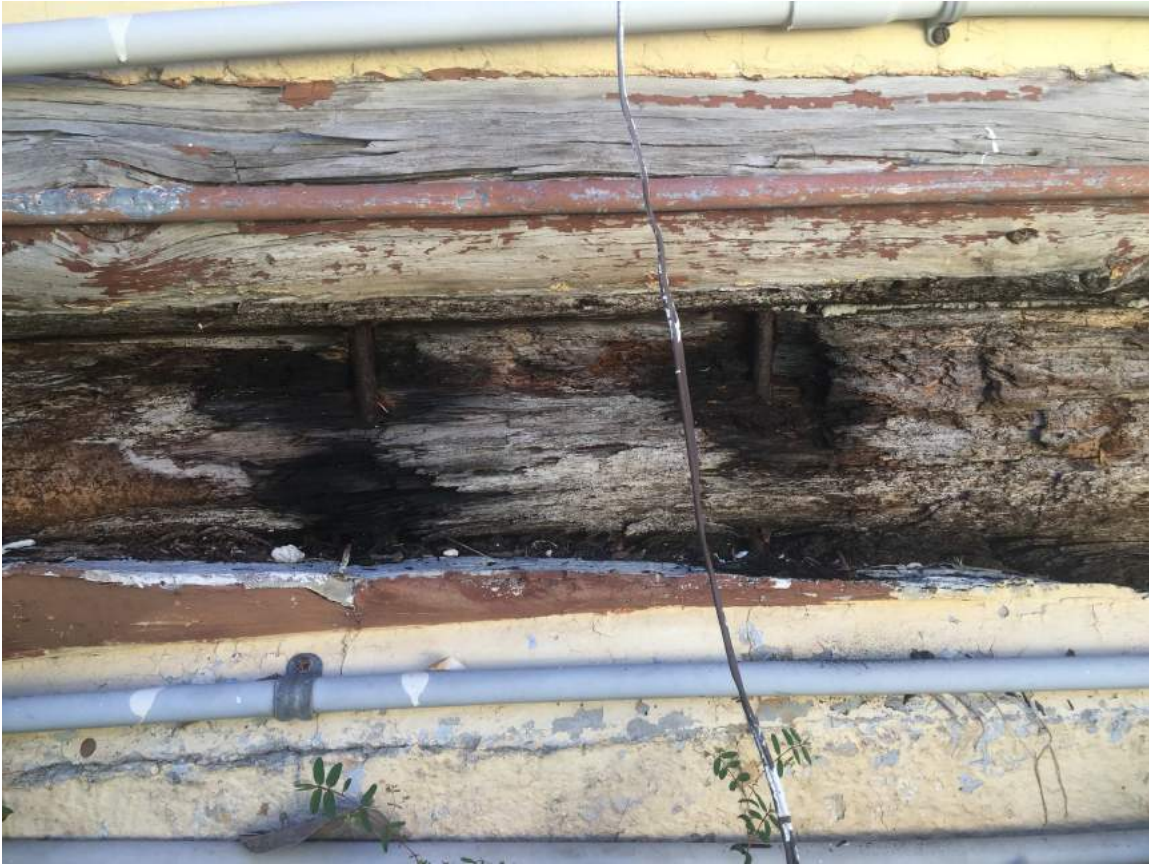
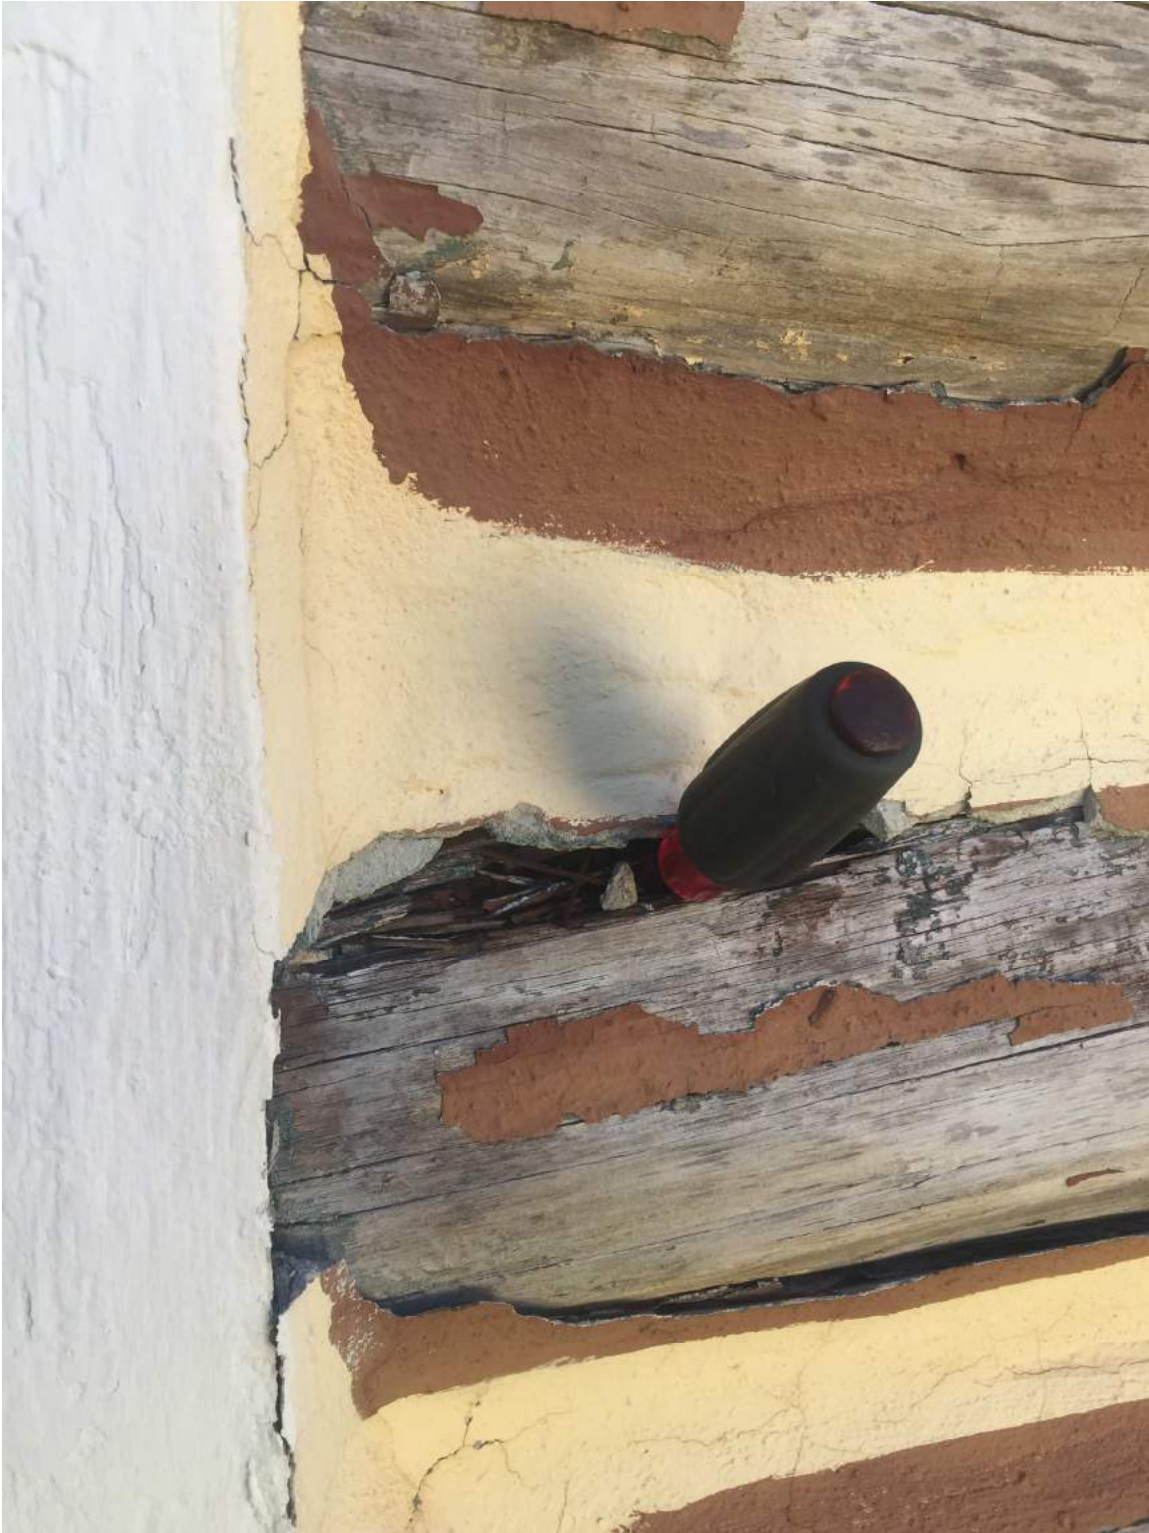
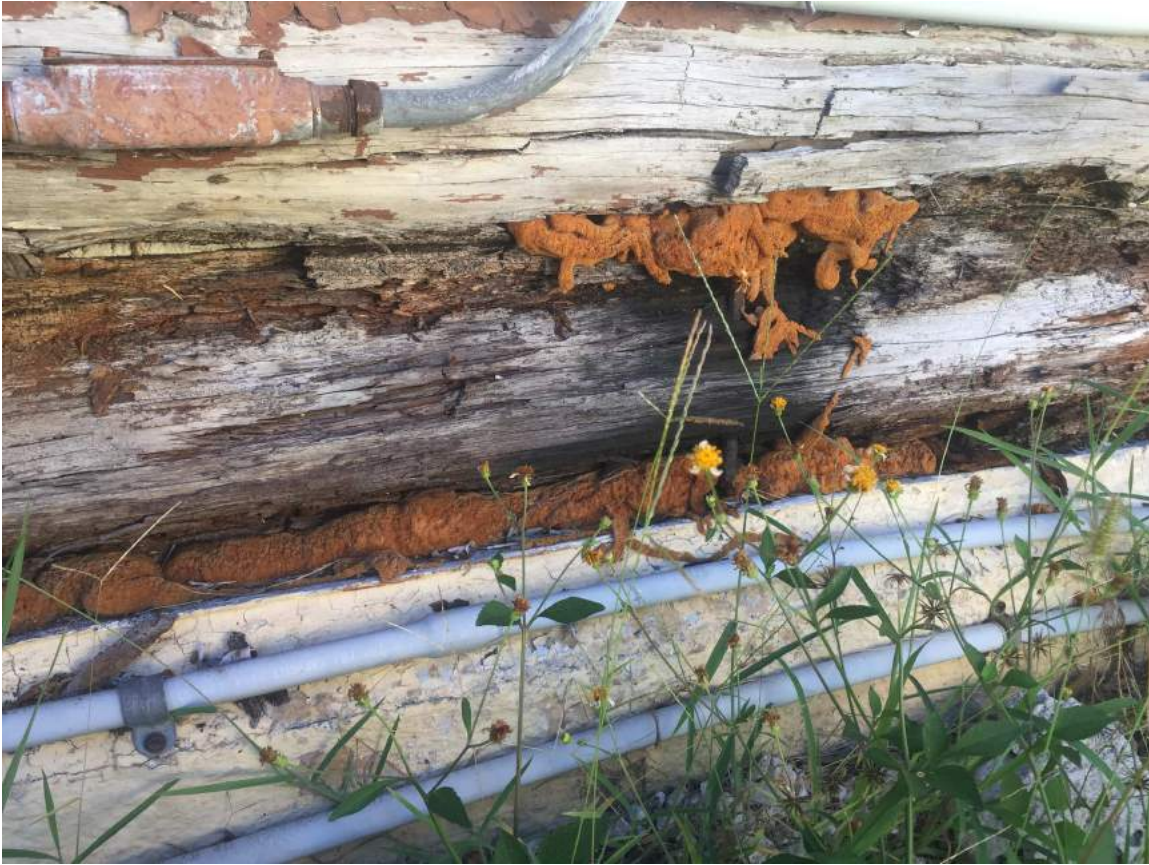
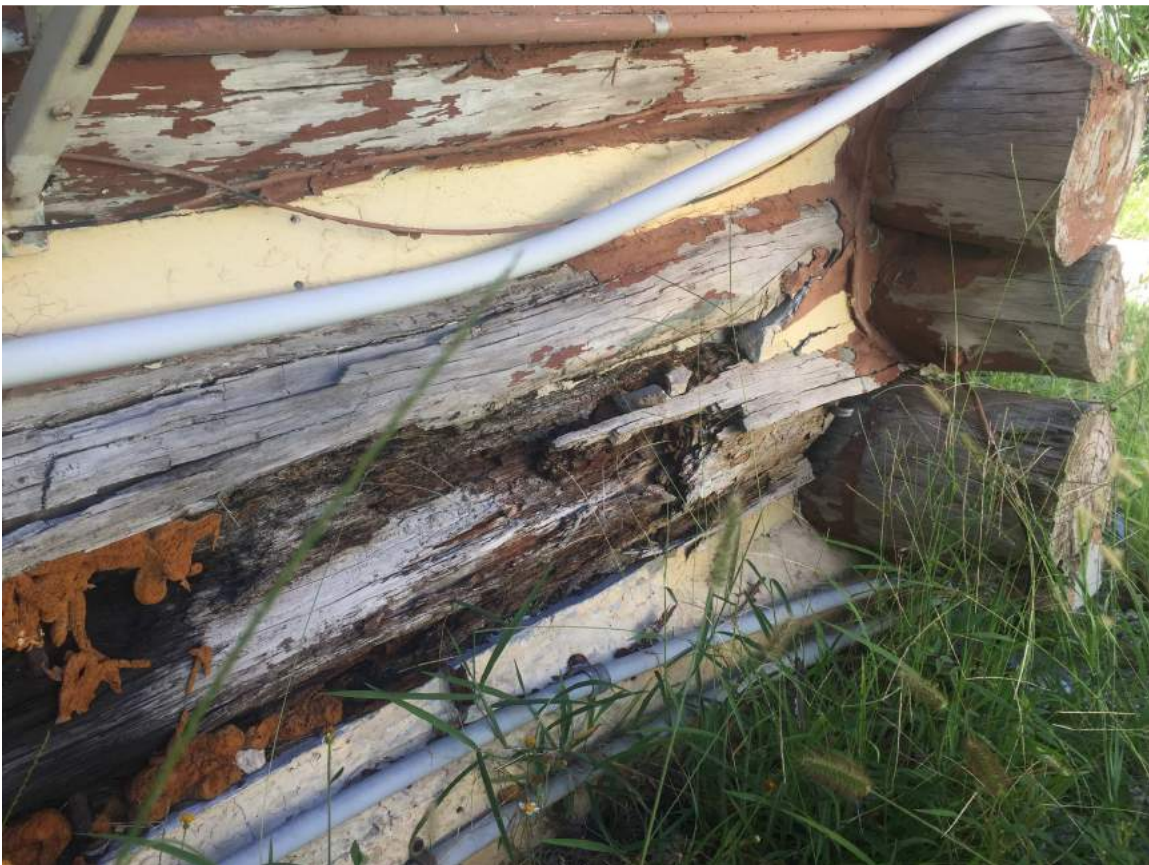
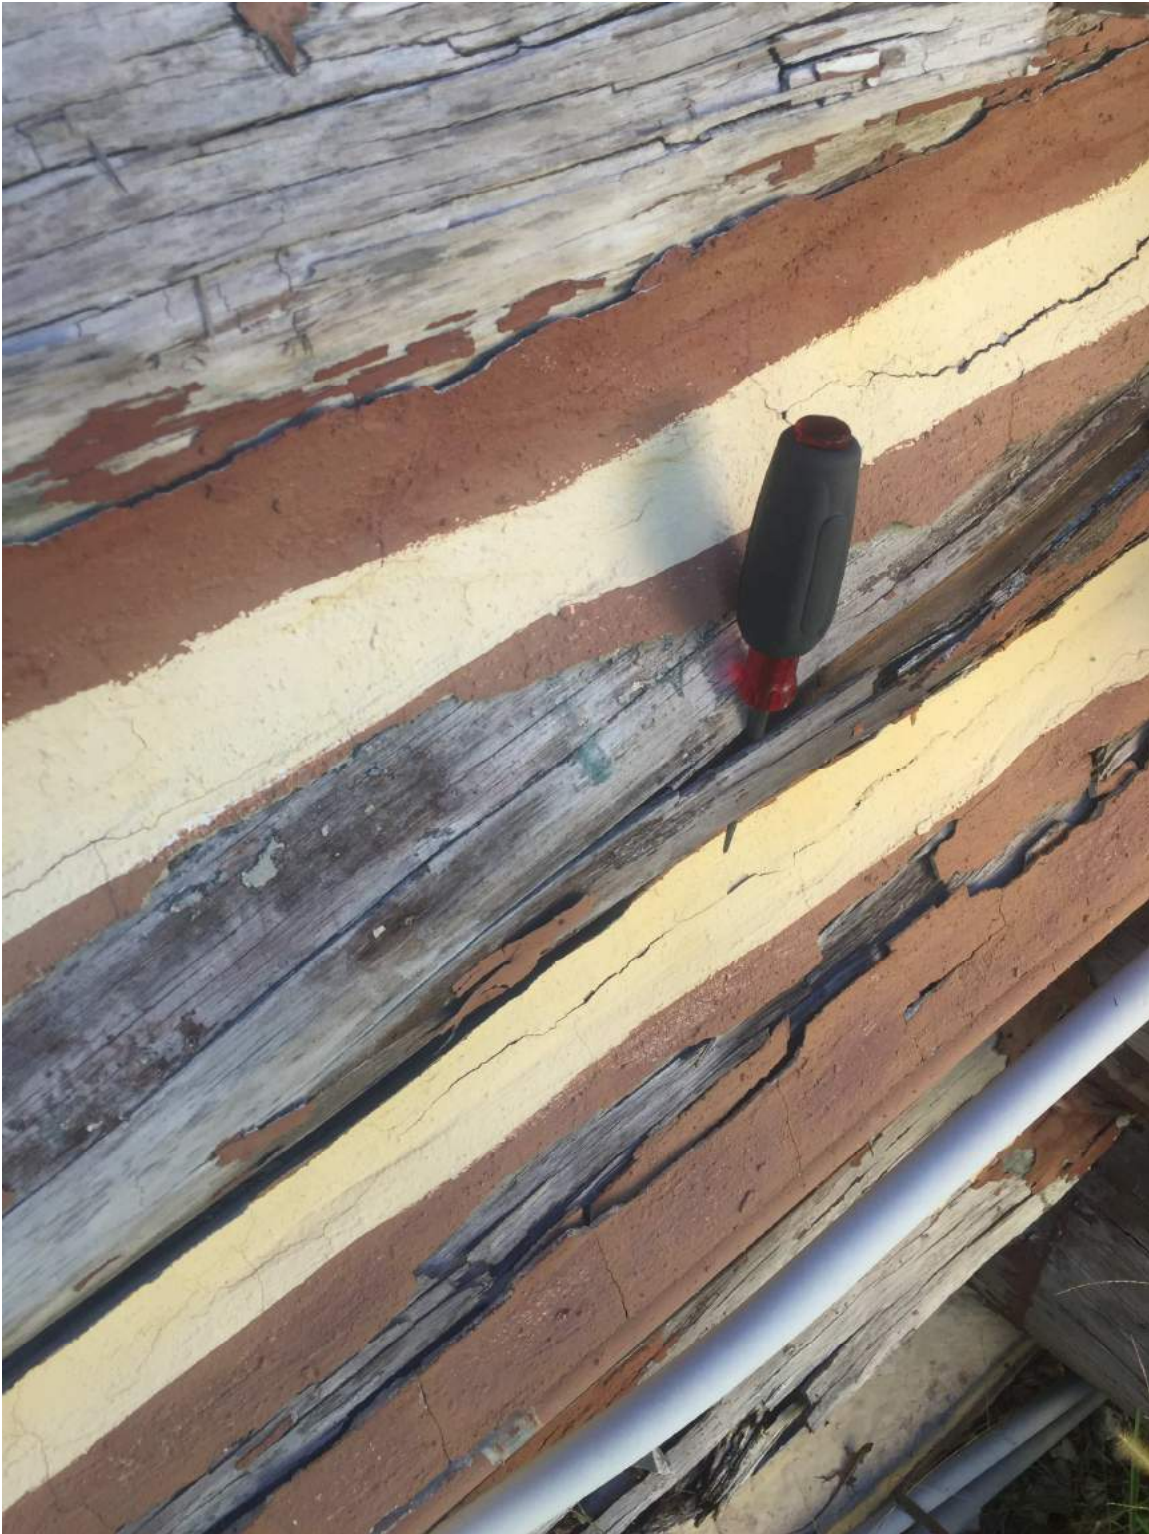
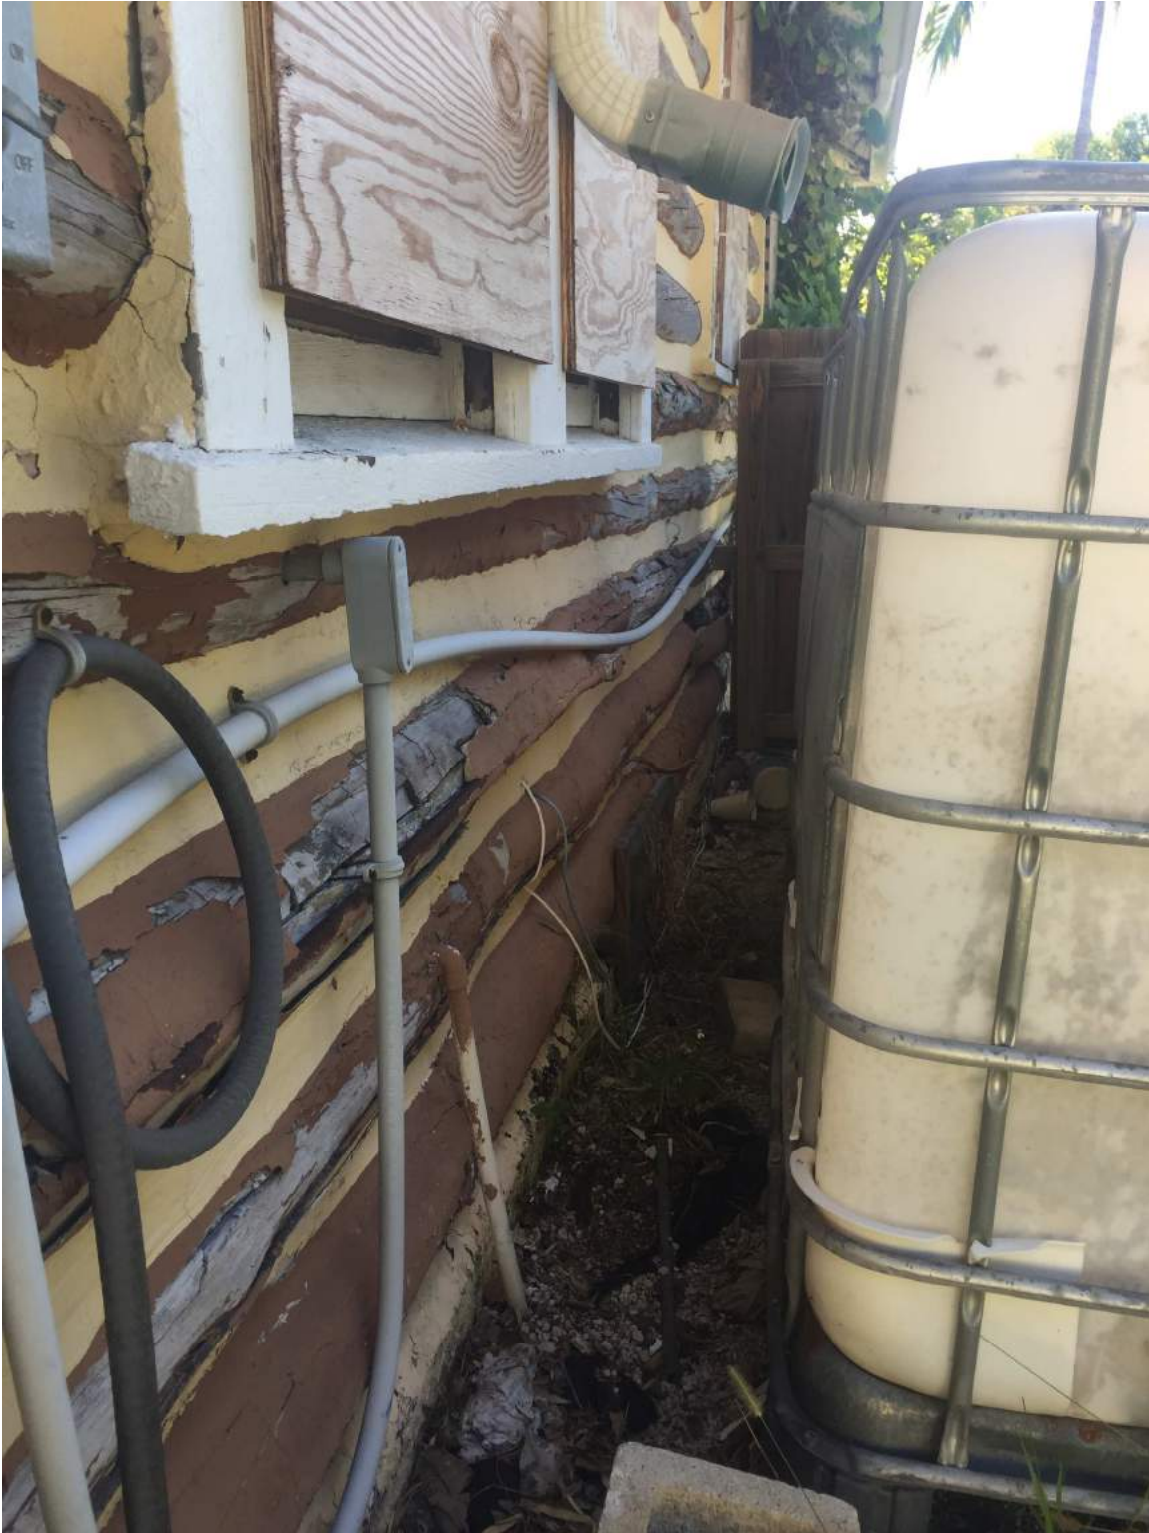
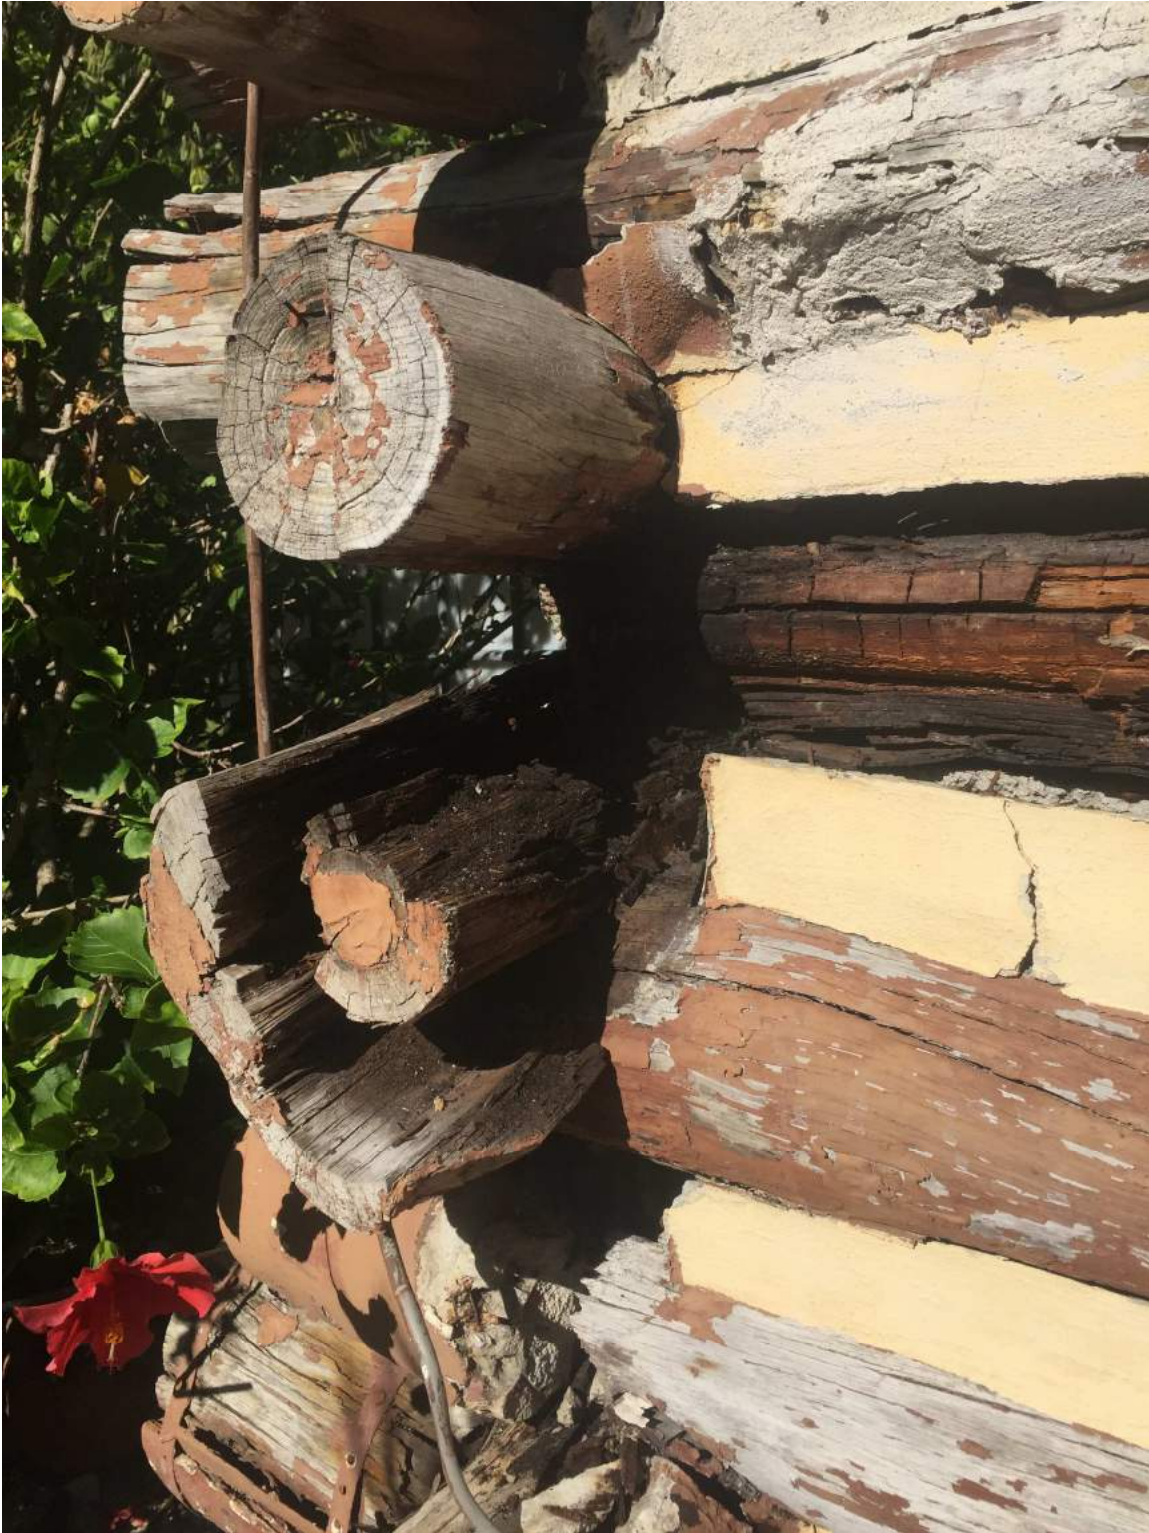
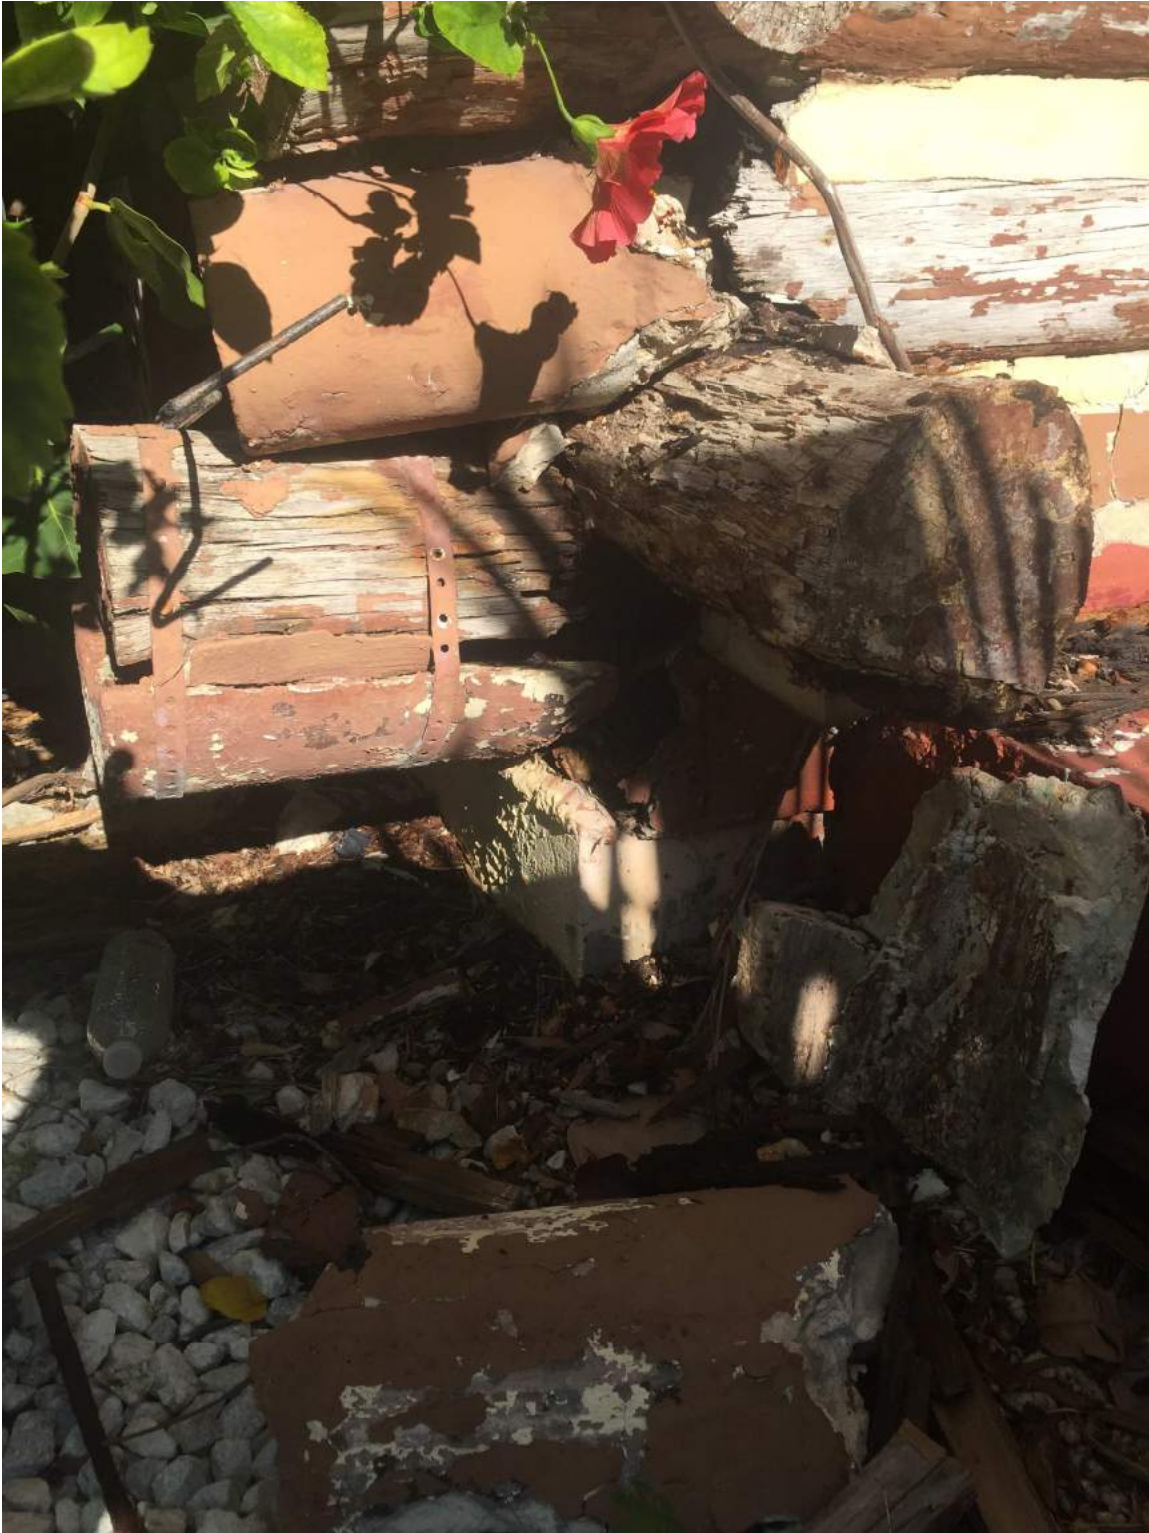
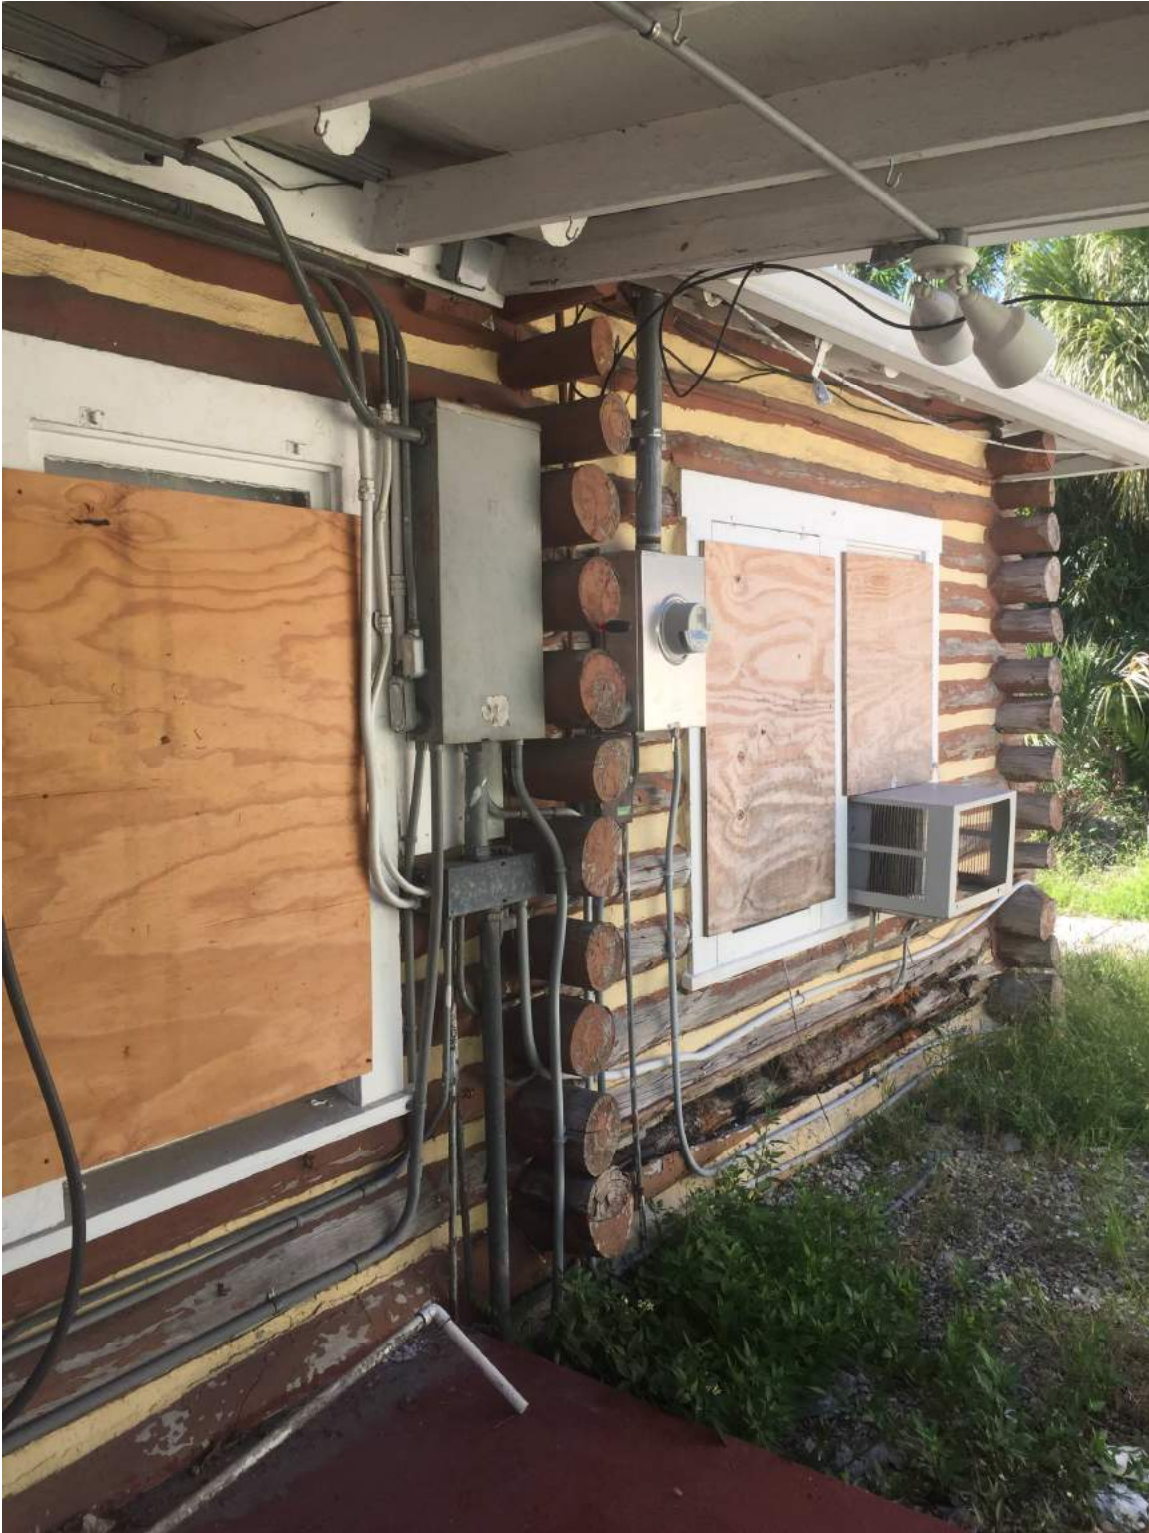
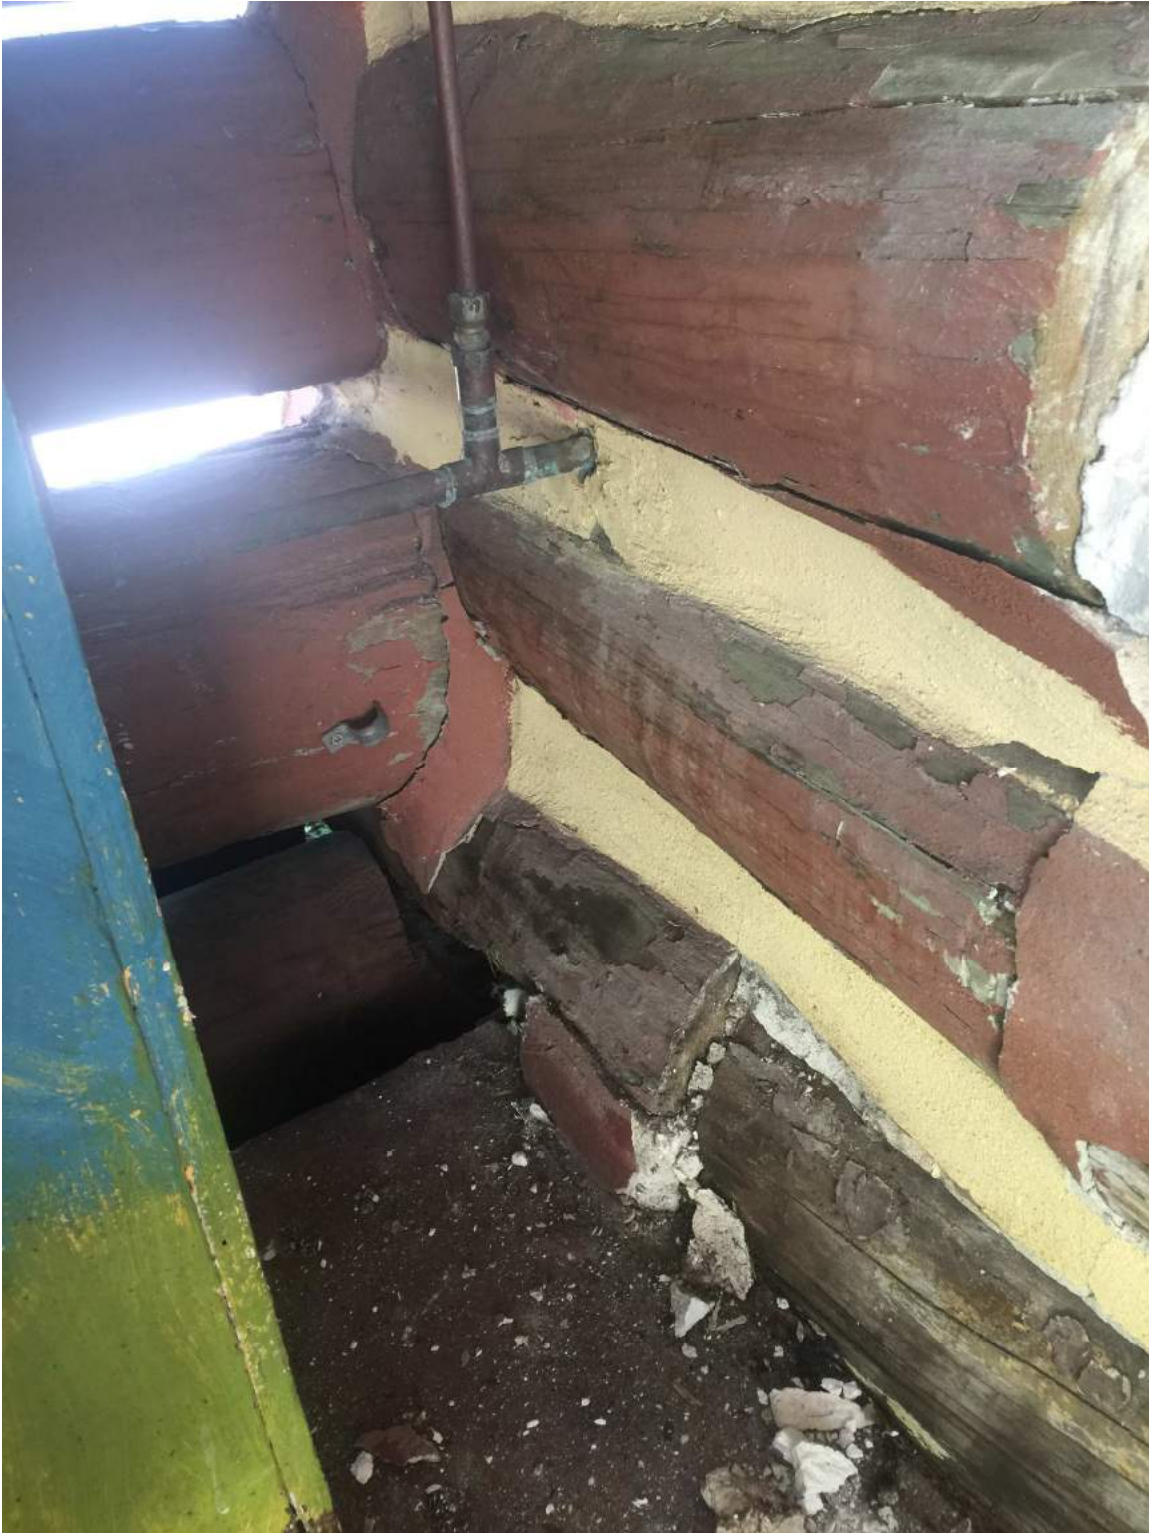
- 4) While the interior surfaces of the logs remain in fair to good condition, the exterior portions of the original logs are significantly deteriorated. Deteriorated conditions

include rot (slight to severe), splitting and delamination of rings (Refer to Photographs Nos. 40 through 59). In many locations, these conditions penetrate deep into the logs.

In our opinion, most of the logs in the exterior walls would need to be replaced. Due to the extent of deterioration, it does not appear to be reasonably feasible to repair the exterior logs. Epoxy products intended for wood repair could be considered, but again, the general extent of repairs, the depth of repairs and the volume of repair appear to be too great. Even if such repair materials were used for portions of the exterior logs, the repair areas would, of course, lack the color, texture and grain of the wood. The exterior would need to be completely repainted. The paint and lack of texture in the patches would likely be esthetically unacceptable for a "historical" restoration. Given these conditions and limitations, it is our opinion that the exterior log walls need to be reconstructed using new materials.

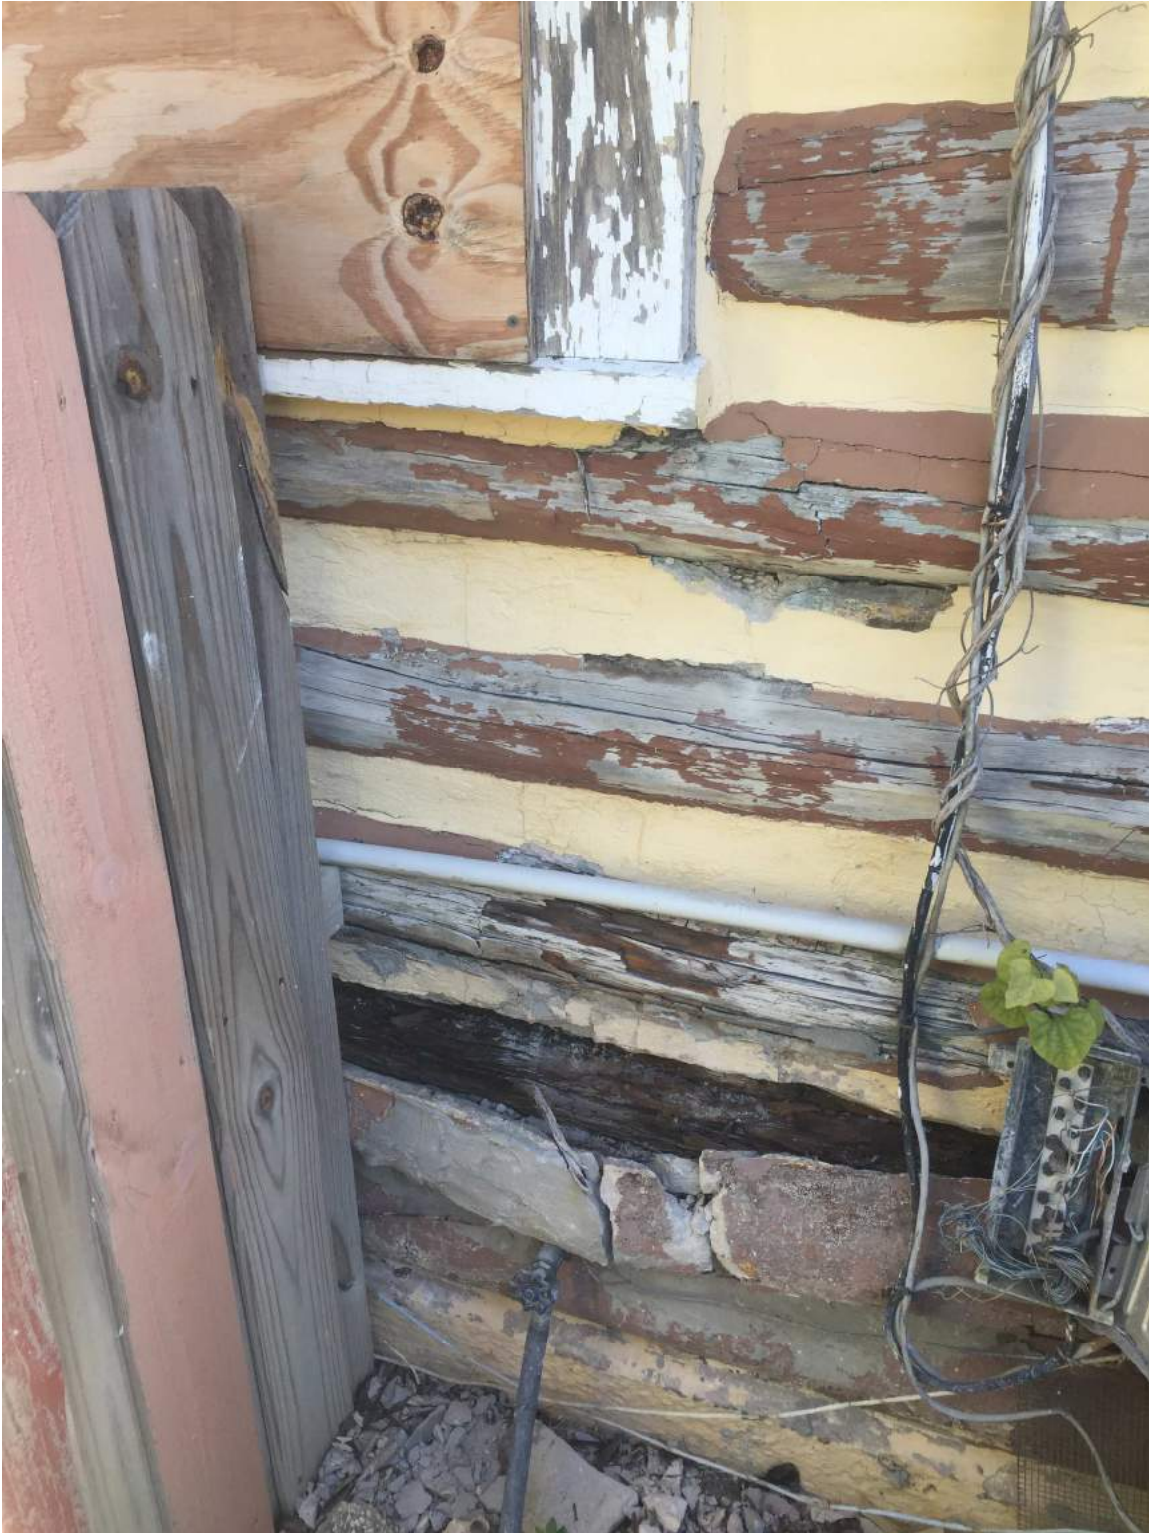
PHOTOGRAPH NO. 48

- 5) Many of the logs have been previously patched with mortar (Refer to Photographs Nos. 48, 49, 61, 62, 63 and 64). Some logs have been patched with inserts of dimension lumber and mortar. These are inappropriate patches. Many of these patches are now failing due to progressive deterioration and rot.
- 6) The chinking between logs in the exterior walls is in generally poor condition. This is particularly true of the exterior sides, but also extends to the interior sides in many locations.

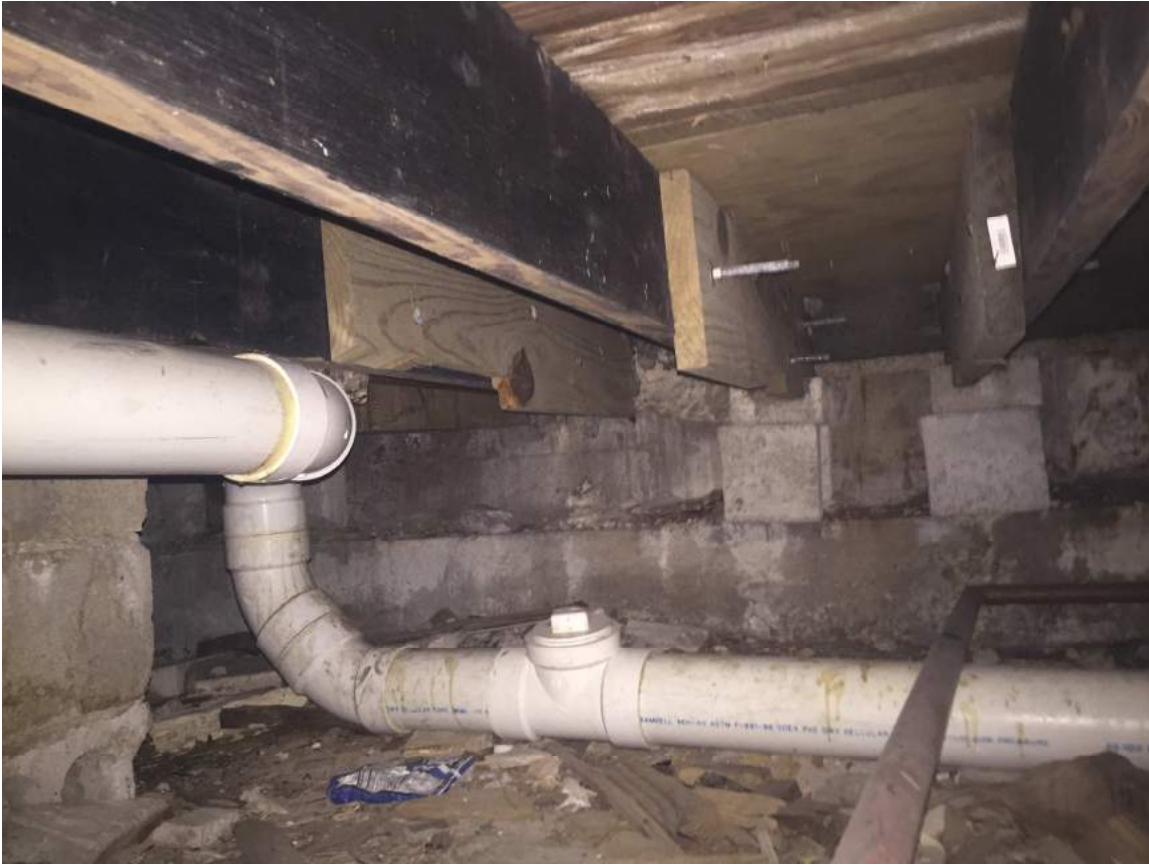
**PHOTOGRAPH NO. 60**

- 1) Some of the floor sheathing and joist segments under the north side restroom (north side of fireplace) have been replaced. The joist splices do not appear to be adequate (Refer to Photograph No. 60).
- 2) There are no provisions for ventilation of the crawl space. Ventilation is a Building Code requirement.
- 3) Where the floor joists bear on the exterior concrete stemwalls, most only bear approximately 1-½" to 2" on to the wall. This is generally an inadequate bearing length. The wood members bear directly on the concrete. In many locations, the joists were set on shims at the stemwall. Many of these shims are loose or have already fallen.
- 4) Where the floor beams bear on the interior concrete piers, they are generally set on unsecured wood blocks or shims (Refer to Photograph No. 29).
