**GENERAL ASSESSMENT REPORT**

**EXISTING LOG CABIN  
8128 COLLINS AVENUE  
MIAMI BEACH, FLORIDA**

**SEPTEMBER 1, 2017**

PREPARED BY:  
**DOUGLAS WOOD ASSOCIATES, INC.**

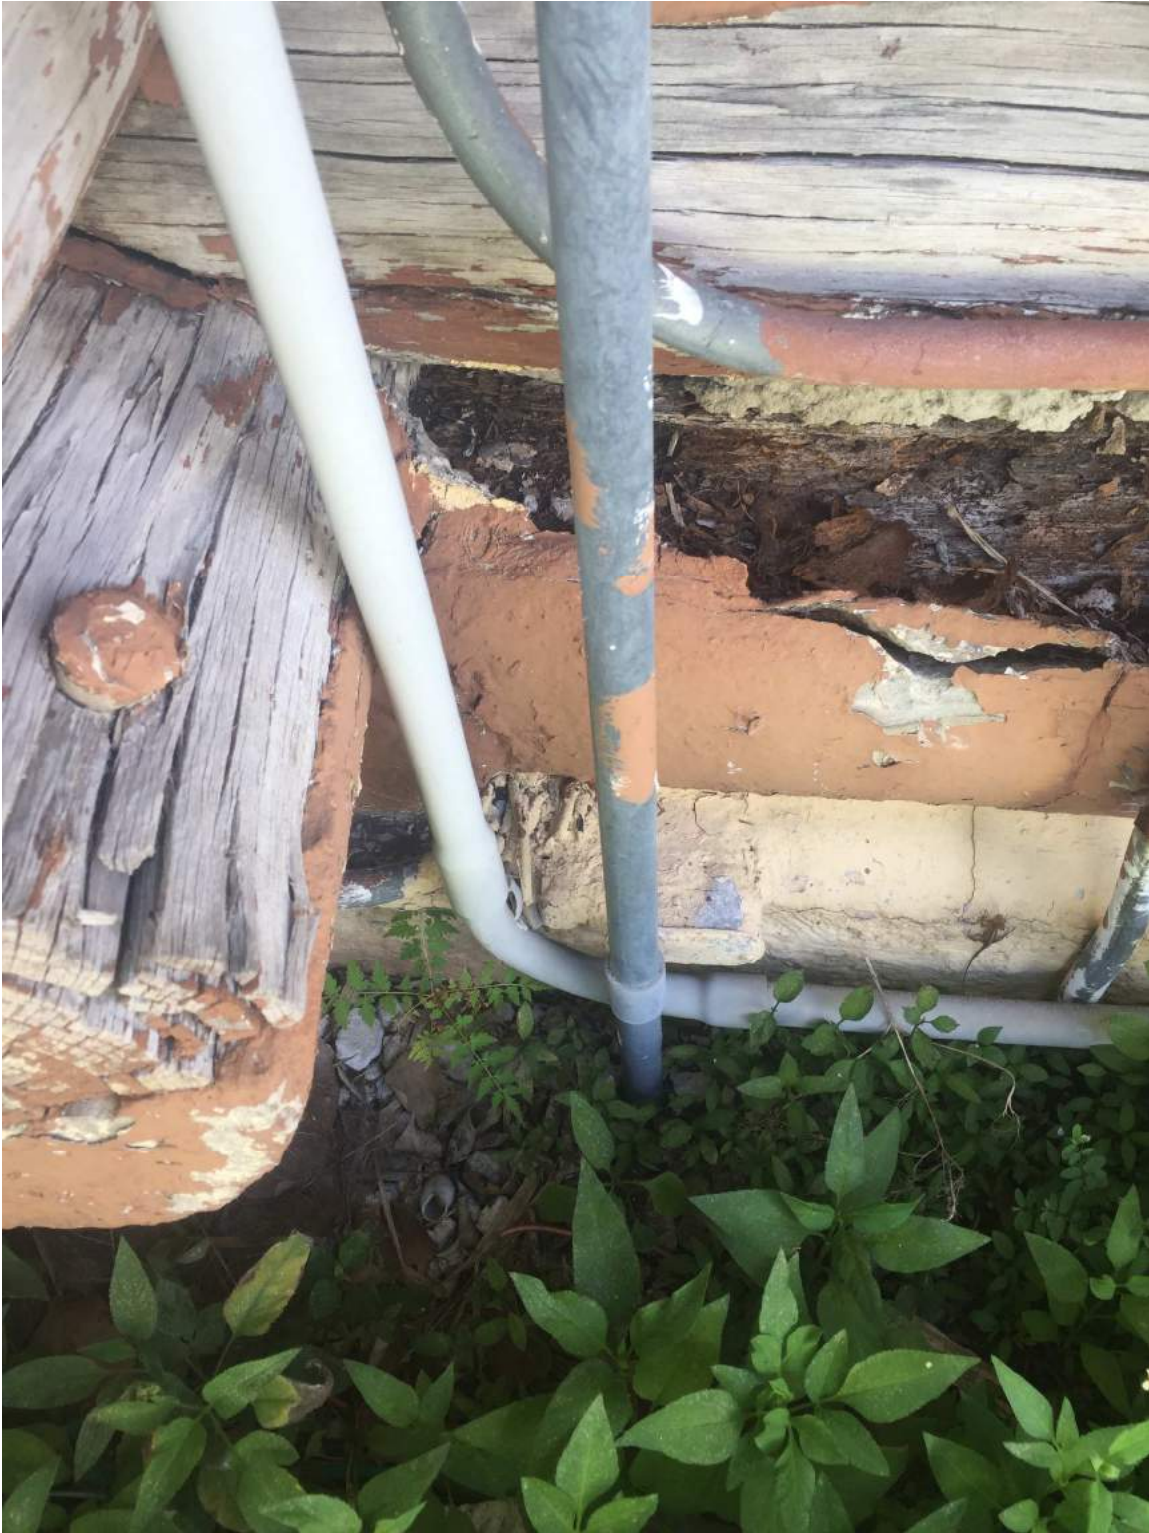
PHOTOGRAPH NO. 61

- 5) Many of the logs have been previously patched with mortar (Refer to Photographs Nos. 48, 49, 61, 62, 63 and 64). Some logs have been patched with inserts of dimension lumber and mortar. These are inappropriate patches. Many of these patches are now failing due to progressive deterioration and rot.
- 6) The chinking between logs in the exterior walls is in generally poor condition. This is particularly true of the exterior sides, but also extends to the interior sides in many locations.

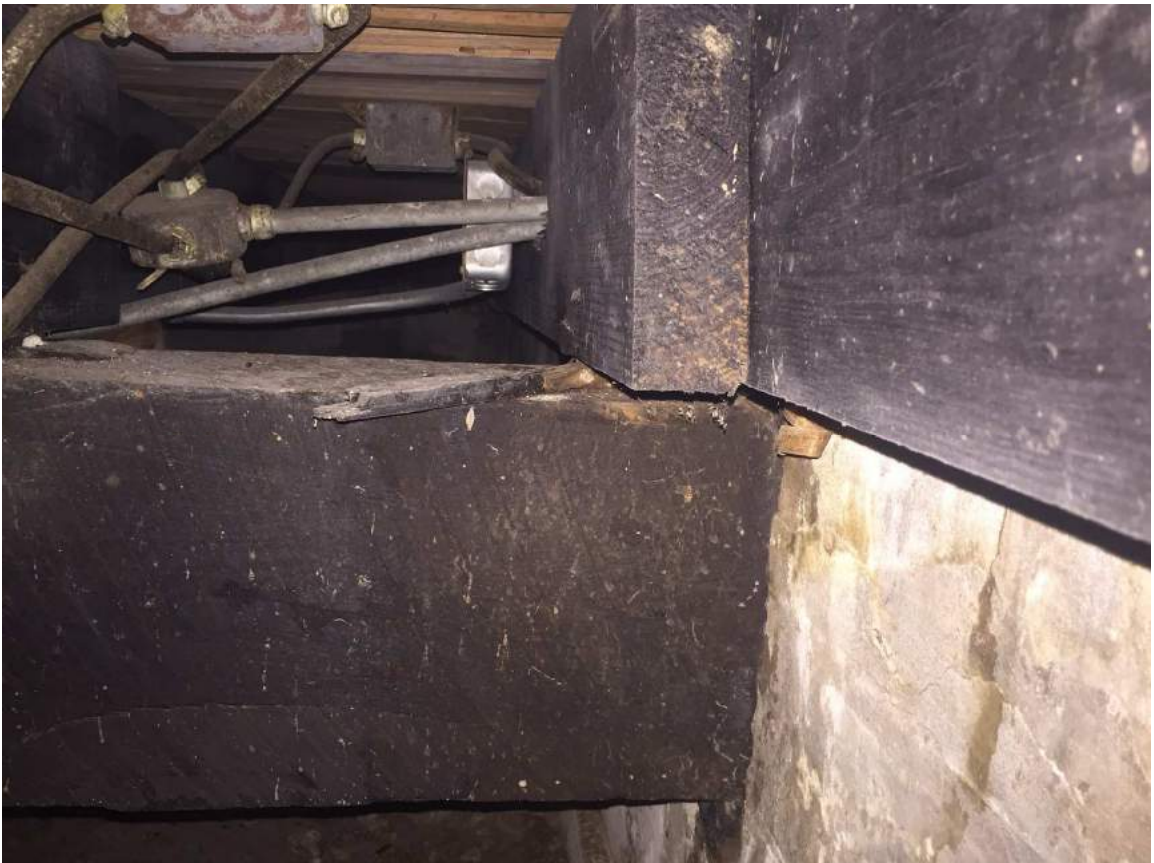
PHOTOGRAPH NO. 65

There are long, generally horizontal cracks at the tops of the concrete stemwalls in some locations (Refer to Photographs Nos. 65 and 66). These cracks may be the result of spalling from corroded reinforcement. Additional investigation would be required to better determine the cause and prognosis of this condition.
