## Historical Preservation Board Report

# 947 Lincoln Road

Miami Beach, Florida

January 31, 2017

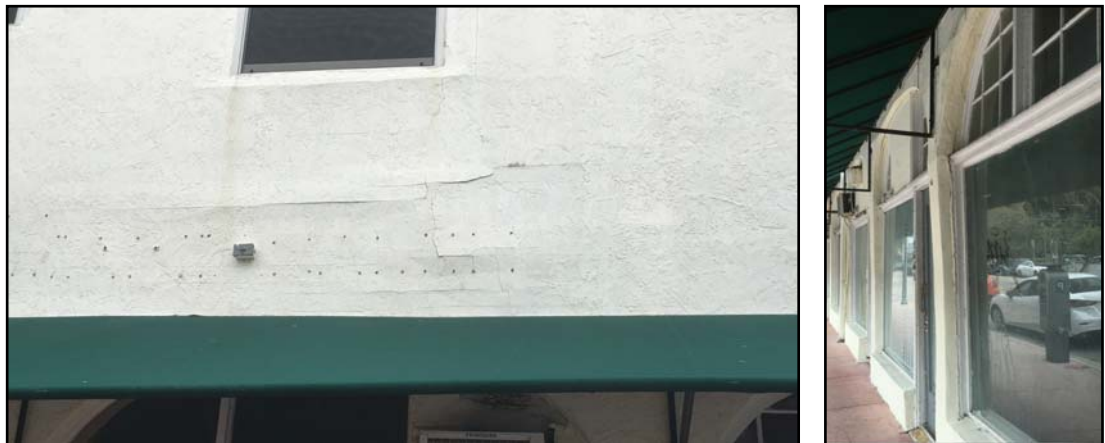
Given their age, the terracotta walls are in fair condition, although cracking and bulging is evident. However, they have little structural capacity to resist design loads of gravity, wind out-of-plane bending or wind in-plane shear.

**Cracking and Bulging at Exterior Walls**

With the exception of the 6-foot-wide section of terracotta wall being removed and replaced by curtainwall at the northwest corner, all of the terracotta walls will remain. To resist all design gravity and wind out-of-plane and in-plane shear loads, we will call for shot-crete to create a 4"-thick concrete wall and attach the terracotta to act as a veneer. All historical features will be maintained and/or restored to the original.

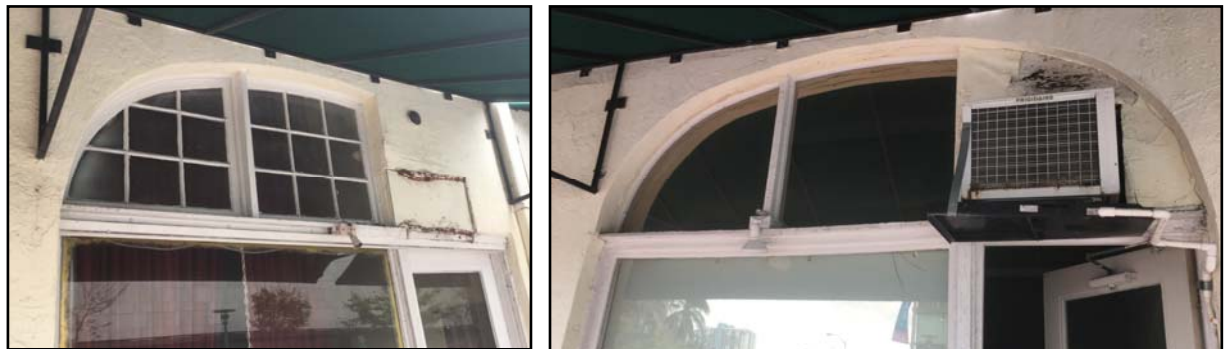
Some of the walls have been infilled with wood that has since rotted, including some historical features such as the arches.

**In-filled Arches would be removed**

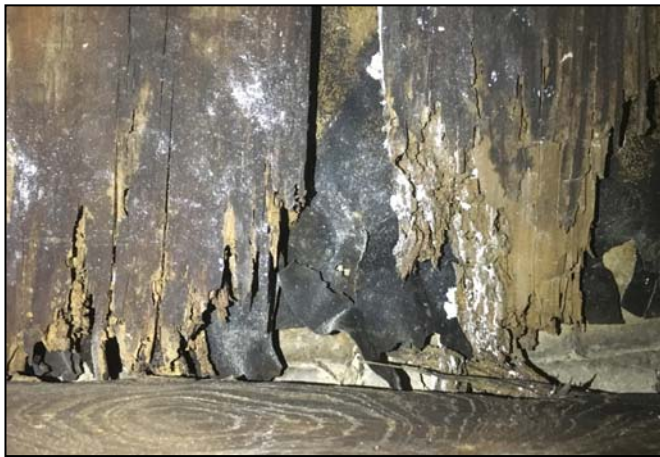
All exposed wood framing (2<sup>nd</sup> floor, roof and 2<sup>nd</sup> story walls) shows evidence of significant rot. We removed wall and ceiling finishes in several locations and all showed evidence of significant rot. All wood walls would have to be replaced or strengthened to bring it up to acceptable material capable of resisting design loads.

**Severe Rotting in Exterior Wood Framed Walls**

The 2<sup>nd</sup> floor efficiencies are not historic. Further, they are wood framed, rotten and unsafe. Therefore, the 2<sup>nd</sup> story will be demolished. The new 2<sup>nd</sup> floor will be framed with concrete slabs capable of resisting the new retail live load, supported by the 4” thick shotcrete wall extending up from the 1<sup>st</sup> story.

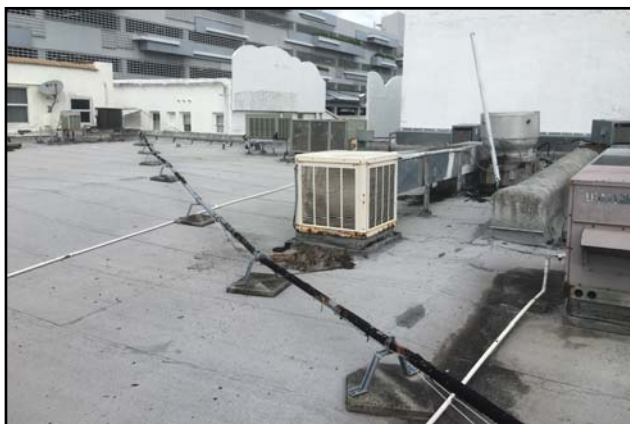
**Roof**

The roofs tremor and shake under the weight of a 200-pound man attempting small jumps. The roof structure and connectors also have very little resistance to wind uplift. Also, weeds/plants have begun to grow on some areas of the roof where water ponds after rain.

The wood roofs are not capable of resisting hurricane uplift forces. All roofs will be removed and replaced with concrete slabs capable of resisting code loads.

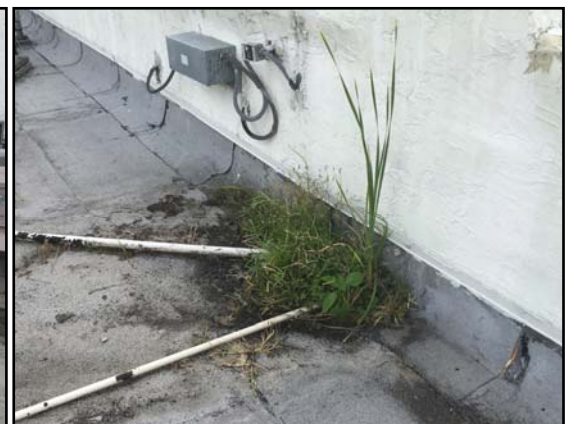
**Plant near drainage spot at roof**
