GENERAL ASSESSMENT REPORT

EXISTING STRUCTURAL SYSTEMS

**819 2ND STREET
MIAMI BEACH, FLORIDA**

JUNE 28, 2017

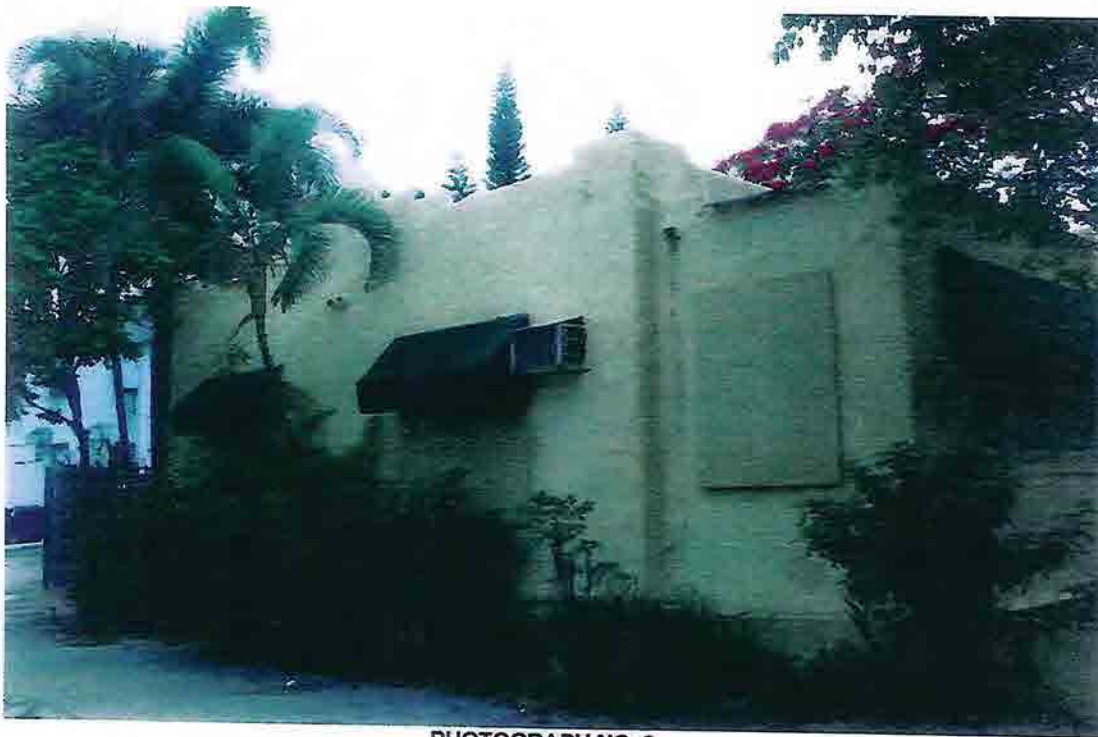
PHOTOGRAPH NO. 3

3. Each of the three original roof areas are drained by only one scupper. There are no overflow drains.
4. The attic spaces are inadequately vented. There are only two pipe vents on each of the east and west sides of the building. Refer to Photographs Nos. 3 and 5.

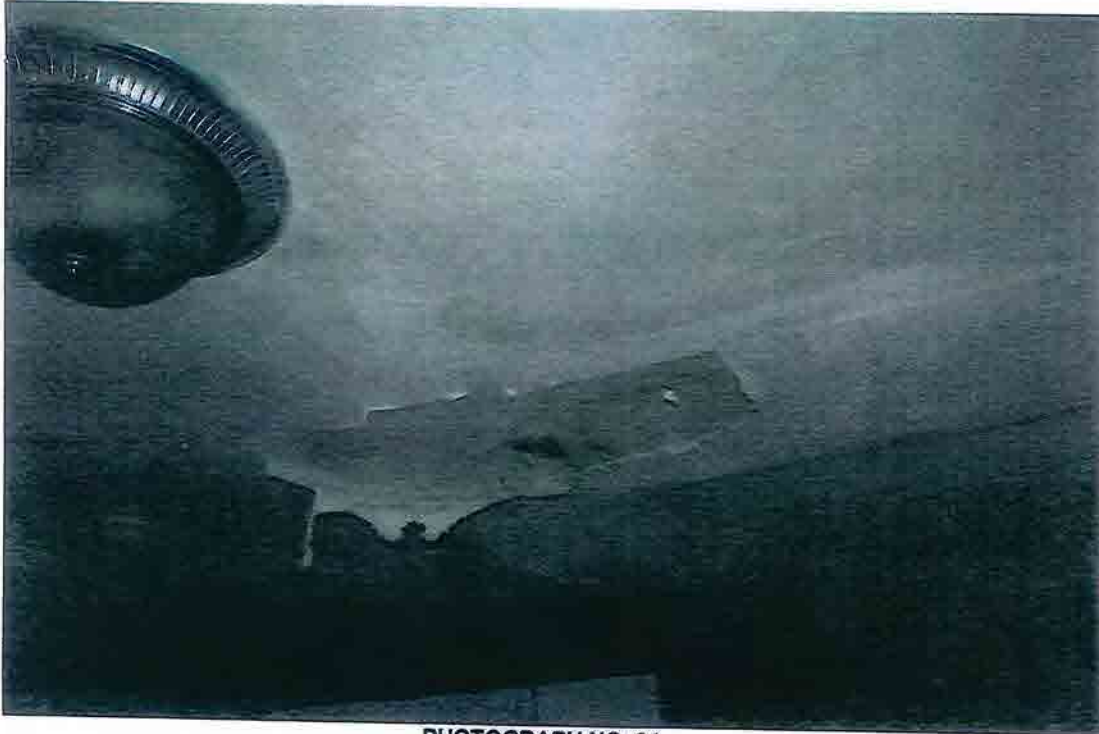
PHOTOGRAPH NO. 24

3. A few areas of the ceilings in the original portions of the building also exhibit collapse or other damage from roof leaks. Refer to Photographs Nos. 24 and 25.

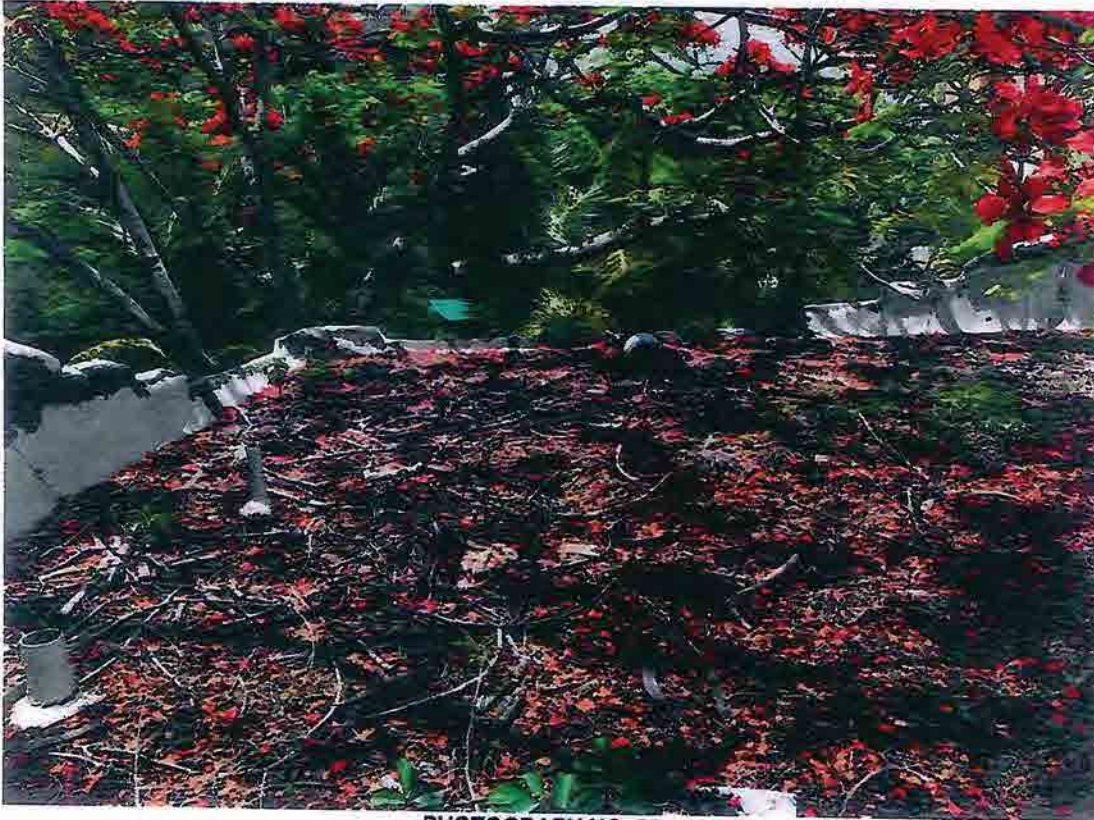
PHOTOGRAPH NO. 27

6. A large area of the main roof is covered in leaves, twigs and debris. Refer to Photograph No. 27. There are numerous plants growing in the debris. The lower roof of the front of the east wing is completely covered with leaves, twigs and debris. Refer to Photograph No. 28. The scupper for this roof is partially clogged. The scupper for the low roof at the front of the west wing is clogged. Refer to Photograph No. 29.

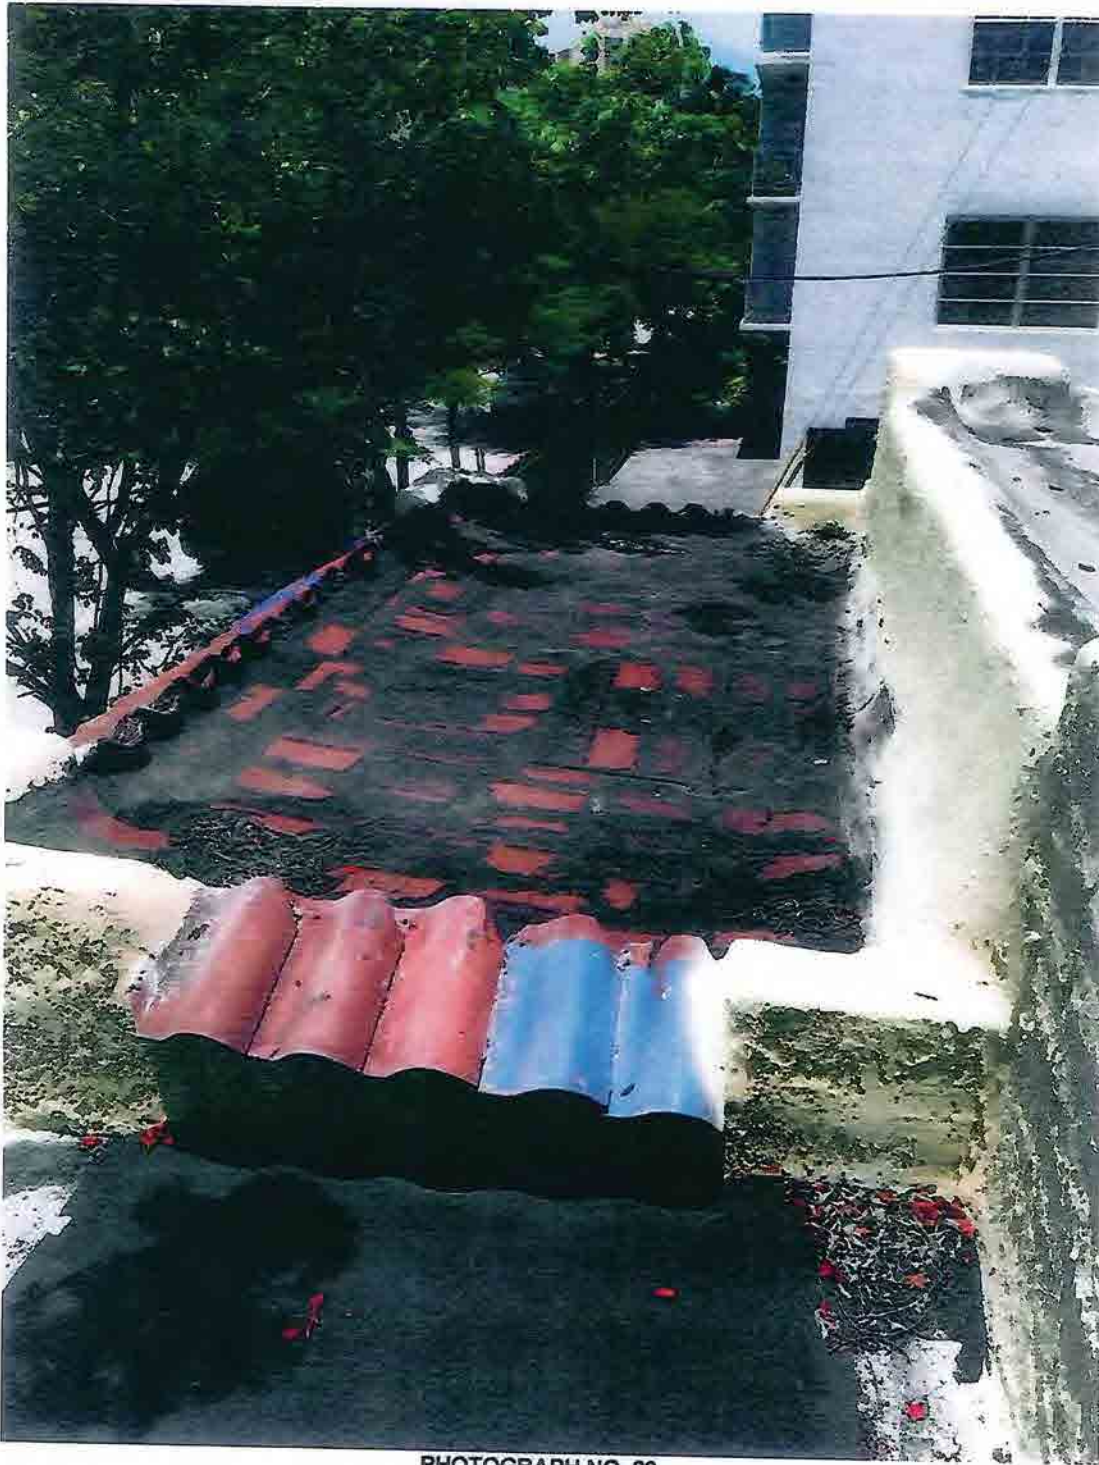
PHOTOGRAPH NO. 29

7. The low roof at the front portion of the west wing was improperly covered with asphalt/fiberglass shingles (approved only for sloped roofs). Refer to Photograph No. 29.

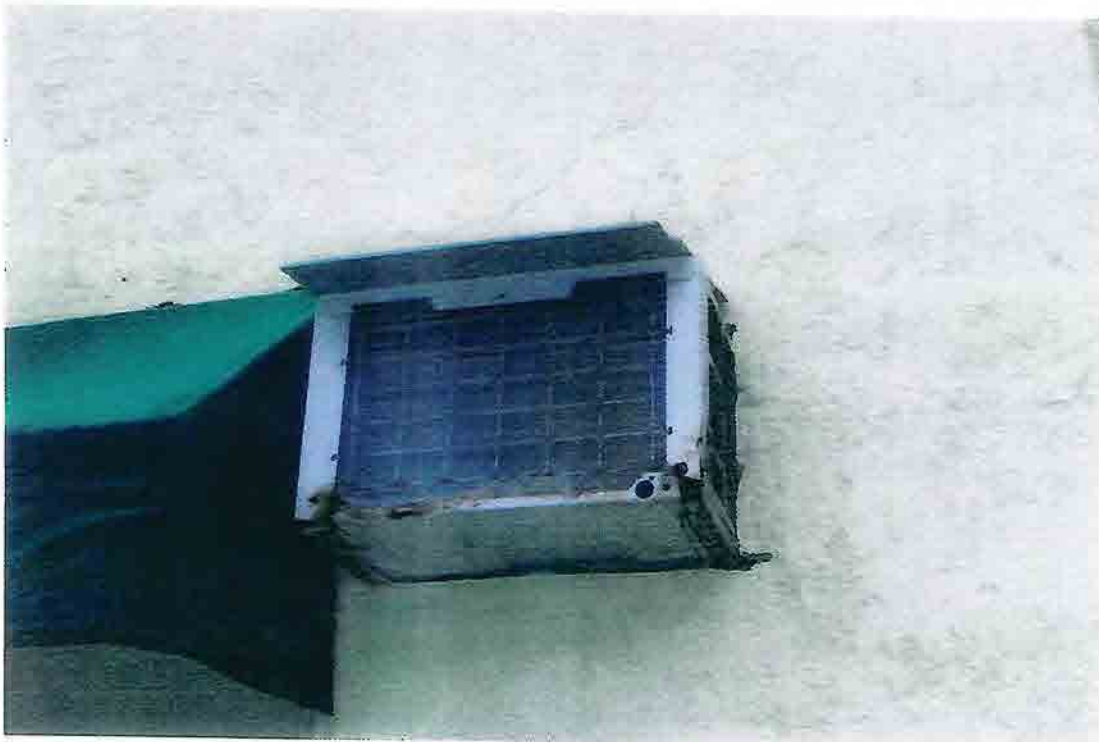
PHOTOGRAPH NO. 38

4. There are two through-wall air-conditioning units with significant gaps around their perimeters. Refer to Photographs Nos. 38 and 39. These gaps can allow water to enter the wall cavities and building interiors, which can cause rot. One of these units is located above the area of the large stucco bulge (Refer to Item No. 3, above). Each of the wall openings appear to be wide enough to have required the cutting of an exterior wall stud.

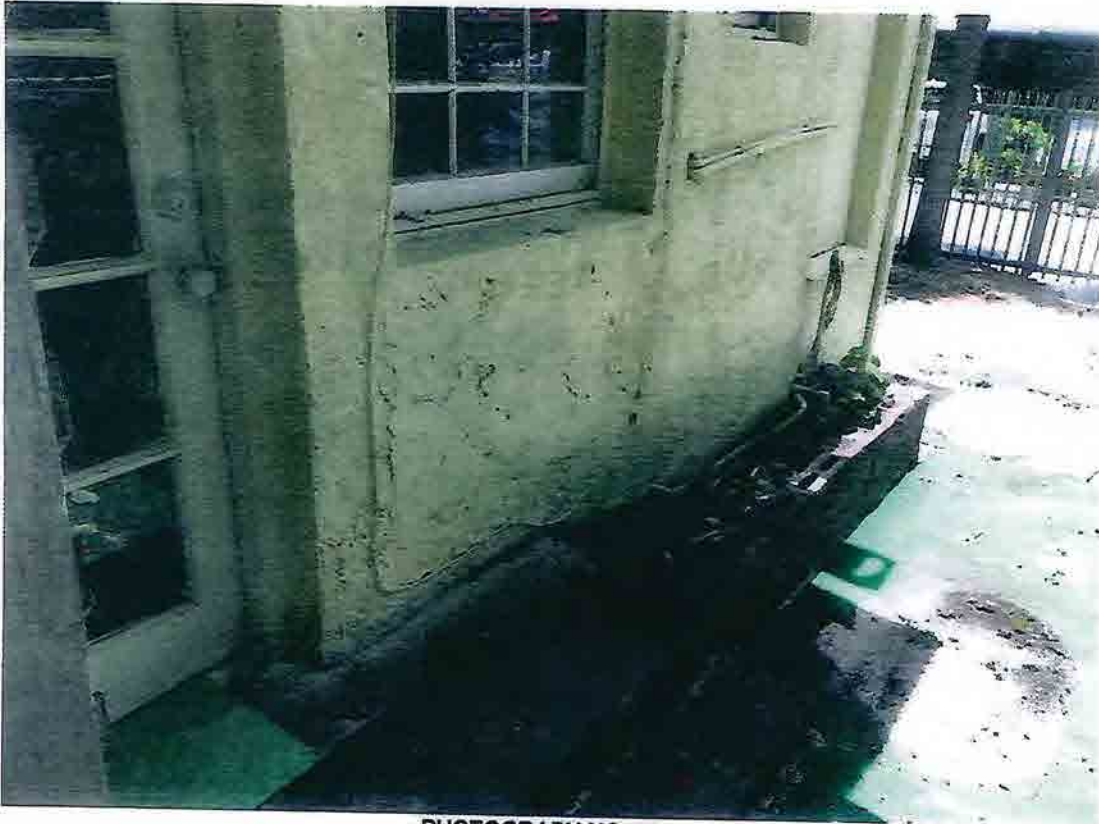
PHOTOGRAPH NO. 43

5. There is a former through-wall A/C opening in the exterior wall of the rear addition which has been in-filled with stucco on wood. Refer to Photograph No. 43. There is another former through-wall A/C opening which has been covered only with plywood. Refer to Photograph No. 44.

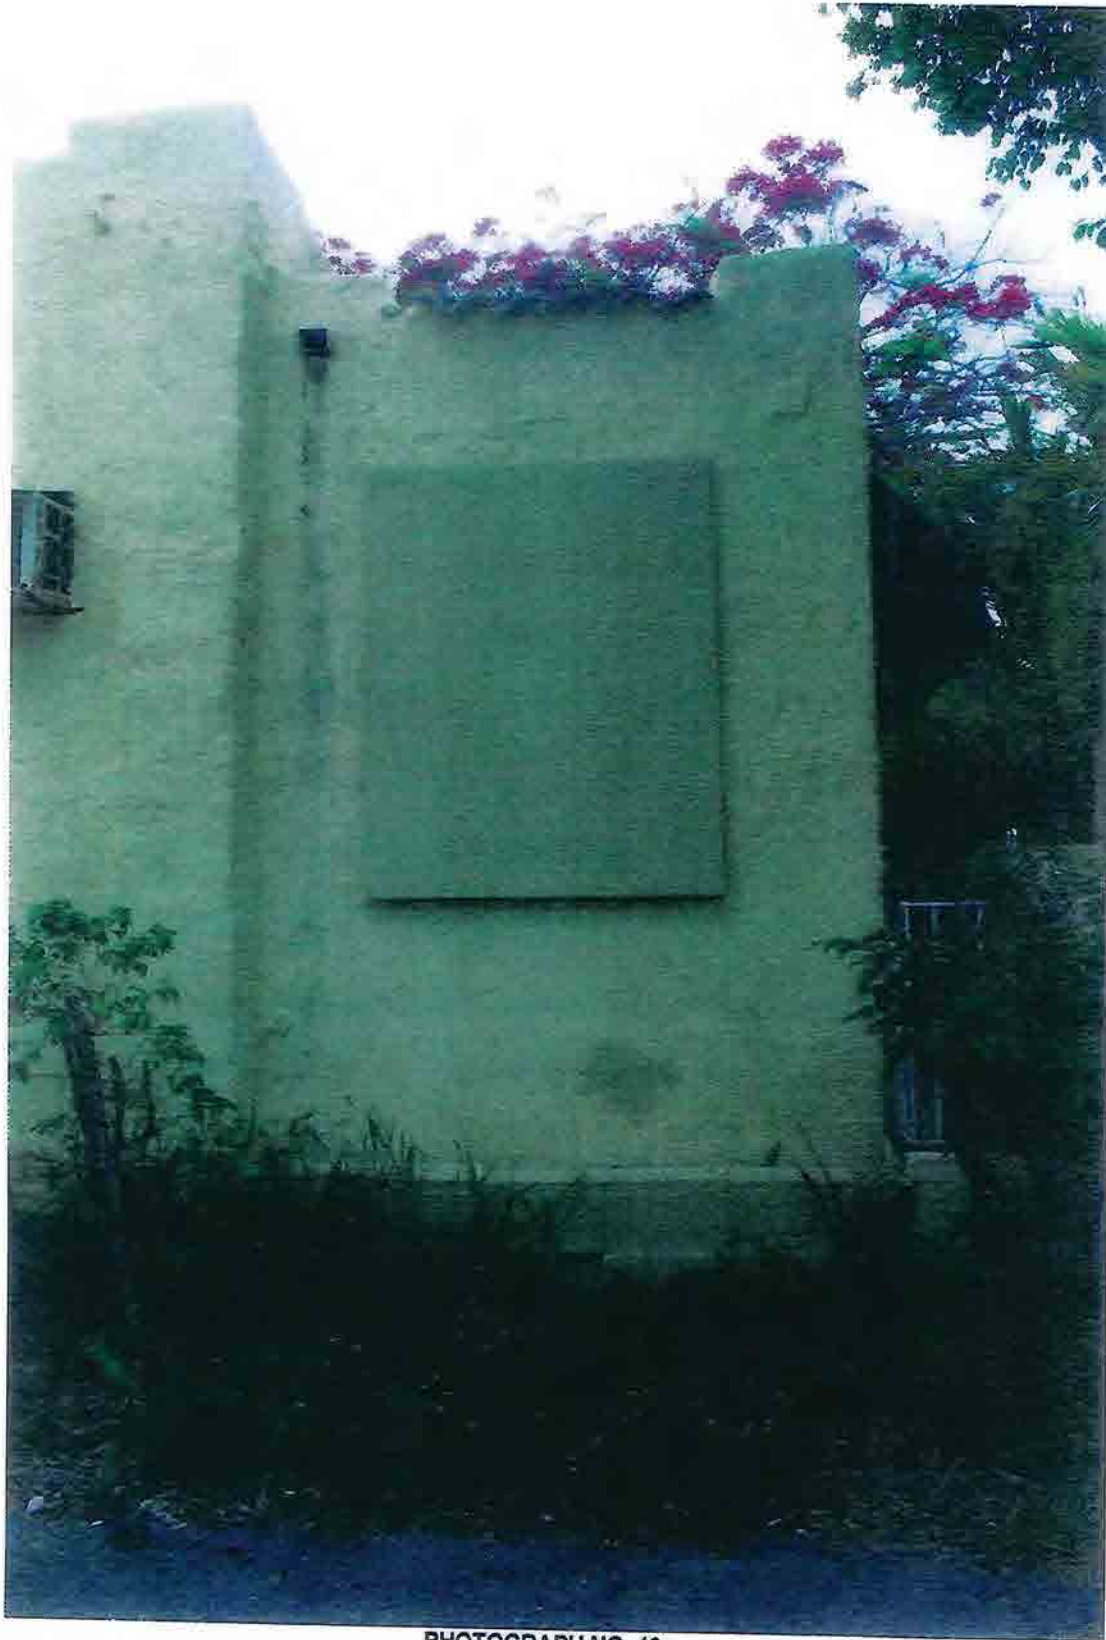
PHOTOGRAPH NO. 46

7. Concrete blocks have been stacked against the stemwall of the west side of the front room of the west wing. Refer to Photograph No. 46. These blocks seem to have been mortared (sparsely) in place and painted. The reason for these blocks is not clear, but they are likely bolstering, or hiding, deterioration in the stemwall.
