# Specimen Tree Report

5465 Pine Tree Drive  
Miami Beach

11/16/2017

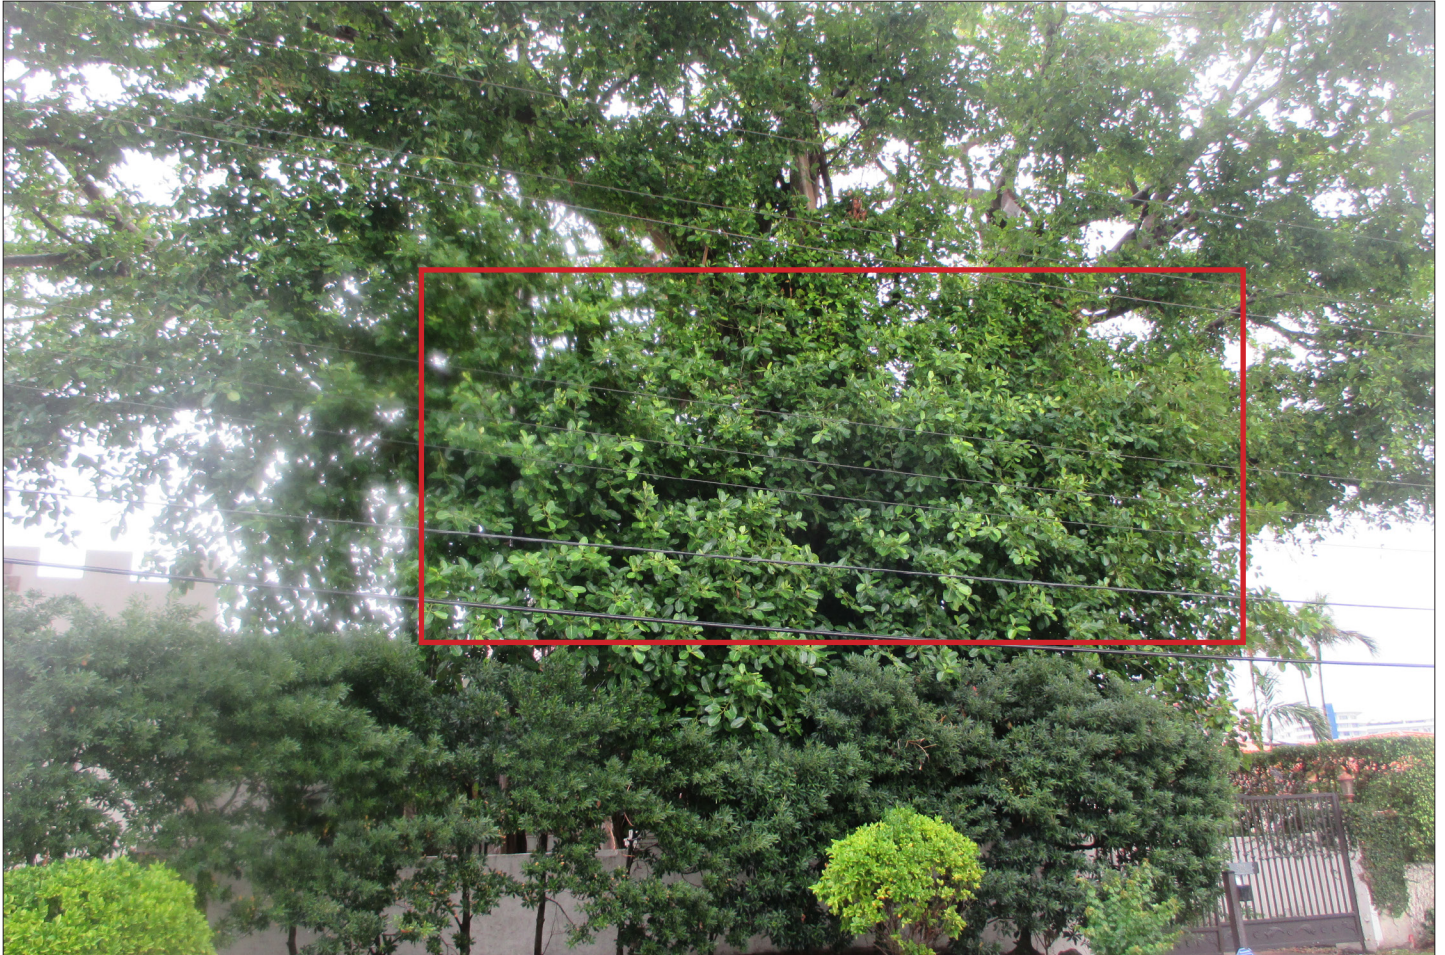
The canopy of the Banyan is wide-spreading at 110ft in spread, reaching across most of the property and into the southern neighbor's. The canopy is narrower in the east-west direction and is about 60ft in spread. On the western side of the tree are overhead powerlines which the lower two-thirds of the canopy is pruned to. The top one-third of the canopy arches high over the powerlines. Because of repeated crown reduction from the powerlines, there is dense shoot growth in this area of the canopy (outlined in red in photo below).

The canopy can be crown cleaned to remove the small amount of deadwood that exists. Dead limbs are more likely to break and have the potential to host disease. The amount of live foliage to be removed should be minimized, especially since the tree lost a large percentage of foliage during Hurricane Irma. Annual pruning away from the powerlines and the house will ensure that only small diameter branches are cut at each pruning session. Some of the epicormic shoots in the lower canopy and main limbs can be removed for aesthetic purposes. The remaining shoots should be left to provide an important source of photosynthate for the tree. Epiphytic plants may be removed for aesthetic purposes if so desired. Canopy pruning shall be performed or supervised by a Certified Arborist and ANSI A300 Pruning Standards shall be followed.

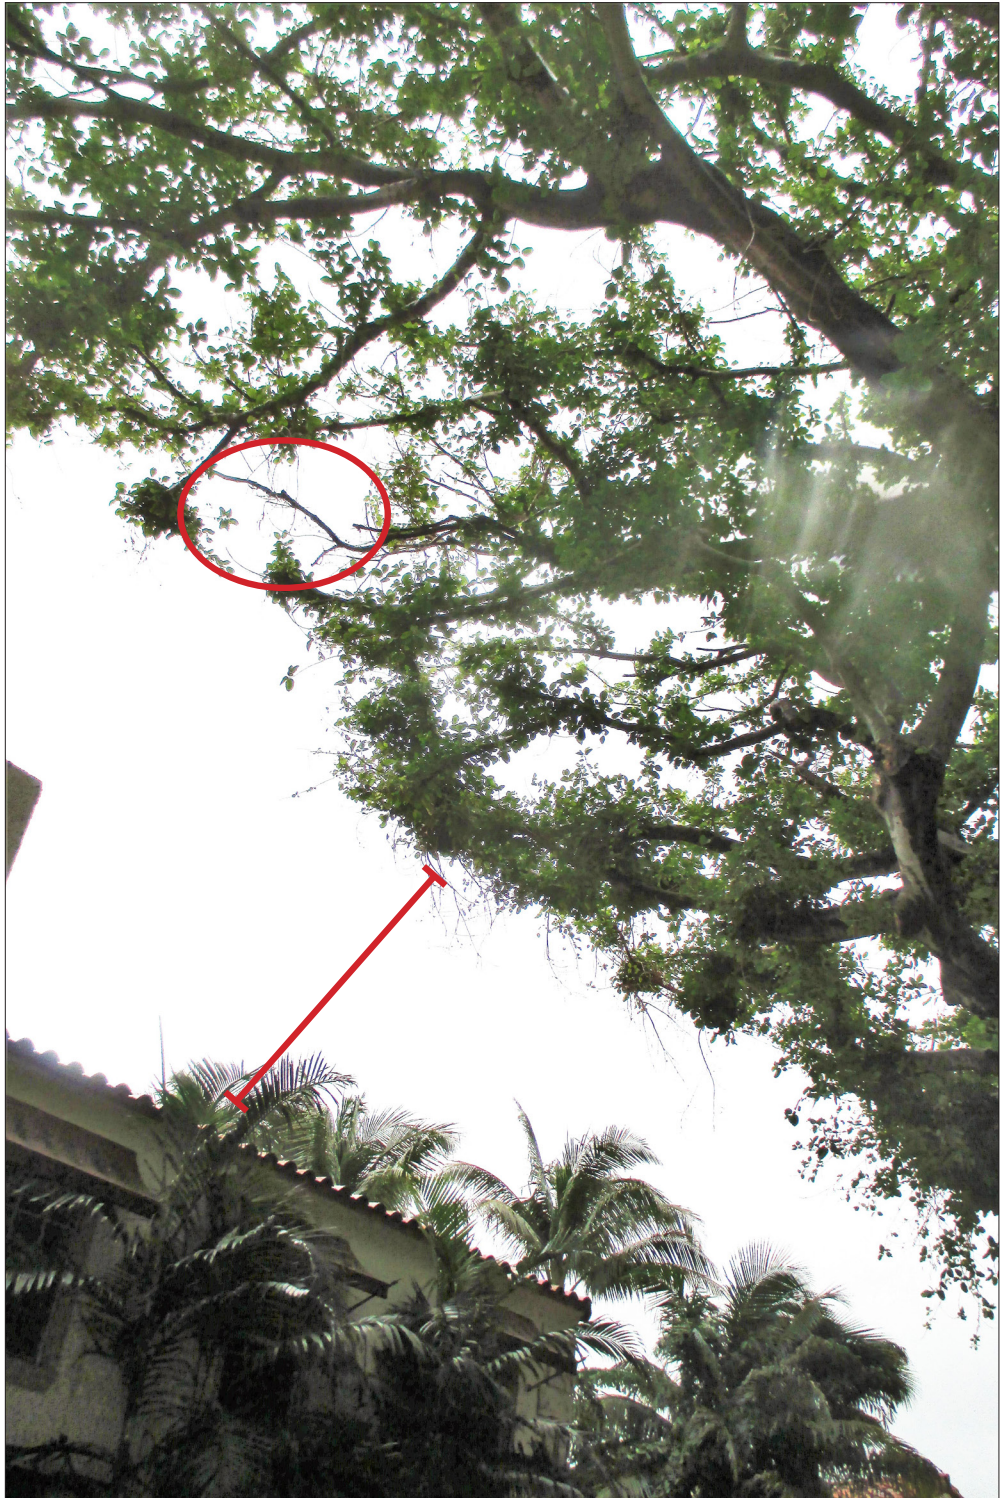
On the east side of the tree, the canopy has also been reduced from the house, but to a lesser extent, as shown in the photo to the right.

A small amount of small-diameter deadwood exists high in the canopy, like the branch circled in red.

The canopy is dense and is composed of healthy green foliage. I did not observe any broken branches or branch stubs and can infer that the tree did not endure much damage during Hurricane Irma two months ago. I was informed that many of the leaves were blown off, which might explain the dense vigorous canopy currently observed. New shoot growth is occurring throughout the canopy.

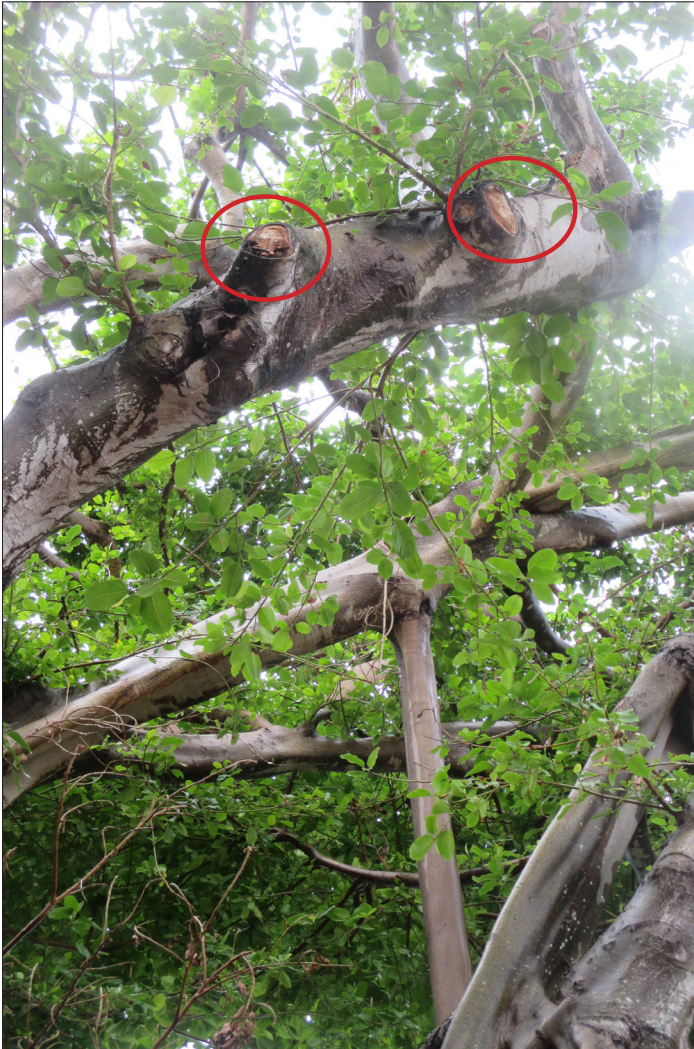
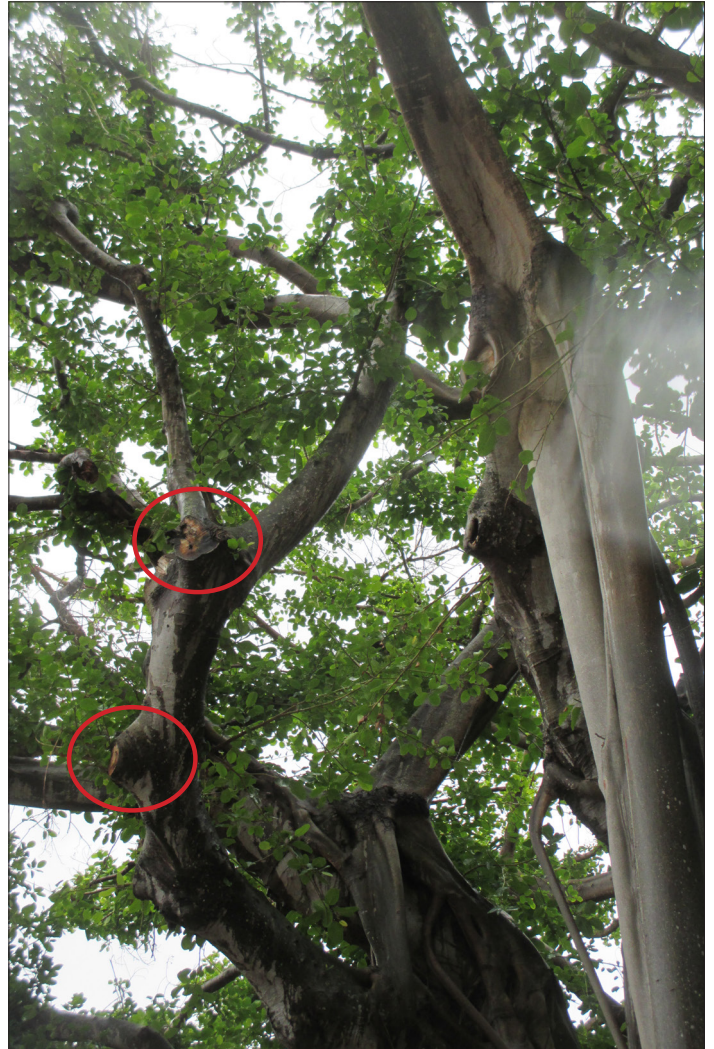
There were some fairly recent pruning cuts (circled in red) on the eastern side of the tree, presumably to provide clearance to the house. Most of these were relatively small in diameter and should close over nicely like some of the older pruning cuts.

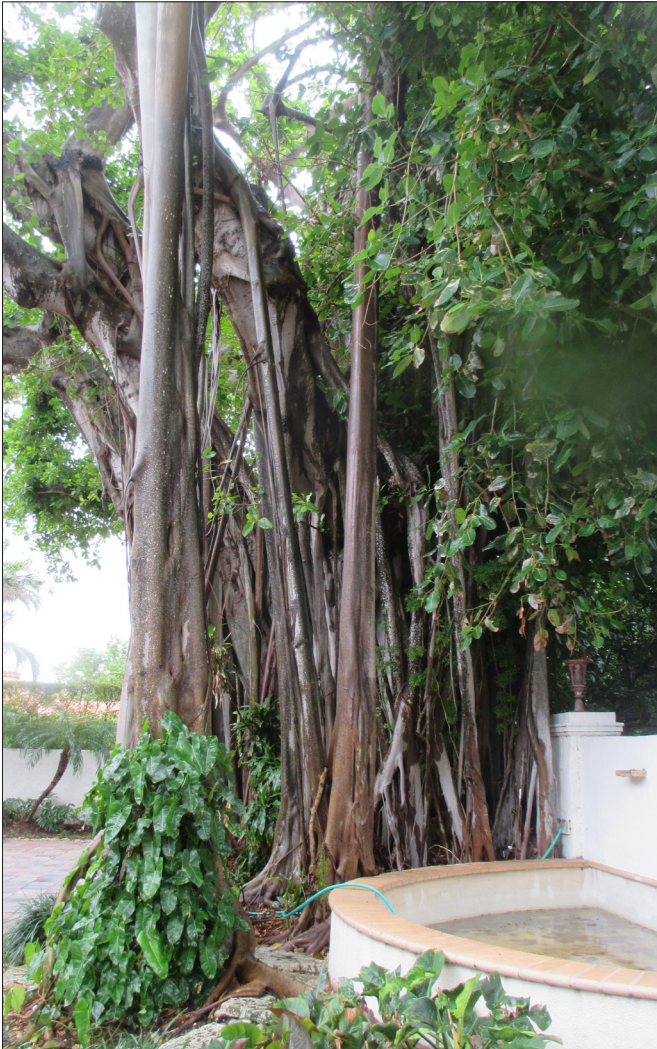
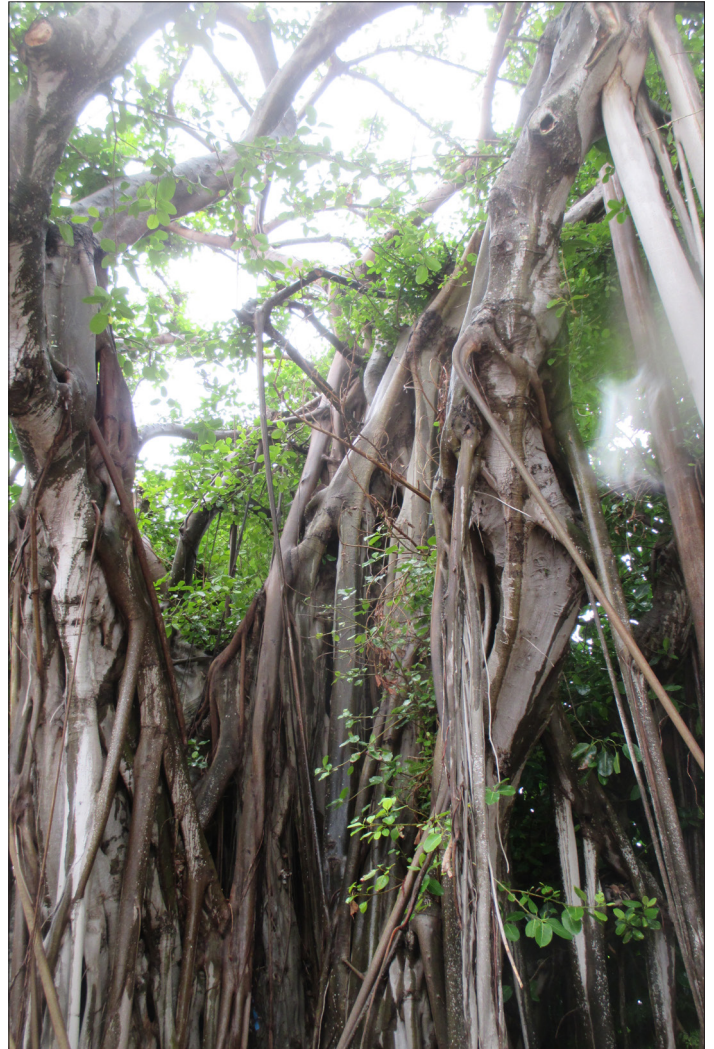
The trunk of the tree is 25 feet in diameter and has many aerial roots that have formed large prop roots which are vital to providing sufficient support during high wind events for a tree of this stature. No wounds or decay were observed in this portion of the tree, although roots potentially obscured any defects. Prop roots have also grown over the adjacent wall.

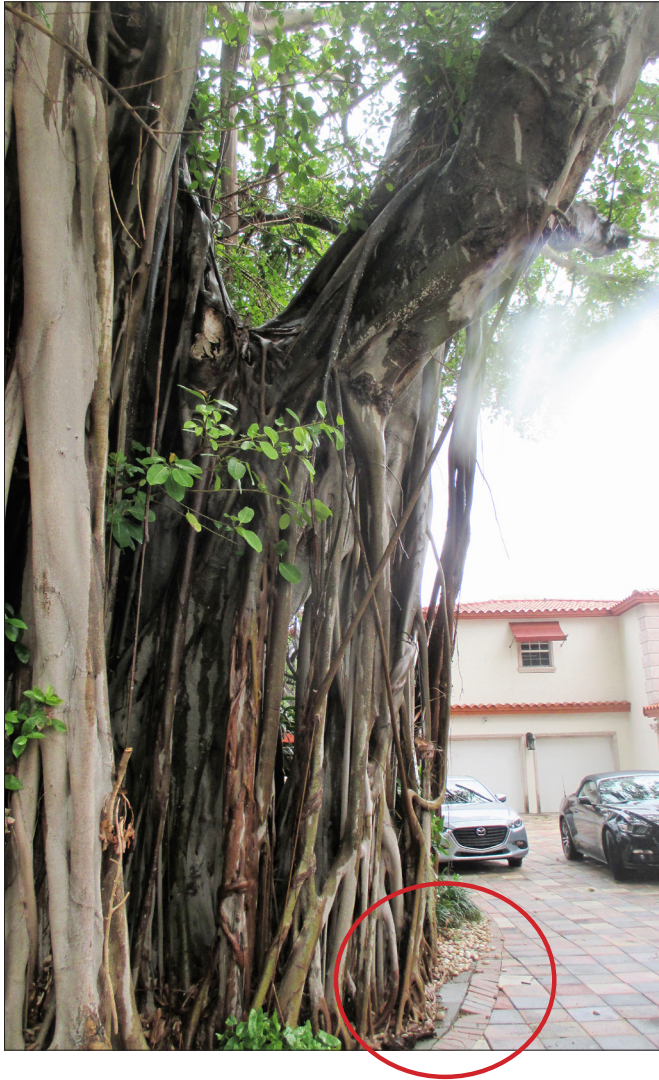
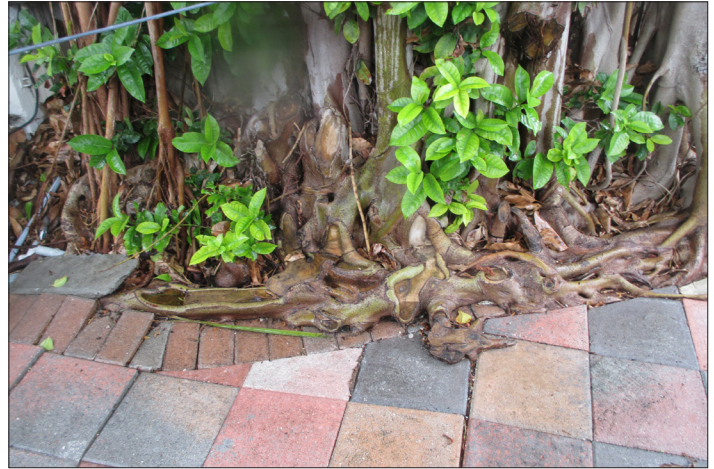
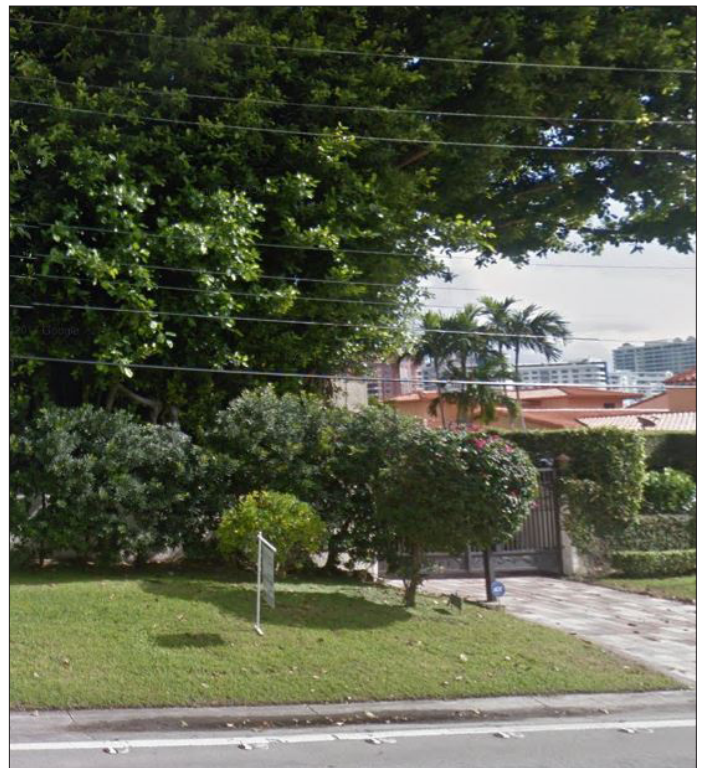
The underground root system is likely extensive, occupying the soil beneath the entire planting bed, the grass area in front of the wall between the two driveways, and much of the paver driveway. The space in the southeast side of the planting bed has been maxed-out, and some of the roots have started to grow over the pavers and beneath the gate. Groundcovers and a fountain occupy the northeastern part of the planting bed.

This tree is to be protected during all construction activities. Installing protective barriers at the dripline is not feasible; instead, protective barriers can be placed around the edge of the existing planting bed and around the grass area in front of the wall between both driveways. The planting bed is approximately 15ft in depth at its widest, and about 45ft long. The grass area is approximately 20ft in depth and about 45ft long. It is recommended that the wall at the front of the property remain as aerial roots have grown down around it and would be negatively impacted by its removal. Removal of the gates, especially the southern one, would also disturb roots, and should be left if feasible. Ideally the existing planting bed depth would be extended towards the house to provide for more rooting space. Installing a new paver driveway set in sand would allow roots to continue to utilize this soil volume.
