November 10, 2017

Re: Report of visit to inspect and verify the structural condition of the residence located at  
7845 Atlantic Way, Miami Beach, FL 33141.

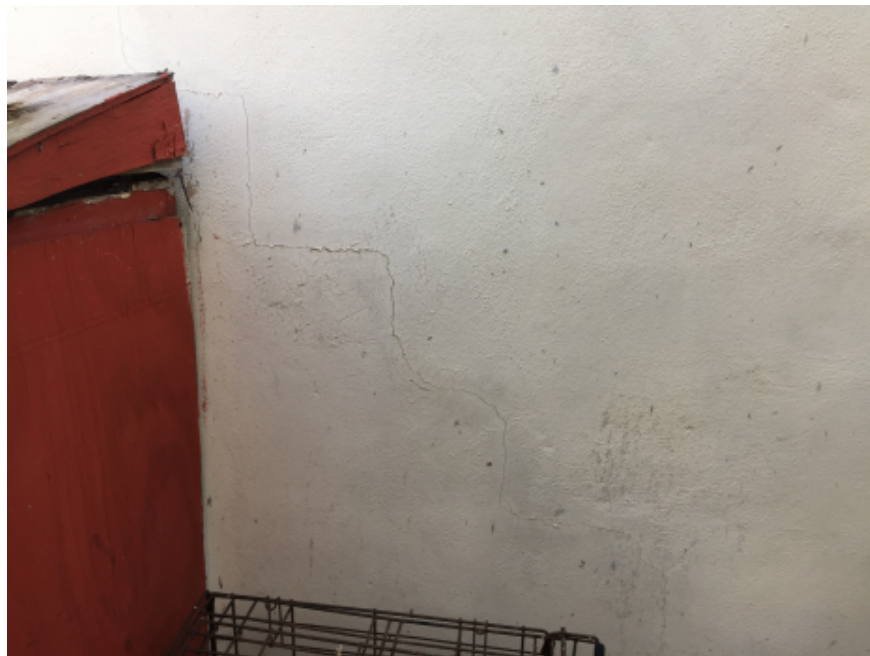
The cracks observed on CMU walls and beams/headers along with the settlement of the ground floor slab are indication of an ongoing process that may be causing differential settlement between the foundations of the load bearing members. The settlement of ground floor slab on compacted fill appears to be due to erosion or to the lost of compaction of the fill, since this residence is located on a flood zone and very close the costal line, what makes that area a very sensitive to the changes on the level of underground water due to either high and low tides or flood.

Photo #1: Step ladder cracks on CMU wall at West side of residence

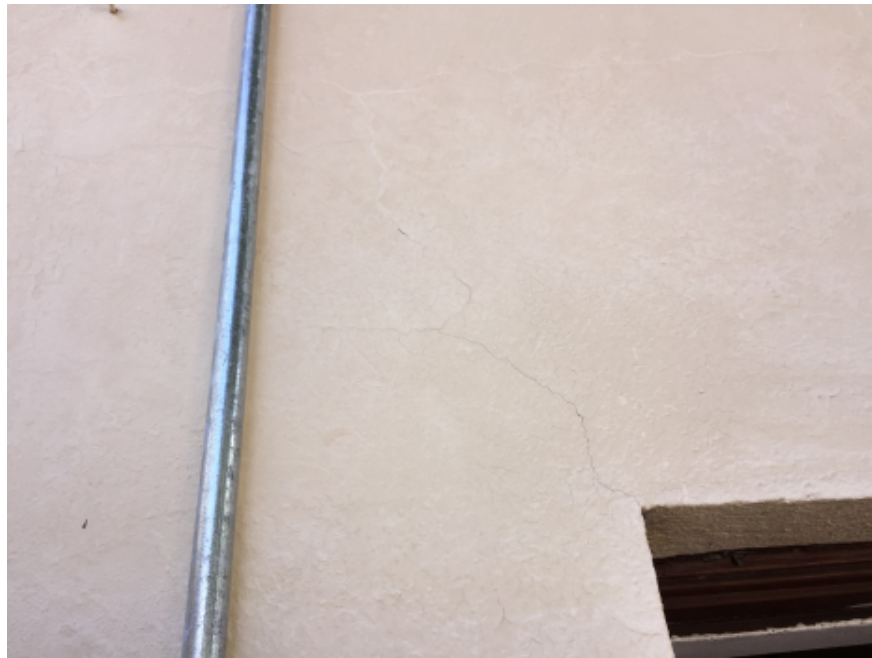
Photo #2: Crack at upper left corner of window opening at West side of residence

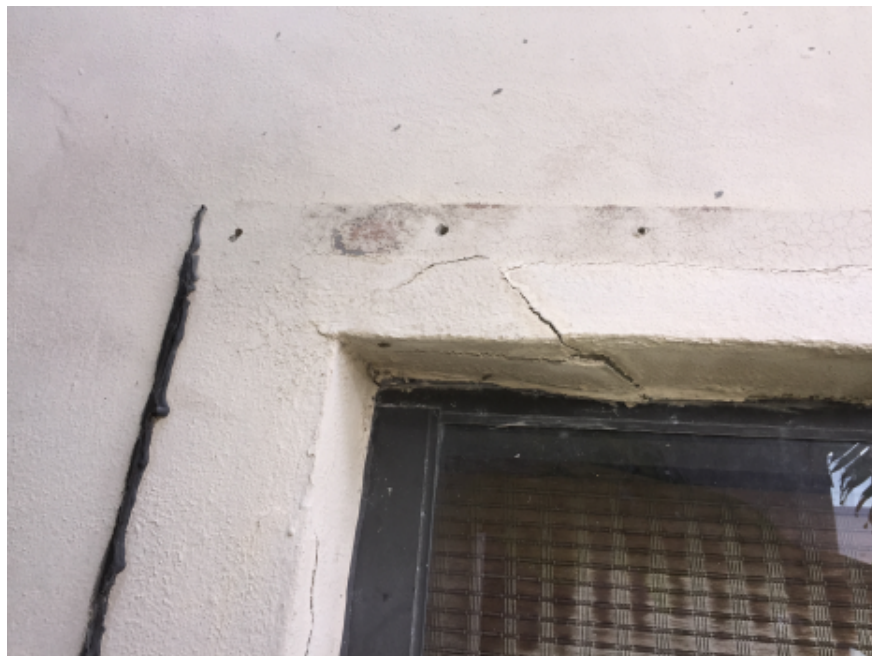
The lost of cover for reinforcement of the second floor and the headers with spalled and unbound concrete at bottom are a clear signs of an ongoing corrosion process that is affecting the structure and even though we can see the exposed reinforcing bars only at some locations, it is known that when this happens is because the corrosion is already extensive.

Photo #3: Header showing big cracks and spalled concrete at upper left corner

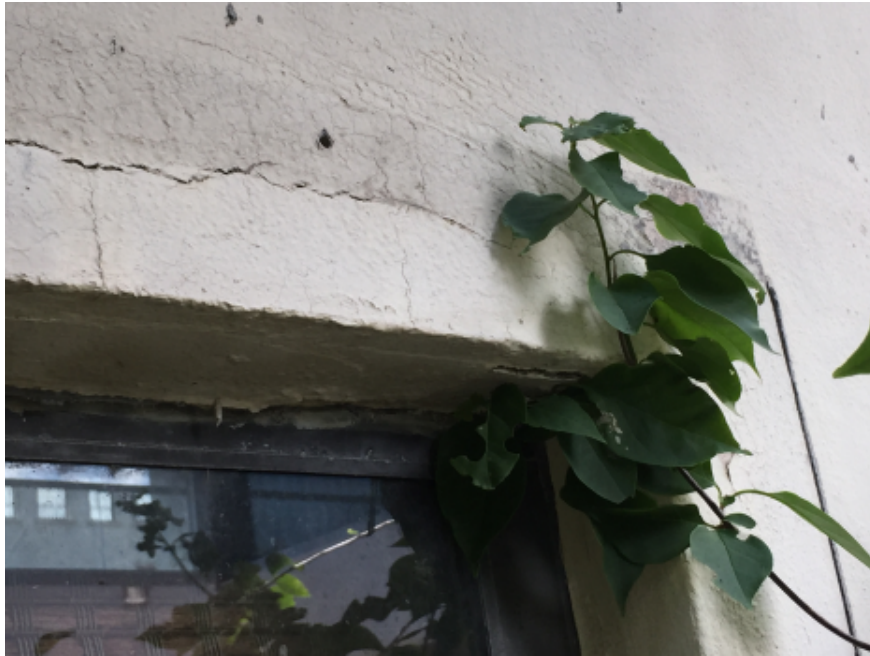
Photo #4: Header showing big cracks and spalled concrete at upper right corner

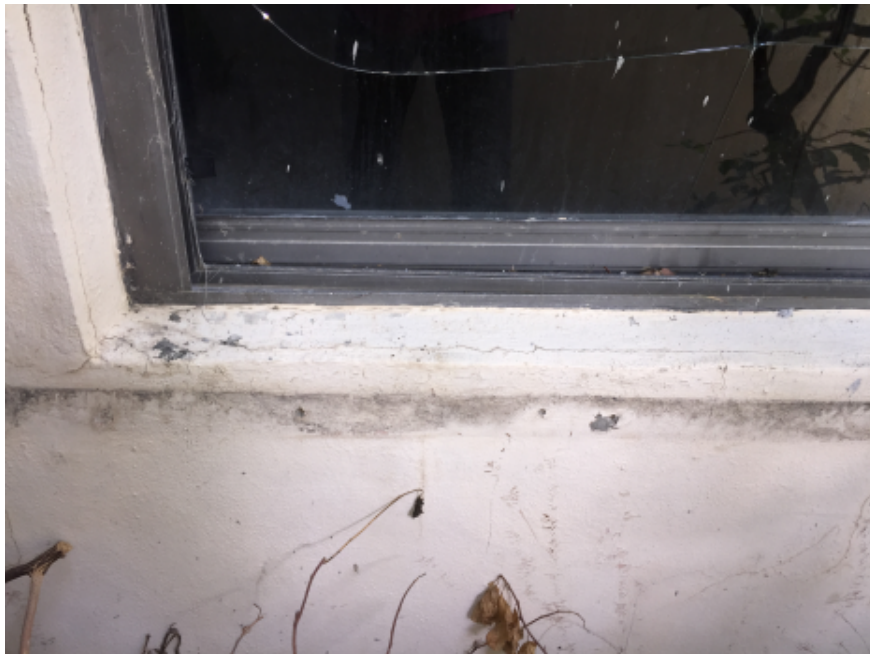
Photo #5: Cracks at sill and jamb of window opening

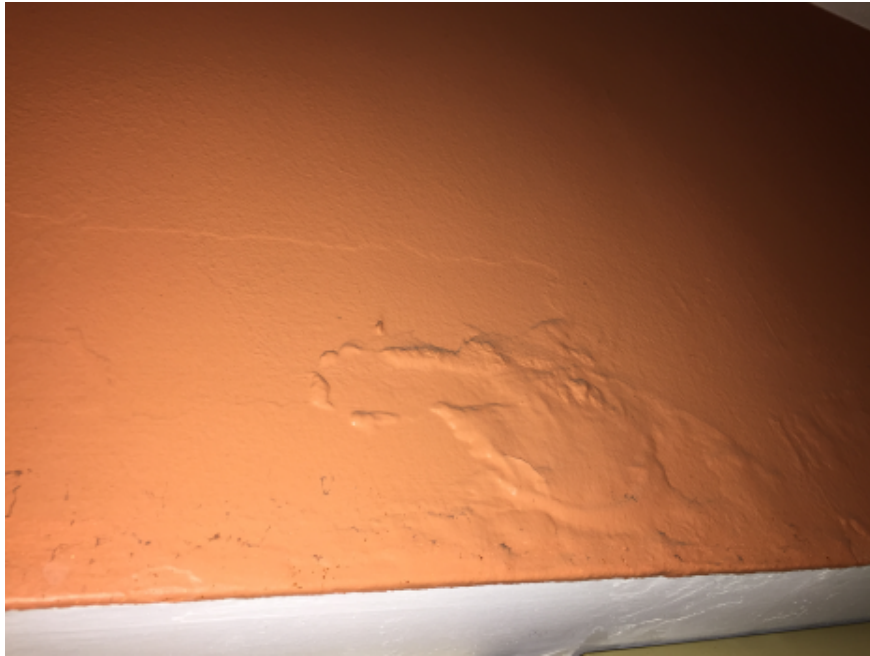
Photo #6: Water blisters at interior side of envelope walls. Evidence of water intrusion.

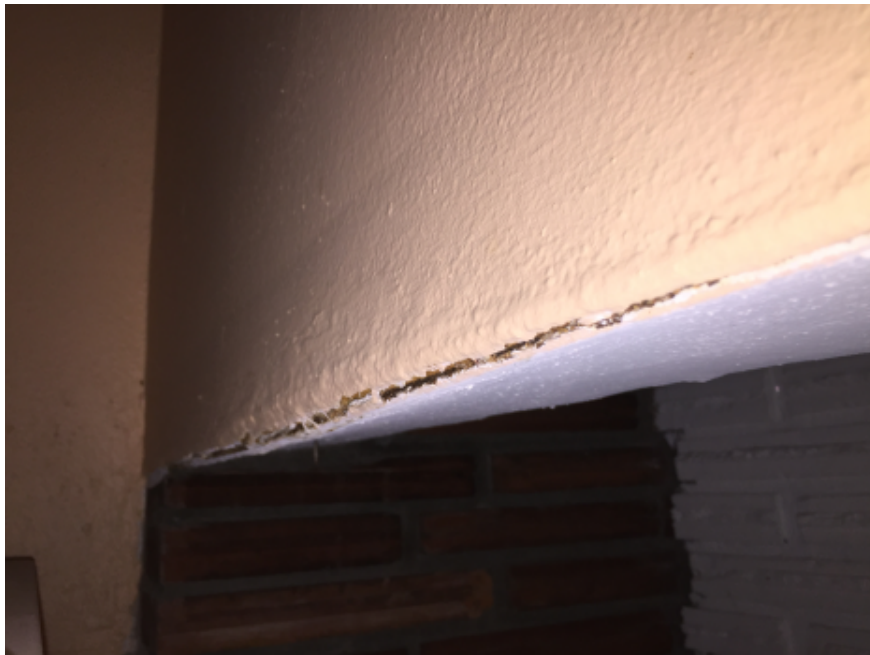
Photo #7: Interior header showing damaged finishing from possible structural damage.

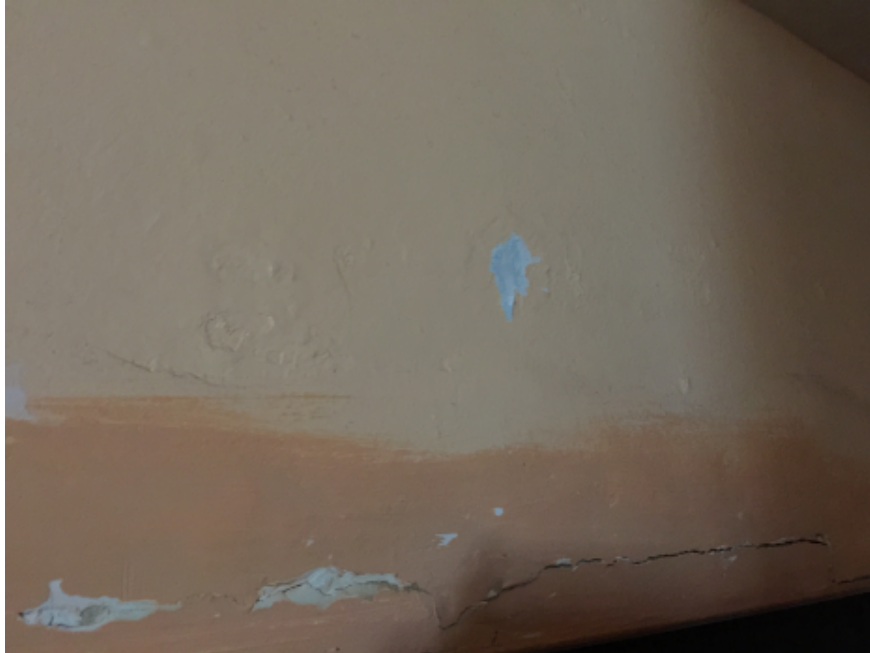
Photo #8: Interior header showing damaged finishing from possible structural damage.

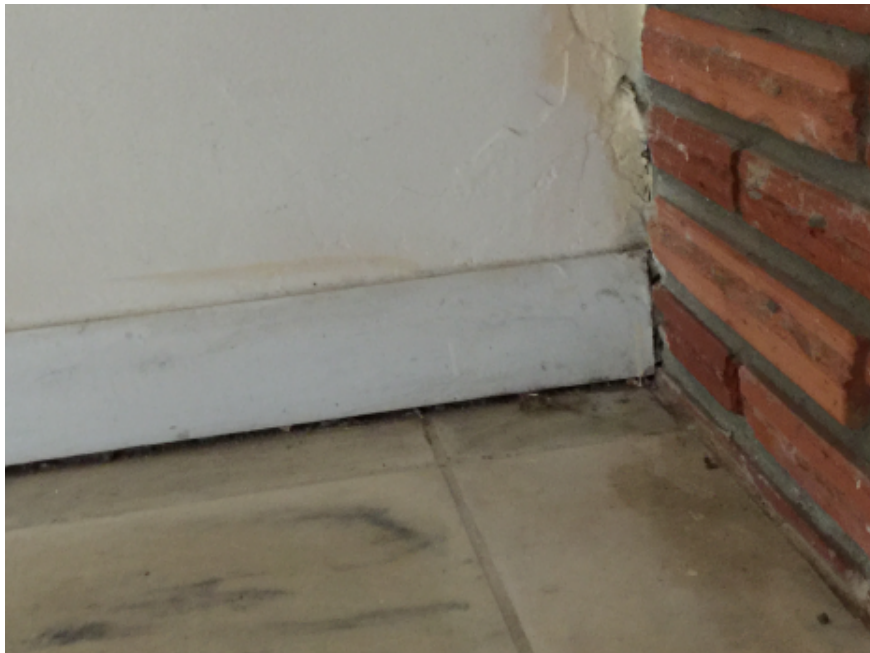
Photo #8: Gap between base board and top of finished floor is indicative of ground floor slab settlement.

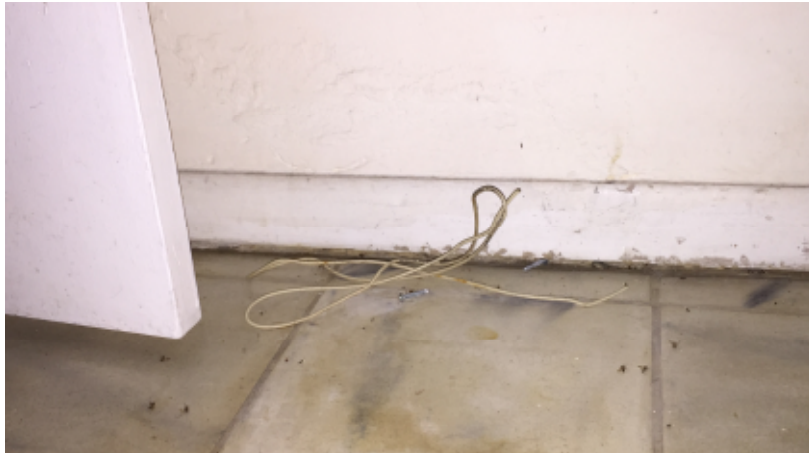
Photo #9: Gap between base board and top of finished floor is indicative of ground floor slab settlement.

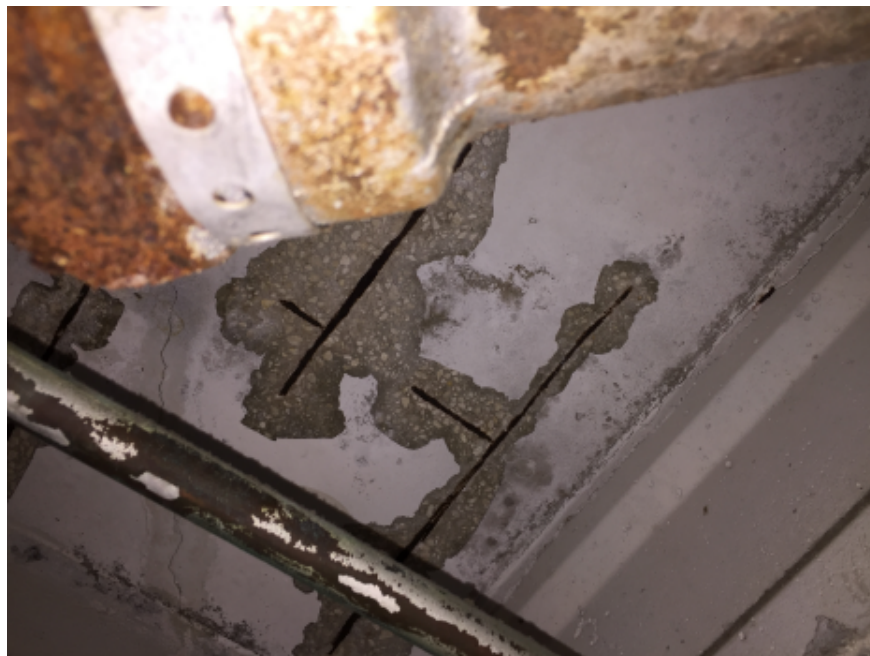
Photo #10: Concrete spalled and exposed bottom reinforcement of 2<sup>nd</sup> floor slab due to corrosion.

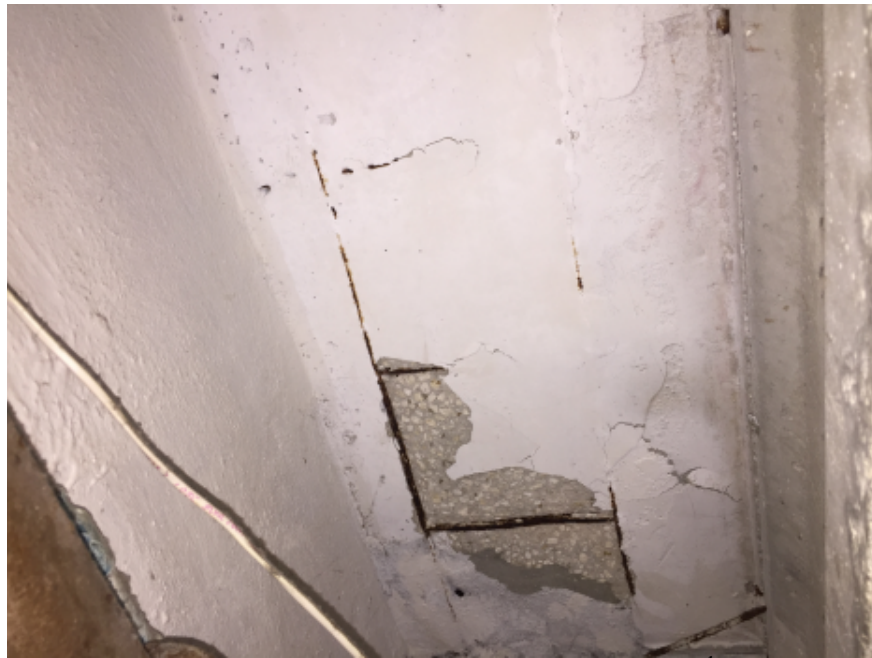
Photo #11: Concrete spalled and exposed bottom reinforcement of 2<sup>nd</sup> floor slab due to corrosion.

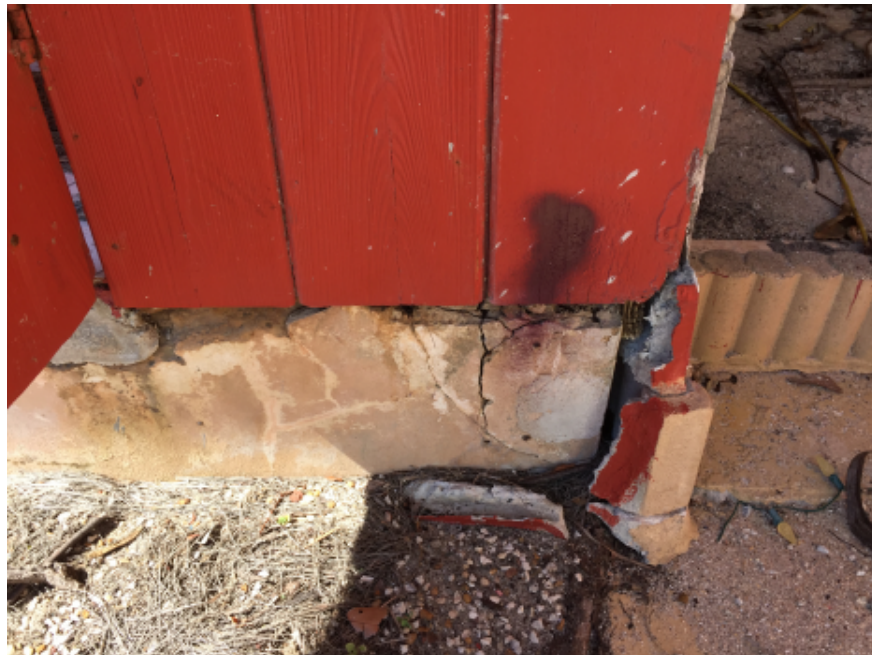
Photo #12: Spalled concrete at top of stem wall. Indicative of corrosion process.

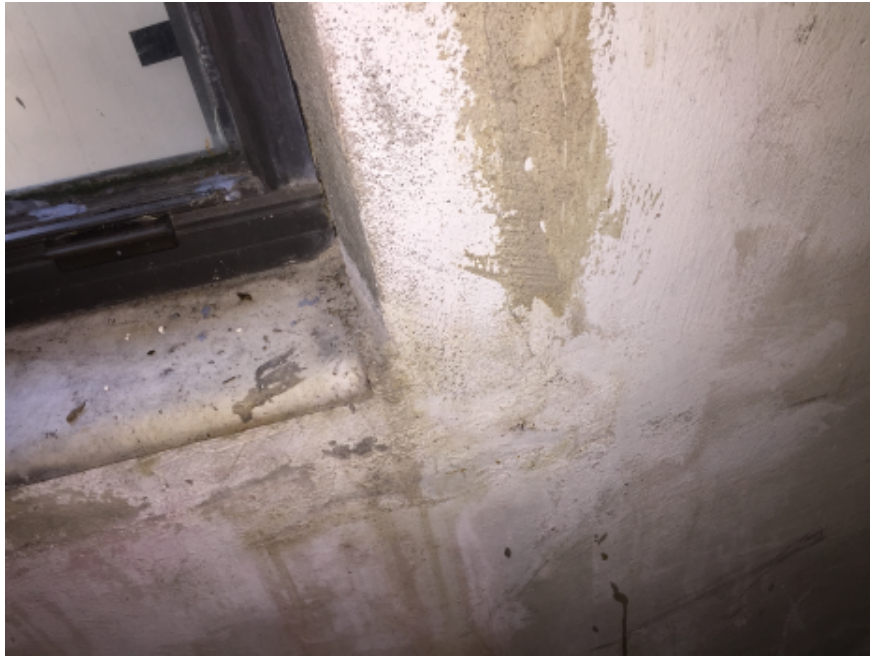
Photo #13: Patching from previous repair work.

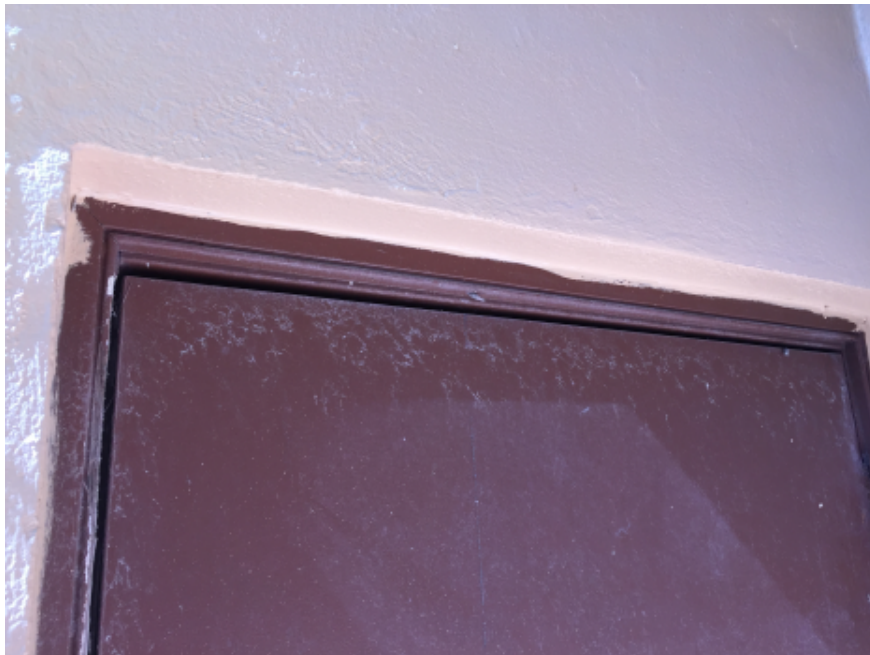
Photo #14: Uneven top and jambs of door plus difficulty to operate are signs of differential settlement.

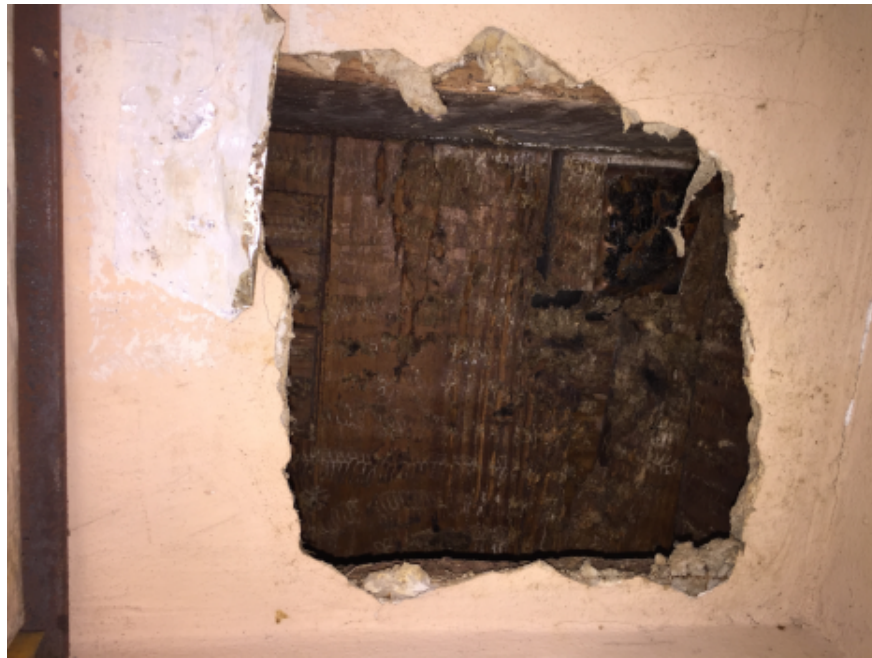
Photo #15: Roof sheathing with signs of water intrusion.

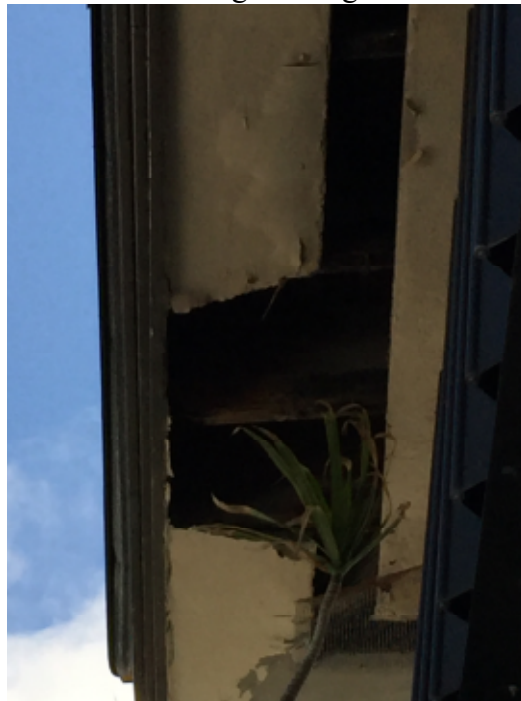
Photo #16: Roof overhang with signs of water intrusion and deterioration at tip of framing members.

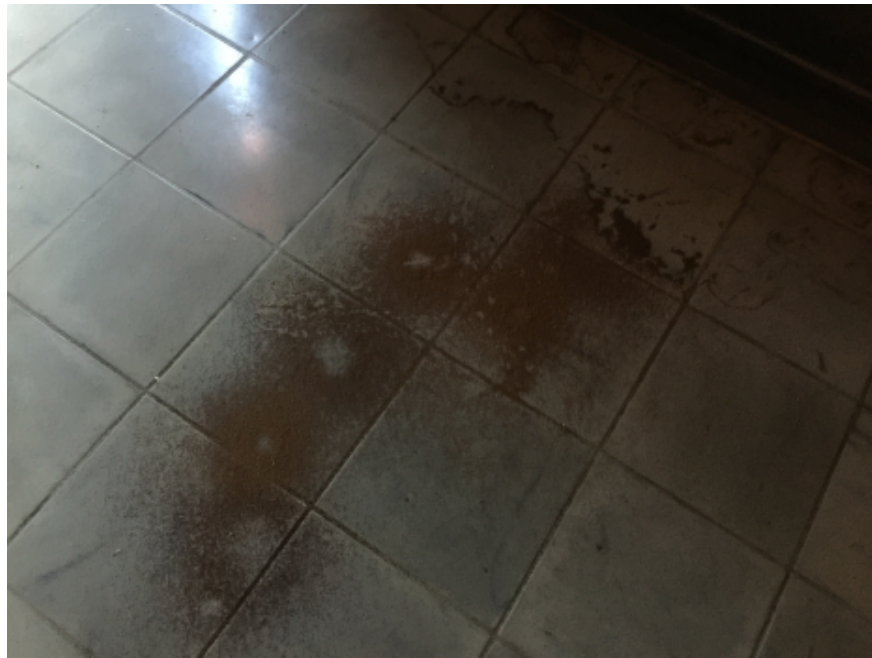
The photos attached to this report show the decay of wood structure and wood finish as well as some wood cabinets. It is evident that the wood structure is infected either by termites or by wood worms which compromises the structural integrity of the residence.

Photo #17: Wood residues at floor. Sign of insects activity.
