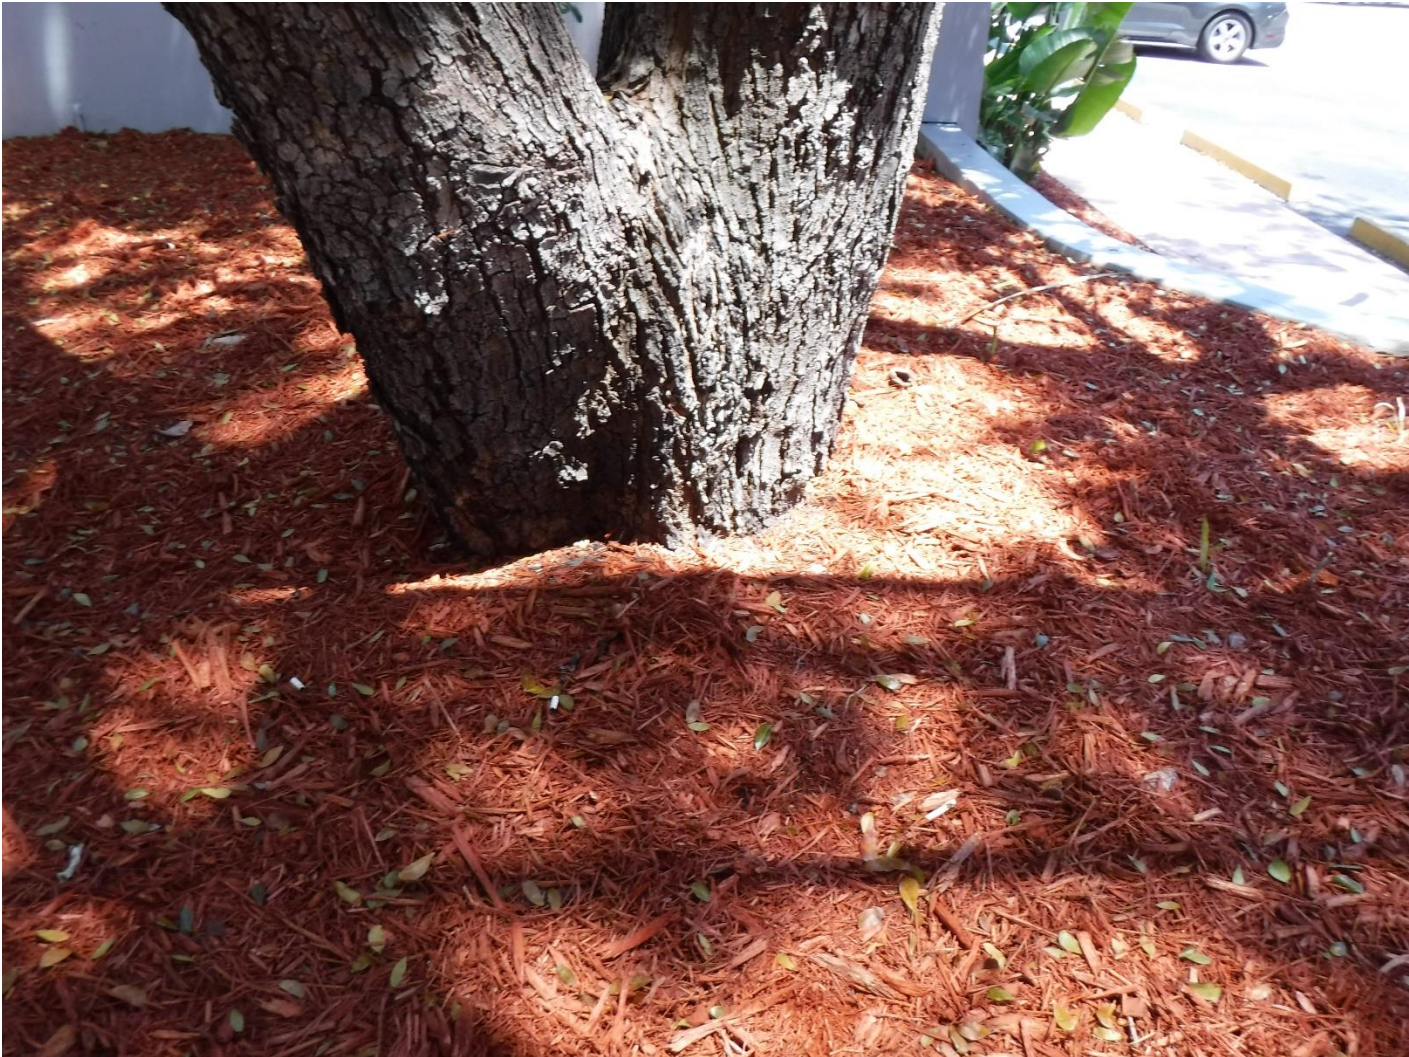
**Buried root collar of tree # 20**

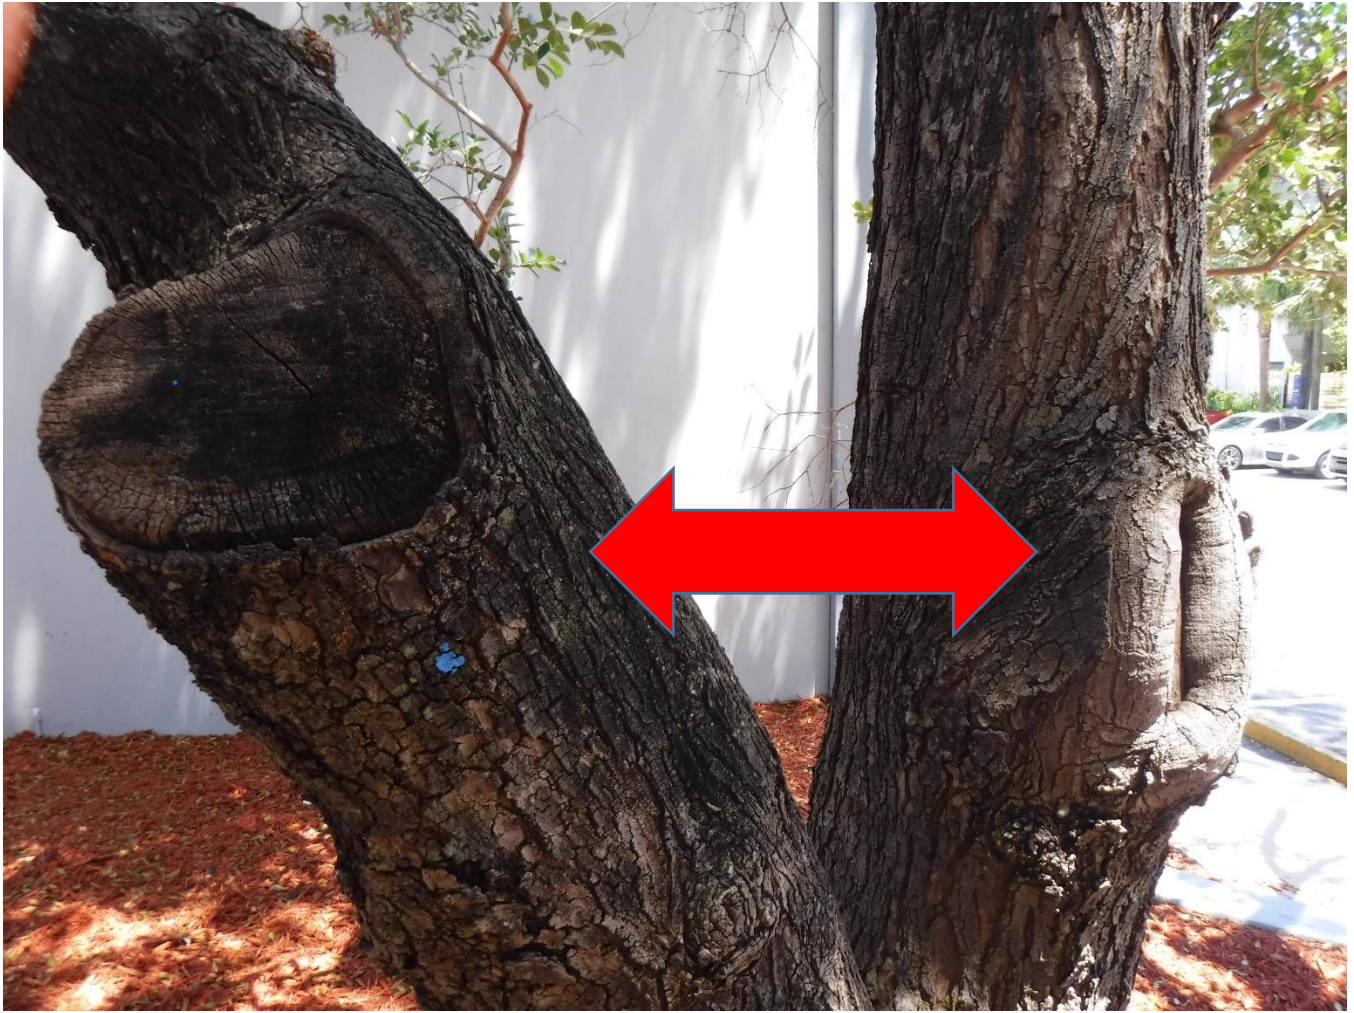
**Large pruning wounds on tree # 20**

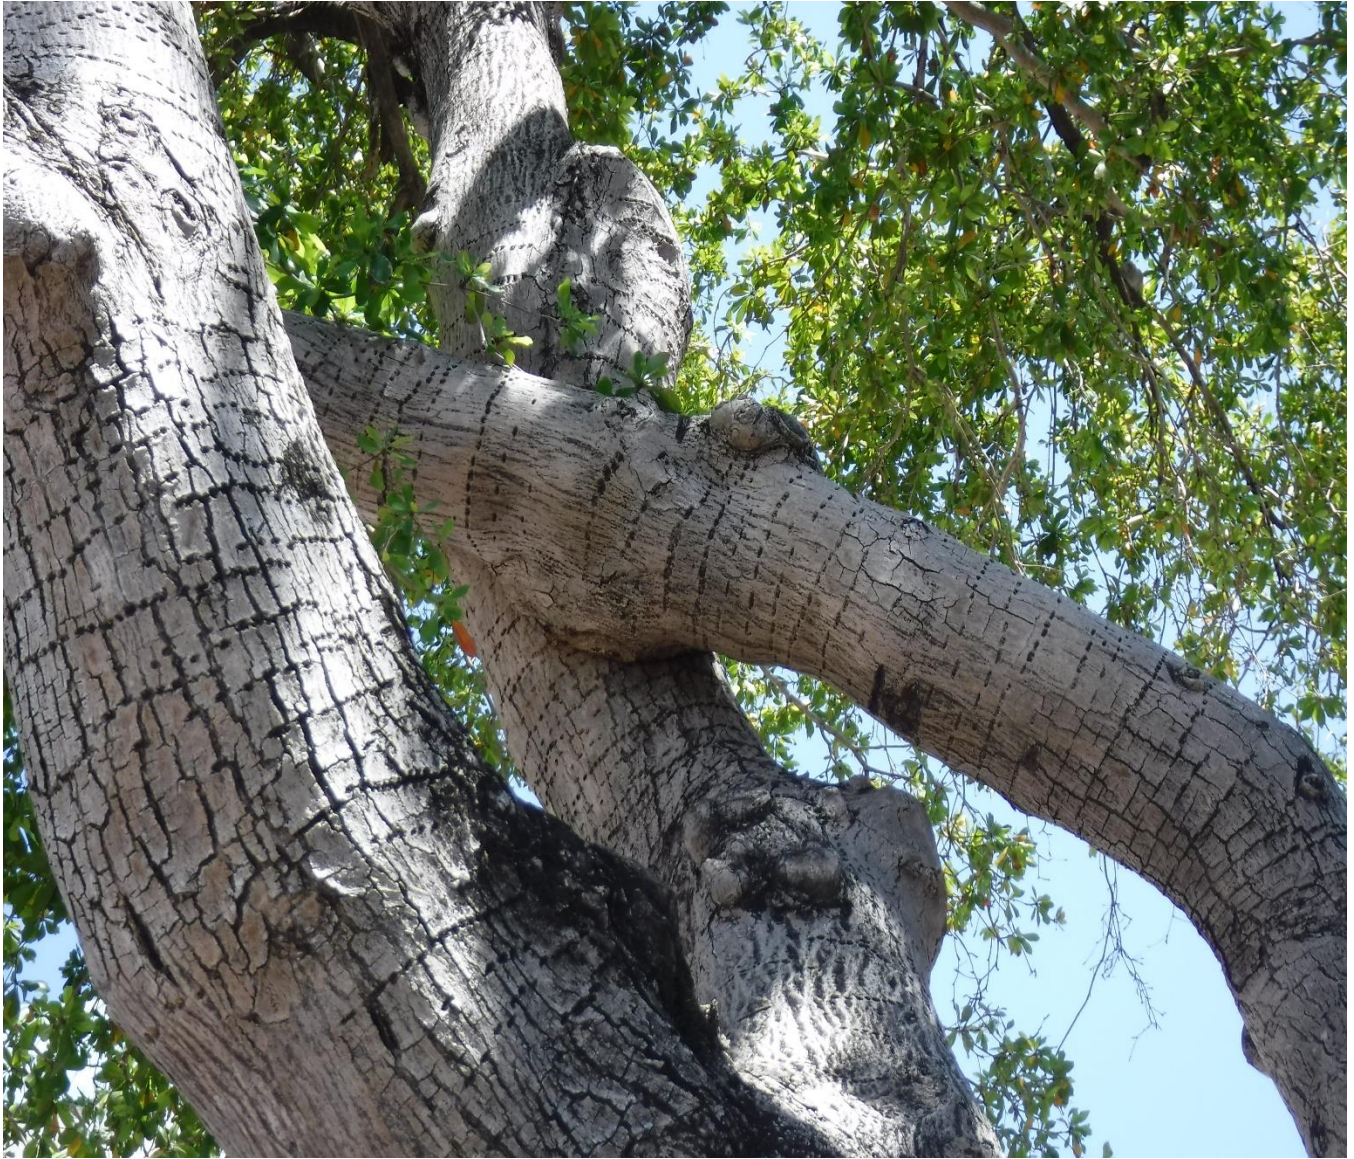
**Rubbing limbs in tree #34**

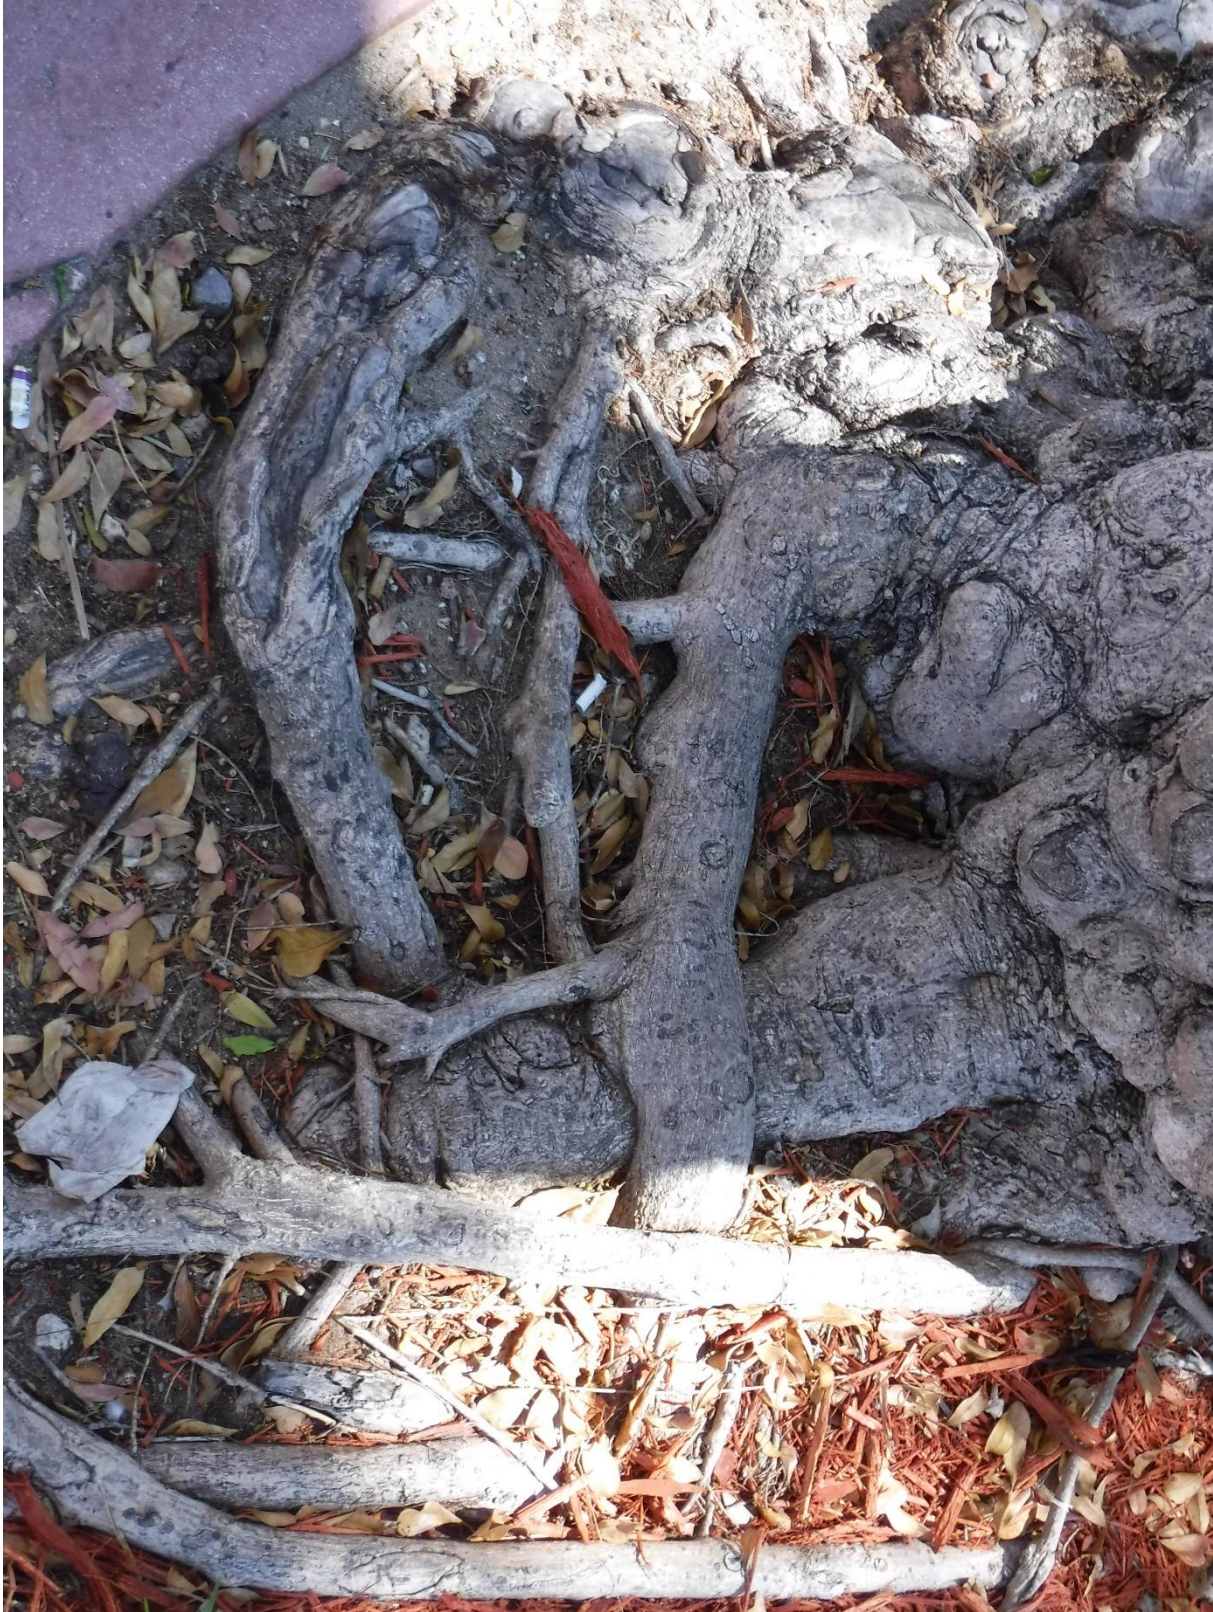
**Girdling roots on tree # 34**

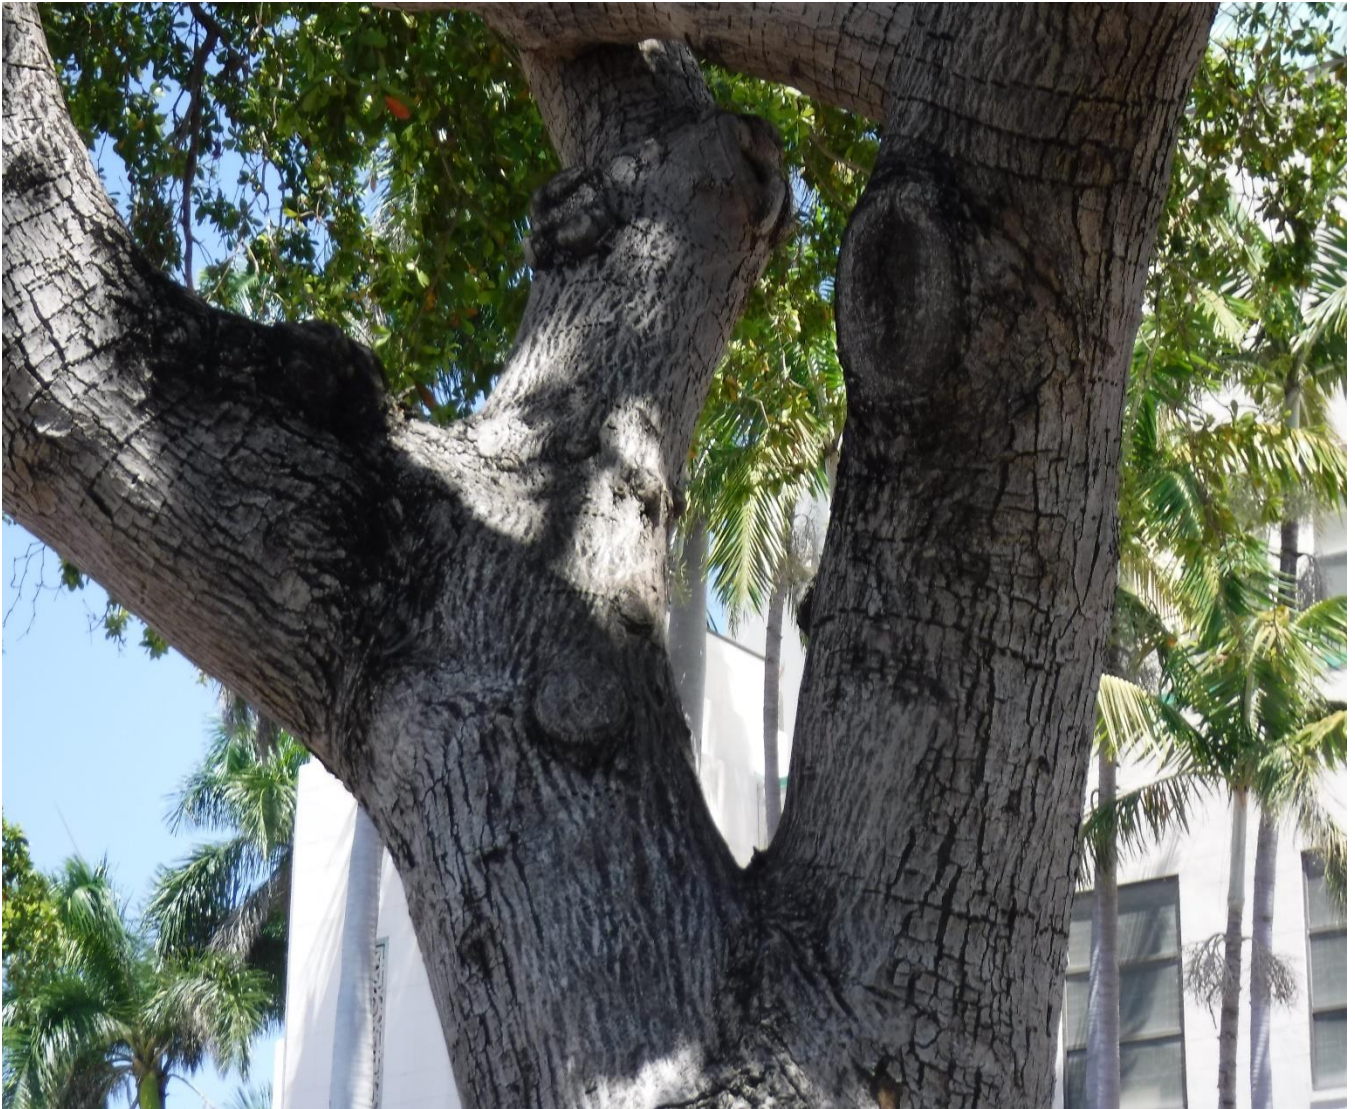
**Codominant stems on tree # 34**

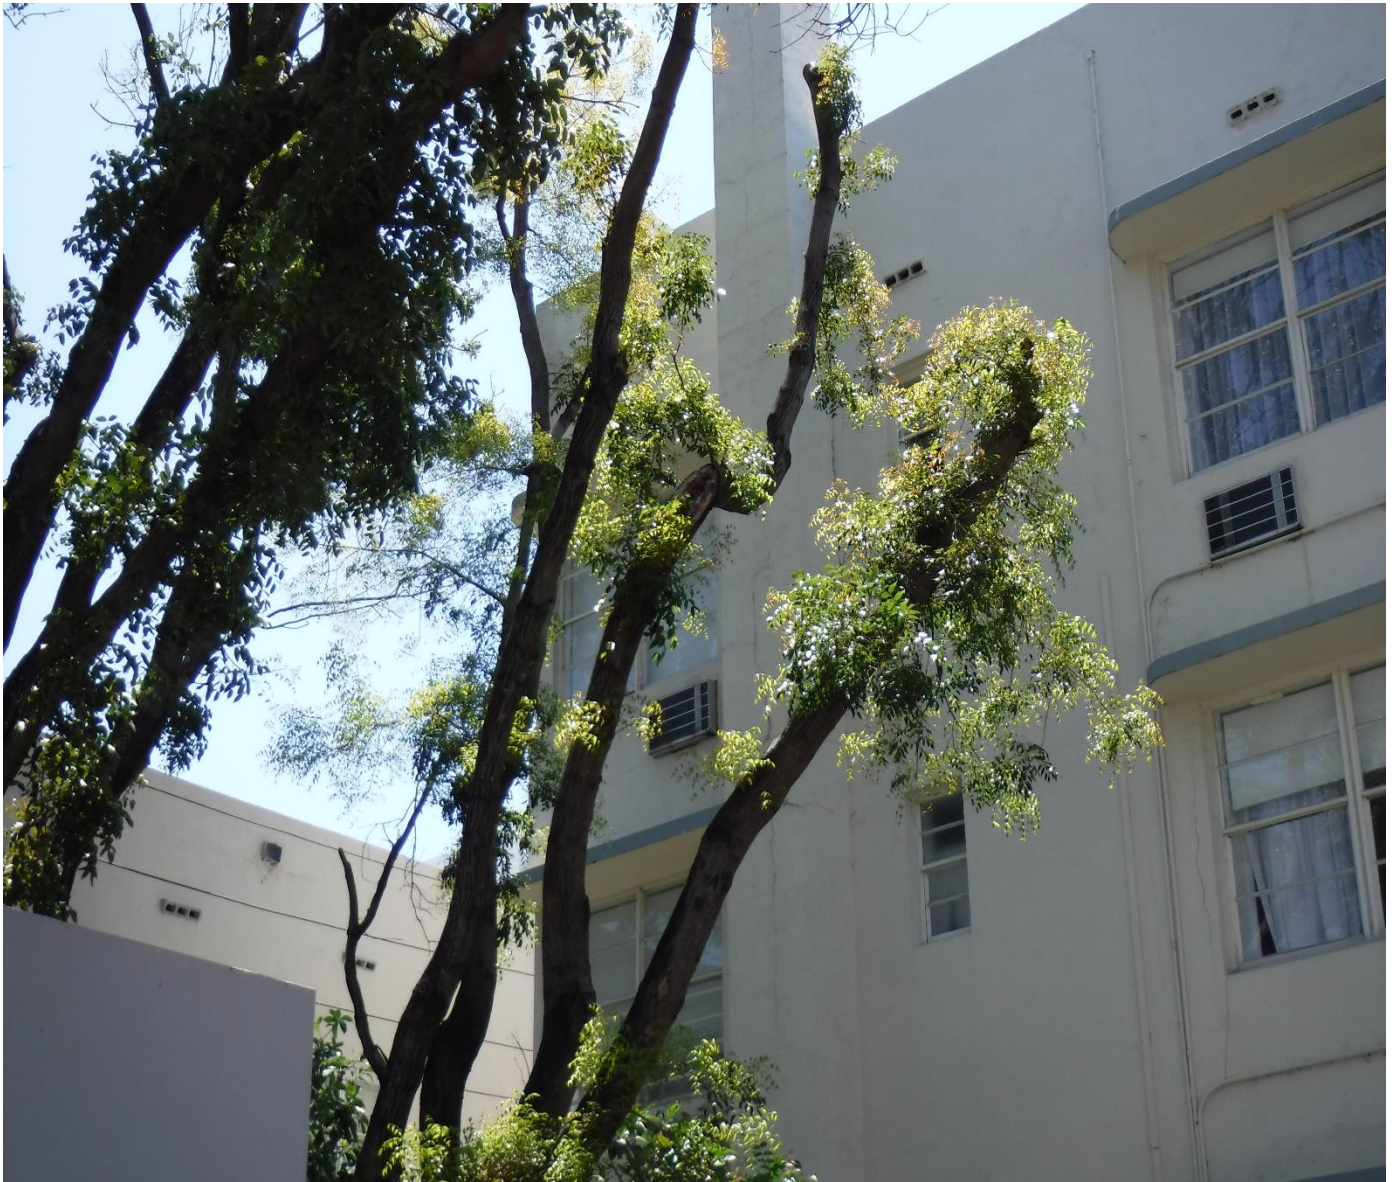
**View of topping cuts on tree # 39**

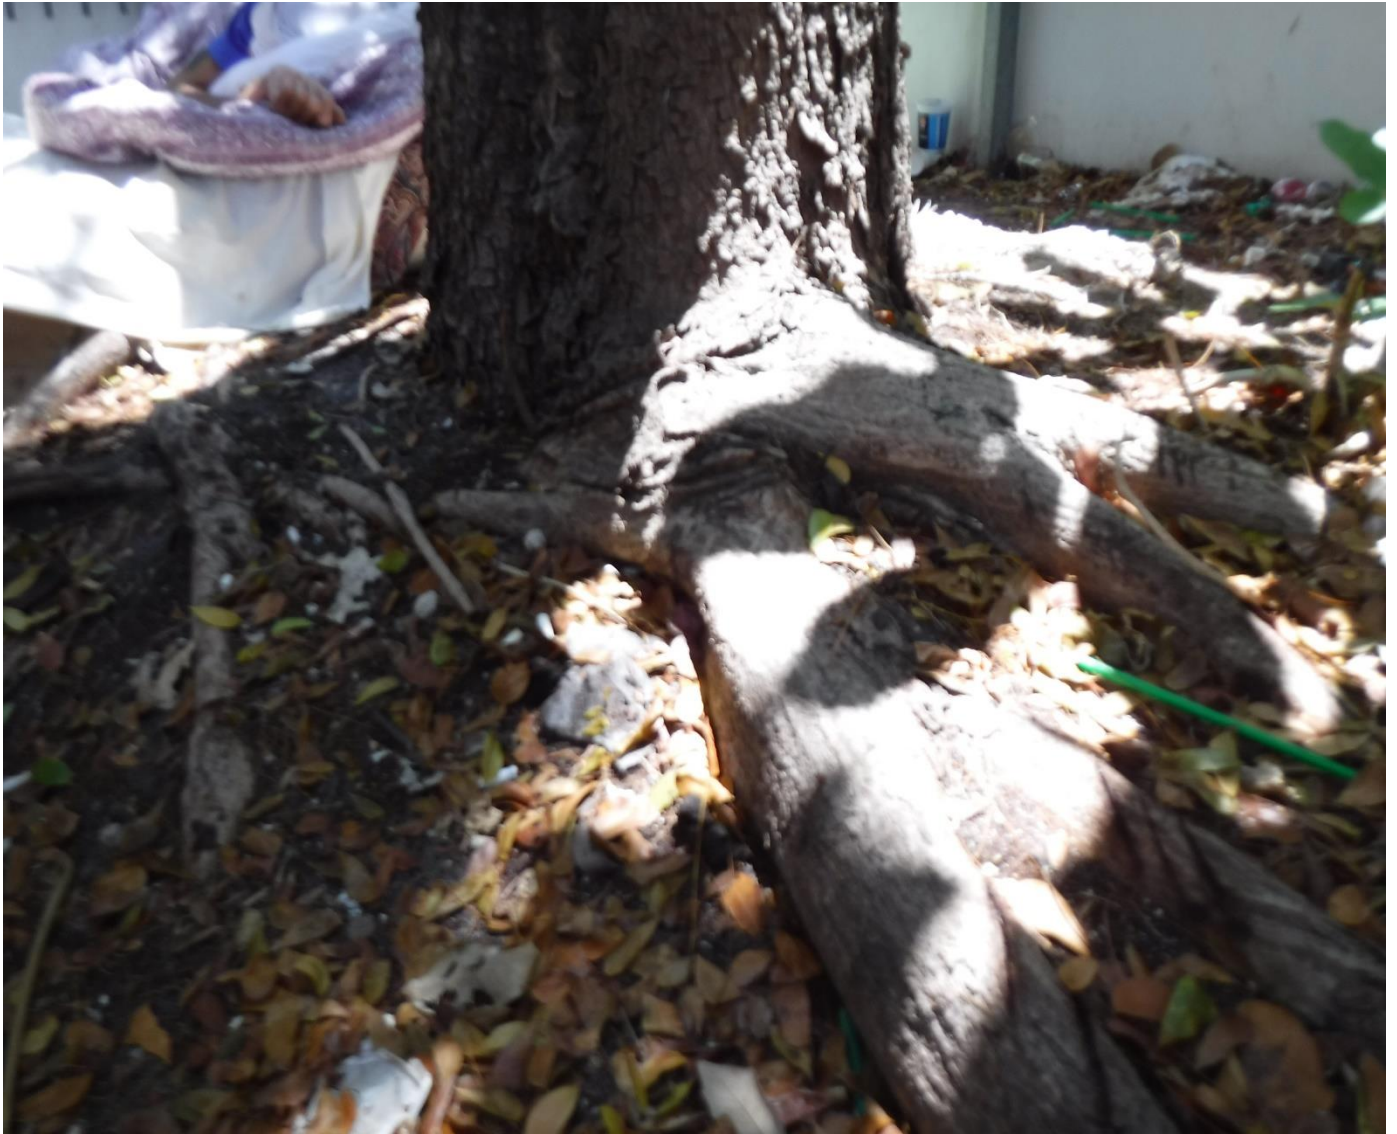
**Girdling roots on tree # 39**

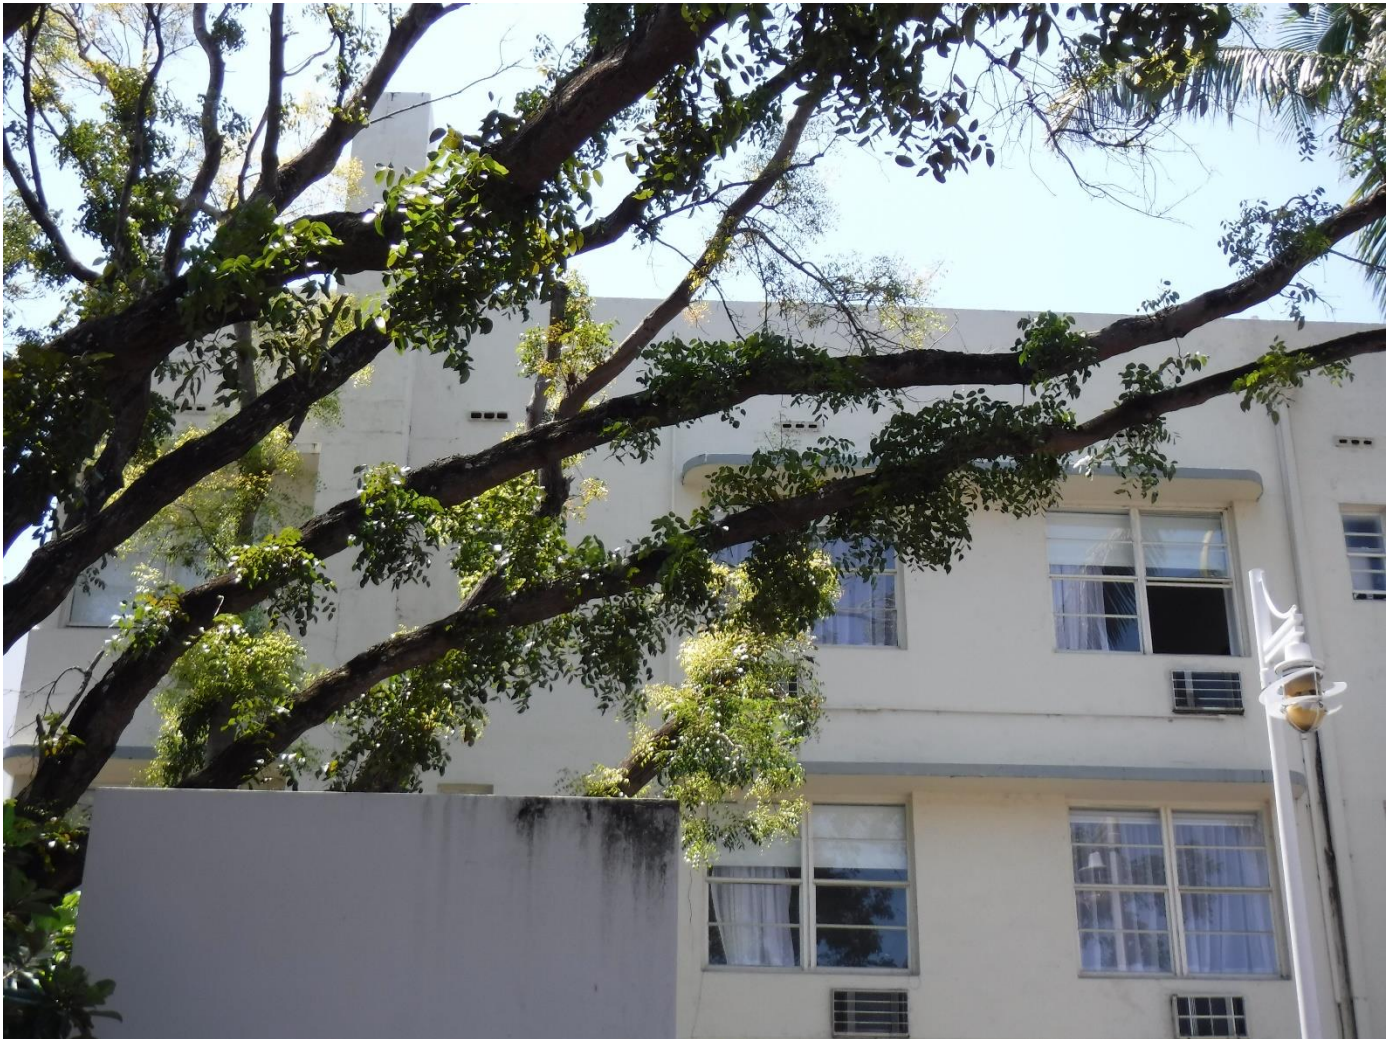
**Overextended branches on west side of tree # 40**

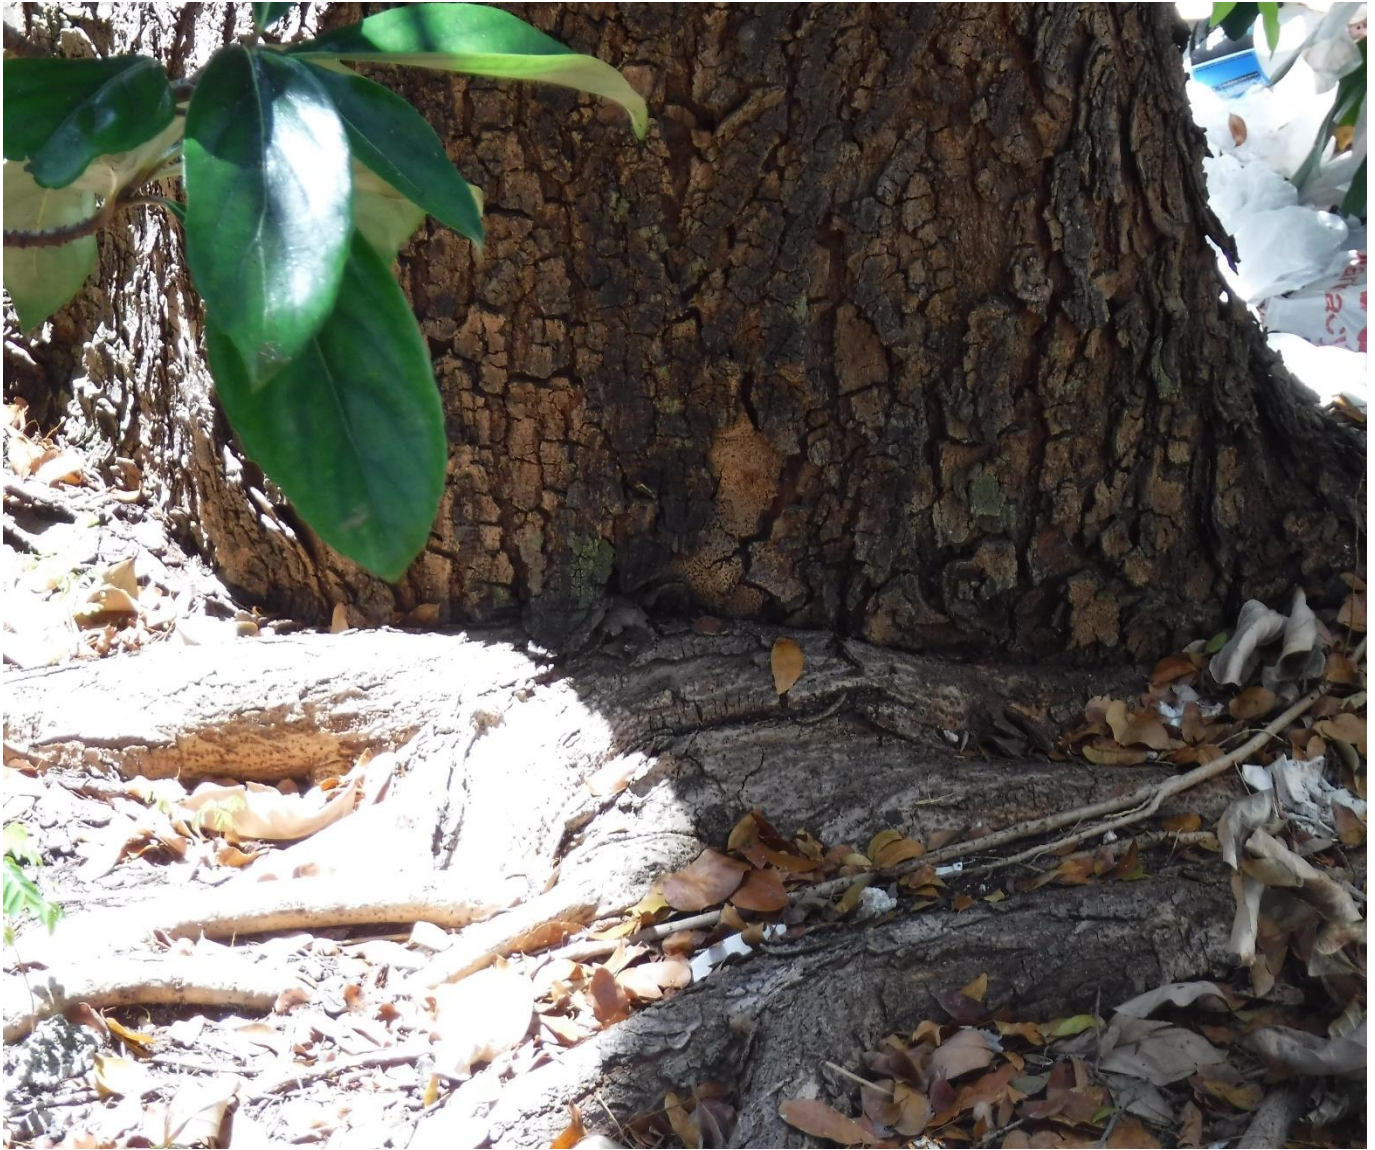
**Severe girdling roots around tree # 40**

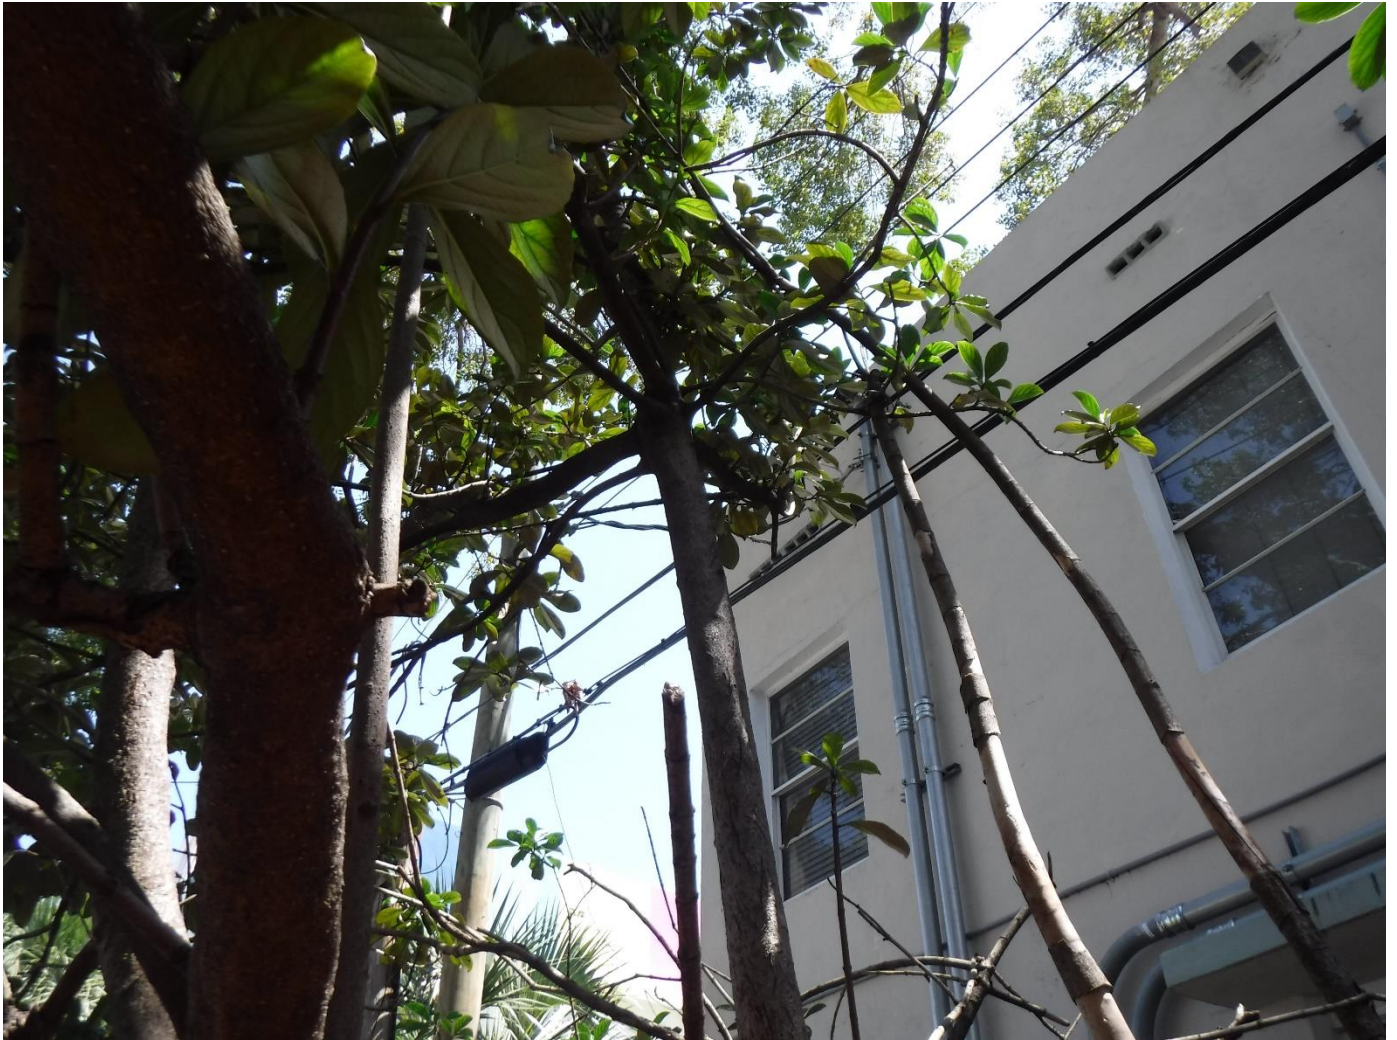
**Tree # 41 growing into overhead wires**

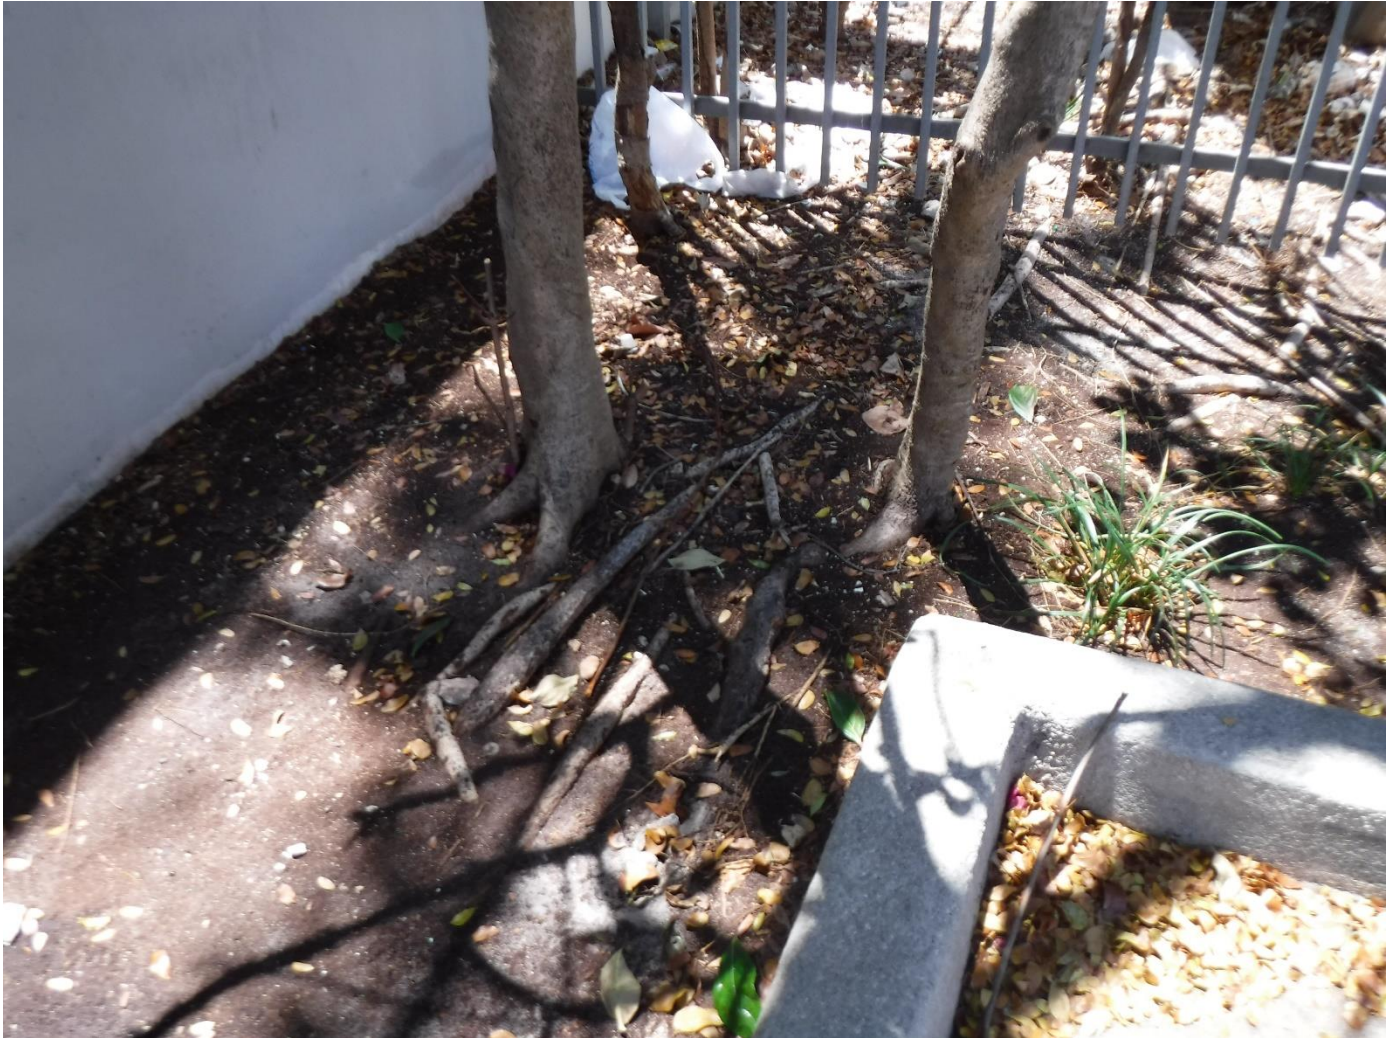
**Girdling roots around tree # 41**
