City of Miami Beach- Historic City Hall- Visual Roof Inspection- 2018

Historic City Hall
1130 Washington Avenue
Miami Beach, FL 33139

Roof Inspection Photos January 2018*

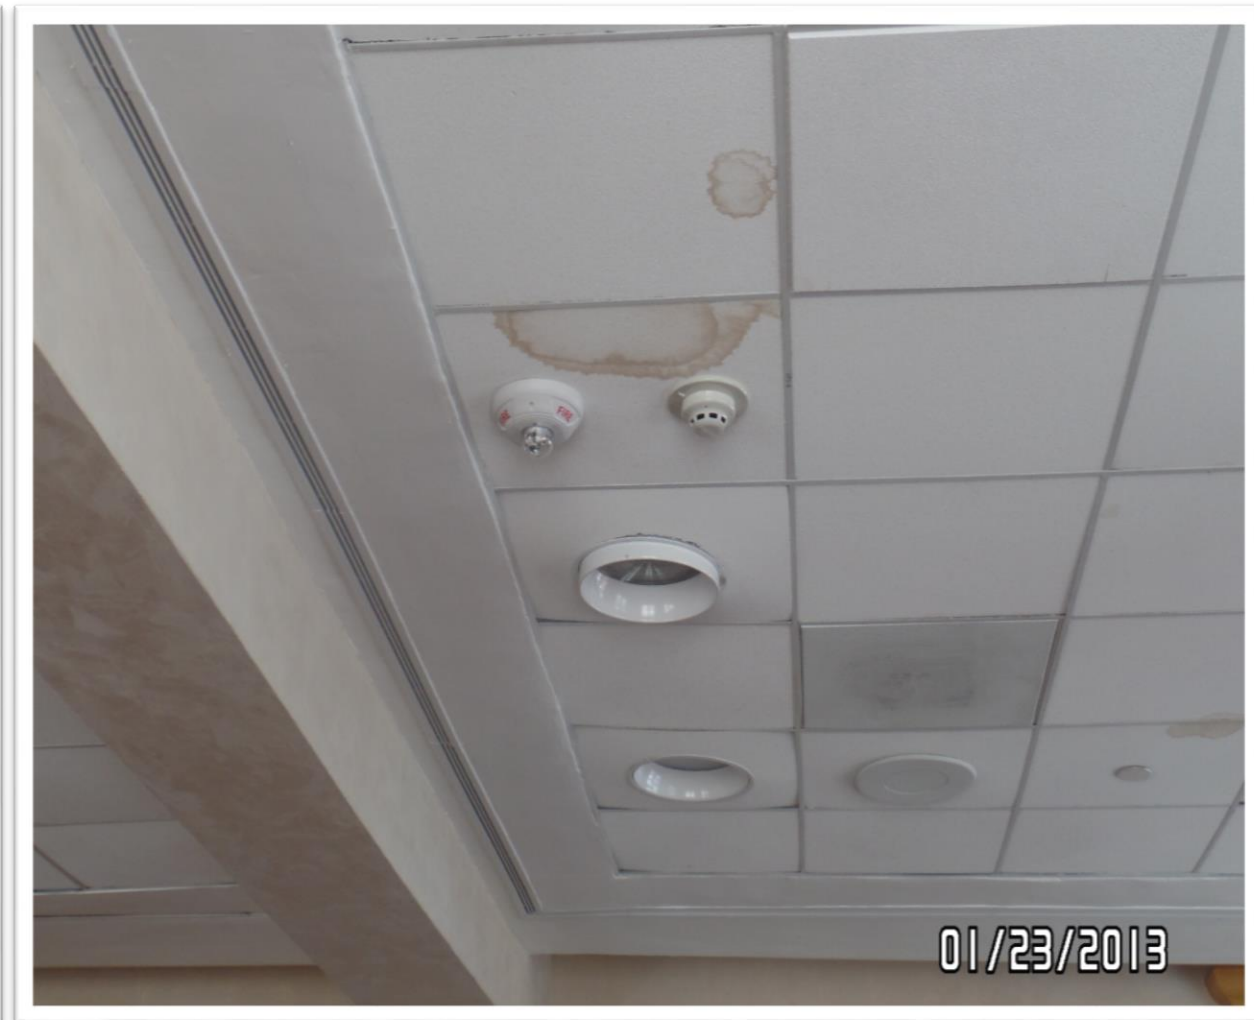
Our inspector was escorted to both the Courtroom 2-1 and an area that serves as a wedding chapel. Stained ceiling tiles were observed both in the courtroom and the chapel area (photos #4- #8). After looking at active leak sites, our inspector was taken up to the roof over the courtroom. The roof section over the courtroom is comprised of both a modified bitumen system and an equipment room that has a barrel tile roof.

4. LEAK IN CEILING_1 IN COURTROOM 2-1

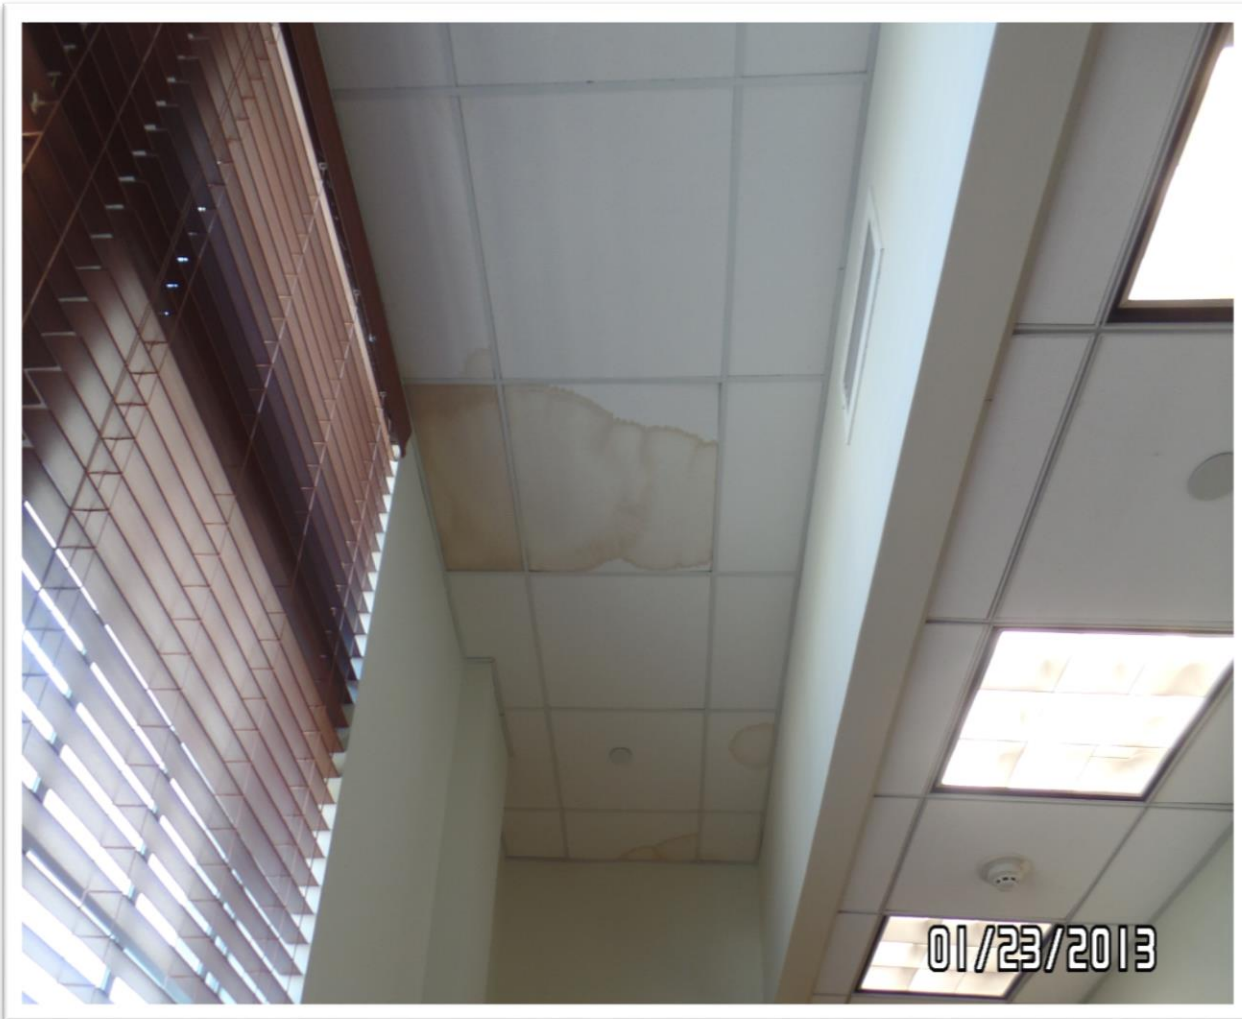
5. LEAK IN CEILING_2 OVER MARRIAGE CHAPEL

The entire barrel tile system should be repaired with closely matching tile. All cracked, split, chipped, and missing tile should be replaced. The area over the breakroom and chapel must be more carefully examined and repaired along the edge of the mansard.

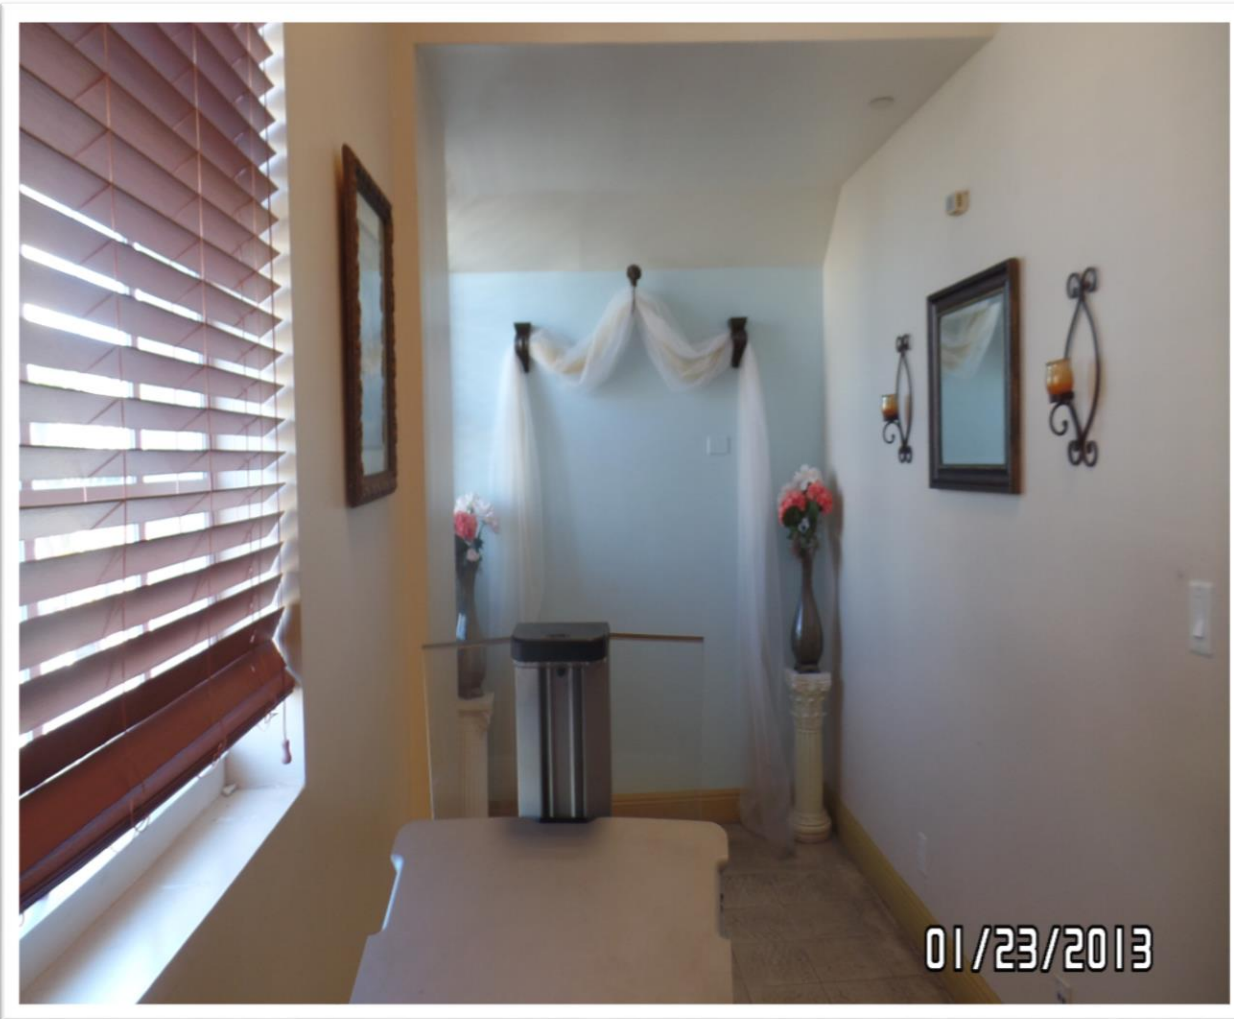
6. LEAK IN CEILING OVER CHAPEL

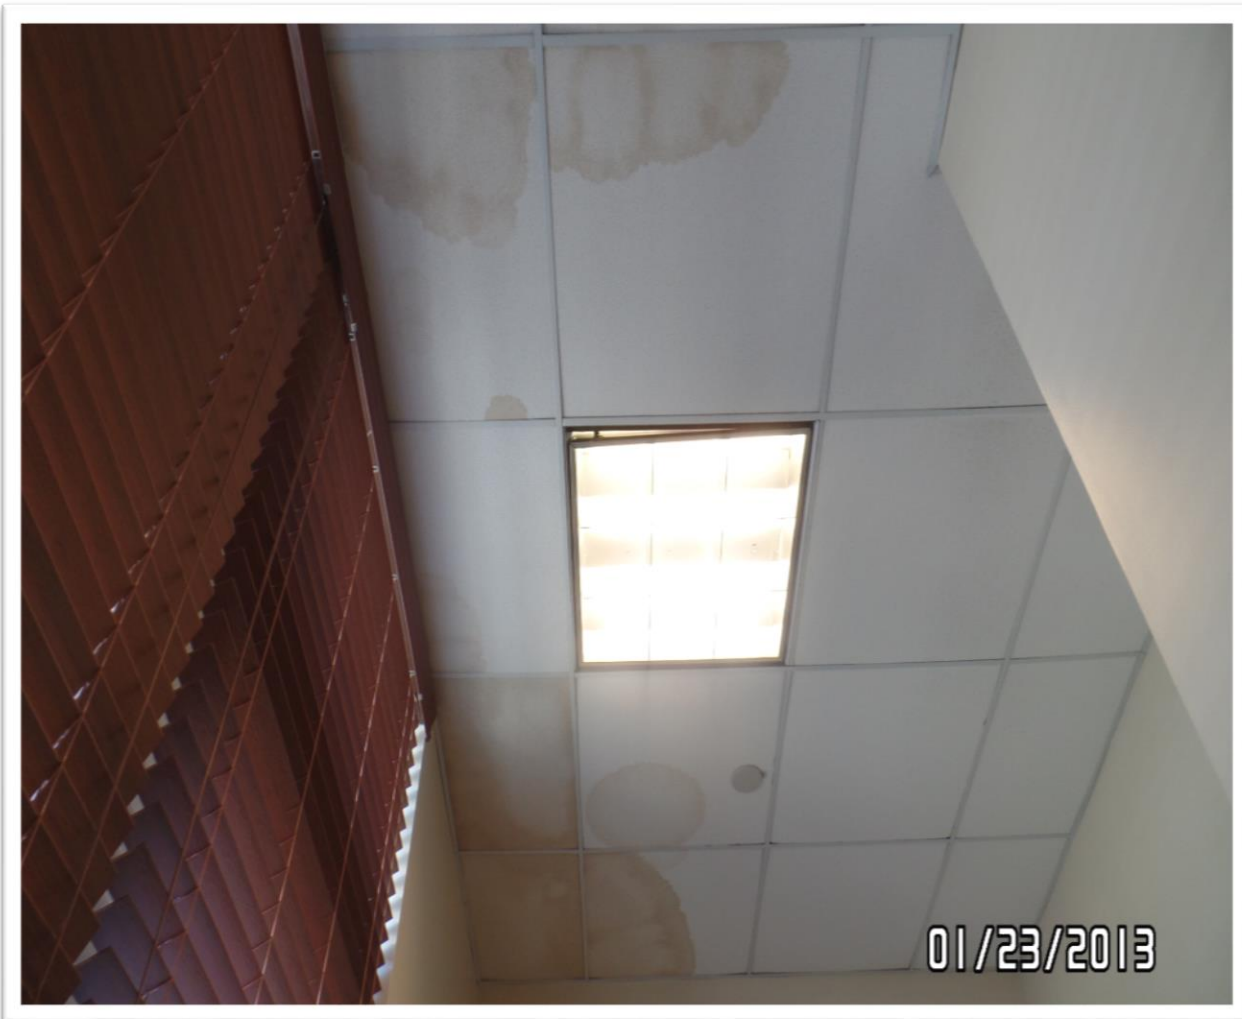
7. LEAK IN CEILING_3 OVER CHAPEL AT THE FRONT OF THE BUILDING

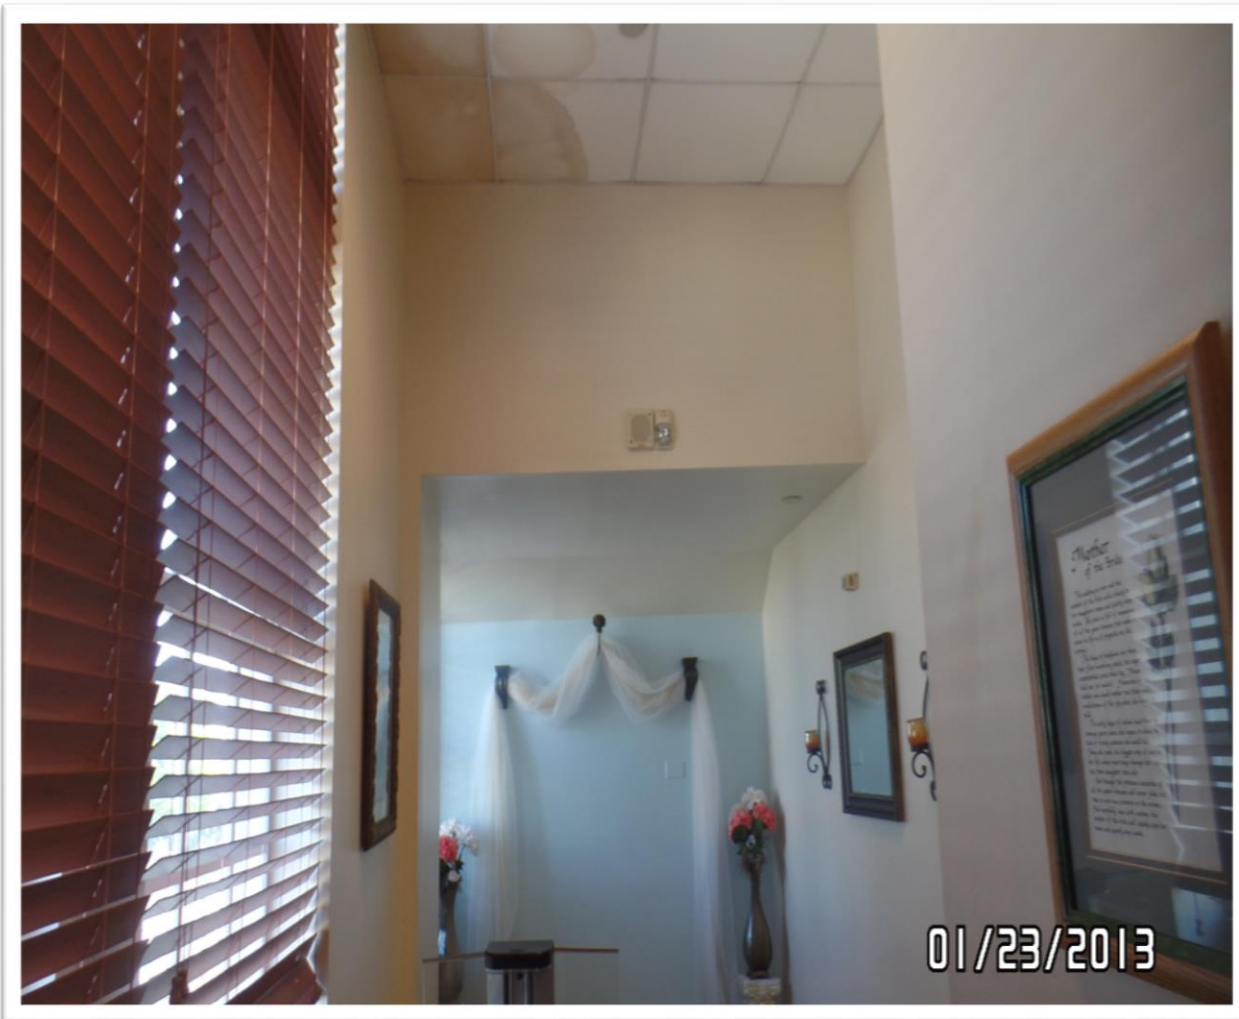
8. LEAK IN CEILING_4 AT MARRIAGE CHAPEL

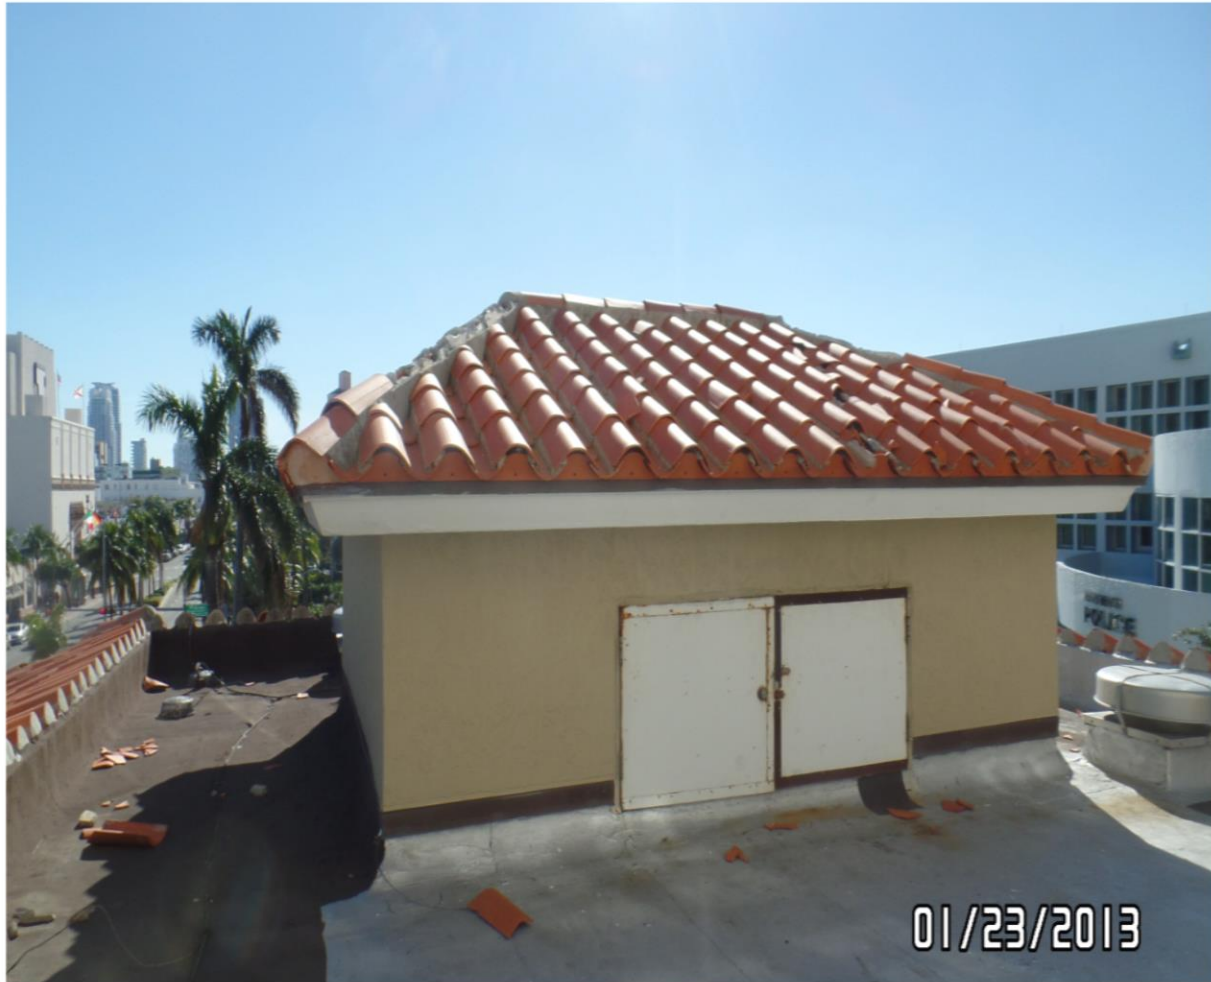
9. MISSING RIDGE TILES
ON CENTER PENTHOUSE OVER COURTROOM 2-1

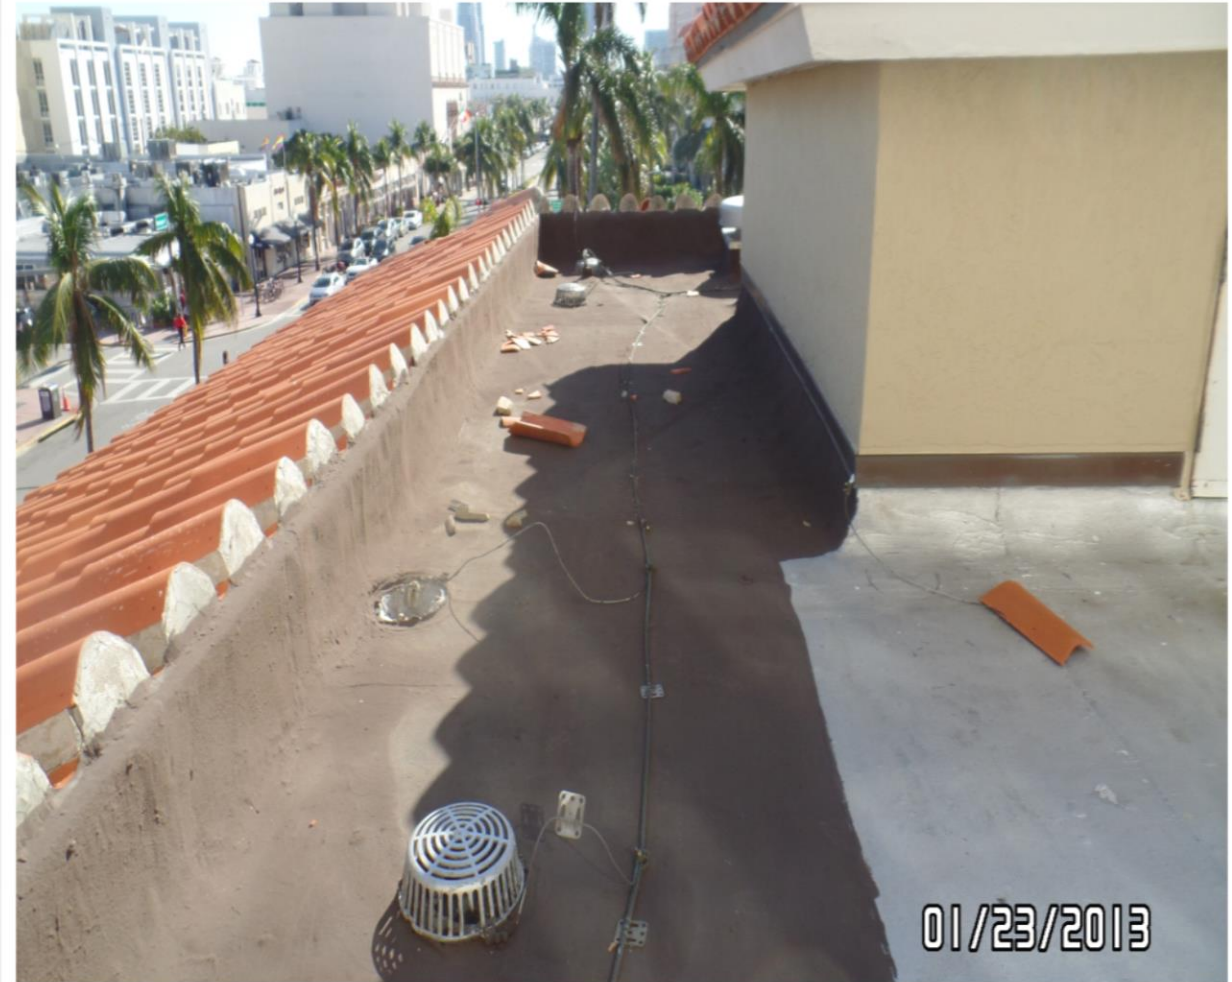
10. MISSING DRAIN GRATE COVER AND
BROKEN BARREL TILES ON ROOF OVER
COURTROOM AREA 2-1

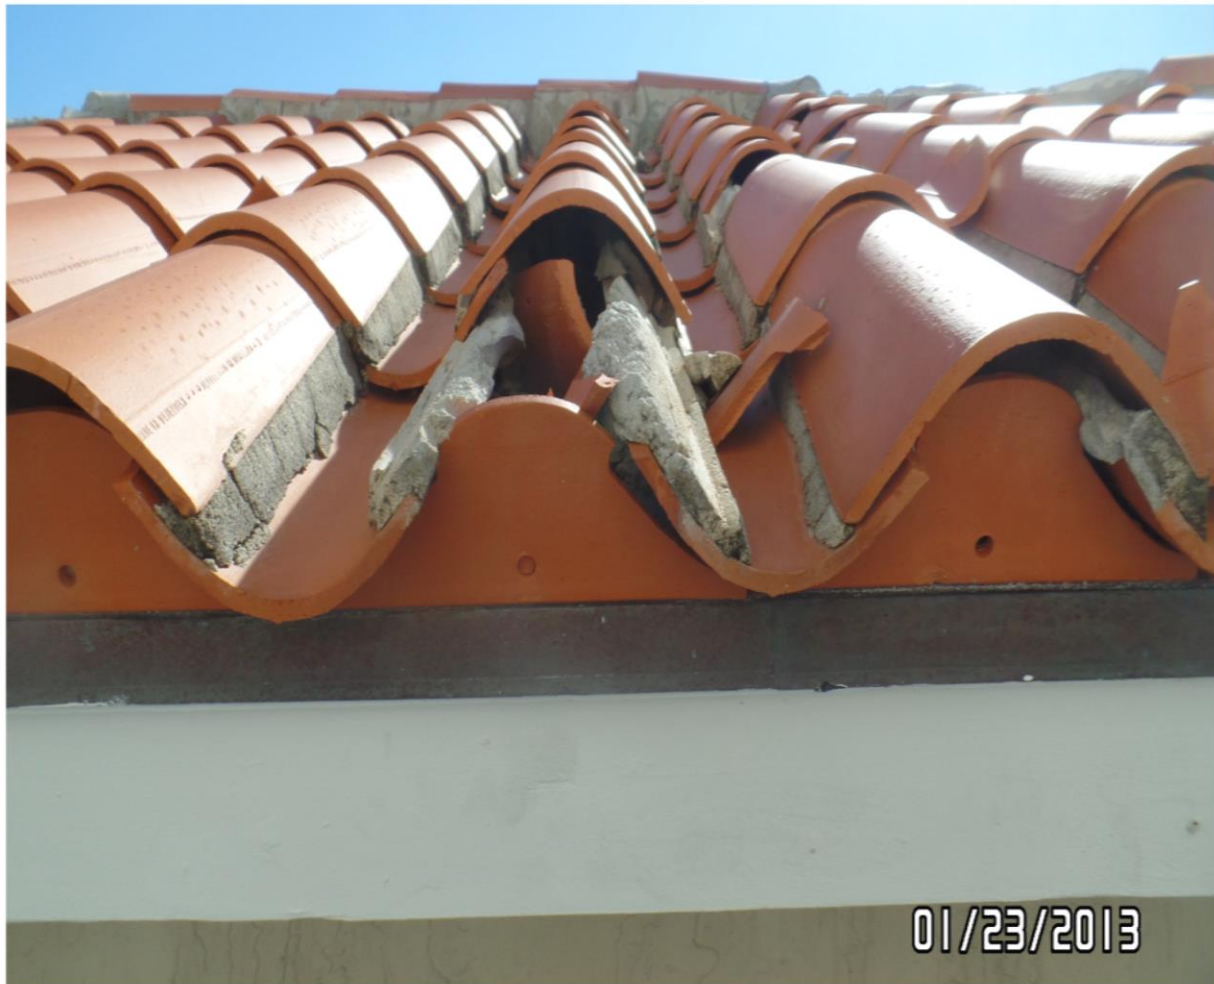
An inspection of the barrel tile roof areas reveals wind damage and uplift that is random on all elevations. The tiles were installed by the concrete paddy method which has limited ability to withstand high winds and negative pressure. Flying tile on a roof creates damage by embedment of the tile into the roof membrane and flashings. It appears that the leaks in the chapel and break room are over the tile mansard and may be the result of metal edge issues or storm damage coupled with age. In order to determine if this is the issue, a further investigation using lifts to the mansard for closer examination is necessary.

11. BROKEN AND MISSING BARREL TILES
ON PENTHOUSE ROOF_1

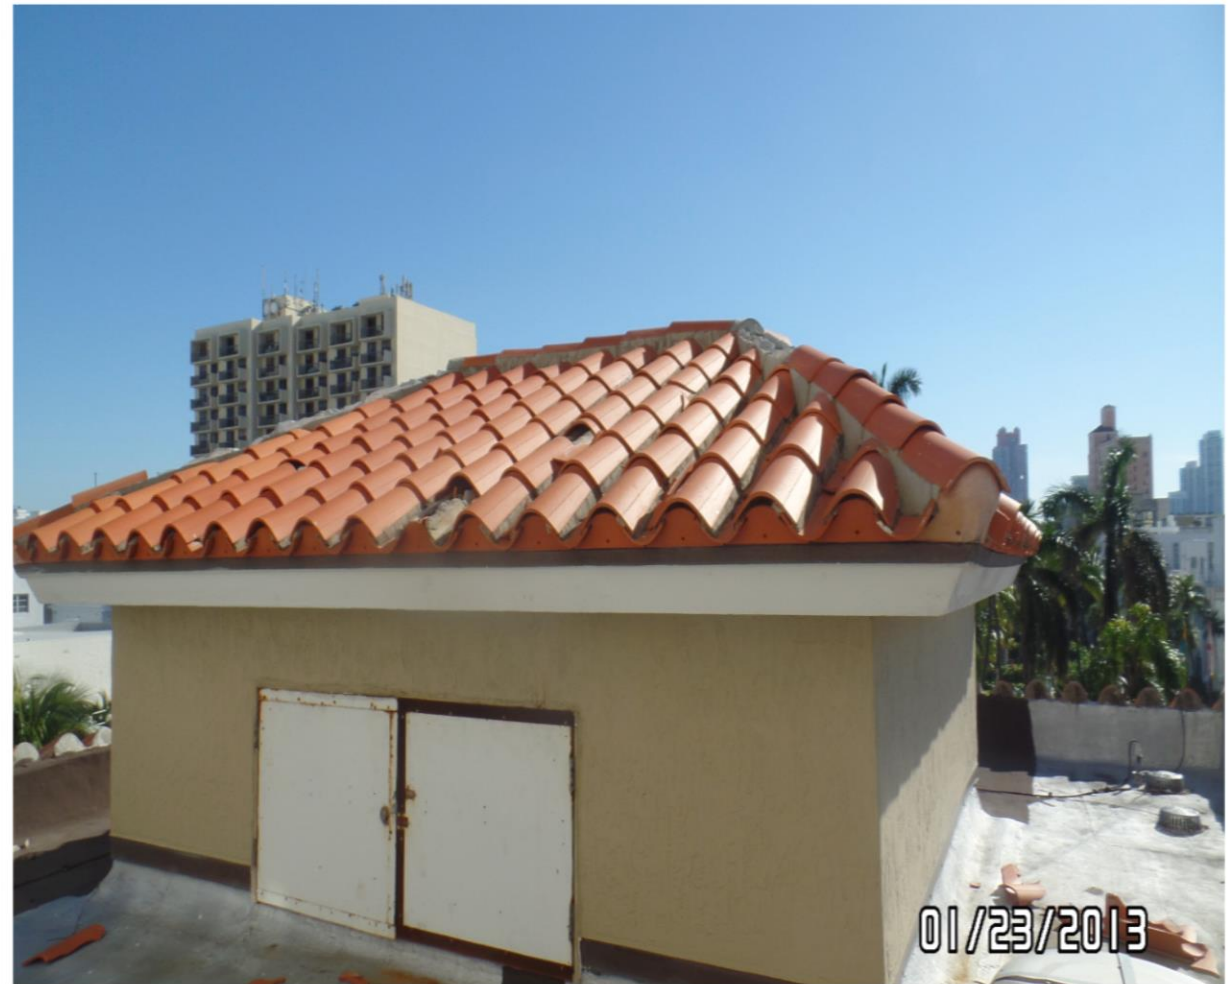
12. BROKEN AND MISSING TILES
ON PENTHOUSE ROOF_2

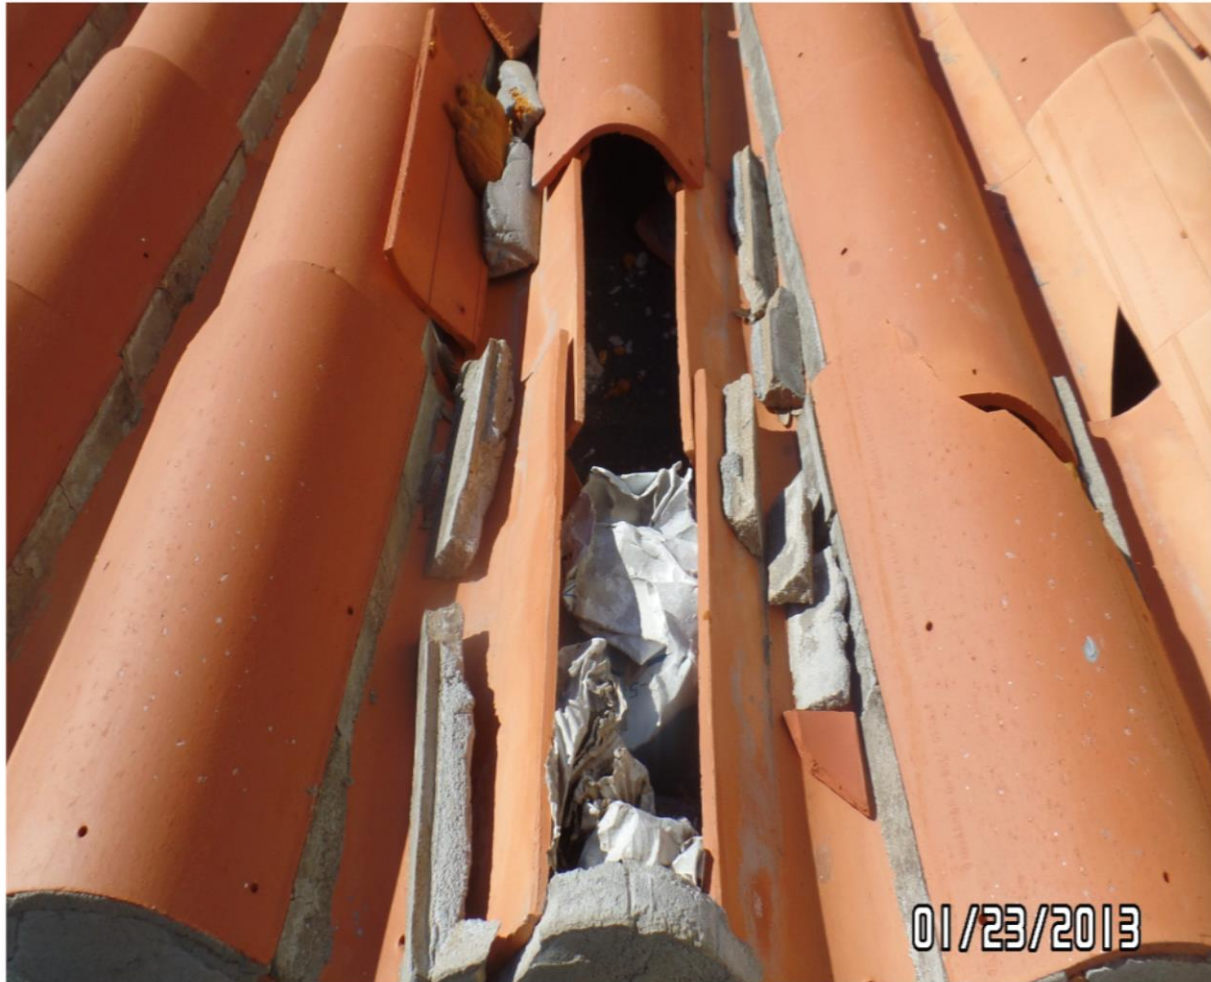
13. BROKEN AND MISSING TILES
ON PENTHOUSE ROOF_3

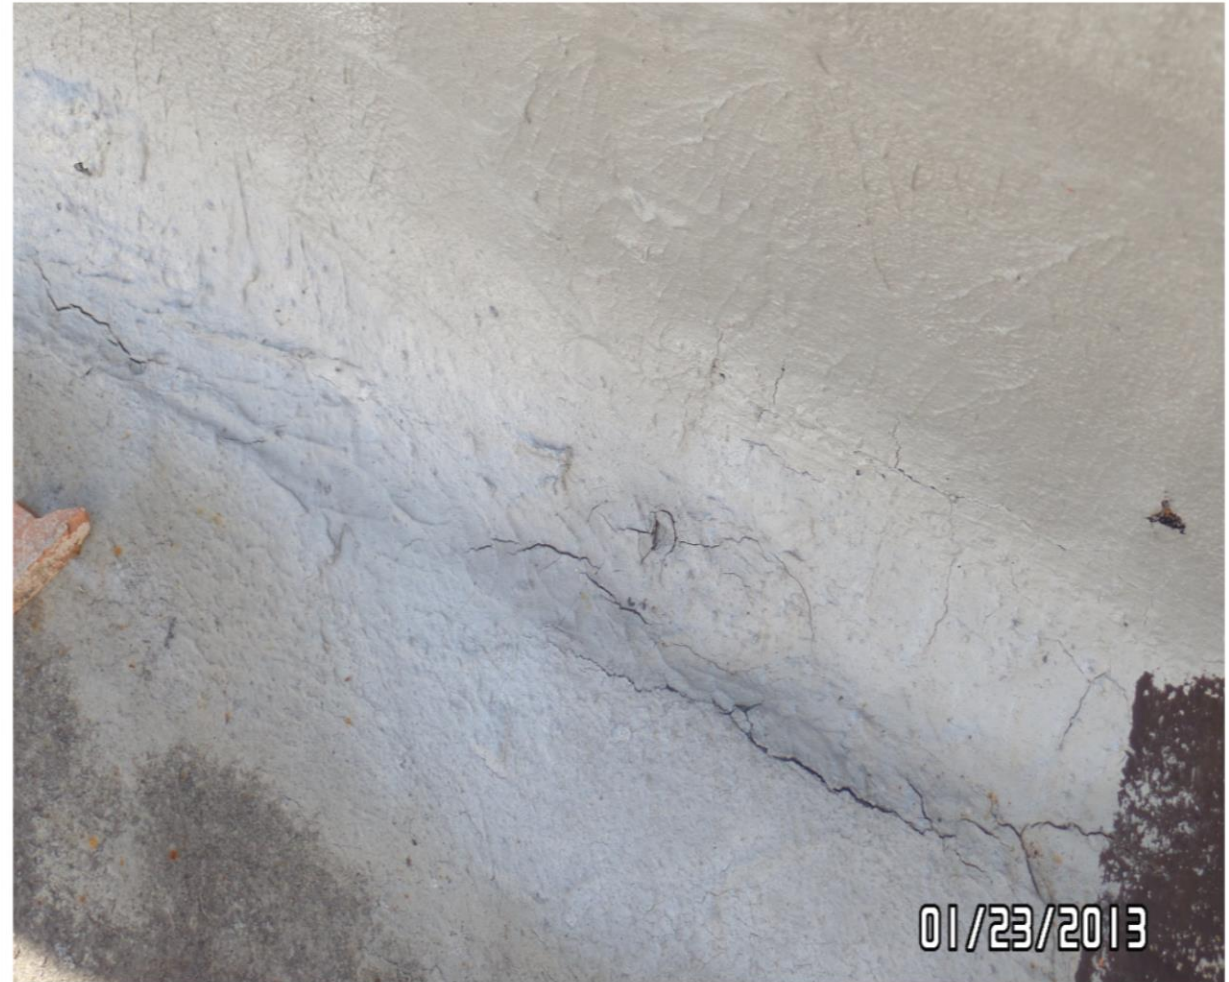
The roof perimeter wall flashings on this roof section consist of a granulated modified bitumen membrane. The flashings are old and do show signs of advanced age and UV degradation.

14. CRACKS, HOLES AND DETERIORATION IN BASE
FLASHING SYSTEM DUE TO AGE AND UV
EXPOSURE

Based on the results of our inspection of these various areas of leakage on many roofing levels it is the opinion of RMS that all the insulated and older modified bitumen roofing systems be removed and replaced with a current code compliant modified bitumen system that is sloped to drain.

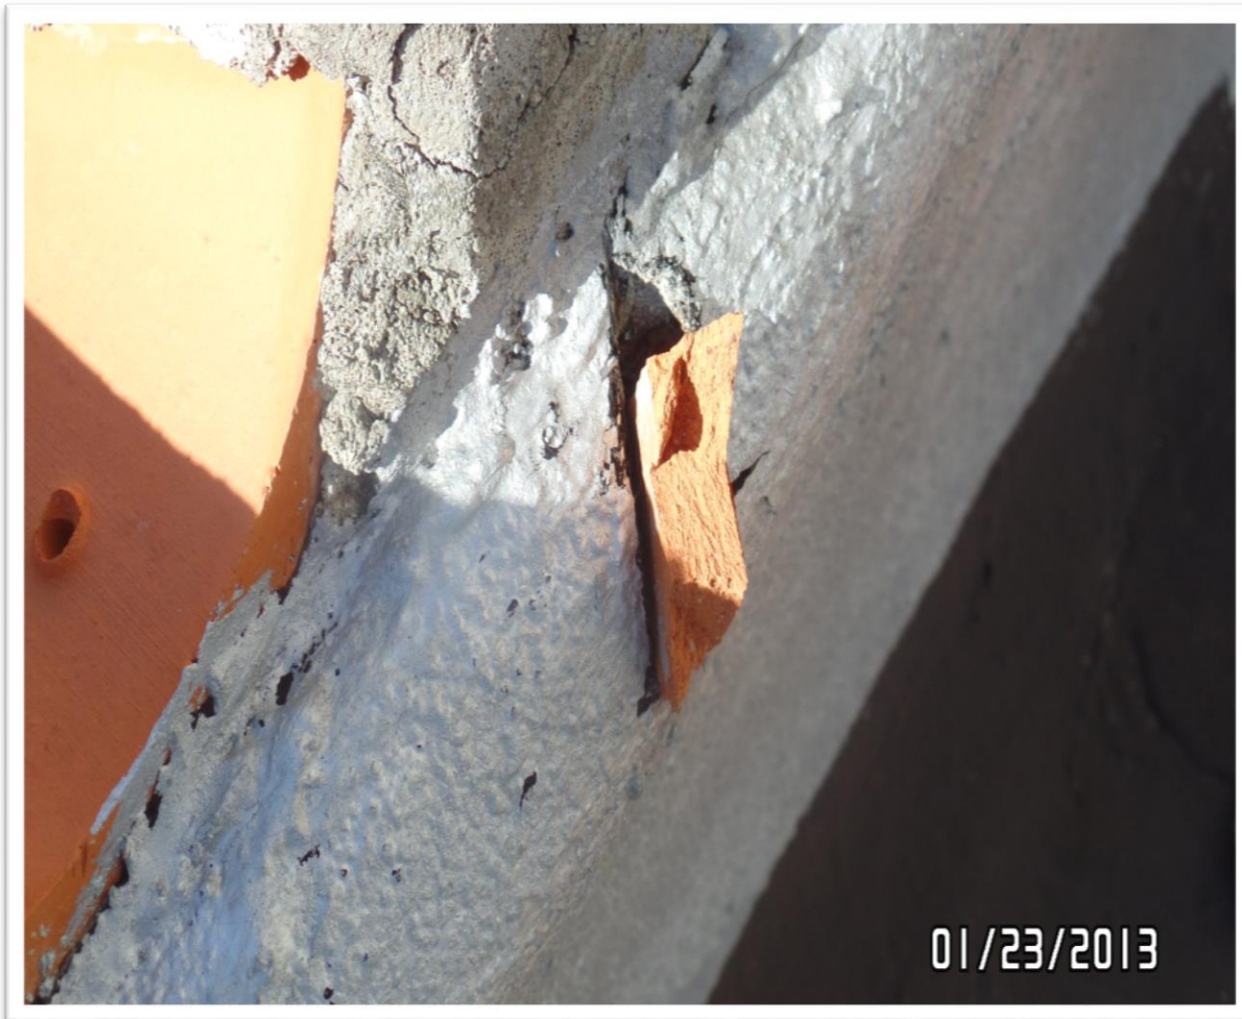
The granulated modified field membrane was observed to be in fair- poor condition. The roof surface is aged and there was broken tile debris throughout. The tile debris must have been created because of hurricane IRMA. Our inspector noted that some of the broken tile was driven into the flashings. An emulsion coating was spread over most of the roof field as an attempt to mitigate the leaks. An inspection of a mechanical room over the courthouse leaks does show rust of the duct work from the ocean that is close by. The flashings along the outside wall of the equipment roof are badly weathered.

15. TILE IMPALED IN BASE FLASHING SYSTEM
FROM HURRICANE IRMA- SOUTH ROOF

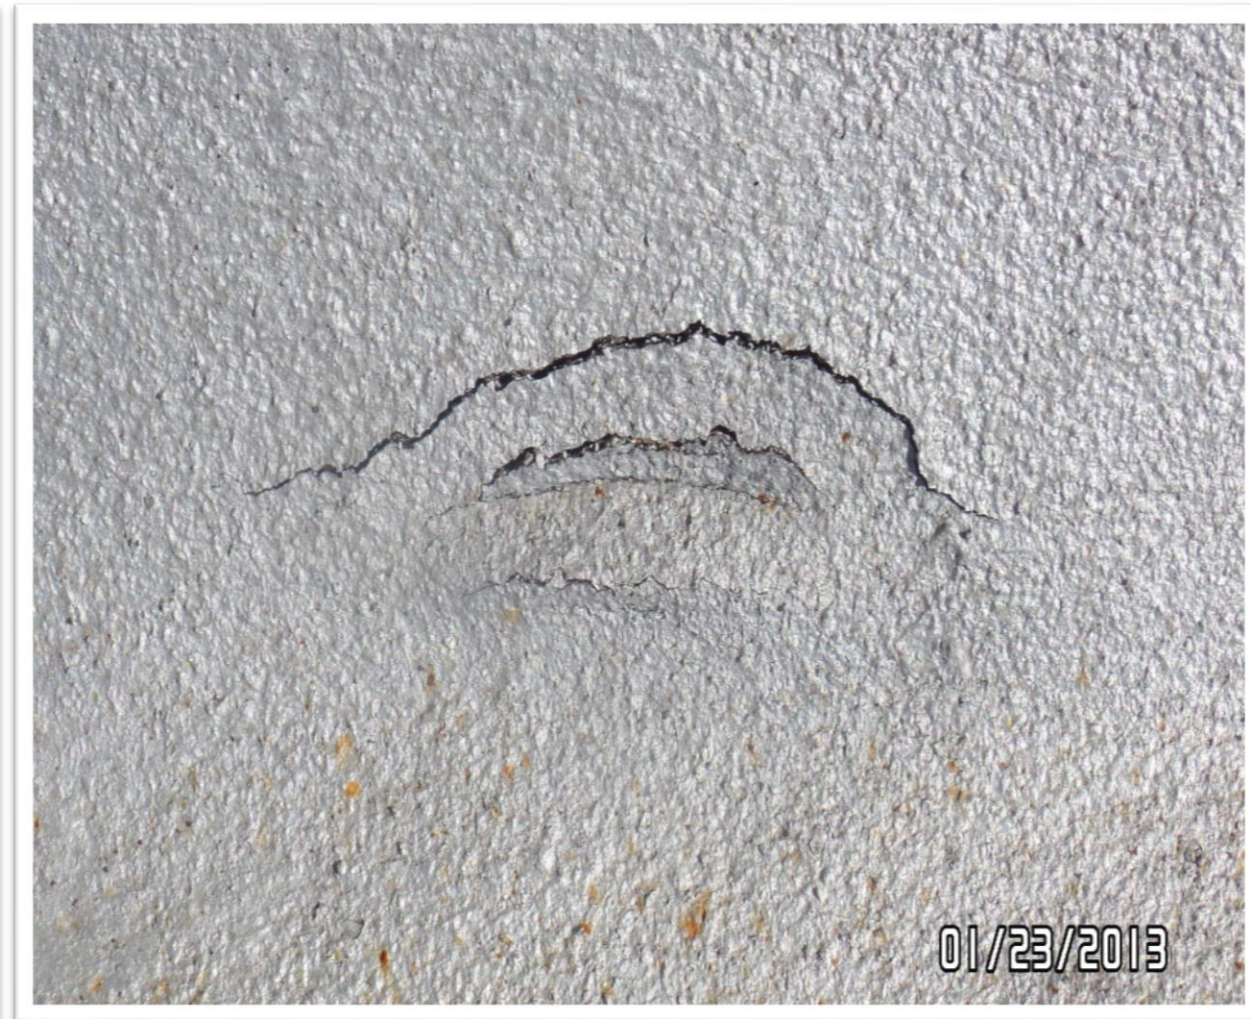
16. HOLE IN BASE FLASHING SYSTEM OF SOUTH ROOF

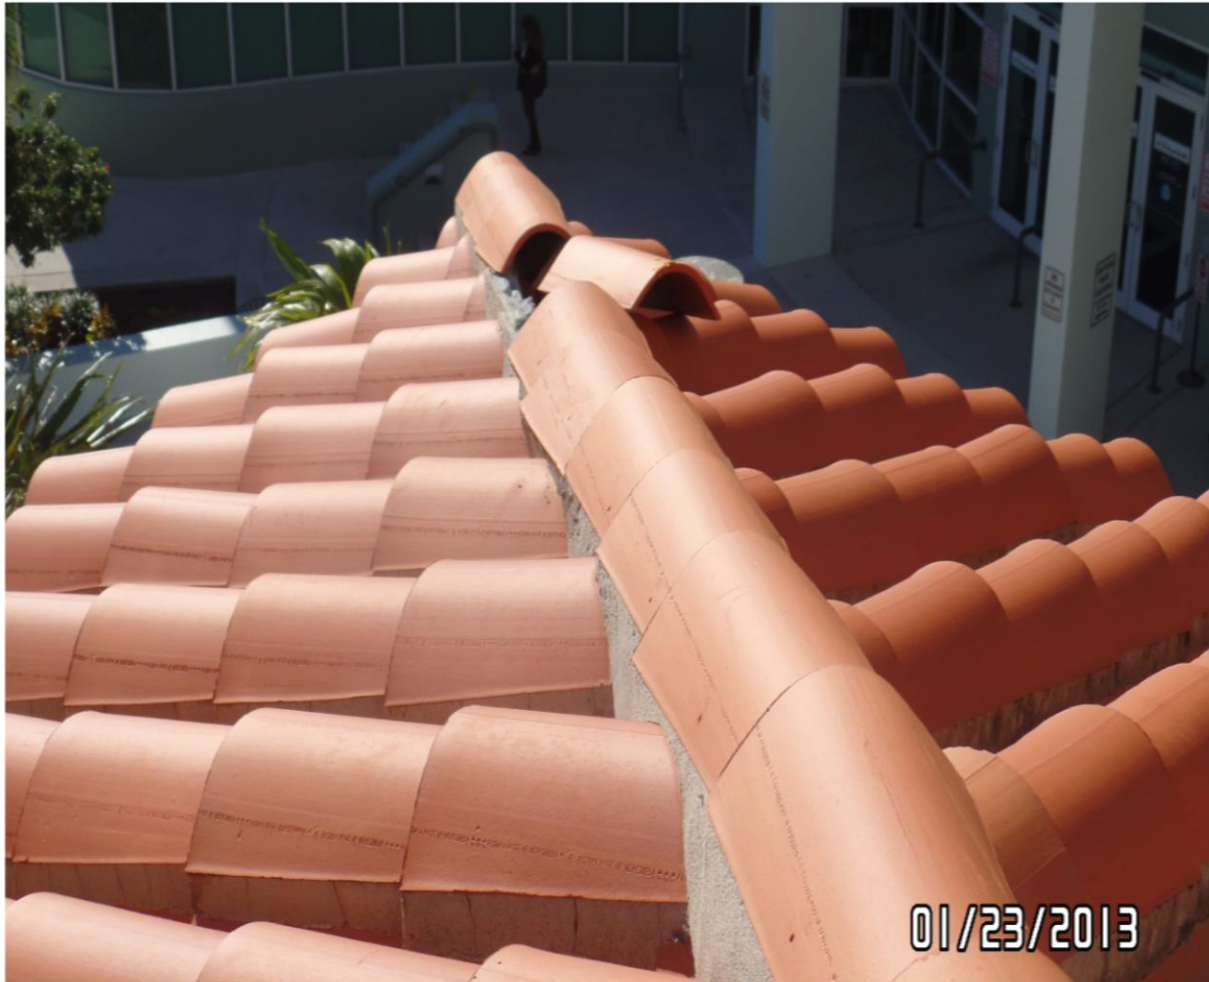
17. MISSING RIDGE CAP TILES

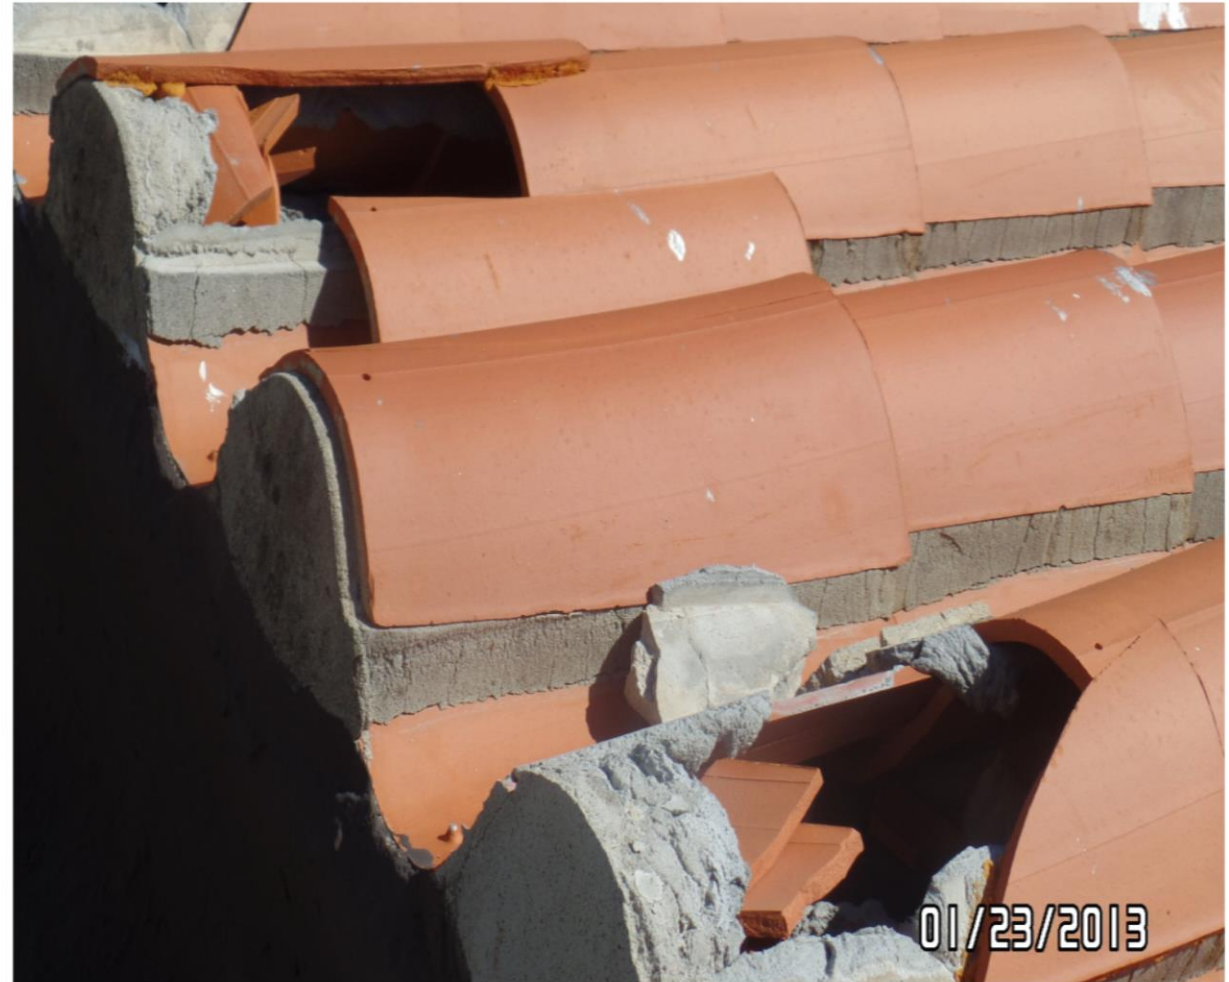
18. BROKEN ROOF TILES FROM EITHER FLYING DEBRIS OR WIND UPLIFT

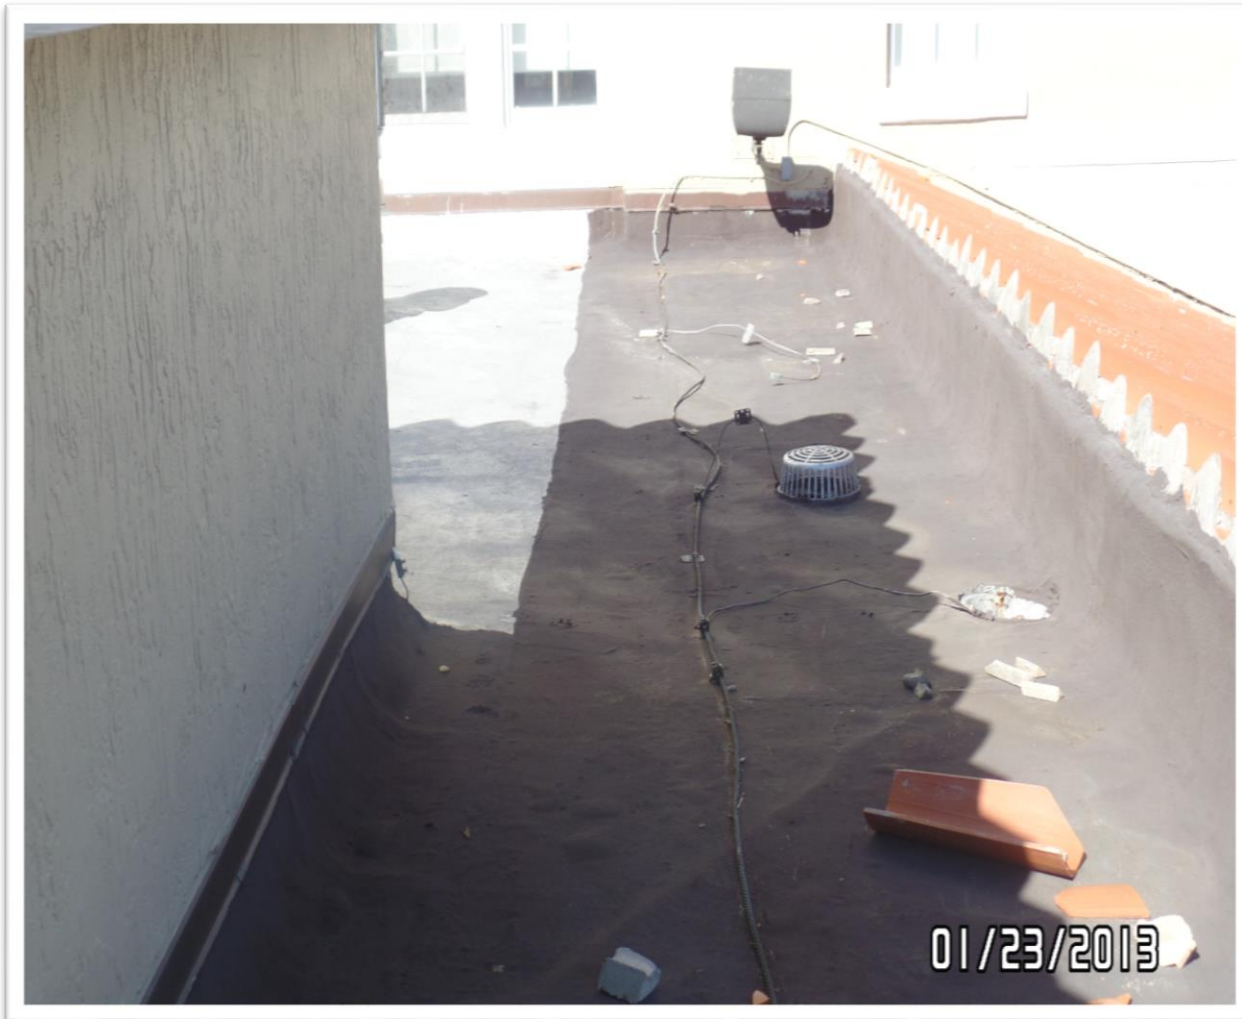
19. ROOF SECTION OVERVIEW SHOWING AN EMULSION COATING AT PARAPET WALL

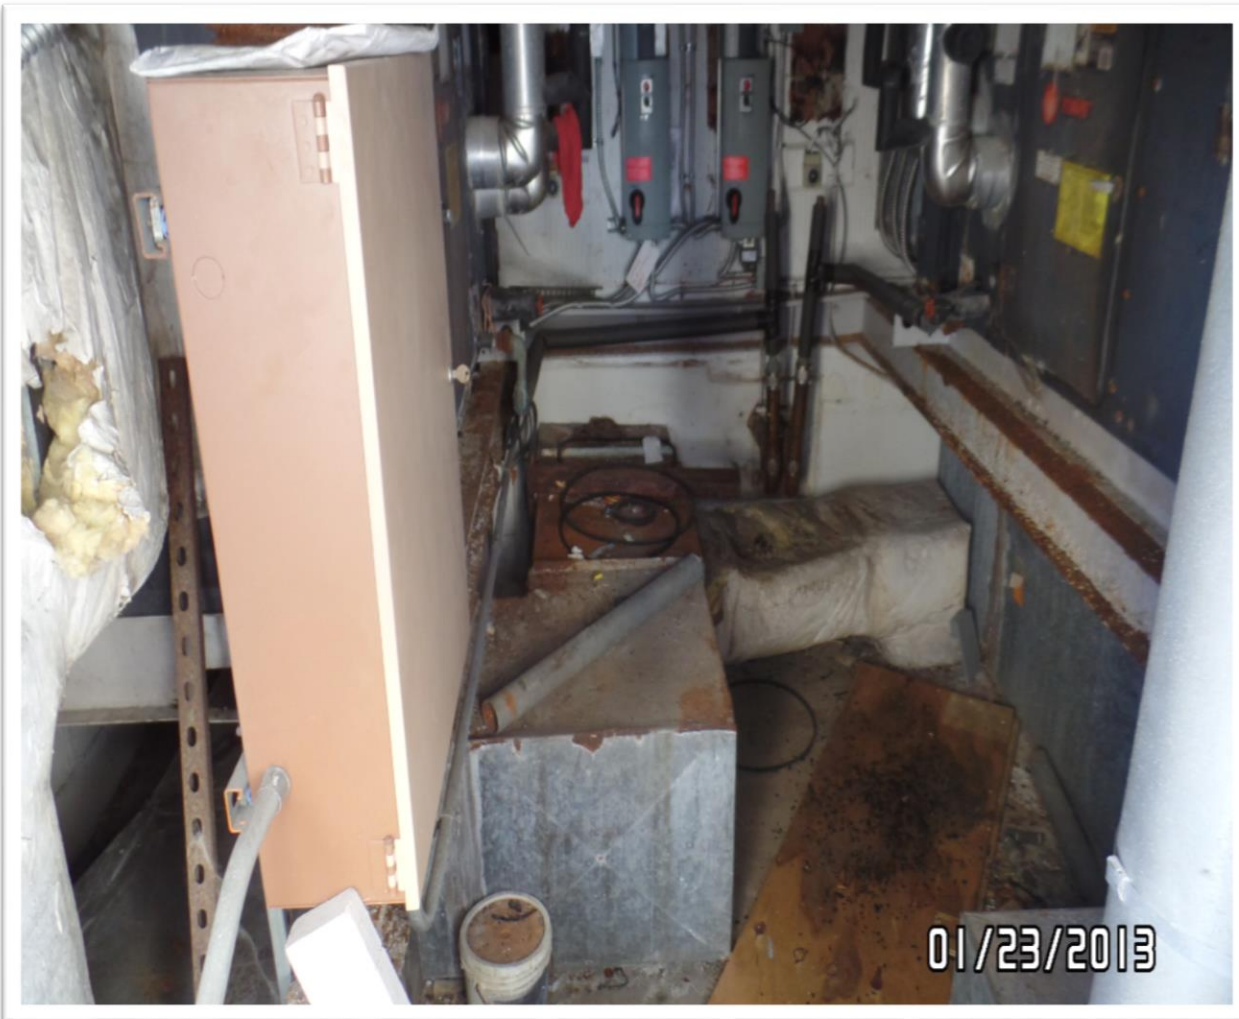
20. INSIDE PENTHOUSE OF COURTROOM 2-1 IN AREAS OF ROOF LEAKS. THE ROOM IS VERY CLUTTERED

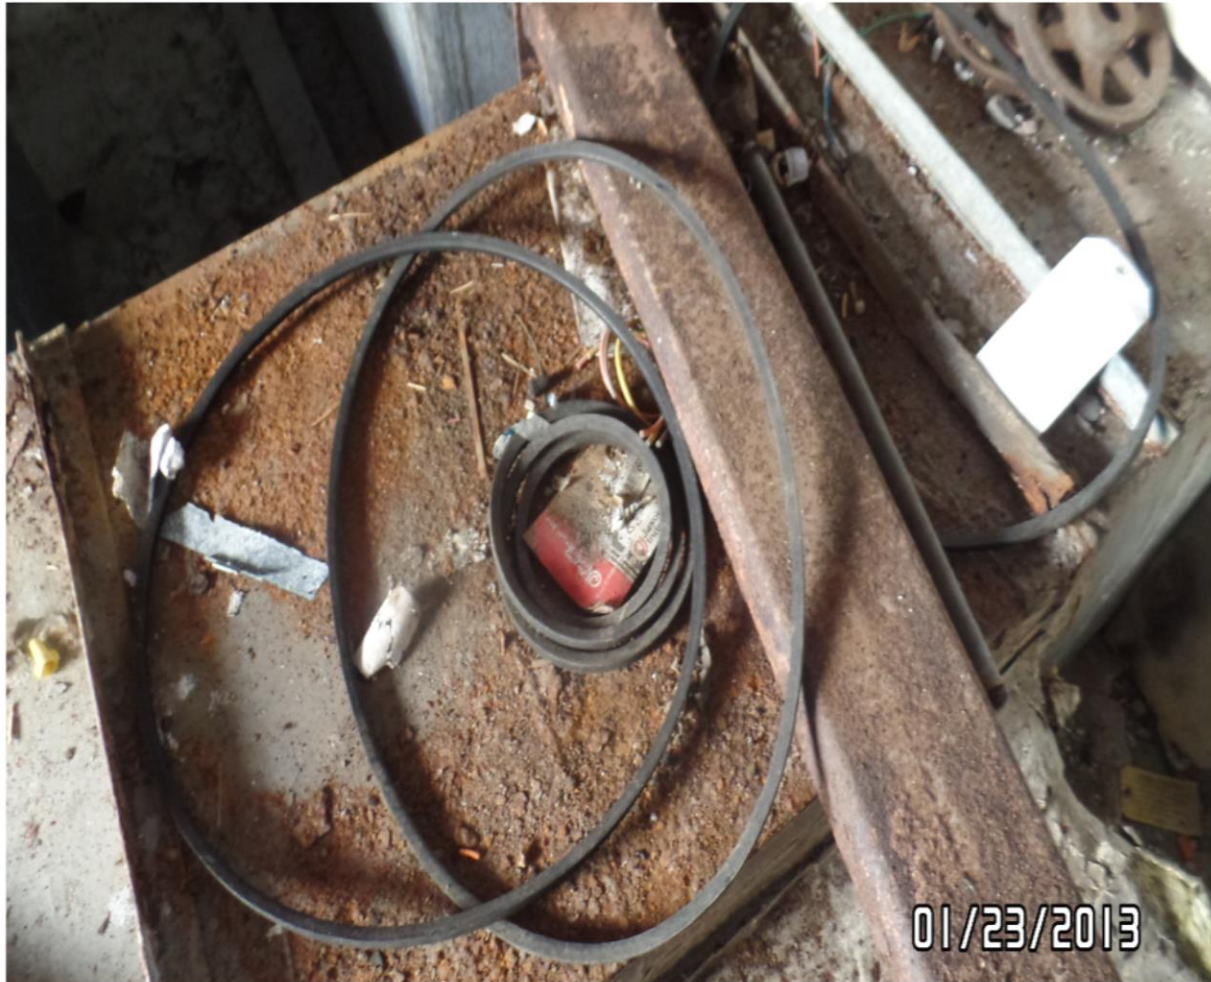
21. AREA OF RUST AND DETERIORATION WITHIN THE SOUTH EQUIPMENT PENTHOUSE
