City of Miami Beach- Historic City Hall- Visual Roof Inspection- 2018

Historic City Hall
1130 Washington Avenue
Miami Beach, FL 33139

Roof Inspection Photos January 2018*

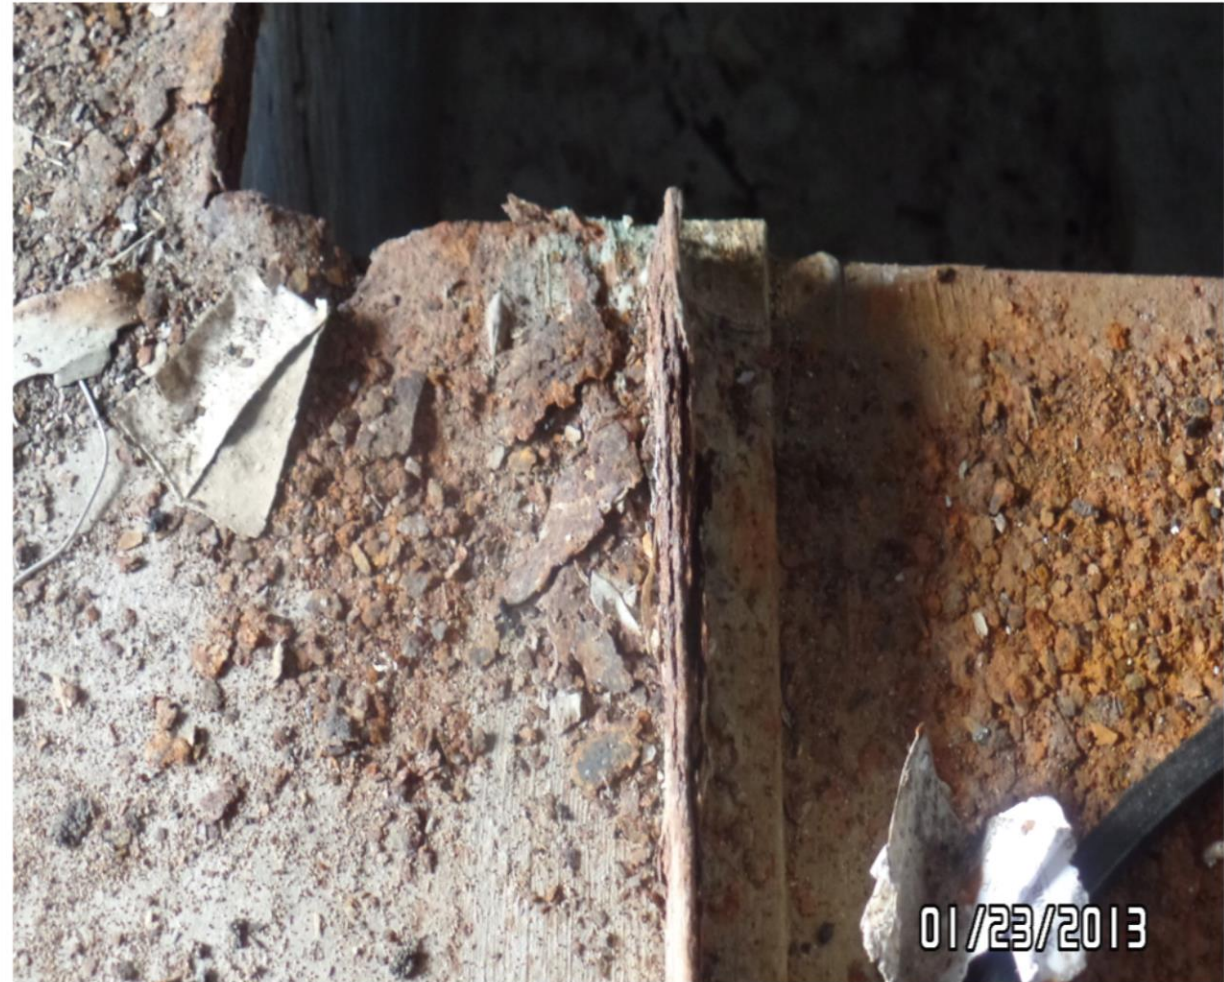
22. RUSTED DUCT SECTIONS WITHIN EQUIPMENT ROOM PENTHOUSE OVER COURTROOM 2-1

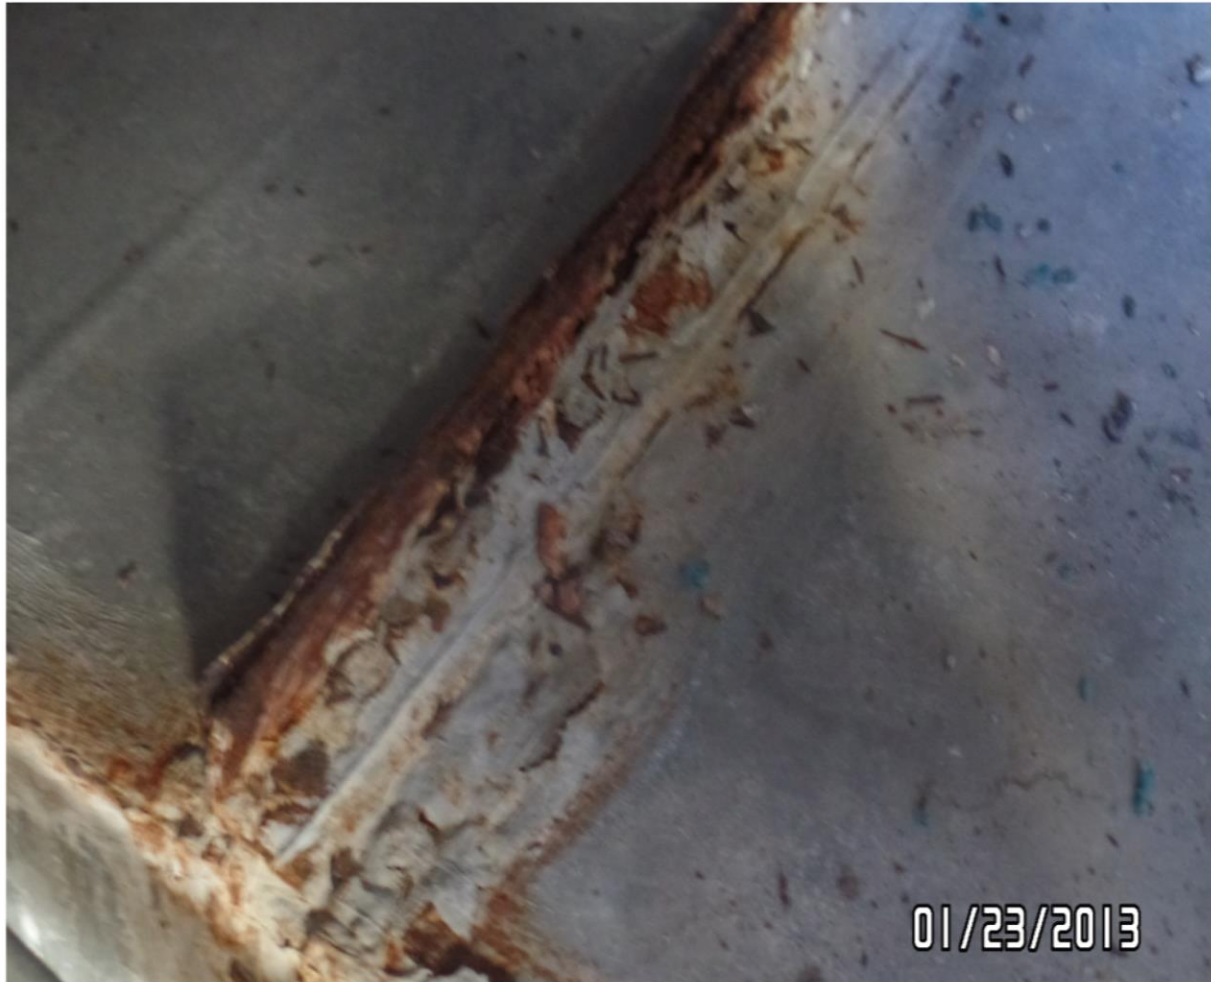
23. RUSTED METAL DUCTWORK IN EQUIPMENT ROOM

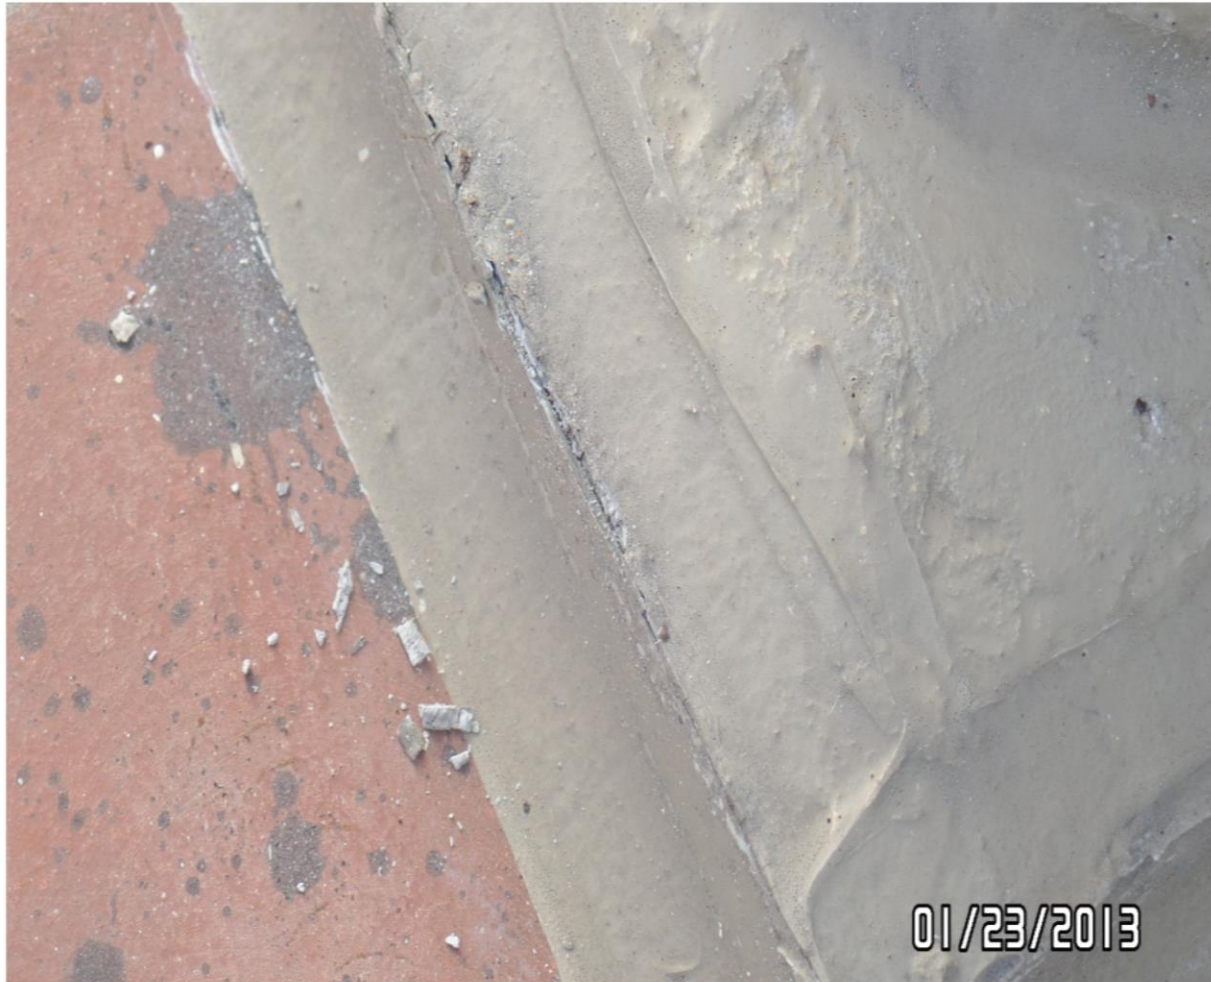
25. MASONRY CRACKS IN CONCRETE COLUMNS OF 8TH FLOOR WEST

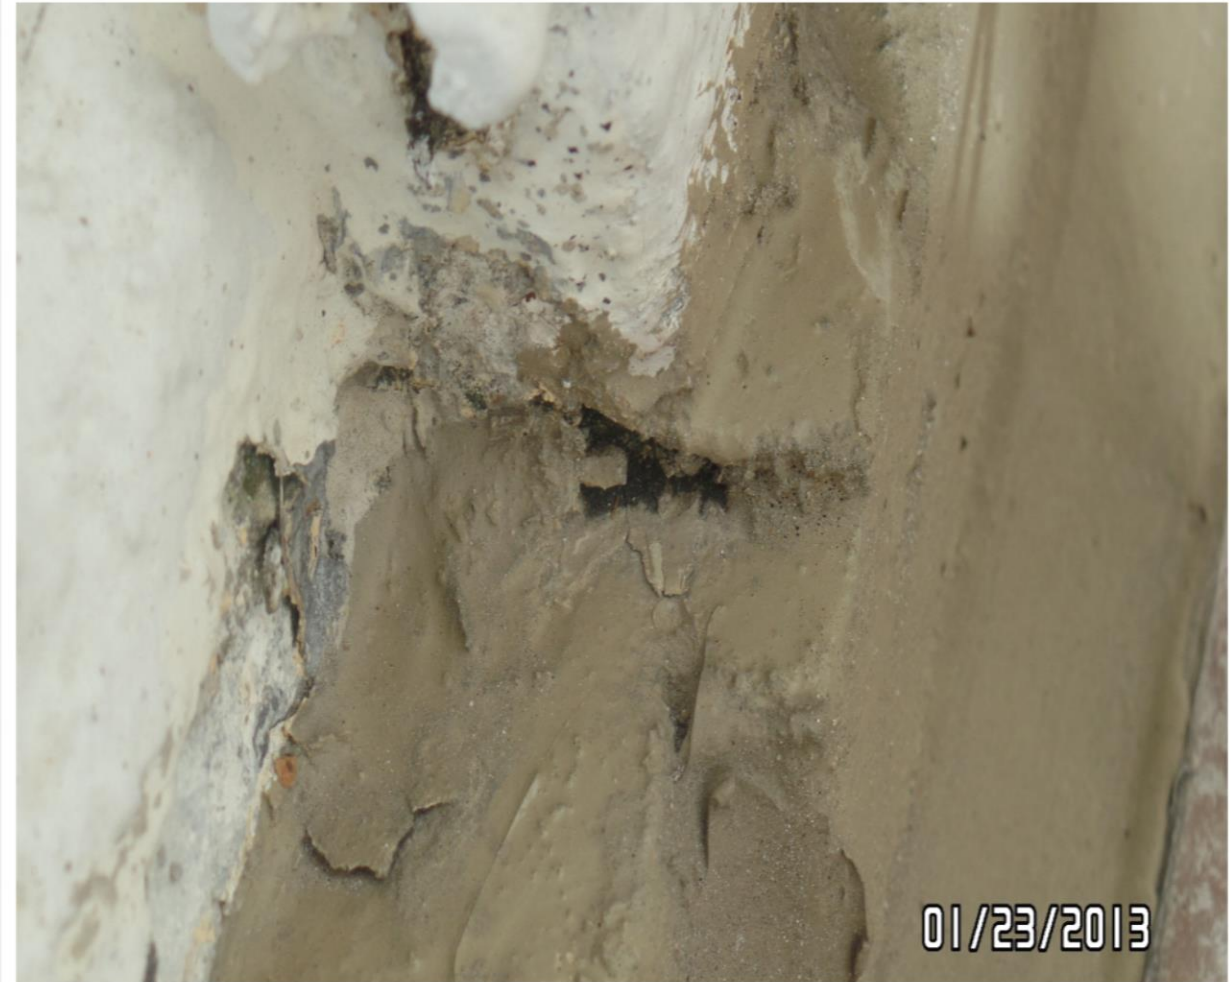
There are small brick surfaced balconies all along the 8th floor. They are composed of brick over concrete. The outer perimeter of the balcony is comprised of a concrete balustrade railing. At the termination to the tile, there is a bead of concrete and caulking. According to Oniel when there is a rain, these balconies leak into the units below. Drainage is accomplished by floor drains. The leak is either a waterproofing problem or a drain issue. It is suggested that the drains, perimeters, both inside and outside be water tested to determine if each of the balconies leak and what is the cause of the leak. Because the building is old, and the balconies have not been replaced, a total renovation of all the balcony tiles may be the best solution.

26. FLASHING OPENINGS AT PERIMETER OF BALCONY ON THE 8TH FLOOR WEST

The 8th floor balconies do require water testing to determine if all the water leakage is either the drains, perimeters, or tile system field. When a determination is made, and it implicates the floor tile and the perimeters, the entire balcony must be replaced with new exterior non slip tile and waterproofing system between the tile and the concrete slab. A structural engineer should be retained to determine if the concrete balustrade is structurally sound.

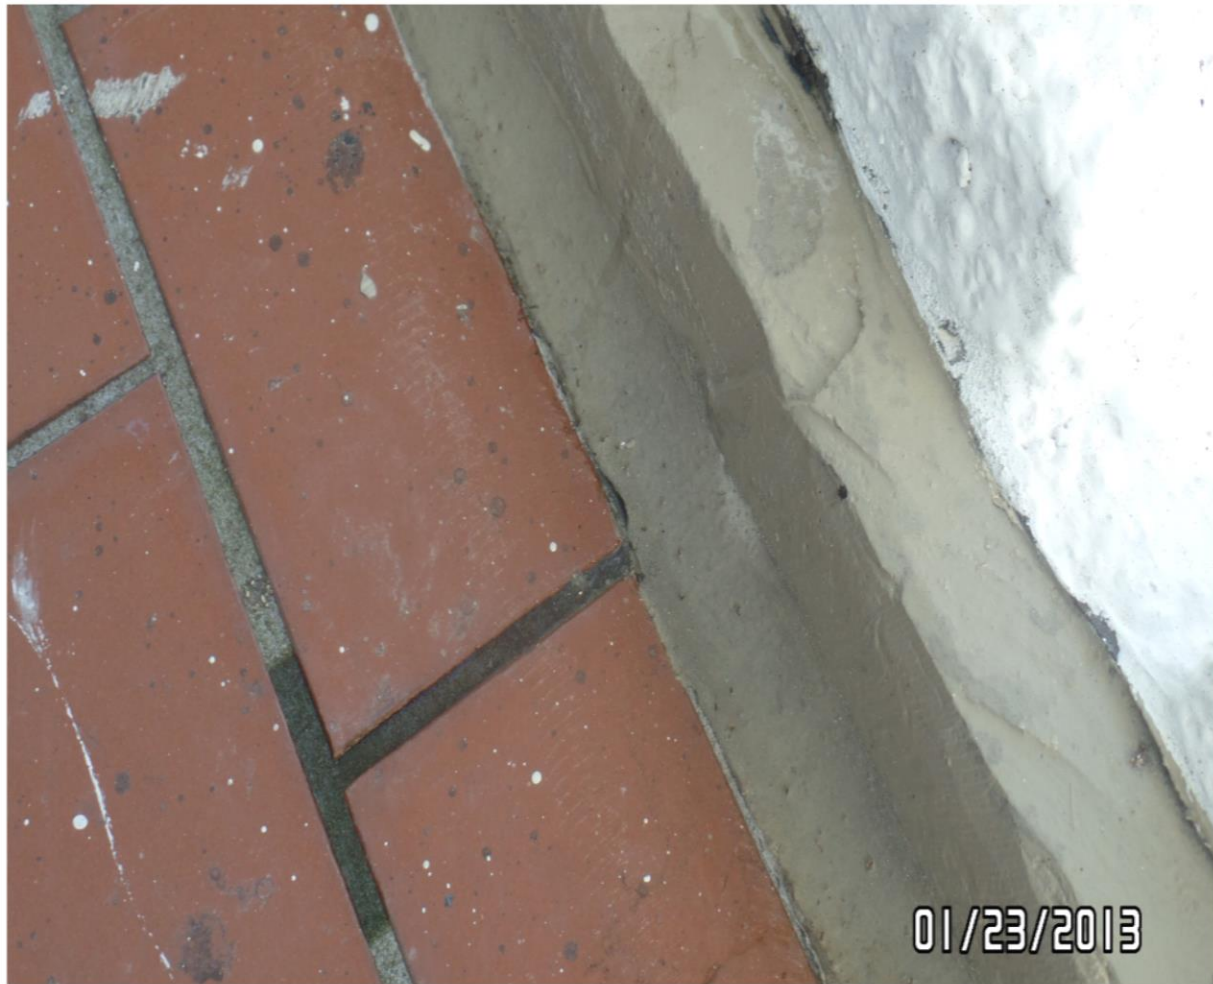
27. TILE AT OUTSIDE WALL IS SHOWING SIGNS OF WATER LEAKAGE

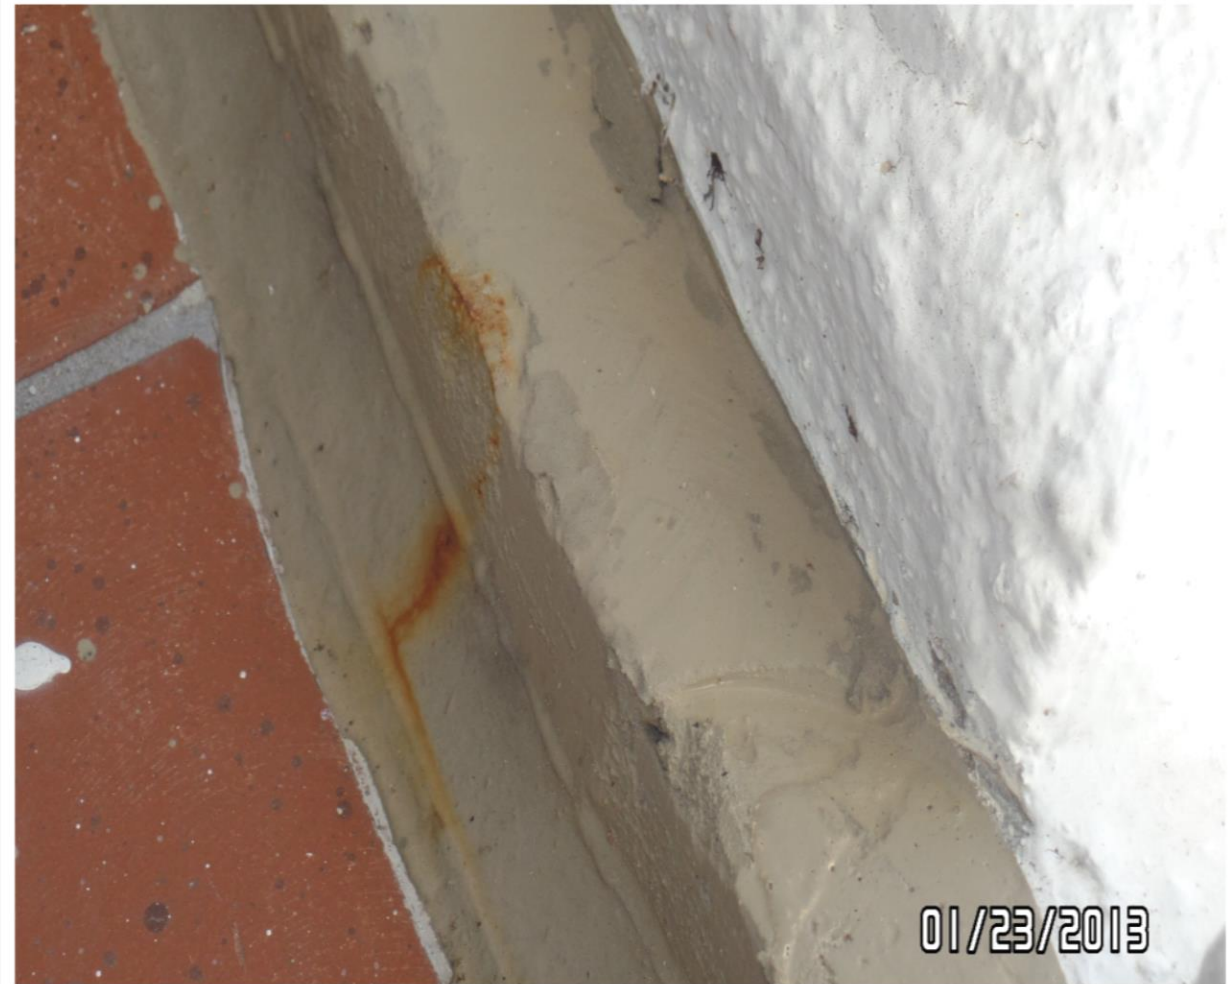
28. RUST COMING FROM WATER INTRUSION OF THE 8TH FLOOR BALCONY DECK

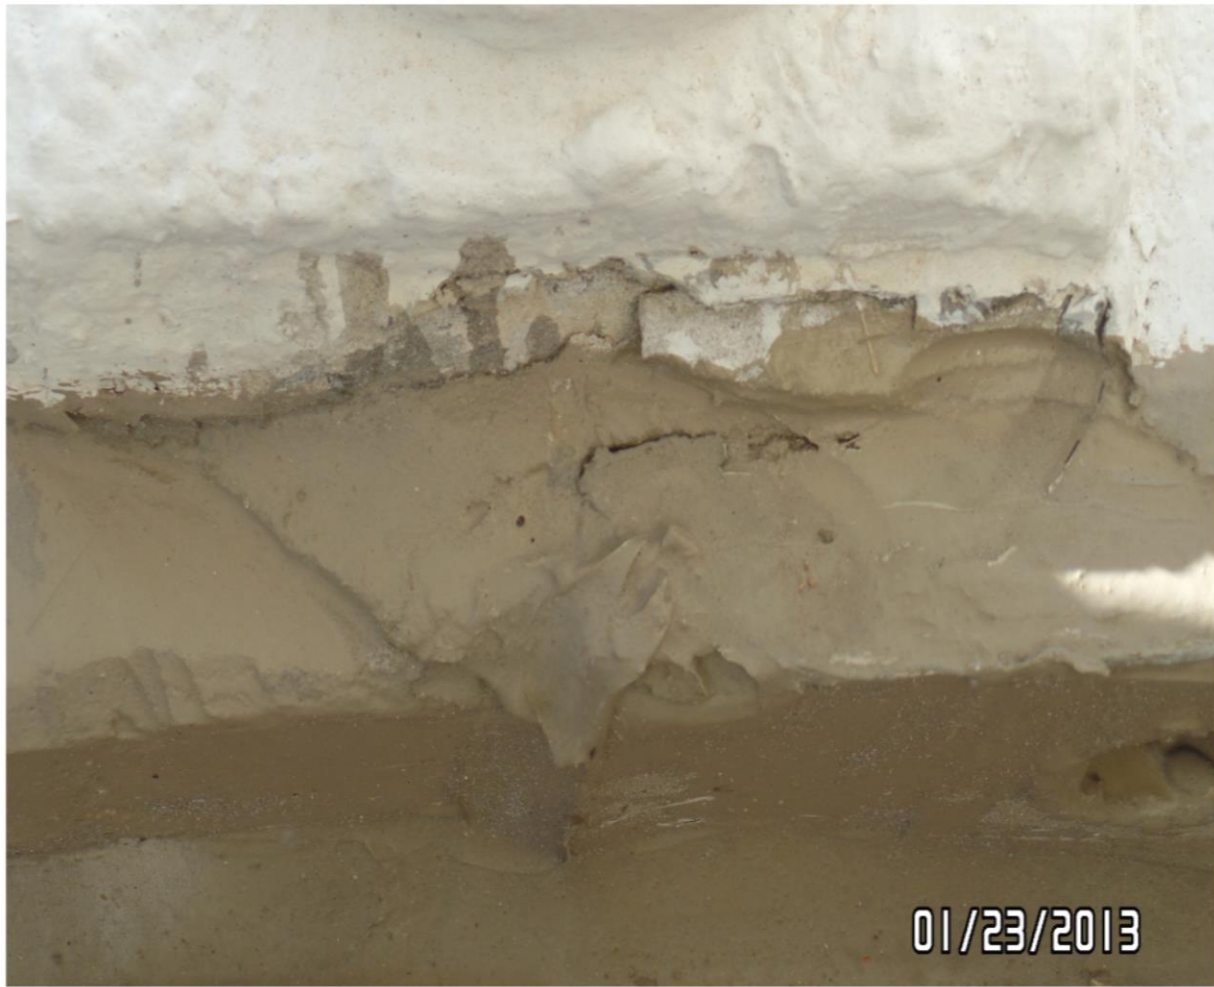
29. CRACKS IN THE OUTSIDE BALCONY FLASHING PERIMETER

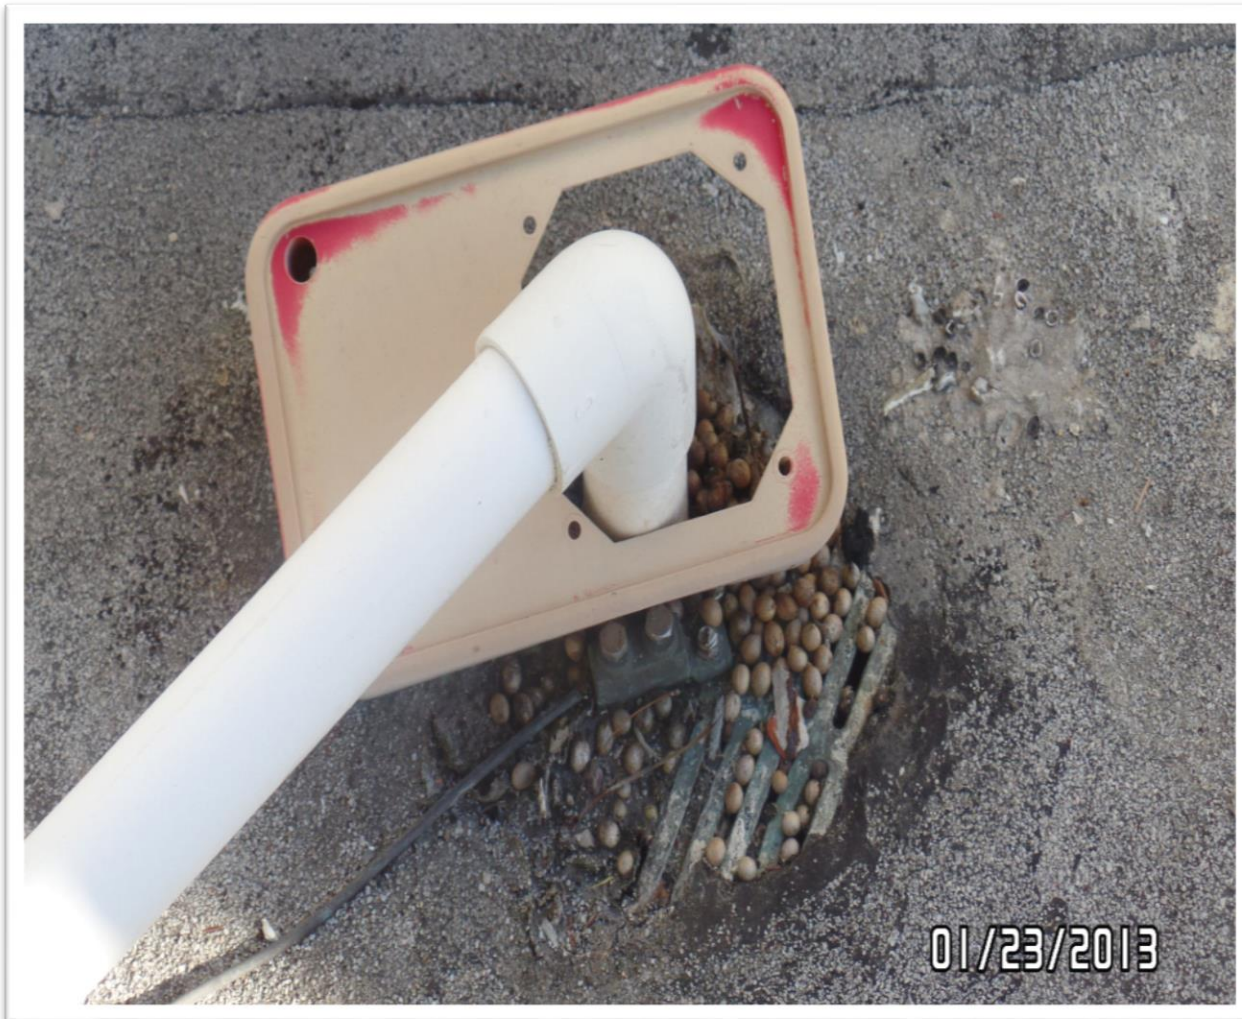
31. BLOCKED INTERNAL DRAIN WITH SEEDS ON THE 9TH FLOOR ROOF

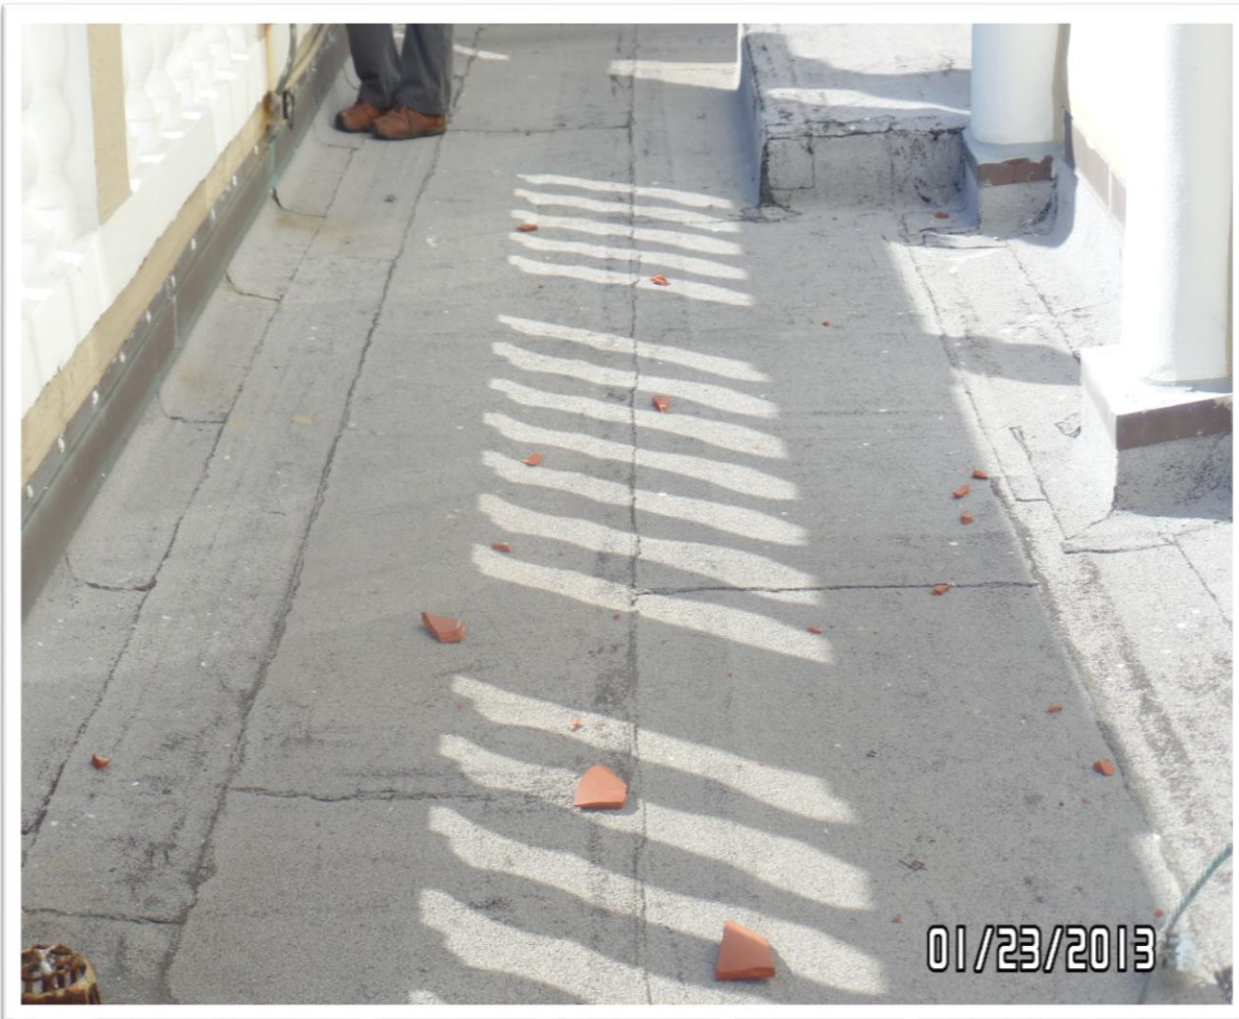
The granulated modified field membrane was observed to be in fair- poor condition. The roof surface is aged and there was broken tile debris throughout. The tile debris must have been created because of hurricane IRMA. Our inspector noted that some of the broken tile was driven into the flashings. An emulsion coating was spread over most of the roof field as an attempt to mitigate the leaks. An inspection of a mechanical room over the courthouse leaks does show rust of the duct work from the ocean that is close by. The flashings along the outside wall of the equipment roof are badly weathered.

32. TILE DEBRIS AND WEATHERED MODIFIED BITUMEN MEMBRANE

Based on the results of our inspection of these various areas of leakage on many roofing levels it is the opinion of RMS that all the insulated and older modified bitumen roofing systems be removed and replaced with a current code compliant modified bitumen system that is sloped to drain.

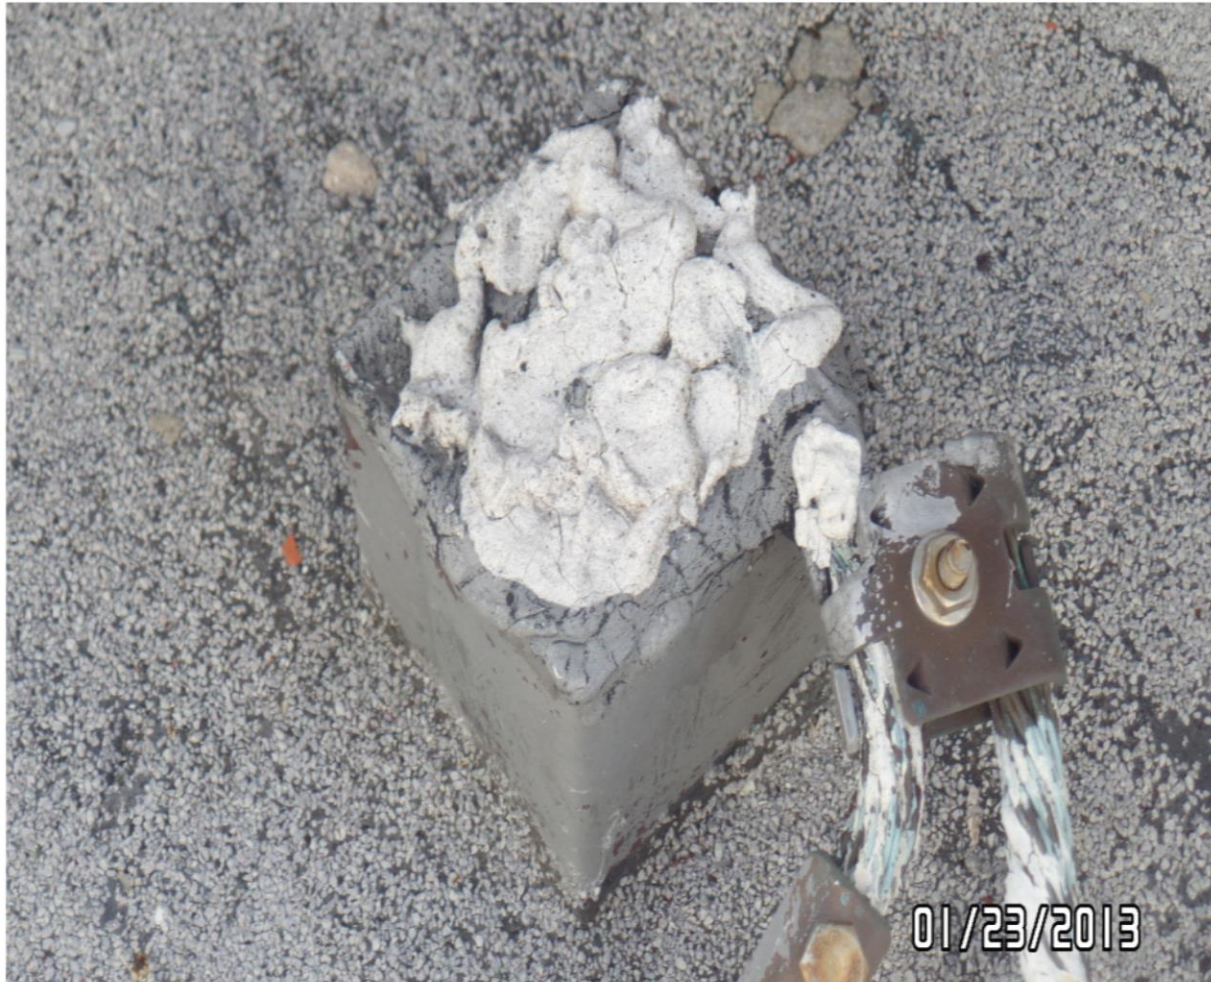
33. FAILING CAULKING AND PITCH PAN FILLER THAT IS TYPICAL ON THIS ROOF SECTION

The modified bitumen system on the 9th Floor roof should be re-coated and restored to “like new” condition. This would involve securing all the seams with specialized mastic and mesh and coating all the flashings and roof field with a multicoat application of elastomeric roof coating. The pitch pans should be replaced and all the drains should be “scoped” or water tested to insure they are not leaking. Particular attention to the concrete railings are necessary as well.

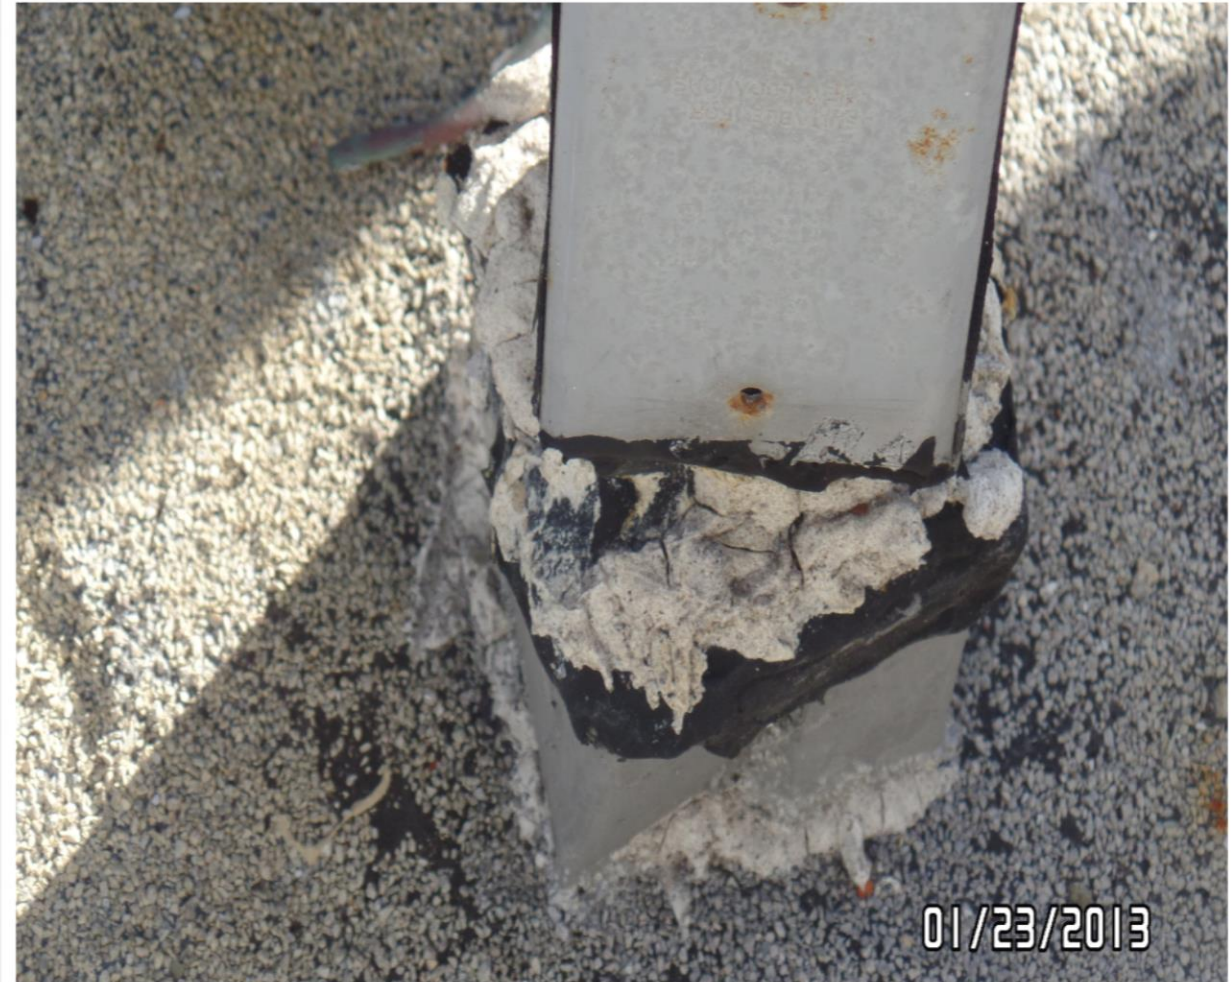
34. ELECTRICAL BOX SURROUNDED BY A FAILING PITCH PAN
