# ***Tree Resource Evaluation for 1030 15<sup>th</sup> Street, Miami Beach***

***May 6, 2018***

## **Summary**

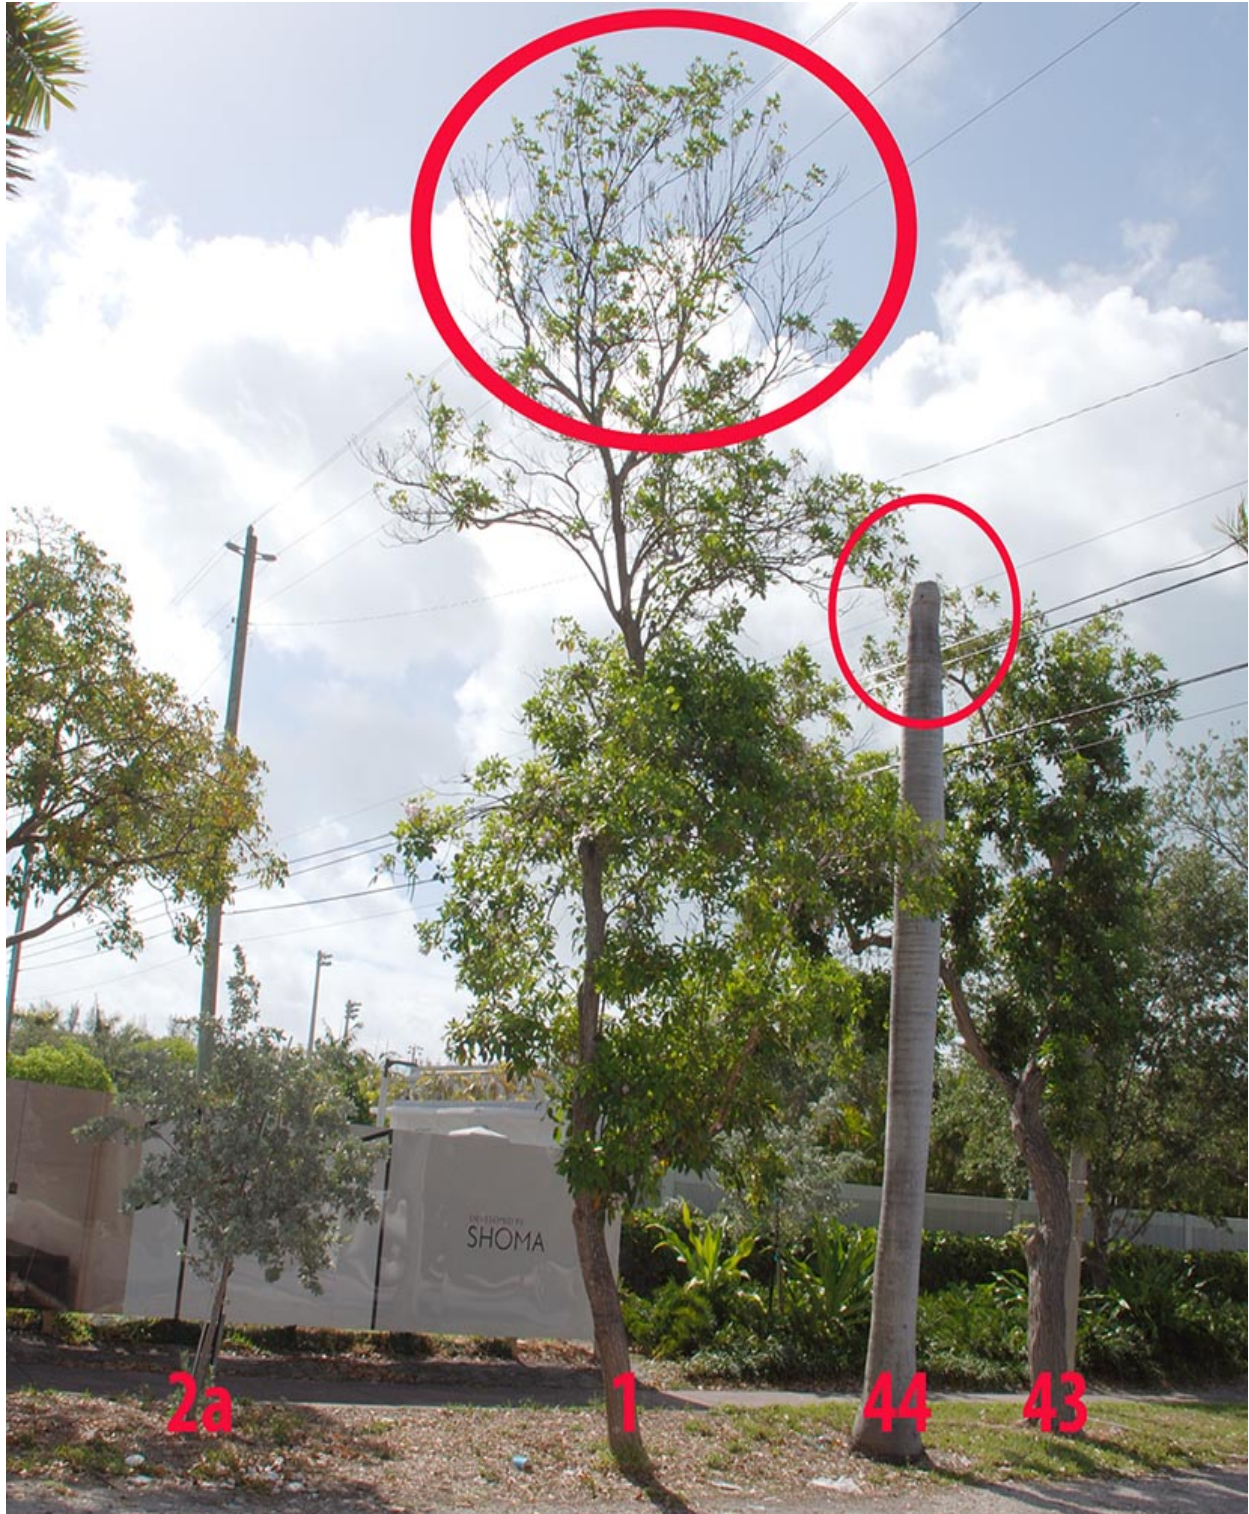
**Photo 1 above tree 1 growing into the powerlines with noticeable dead wood in the upper canopy. Tree 43 is also growing into the powerlines. Palm 44 is dead.**

Any trees that are to remain should have their canopies cleared of dead wood and hazardous branches by a certified arborist.

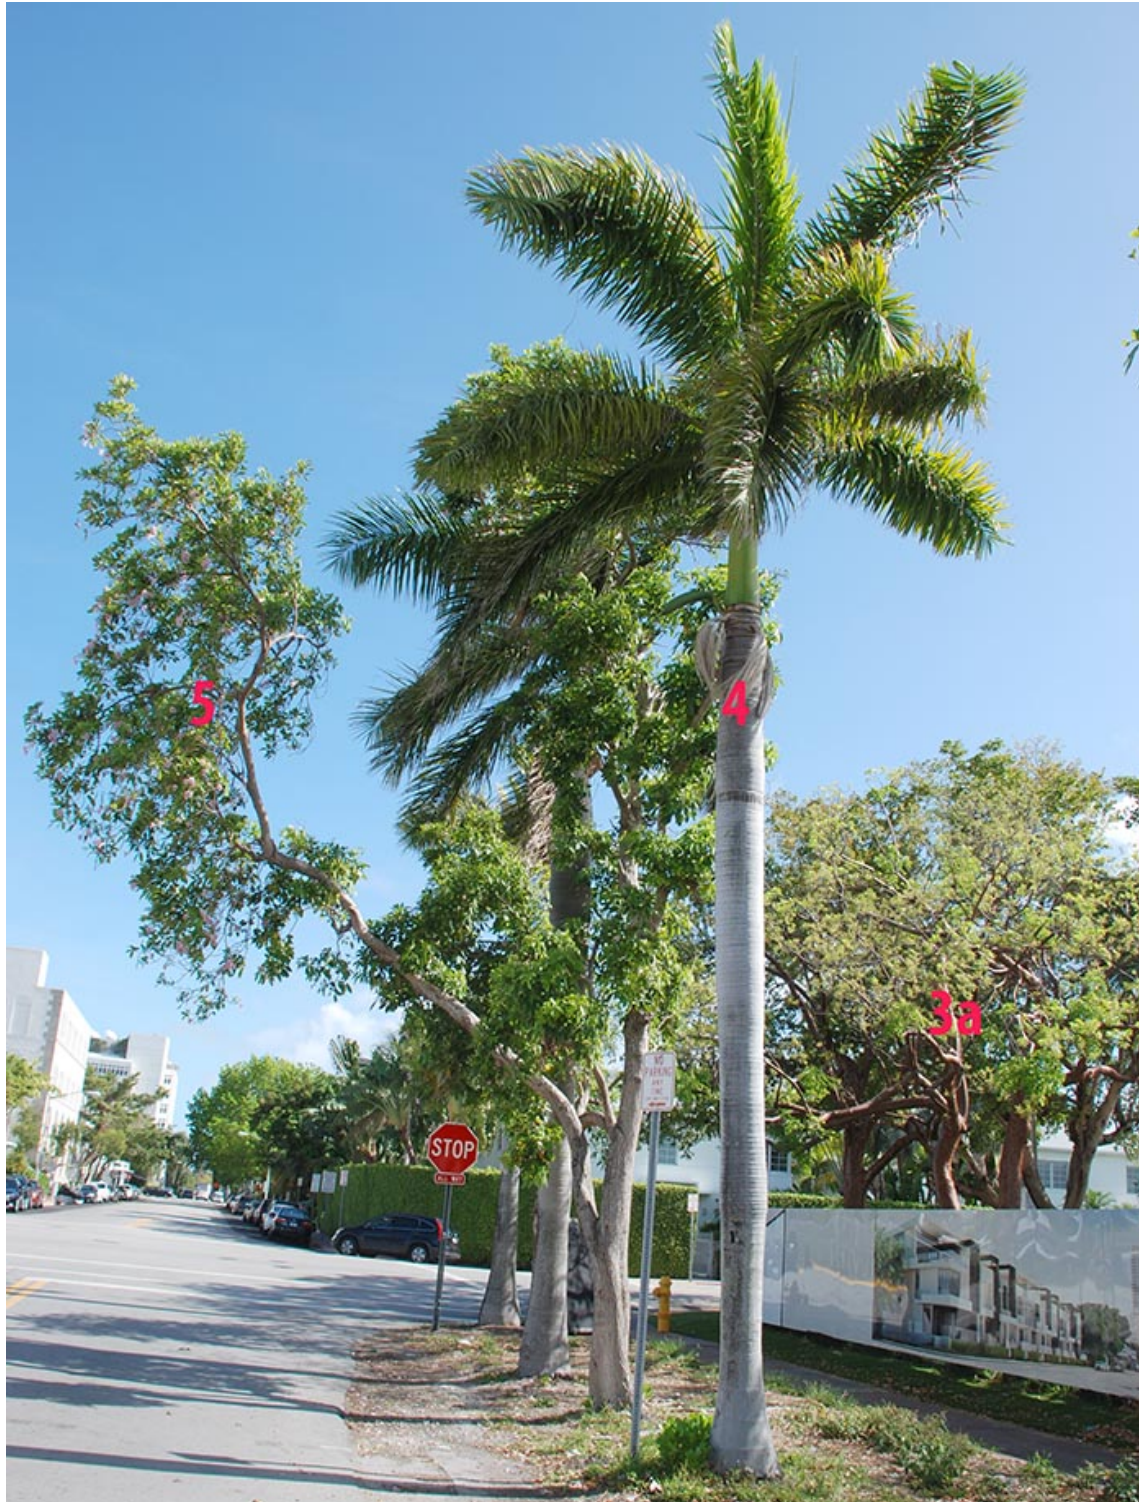
**Photo 2 above is palm 4 and tree 5 viewed from the south. The over-extended canopy branch over the road needs to be reduced about 15 to 18 feet or more to keep it out of the roadway.**

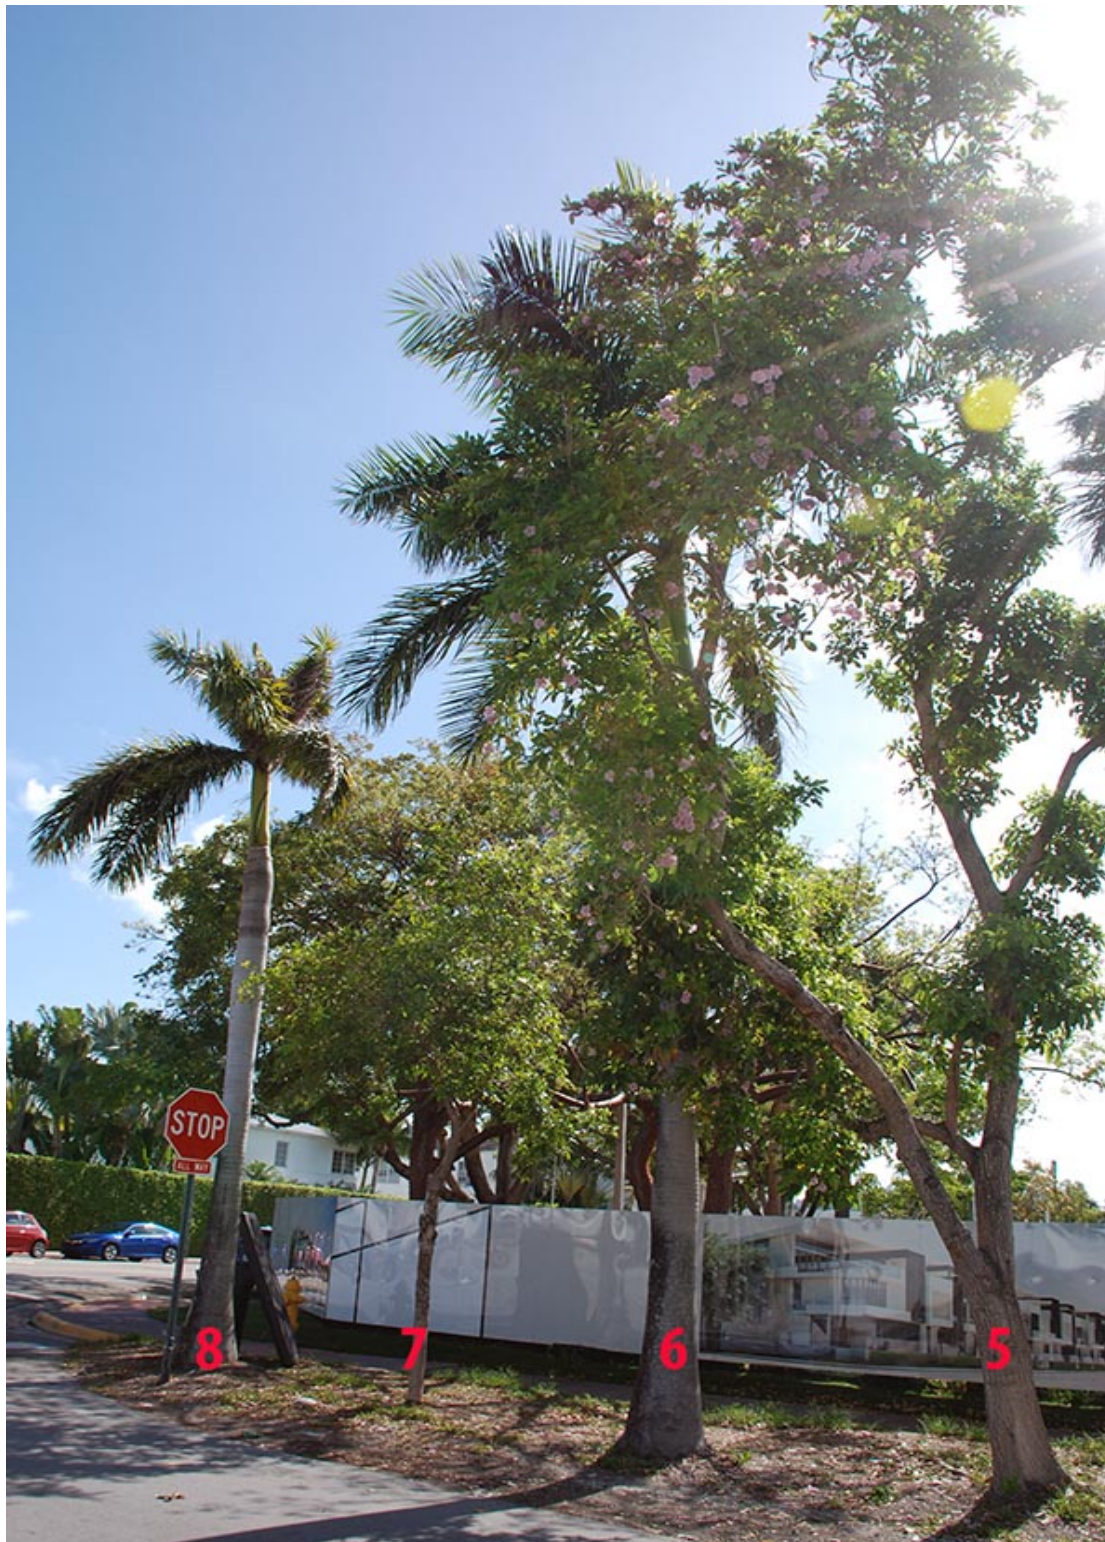
**Photo 3 above is tree 5 & 7 and palms 6 & 8.**

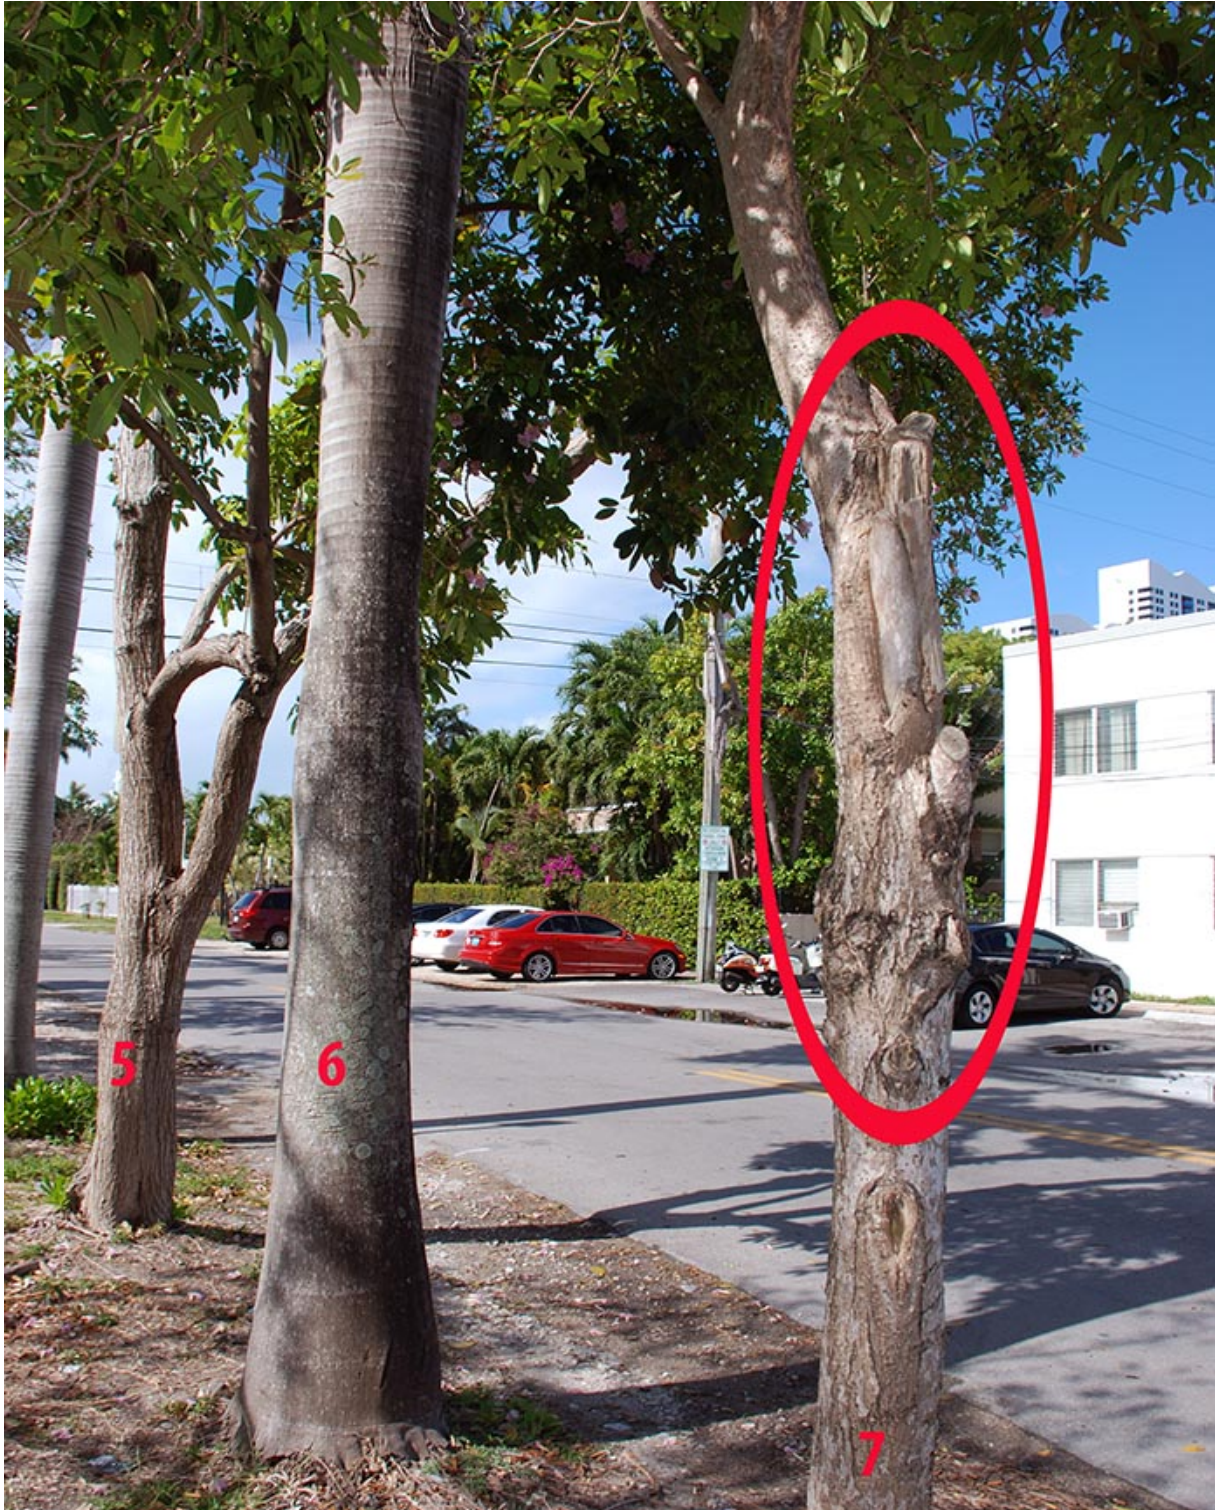
**Photo 4 above is the trunk of tree 7 showing extensive damage. This tree should be removed.**

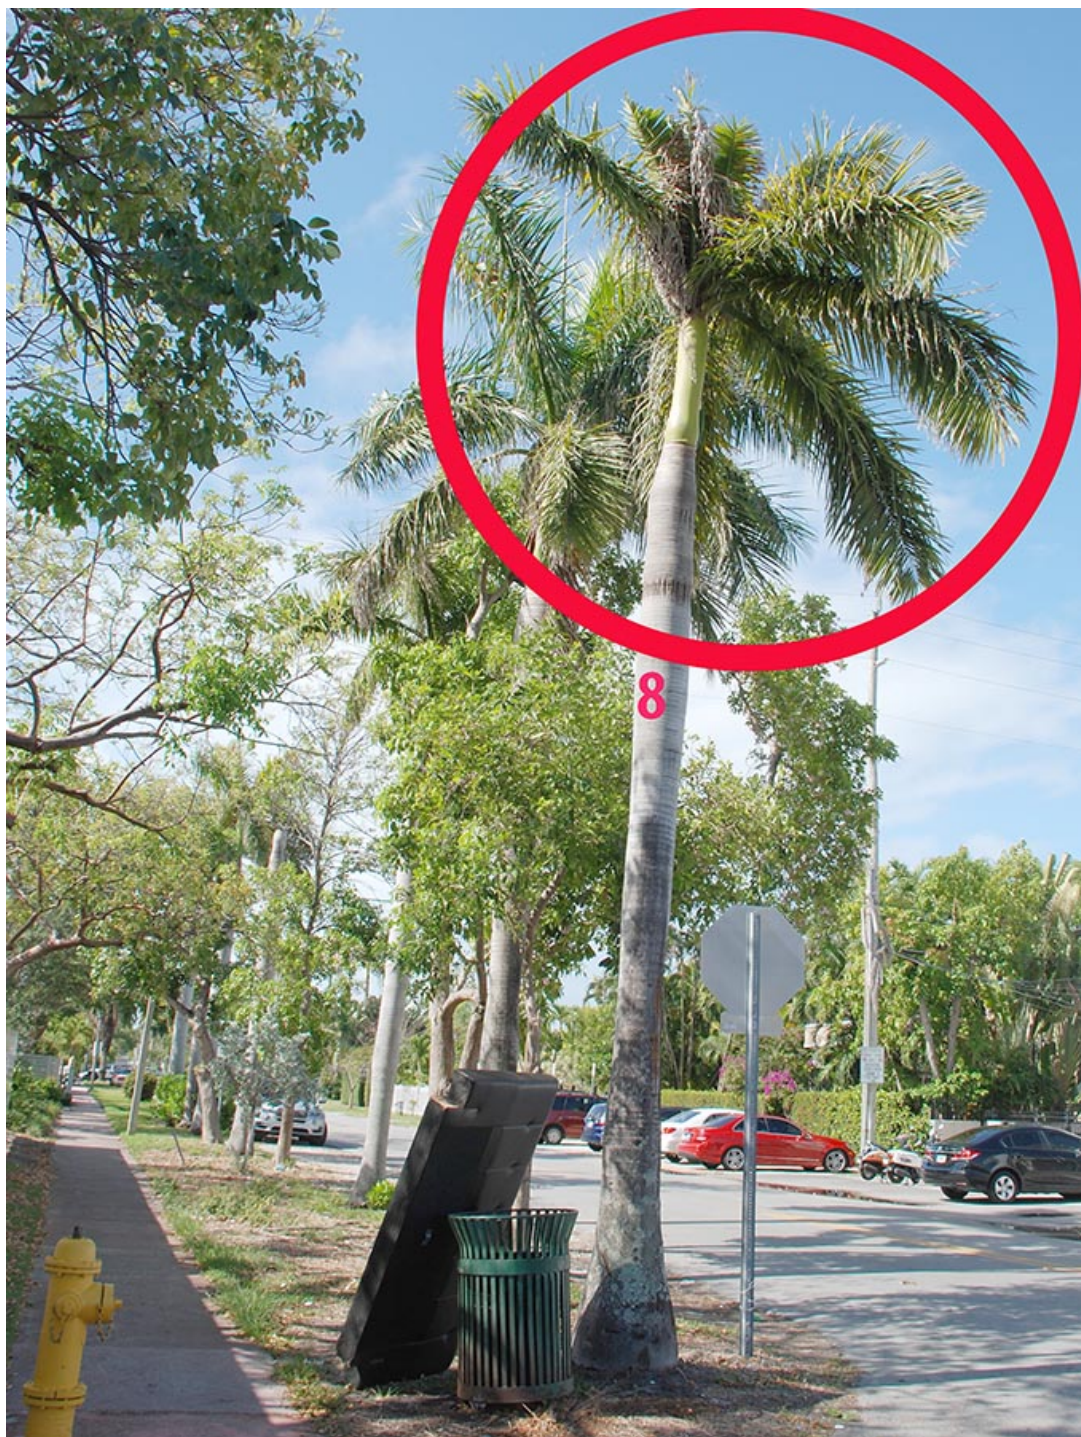
**Photo 5 above is palm 8 showing signs of a severe non-correctable nutrient deficiency. This palm should be removed.**

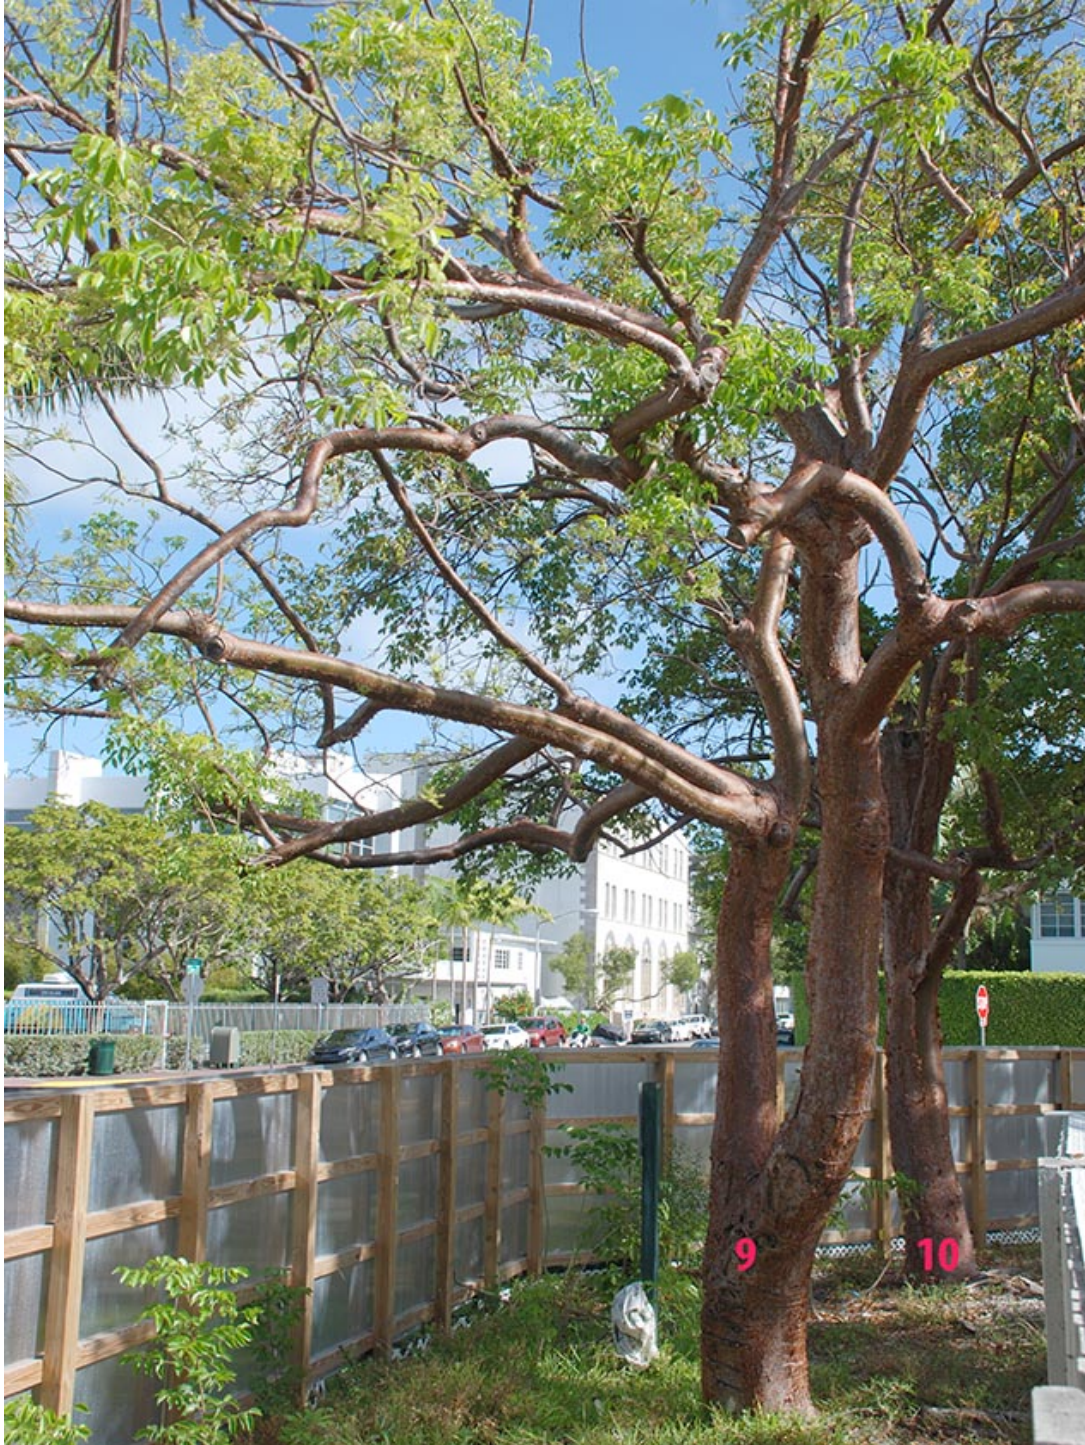
**Photo 6 above is trees 9 & 10 viewed from the south.**

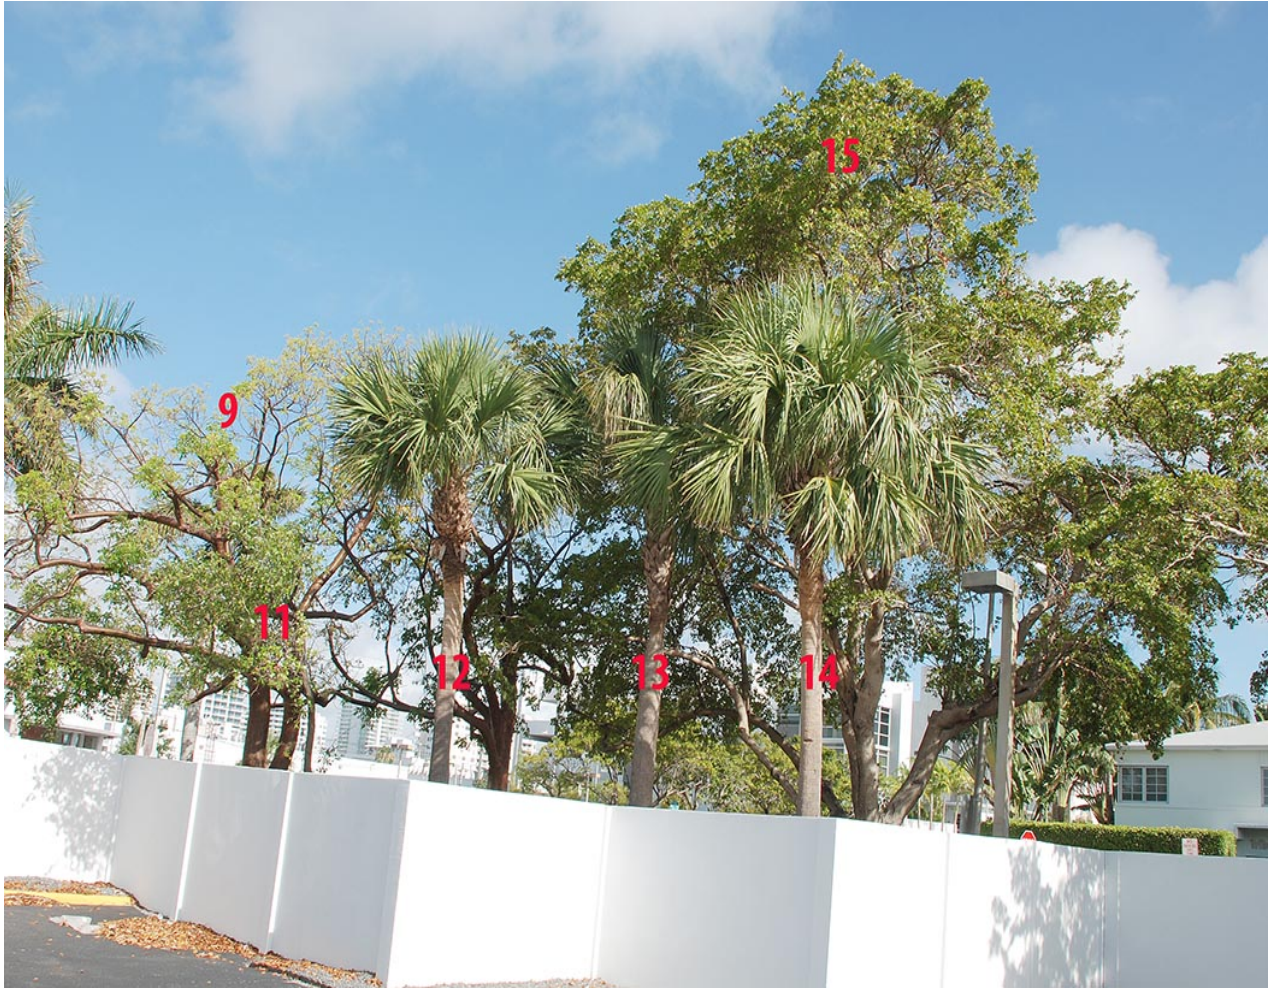
**Photo 7 above is the northwest corner of the property.**

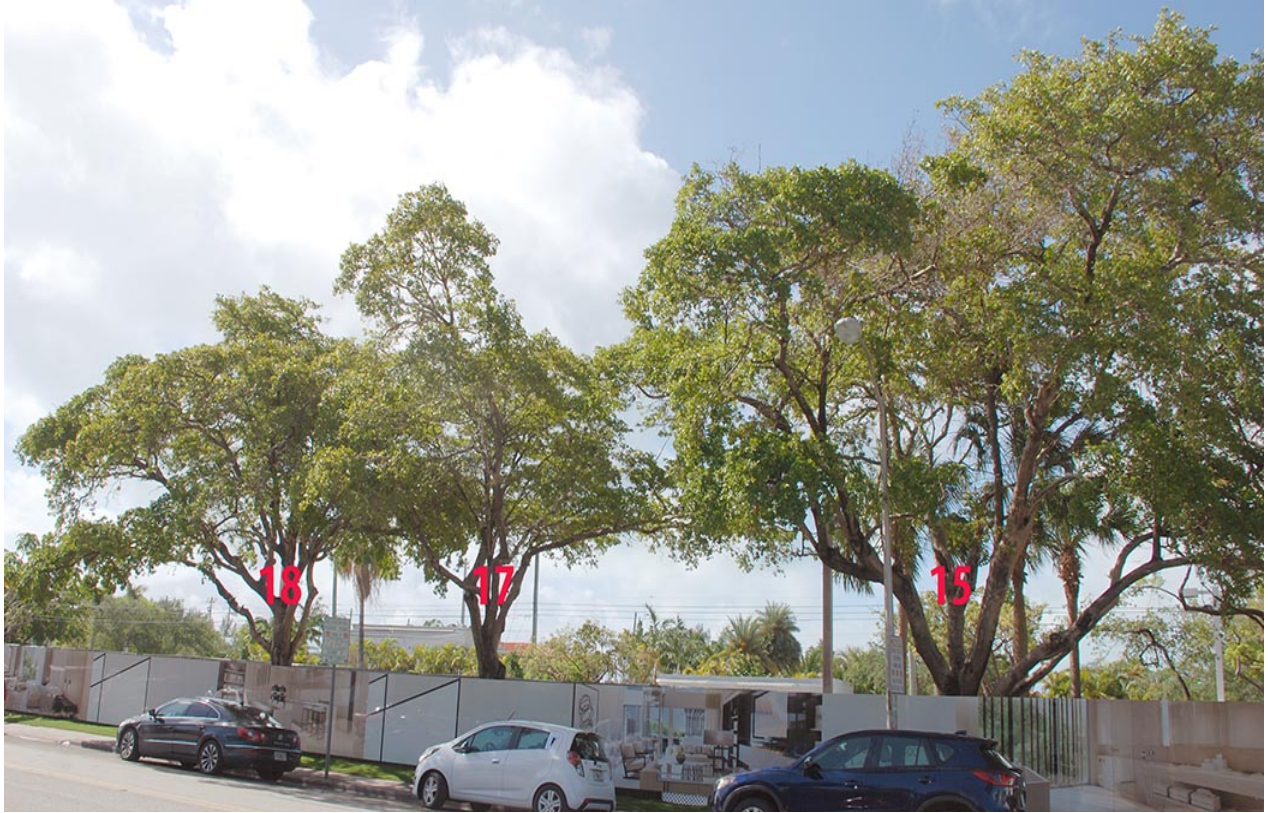
**Photo 8 above is trees 15, 17 & 18 viewed from the northwest.**

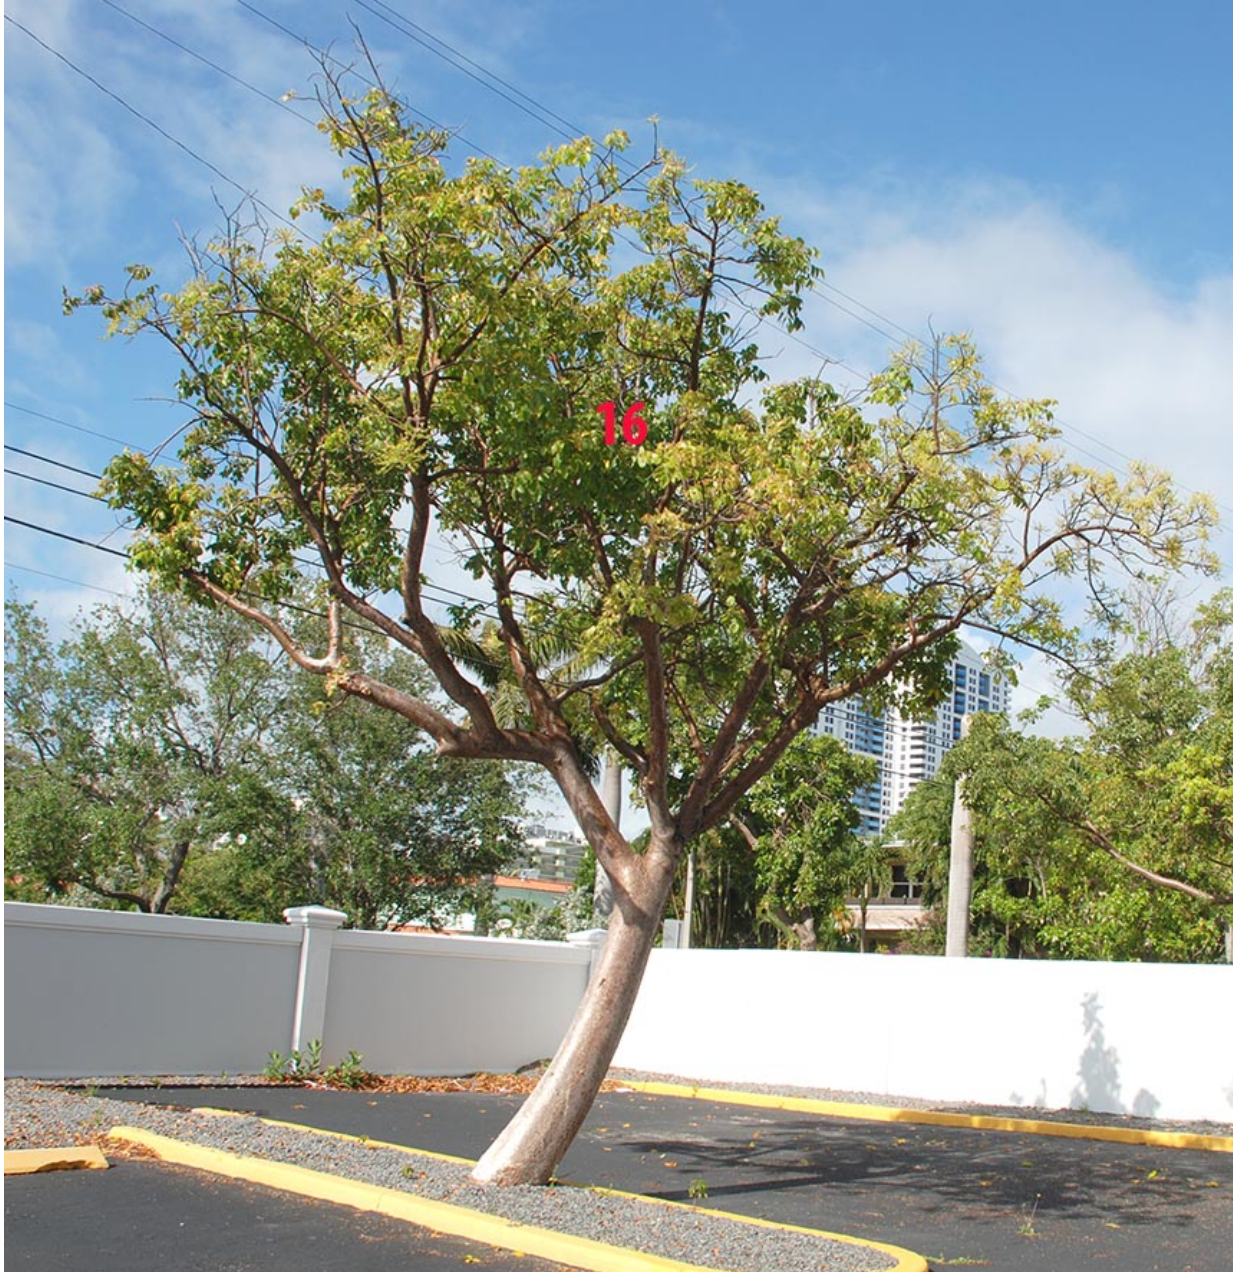
**Photo 9 above is tree 16 growing in a planter that is too small for this species of tree.**

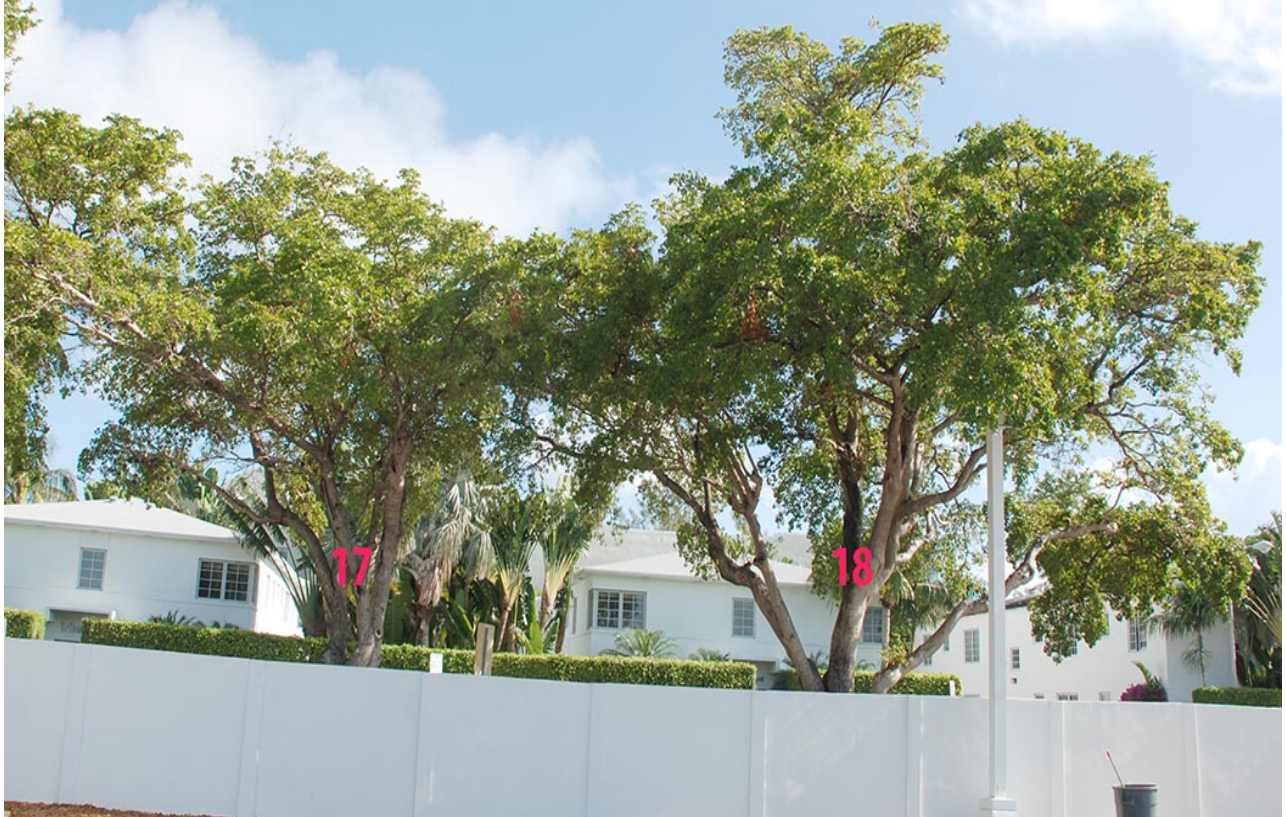
**Photo 10 above is trees 17 & 18 viewed from the south.**

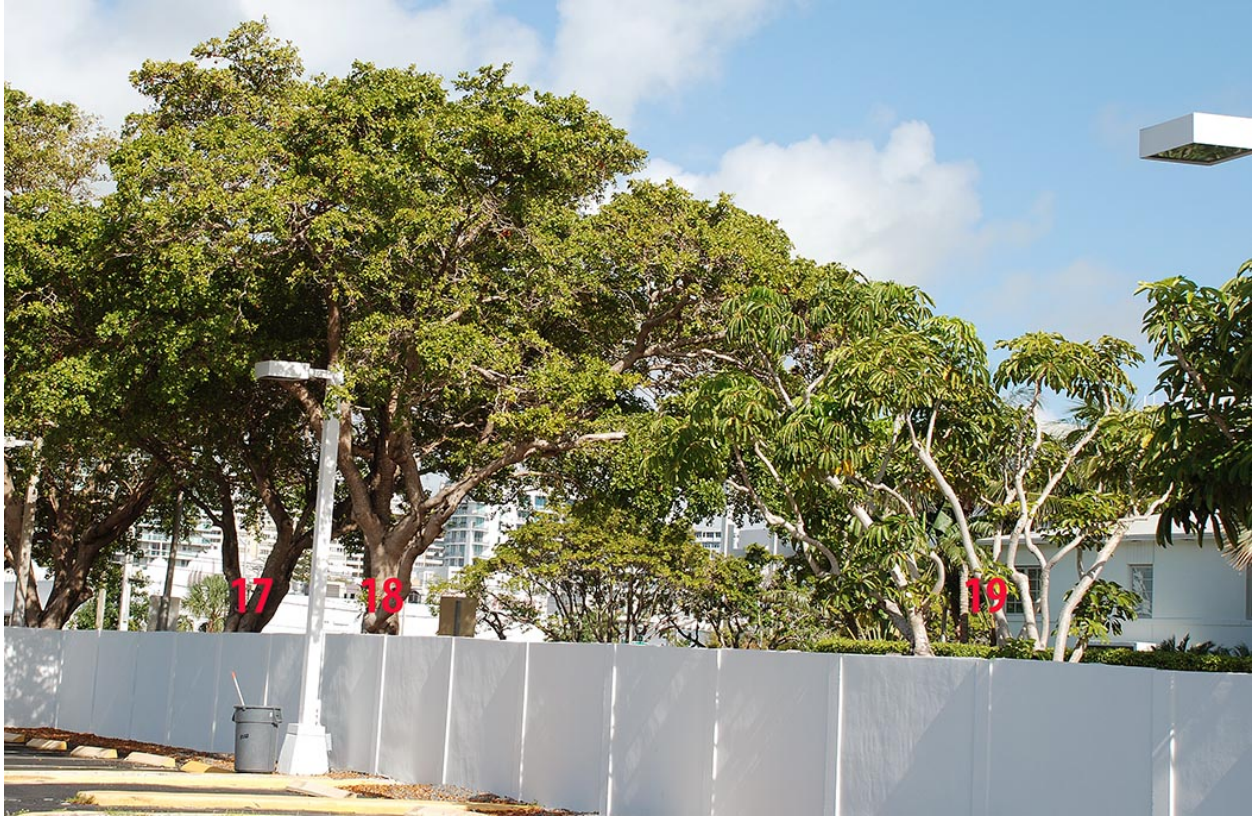
**Photo 11 above is tree 19 an invasive species viewed from the southeast.**

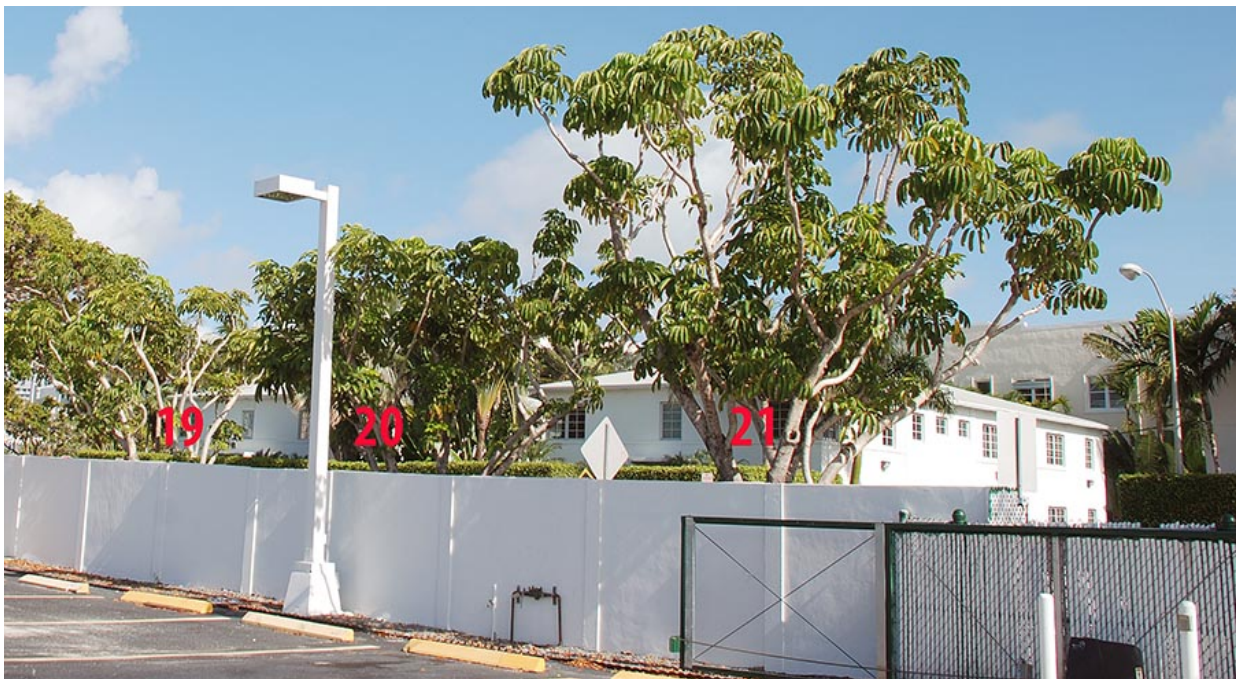
**Photo 12 above is invasive species 19, 20 & 21.**

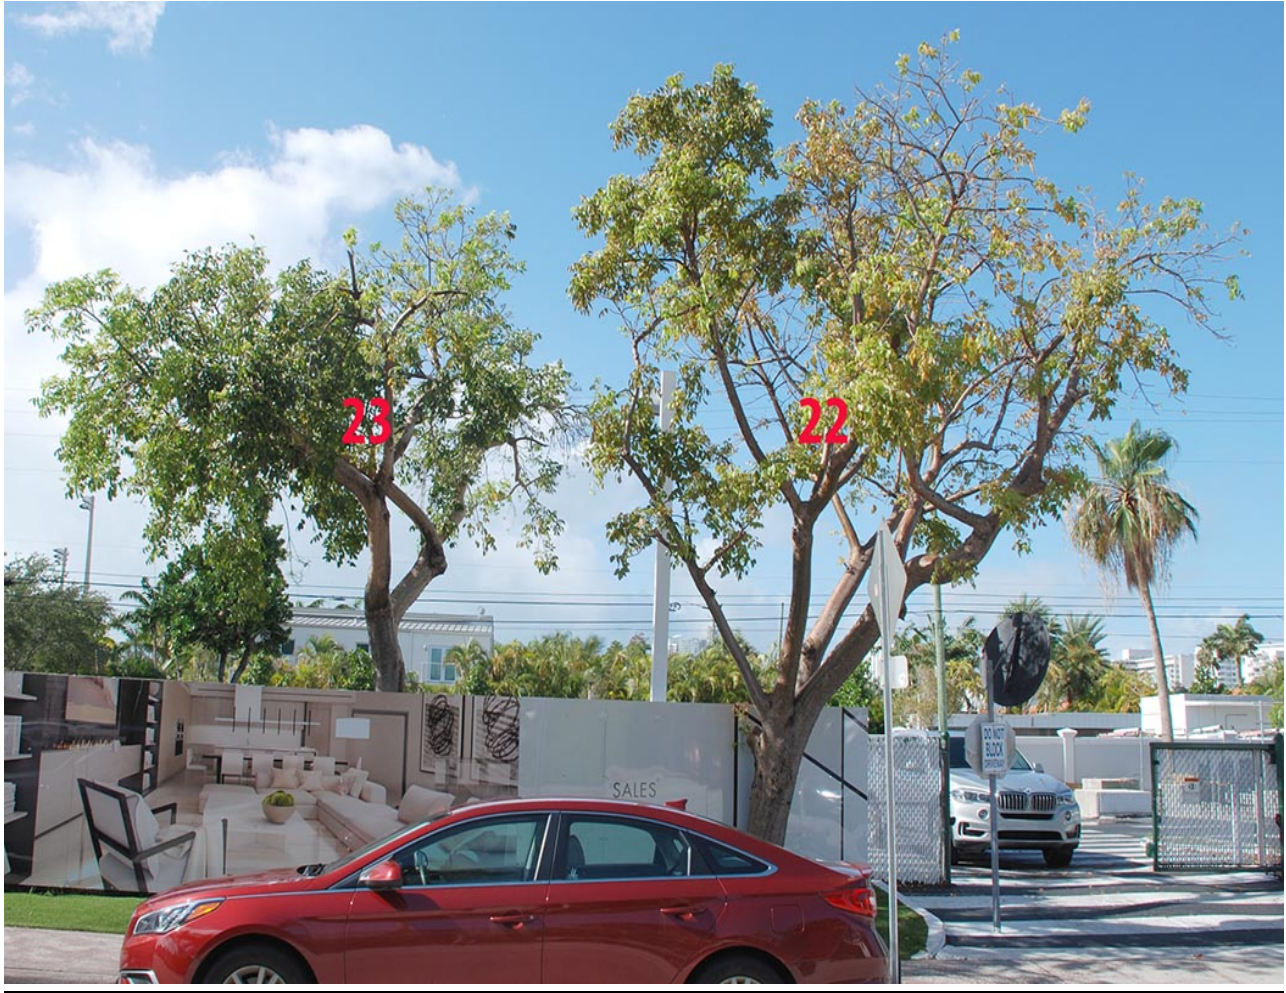
**Photo 13 above is trees 22 & 23 viewed from the south.**

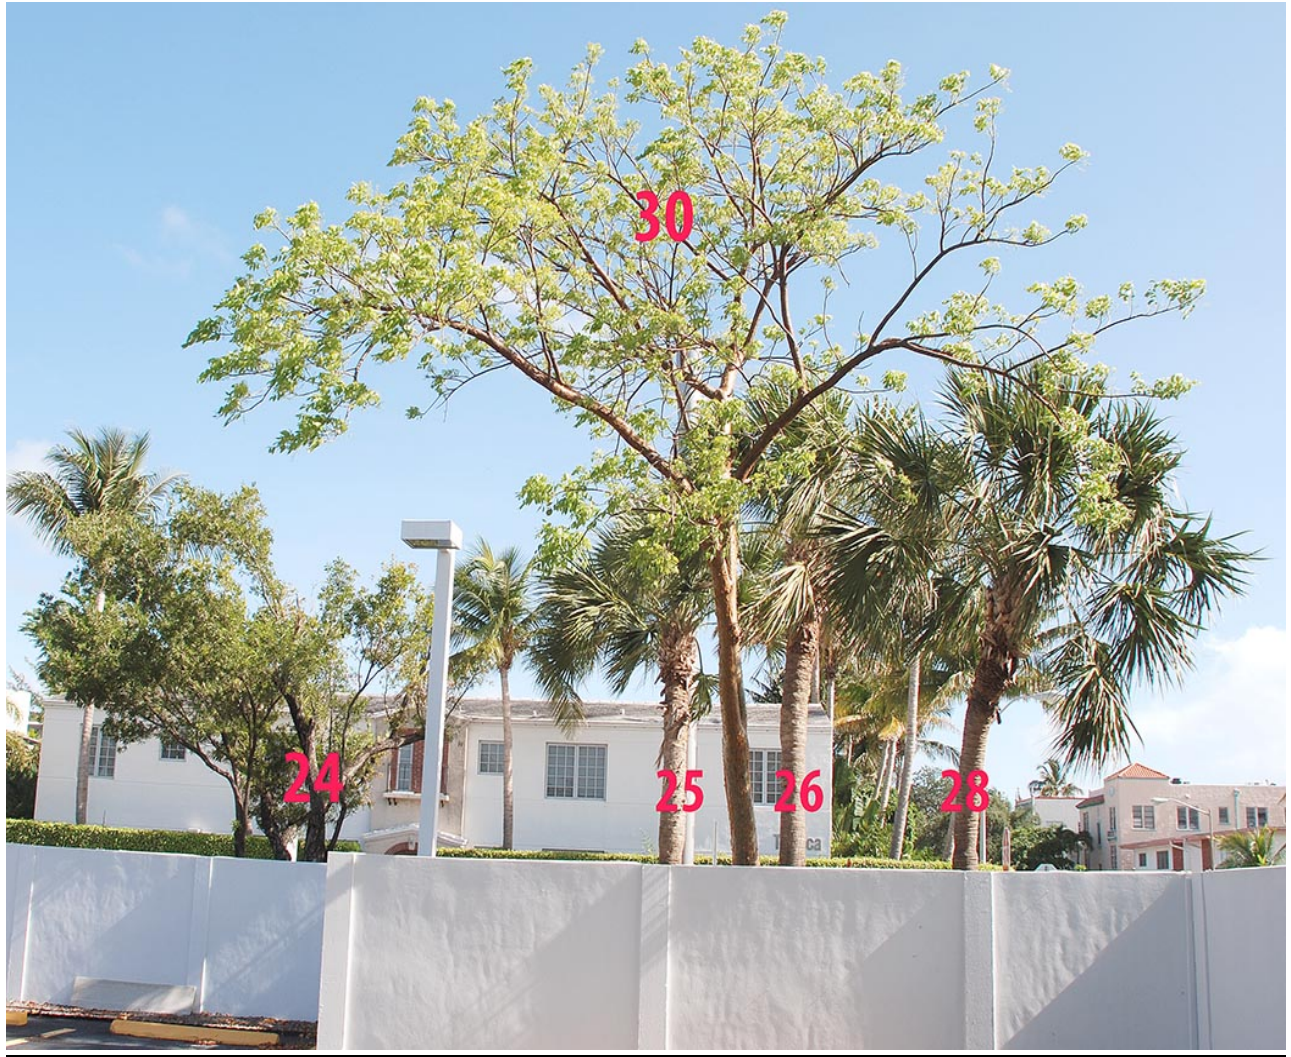
**Photo 14 above is the northeast corner of the property viewed from the south.**

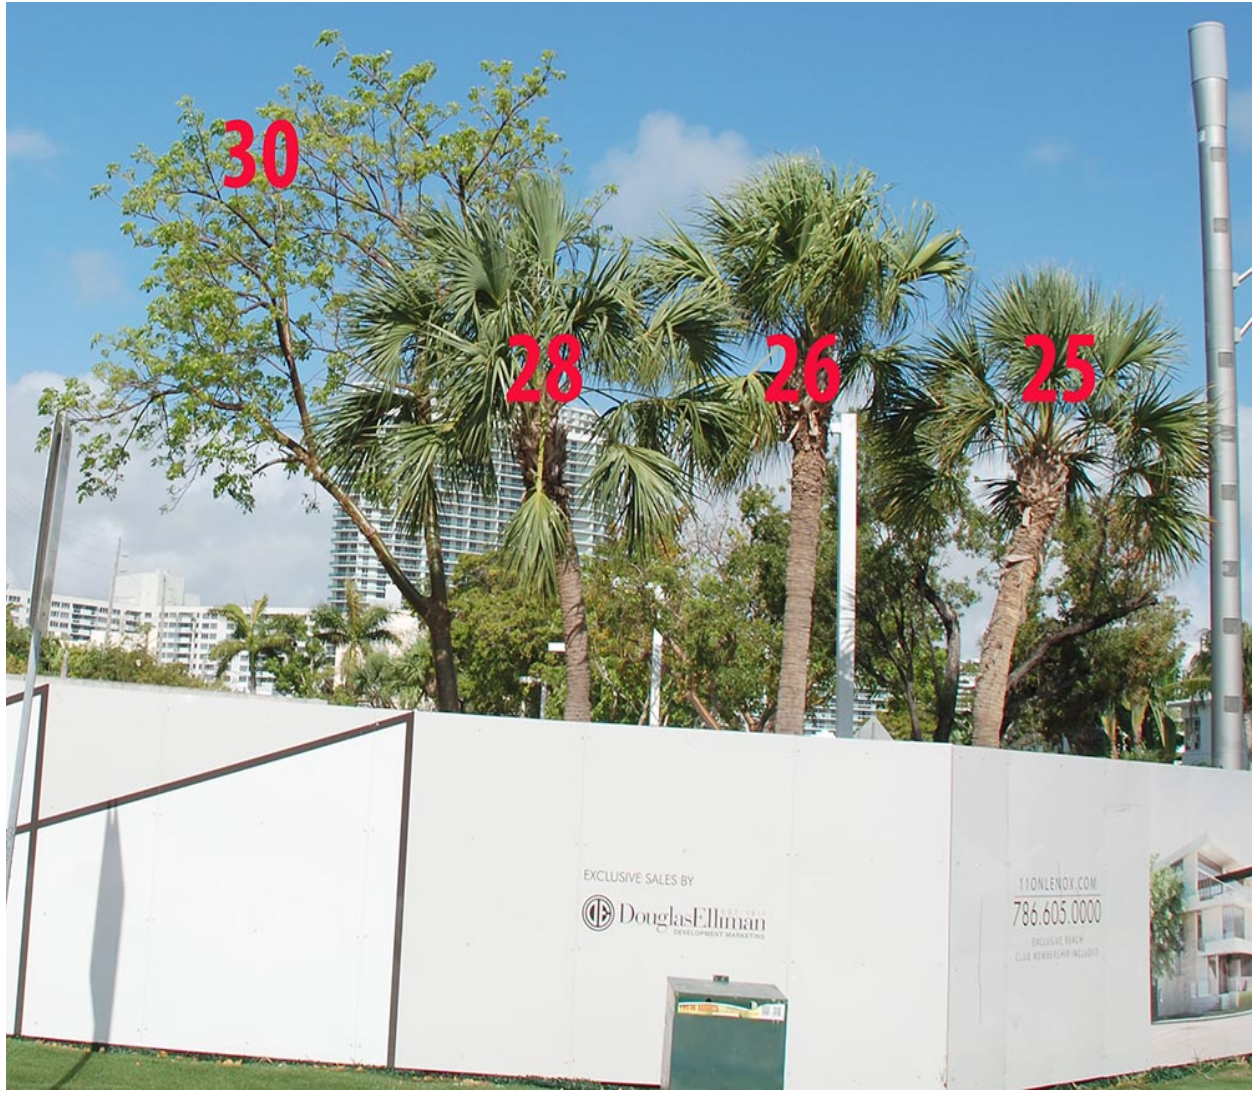
**Photo 15 above is the northeast corner of the site viewed from the east.**

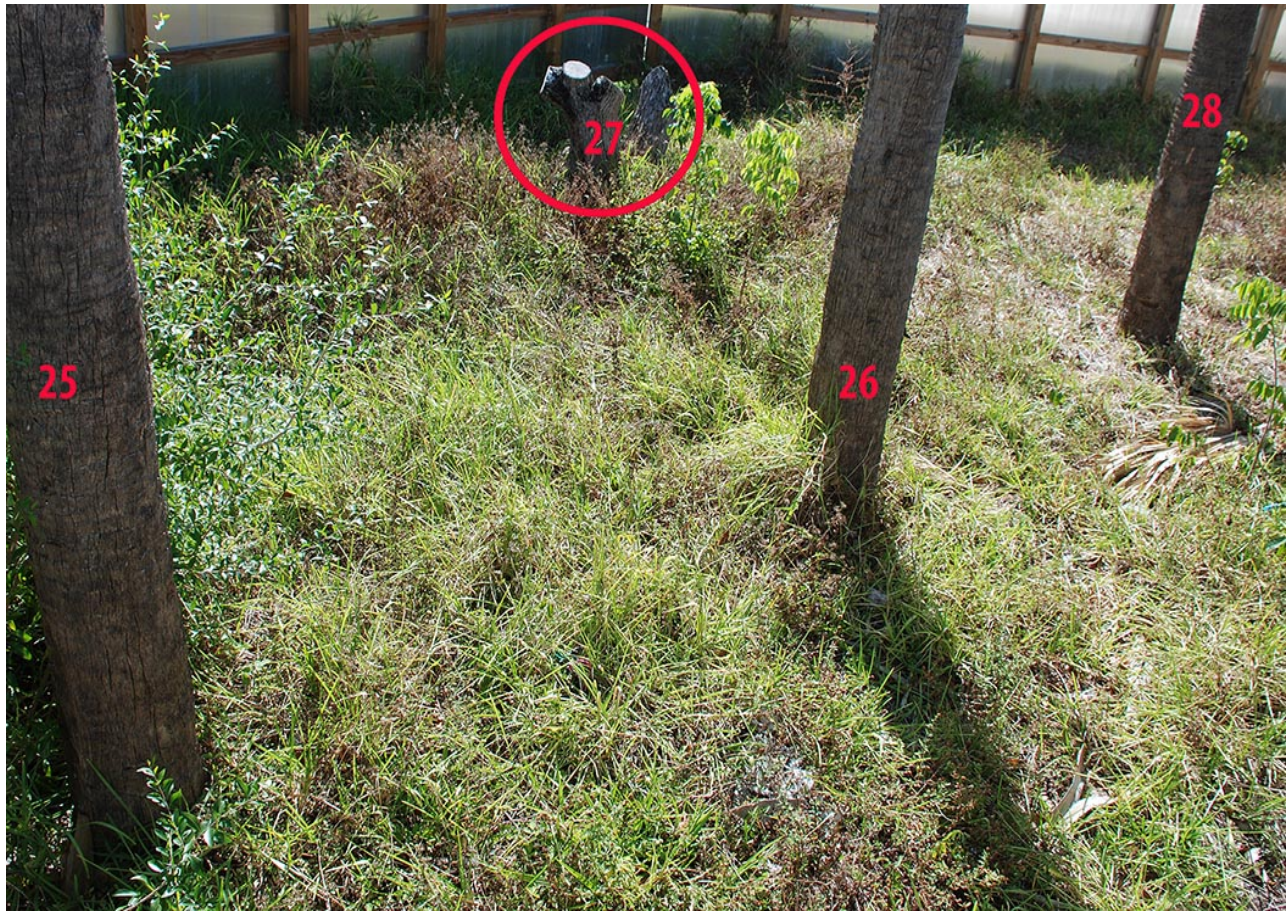
**Photo 16 above shows cut trunk 27.**
