# ***Tree Resource Evaluation for 1030 15<sup>th</sup> Street, Miami Beach***

***May 6, 2018***

## **Summary**

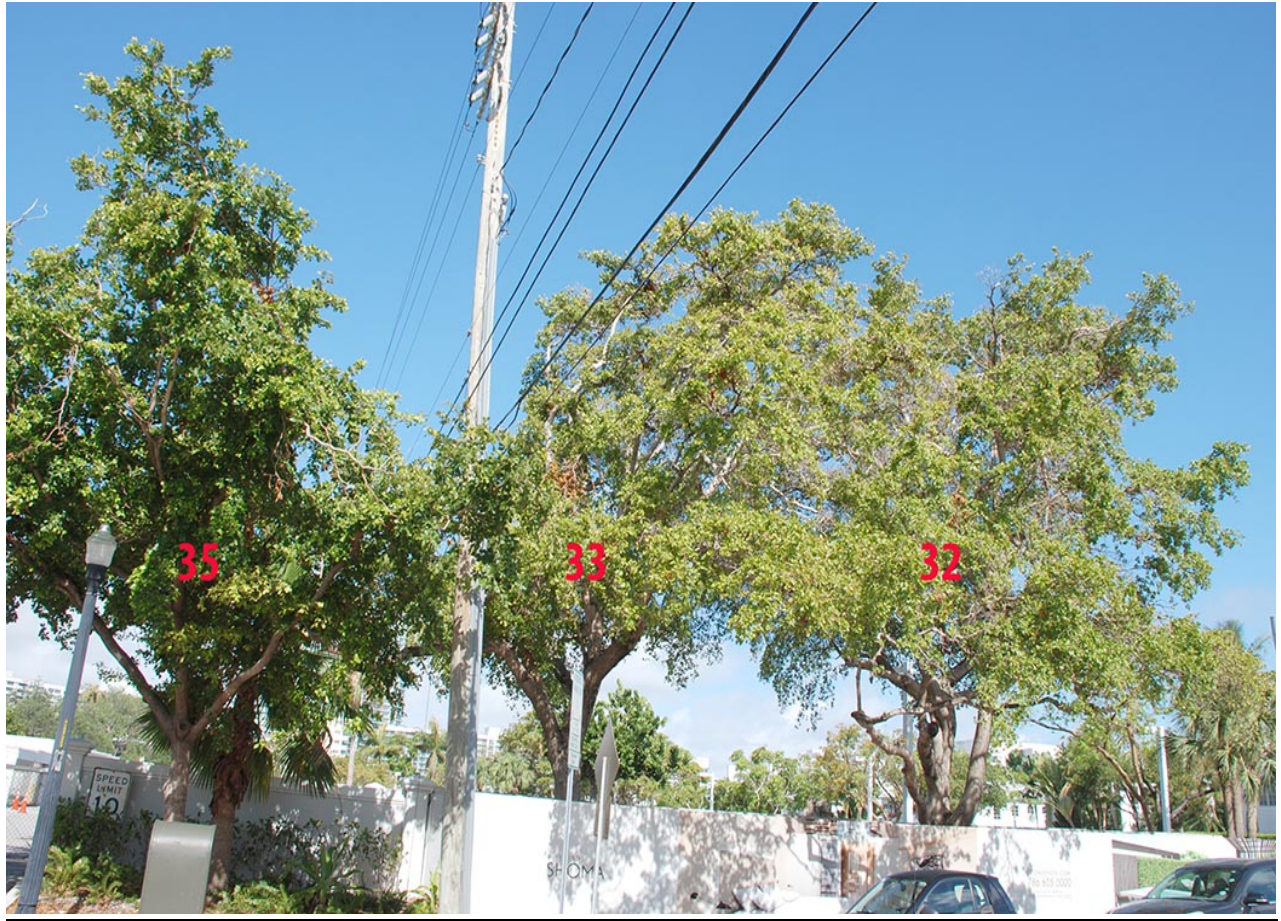
**Photo 17 above is trees 32, 33 & 35 viewed from the east. Note that tree 33 & 35 are growing into the powerlines.**

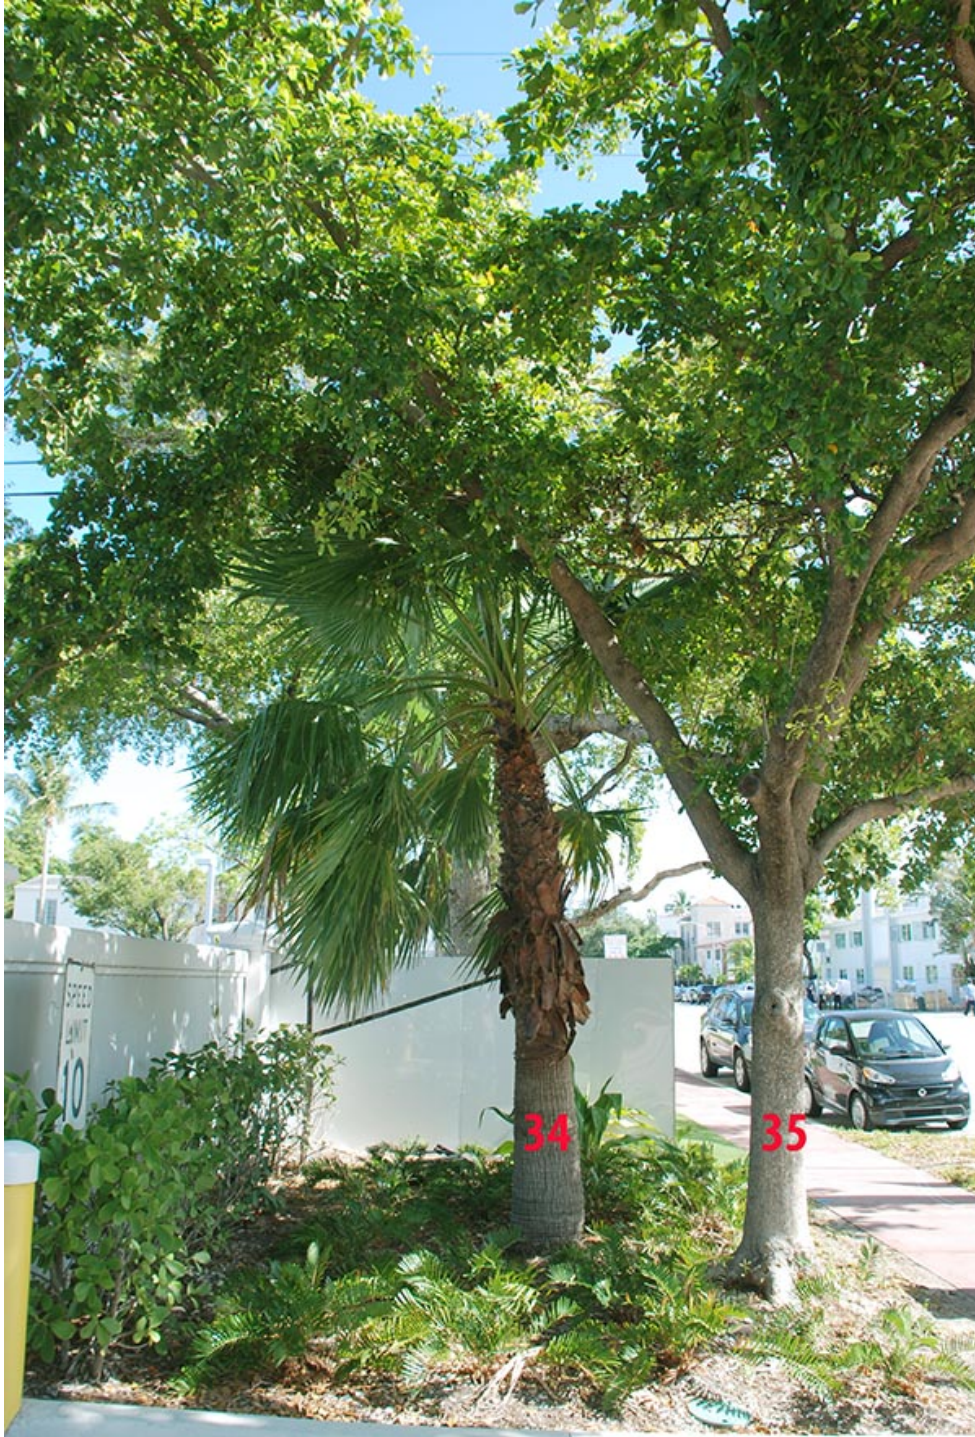
**Photo 18 above is palm 34 & tree 35 viewed from the south.**

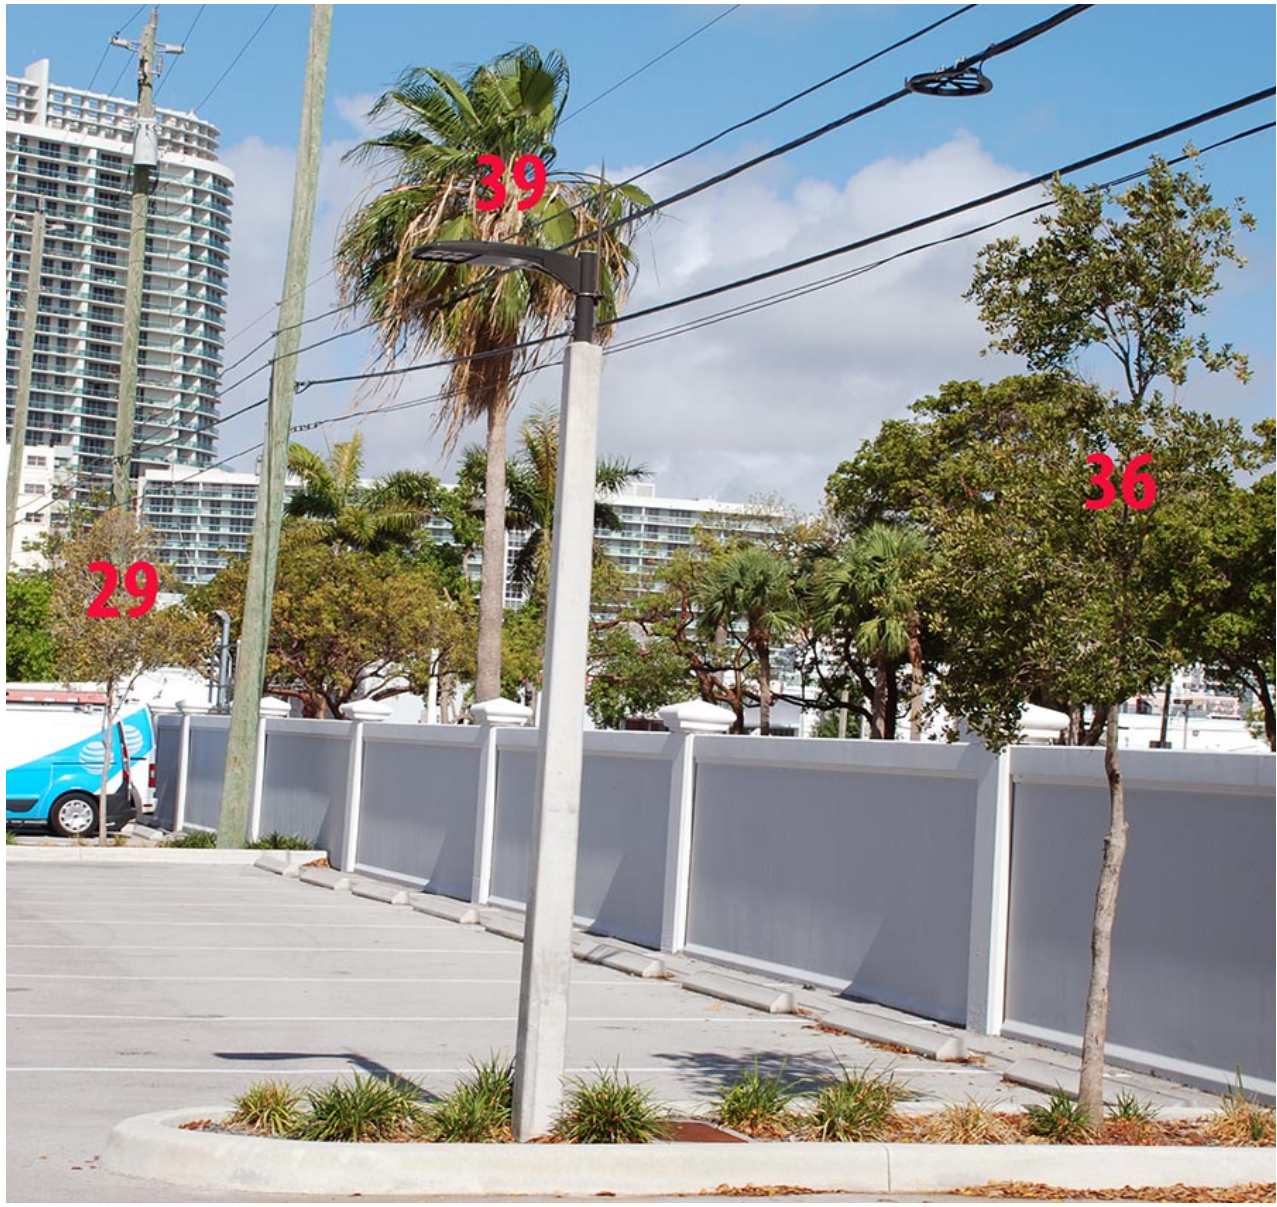
**Photo 19 above is trees 29 & 36 viewed from the east.**

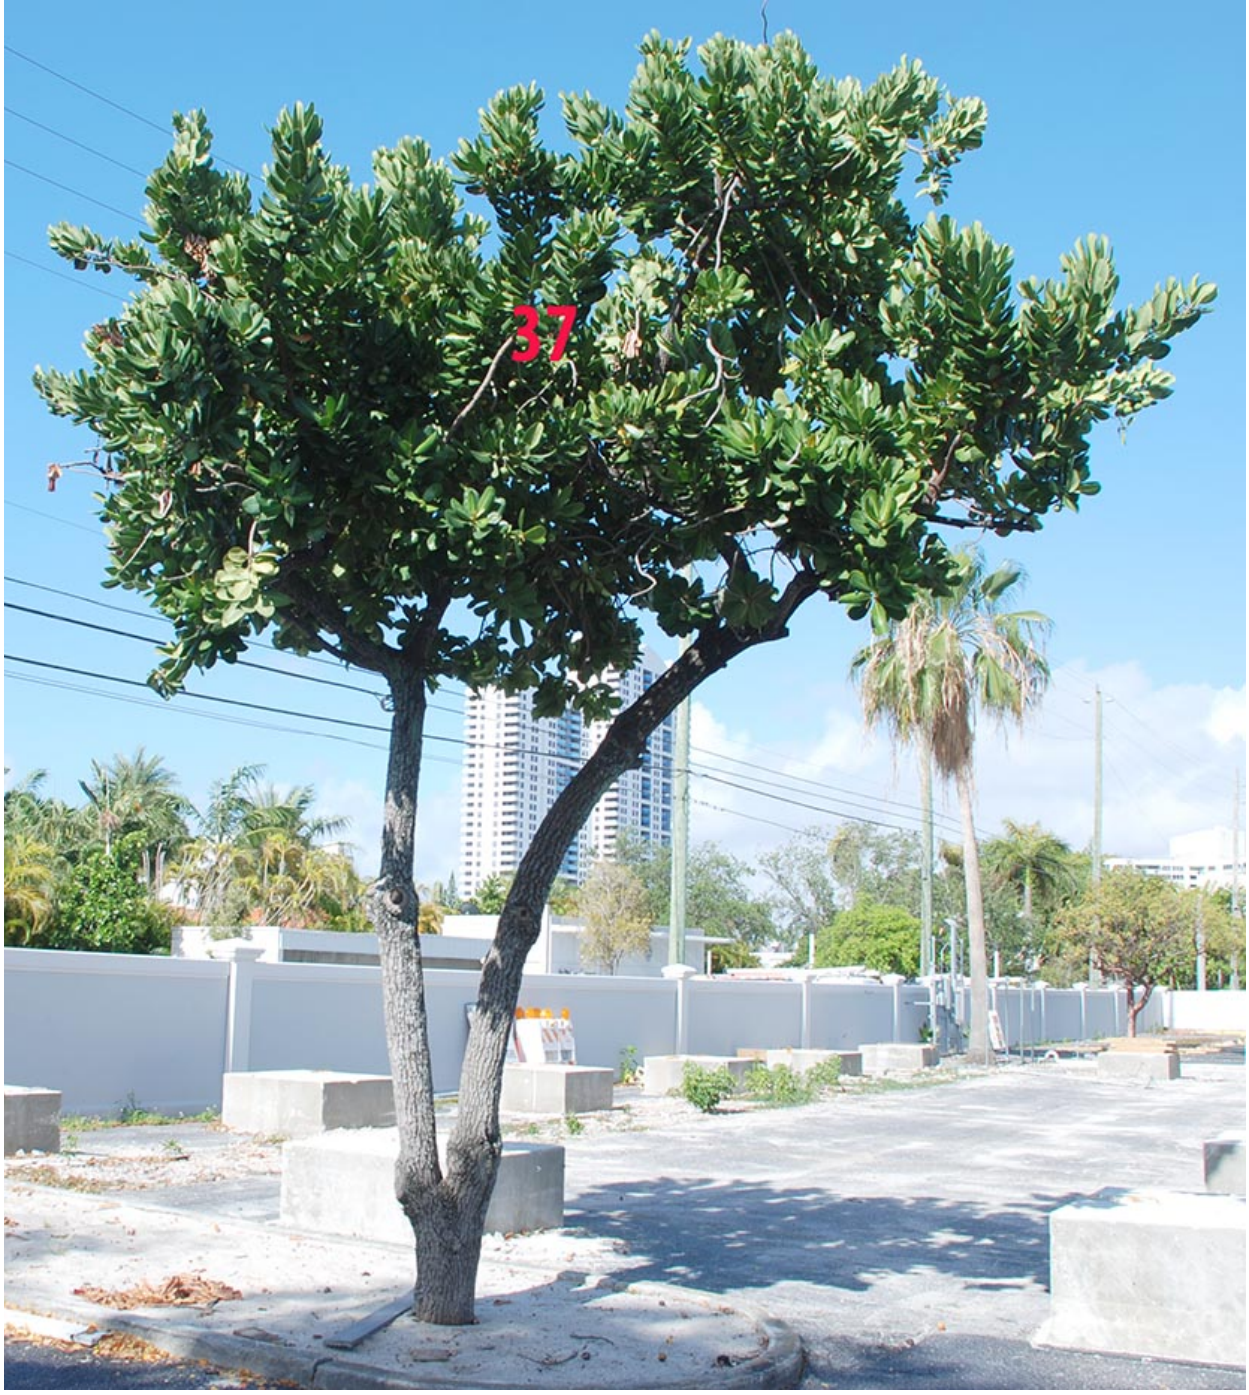
**Photo 20 above is tree 37 viewed from the east. This tree is growing in a planter that is too small for this species of tree.**

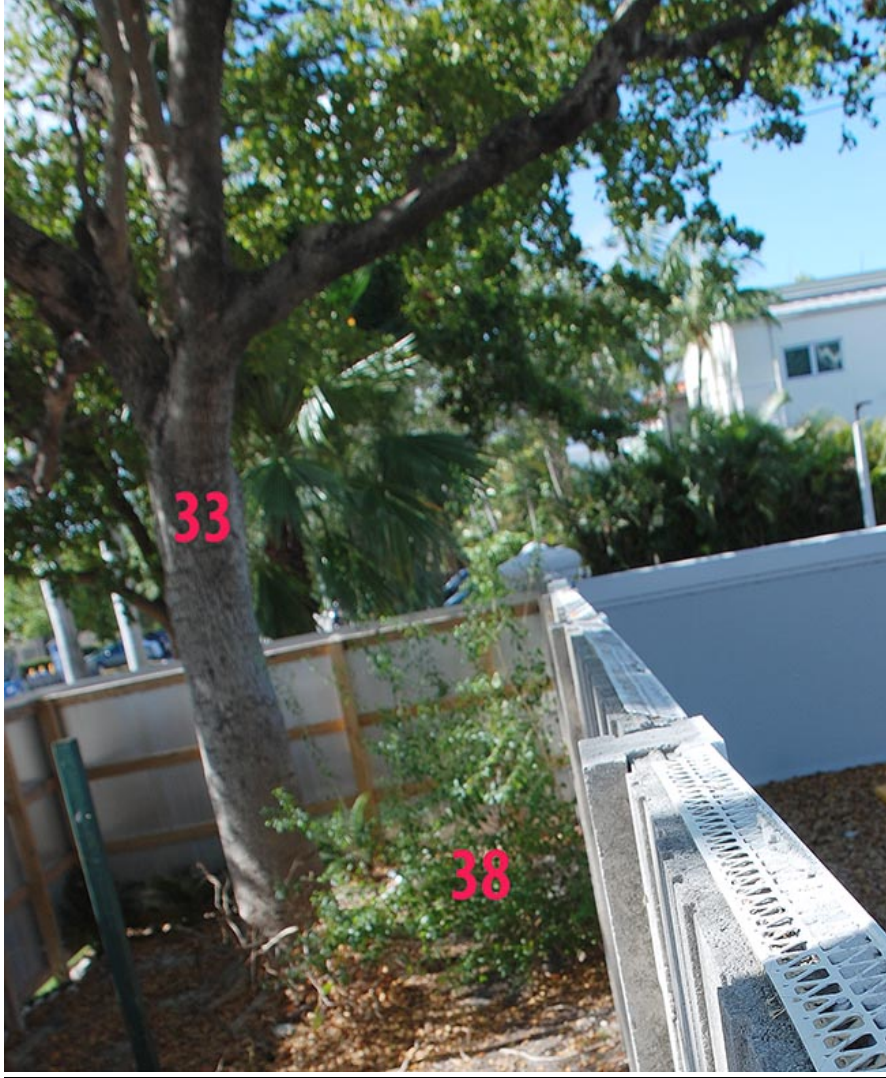
**Photo 21 above shows shrub 38. This is not a tree.**

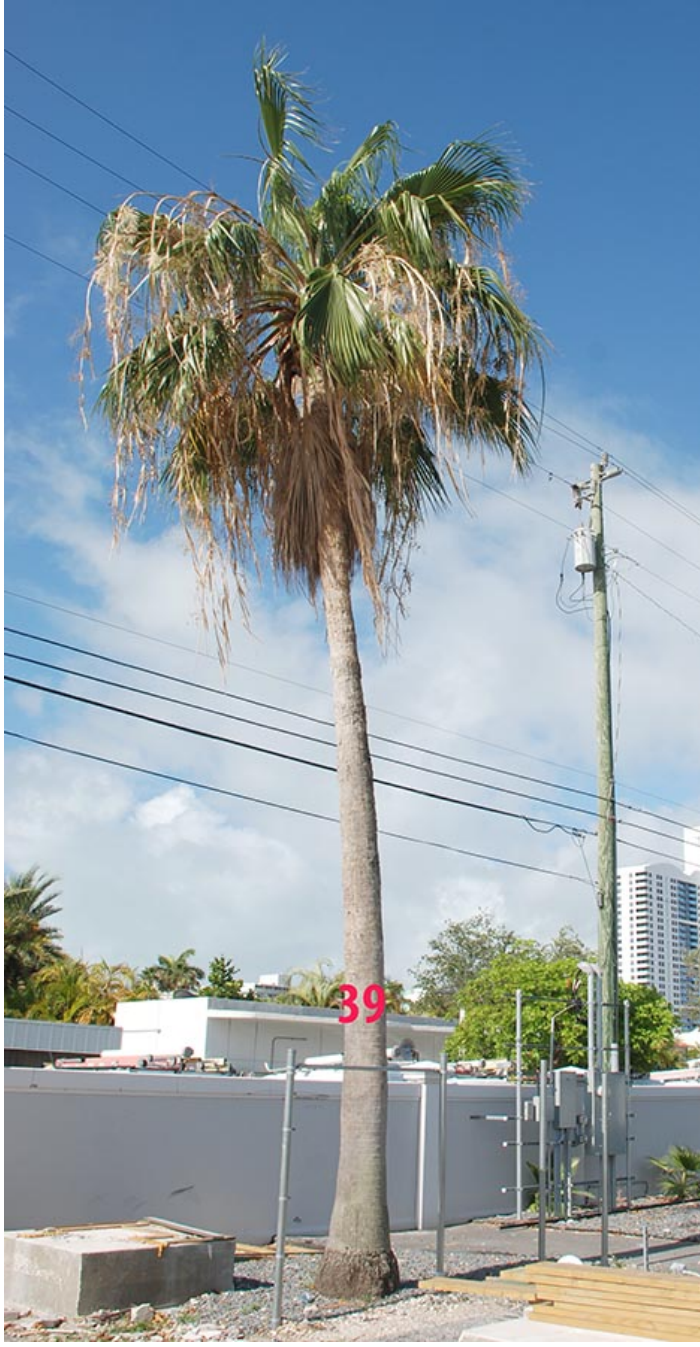
**Photo 22 above is palm 39 viewed from the east.**

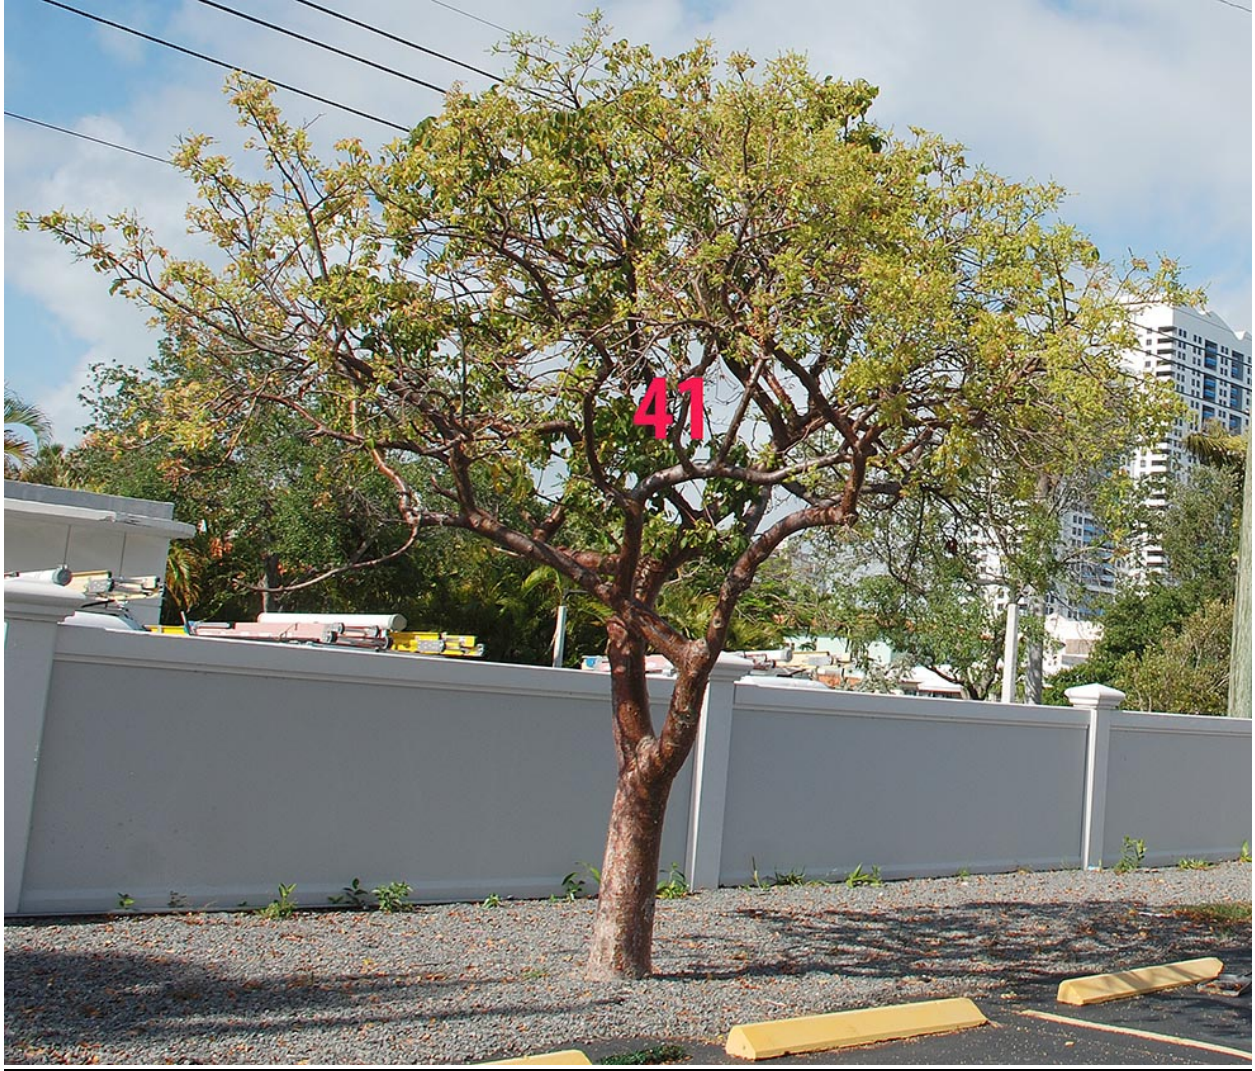
**Photo 23 above is tree 41 viewed from the northeast.**

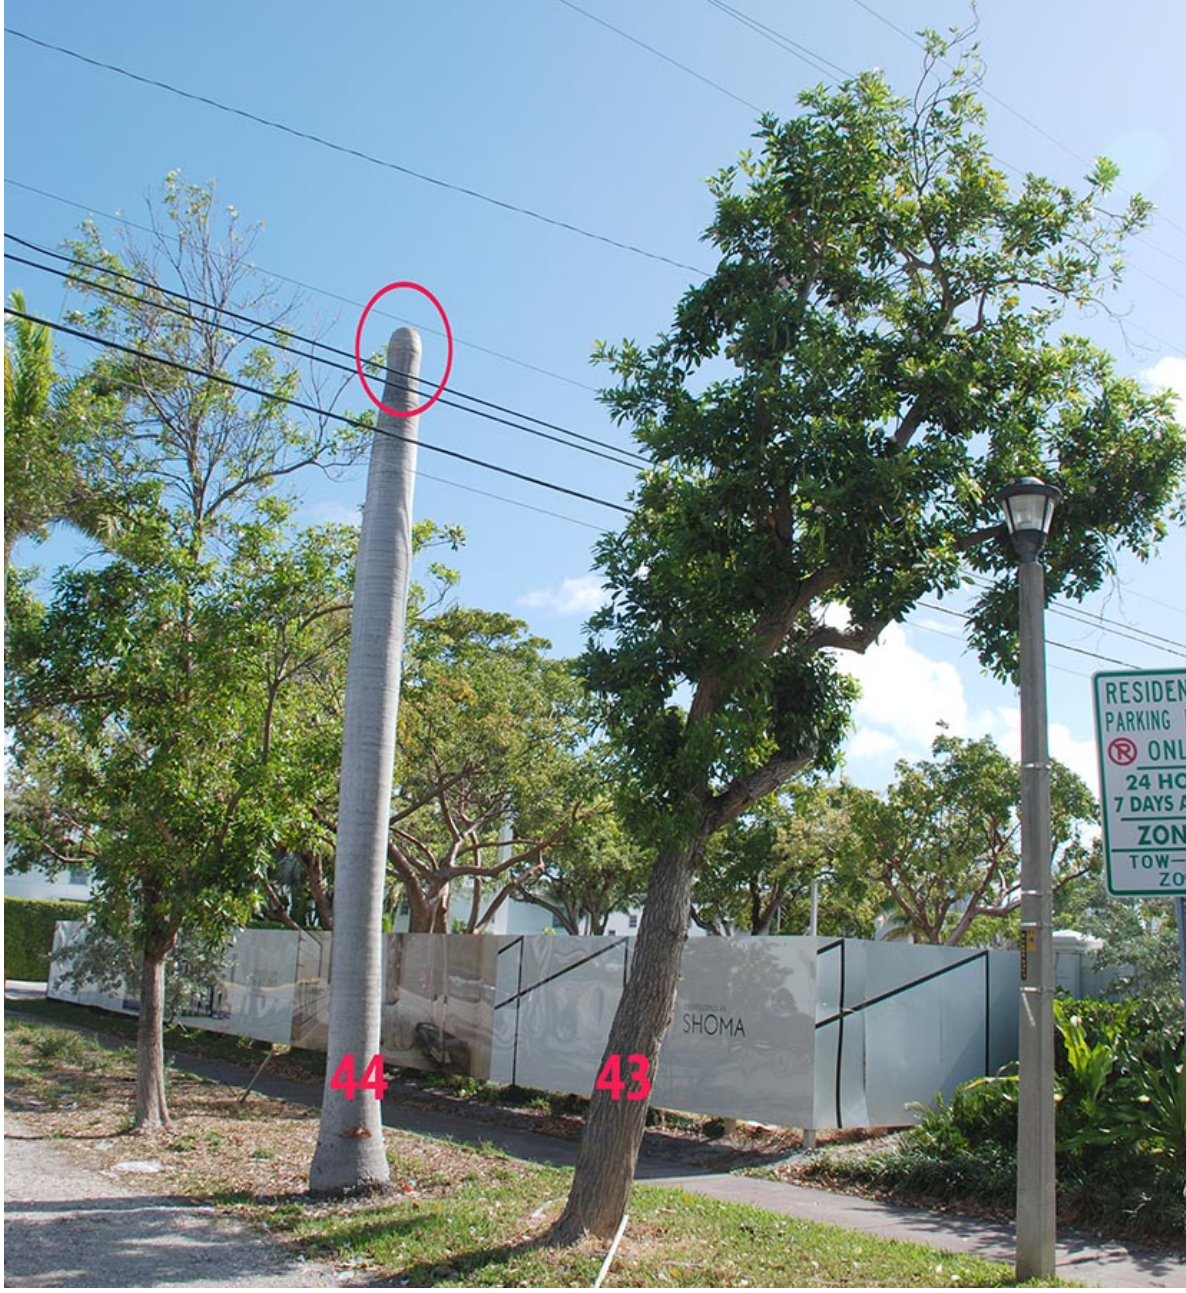
**Photo 24 above is tree 43 & palm 44 which is dead viewed from the south.**
