RE: 6431 Allison Road, Miami Beach, Florida
Opinion of Title Lot Split Application
Planning Board
Folio No. 02-3211-003-0100

Tree Resource Evaluation for 6431 Allison Road, Miami Beach

July 19, 2018

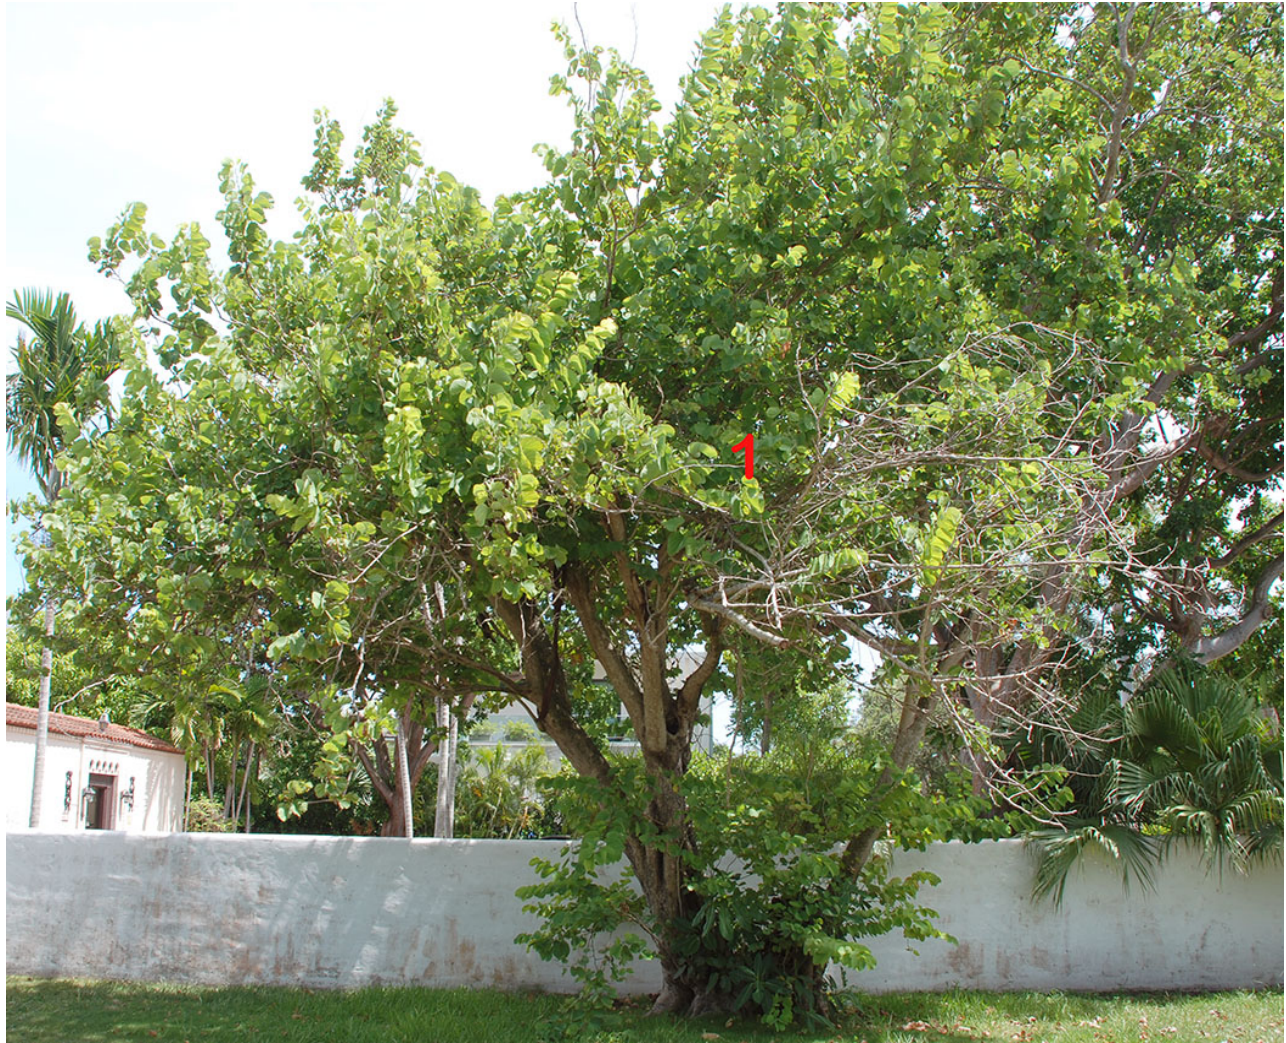
Photo 1 above is tree 1 viewed from the north. The trunk of this tree is significantly decayed on the south side. See following photo. This tree should be removed.

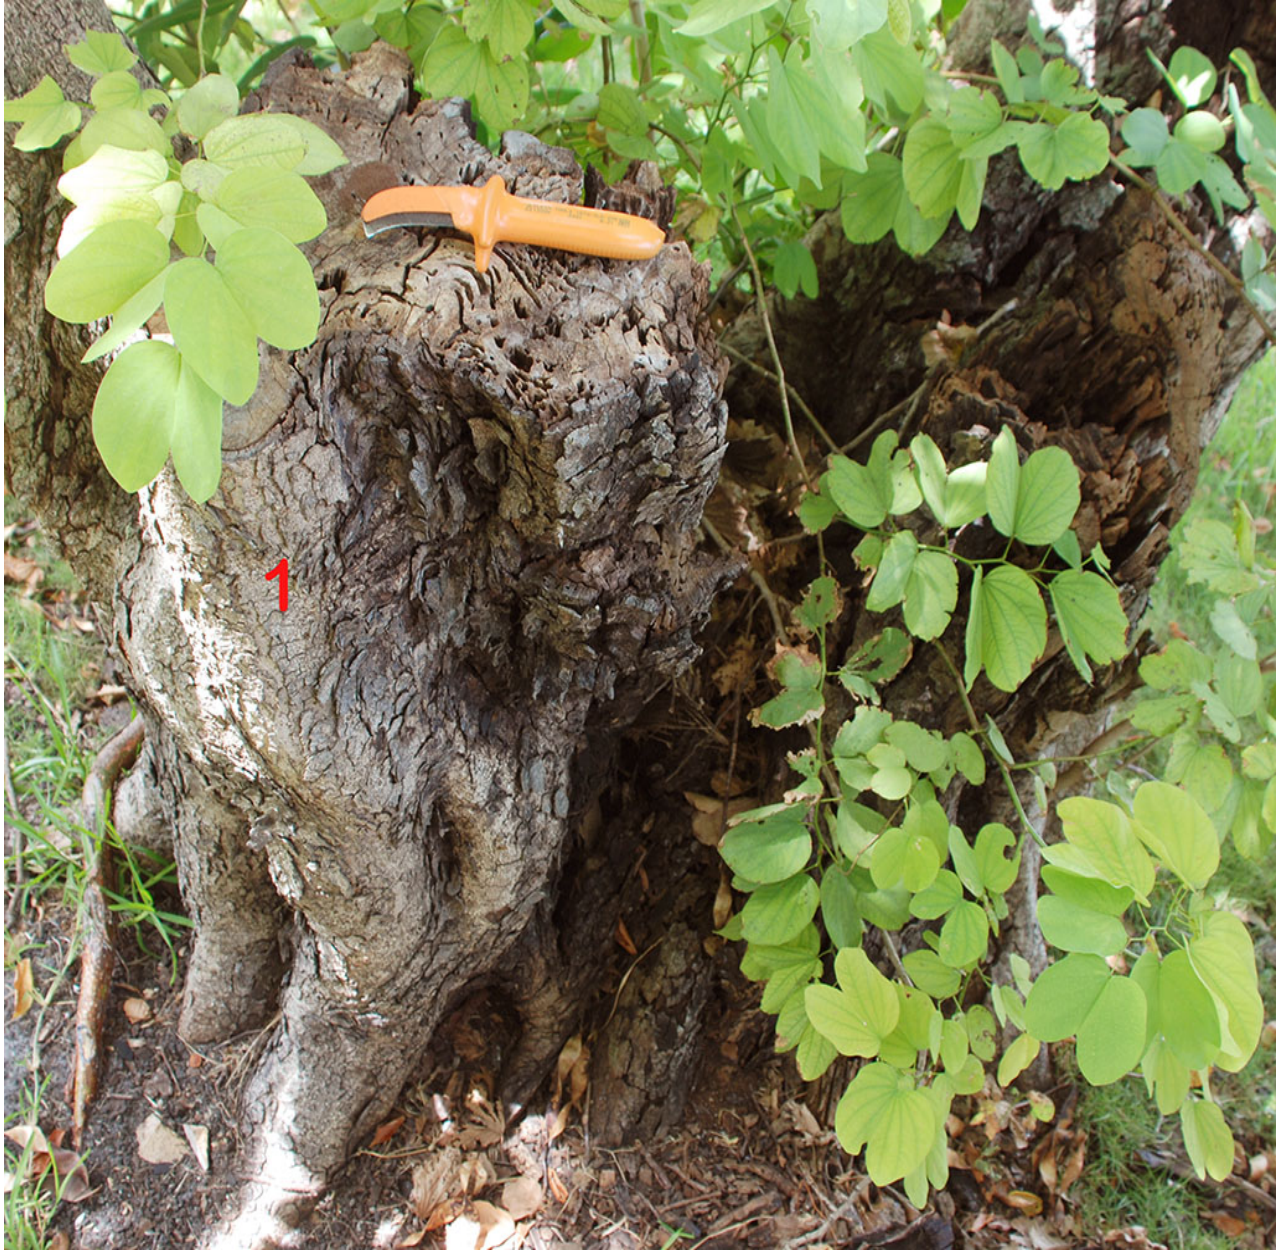
Photo 2 above is the south side of the trunk of tree 1 showing signs of significant decay. The orange knife is 7 inches in length.

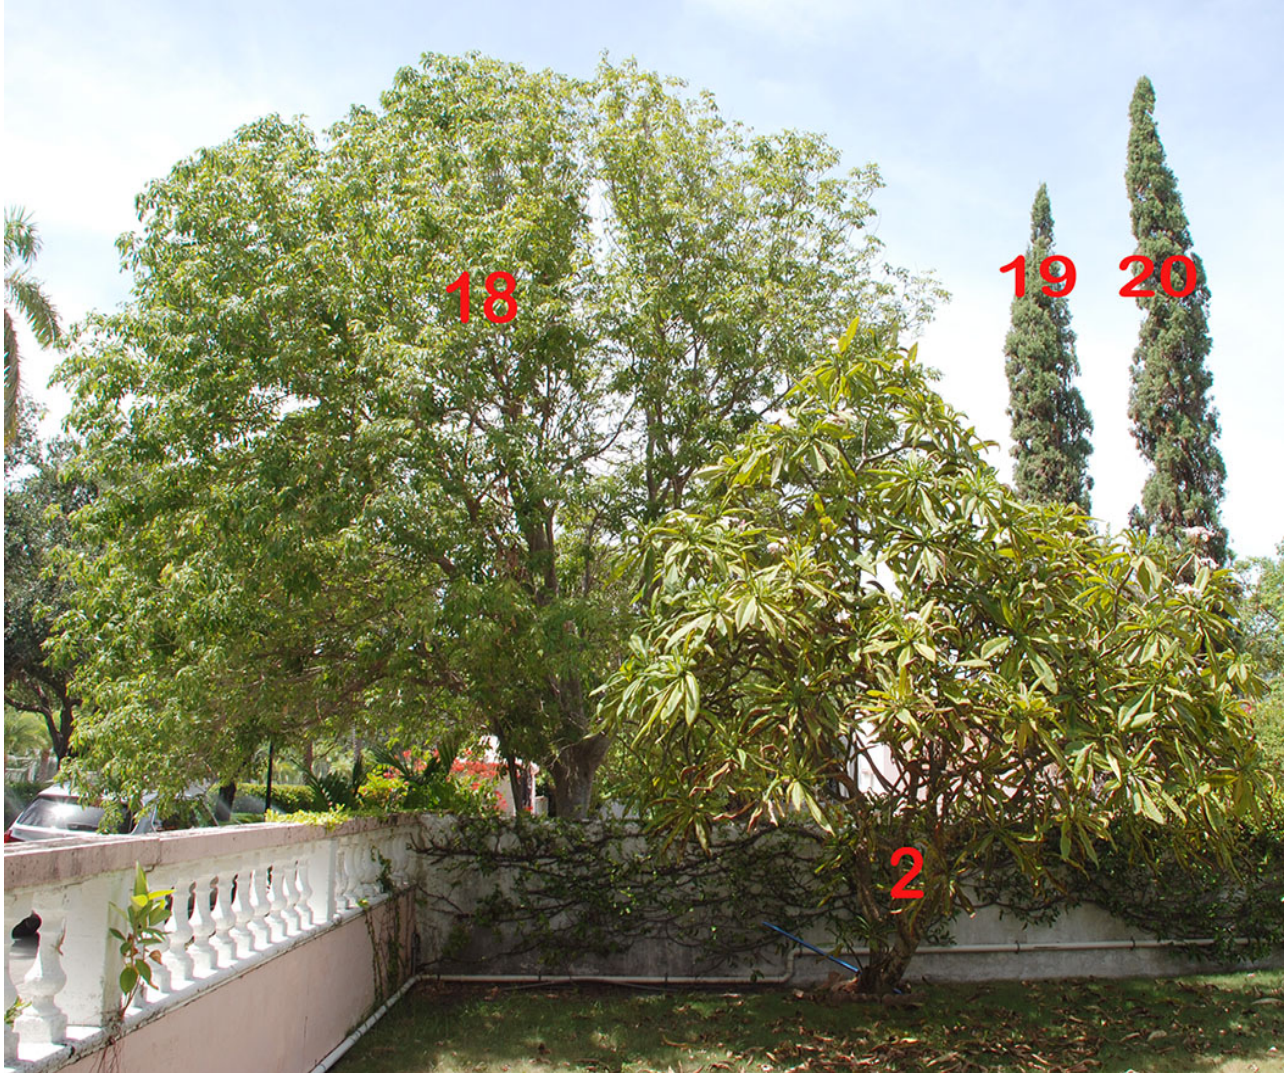
Photo 3 above is tree 2 viewed from the south. This tree is currently in the seasonal process of losing its leaves.

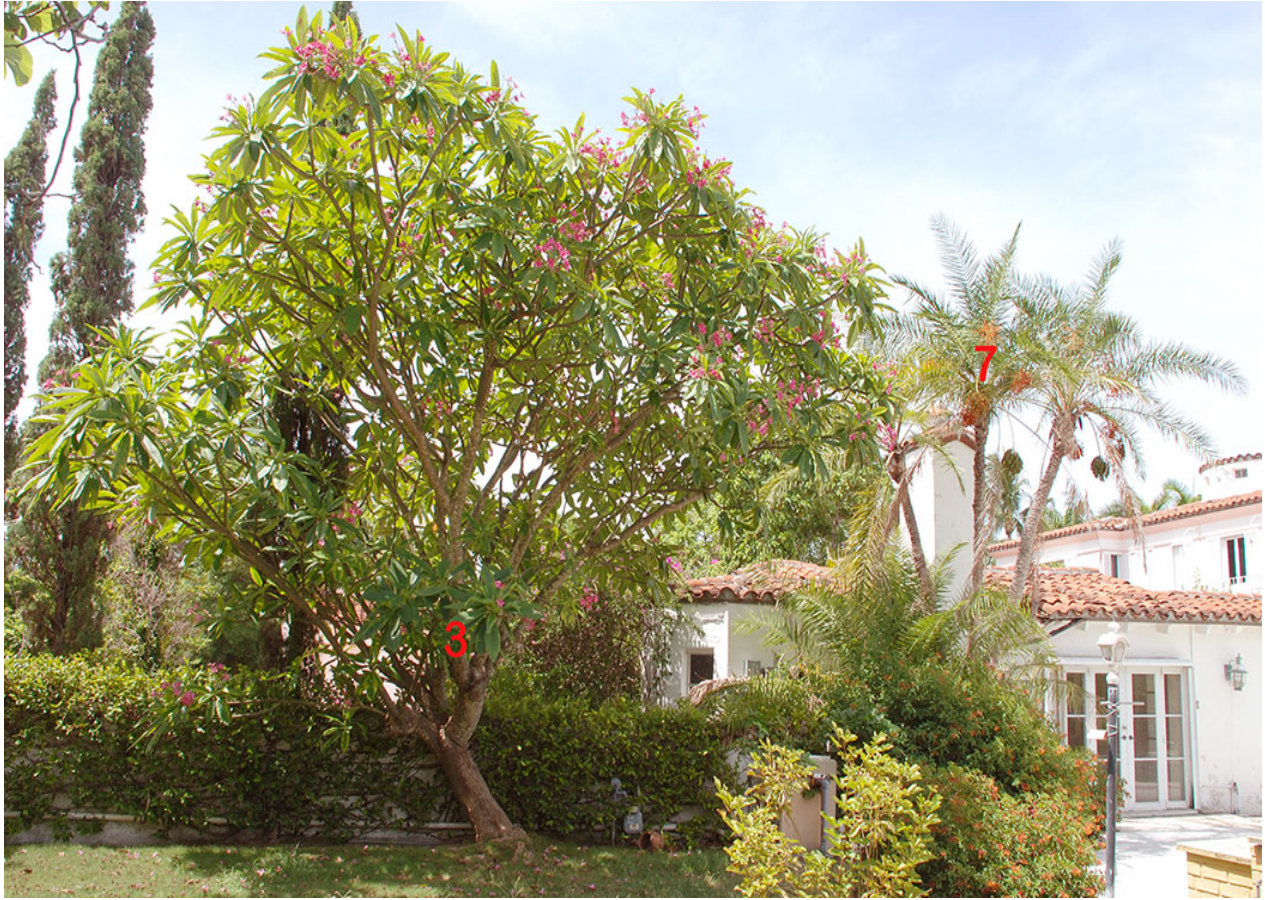
Photo 4 above is tree 3 viewed from the south. Palm 7 has three trunks but they should not be counted individually, hence the numbers 8 & 9 removed from Appendix A.

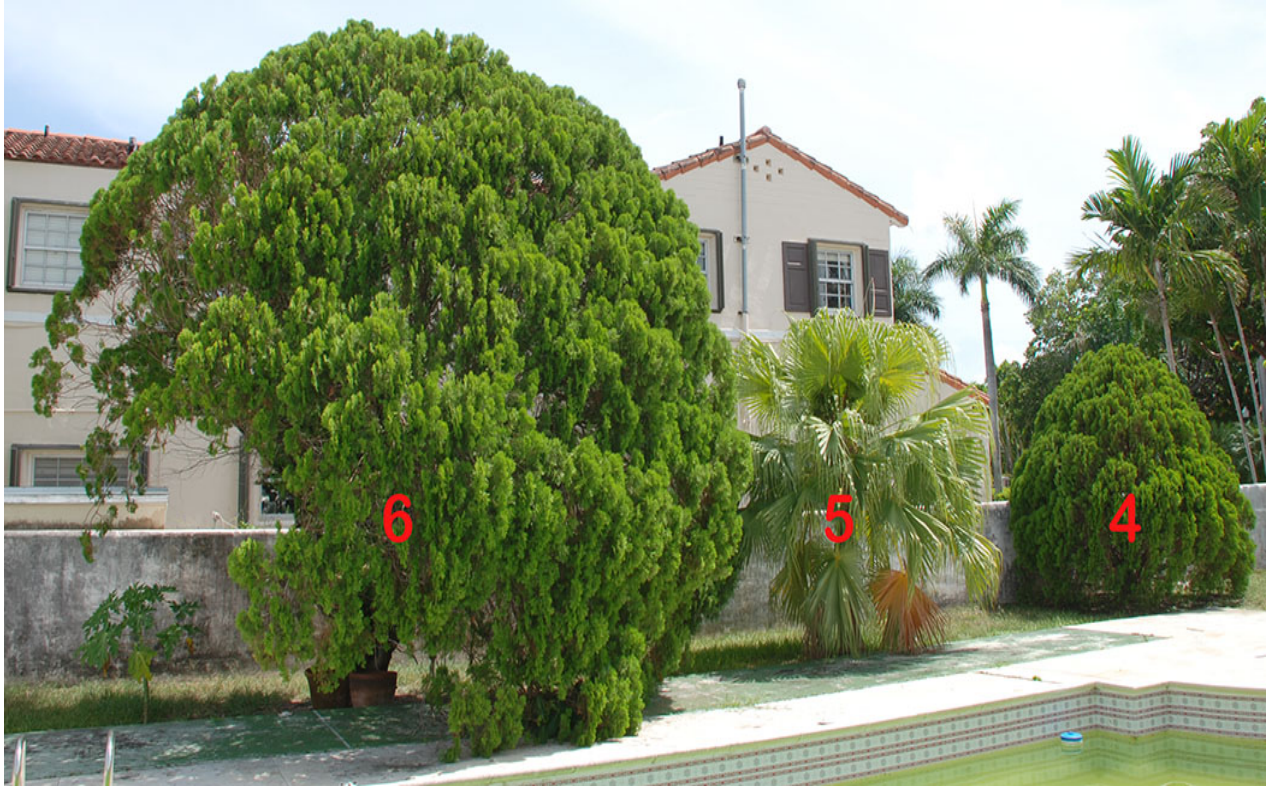
Photo 5 above is trees 4 & 6 and palm 5 along the southern edge of the property. Tree 6 is in moderate condition due to the large branches removed on the east side of the tree.

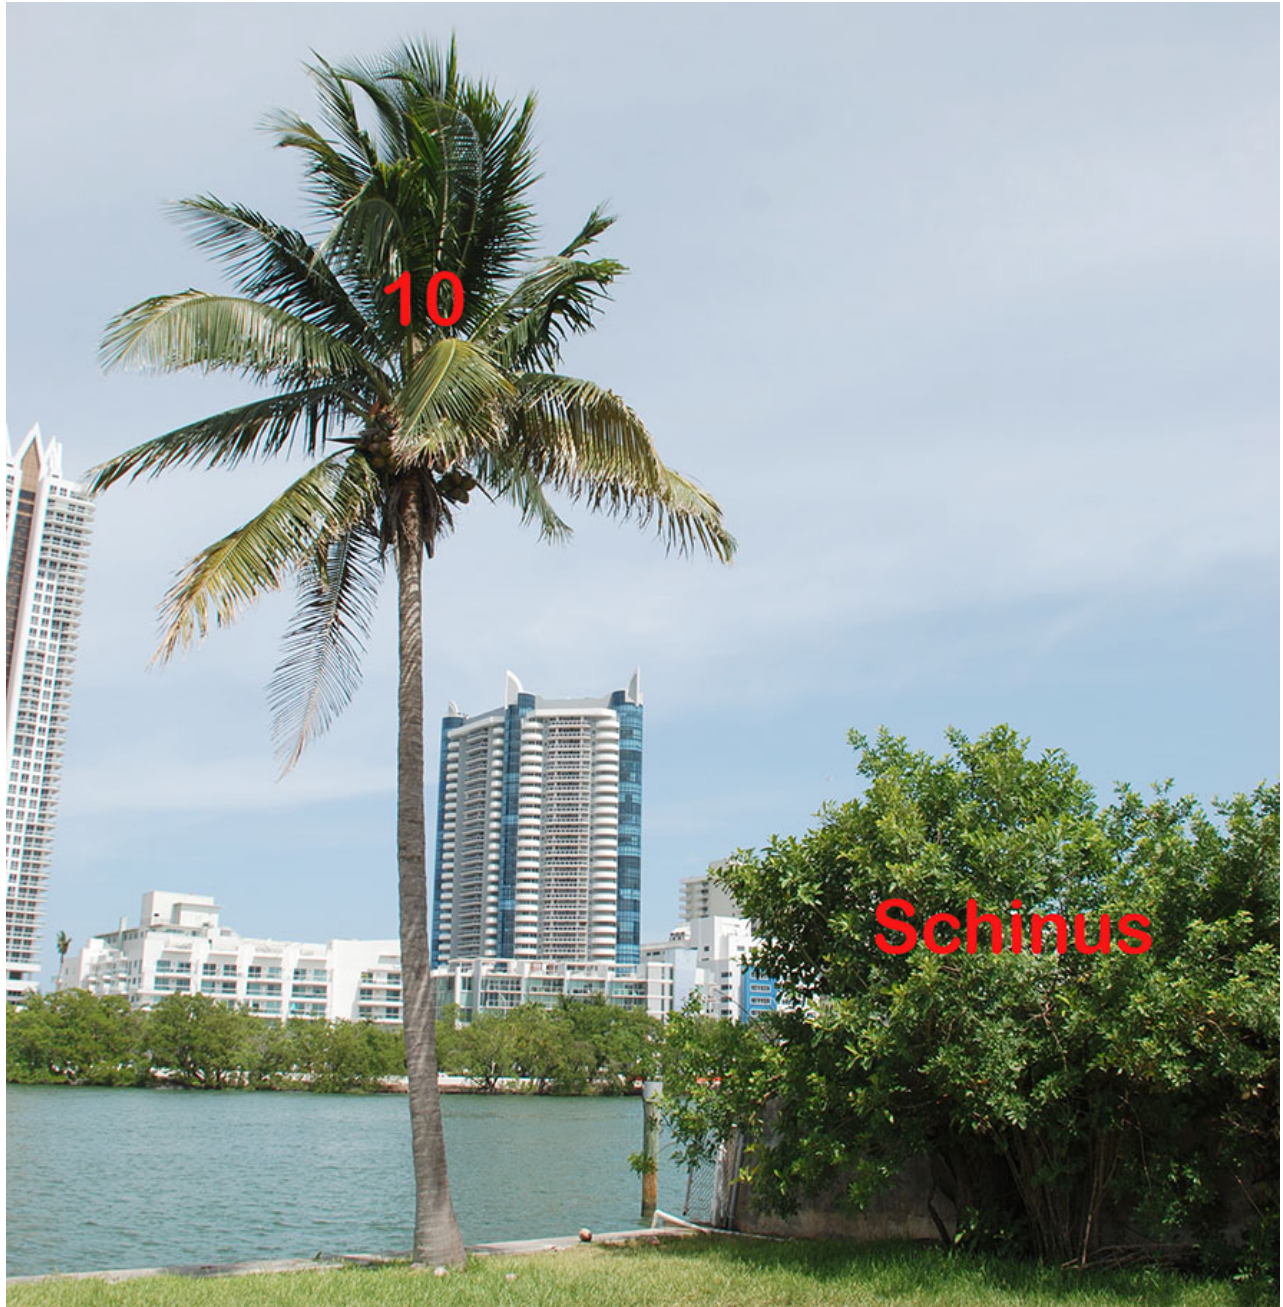
Photo 6 above is palm 10 near the southeast corner of the property. The bush to the right is *Schinus terebinthifolius*, Brazilian pepper which is an invasive exotic species.

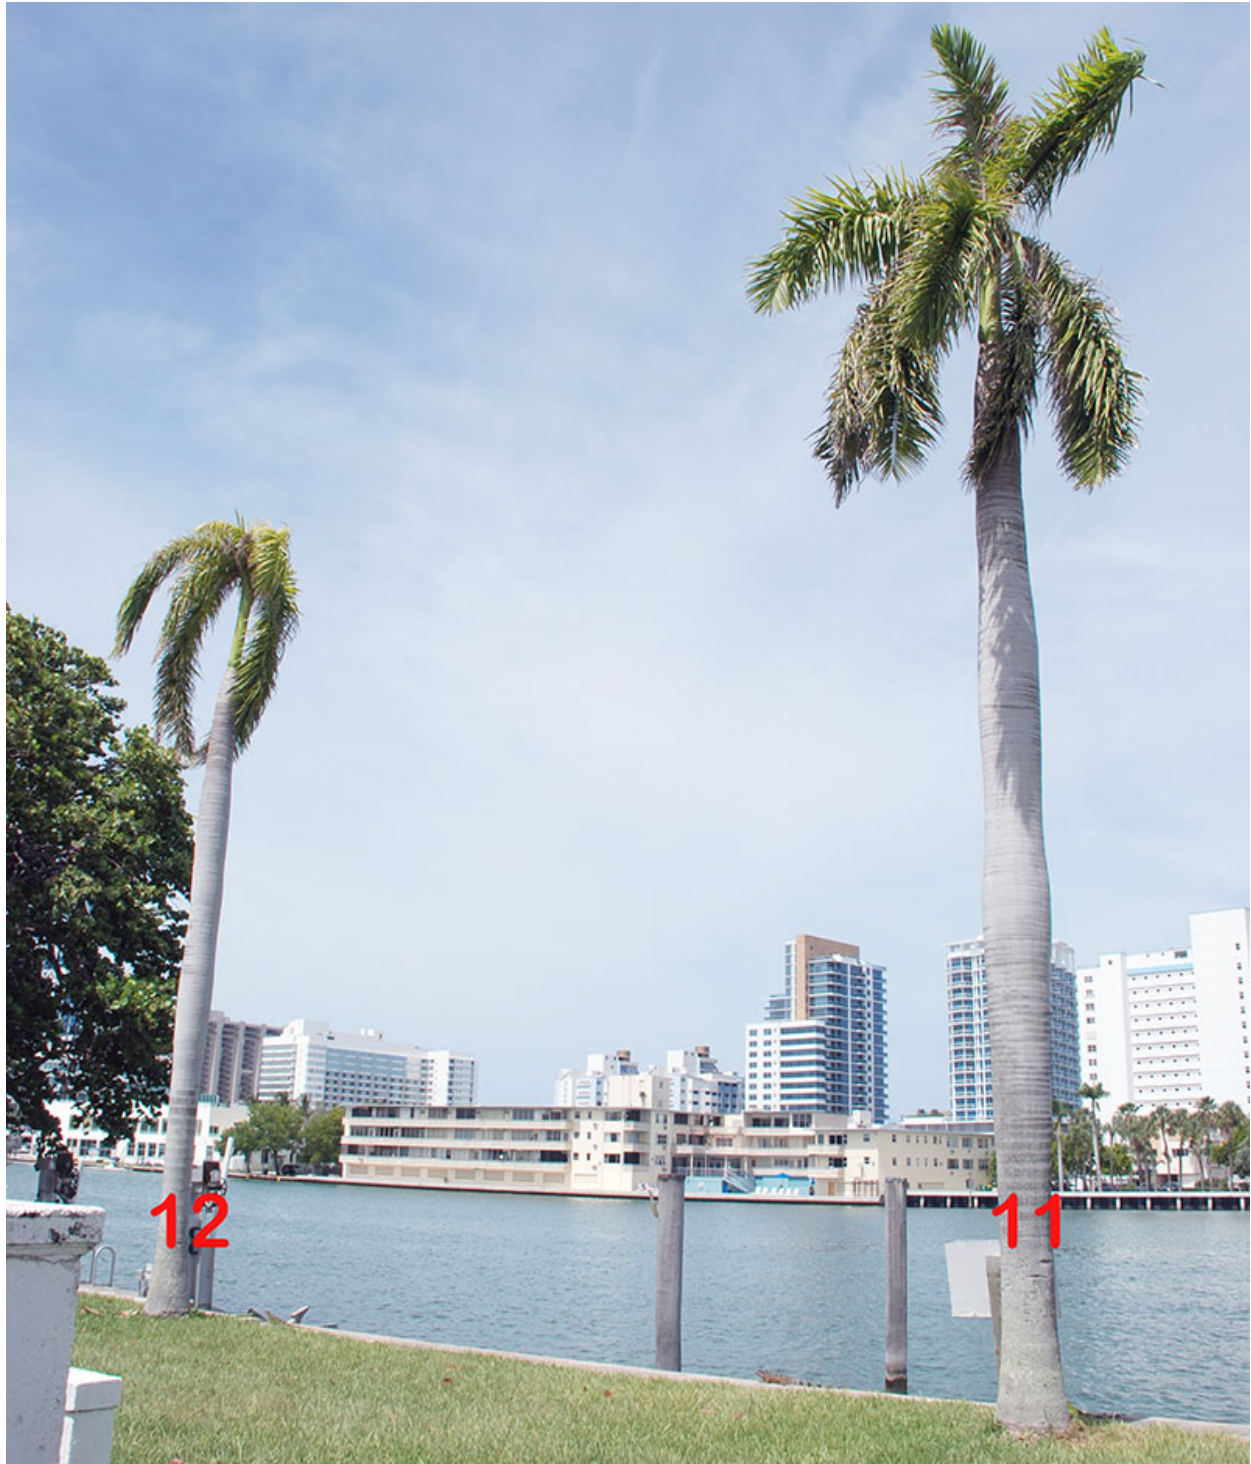
Photo 7 above is palms 11 & 12 along the eastern edge of the property. Both palms have severe uncorrectable nutrient deficiencies and pining crownshafts. They both should be removed.

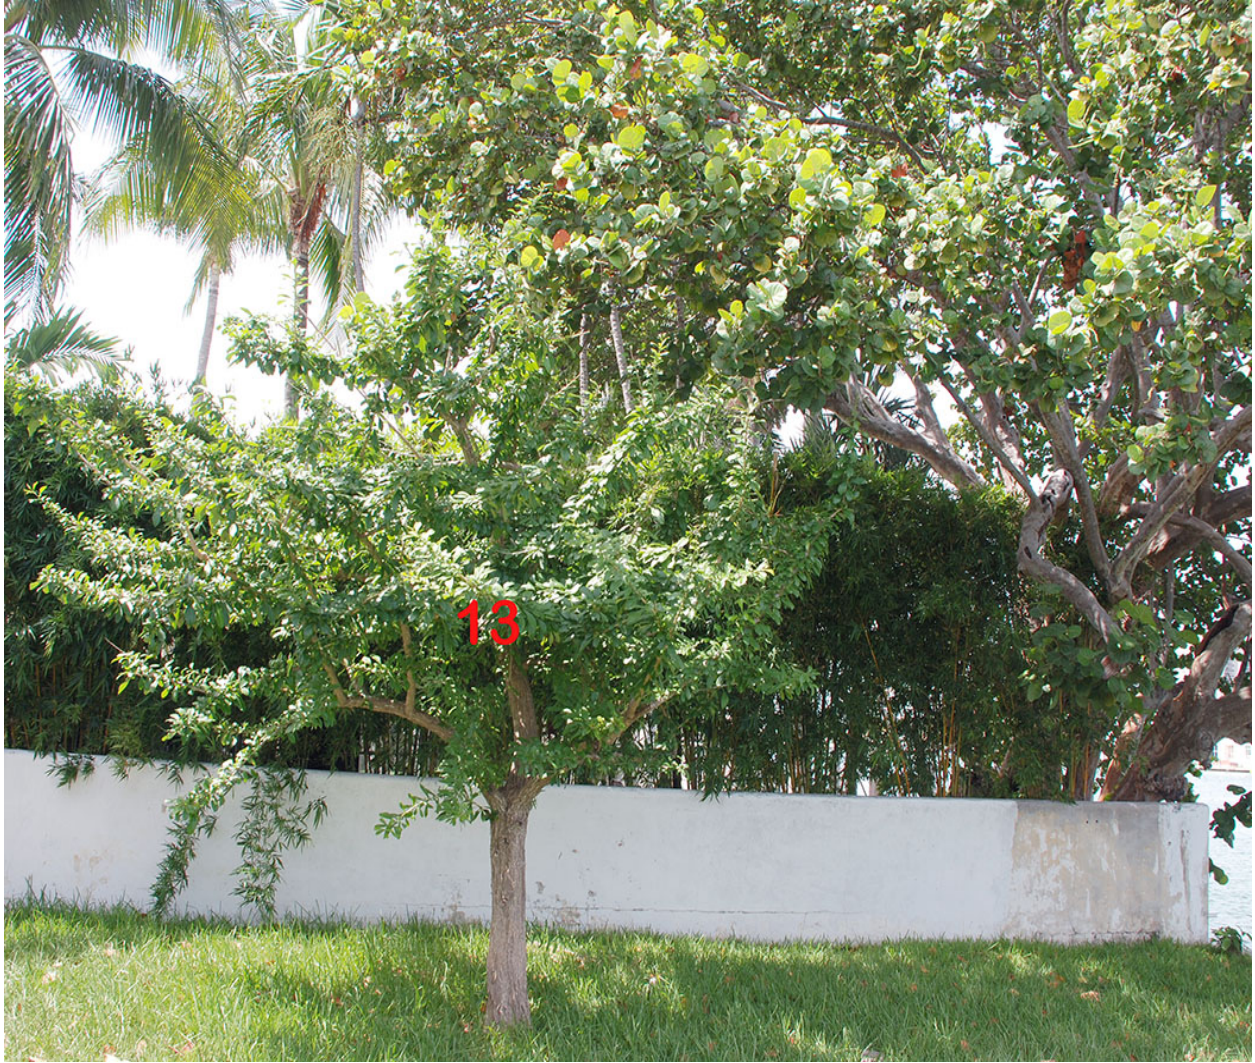
Photo 8 above is tree 13 near the northeastern corner of the property. This tree is a good candidate for relocation.

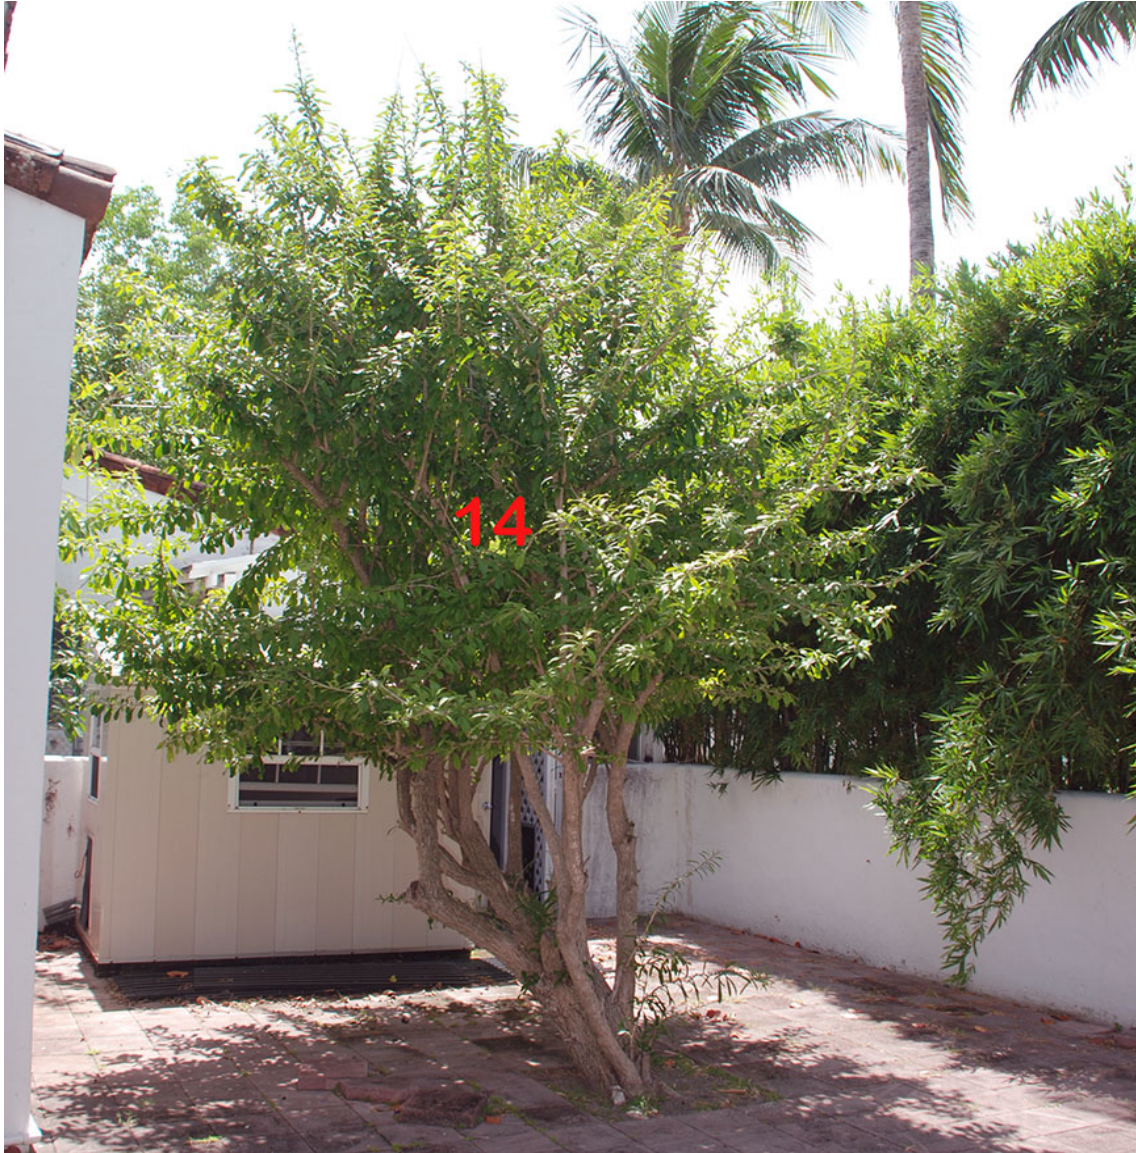
Photo 9 above is tree 14 viewed from the east. This tree is a good candidate for relocation.

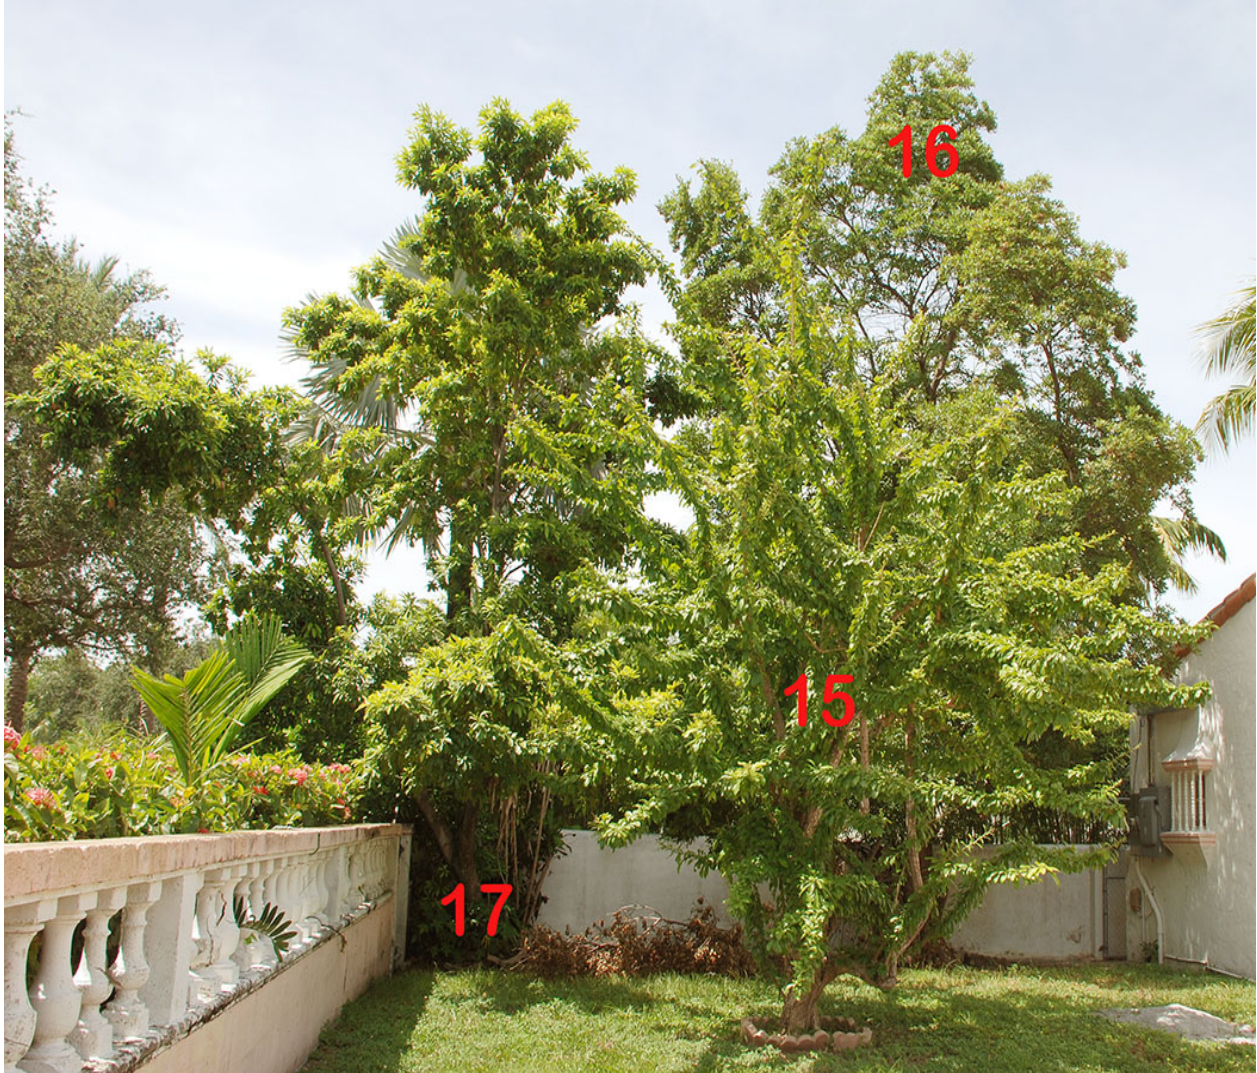
Photo 10 above is tree 15 viewed from the south. This tree is a good candidate for relocation.

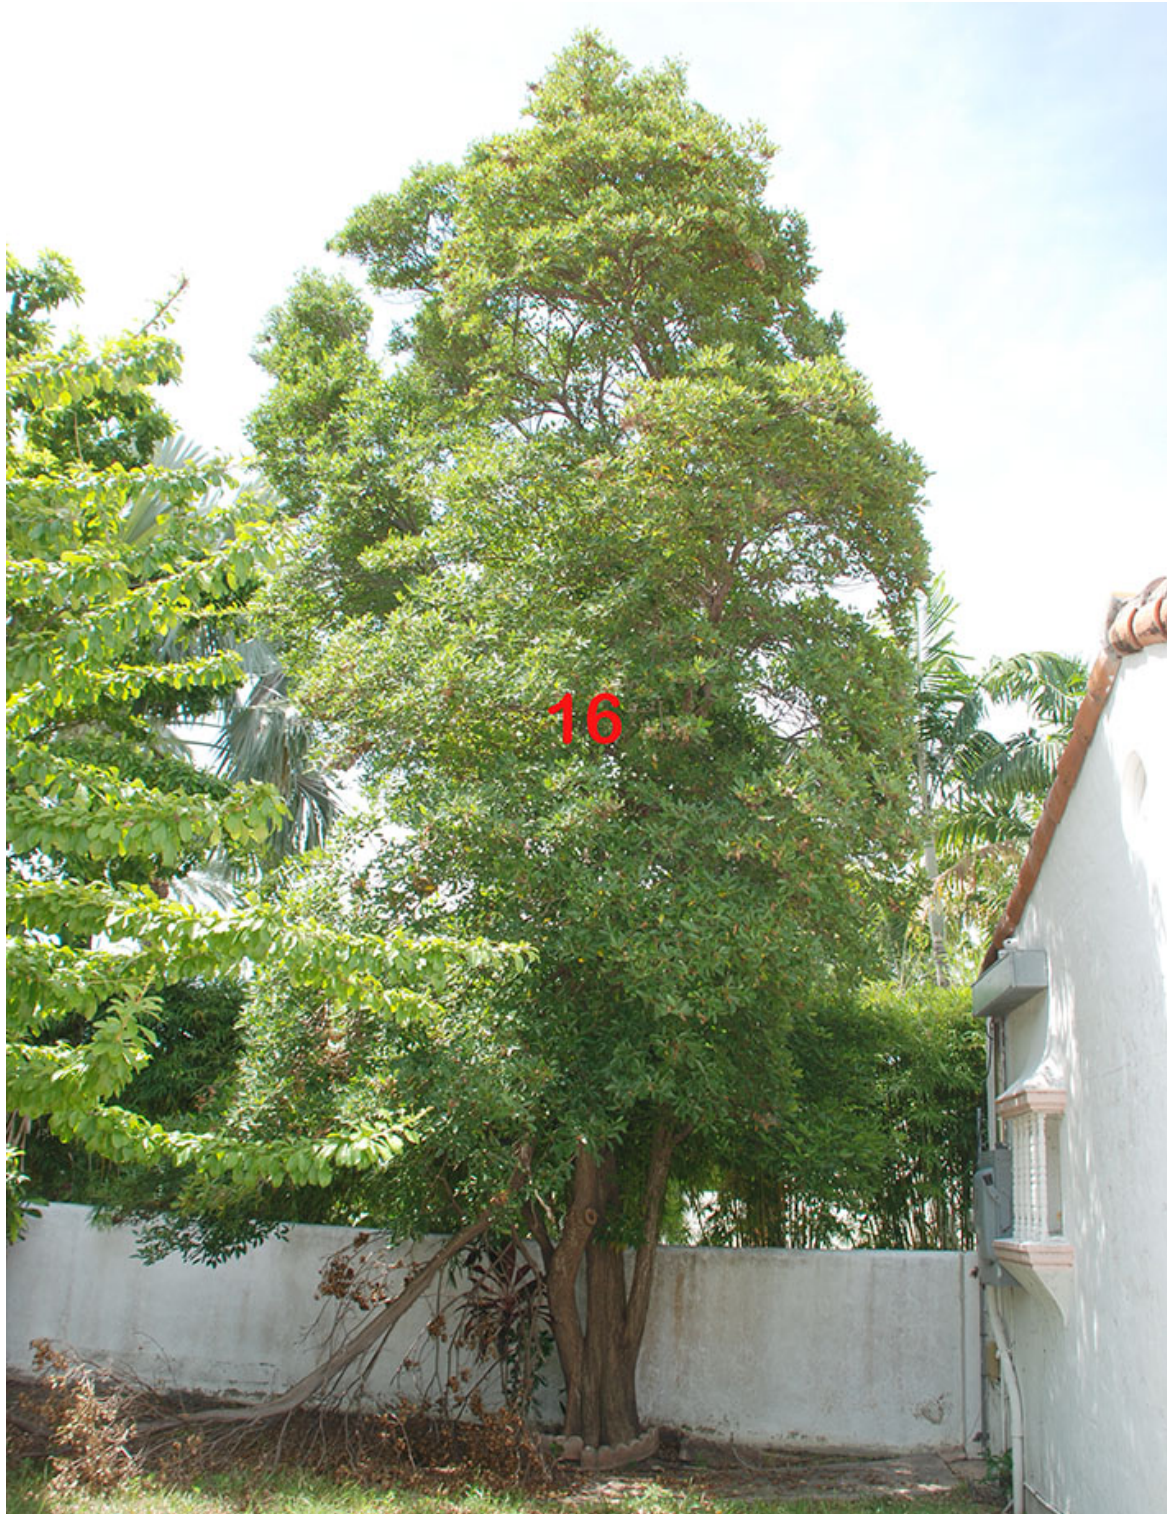
Photo 11 above is tree 16 viewed from the south. This tree is not a good candidate for relocation due to the greatly restricted root plate.

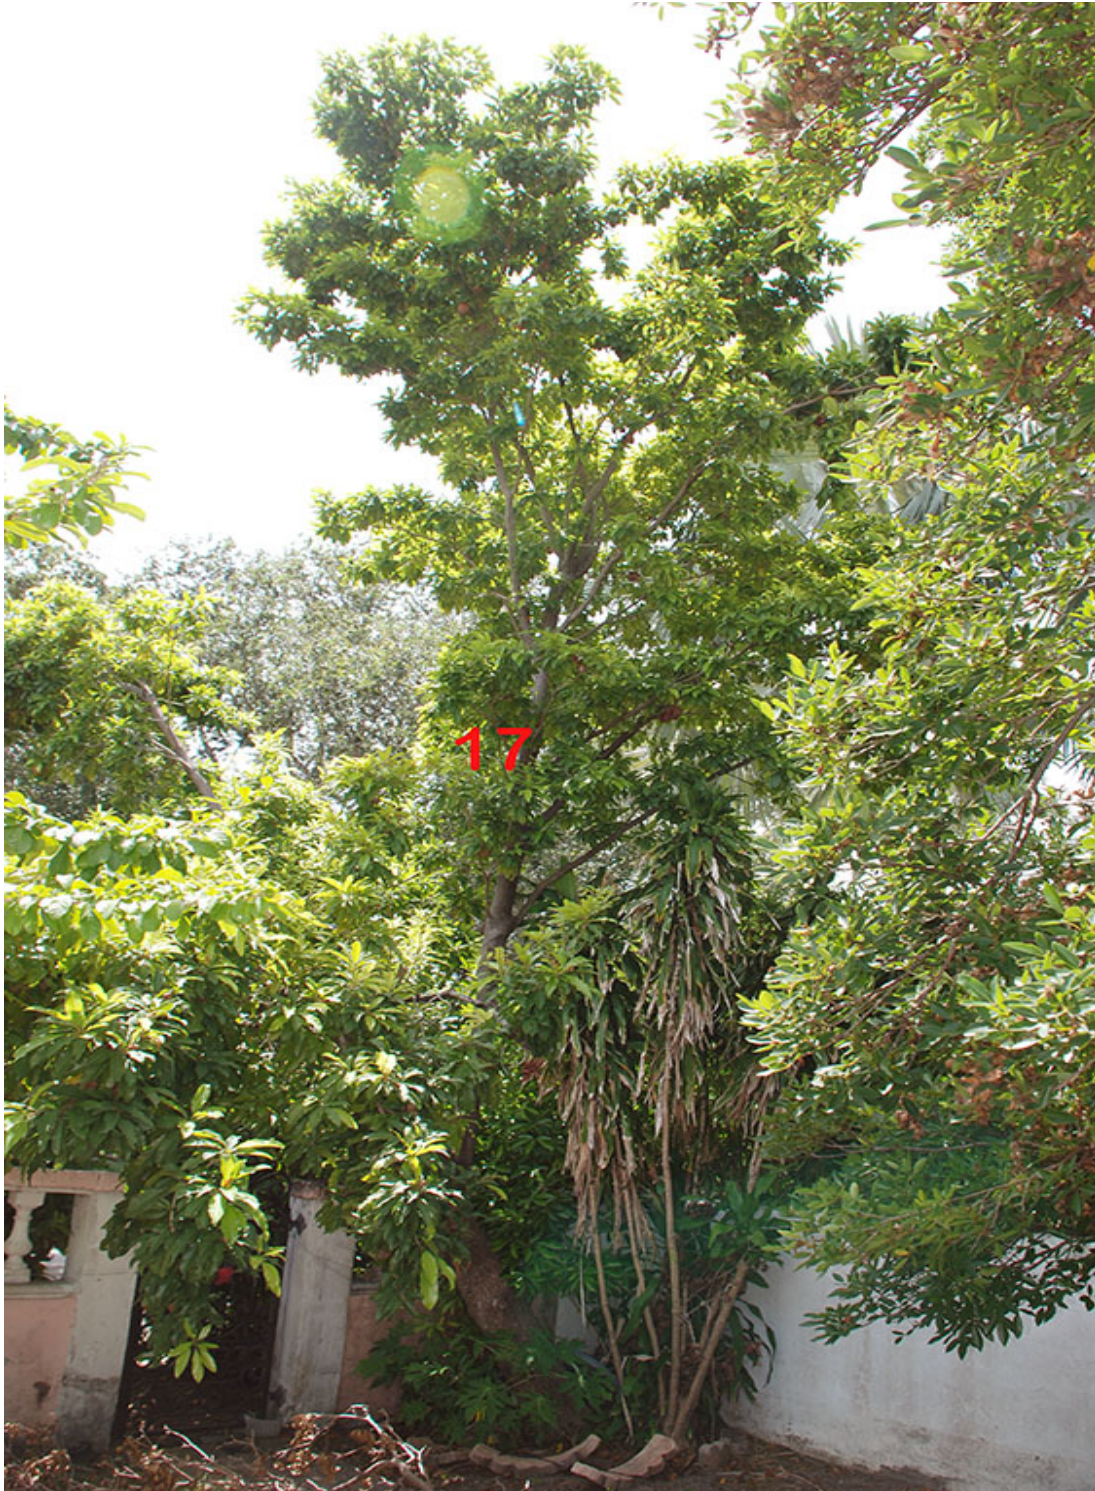
Photo 12 above is tree 17 viewed from the east. This tree is not a good candidate for relocation due to the greatly restricted root plate.

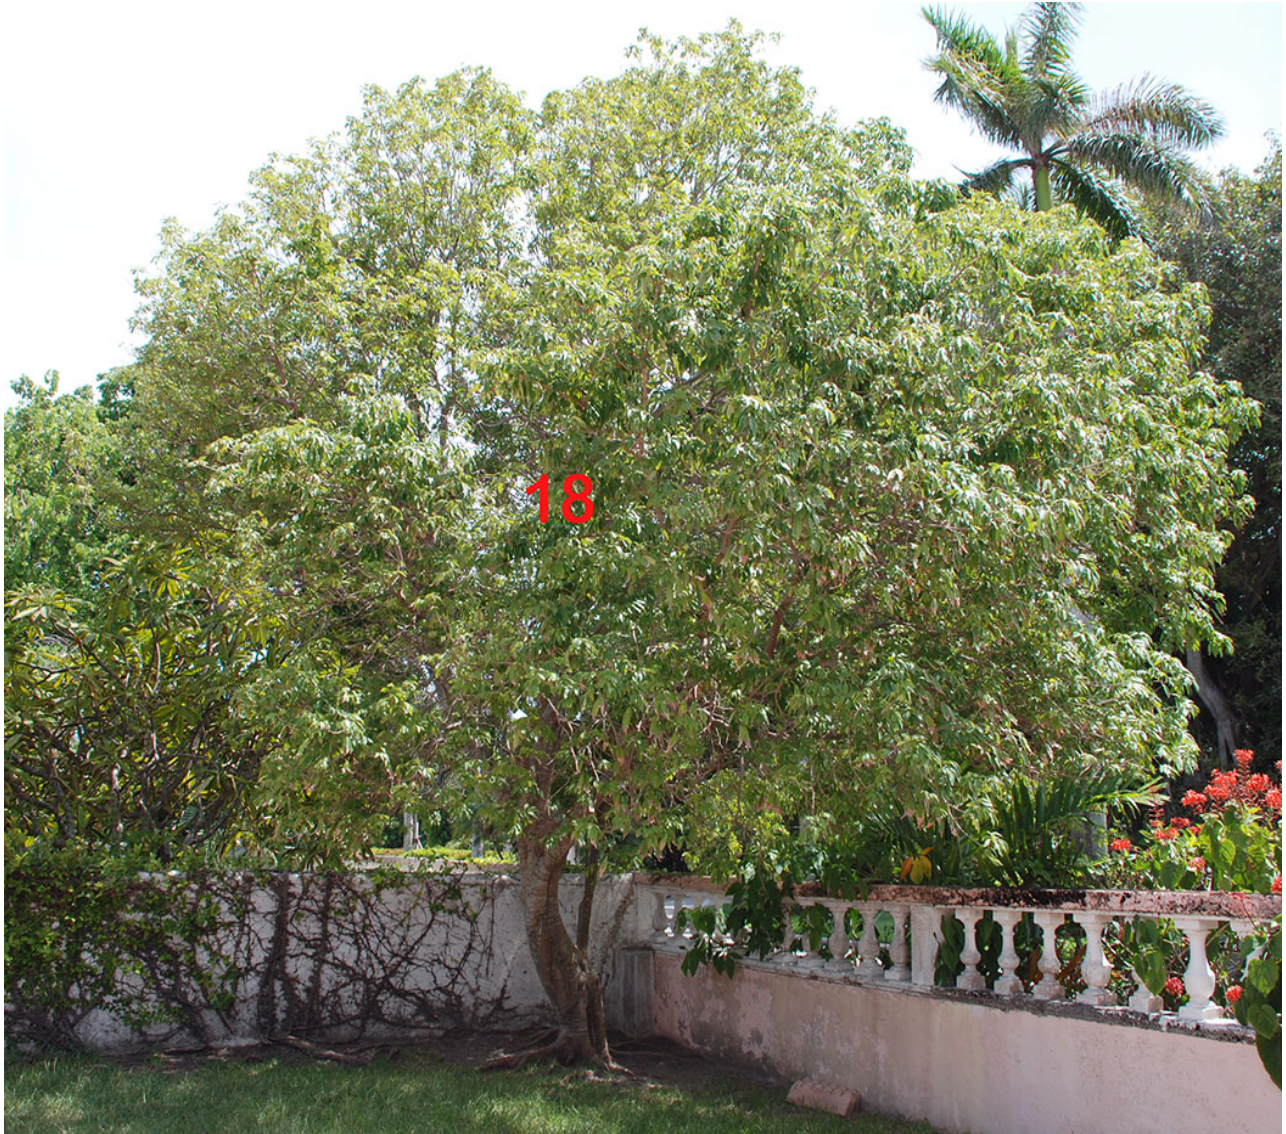
Photo 13 above is tree 18 viewed from the north. This tree is not a good candidate for relocation due to the greatly restricted root plate.

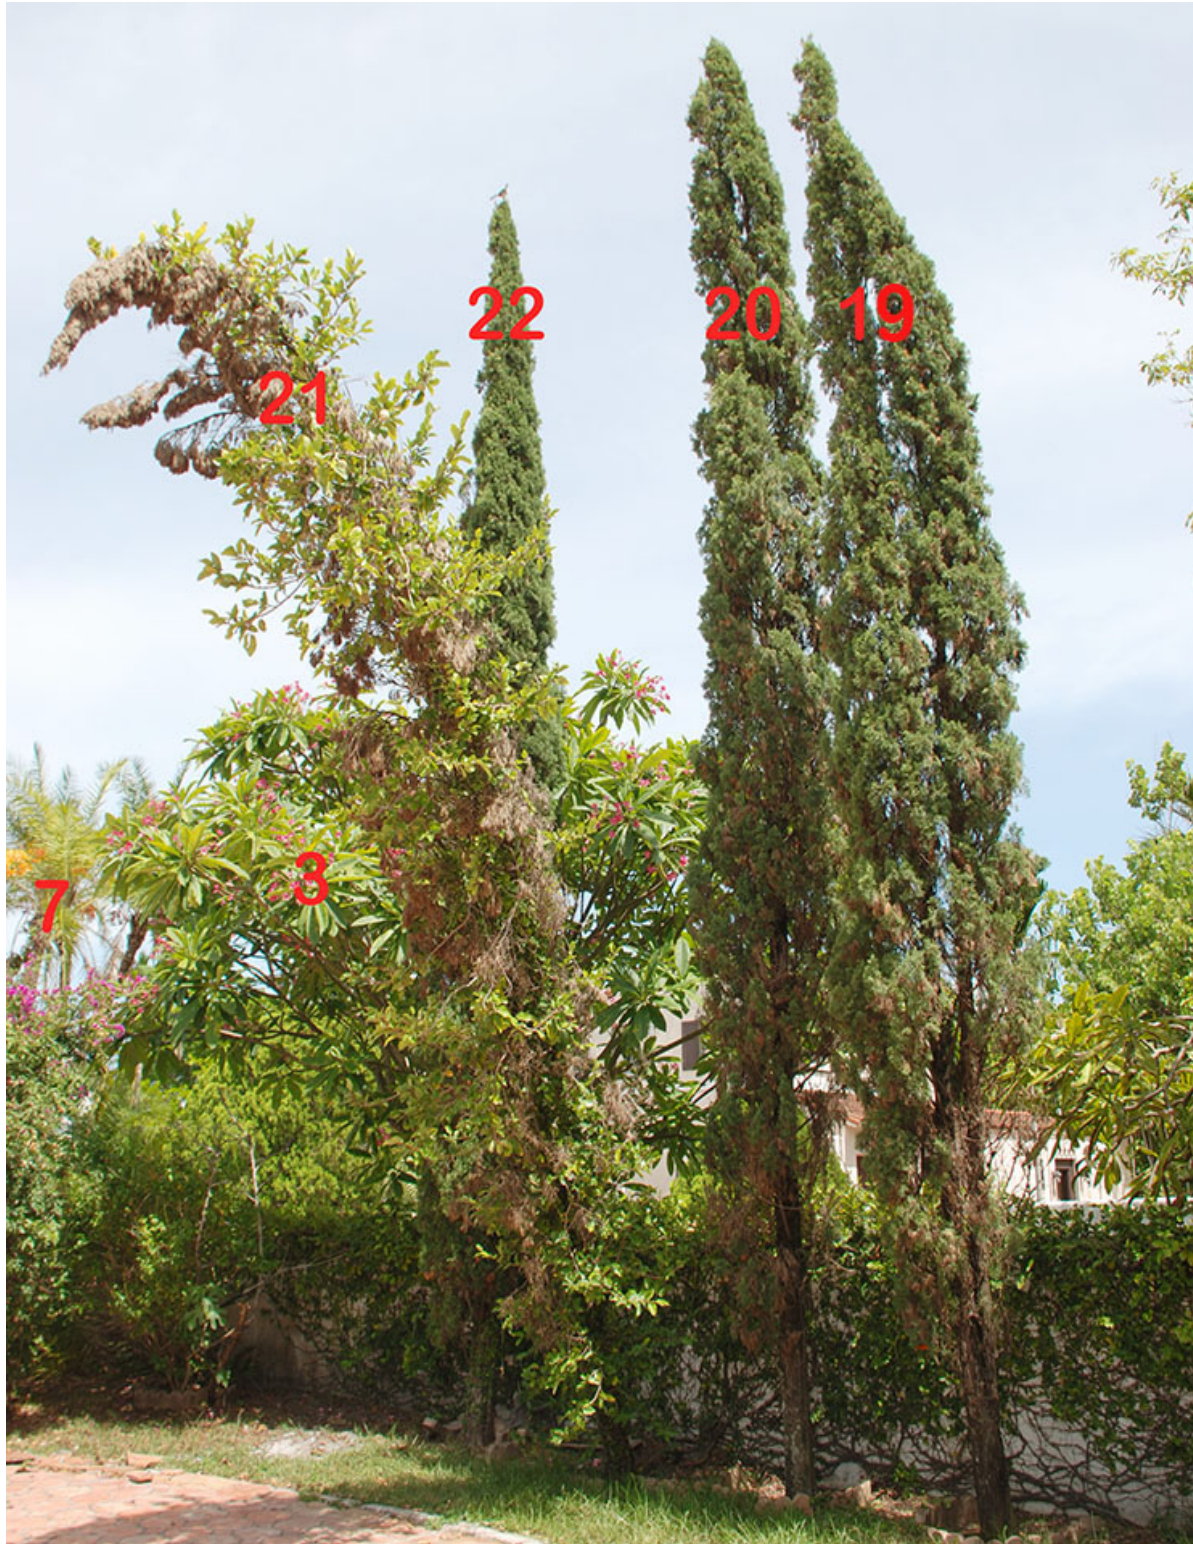
Photo 14 above is trees 19, 20, 21 & 22 viewed from the west. Tree 21 is dead.

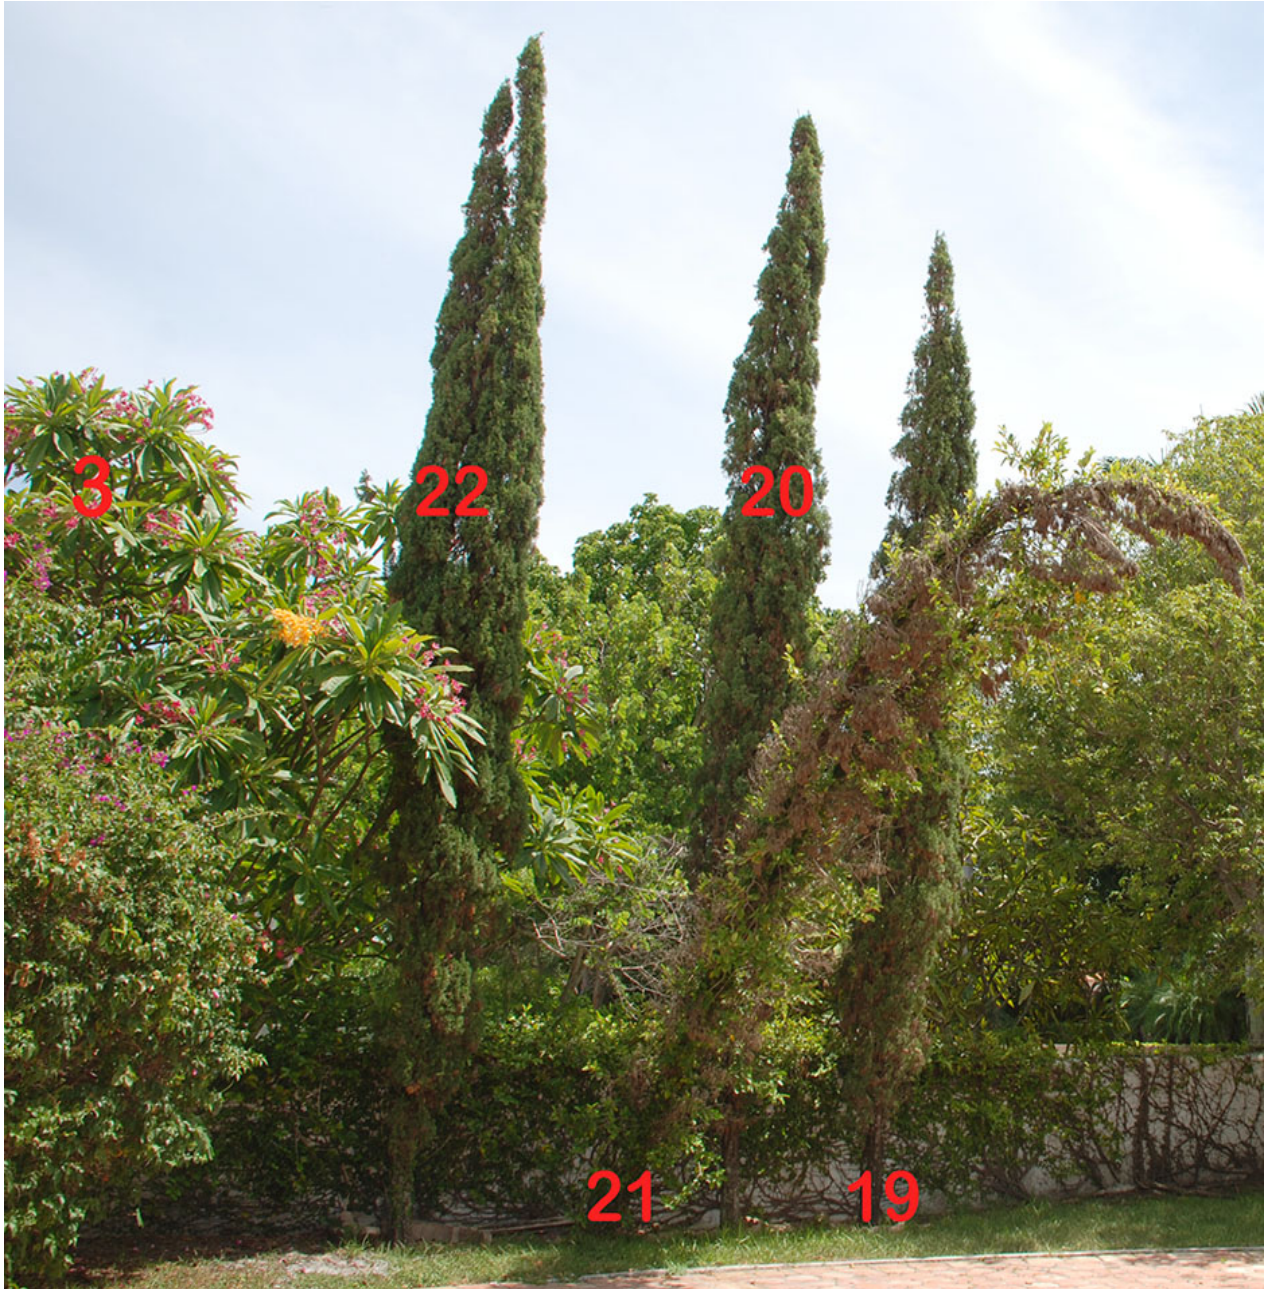
Photo 15 above is trees 19, 20, 21 & 22 viewed from the north. Tree 21 is dead. The green on tree 21 is a climbing fig vine.
