RE: 6431 Allison Road, Miami Beach, Florida
Opinion of Title Lot Split Application
Planning Board
Folio No. 02-3211-003-0100

Tree Resource Evaluation for 6431 Allison Road, Miami Beach

July 19, 2018

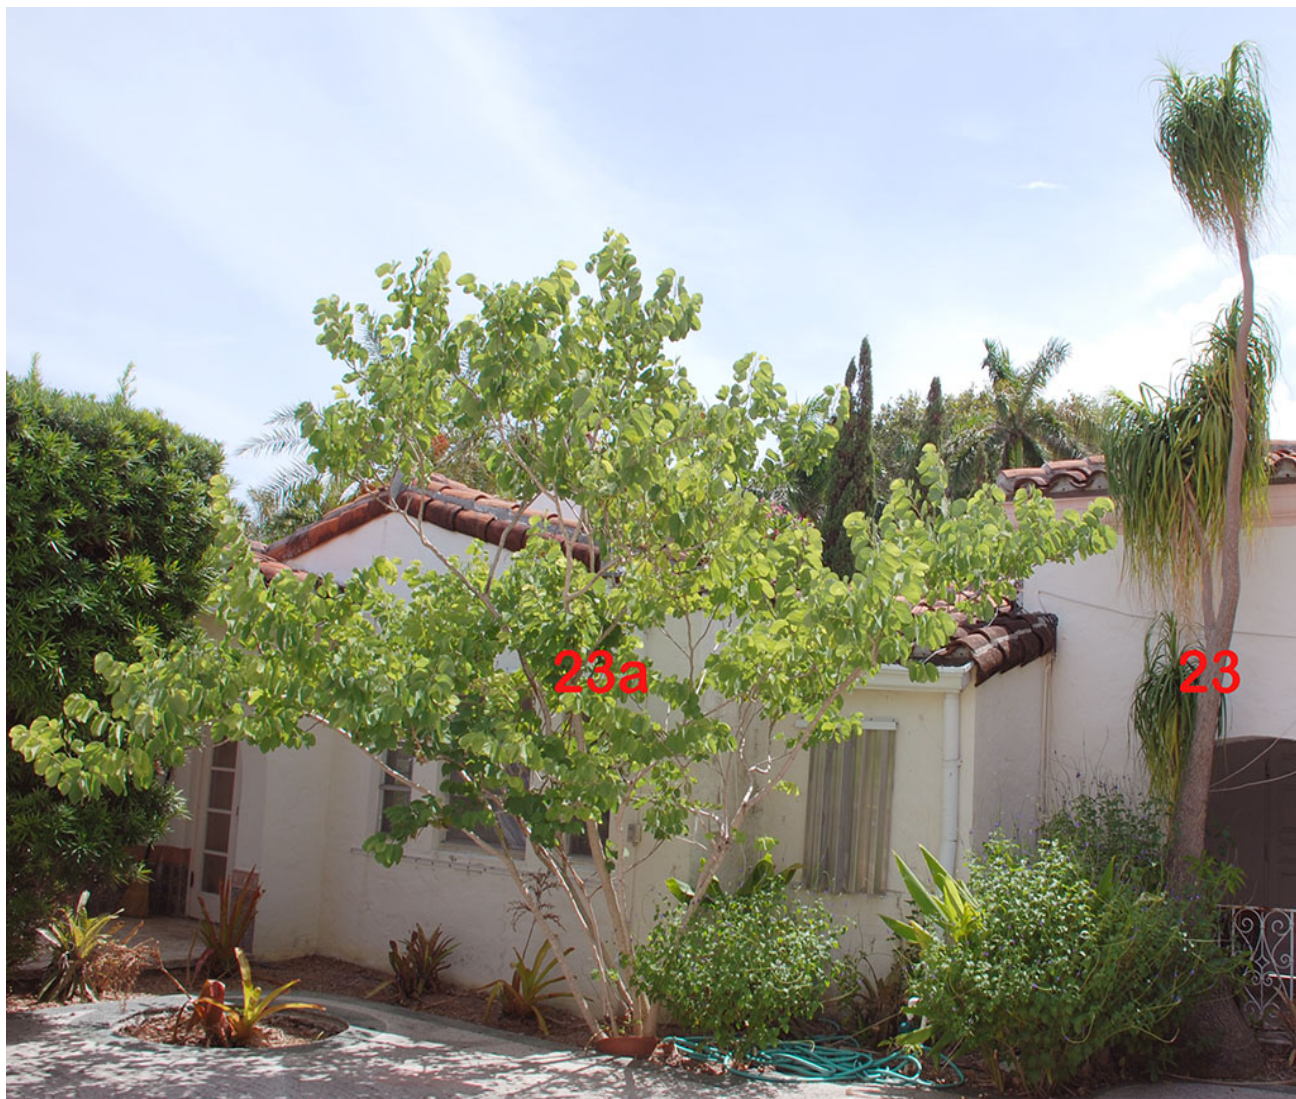
Photo 16 above is ponytail palm 23 (not a true tree or palm) and tree 23a with poor branch structure and grown-in as a volunteer. This tree should be removed.

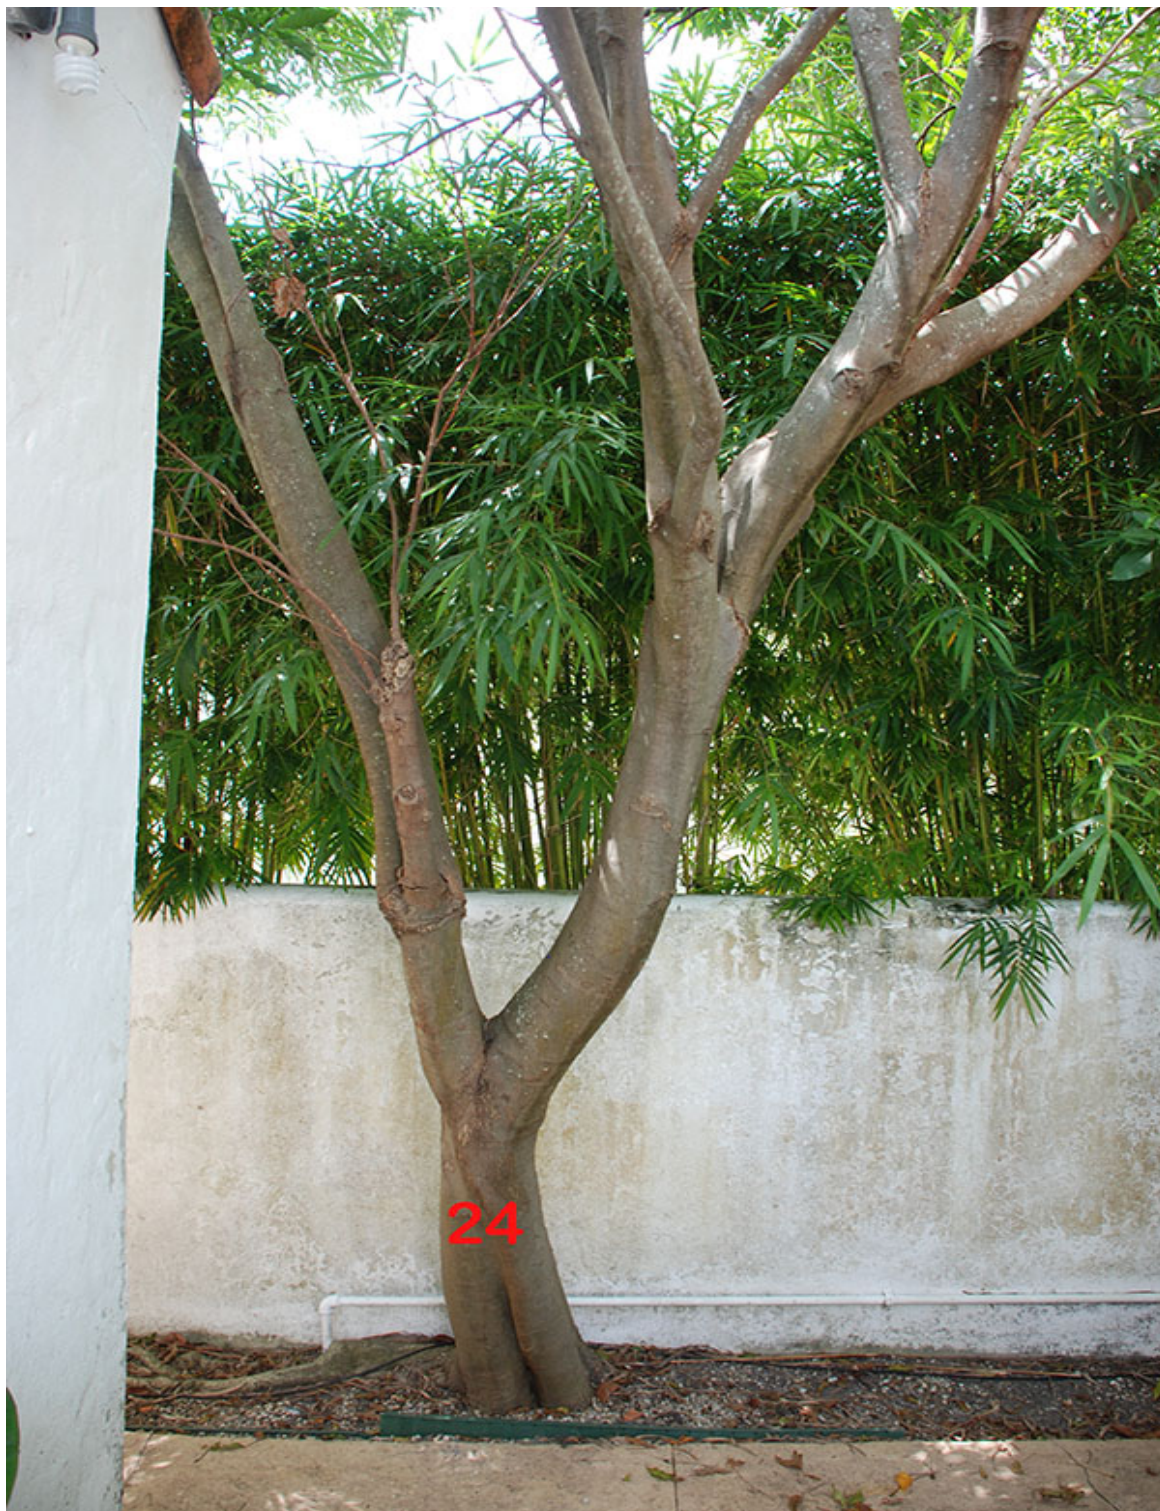
Photo 17 above is tree 24 viewed from the south. This tree is not a good candidate for relocation due to the greatly restricted root plate.

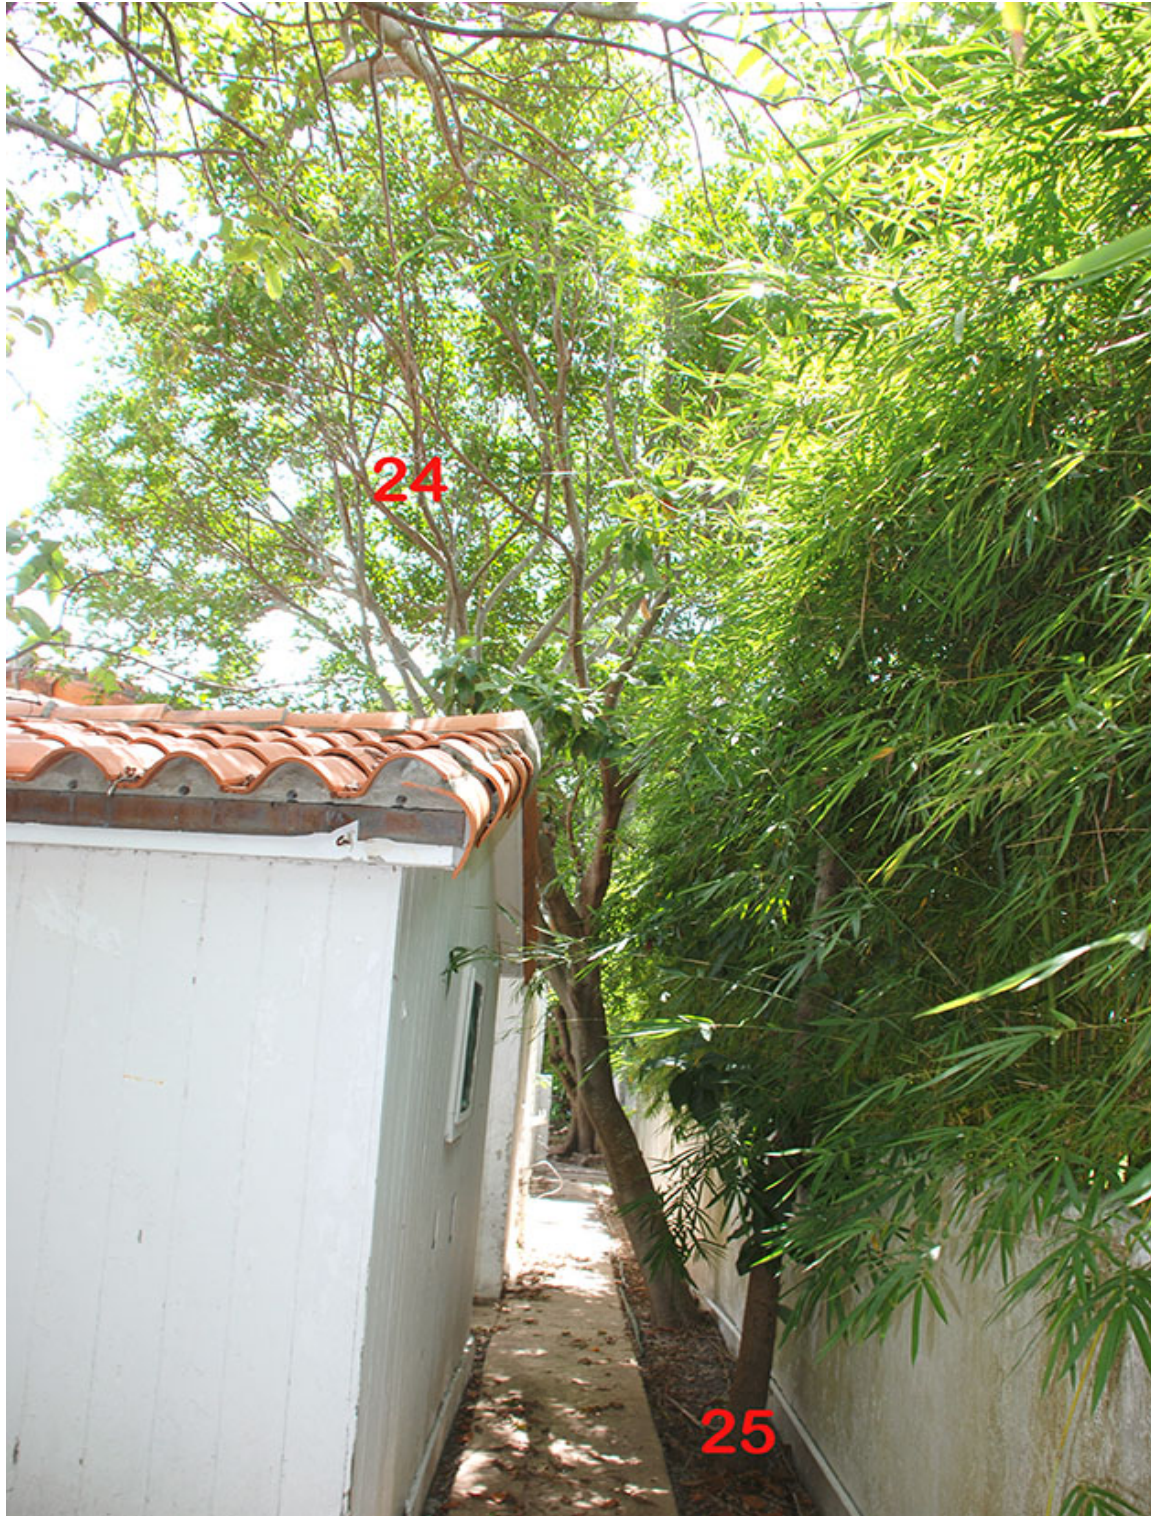
Photo 18 above is tree 25 viewed from the east. This tree is not a good candidate for relocation due to the greatly restricted root plate.

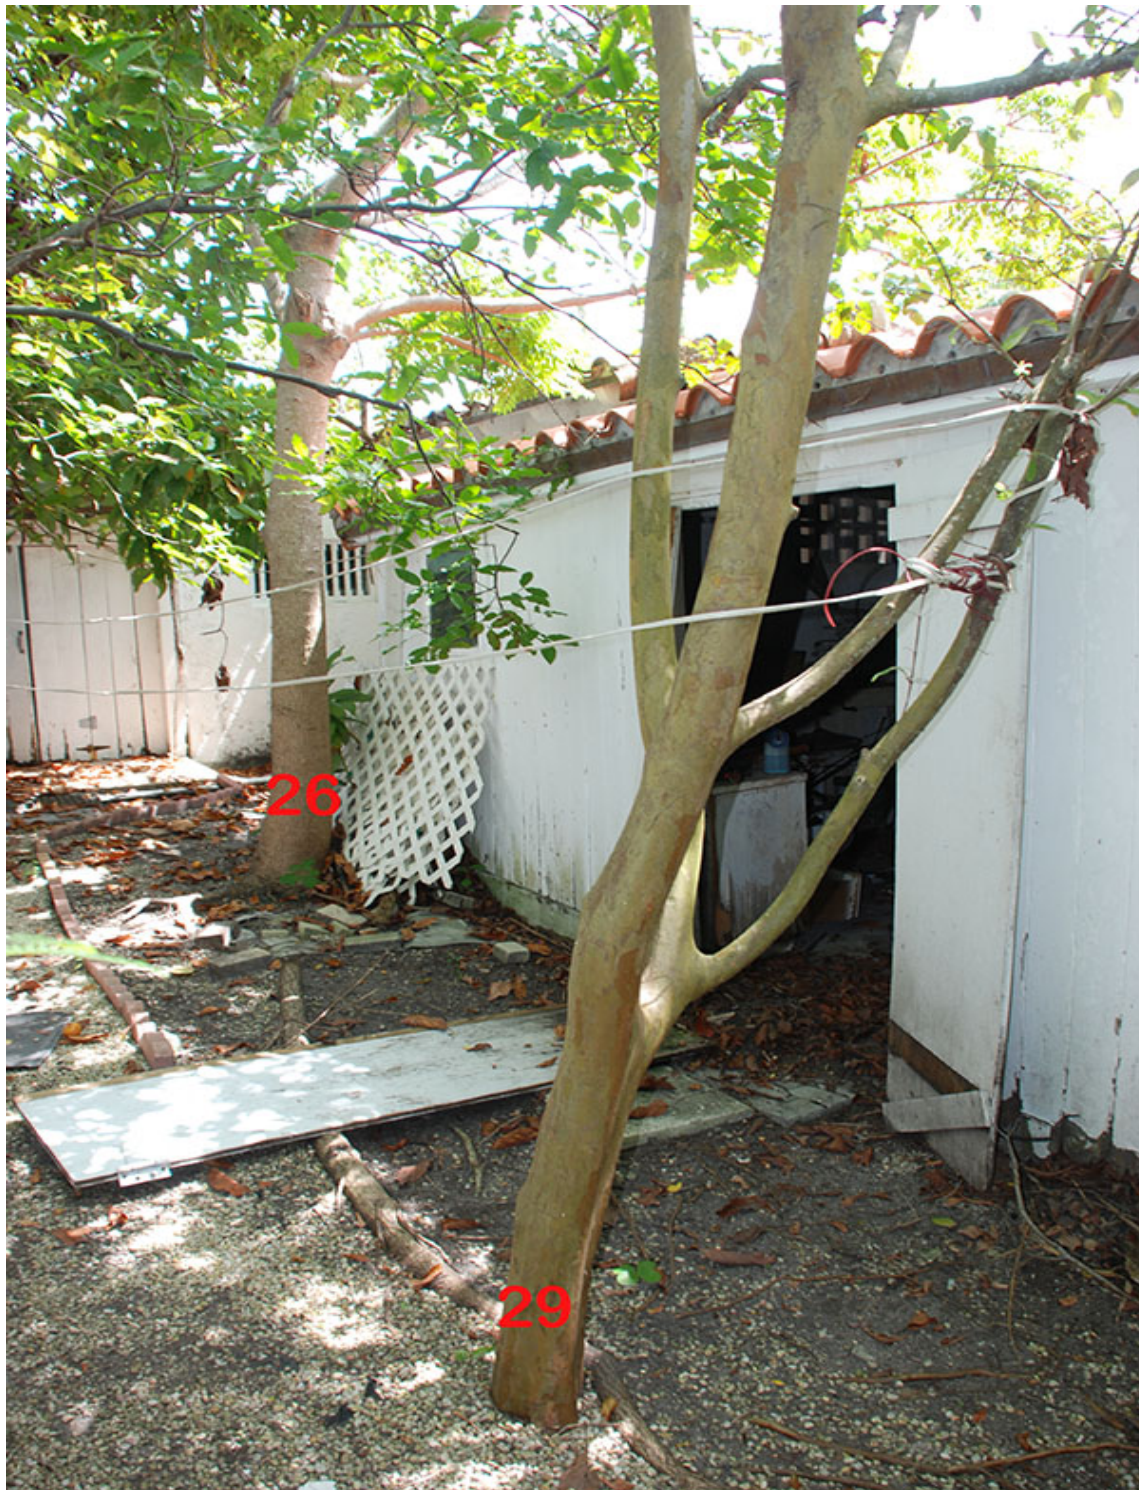
Photo 19 above is trees 26 & 29 viewed from the north. These trees are not good candidates for relocation due to the greatly restricted root plates and poor branch taper.

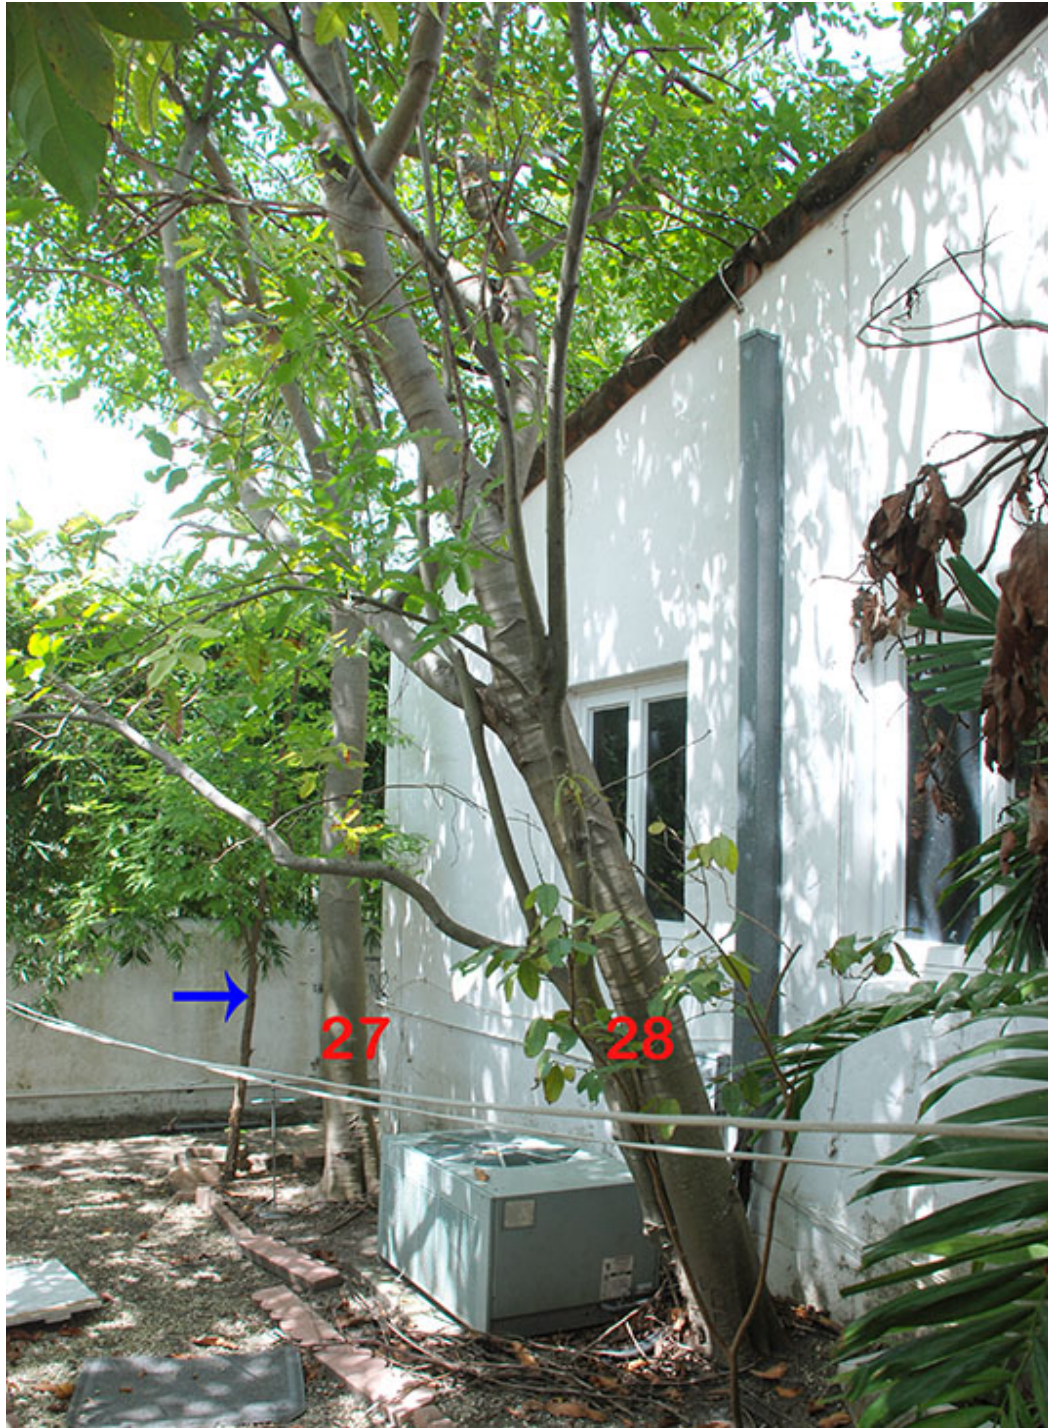
Photo 20 above is trees 27 & 28 viewed from the south. These trees are not good candidates for relocation due to the greatly restricted root plates and poor branch taper. The blue arrow indicates a tamarind (*Tamarindus indicus*) with a DBH of 1 inch.

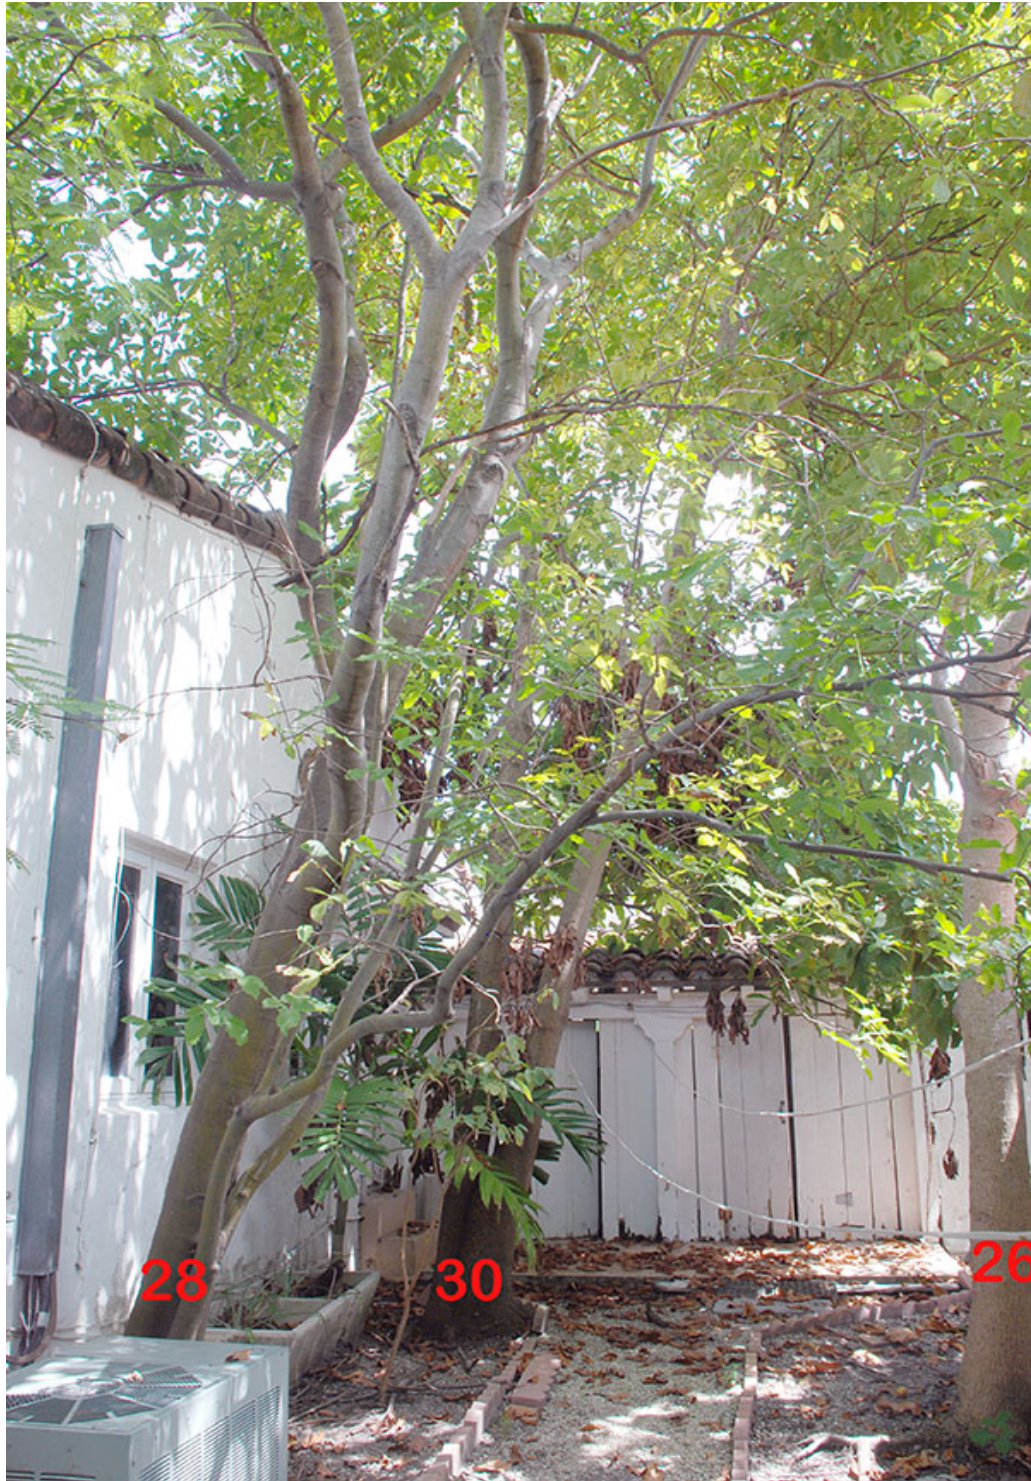
Photo 21 above is trees 26, 28 & 30 viewed from the north. These trees are not good candidates for relocation due to the greatly restricted root plates and poor branch taper.
