FEASIBILITY REPORT FOR PRINCE MICHAEL HOTEL 2618 COLLINS AVENUE MIAMI BEACH, FLORIDA

STRUCTURAL FEASIBILITY REPORT FOR

**PRINCE MICHAEL HOTEL
2618 COLLINS AVENUE
MIAMI BEACH, FLORIDA**

JANUARY 17, 2017

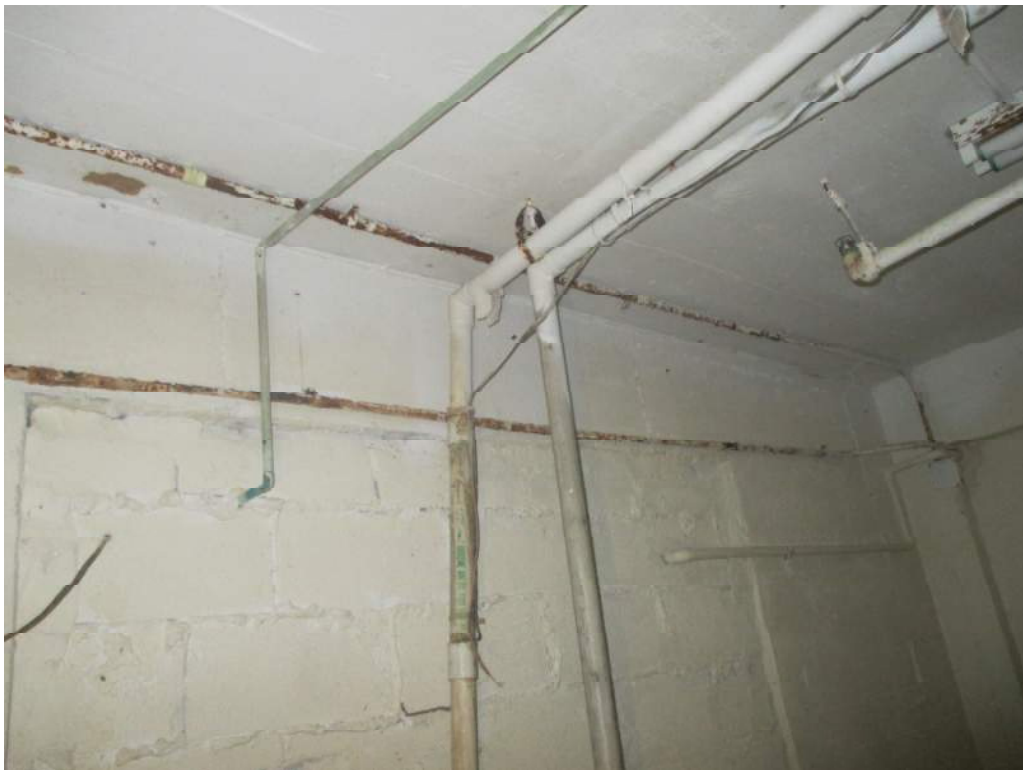
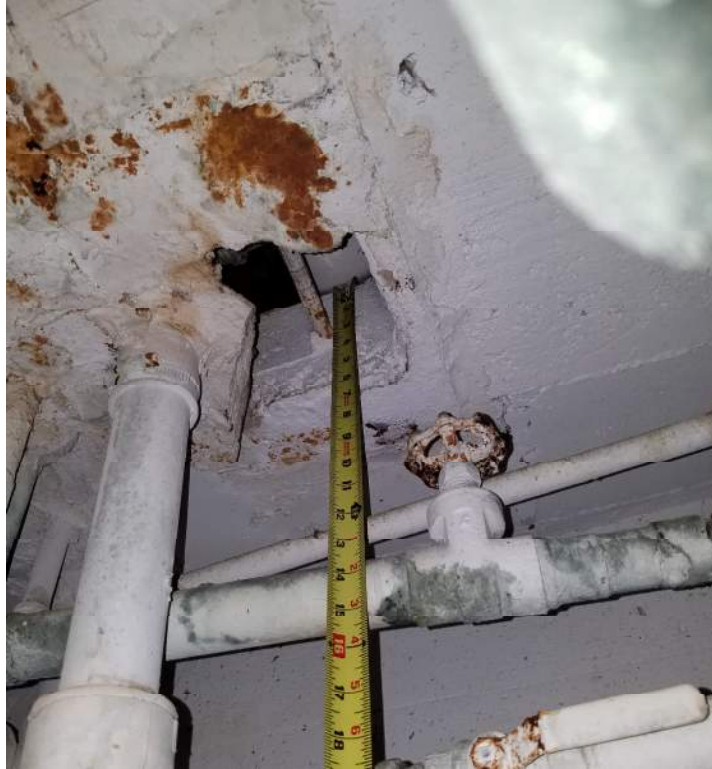
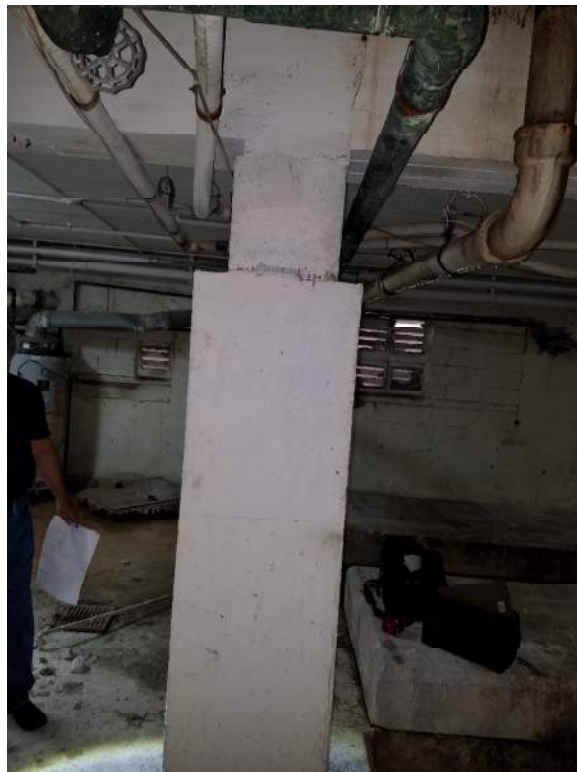
There is a partial basement at the center of the building. The basement is constructed of bearing C.M.U. walls, concrete columns, concrete beams. The concrete slab appears to be a concrete slab-on-ground since it was observed to have minimal reinforcement. This slab is not a hydrostatic reinforced structural slab (Refer to Photographs Nos. 12 through 15).

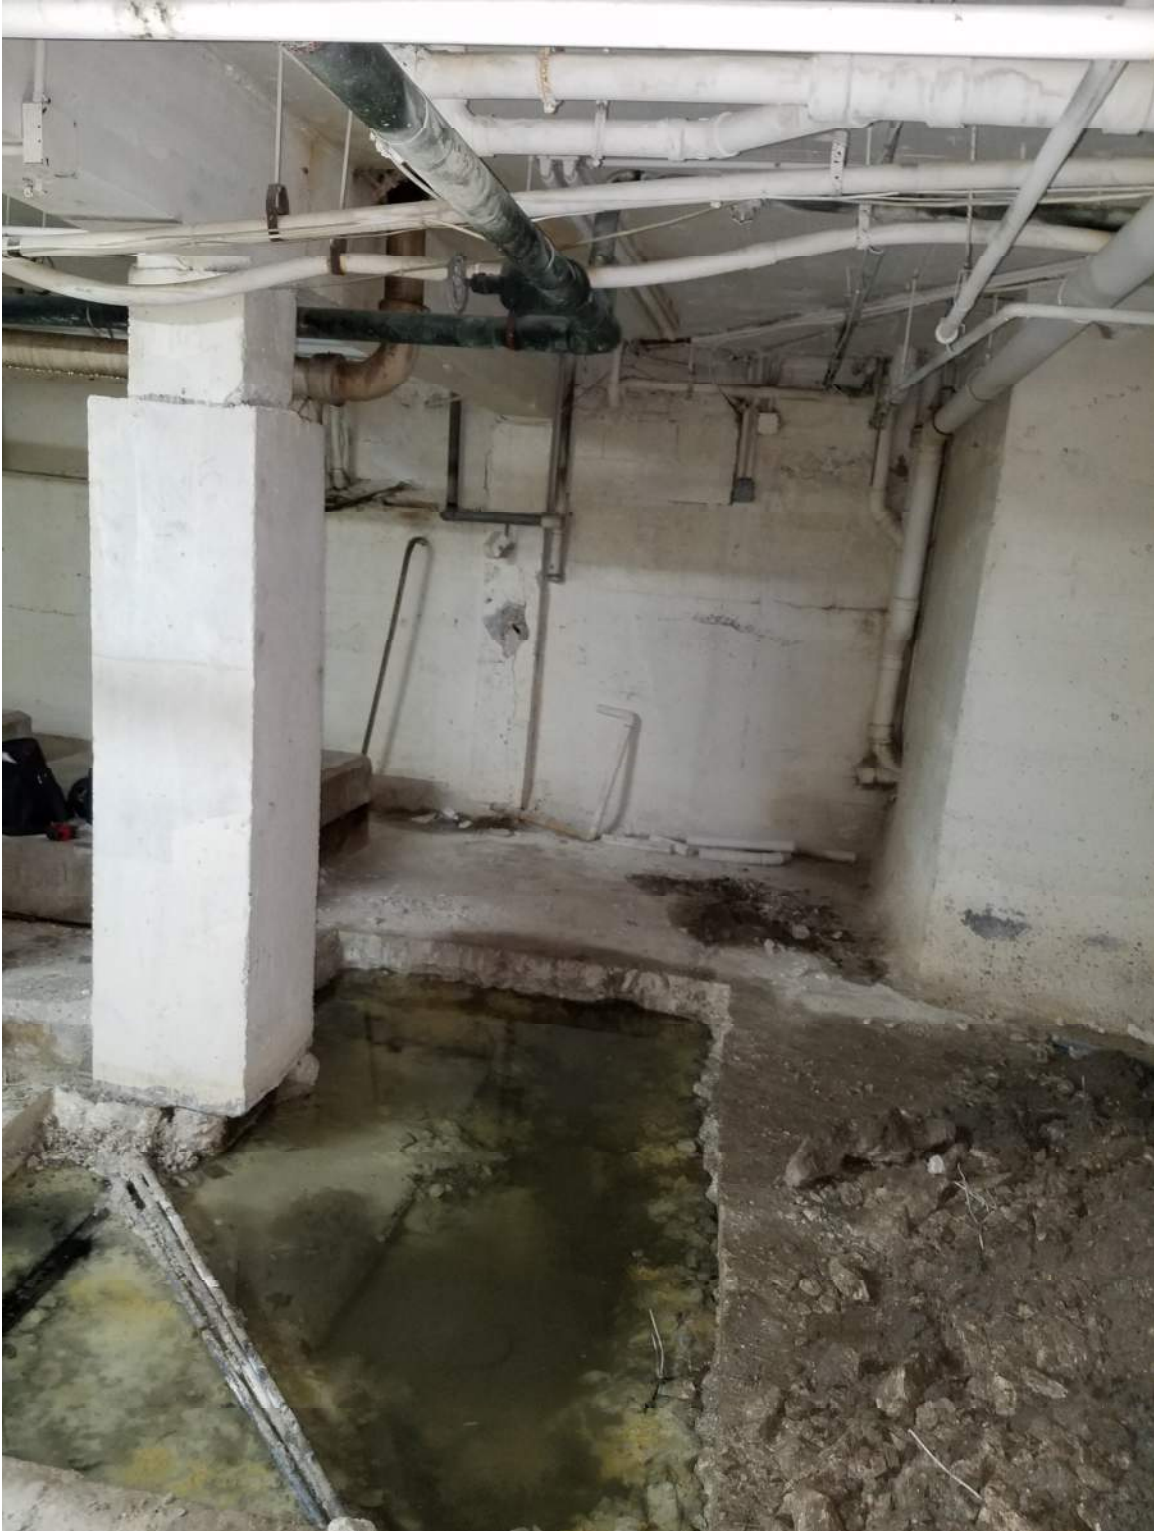
PHOTOGRAPH NO. 15

At the basement area, one column foundation was excavated to observe the existing foundation. Only the top of the foundation was exposed, it seems to be a four piles pile cap just like the ones observed at the crawl space. The basement floor is a structural concrete slab-on-ground (Refer to Photograph No. 15).

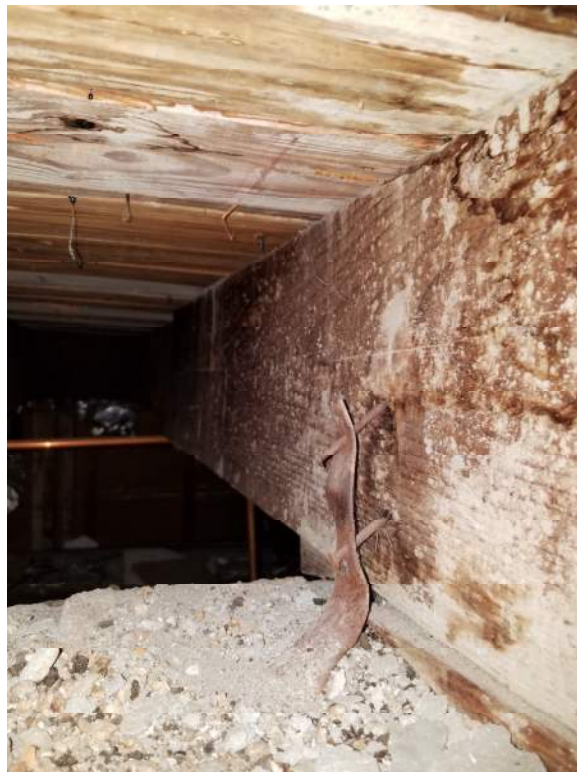
PHOTOGRAPH NO. 36

Light damage can be seen in several wood framing members at the few locations where openings were provided for observation purposes. The wood damage was primarily at the bathroom locations. Most of the wood framing members that were observed are in good condition considering the age of the building. Light to moderate deterioration was also observed at the roof and the crawl space locations (Refer to Photographs Nos. 26, 33, 34, 61 and 62). However, the scope of our work in this aspect was limited due to the few accessible locations. Once all the areas are exposed, we will determine better the general conditions of the wood framing members throughout the building. The wood joists are anchored to the perimeter walls approximately at 5'-4" on center or larger spacing with metal straps (Refer to Photographs Nos. 35 and 36).

The present level of deterioration varies from light to moderate in the majority of structural wood members at the observed areas. The moderate deteriorated wood members will need to be removed. The connections will have to be replaced and additional connections will need to be provided. Also, the spacing of the anchor bolts at the wood plates seems to be more than 5'-4" on center. Additional anchor bolts would be required in order to properly transfer the lateral loads from the diaphragm to the concrete beams.

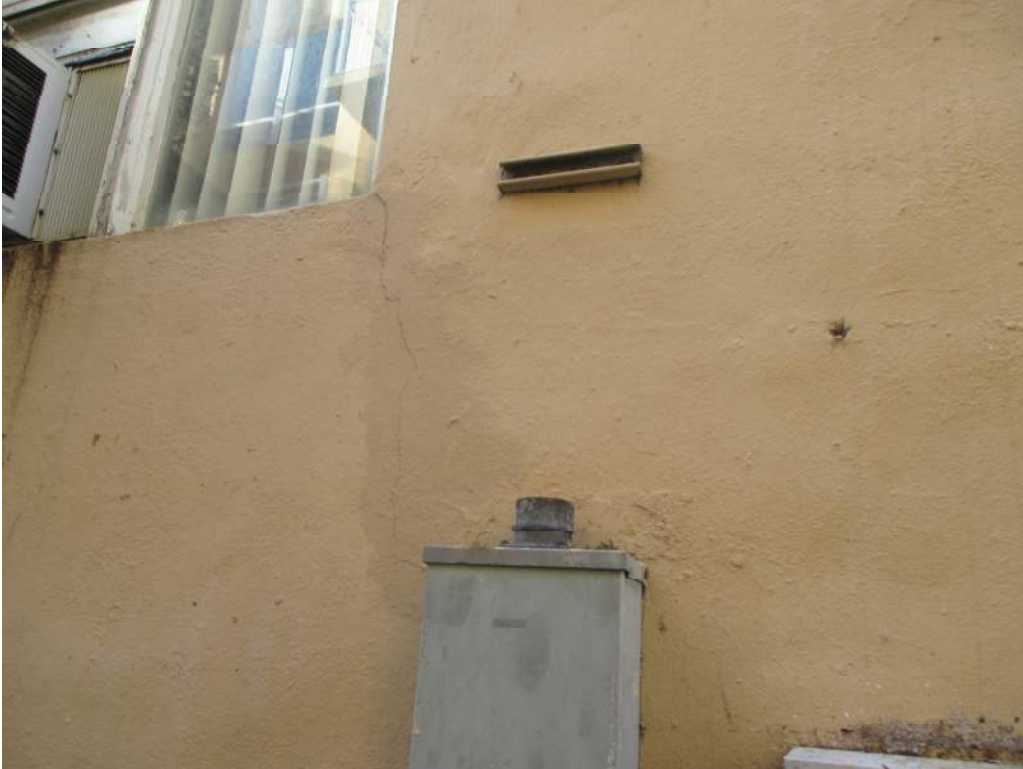
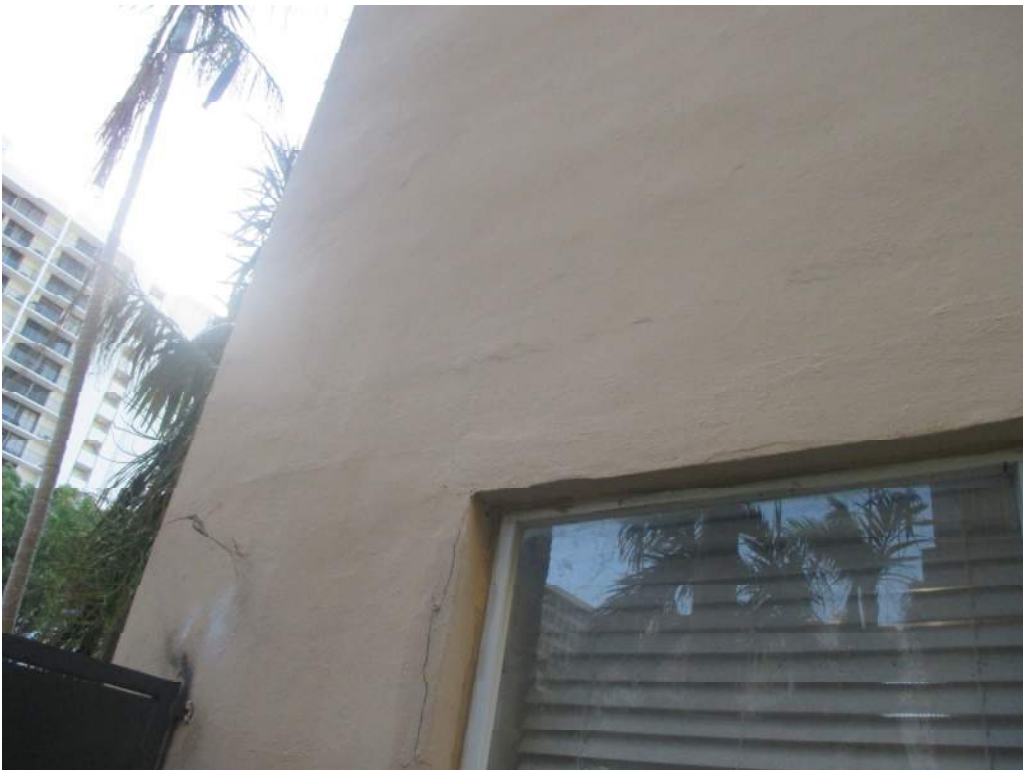
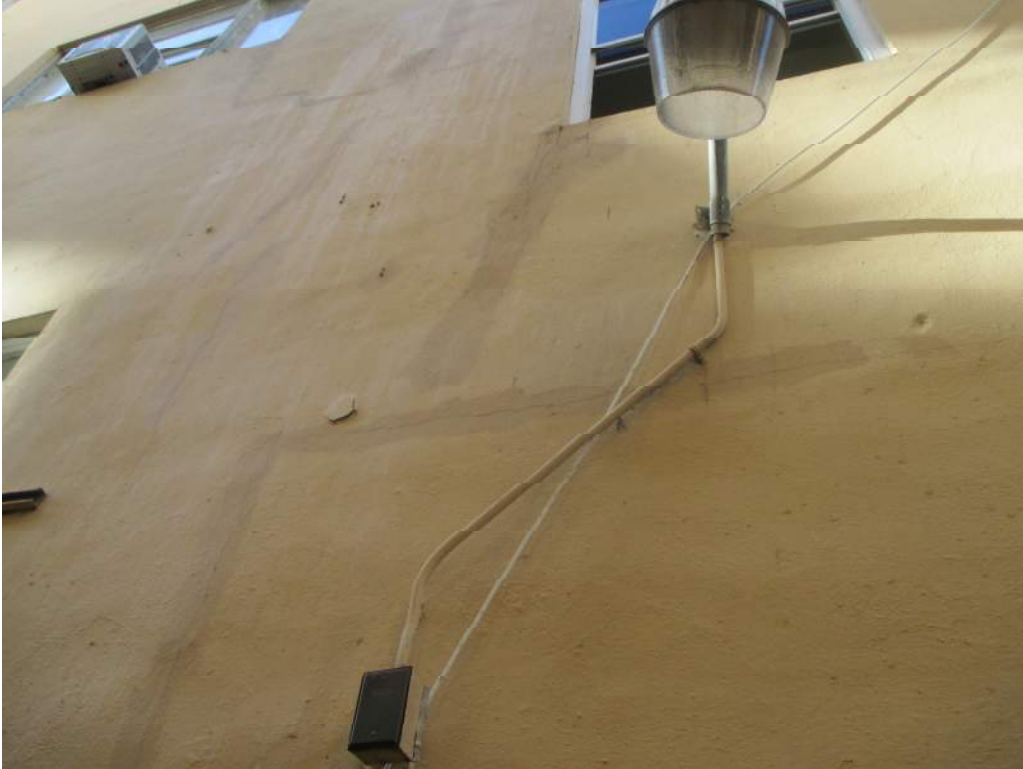
There are many cracks in the exterior stucco throughout the building. Most of these cracks appear to be caused by small differential movement of the joint between the concrete elements (columns, beams and the masonry walls). These cracks prominently appear around windows and doors openings (Refer to Photograph Nos.37 through 39).

Where loose and where cracked due to concrete deterioration, the existing stucco should be removed. After the stucco removal, the existing concrete beams, columns and masonry can be examined for concrete cracks and spalls and for corroded reinforcement. Any spalled concrete, corroded reinforcement, cracks, etc. will need to be repaired prior to reapplying the exterior stucco finish. The stucco should be re-applied in such a manner as to diminish the possibility of a crack reappearing, especially if the original crack was related to movement of a joint. This would include using stucco accessories that allow for small movements in the stucco.

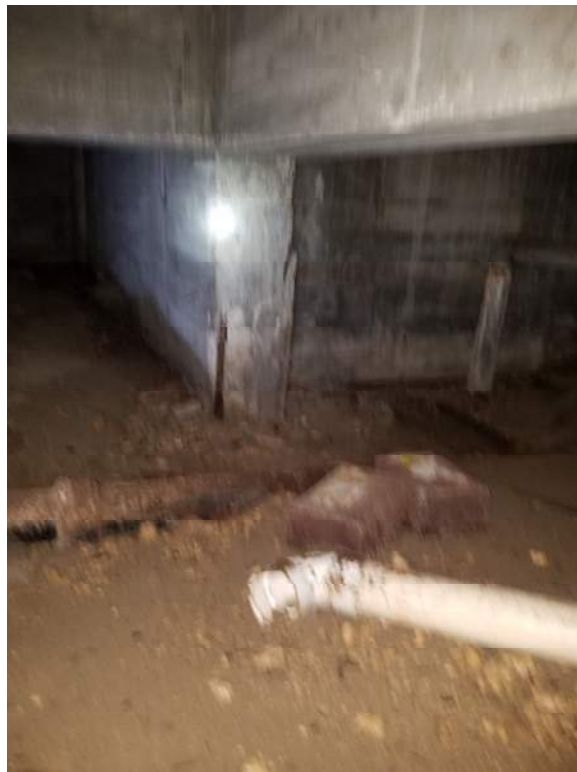
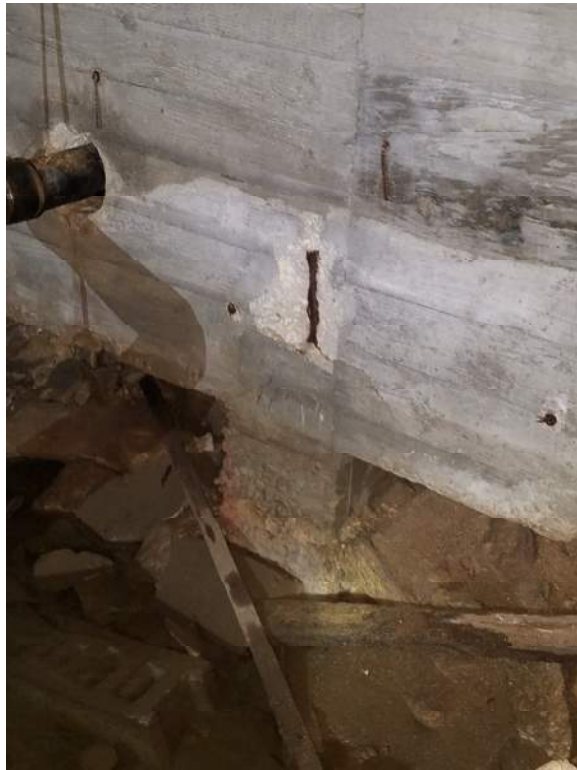
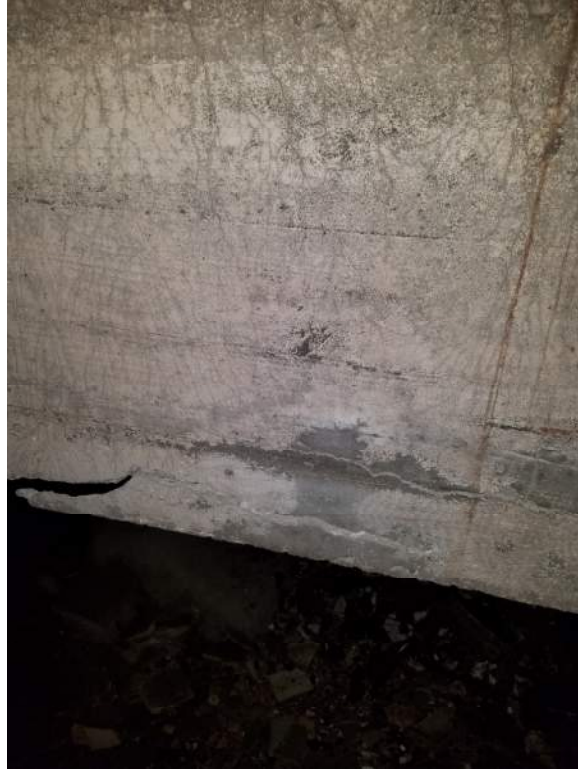
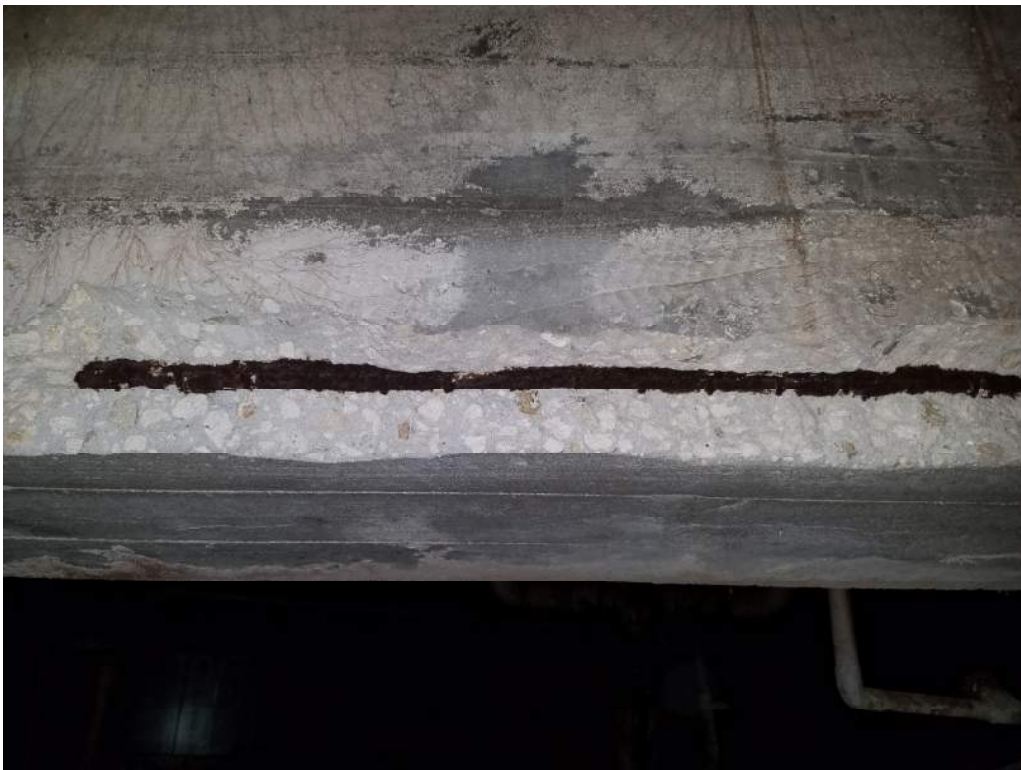
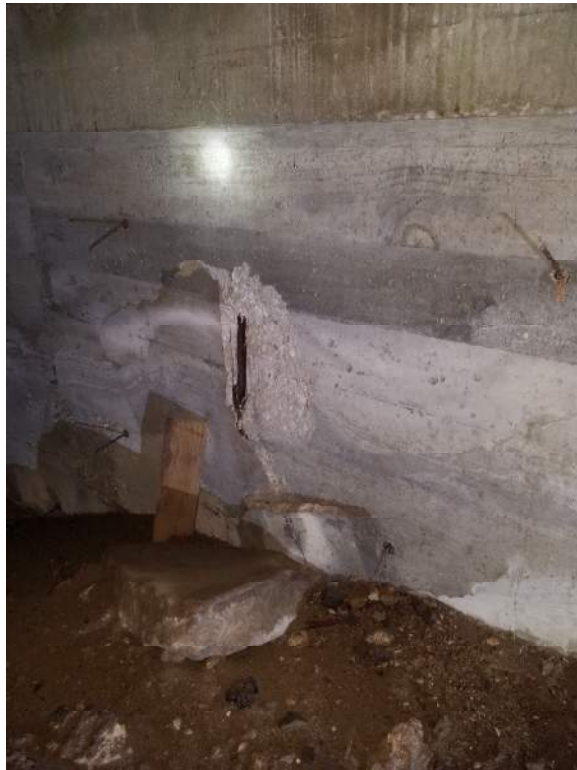
Spalled and cracked concrete was observed in several locations throughout the building, mainly in the crawl space area (Refer to Photograph Nos. 40 through 46), the elevator machine room (Refer to Photograph Nos. 51 through 53), and the basement (Refer to Photograph Nos. 54 and 56). At the crawl space, beams and columns present minor to moderate cracks and spalling, the elevator machine room and basement present spalls and cracks mostly at columns. All other areas present minor concrete deterioration.

Spalled and cracked concrete should be repaired using conventional, industry- approved, ICRI-compliant methods. In general, the areas of spalled and cracked concrete which were observed were minor to moderate. It should be expected that shoring and bracing due to concrete repair work will be minimal, if accomplished in accordance with conventional ICRI-compliant methods.

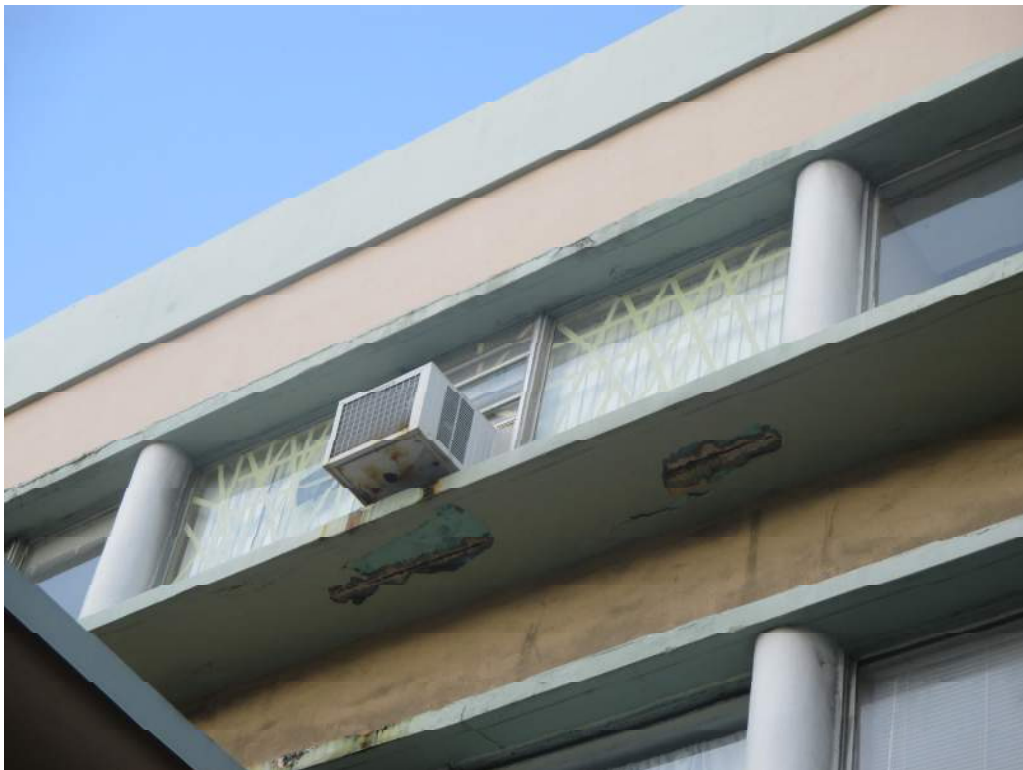
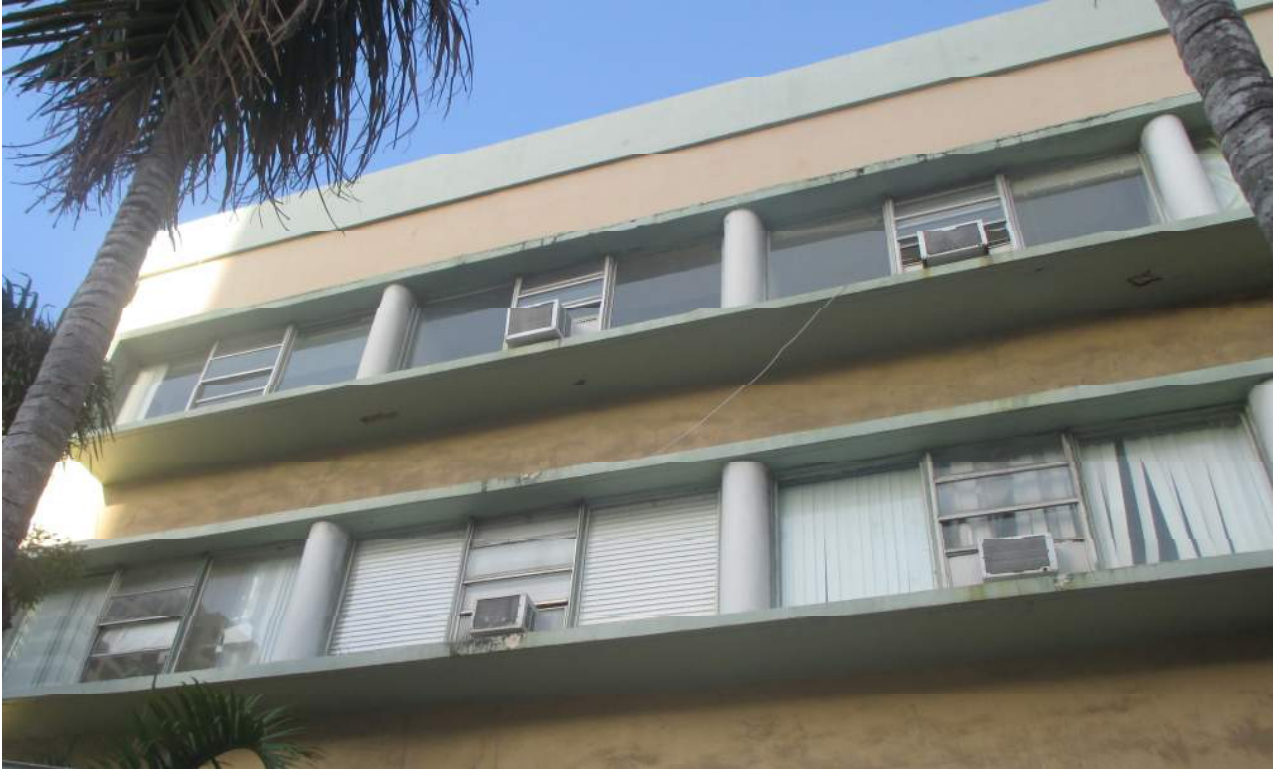
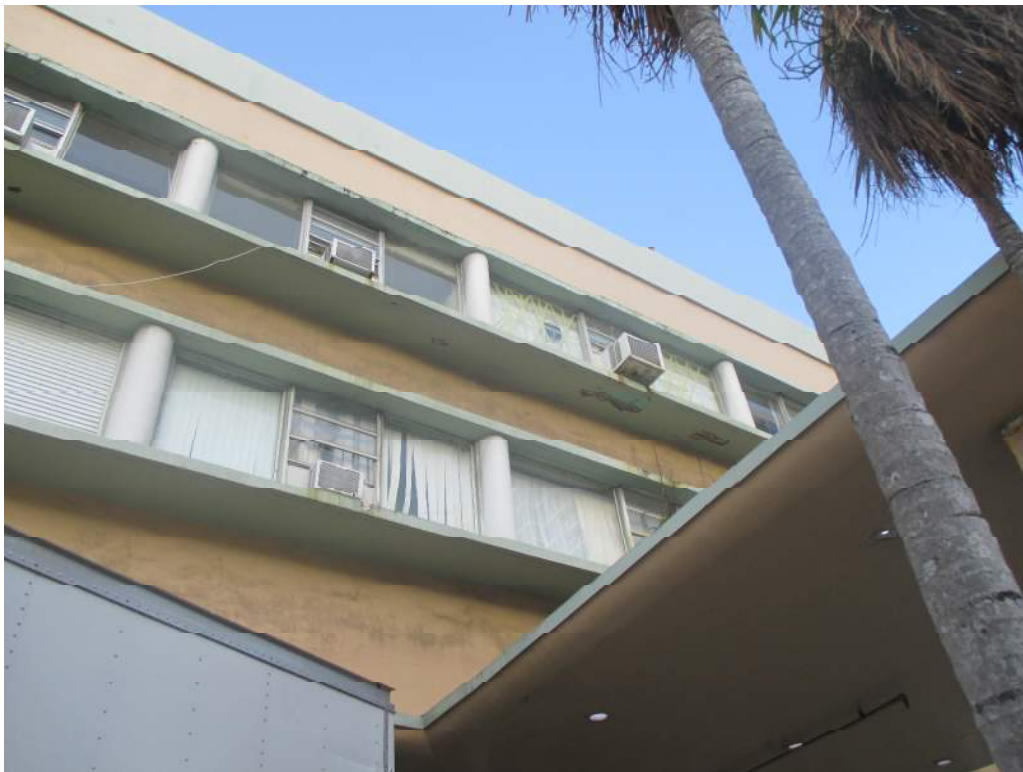
The underside of the eyebrows is finished with stucco. Spalled stucco and spalled concrete were observed at the underside of the concrete eyebrows at the east elevation (Refer to Photographs Nos. 48 through 50).

All stucco should be observed and sounded at close range. If spalled or delaminated, the stucco should be removed. The concrete substrate should be observed and repaired where found to be damaged or deteriorated, and the stucco replaced. If the corrosion of the reinforcement is found to be severe and extensive, it will be necessary to chip out the full depth of the entire or damaged portion of the eyebrow, replace the steel reinforcement with epoxy-coated or galvanized steel bars (spliced to an adequate length of sound existing reinforcement) and recast the concrete. We recommend that water proofing be added to the concrete eyebrows.

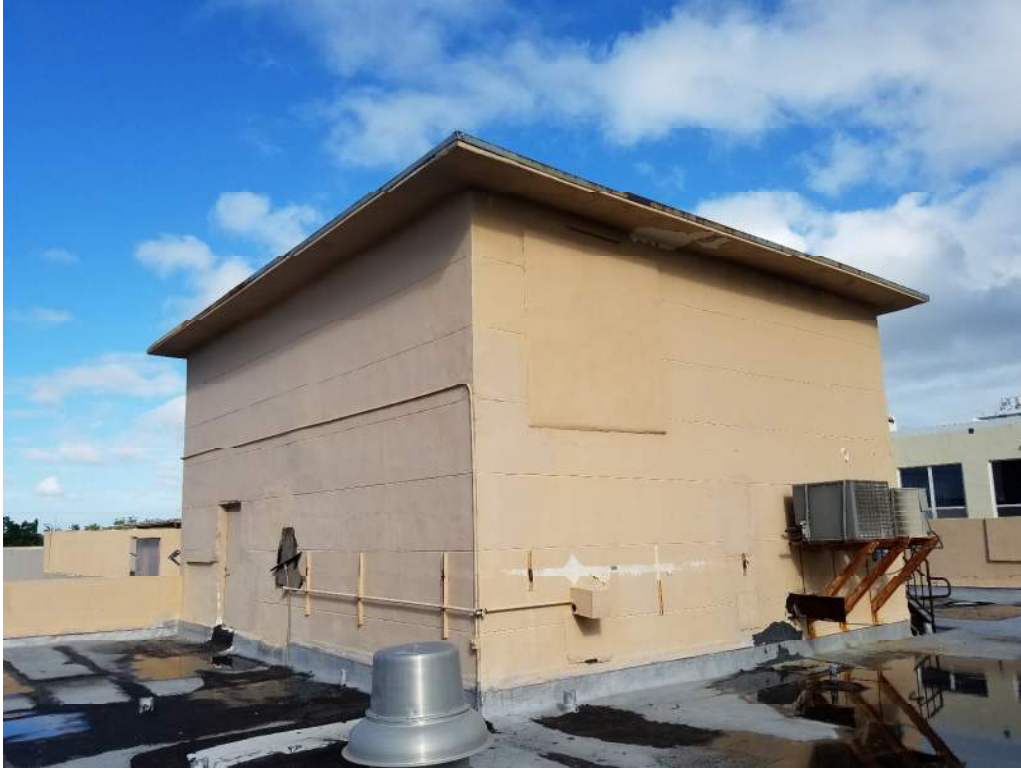
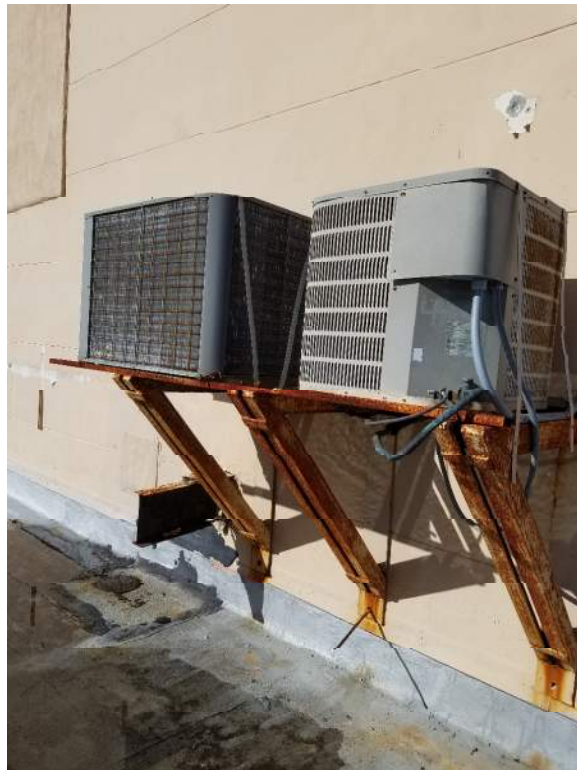
1. The framing of the AC units mounts at the roof level are severely corroded (Refer to Photograph Nos. 59 and 60). Also, the supports seem to be missing anchors.

If retained, it would be necessary to clean, remove all corrosion, repair (if necessary), enhance and recoat these steel members with a corrosion inhibiting paint system.

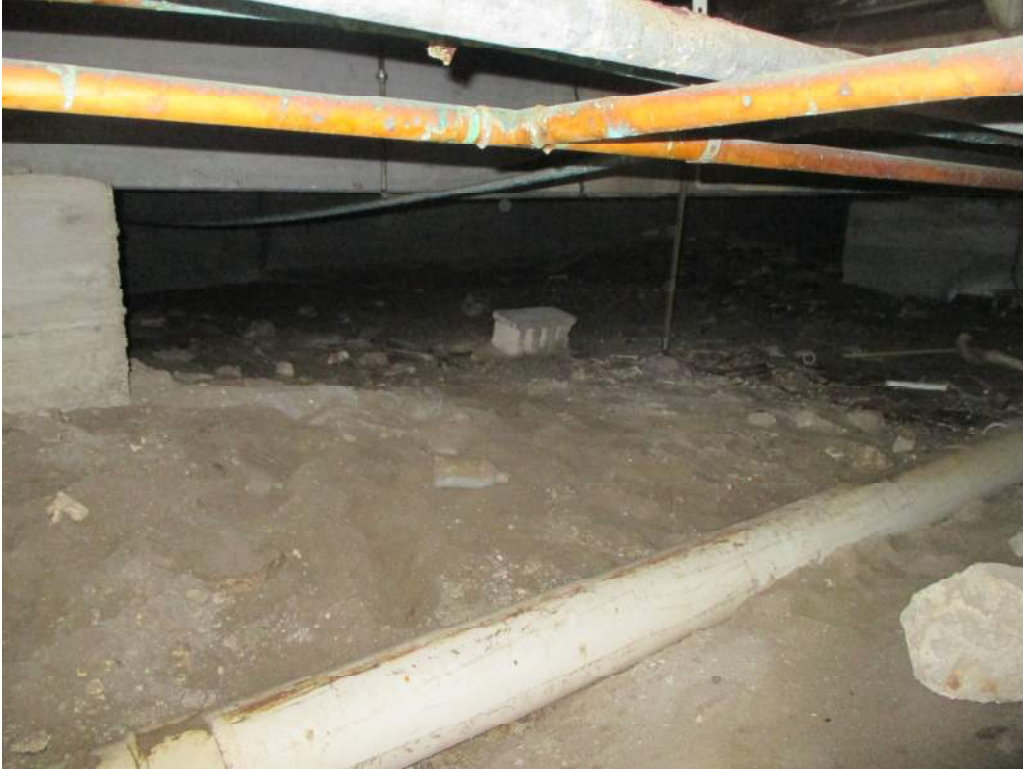
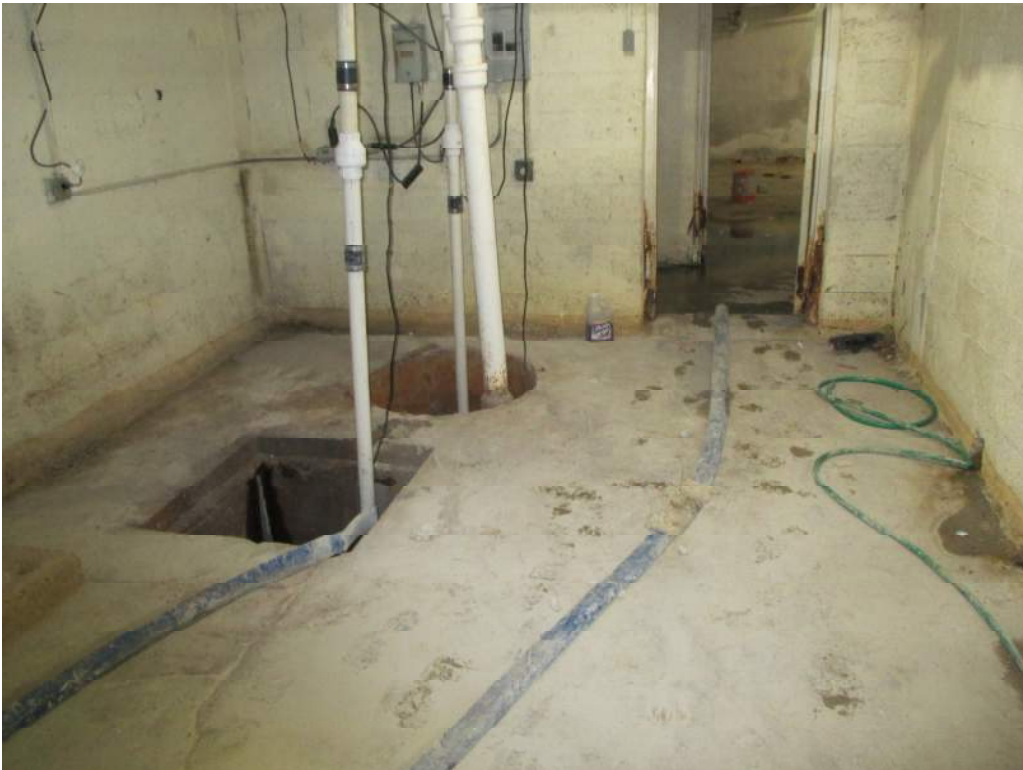
We performed a site visit during high tide to observe if there was any water infiltration into the crawl space and the basement. None of these areas were flooded at the time of the high tide (refer to photographs Nos. 63 and 64).
