Tree Resource Evaluation for 6431 Allison Road, Miami Beach

Prepared for:

Strang Architecture

July 19, 2018

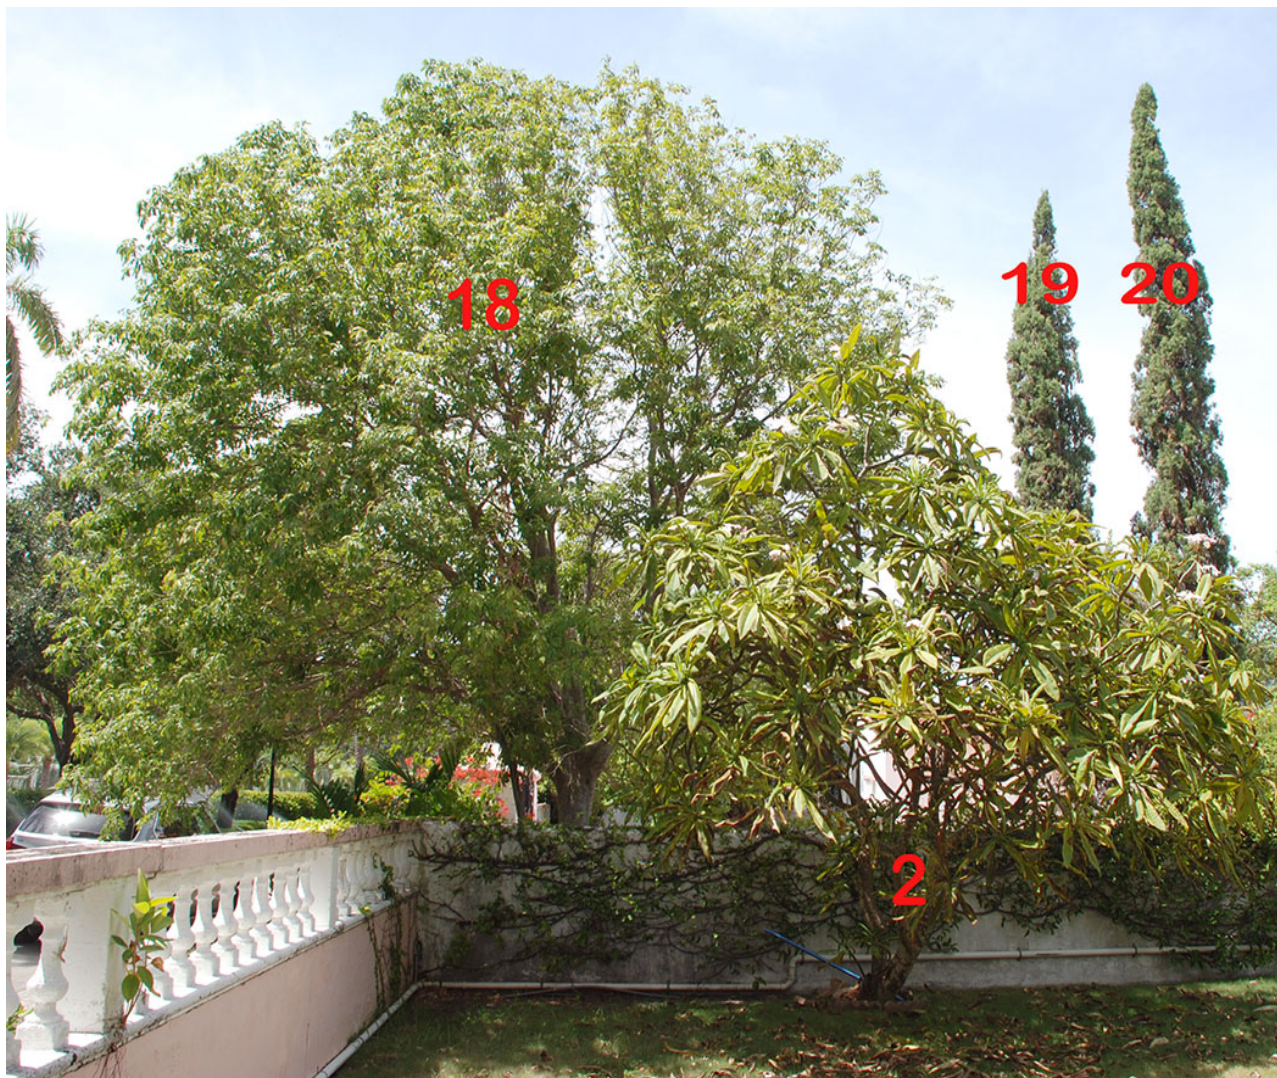
Photo 3 above is tree 2 viewed from the south. This tree is currently in the seasonal process of losing its leaves.

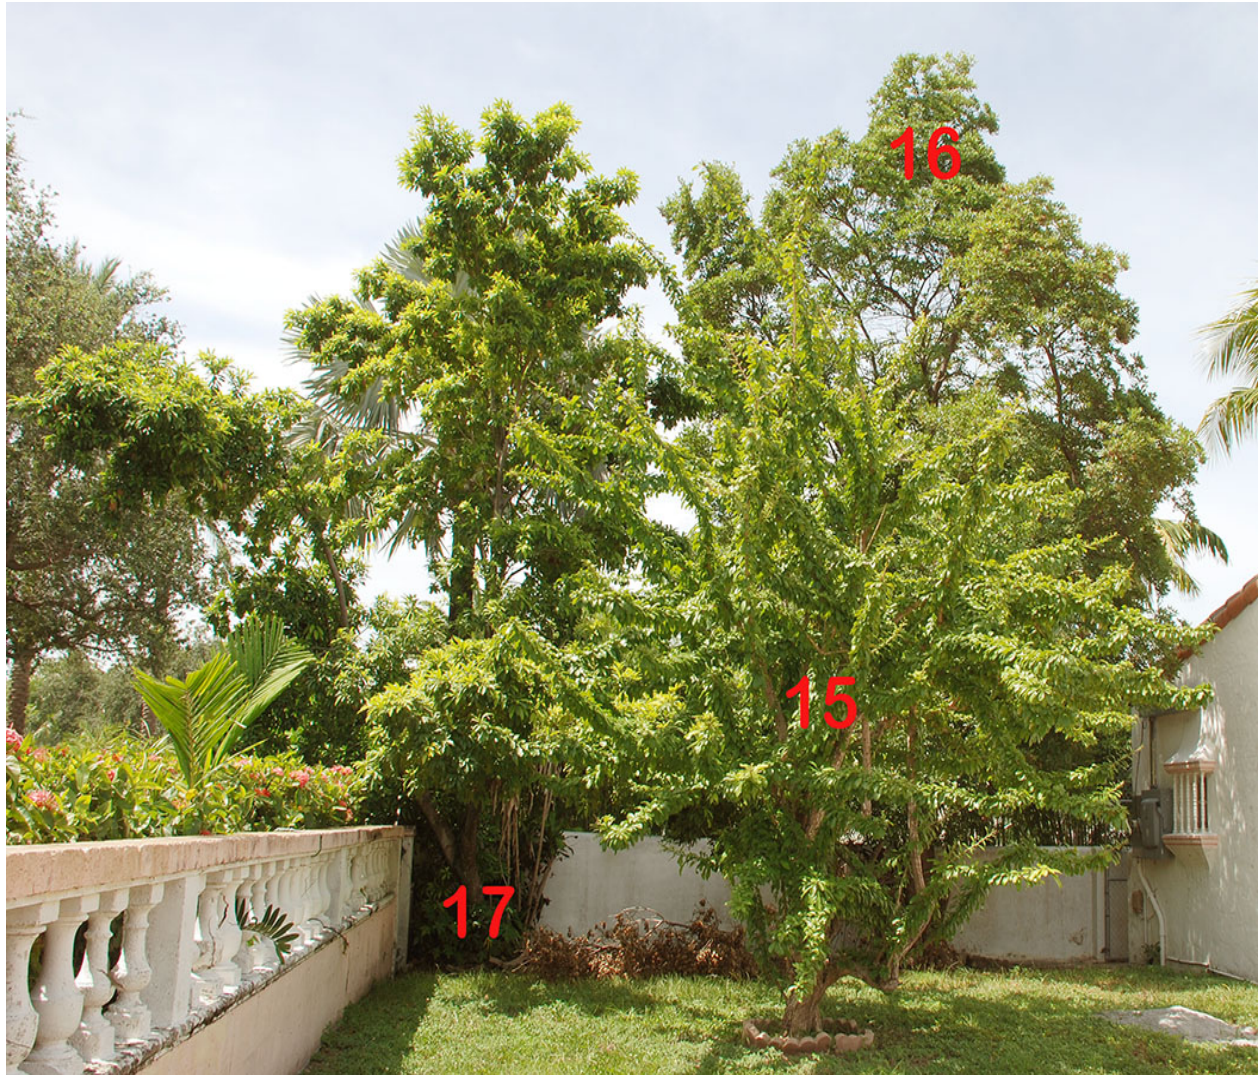
Photo 10 above is tree 15 viewed from the south. This tree is a good candidate for relocation.

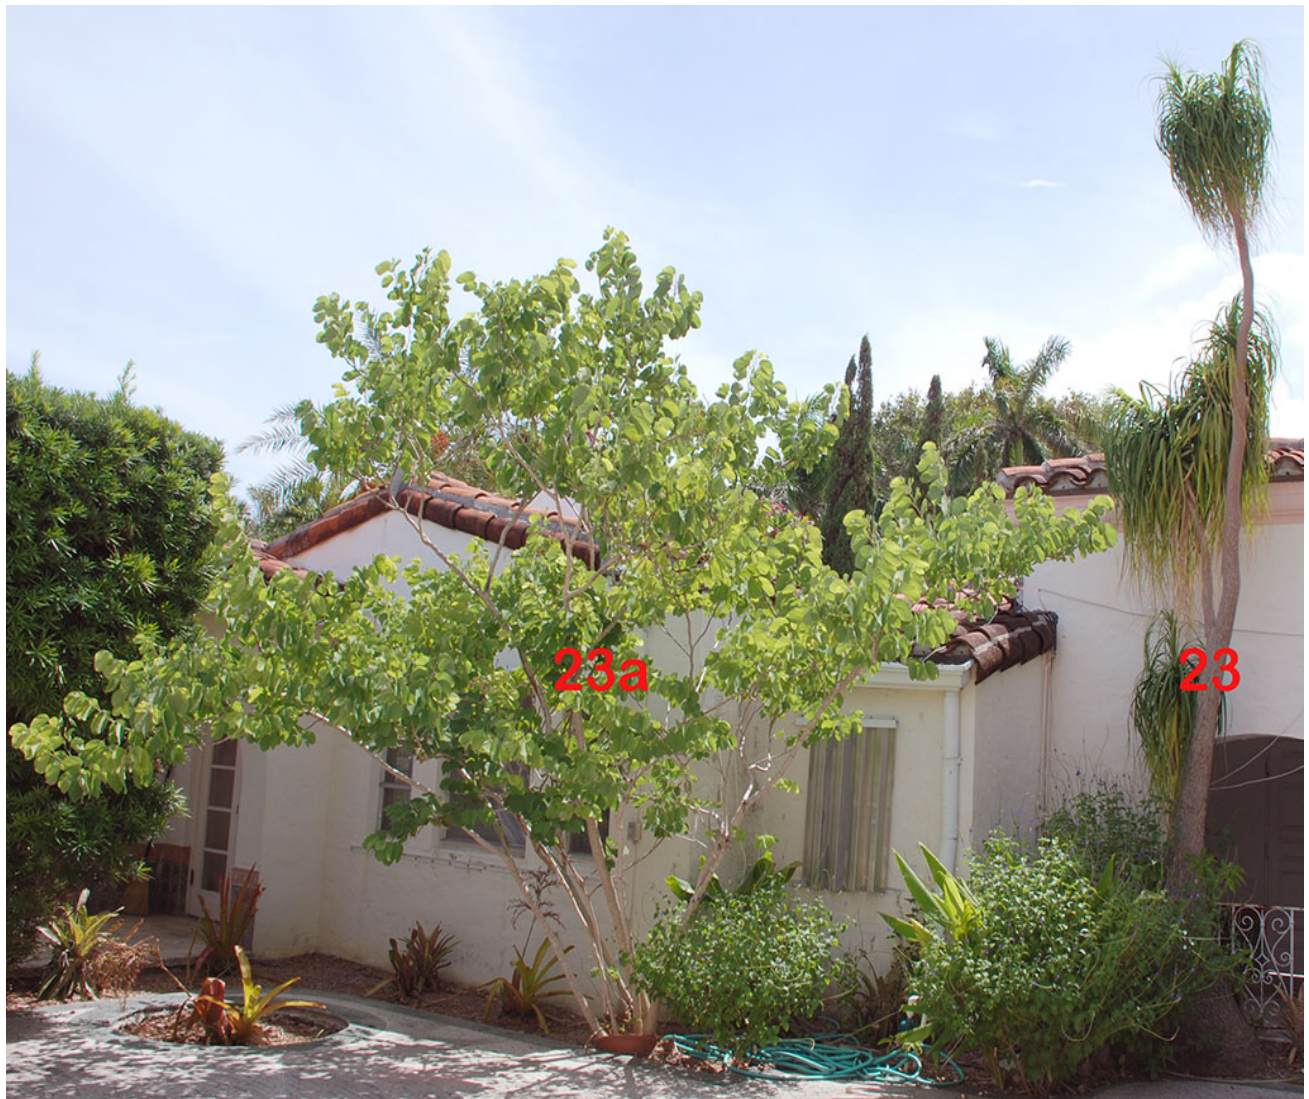
Photo 16 above is ponytail palm 23 (not a true tree or palm) and tree 23a with poor branch structure and grown-in as a volunteer. This tree should be removed.

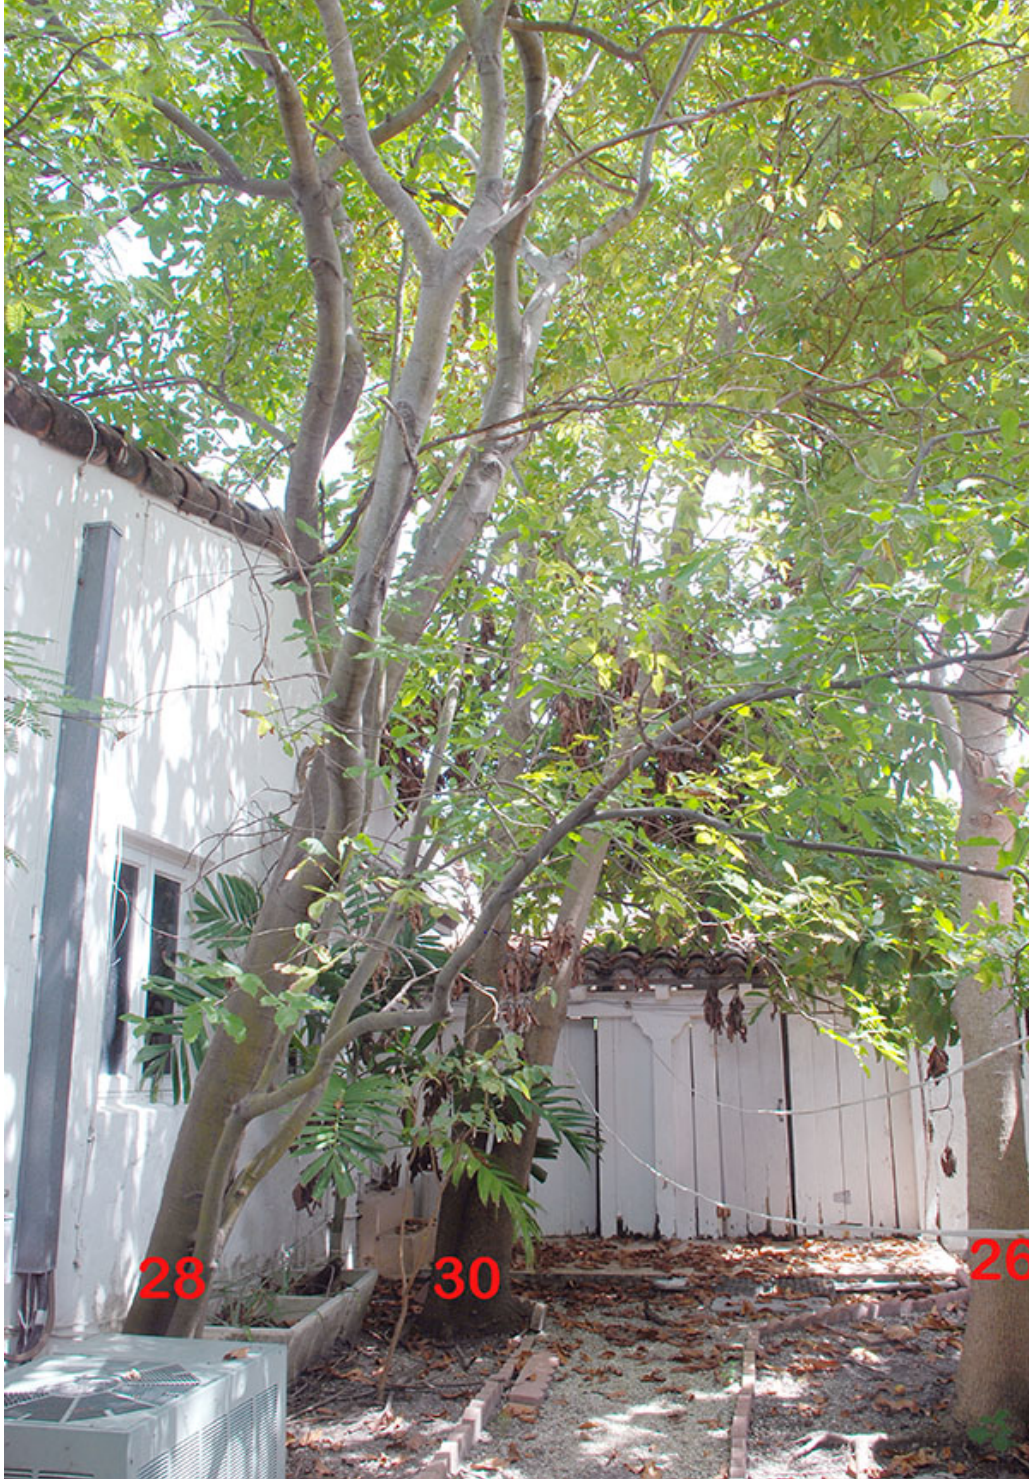
Photo 21 above is trees 26, 28 & 30 viewed from the north. These trees are not good candidates for relocation due to the greatly restricted root plates and poor branch taper.
