Tree Resource Evaluation for 6431 Allison Road, Miami Beach

Prepared for:

Strang Architecture

July 19, 2018

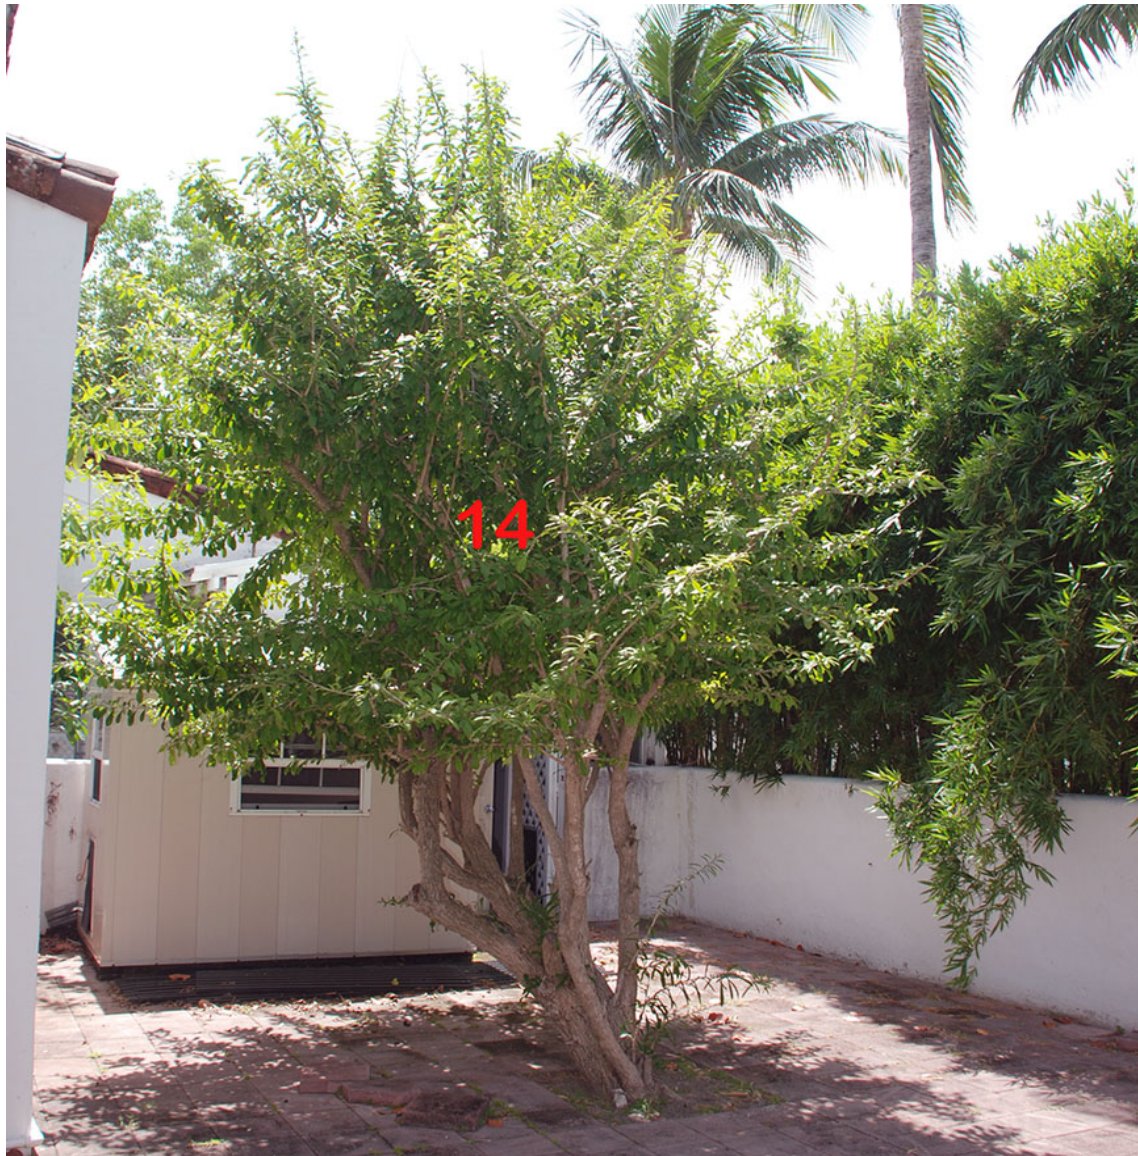
Photo 9 above is tree 14 viewed from the east. This tree is a good candidate for relocation.

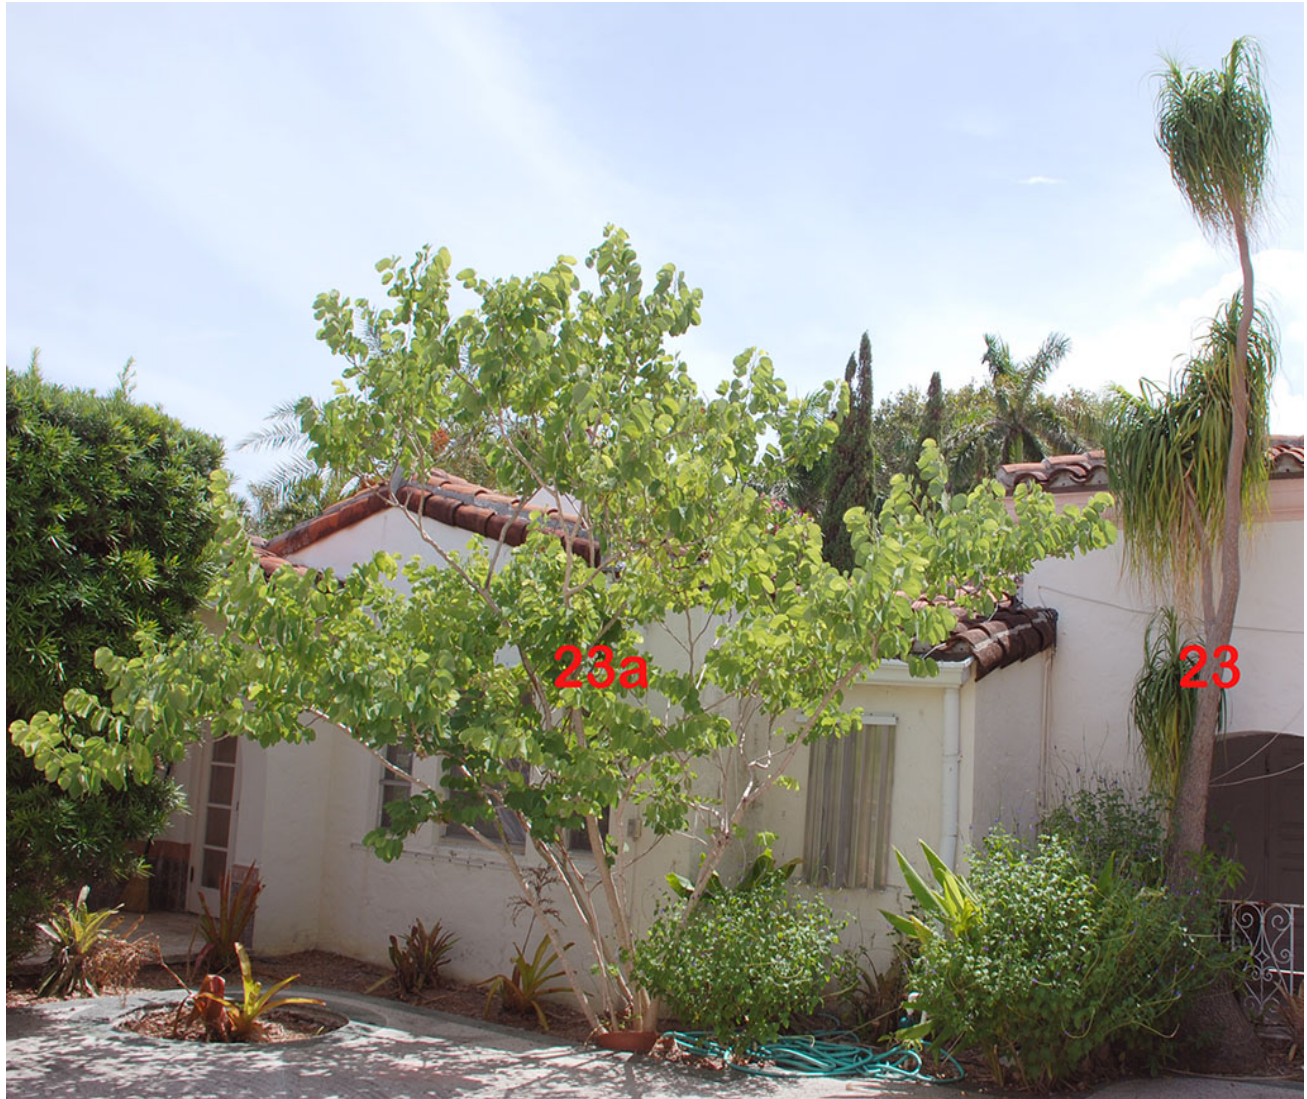
Photo 16 above is ponytail palm 23 (not a true tree or palm) and tree 23a with poor branch structure and grown-in as a volunteer. This tree should be removed.
