# HISTORIC RESOURCES REPORT

7925-7031 + 7935-7041 CRESPI BOULEVARD

STRUCTURAL CONDITION ASSESSMENT  
7925-7935 Crespi Blvd  
Miami Beach, Florida 33141

STRUCTURAL CONDITION ASSESSMENT for  
7925-7935 Crespi Blvd  
Miami Beach, Florida

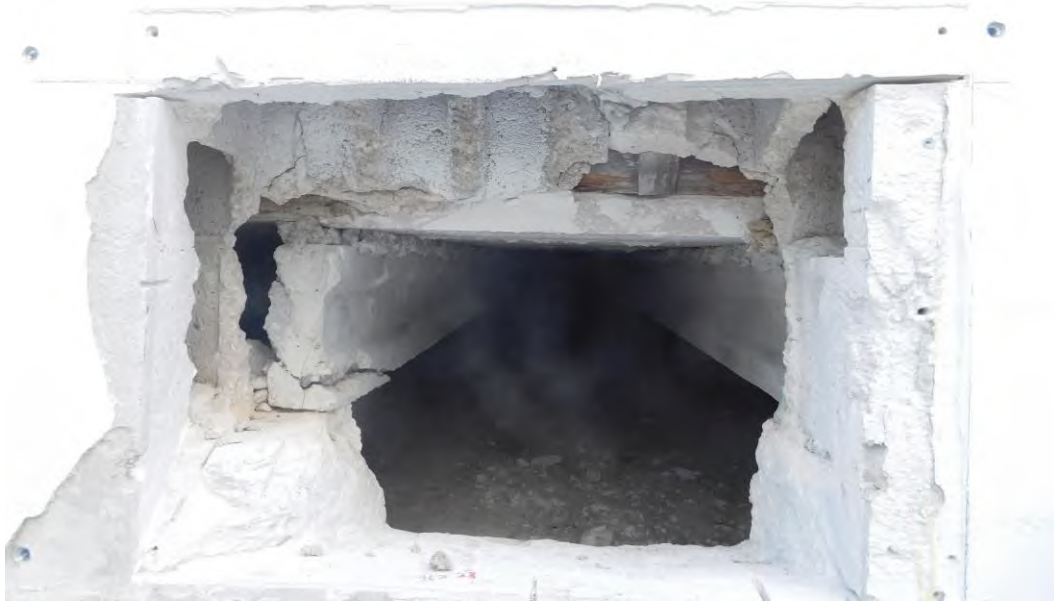
View of typical profile of floor framing.

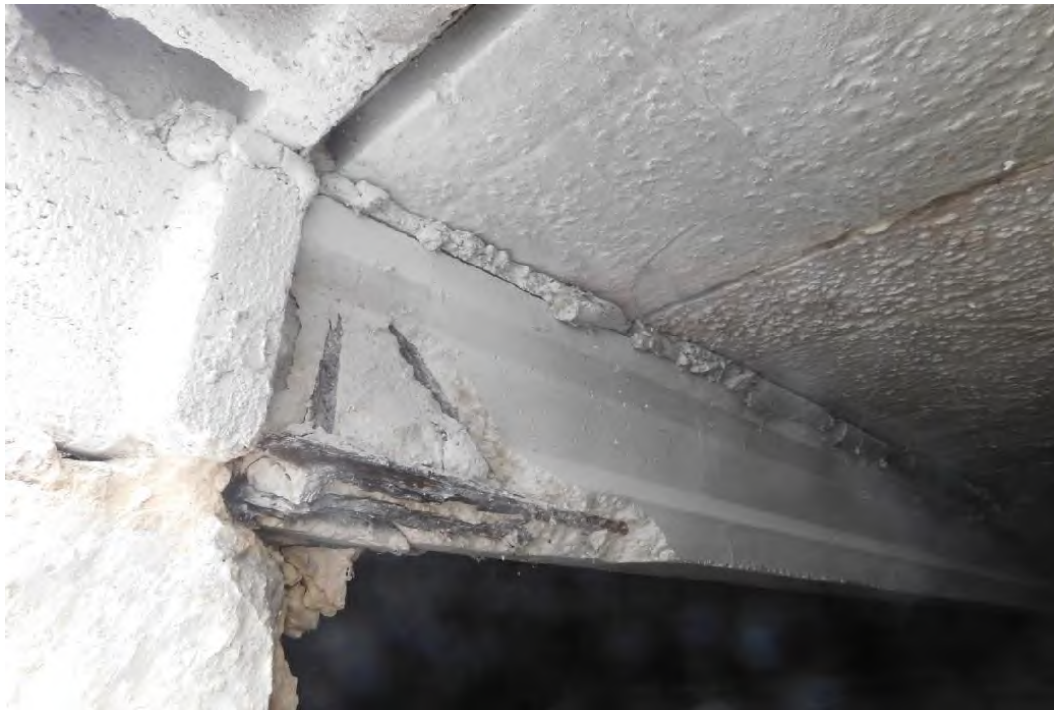
View of significant deterioration of floor joist at support section.

It is our opinion, that water intrusion damage, weathering, and aging has caused significant deterioration to most of the precast joists of the subfloor system. The deterioration is revealed through the cracking, deflection, and loss of structural section that are visible on the affected precast members. The deterioration was also revealed through spalling, delamination, and surface corrosion of the steel reinforcement of the concrete precast joists. The deterioration was more prevalent on the precast joists.

Based on our observations, the damage in most of the precast joists appears to be greater than 10% of their section, with numerous joists where the damage was greater than 20% of their section. The deterioration becomes significant on numerous joists to the point where their integrity, stability, and load carrying ability are diminishing with time. Evidence of local failure was revealed through excessive deflection observed on numerous precast joists and on the tiling system.

Based on our evaluation, it is our professional engineering opinion that the existing floor framing is nearing the end of its useful life. However, although there is significant deterioration of numerous floor joists, the floor framing is still capable of supporting its intended load capacity. An appropriate remediation program must be completed within a year to return the individual structural integrity to the significantly deteriorated floor-framing members.

Alternatively, you could design and install a new wood floor frame. The new wood floor frame should be designed to support 100% of the floor load system in order to replace the structural function of the existing precast joist system. This option would allow leaving the precast joists on their existing conditions. In addition, we recommend that the existing precast joists remain in place.

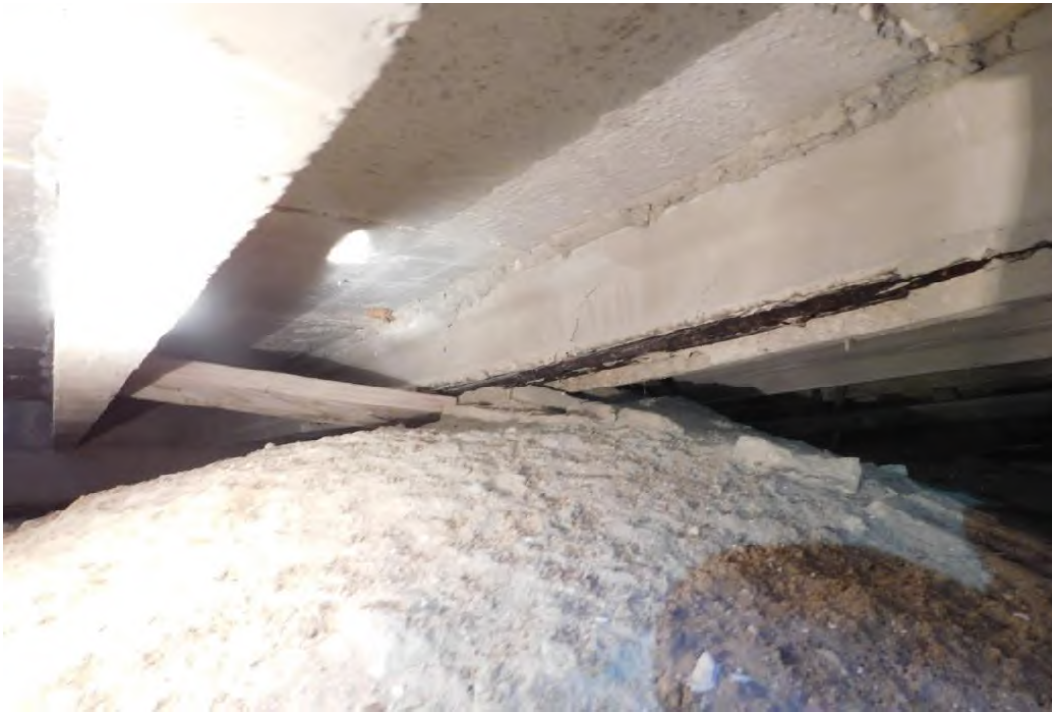
View of significant deterioration of floor joist at mid span section.

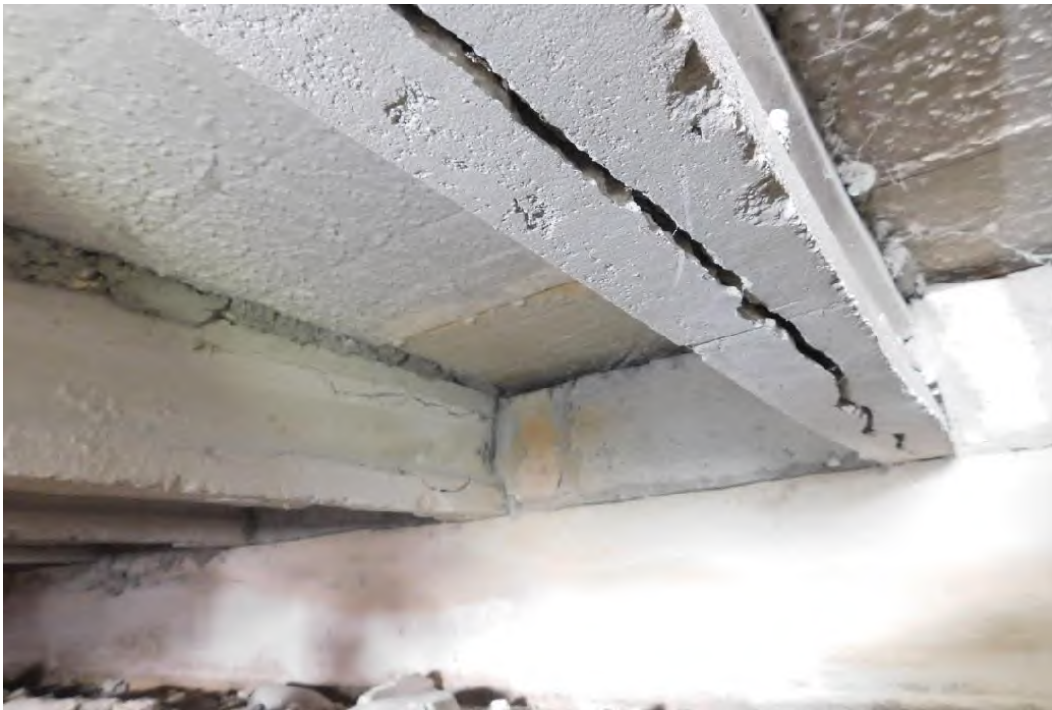
View of significant deterioration of floor joist at support section.

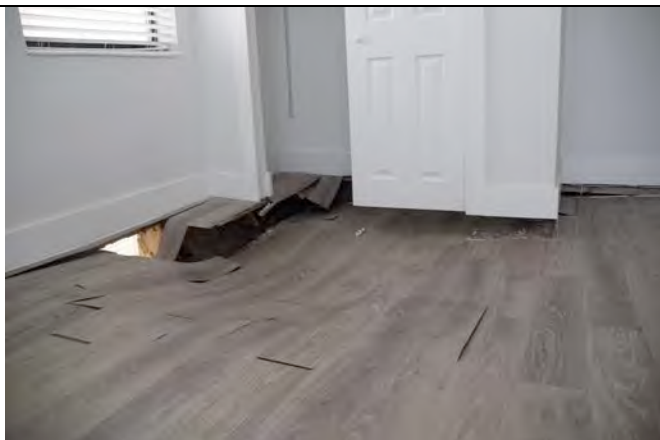
Currently, there is one location in building 7935 that has total collapse of the concrete subfloor joists (please see photos). The joists have collapsed and fallen to grade into the crawl space, these joists are beyond repair.

Photo 2- failed joist system in 7935

Based on the site observations of the conditions of structural members of the buildings, the structural members of this building need to be replaced rather than repaired, that is evident by the collapse of the joist system and missed alignment of the stem walls due to settlement. Hence, in order to do so, these structural members need to be demolished.

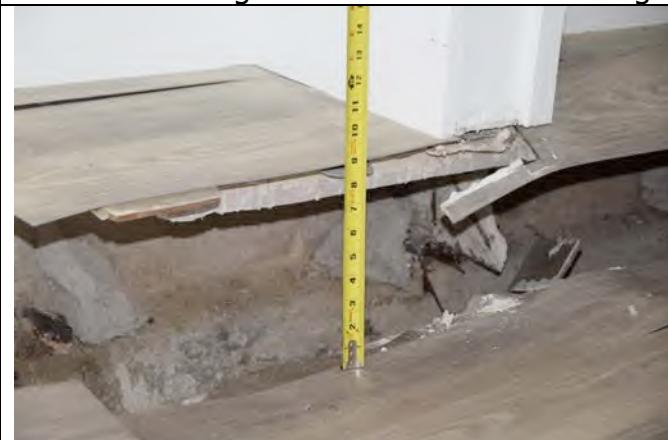
Photo 3 - failed joist system in 7935

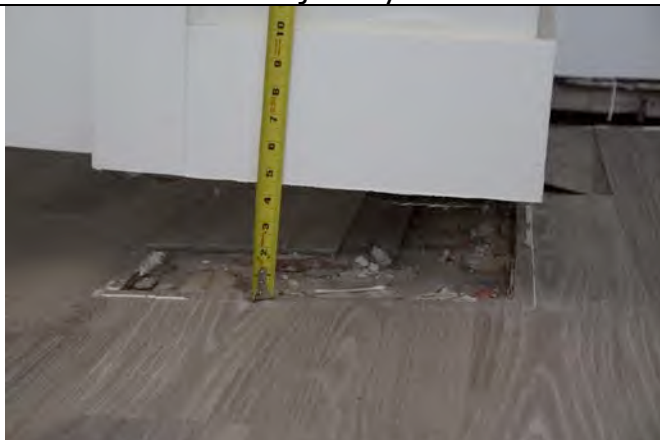
Photo 4 - failed joist system in 7935

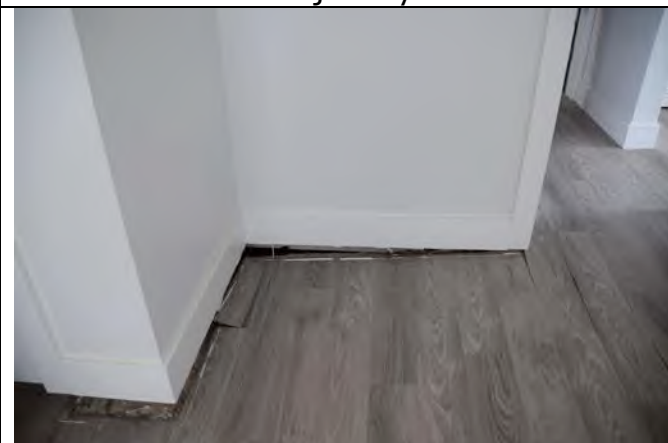
Photo 5- separation between joists and walls

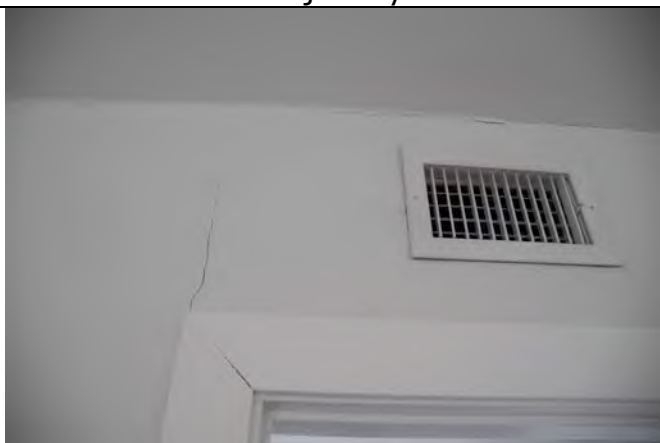
The foundations exhibit substantial settlement that is exhibited by typical cracking of the exterior walls, please see photos.

Photo 6 - Cracking due to settlement

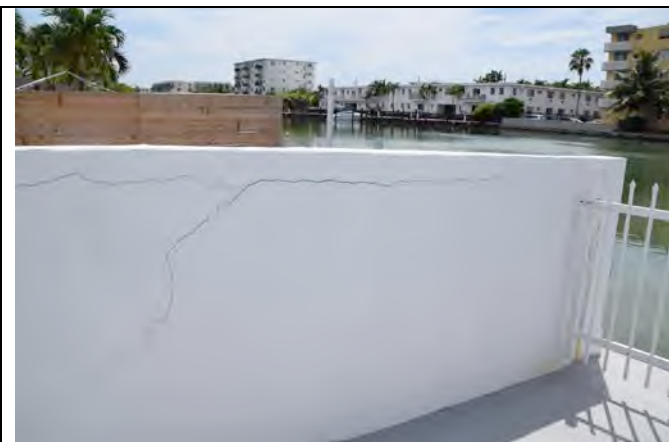
The Whole site is depressed and slanted towards the north east including the settlement of the structures, the settlement of the property walls and the site concrete slabs. The most probable culprit is the deficient seawall on the Tatum canal. The seawall is damaged and undermined. Loss of subsoil coupled with shallow foundations will lead to the exhibited deficiencies in the structures and property walls. Moreover, we observed fish in the canal swimming into and under the wall, leading to the presumption of voids under it.

Photo 7 - Cracking of property wall due to settlement

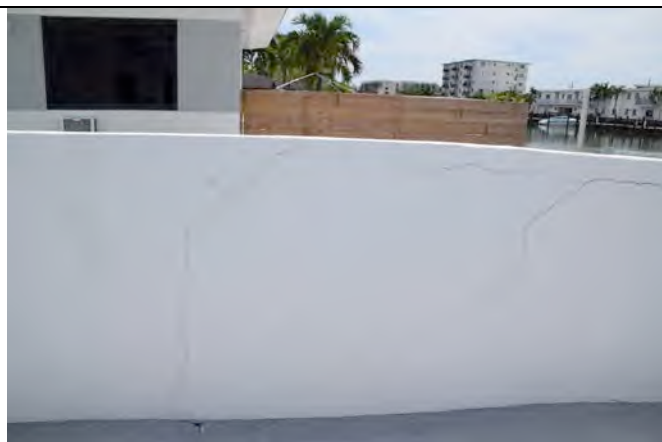
Photo 8 - Cracking of property wall due to settlement

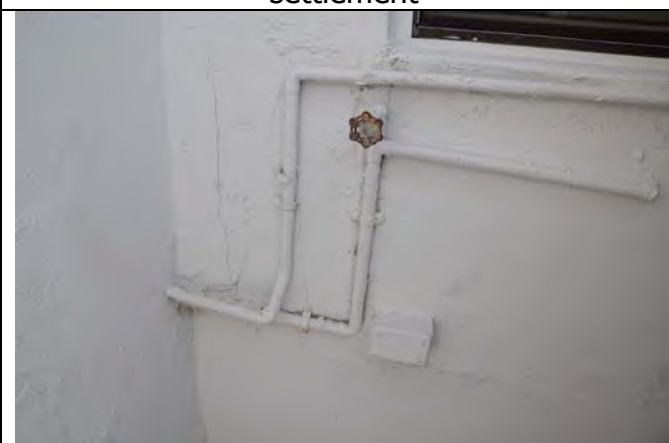
**Masonry members;** which comprise the exterior walls of the building, is mostly in fair condition, but do exhibit cracking to settlement of the foundations. There are several hairline cracks in the masonry that are attributed to age, and exposure to the elements.

Photo 9 - Cracking in exterior walls

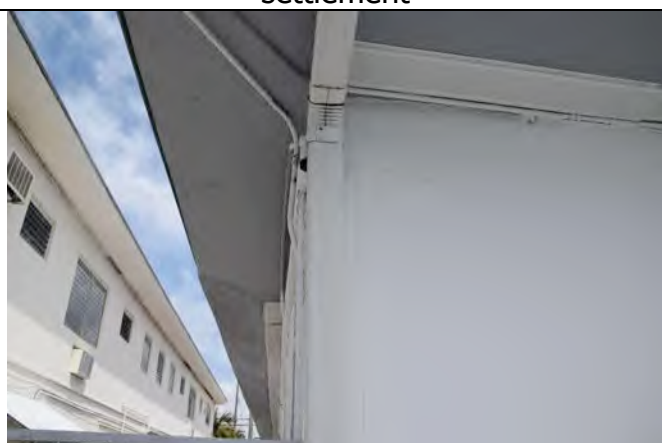
Photo 10 - Cracking in exterior walls

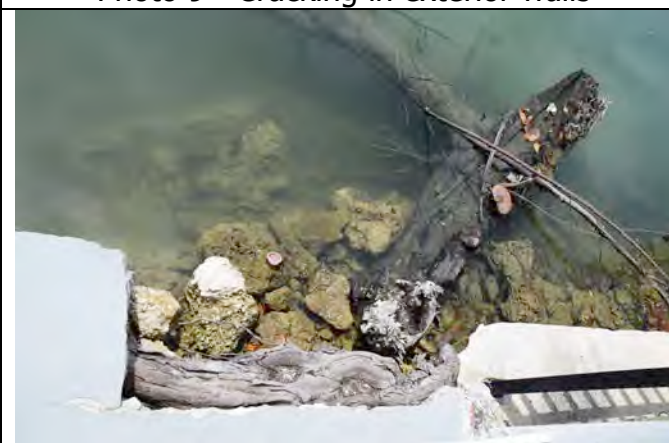
Photo 11 - Failed seawall

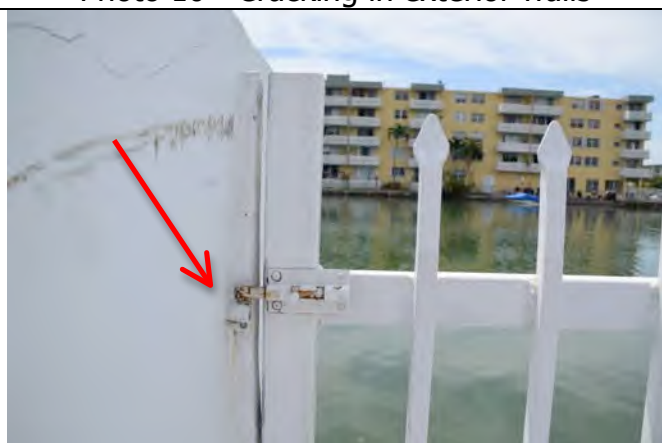
Photo 12 - settlement in wall, notice gate lock

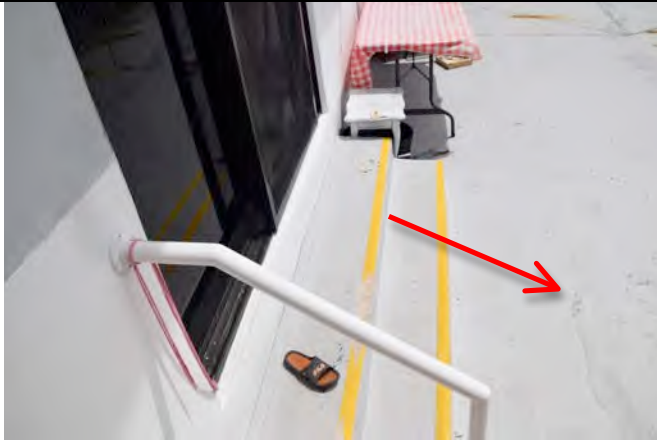
Photo 13 - Cracking in concrete patio

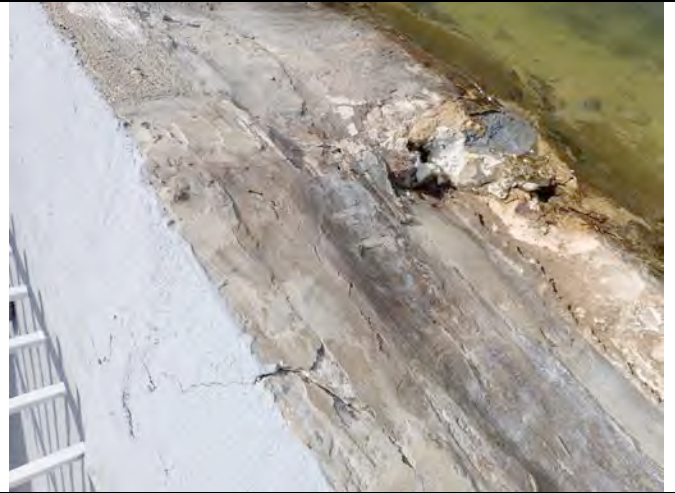
Photo 14 - Seawall deteriorated condition

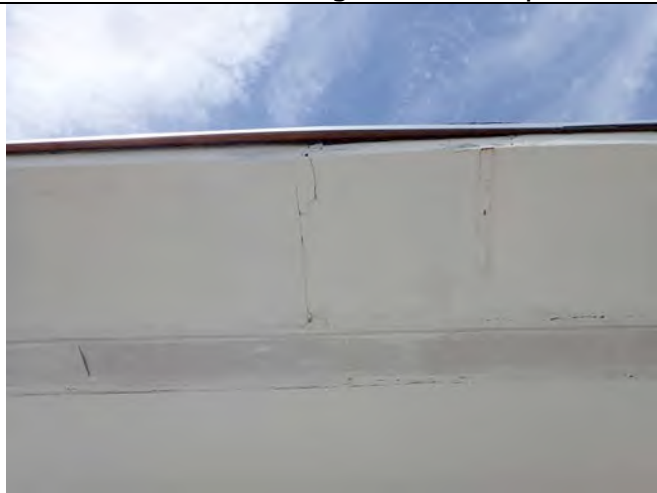
Photo 15 - Structure eave cracking

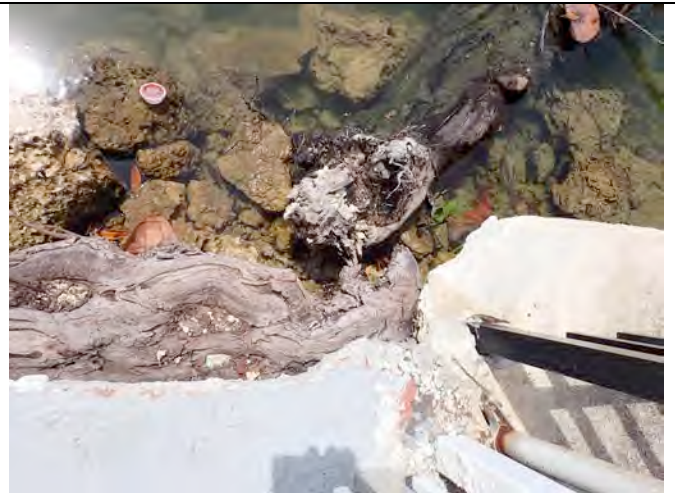
Photo 16 - Seawall deteriorated condition

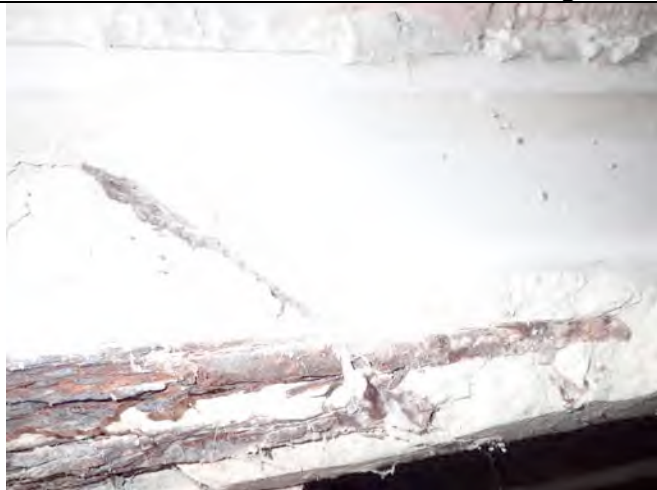
There are several concrete precast joists in the subfloor system that has exposed reinforcing rebars where the concrete has completely spalled off the members. Reinforcing rebars are corroded in multiple locations. Several of the joists has severe cracking. Concrete deterioration is evident in the concrete joists and have occurred at full width of the joists. There are previous attempts to restore the concrete members, and those attempts themselves have failed. Previous attempts were to replace the concrete joists with wood joists in the 7925 building.

Photo 17 - Rebar corrosion and Concrete spalling of concrete joist system

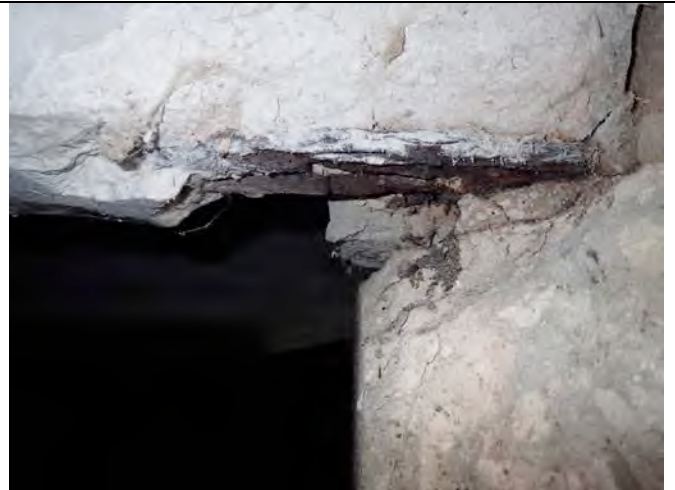
The concrete joists deterioration is substantial on most of the joists where stability and load carrying capacity are greatly reduced. Local bearing failure is evident though out the buildings with coupled with observed cracking.

Photo 18 - Rebar corrosion and Concrete spalling of concrete joist system, and loss of bearing

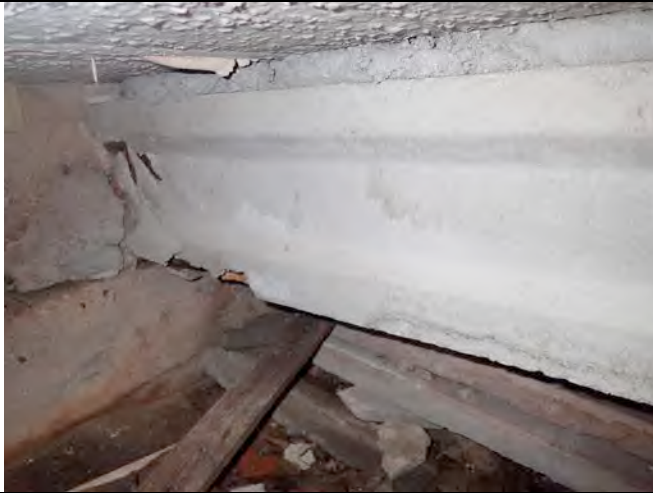
Photo 19 - Rebar corrosion and Concrete spalling of concrete joist system, and loss of bearing

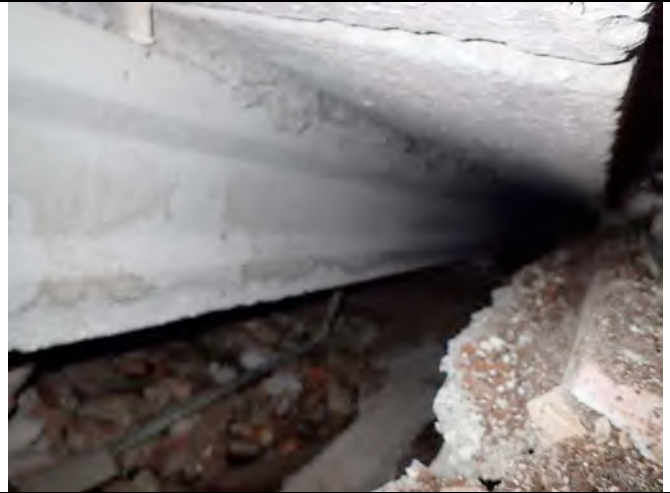
Photo 20 - concrete floor failure

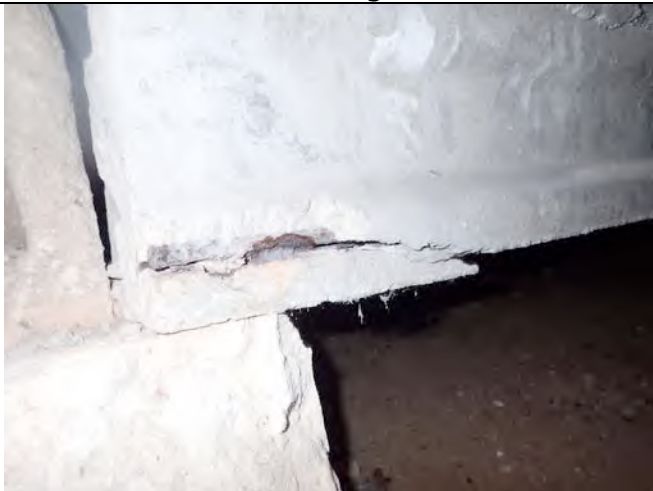
Photo 21 - Rebar corrosion and Concrete spalling of concrete joist system, and loss of bearing

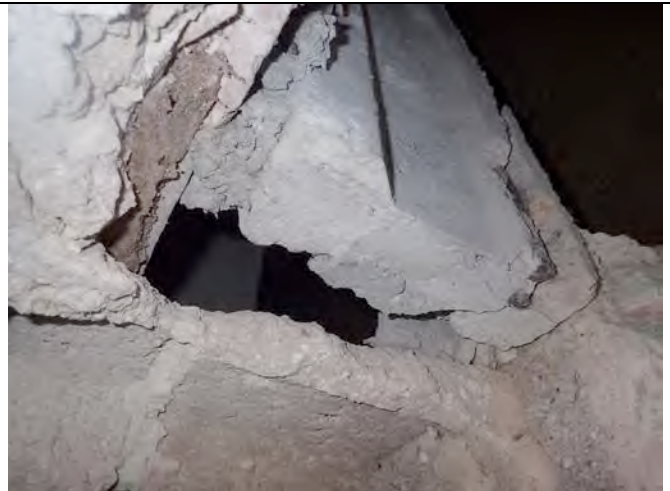
Photo 22 Rebar corrosion and Concrete spalling of concrete joist system, and loss of bearing

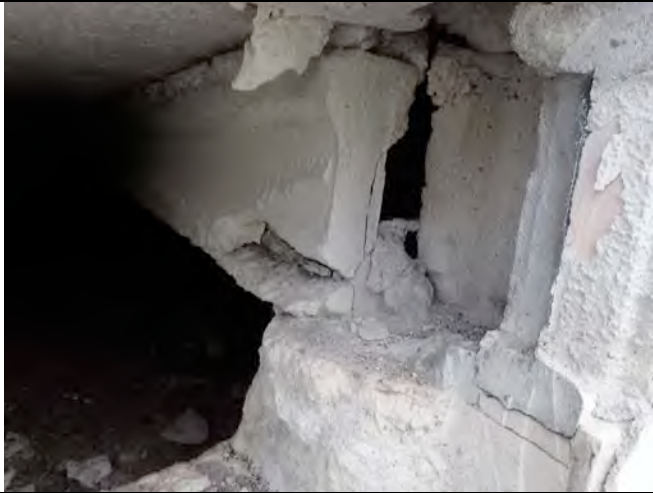
Photo 23 - Rebar corrosion and Concrete spalling of joist system, and loss of bearing

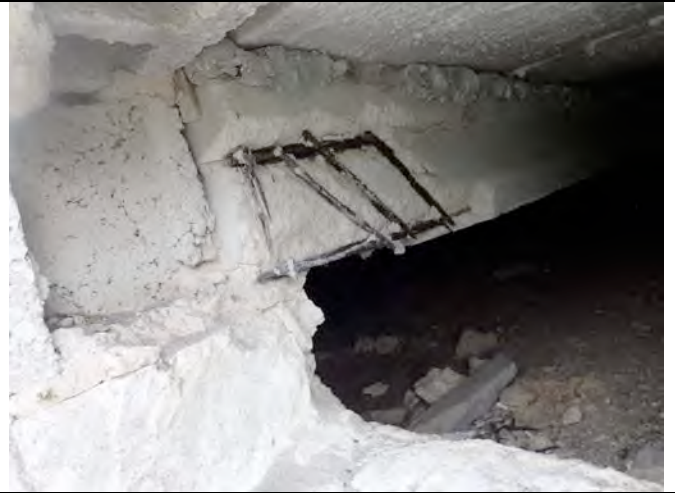
Photo 24 - Rebar corrosion and Concrete spalling of joist system, and loss of bearing

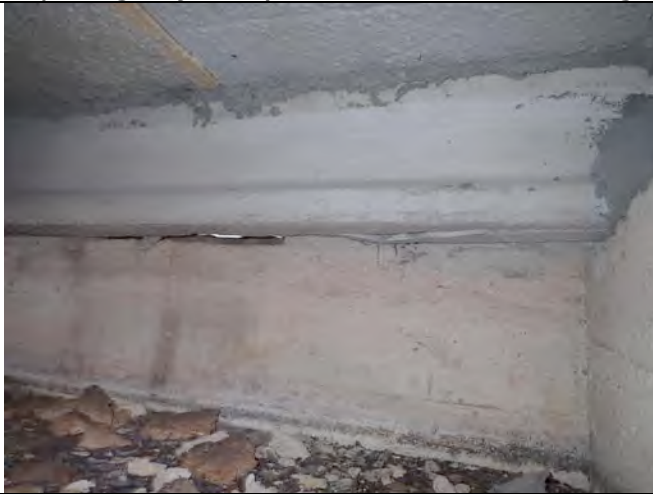
Photo 25 - previous repairs

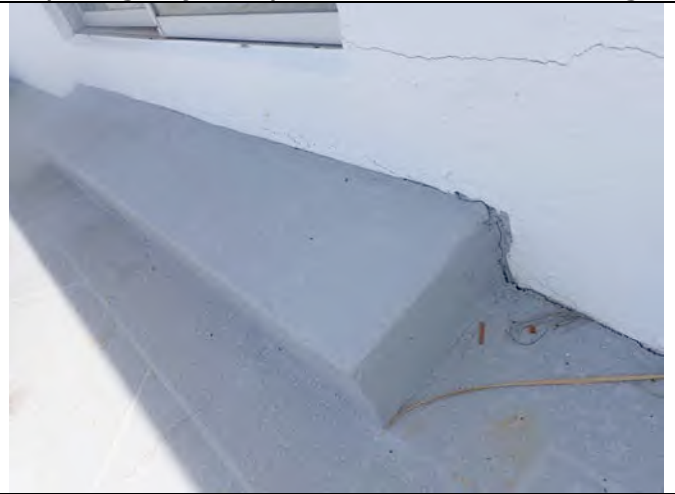
Photo 26 - cracking in exterior walls

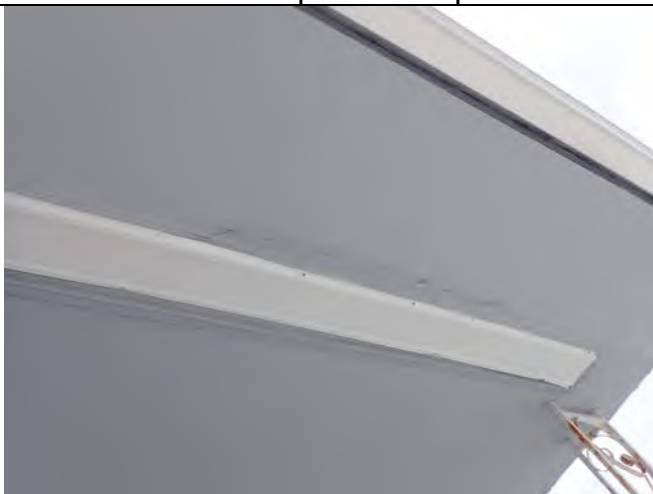
Photo 27 - cracking in soffits

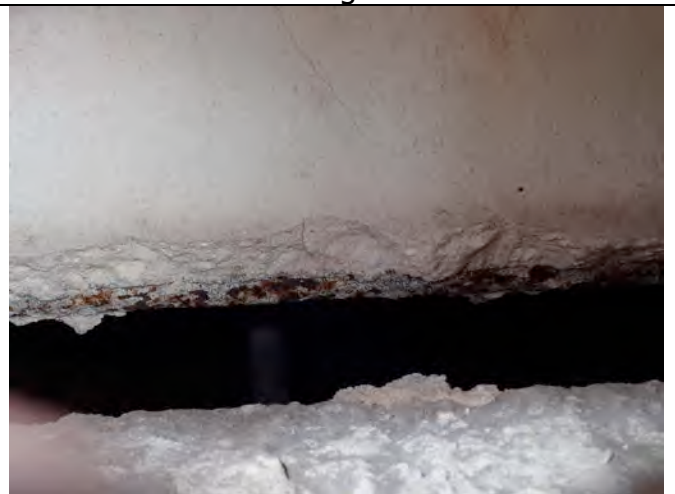
Photo 28 - Rebar corrosion and Concrete spalling of concrete joist system, and loss of bearing

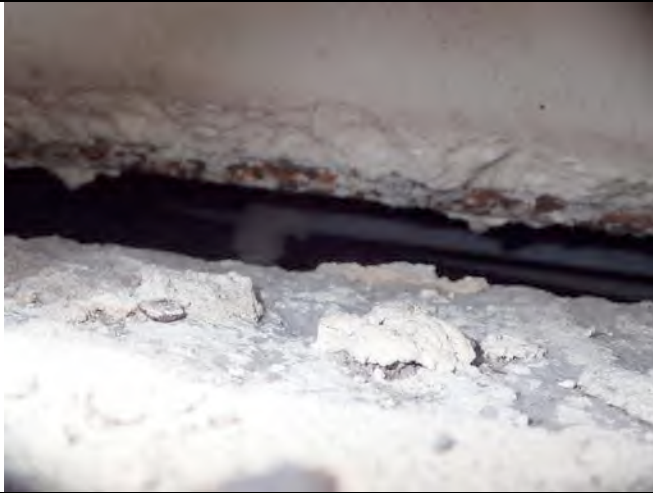
Photo 29 - Rebar corrosion and Concrete spalling of concrete joist system

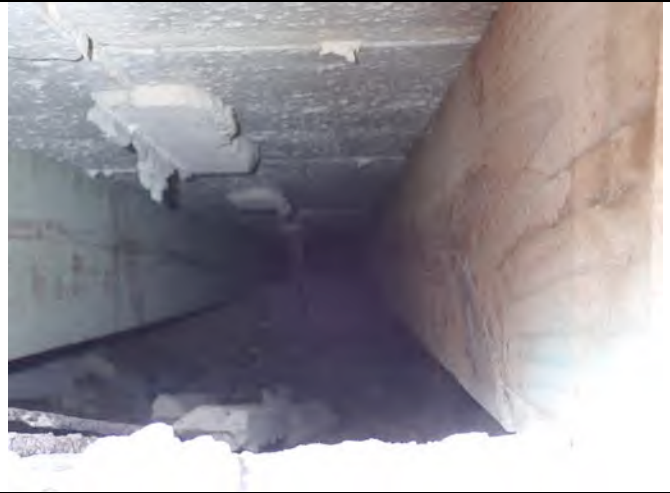
Photo 30 - Wood joist replacing concrete

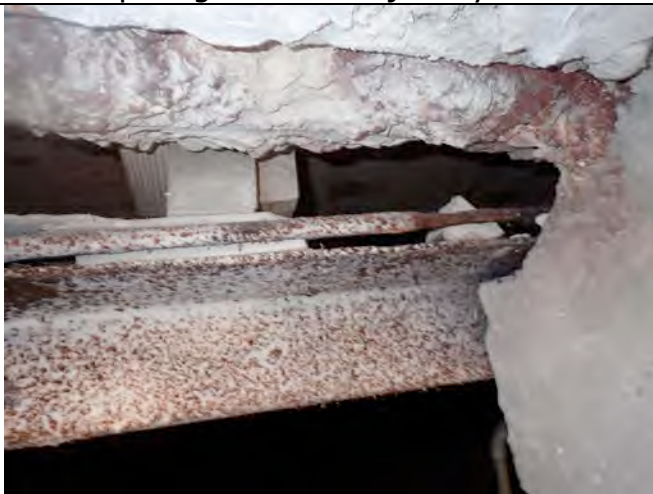
Photo 31 - Rebar corrosion and Concrete spalling of concrete joist system

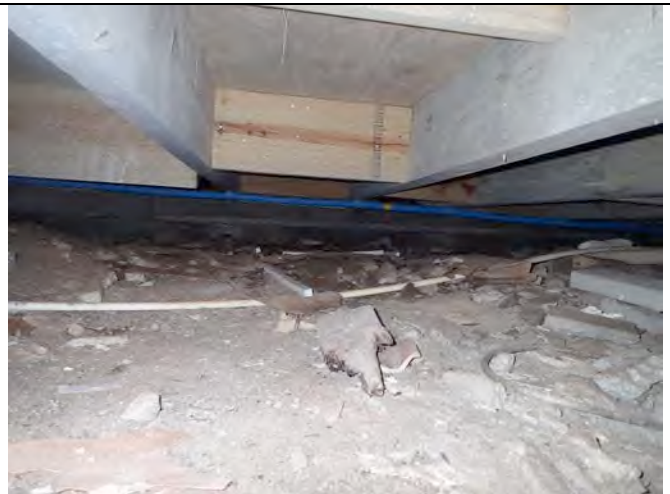
Photo 32 - Wood joist replacing concrete

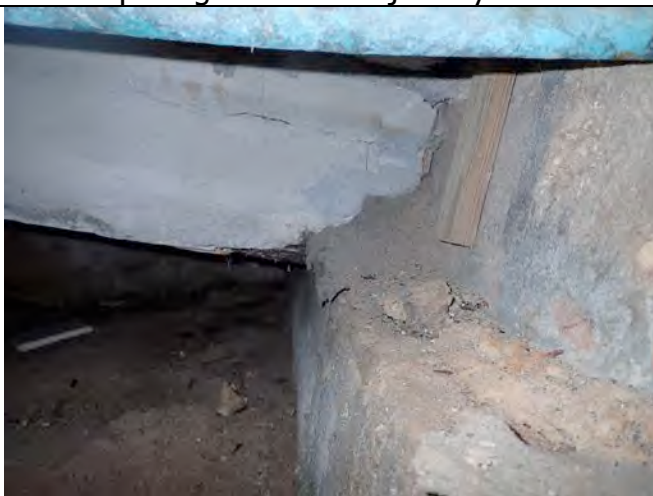
Photo 33 - Inadequate Previous repairs
