To: Board of Directors
Tower House Condominium Association
5500 Collins Avenue
Miami Beach, Florida 33140

Re: Balcony and Pool Deck Pre-Cast Railings

TOWER HOUSE CONDOMINIUM BUILDING CONDITION SURVEY SUMMARY

Re: Pre-Cast Railing Investigation

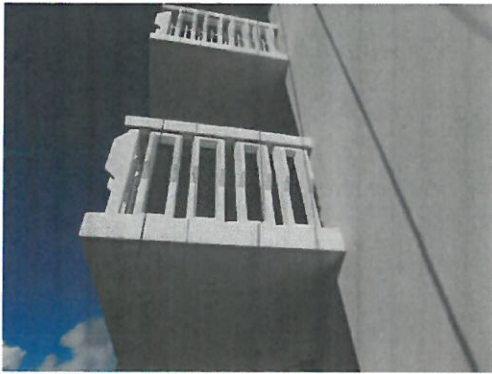
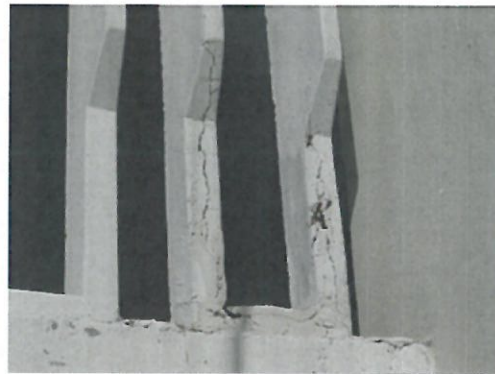
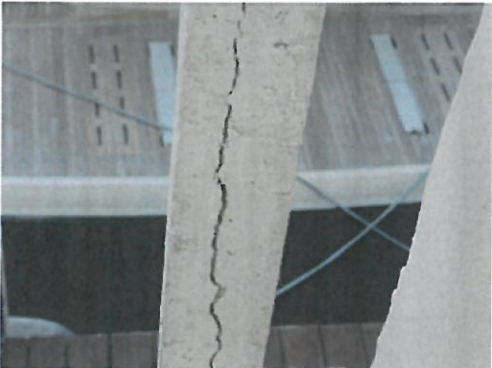
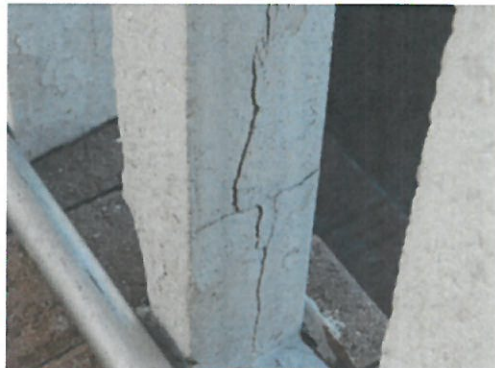
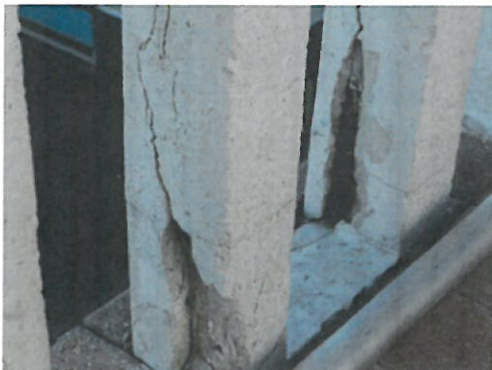
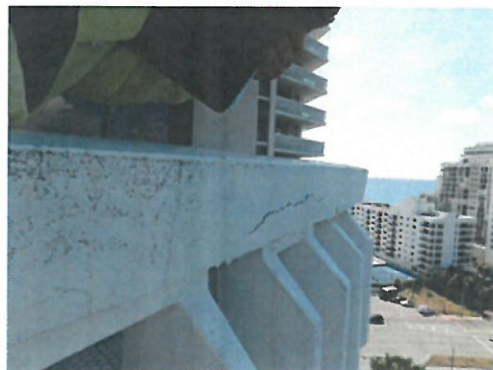
Damaged Baluster Photos

We recently conducted a survey of all the pre-cast concrete railings on the building and identified a considerable number of damaged balusters, 2484 ea. (64%) and handrails, 578 LF (11%). These were in varying degree of deterioration from hairline cracks to fallen pieces of concrete because of corrosion to the steel reinforcement inside the concrete. Additionally, numerous cracked balusters and handrails were caulked and painted over, thereby hiding much of the damage. These repaired balusters and handrails will most likely continue to develop fractures and cracks in the future as exposure to the ocean environment continues to cause corrosion damage. The existing railing conditions can be considered dangerous and unsafe to the occupants of the units using the balconies under the applicable building codes and to people below exposed to possible falling pieces of concrete.

Based on our evaluation of the railings, their existing condition is unsafe and dangerous because of (1) falling pieces of concrete from cracked and spalling balusters and handrails, (2) diminished or weakened structural capacity because of the many cracks, (3) the spacing between pickets being larger than allowed, (4) the open to above nature of the design between precast balusters and, (5) in numerous cases, insufficient railing heights.

Our recommendation is that the railing system be immediately repaired or replaced in accordance with code. Since so many balusters and handrails are damaged, easily over half the railings, and the building's restoration program requires the removal of at least 20 percent of the railings to facilitate the repairs, a complete replacement with a new system should be strongly considered as the more efficient option with the best long term advantages.
