**5840 North Bay Road Miami Beach, Florida
Specimen Tree Arborist Report**

5840 North Bay Road Miami Beach, Florida
SPECIMEN TREE REPORT

May 6, 2018

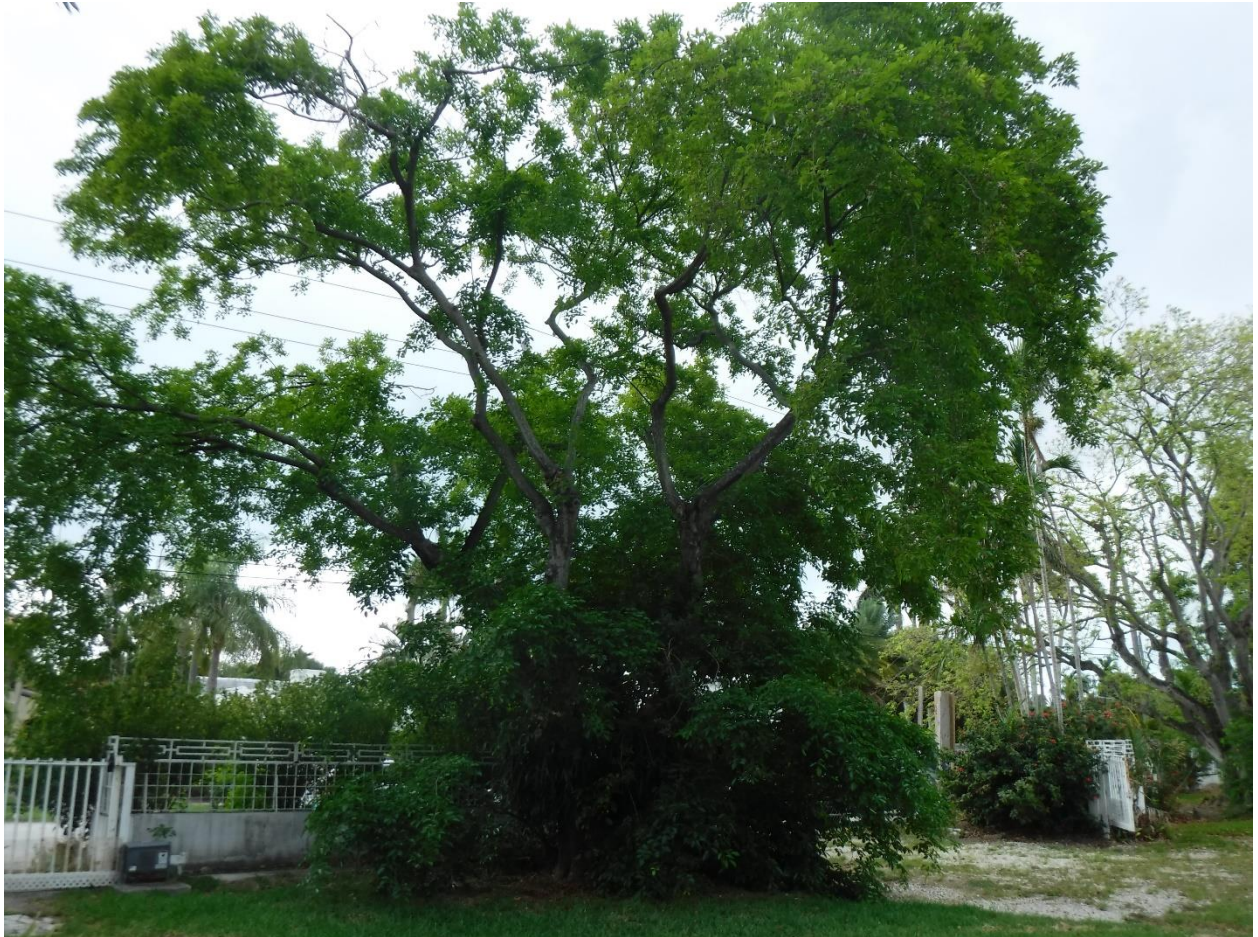
Tree number three

This Pongam is in fair condition with a 60% health condition. The tree is 35 feet tall and 46 feet wide. The diameter measured at two feet above grade was 40 inches. The tree has codominant stems and large pruning wounds on the south side. There is evidence of storm damage with broken limbs two to four inches in diameter within the canopy, and a chain girdling one of the main leaders.

View looking east Pongam, minor dieback within upper canopy

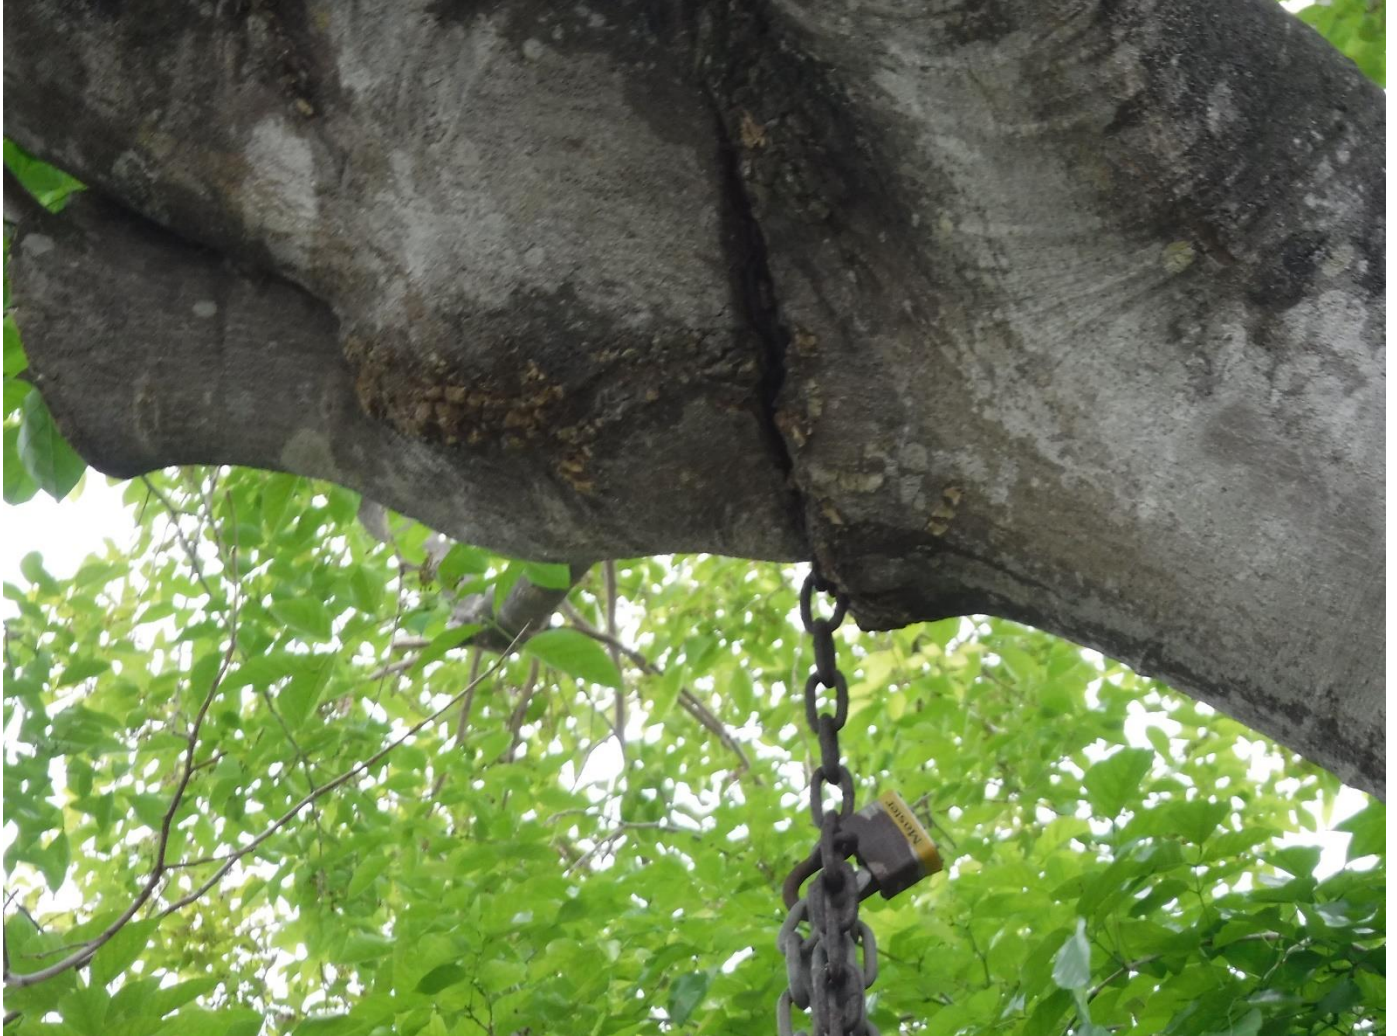
View of girdling material on east stem

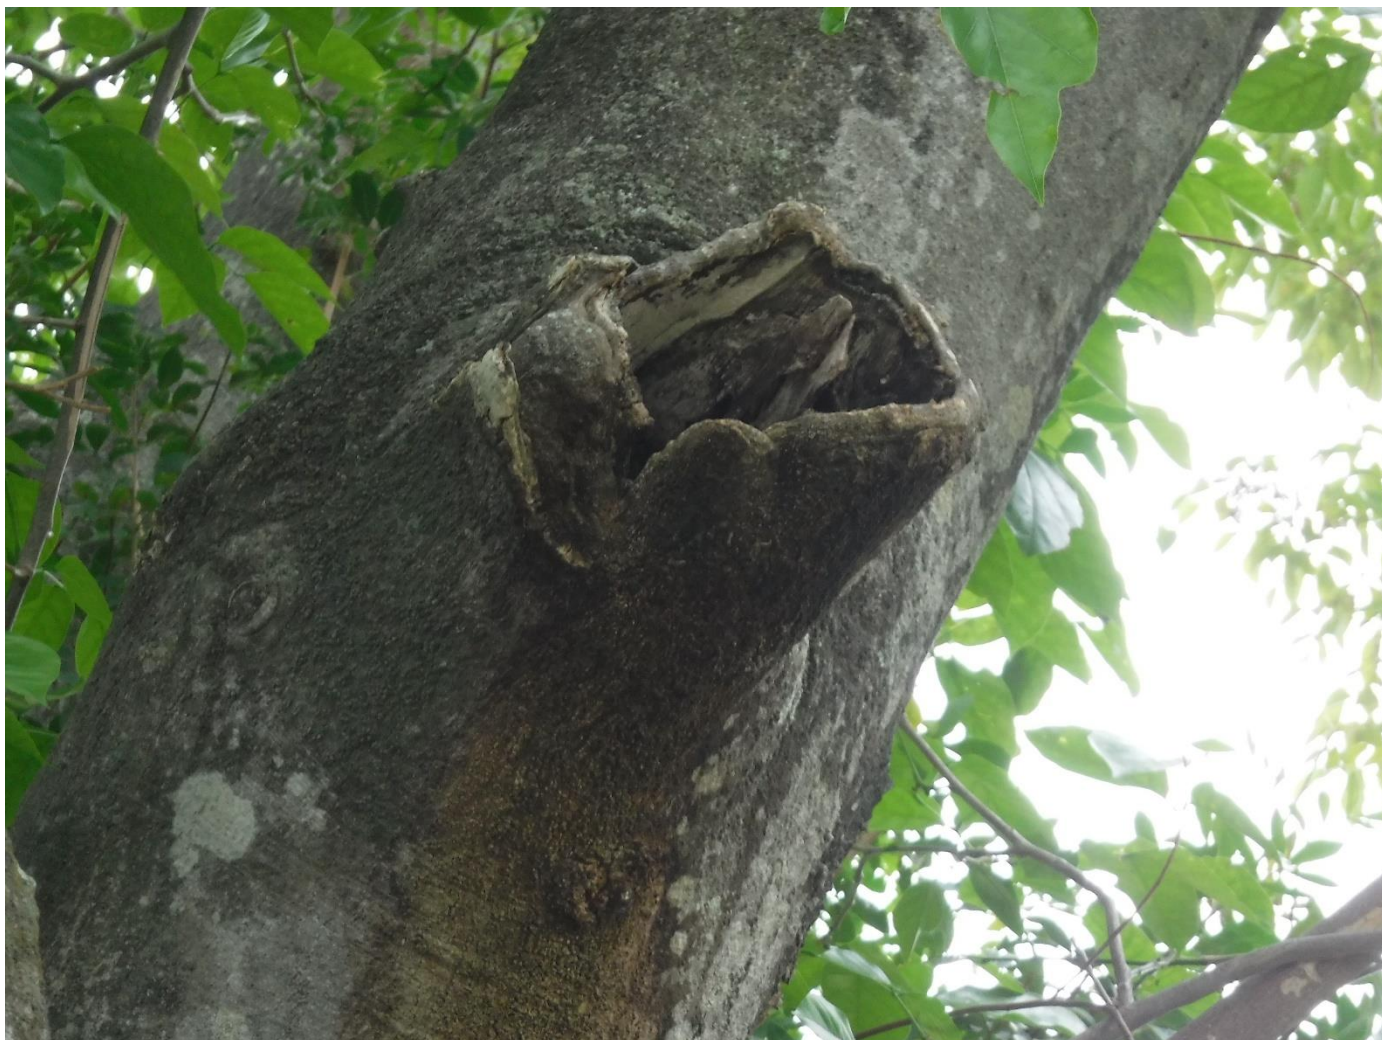
Decay in leader

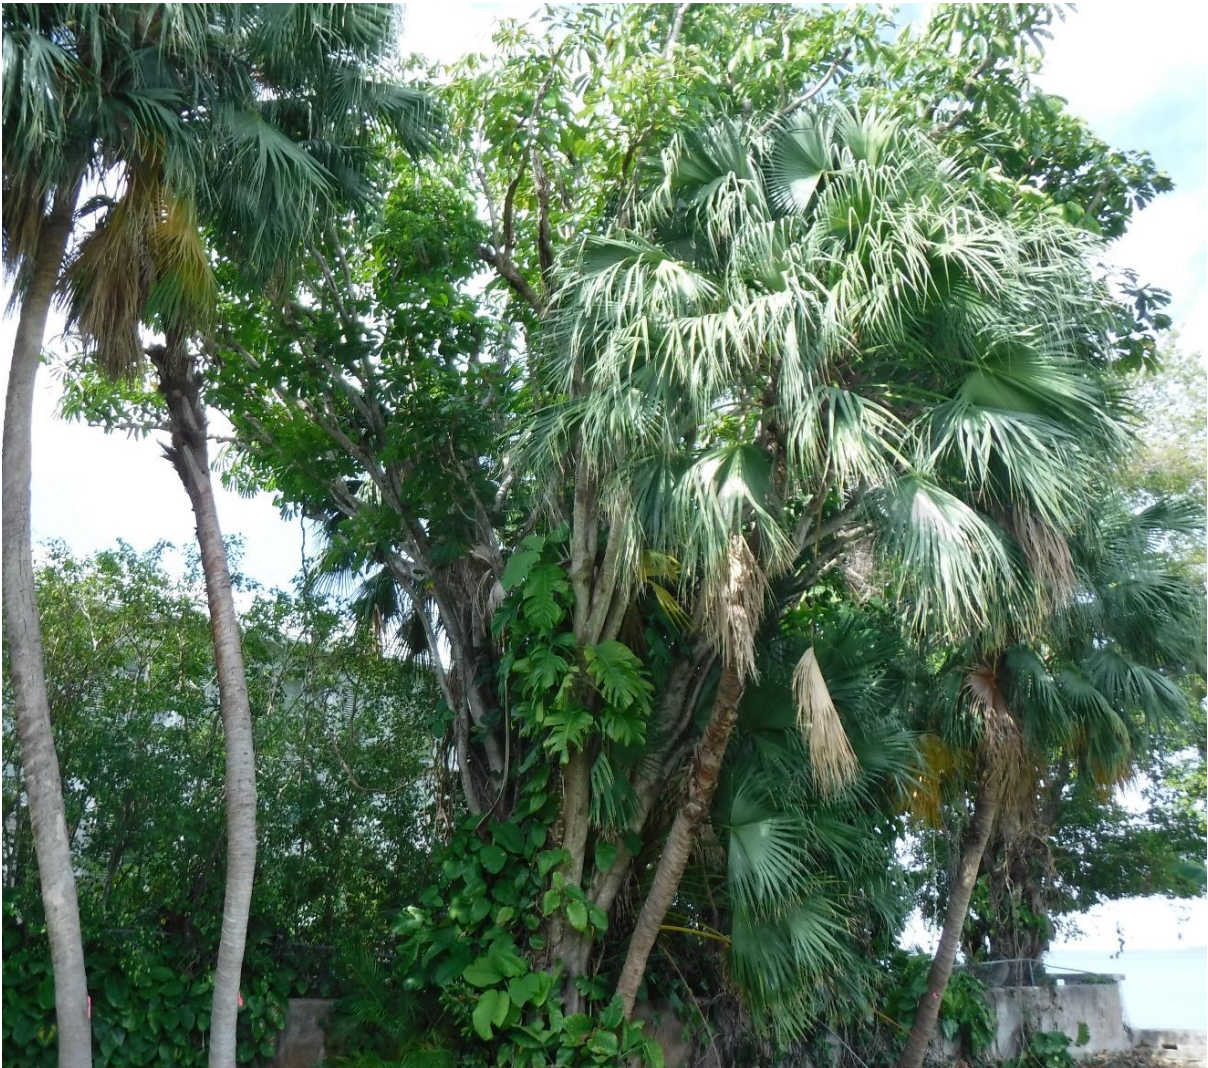
Tree number 20

This Umbrella tree has a height of 35 feet and a width of 24 feet. The diameter of the tree measured 61 inches at breast height and has a rating of 65%. It has two main codominant leaders and some dead branches greater than two inches in diameter. This tree is listed as a Prohibited Species per Miami-Dade Chapter 19.

View of tree looking south west

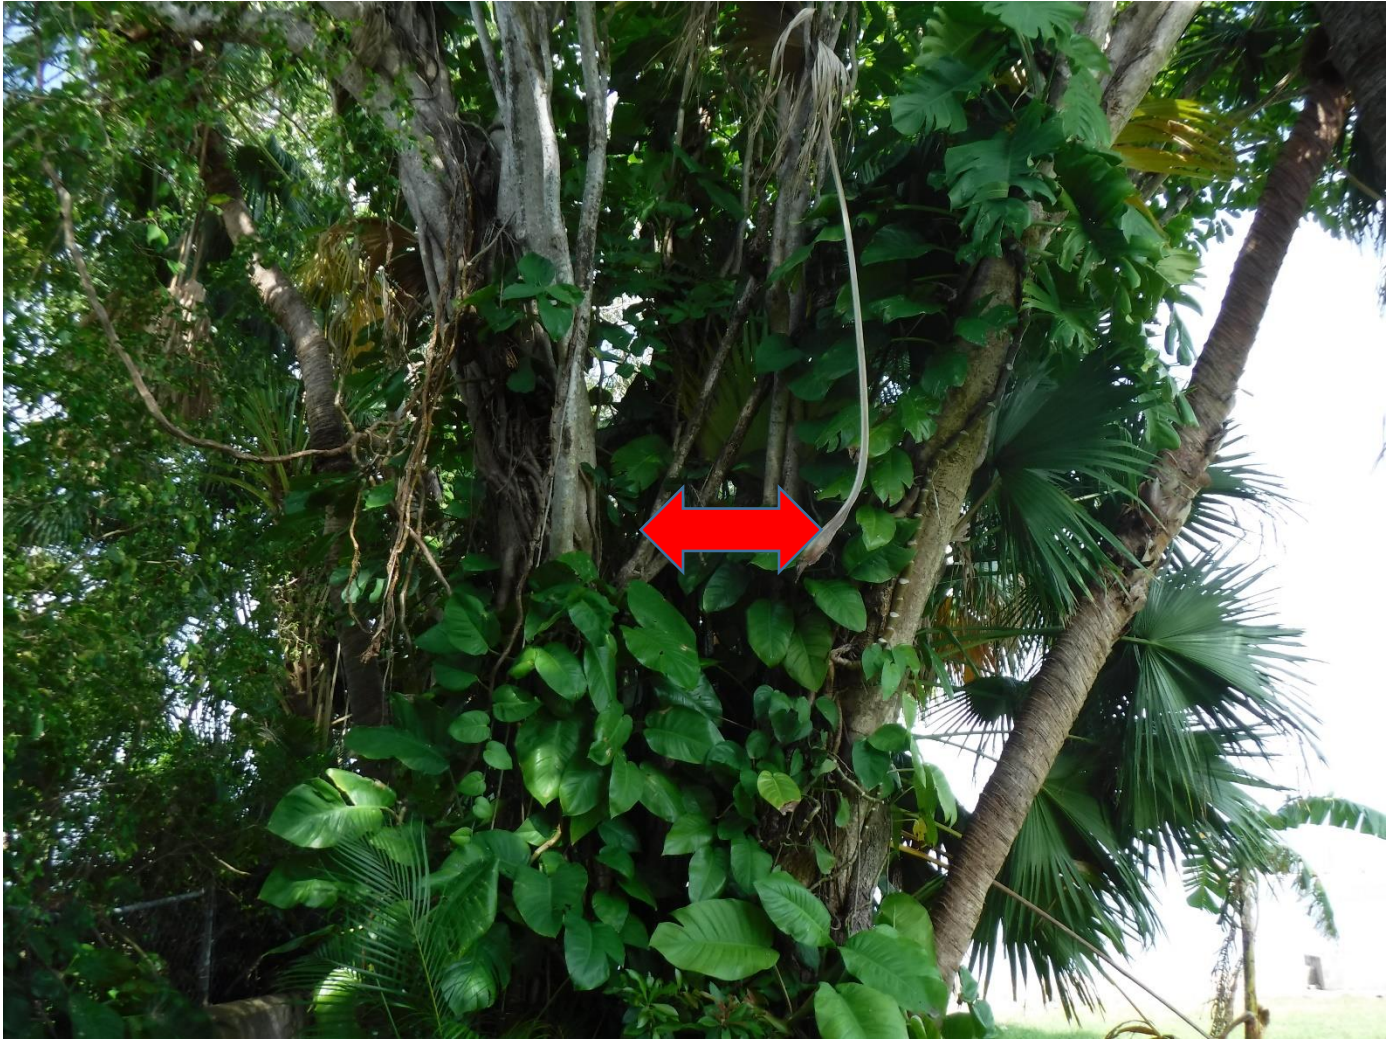
View of codominant leaders

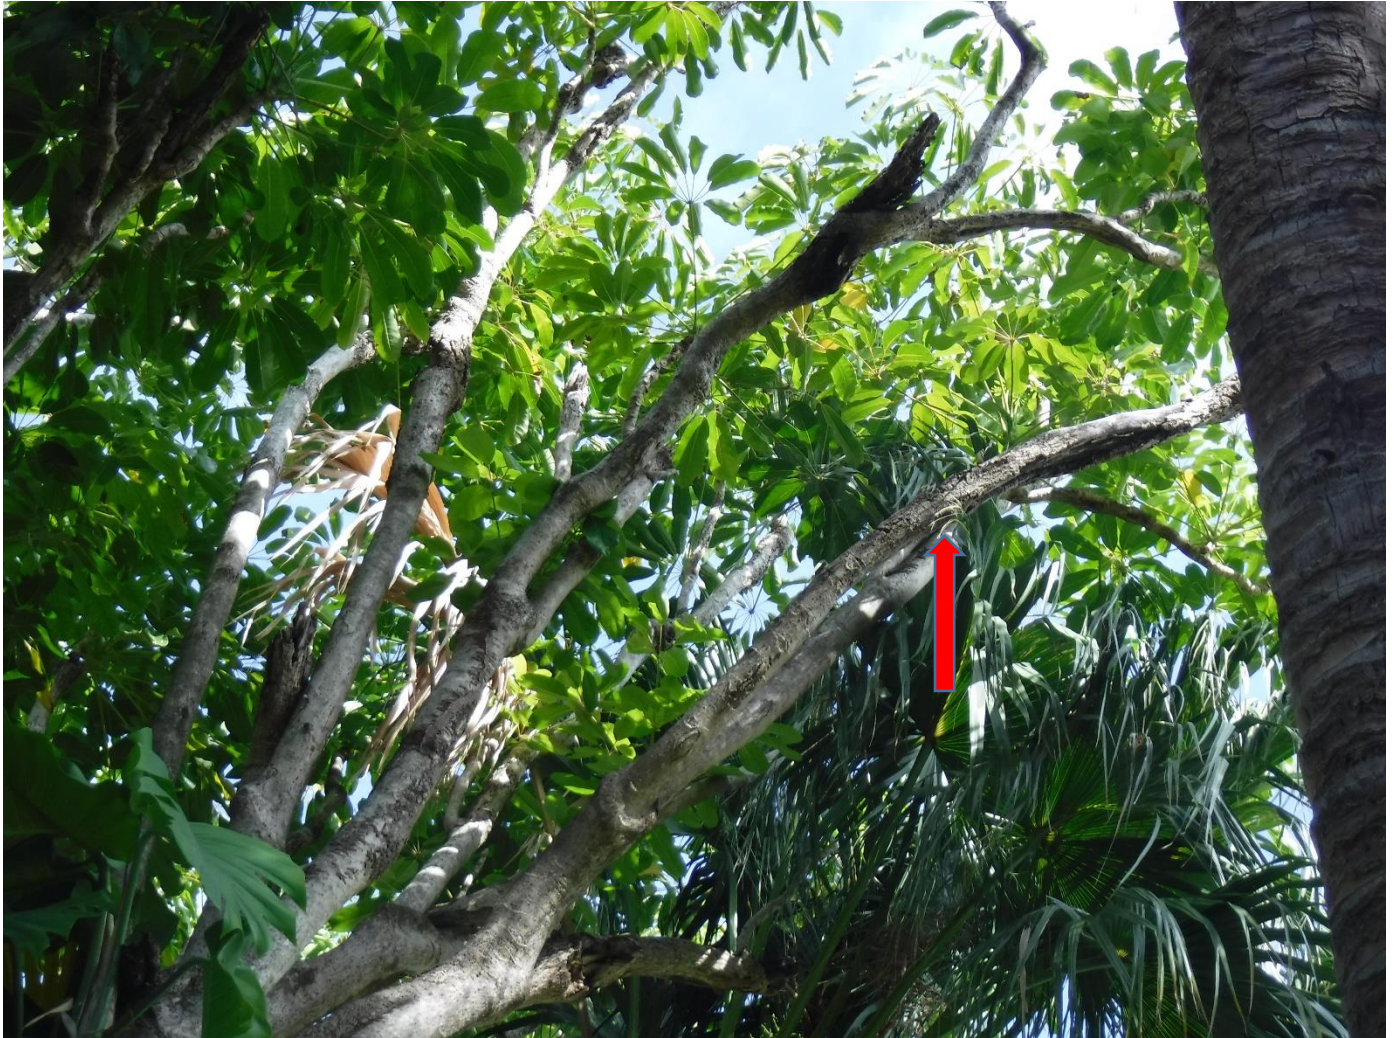
View of dead branches

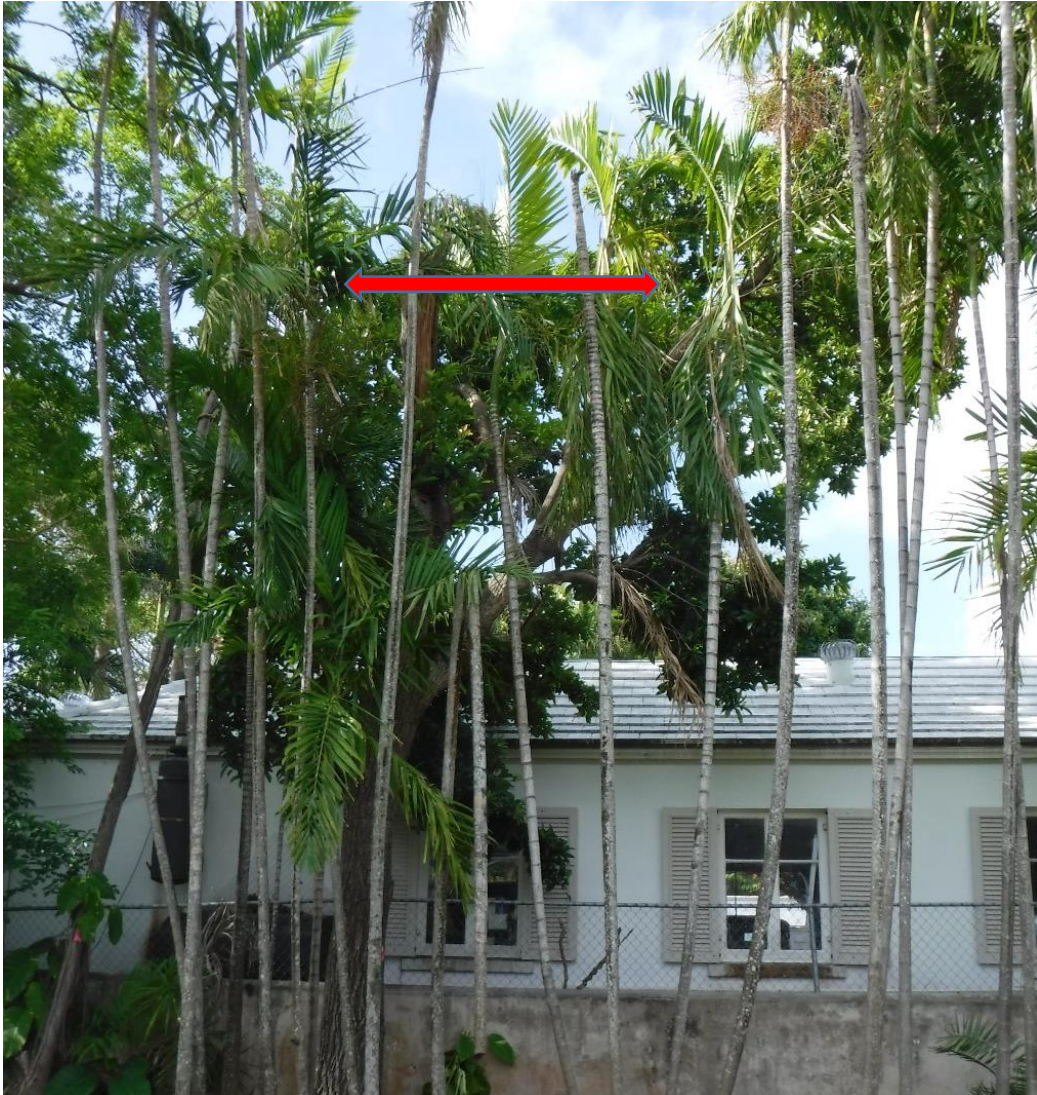
Tree number 26

The Sapodilla is a mature tree with a height of 30 feet and a width of 22 feet and a diameter of 18 inches measured at breast height. It has a health rating of 40%, there is some storm damage to the dominant central leader, as well as an uneven crown hanging over the south neighbor's house.

View looking south

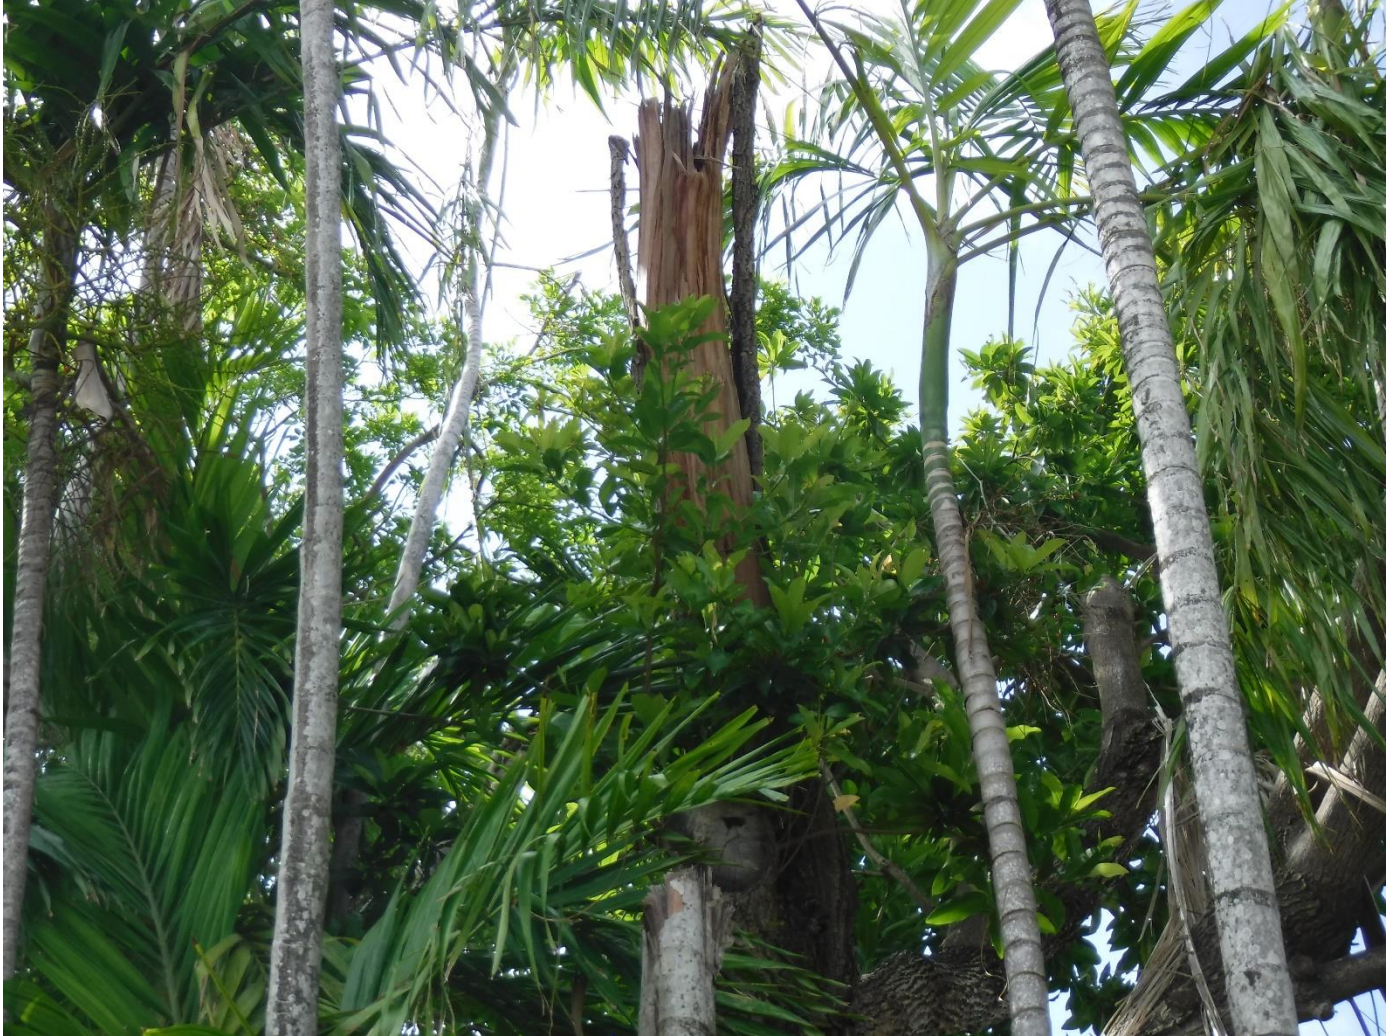
View of broken leader

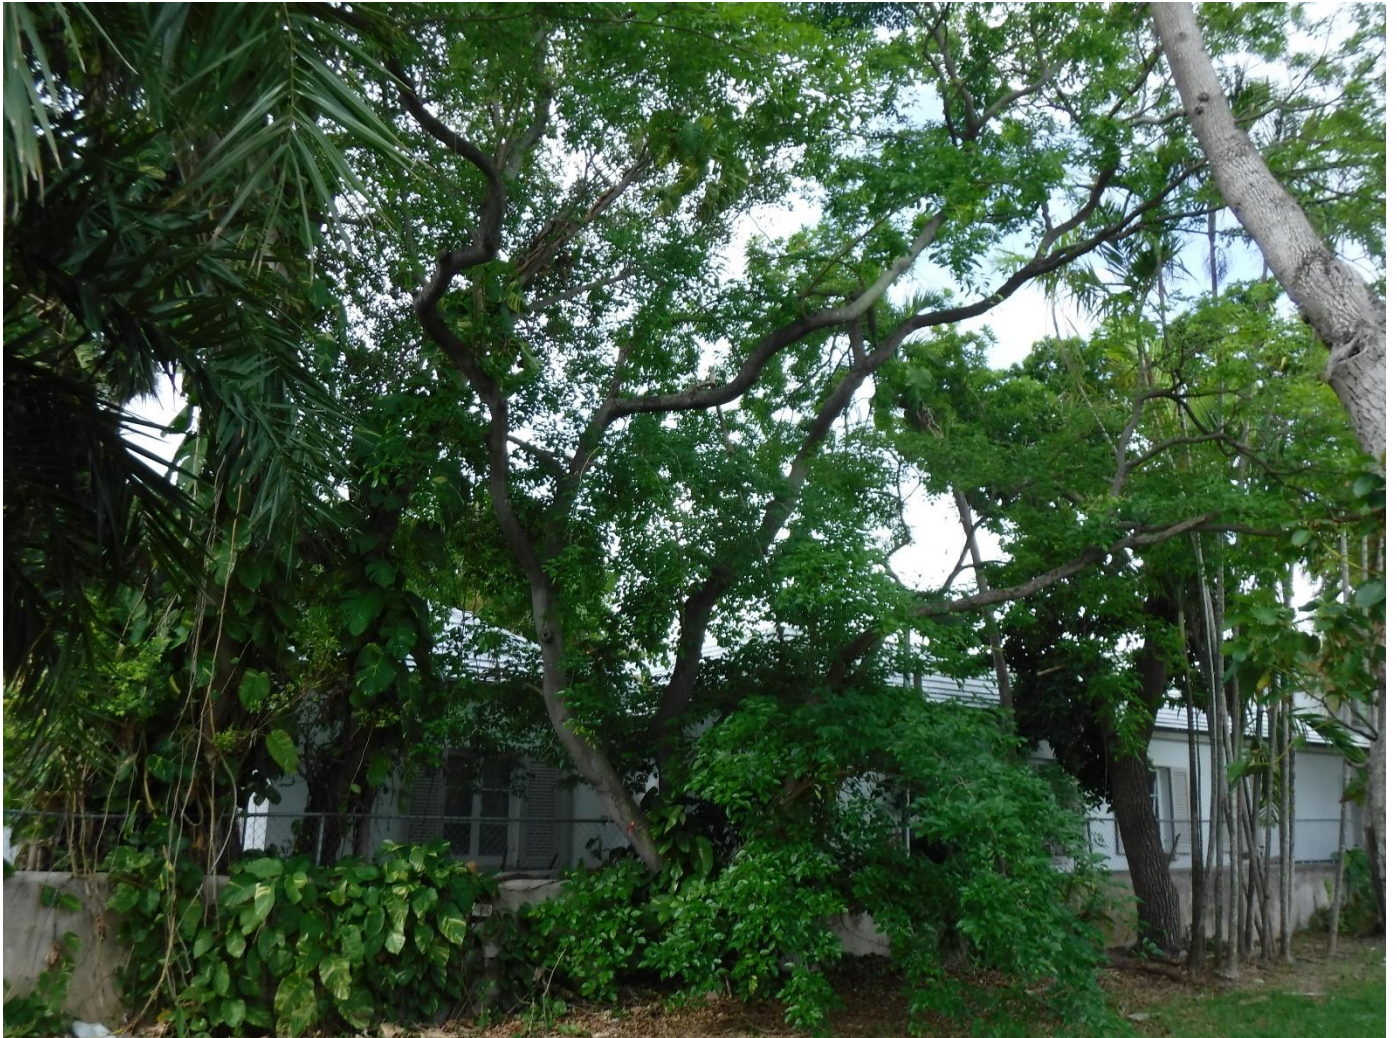
Tree number 28

This Pongam has a height of 40 feet and a width of 34 feet and two stems with diameters of 16 inches and 13 inches measured at breast height. The rating for this tree is 60%. The defects of this tree include codominant leaders and a pruning wound, the location for this tree is also poor.

View looking south west

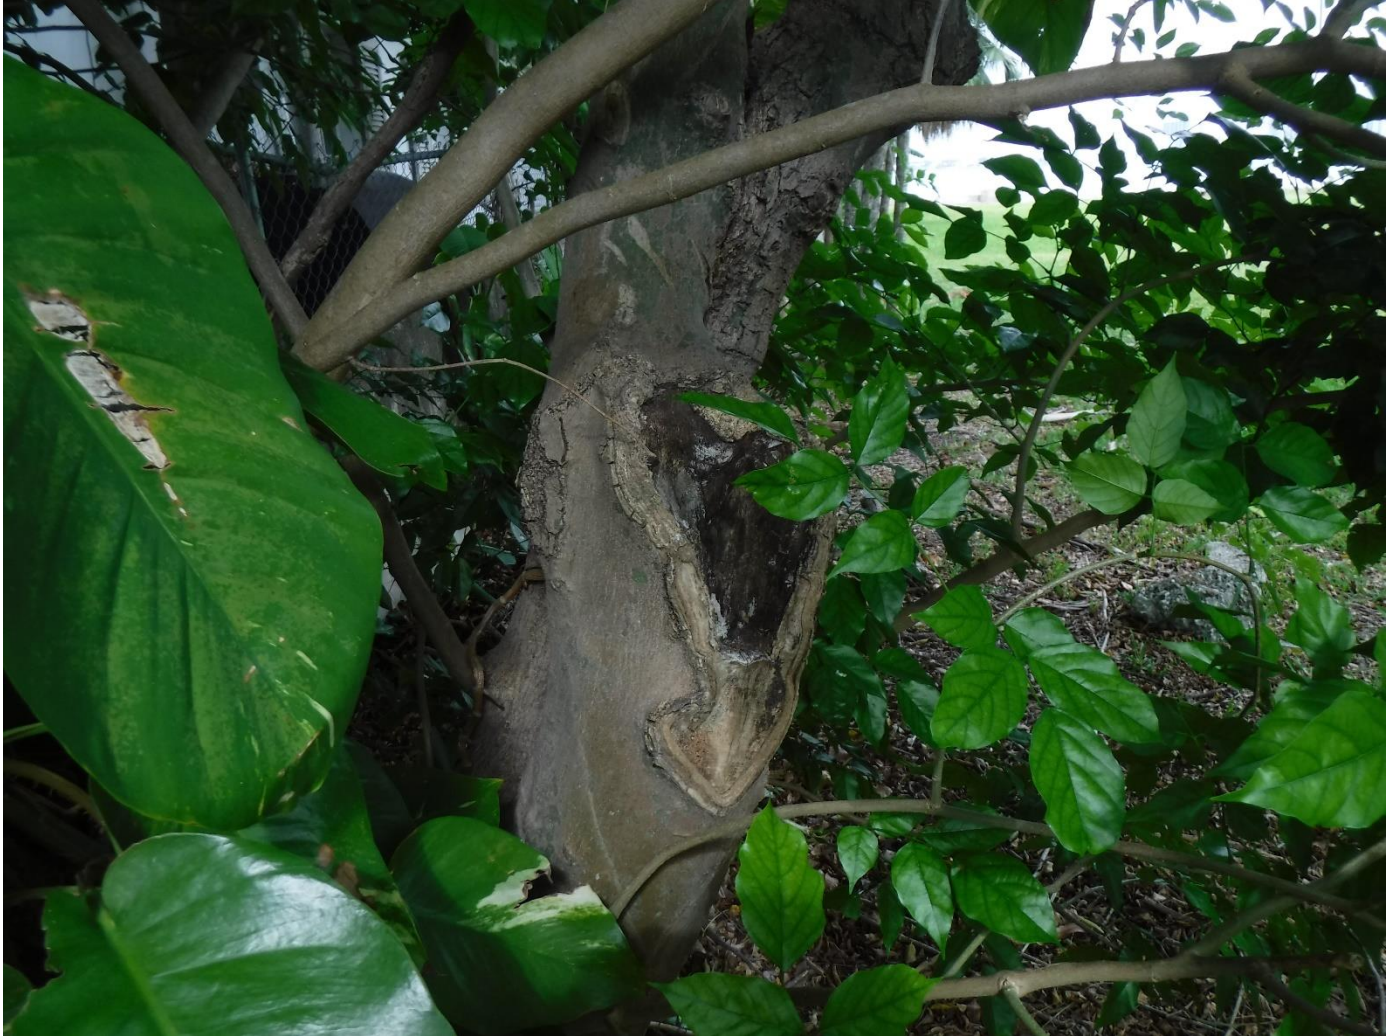
View of wound in stem

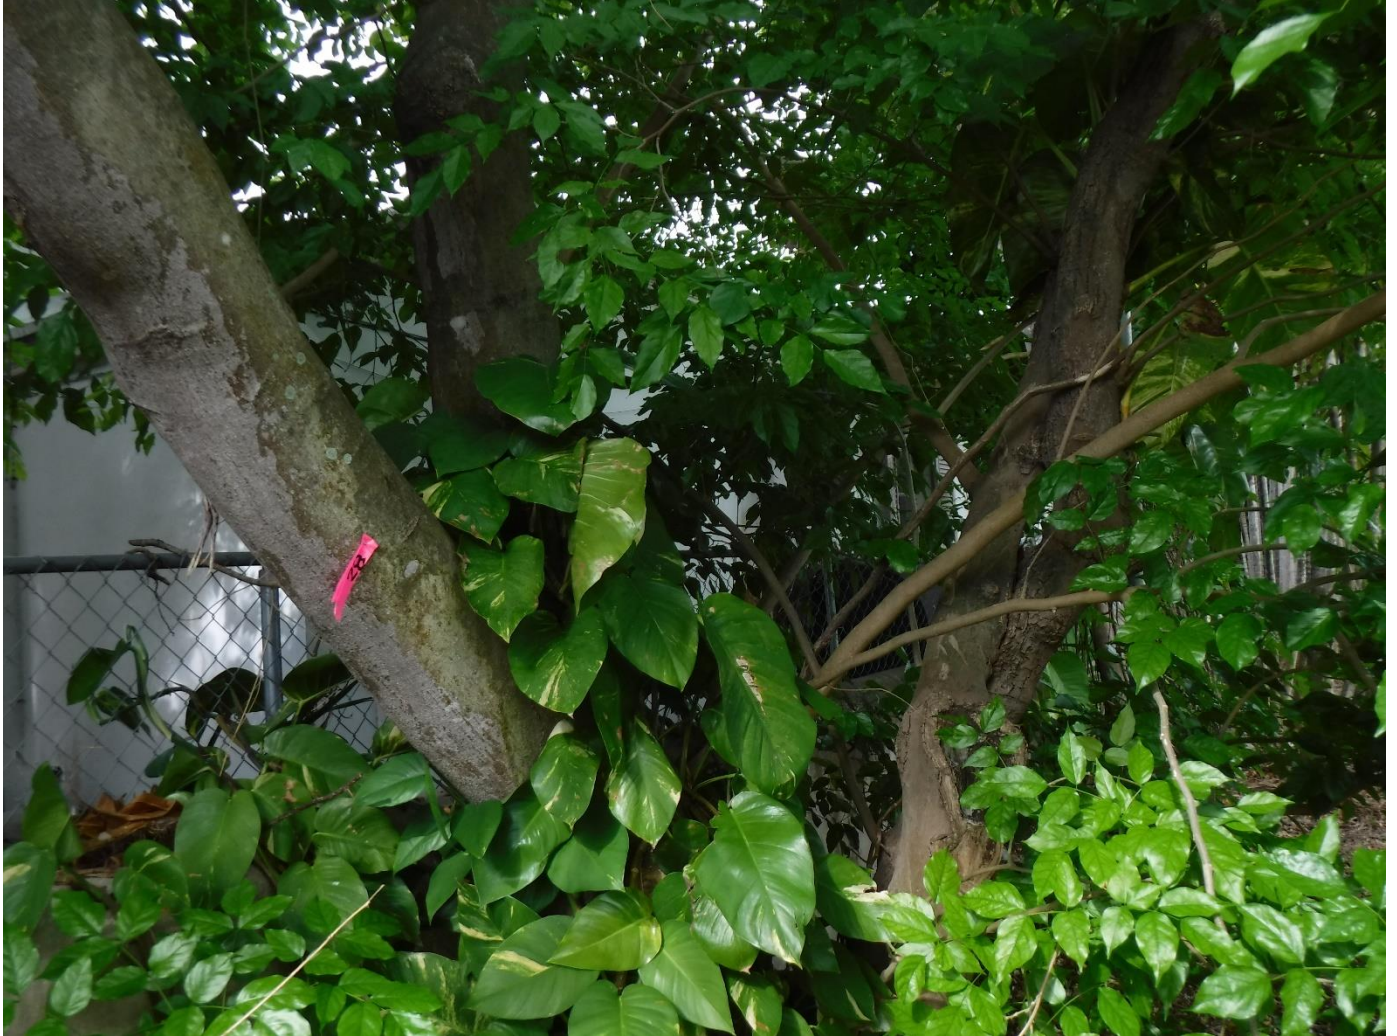
View of codominant leaders

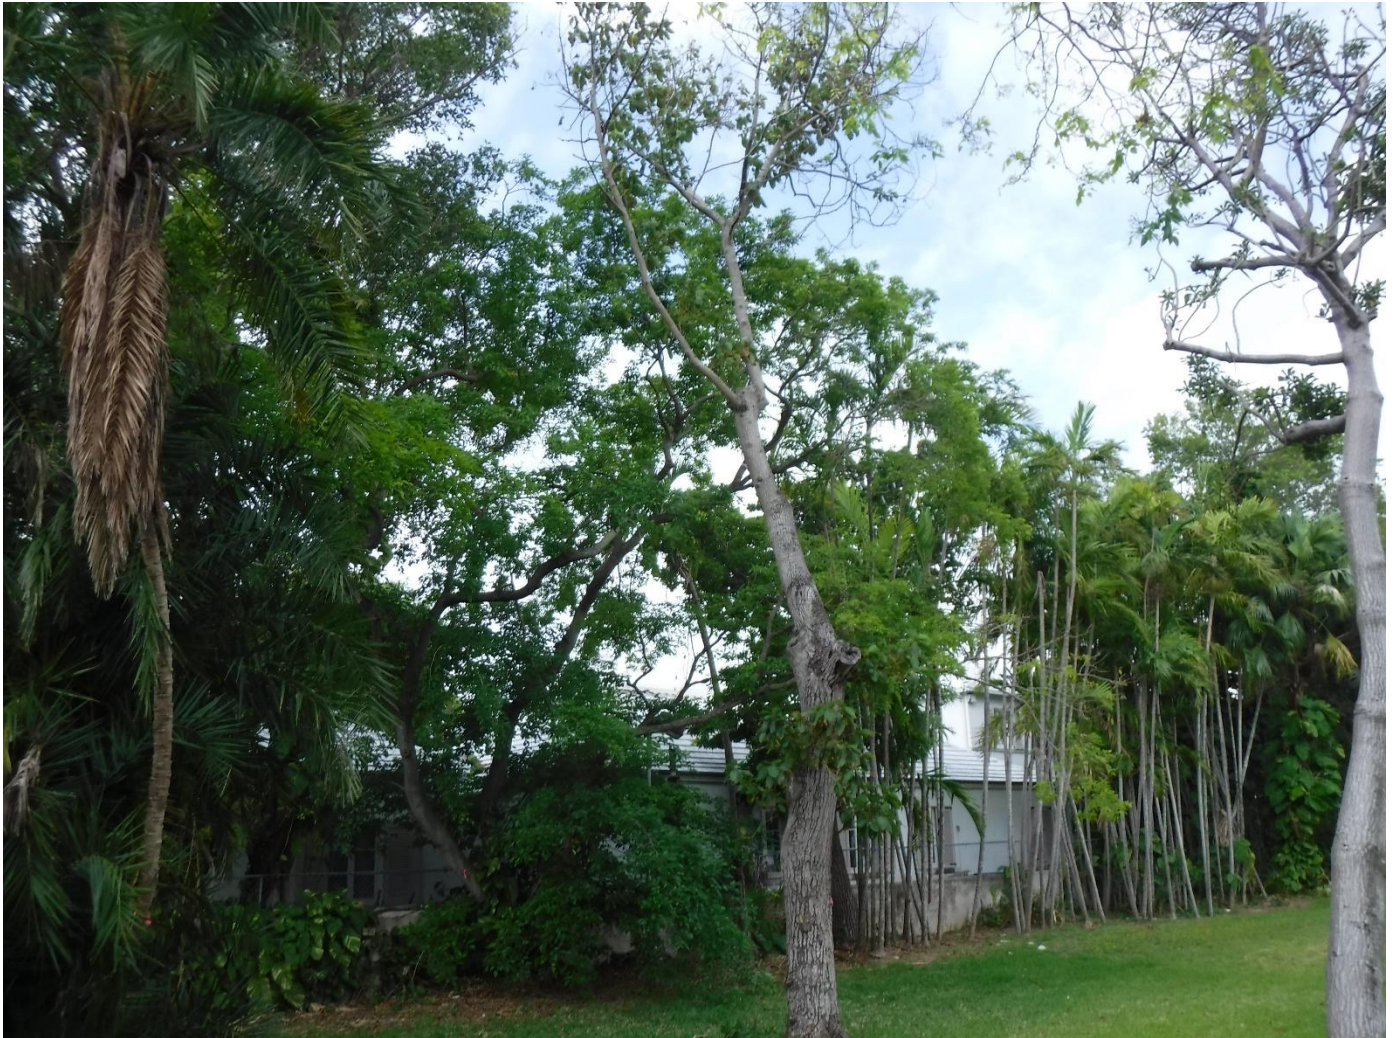
Tree number 30

The Avocado has a height of 40 feet ,a width of 14 feet and a diameter of 17 inches measured at breast height as well as a health rating of 30% due to previous topping/heading cuts, as well as the column of decay in the stem and the low live crown ratio. There is also sings of dieback in the crown.

View looking south west

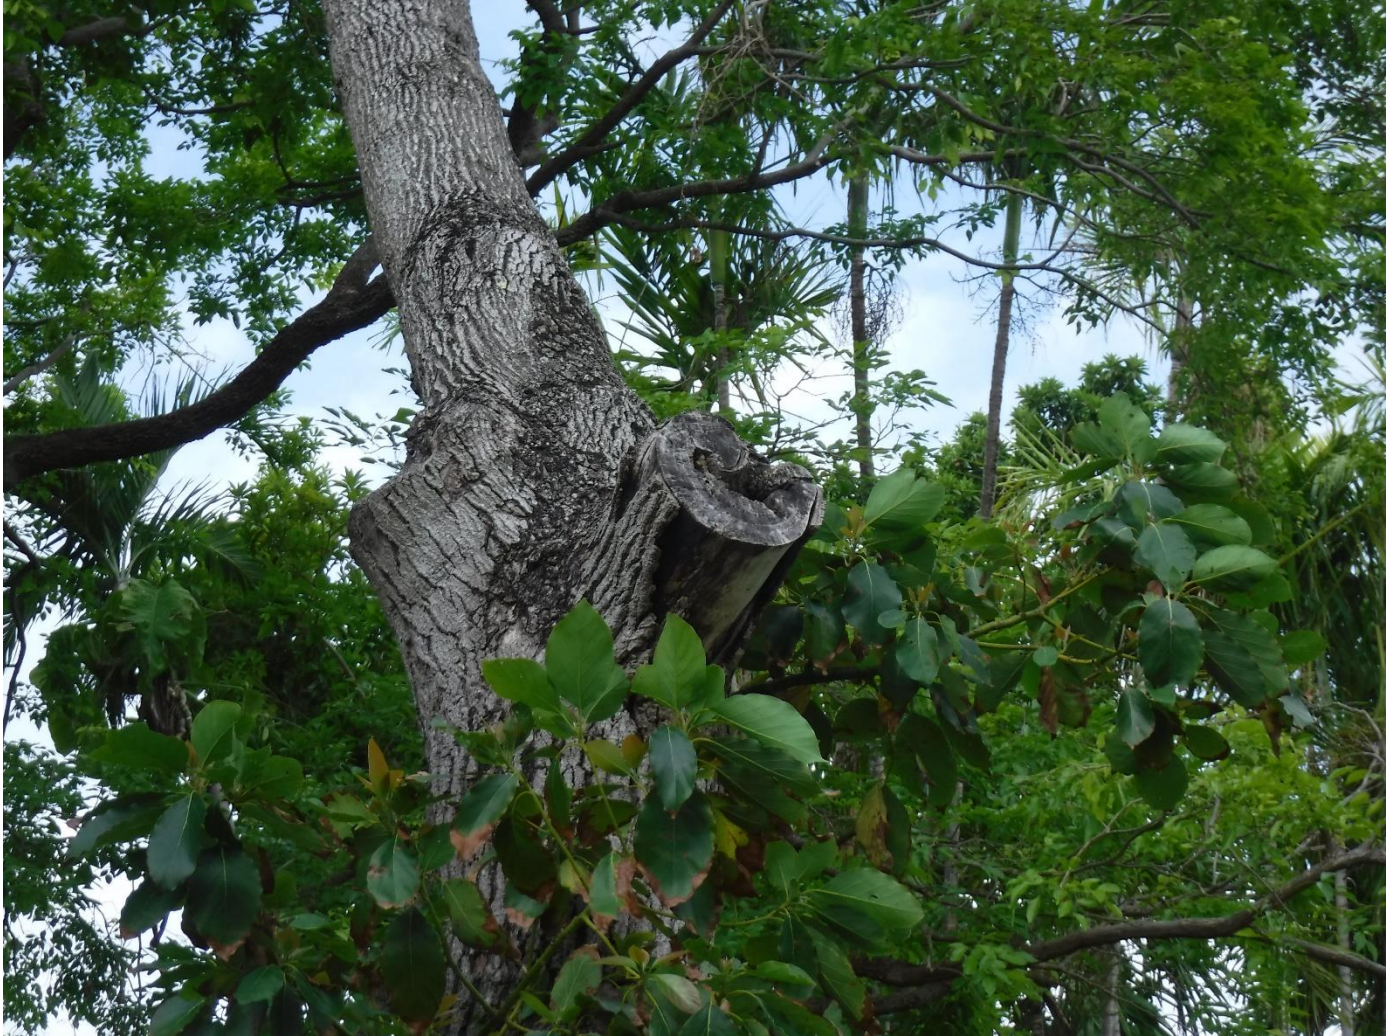
View of old pruning wounds

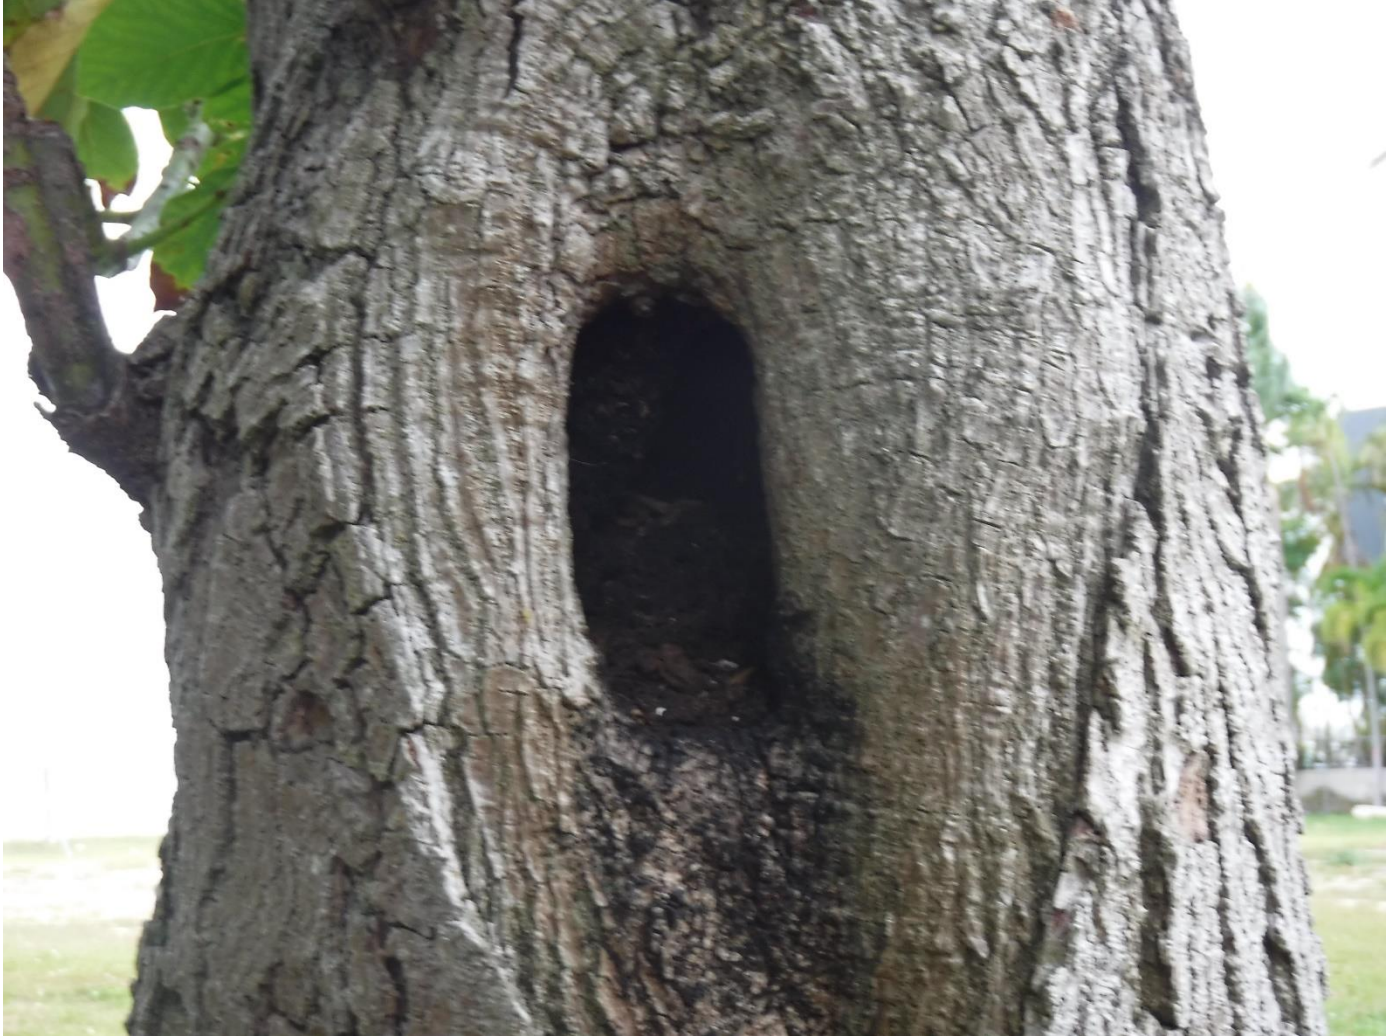
View of pocket of decay in stem

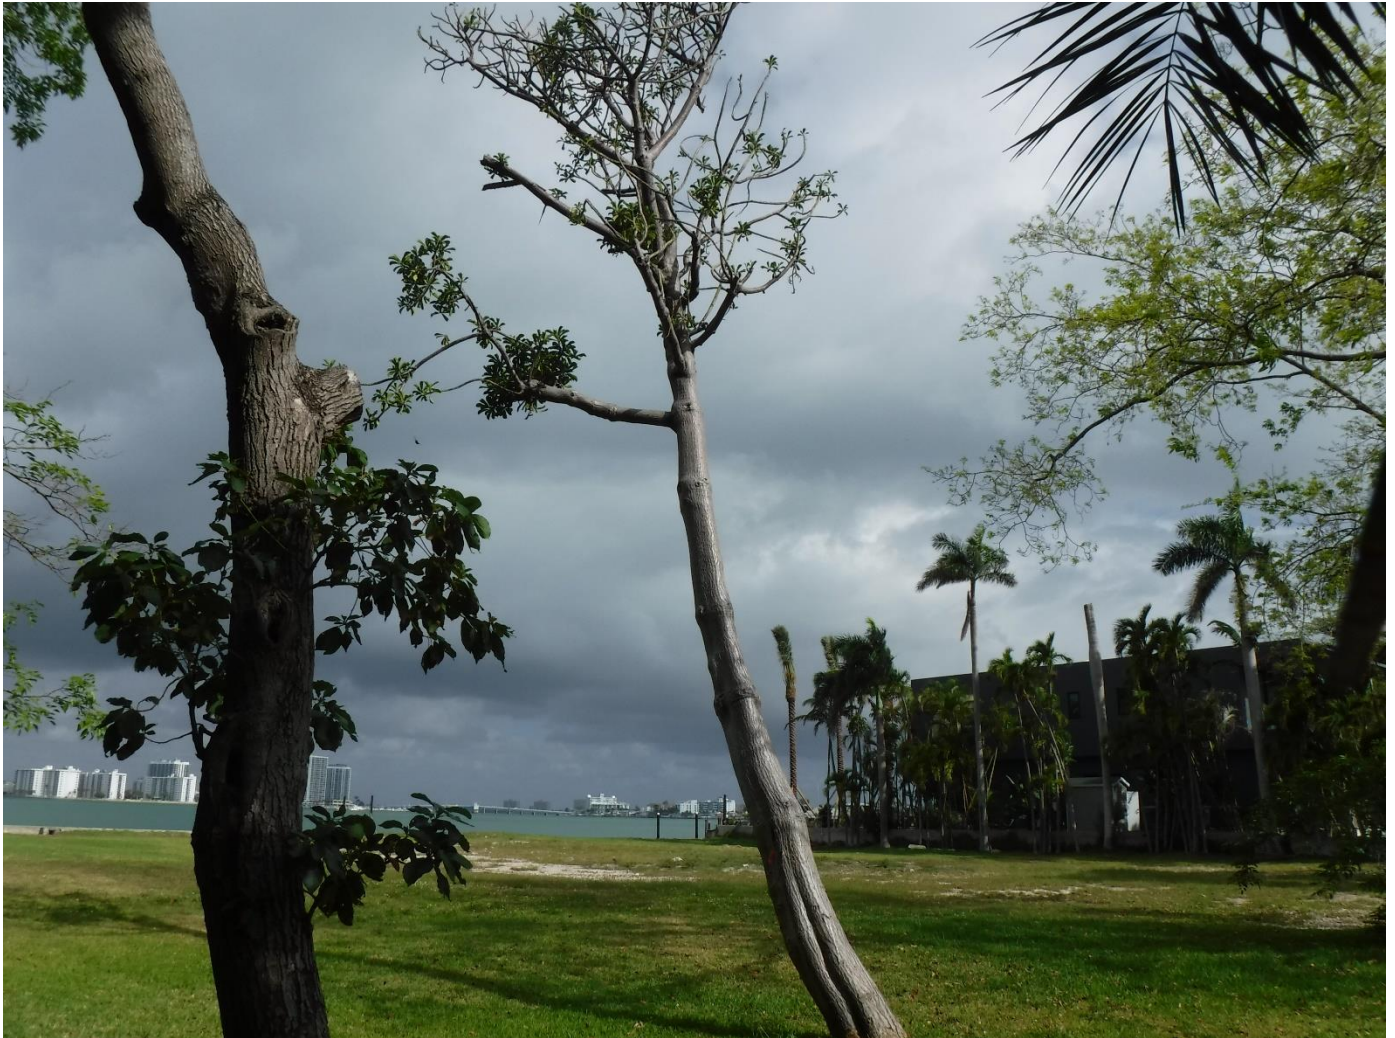
Tree number 31

This is a Euphorbia species with a height of 30 feet as well as a width of 10 feet and a diameter of 16 inches measured at breast height. It has a health rating of 45% due to the fact that it has a severe lean and evidence of soil heaving as well as a low live crown ratio.

View looking North West

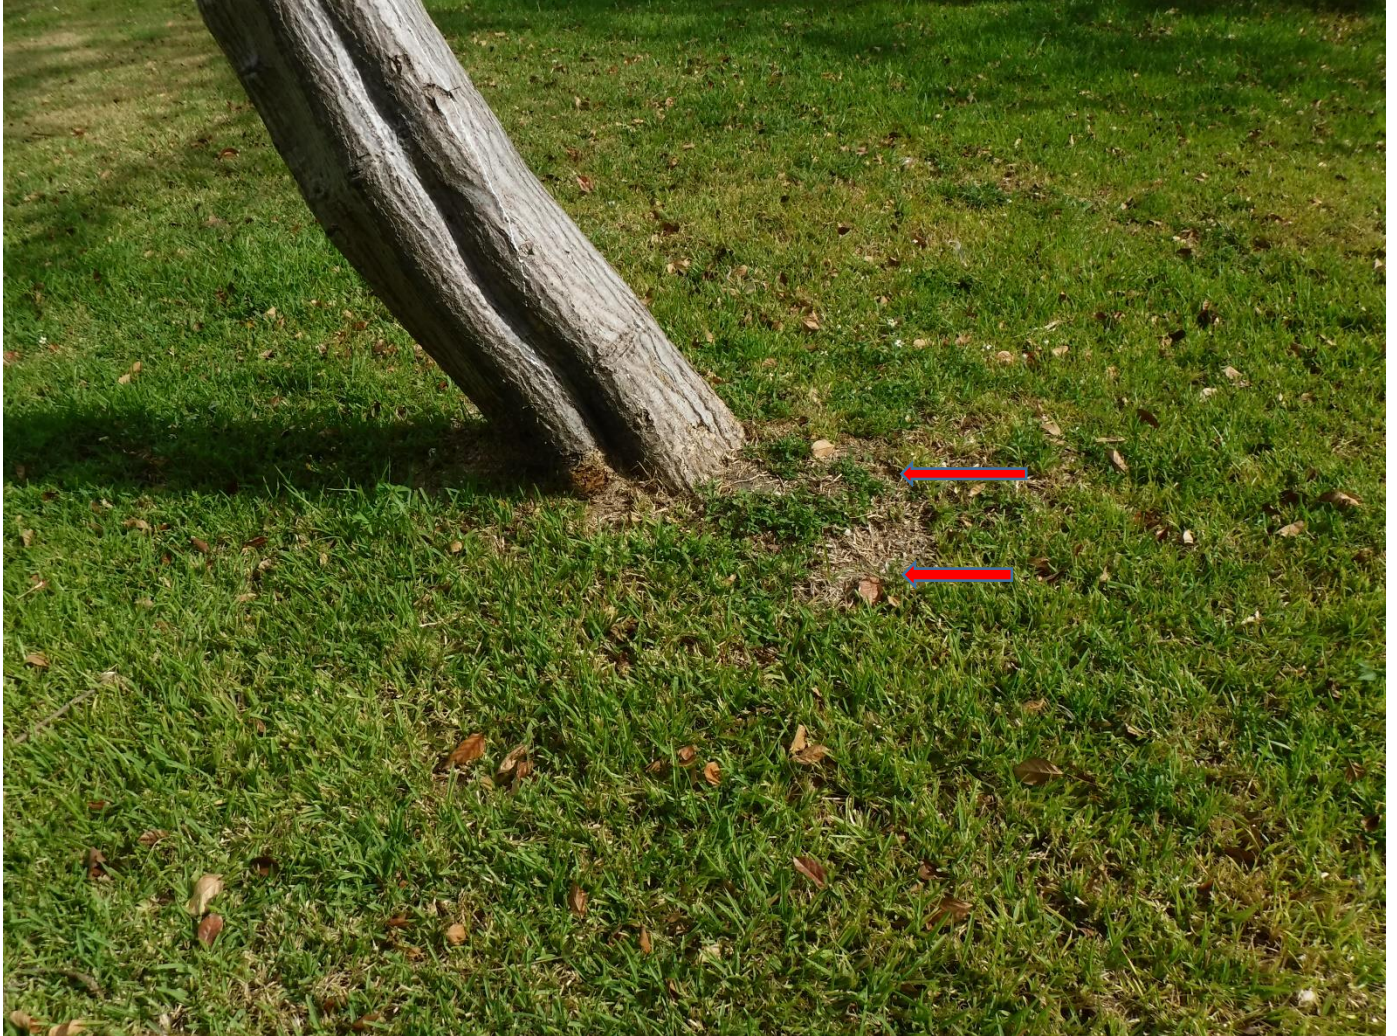
View of soil heaving
