**5840 North Bay Road Miami Beach, Florida
Specimen Tree Arborist Report**

5840 North Bay Road Miami Beach, Florida
SPECIMEN TREE REPORT

May 6, 2018

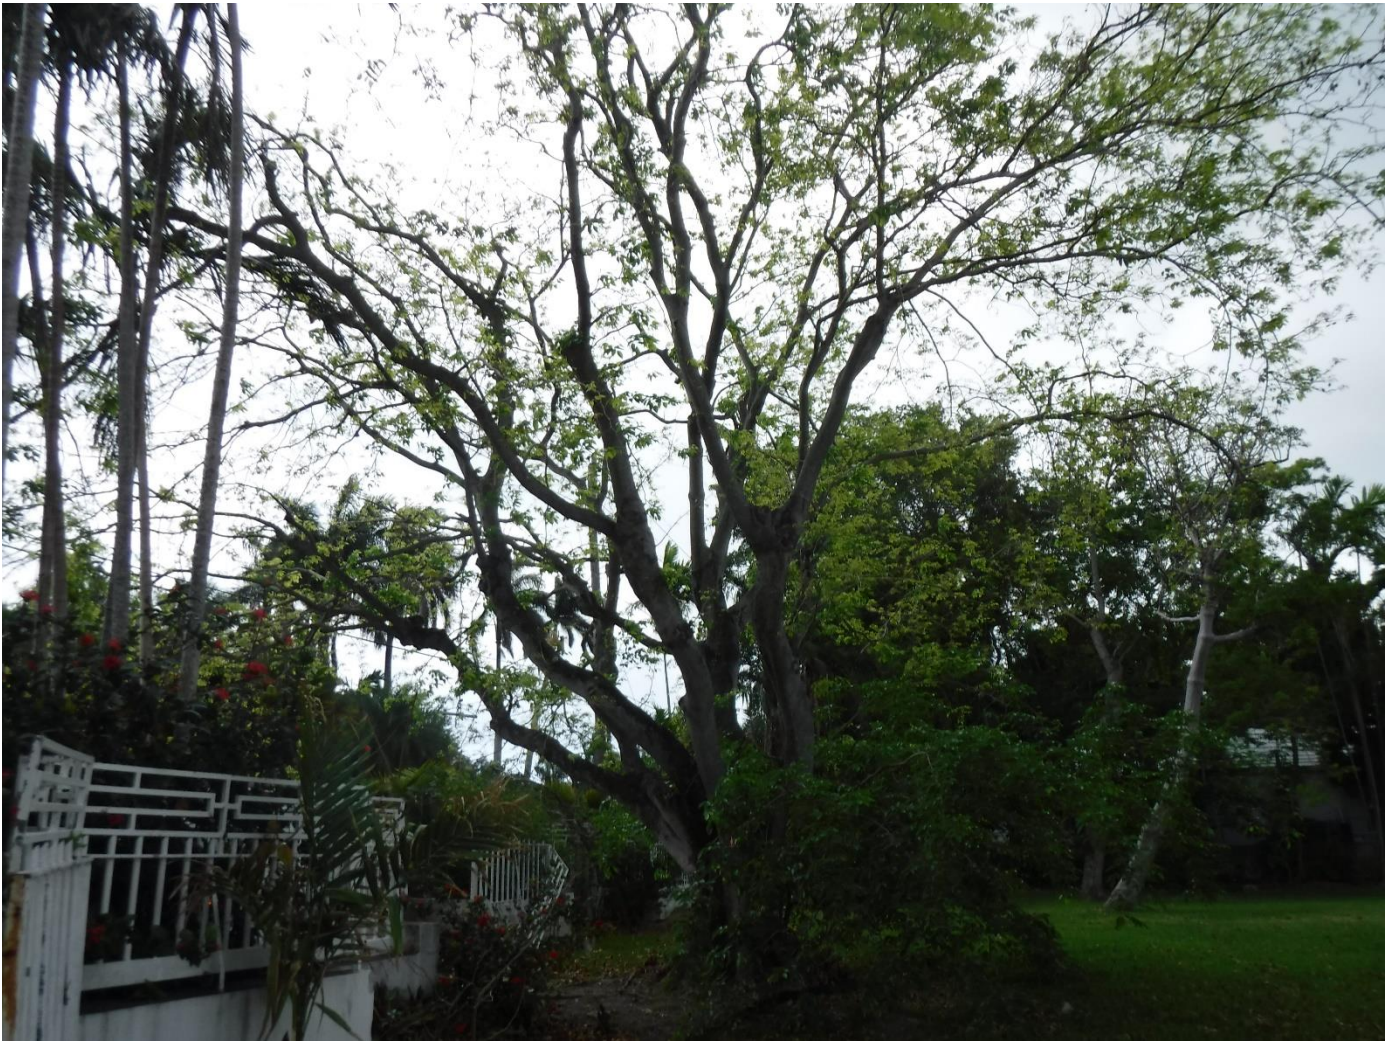
Tree number 32

The Pongam is in fair condition with a 35% health condition. The tree is 35 feet tall and 48 feet wide. The diameter measured at breast height was 40 inches. The tree has included bark, as well as codominant leaders, a wound in the branch on the east side, poor structure , and girdling roots on the east side. The tree has minor storm damage and dieback of leaves present on the outer edge of the canopy.

View looking south heading cuts evident

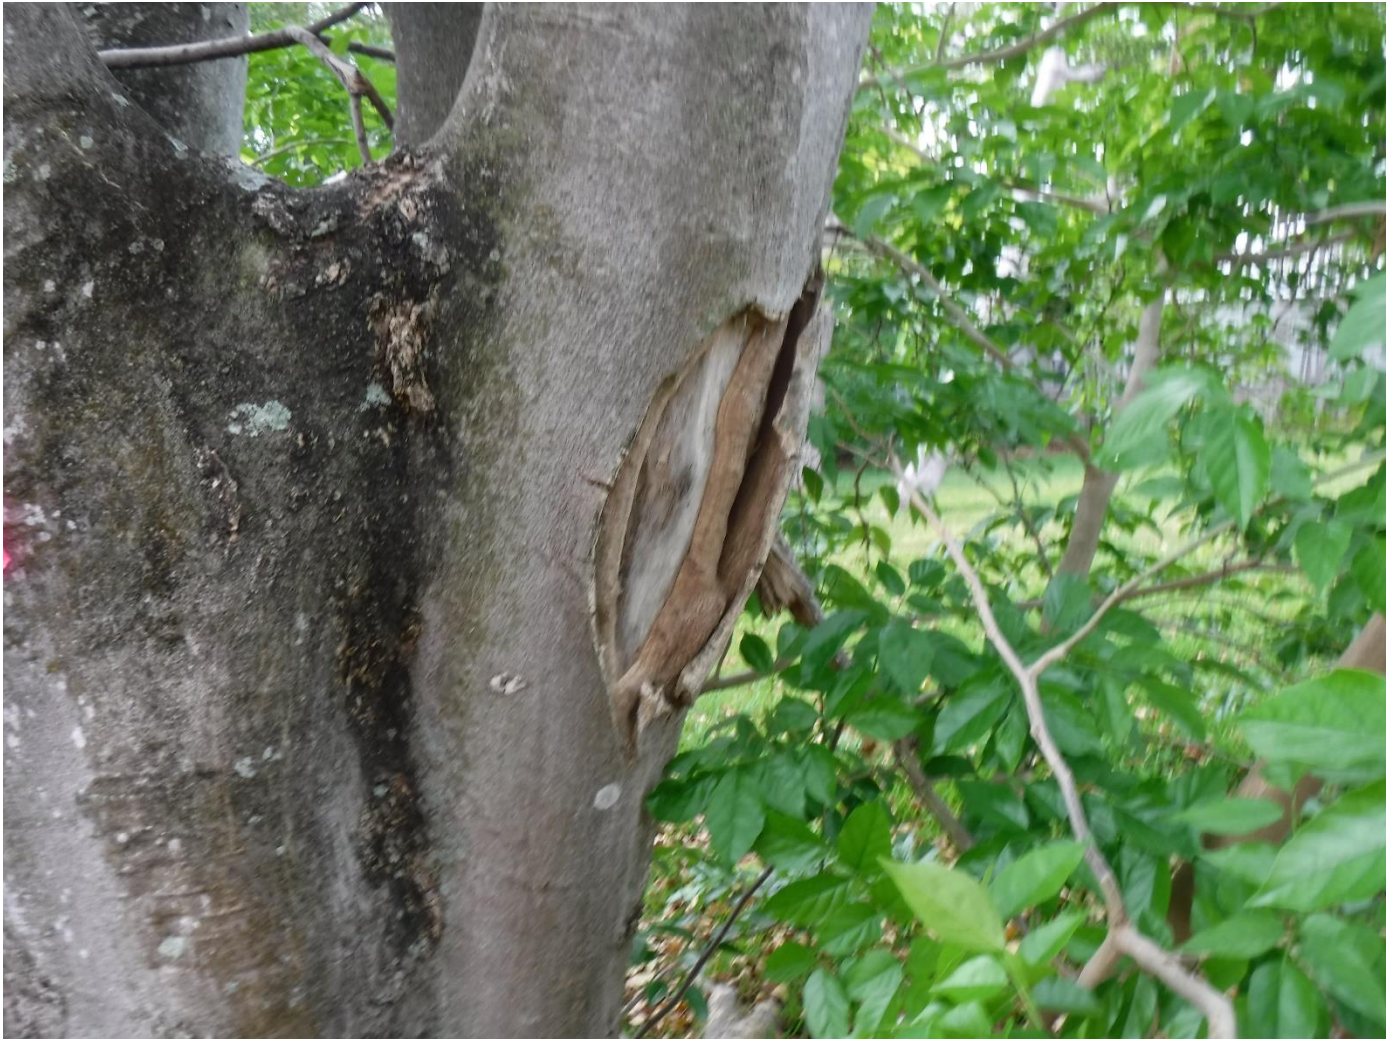
Wound in stem of tree

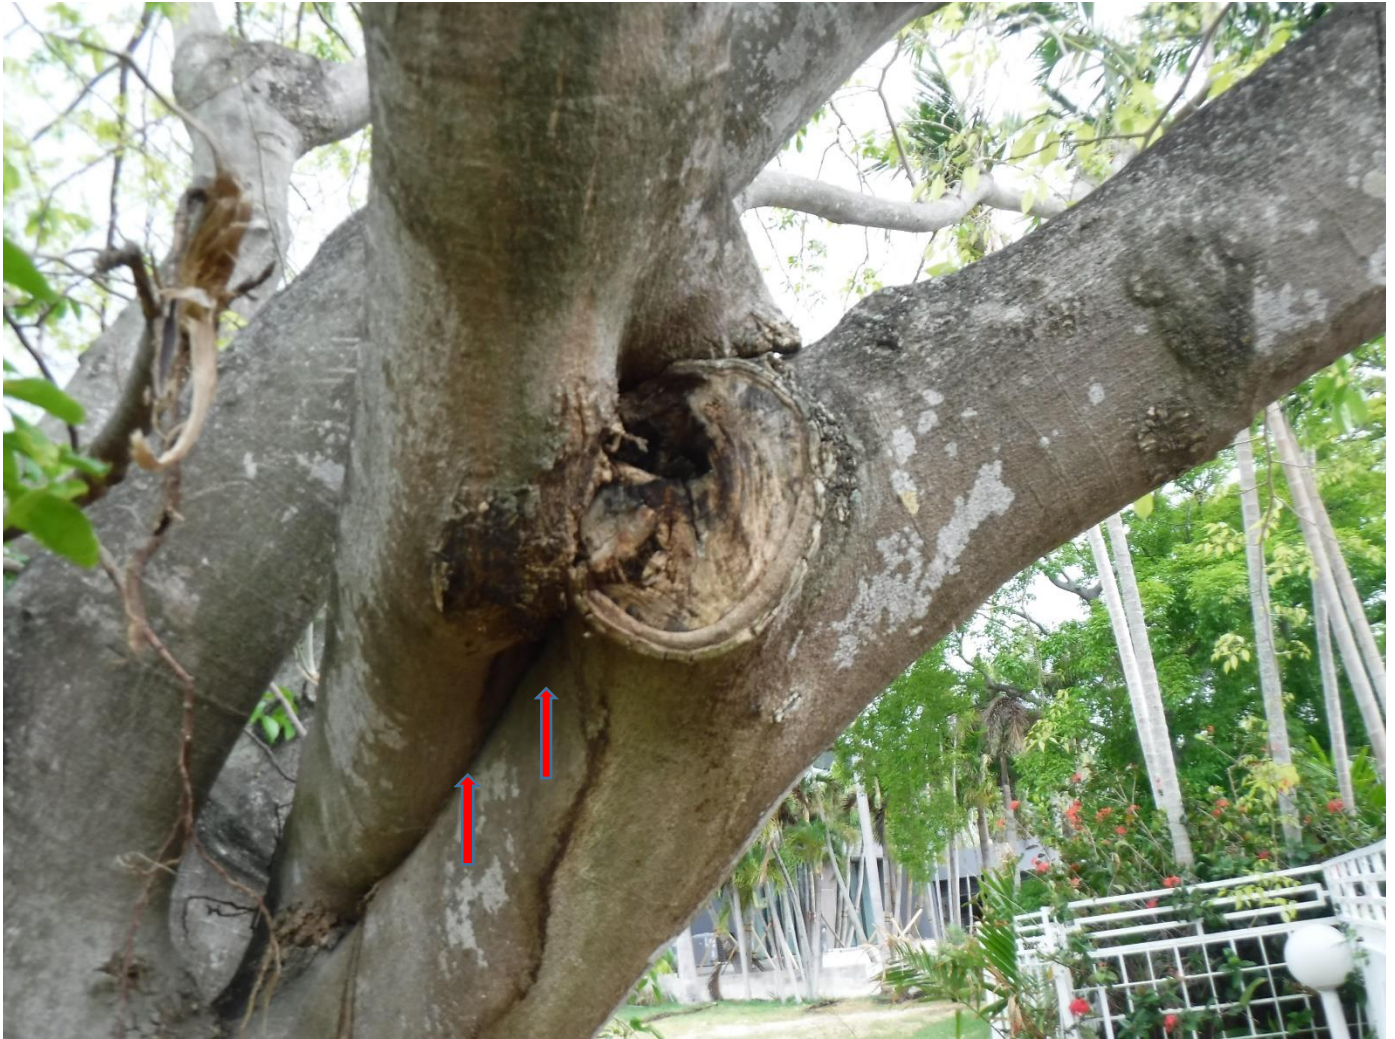
Included bark and wound in branches
