HISTORIC RESOURCES REPORT

STRUCTURAL CONDITION ASSESSMENT
7925-7935 Crespi Blvd
Miami Beach, Florida 33141

STRUCTURAL CONDITION ASSESSMENT for
7925-7935 Crespi Blvd
Miami Beach, Florida

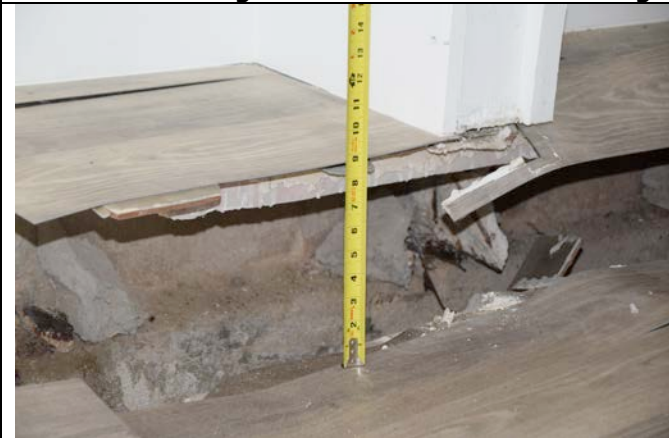
Currently, there is one location in building 7935 that has total collapse of the concrete subfloor joists (please see photos). The joists have collapsed and fallen to grade into the crawl space, these joists are beyond repair.

Photo 2- failed joist system in 7935

Based on the site observations of the conditions of structural members of the buildings, the structural members of this building need to be replaced rather than repaired, that is evident by the collapse of the joist system and missed alignment of the stem walls due to settlement. Hence, in order to do so, these structural members need to be demolished.

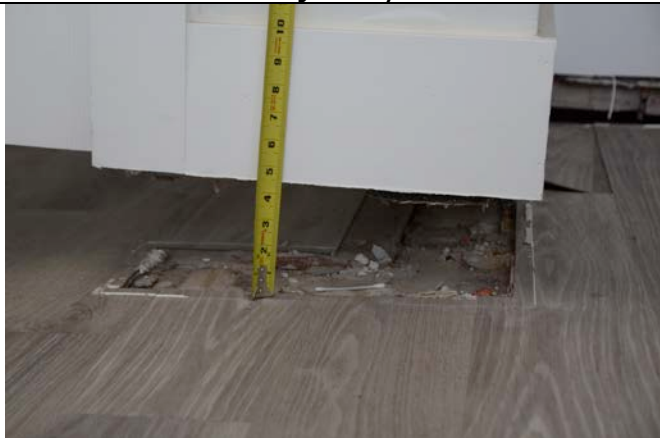
Photo 3 - failed joist system in 7935

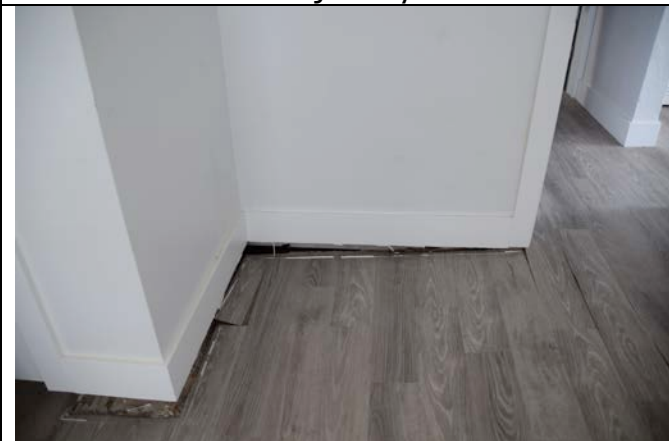
Photo 4 - failed joist system in 7935

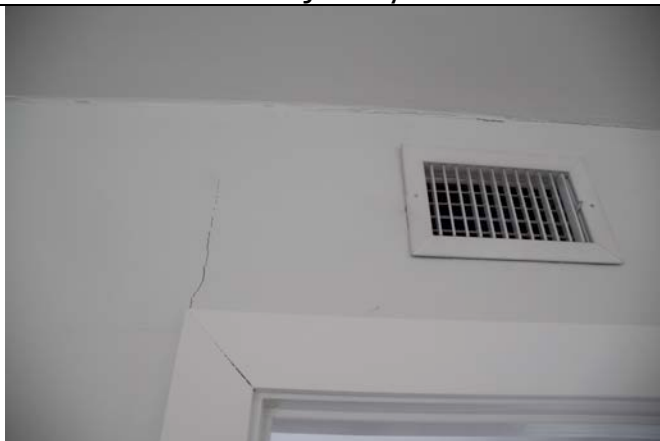
Photo 5- separation between joists and walls

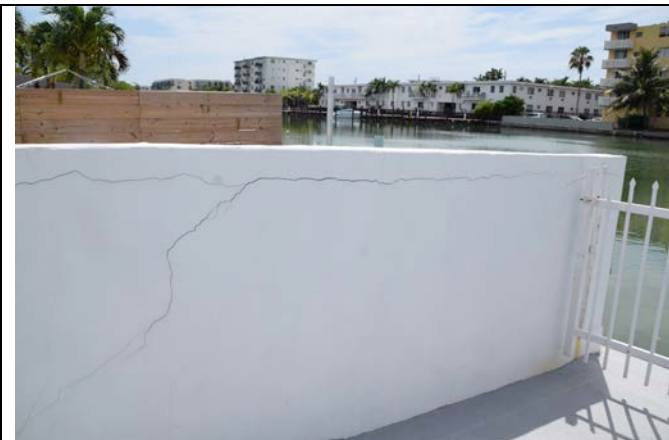
The foundations exhibit substantial settlement that is exhibited by typical cracking of the exterior walls, please see photos.

Photo 6 - Cracking due to settlement

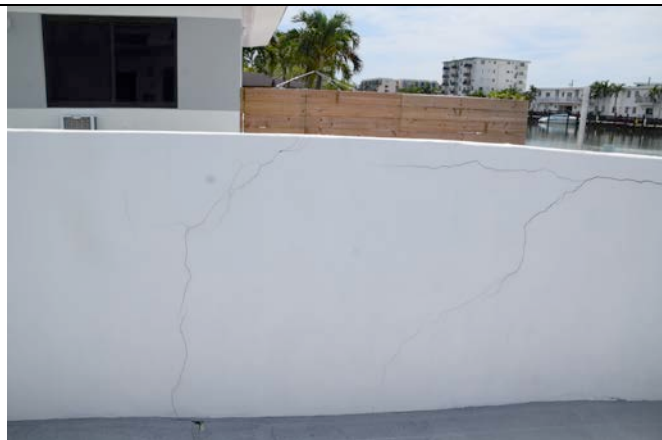
The Whole site is depressed and slanted towards the north east including the settlement of the structures, the settlement of the property walls and the site concrete slabs. The most probable culprit is the deficient seawall on the Tatum canal. The seawall is damaged and undermined. Loss of subsoil coupled with shallow foundations will lead to the exhibited deficiencies in the structures and property walls. Moreover, we observed fish in the canal swimming into and under the wall, leading to the presumption of voids under it.

Photo 7 - Cracking of property wall due to settlement

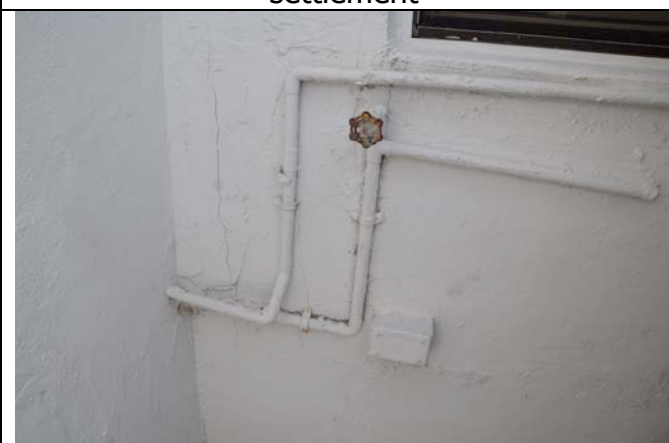
Photo 8 - Cracking of property wall due to settlement

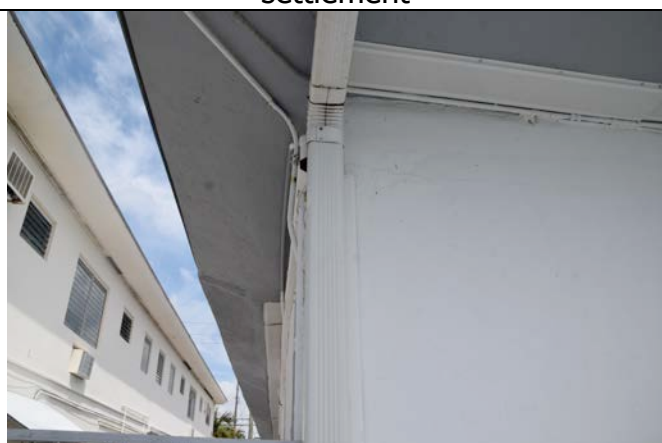
Masonry members; which comprise the exterior walls of the building, is mostly in fair condition, but do exhibit cracking to settlement of the foundations. There are several hairline cracks in the masonry that are attributed to age, and exposure to the elements.

Photo 9 - Cracking in exterior walls

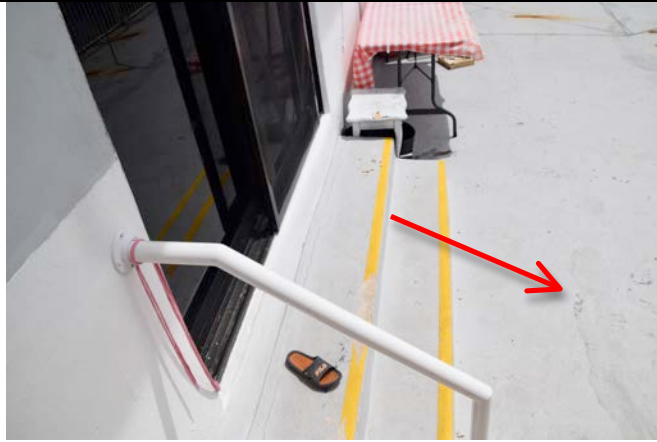
Photo 12 - settlement in wall, notice gate lock

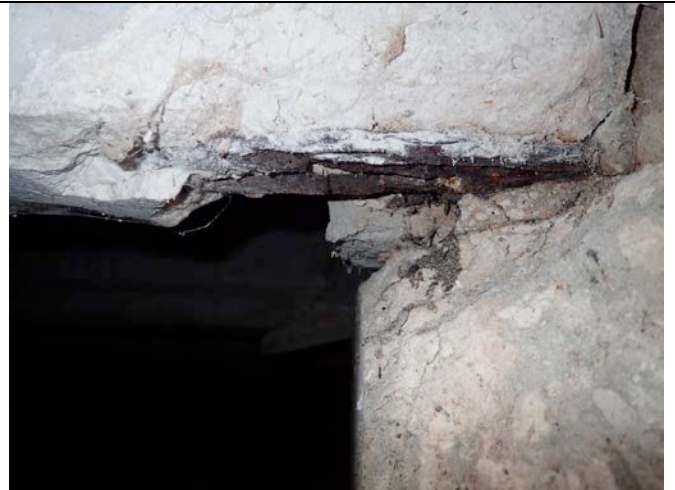
There are several concrete precast joists in the subfloor system that has exposed reinforcing rebars where the concrete has completely spalled off the members. Reinforcing rebars are corroded in multiple locations. Several of the joists has severe cracking. Concrete deterioration is evident in the concrete joists and have occurred at full width of the joists. There are previous attempts to restore the concrete members, and those attempts themselves have failed. Previous attempts were to replace the concrete joists with wood joists in the 7925 building.

Photo 17 - Rebar corrosion and Concrete spalling of concrete joist system

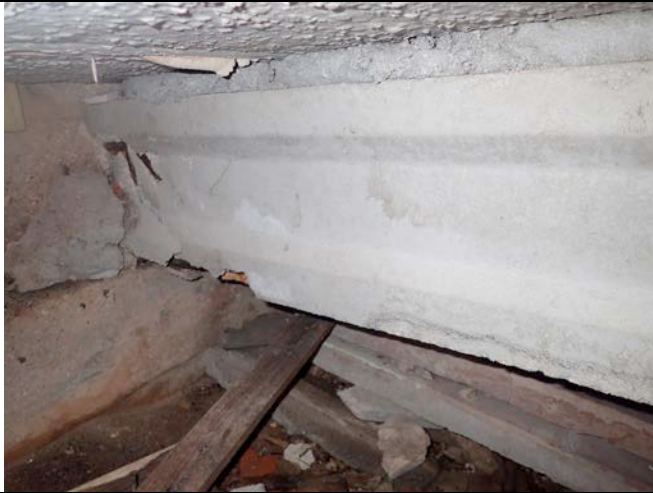
Photo 18 - Rebar corrosion and Concrete spalling of concrete joist system, and loss of bearing

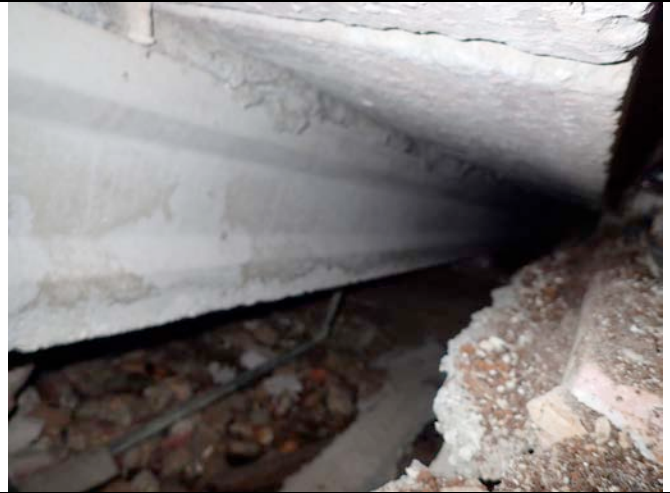
Photo 19 - Rebar corrosion and Concrete spalling of concrete joist system, and loss of bearing

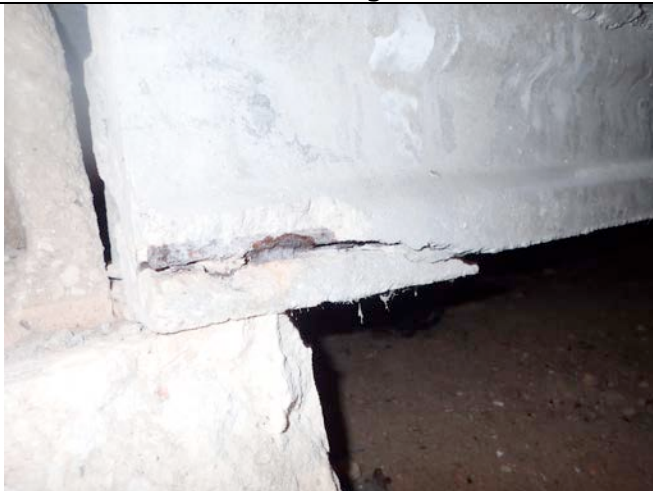
Photo 20 - concrete floor failure

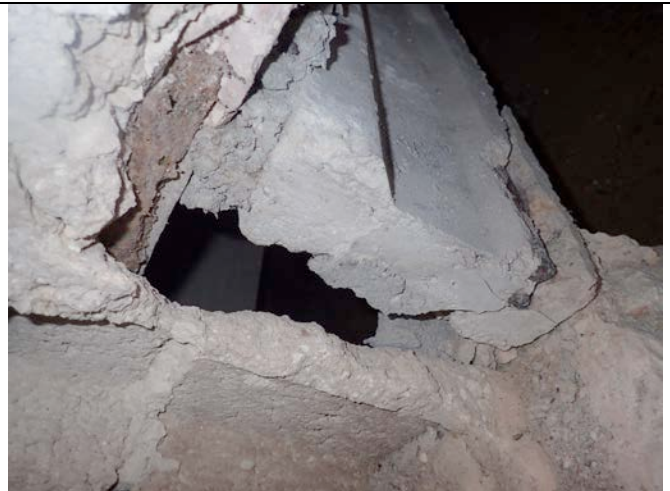
Photo 21 - Rebar corrosion and Concrete spalling of concrete joist system, and loss of bearing

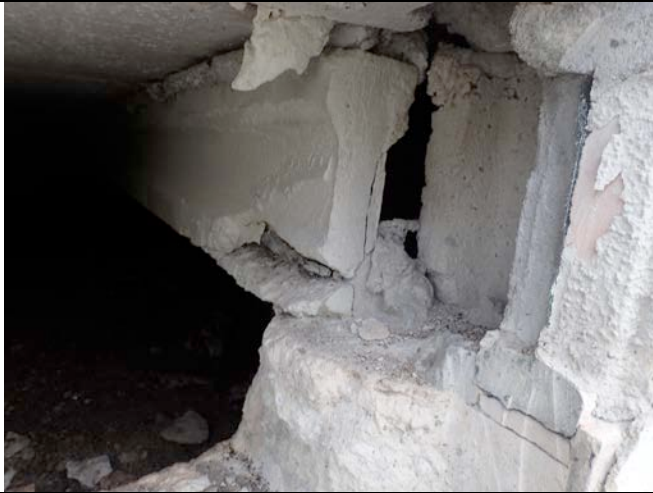
Photo 22 Rebar corrosion and Concrete spalling of concrete joist system, and loss of bearing

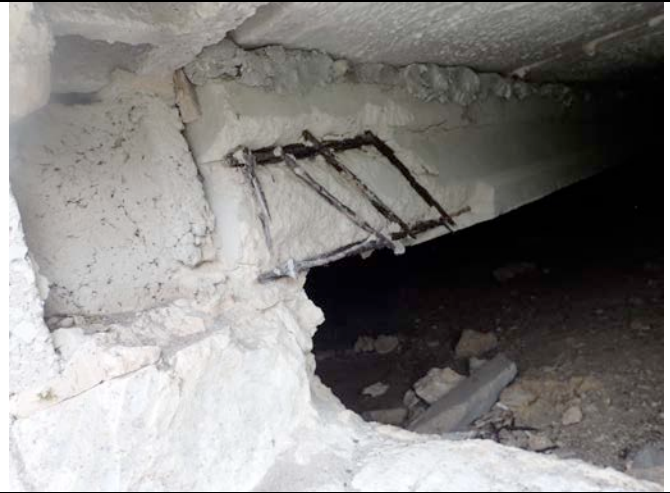
Photo 23 - Rebar corrosion and Concrete spalling of joist system, and loss of bearing

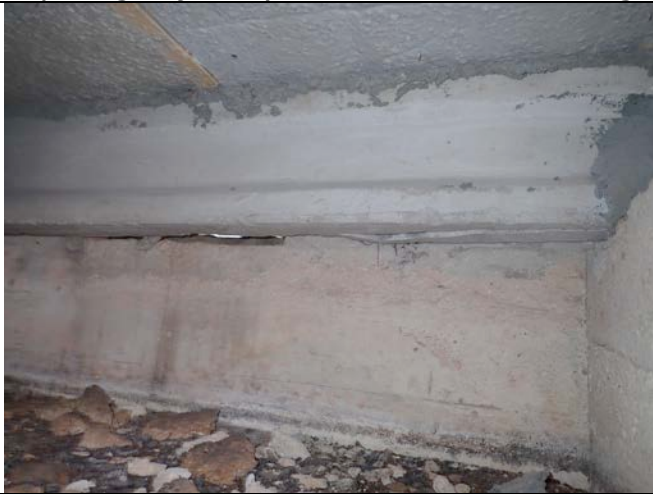
Photo 24 - Rebar corrosion and Concrete spalling of joist system, and loss of bearing

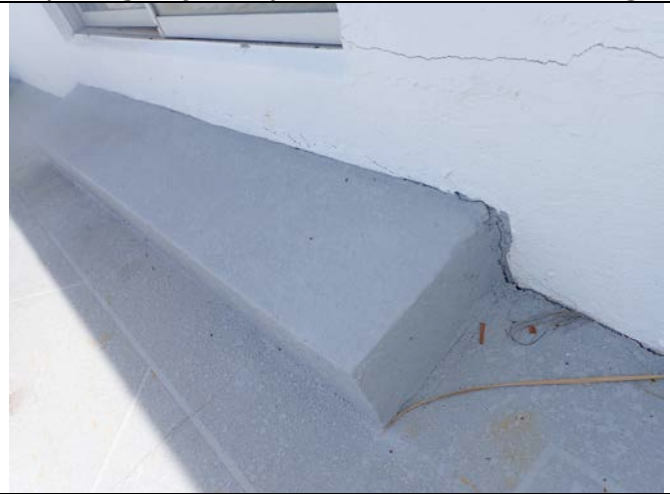
Photo 25 - previous repairs

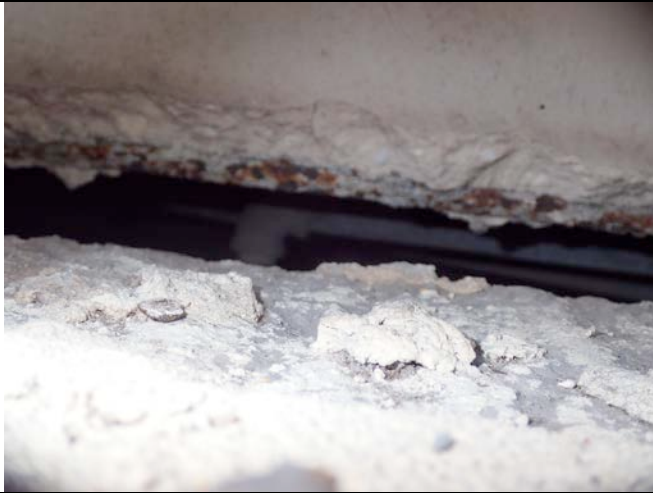
Photo 28 - Rebar corrosion and Concrete spalling of concrete joist system, and loss of bearing

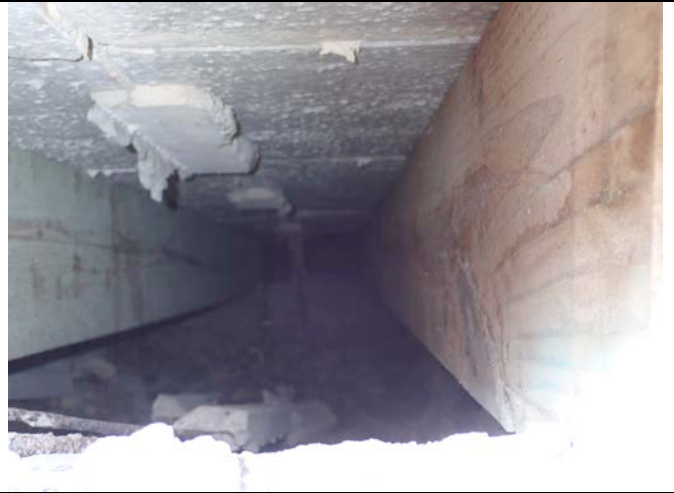
Photo 29 - Rebar corrosion and Concrete spalling of concrete joist system

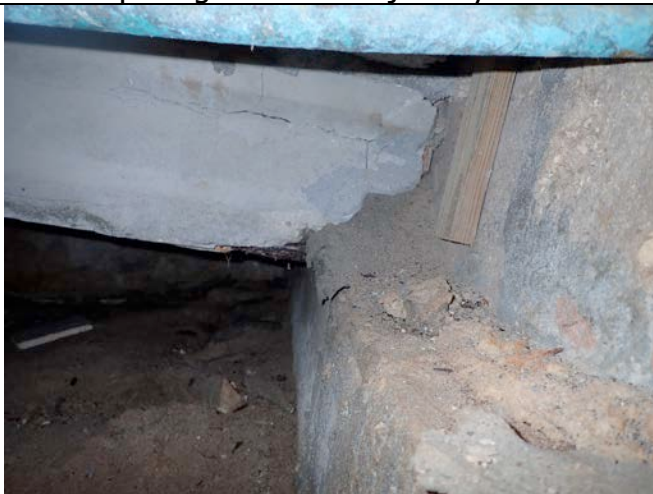
Photo 32 - Wood joist replacing concrete

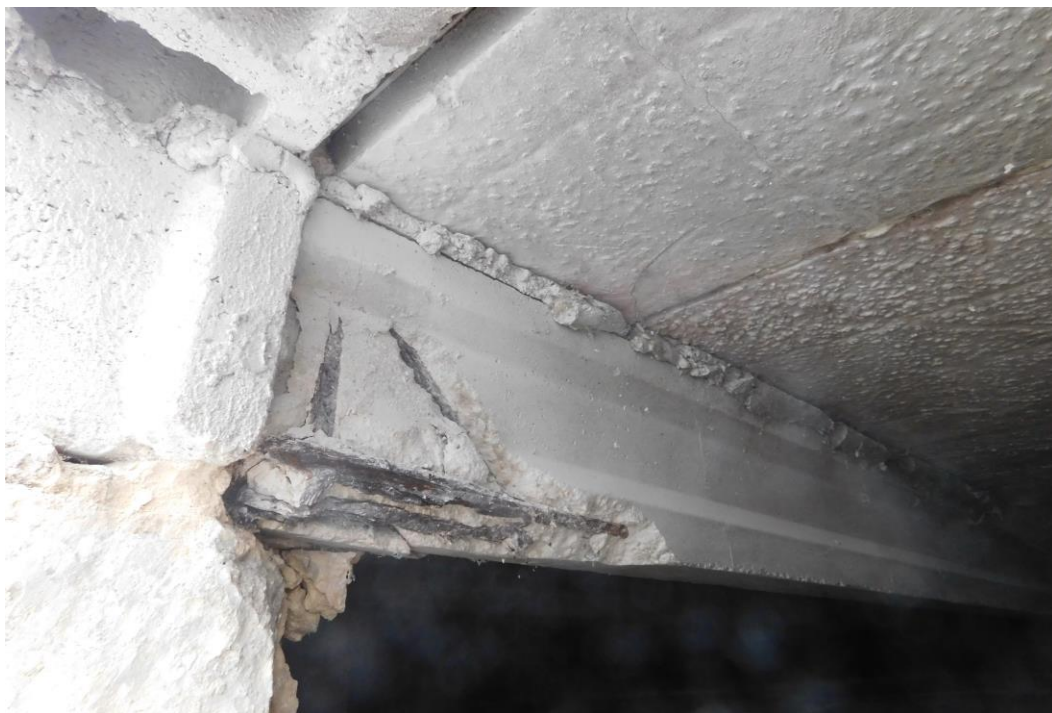
View of significant deterioration of floor joist at support section.

It is our opinion, that water intrusion damage, weathering, and aging has caused significant deterioration to most of the precast joists of the subfloor system. The deterioration is revealed through the cracking, deflection, and loss of structural section that are visible on the affected precast members. The deterioration was also revealed through spalling, delamination, and surface corrosion of the steel reinforcement of the concrete precast joists. The deterioration was more prevalent on the precast joists.

Based on our observations, the damage in most of the precast joists appears to be greater than 10% of their section, with numerous joists where the damage was greater than 20% of their section. The deterioration becomes significant on numerous joists to the point where their integrity, stability, and load carrying ability are diminishing with time. Evidence of local failure was revealed through excessive deflection observed on numerous precast joists and on the tiling system.

Alternatively, you could design and install a new wood floor frame. The new wood floor frame should be designed to support 100% of the floor load system in order to replace the structural function of the existing precast joist system. This option would allow leaving the precast joists on their existing conditions. In addition, we recommend that the existing precast joists remain in place.

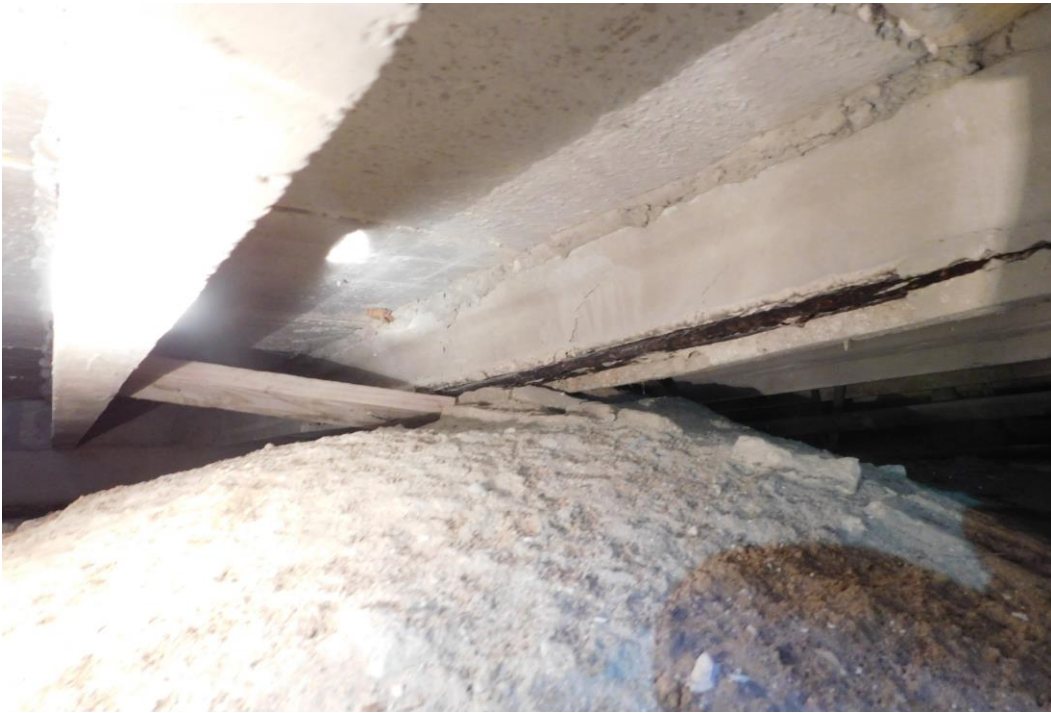
View of significant deterioration of floor joist at mid span section.

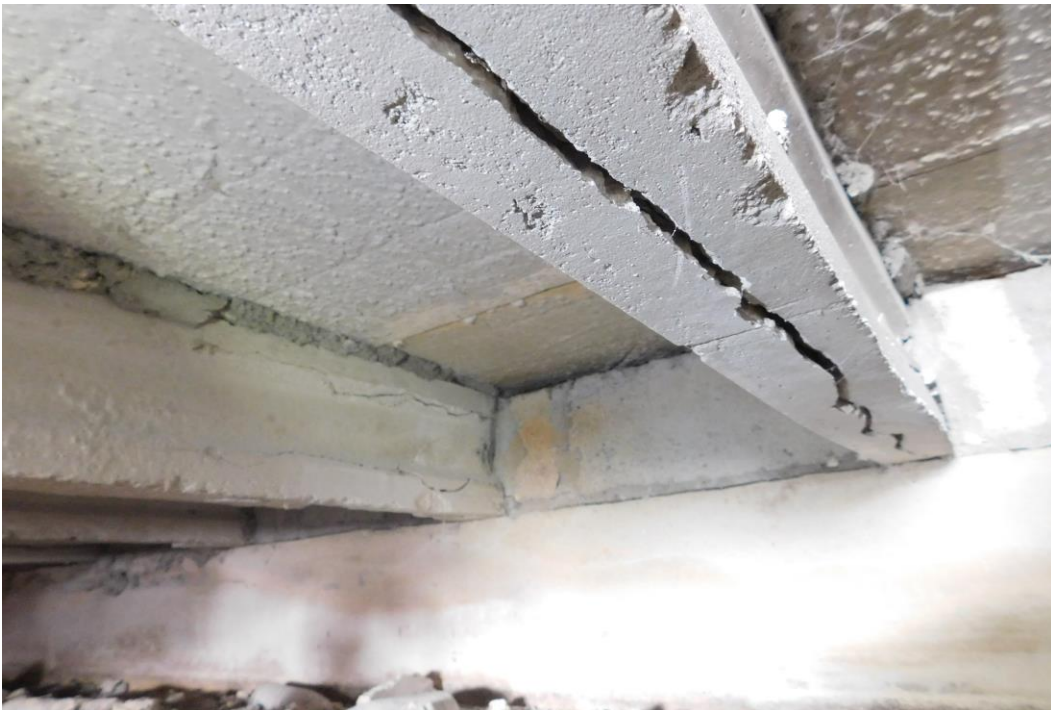
View of significant deterioration of floor joist at support section.
