SUBJECT: **A DISCUSSION REGARDING INTERIOR FLOODING AT THE BYRON CARLYLE THEATER.**

LIMITED CONDITIONS ASSESSMENT REPORT

**BYRON CARLYLE THEATER
500 71ST STREET
MIAMI BEACH, FLORIDA**

MARCH 4, 2016

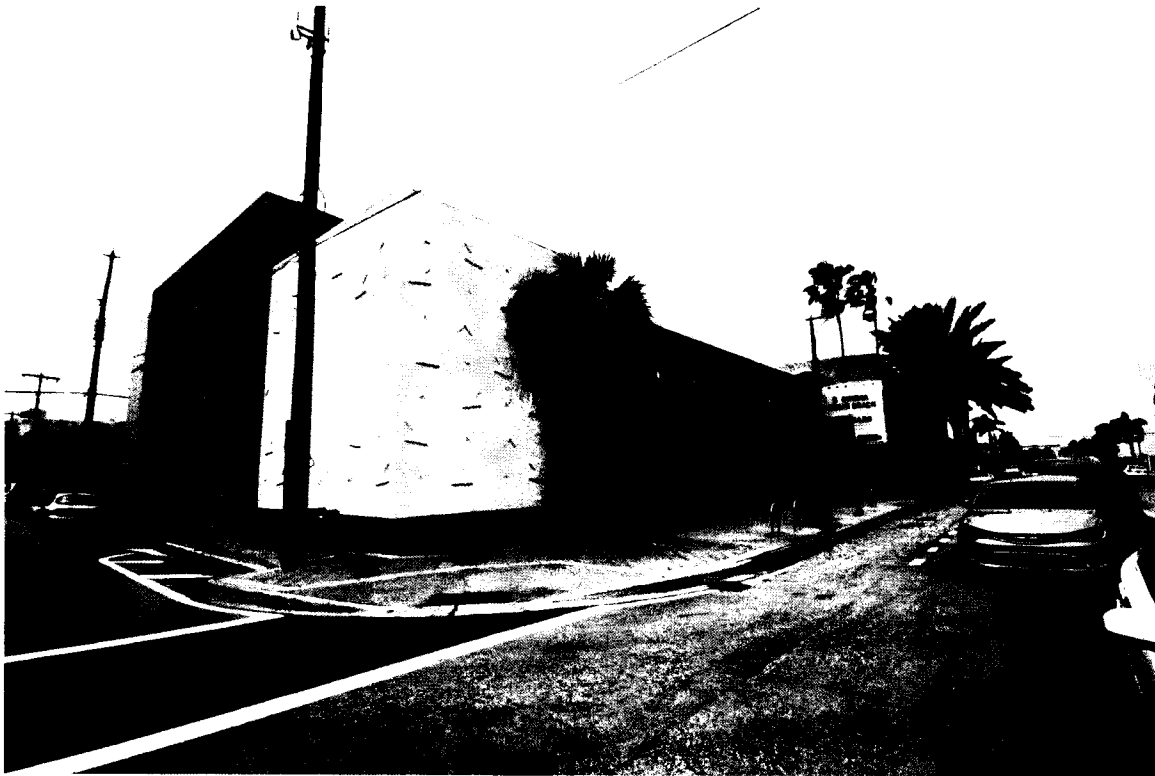
PHOTOGRAPH NO. 1
NORTHEAST CORNER OF BUILDING
(NOTE STREET, SIDEWALK & DOOR ELEVATIONS. NOTE PROXIMITY OF STREET DRAINS)

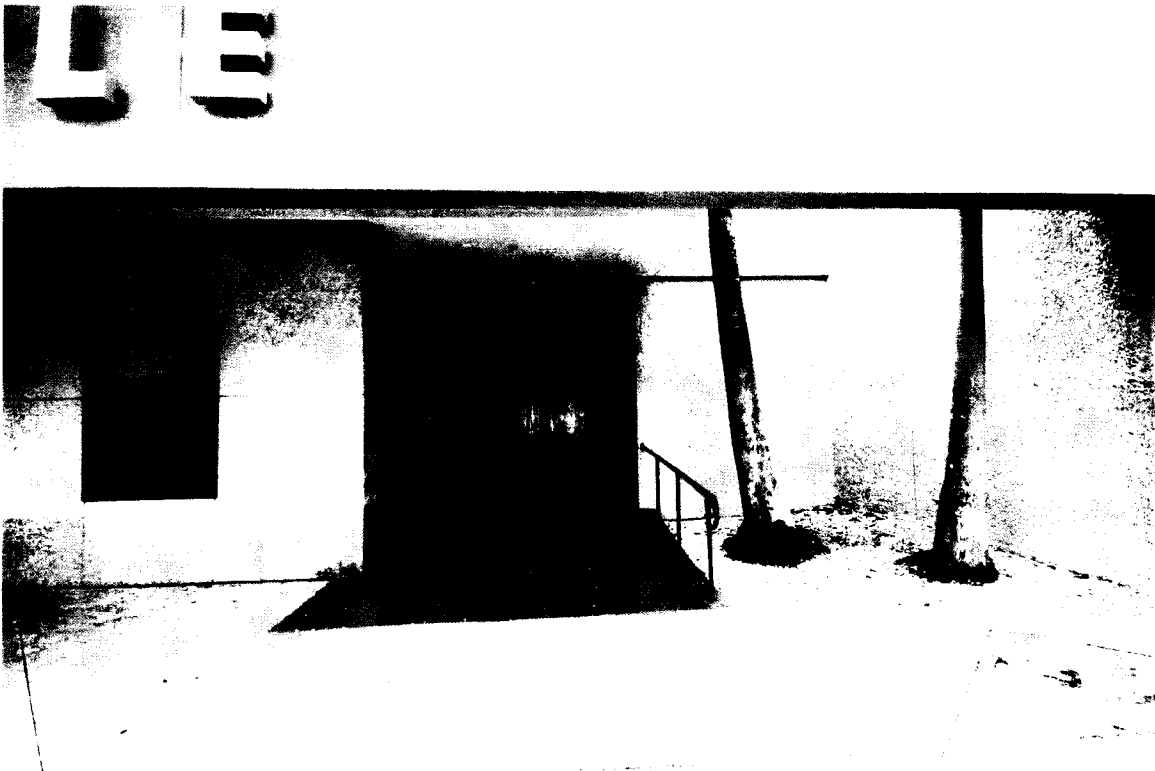
PHOTOGRAPH NO. 2
NORTH SIDE EXIT DOORS

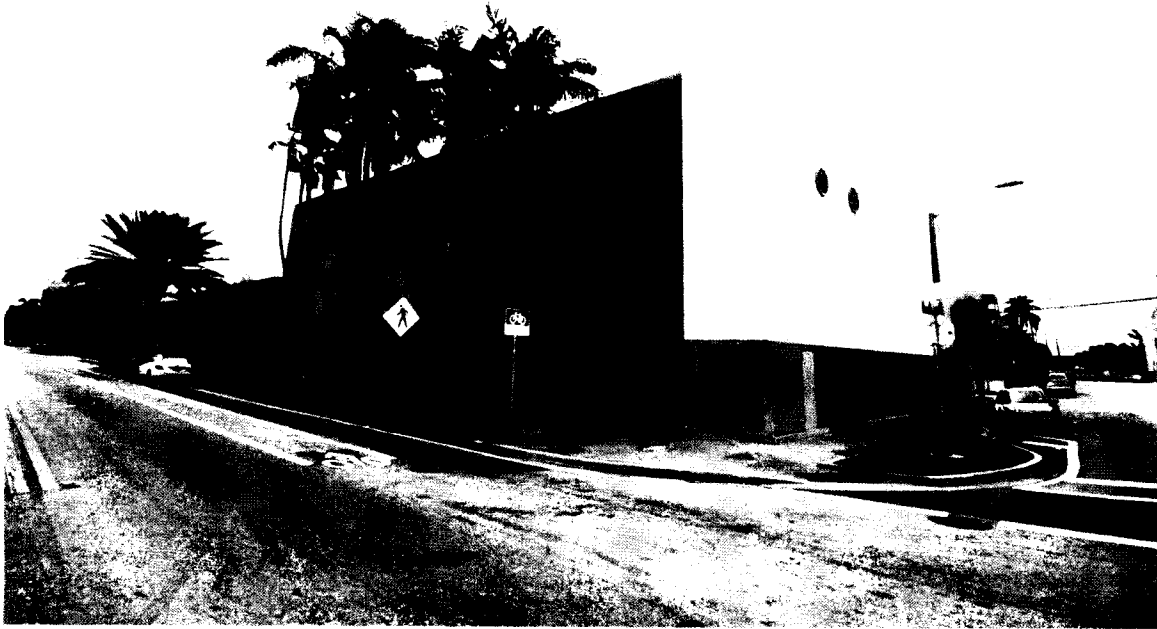
PHOTOGRAPH NO. 3
NORTHWEST CORNER OF BUILDING
(NOTE STREET, SIDEWALK & DOOR ELEVATIONS. NOTE PROXIMITY OF STREET DRAINS)

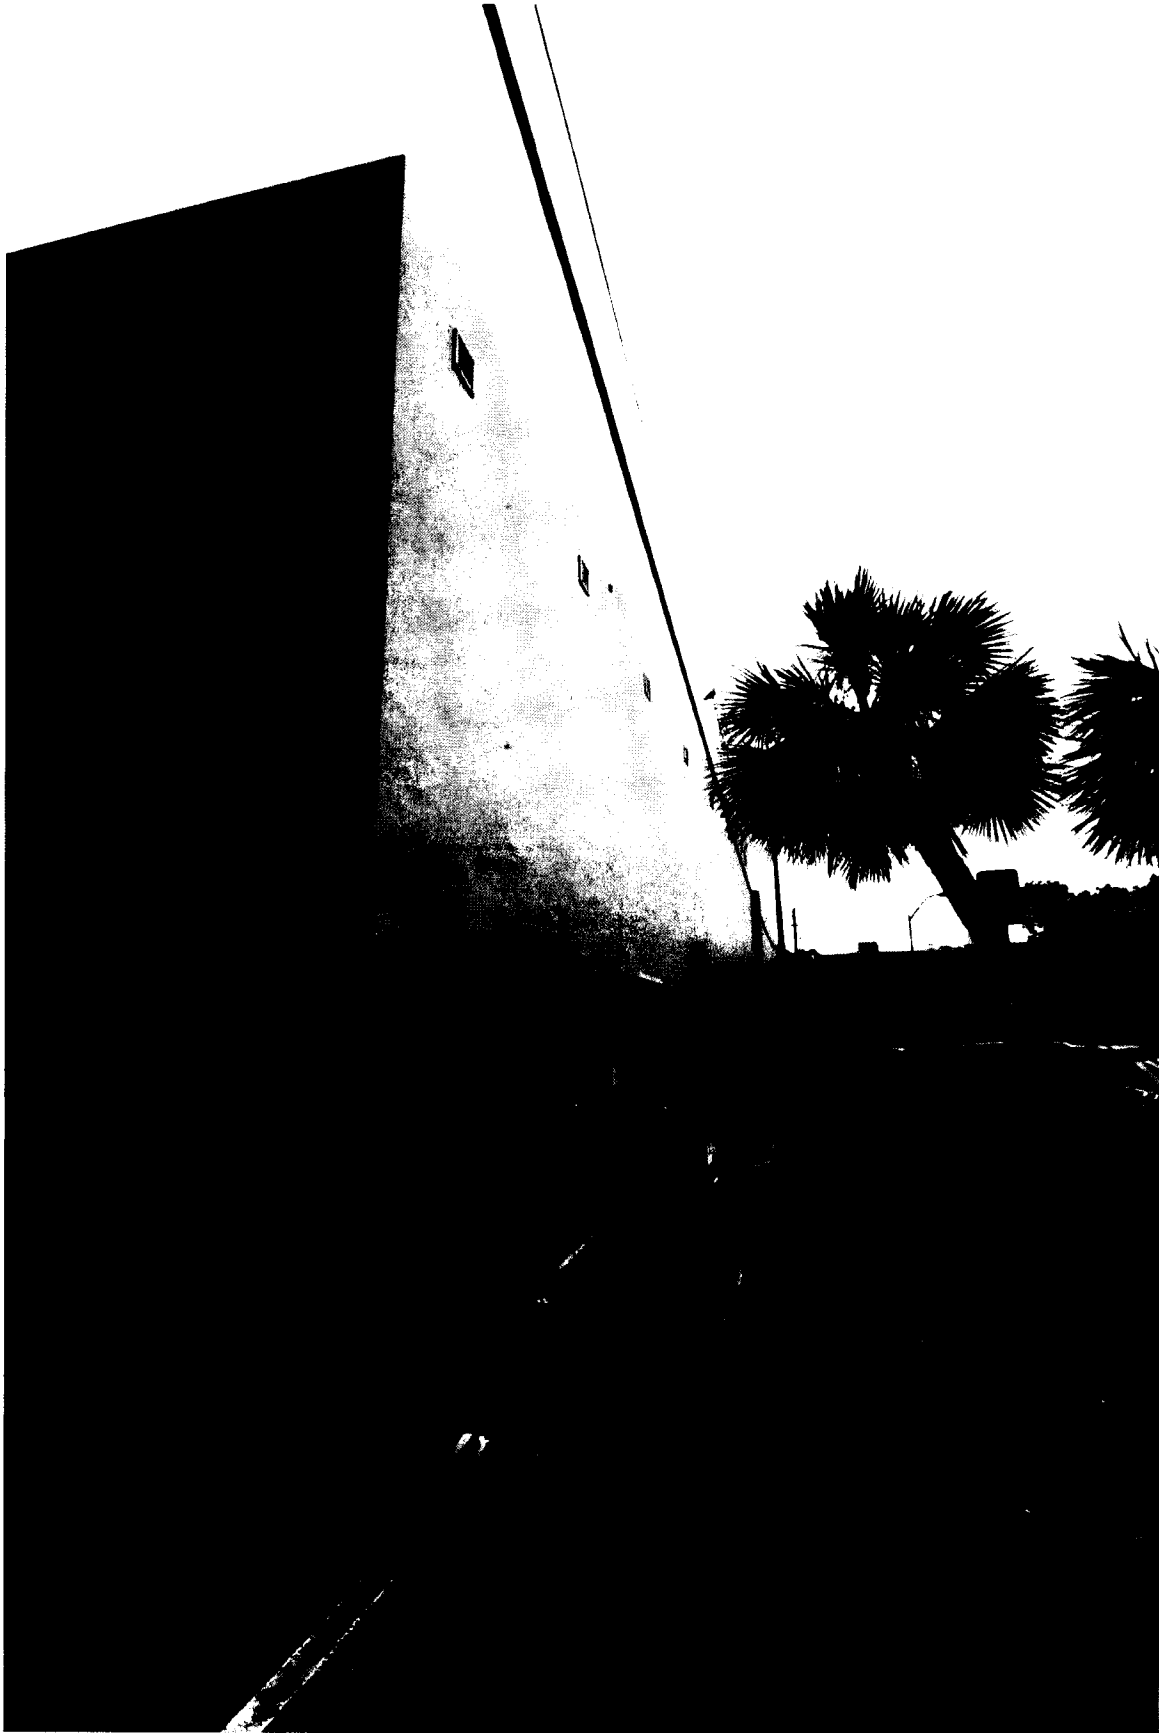
PHOTOGRAPH NO. 4
SOUTHWEST CORNER OF BUILDING
(NOTE SIDEWALK AND DOOR ELEVATION)

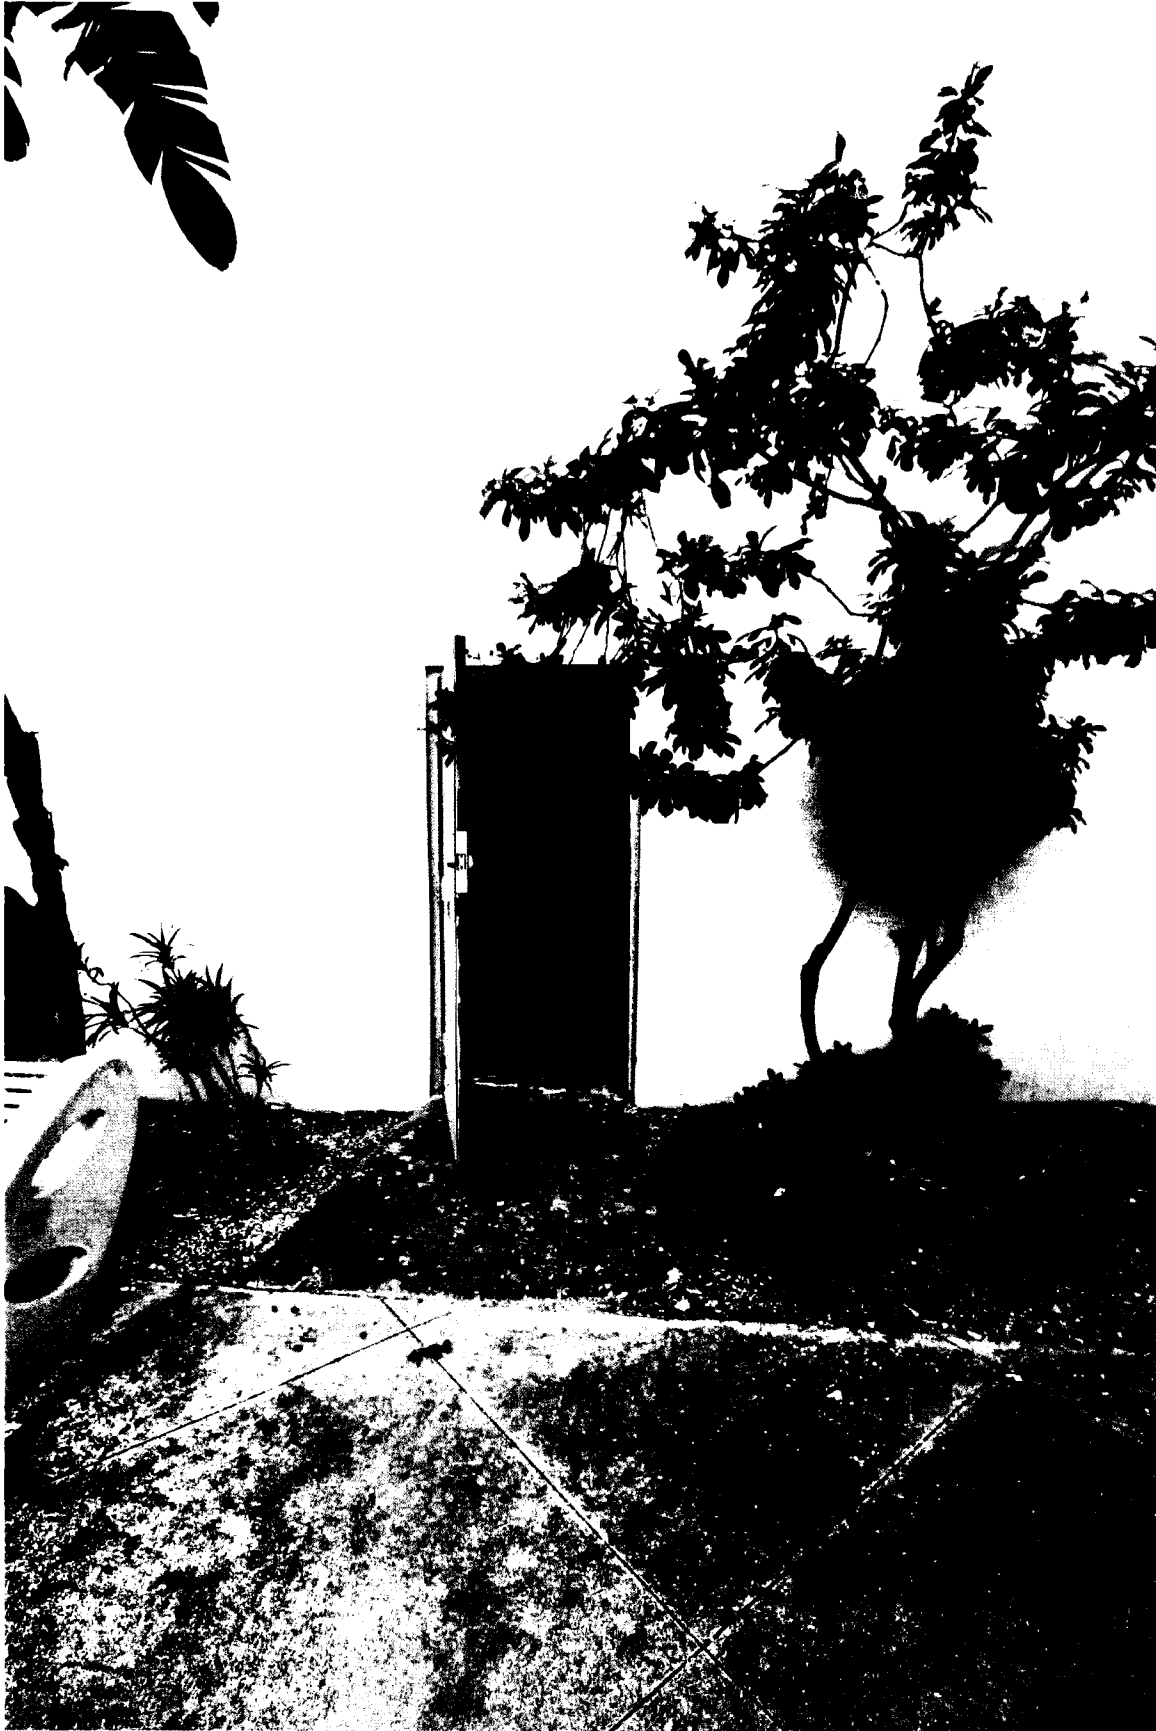
PHOTOGRAPH NO. 5
NORTH SIDE EXIT DOOR
(NOTE THRESHOLD ELEVATION RELATIVE TO SIDEWALK)

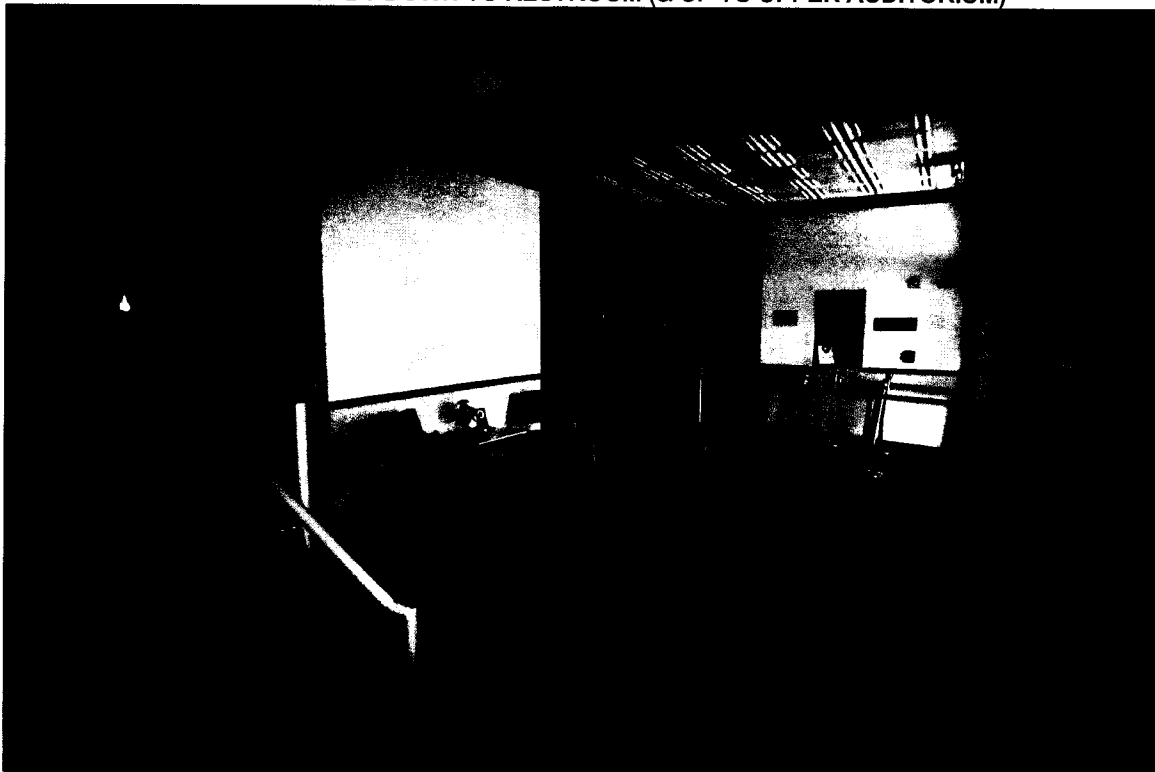
PHOTOGRAPH NO. 10
MAIN LOBBY
(SLIGHT RAMP UP FROM SIDEWALK-LEVEL ENTRY DOORS)
