493-2018

SUBJECT: **BYRON CARLYLE FACILITY CONDITION UPDATE**

Reference: 50-Year Recertification
Byron Carlyle Theater
500 71 St., Miami Beach, Florida
Folio 02-3211-002-1070

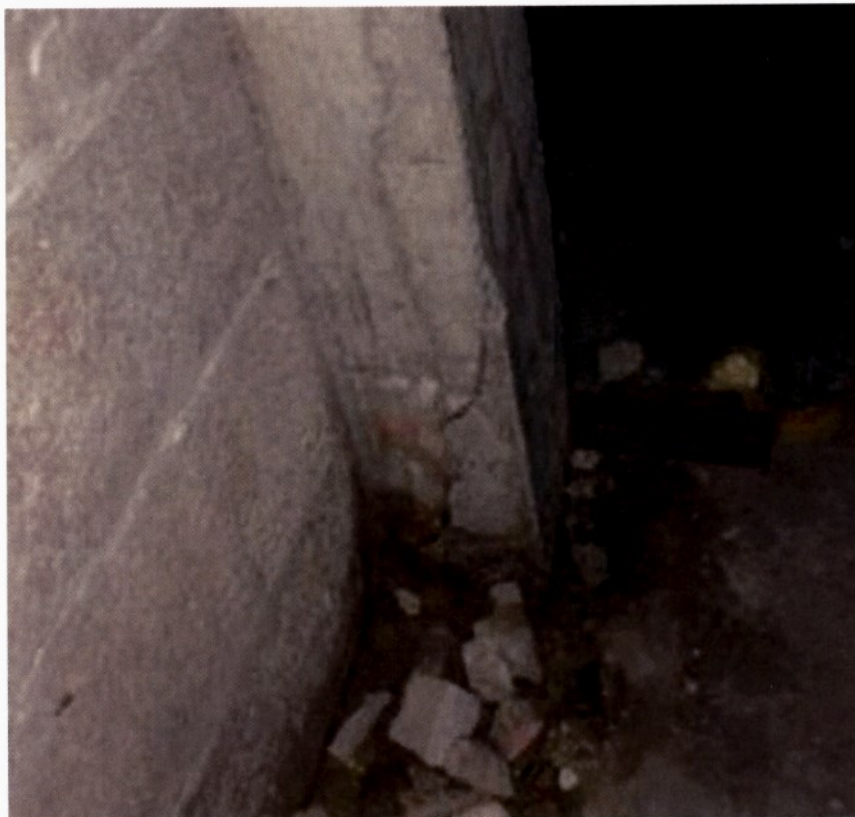
- 1) Concrete column located in hallway adjacent to the underground restrooms (at the west side) is spalled at the base (refer to Photograph 12).
- 2) Concrete slab above the electrical room at the ground floor (at corner of room, towards South facade) in between the east and west sides of the buildings is spalled (see Photograph 13).

Photograph No. 12 – Spalled Concrete Column at Underground Hall

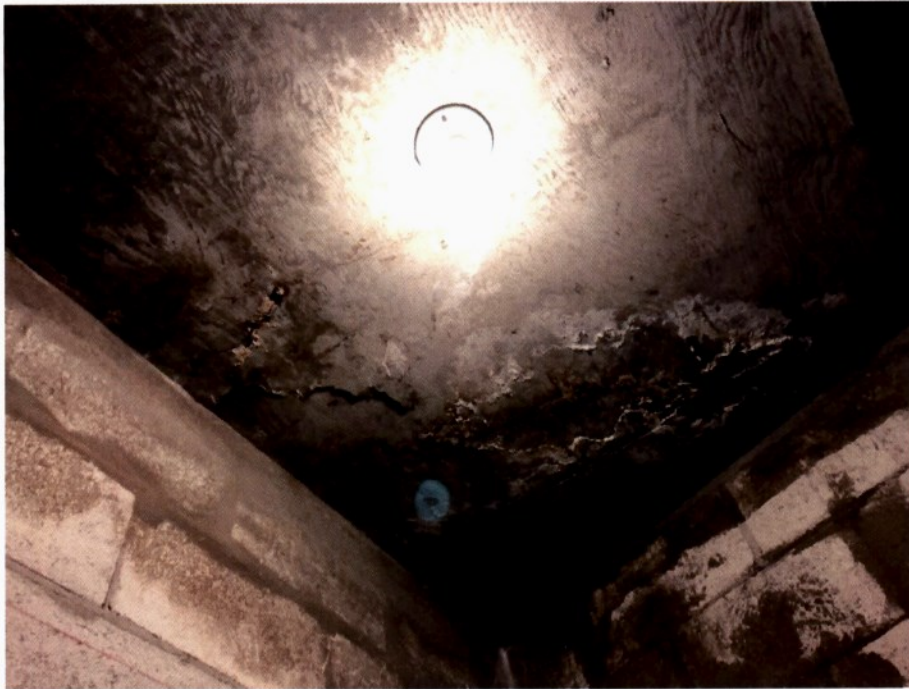
Photograph No. 13 – Spalled Concrete Slab above Electrical Room at Ground Floor

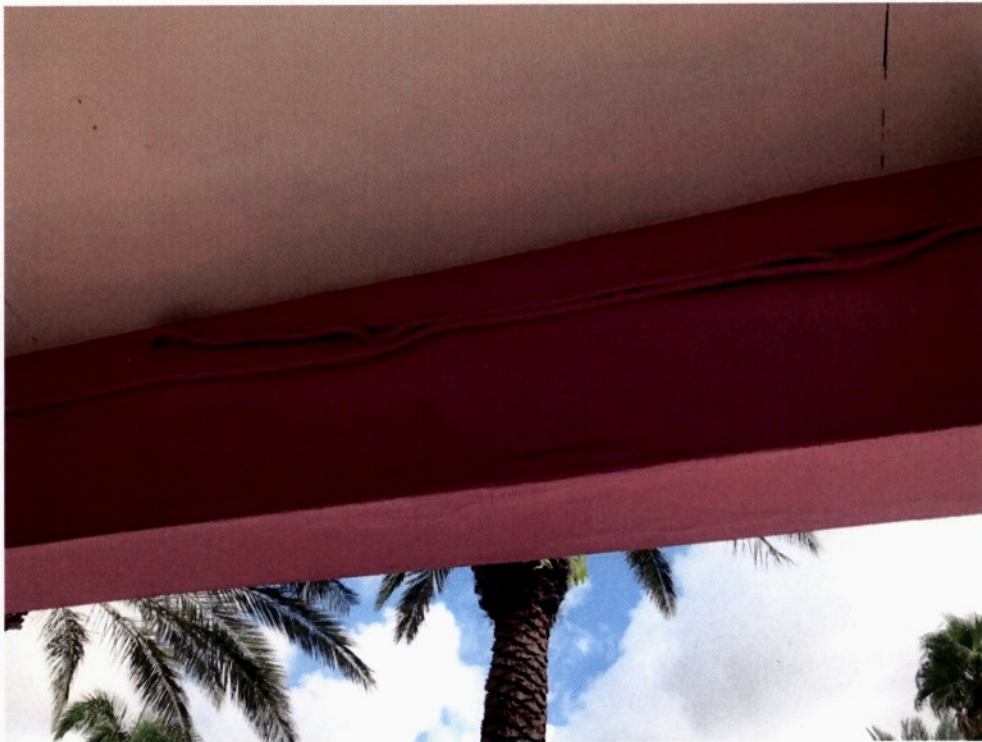
- 3) Exterior concrete beams at the north facade of the building are spalled at the bottom (see Photographs 14 and 15).
- 4) 2nd floor concrete slab in the south façade of the building (towards the center, above the men's restroom) has a large opening (about 9" in diameter) (refer to Photograph 16). Exposed reinforcement is observed at the perimeter of the opening as well as perpendicular narrow cracks. Additionally, a water tank seems to be bearing above this opening.

Photograph No. 14 – Spalled Exterior Concrete Beam at North Façade

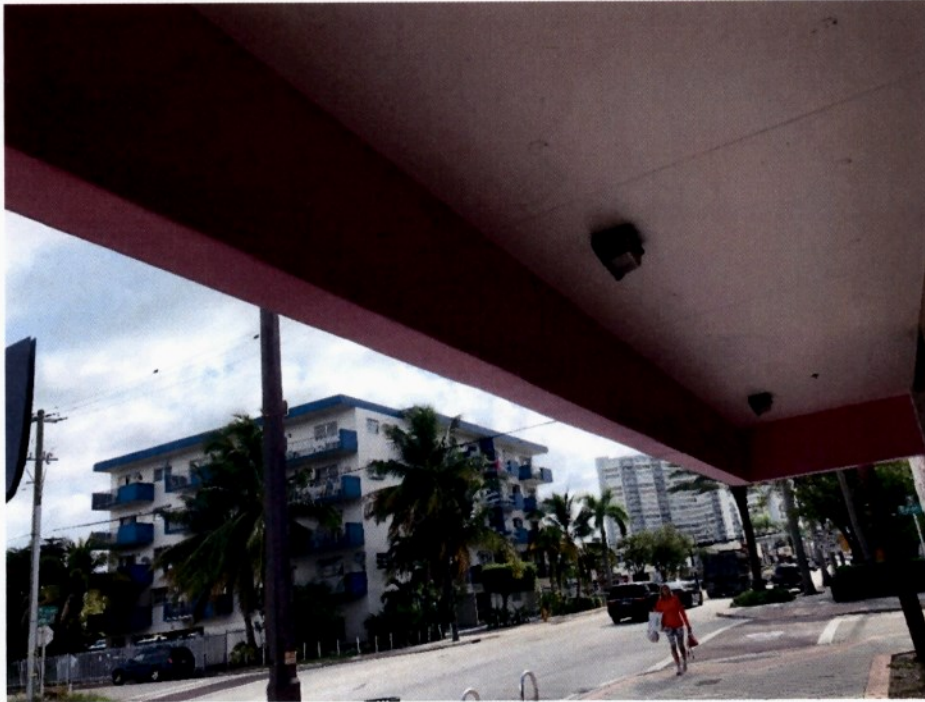
Photograph No. 15 – Spalled Exterior Concrete Beam at North Façade

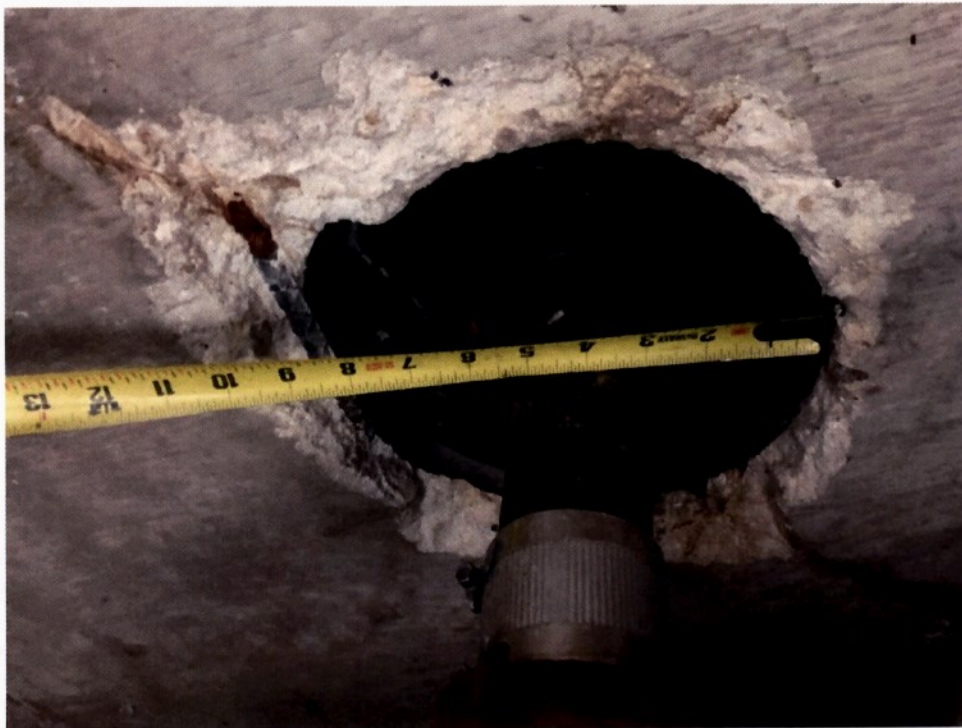
Photograph No. 16 – Opening in Slab above Men's Restroom (near South Façade)

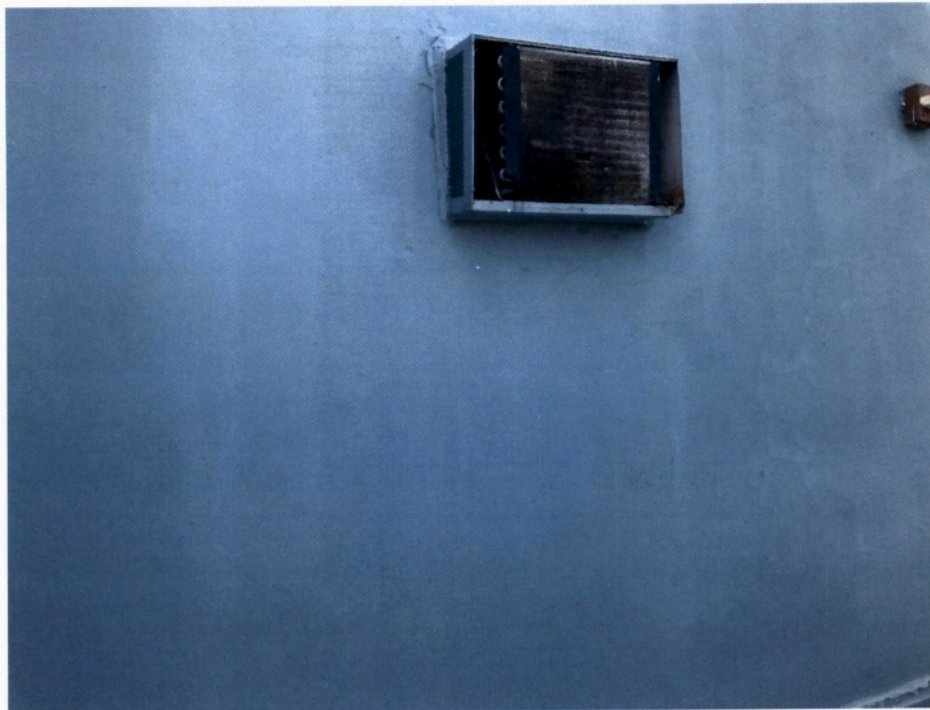
Photograph No. 17 – Uncovered Air Conditioning Unit in 2nd floor Room at the South End of Building (Between east and West Theaters).

- 23) Provide exterior cover to air conditioning unit in 2nd floor room at south end of the building, in between the east and west theaters, to prevent moisture intrusion (refer to Section 2.b.19.)

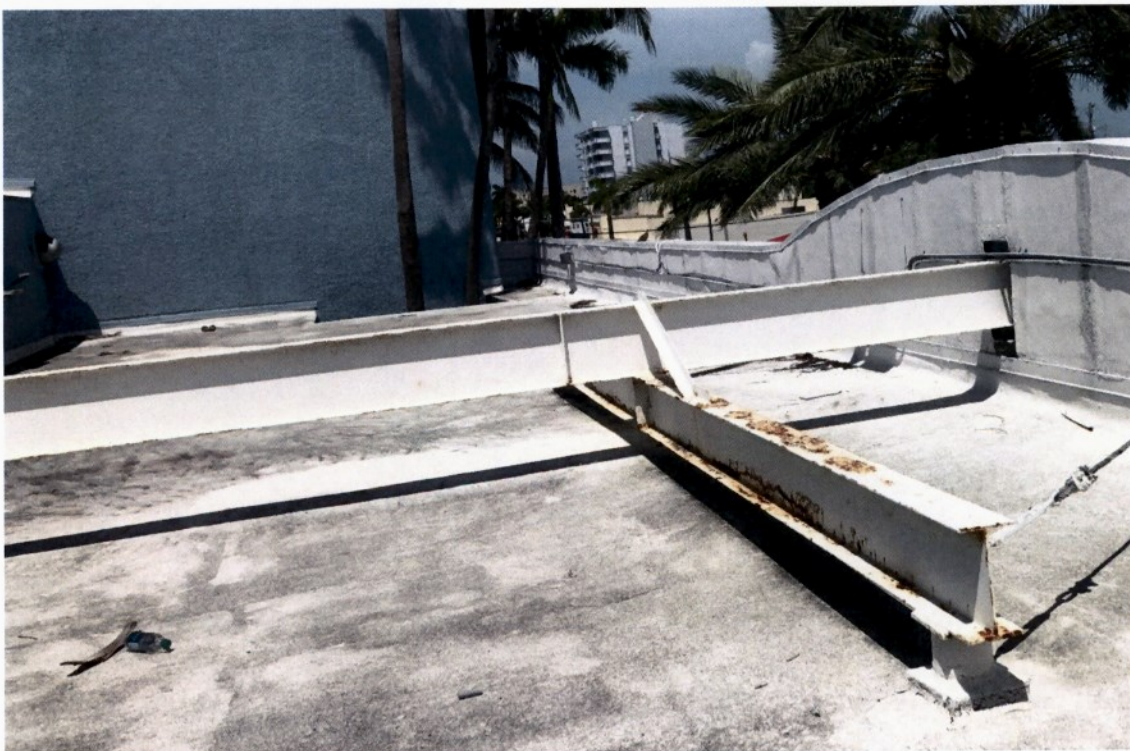
Photograph No. 18 – Corroded Structural Steel Supporting Theater Sign

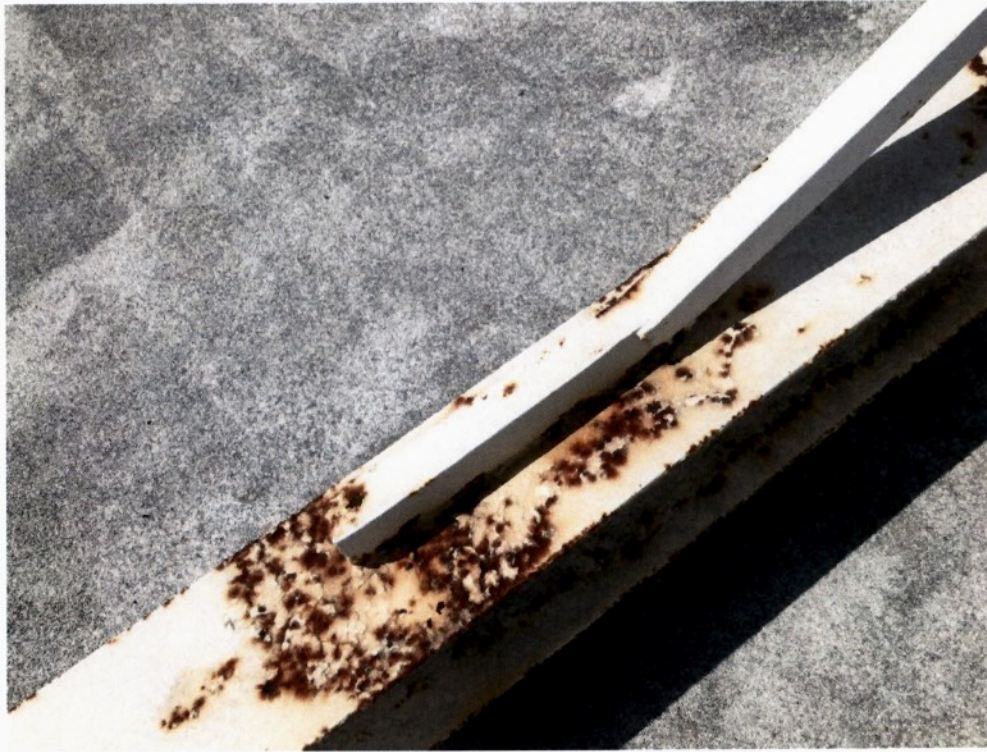
Photograph No. 19 – Corroded Structural Steel Supporting Theater Sign

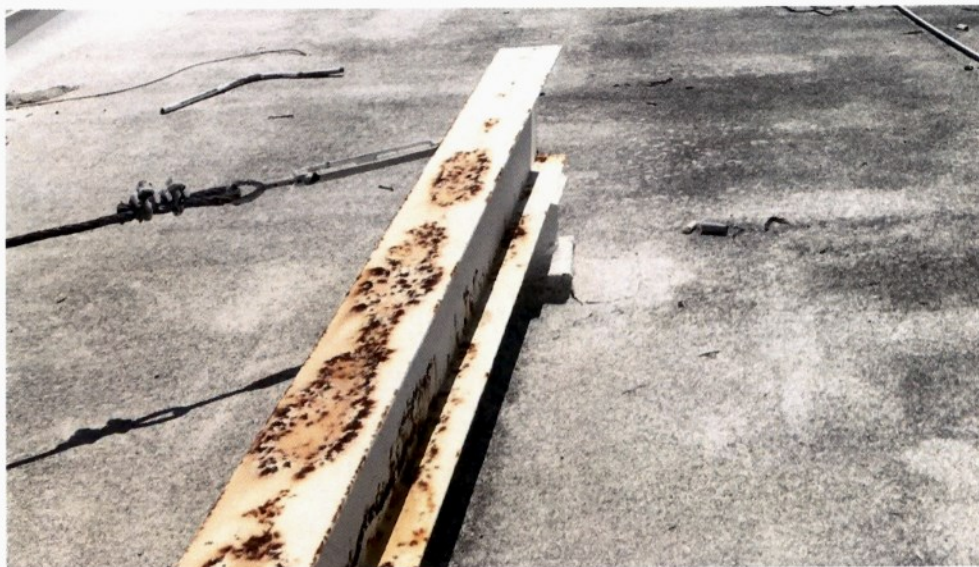
Photograph No. 20– Corroded Structural Steel Supporting Theater Sign

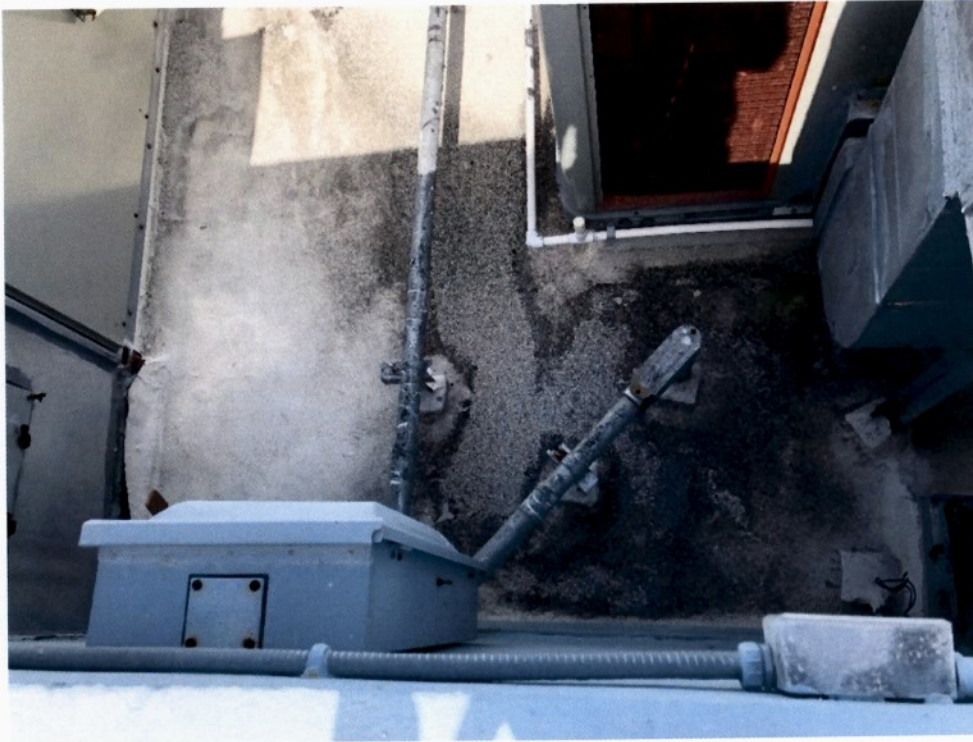
Photograph No. 23 – Deteriorated roofing at Eastern Lower Roof

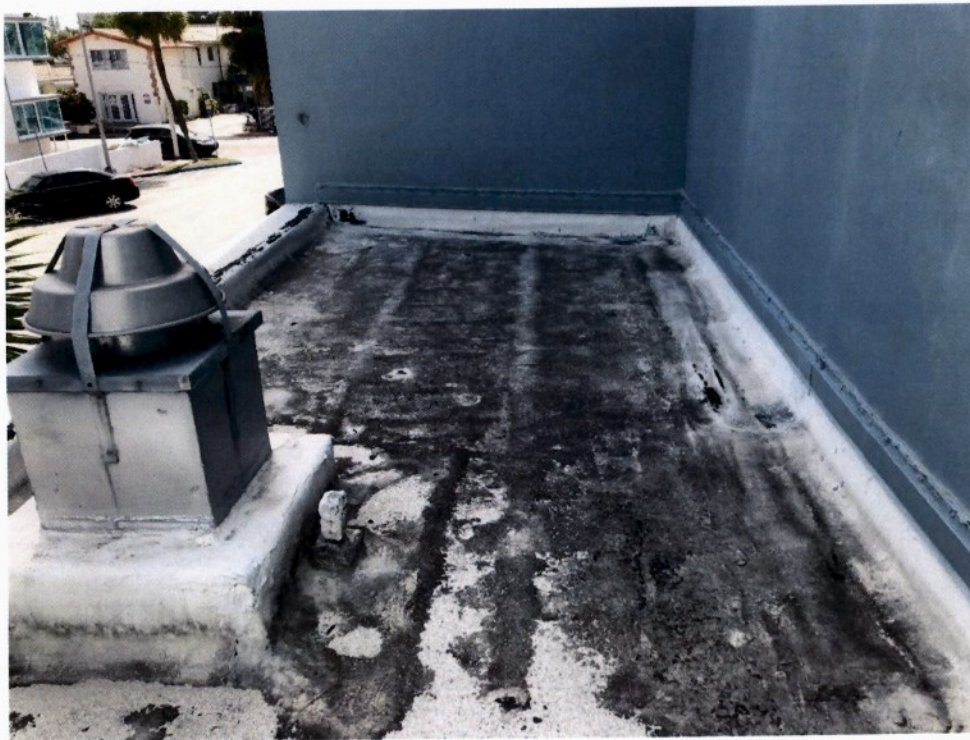
Photograph No. 24 – Deteriorated roofing at Lower Roof at the 2nd Floor towards South Façade

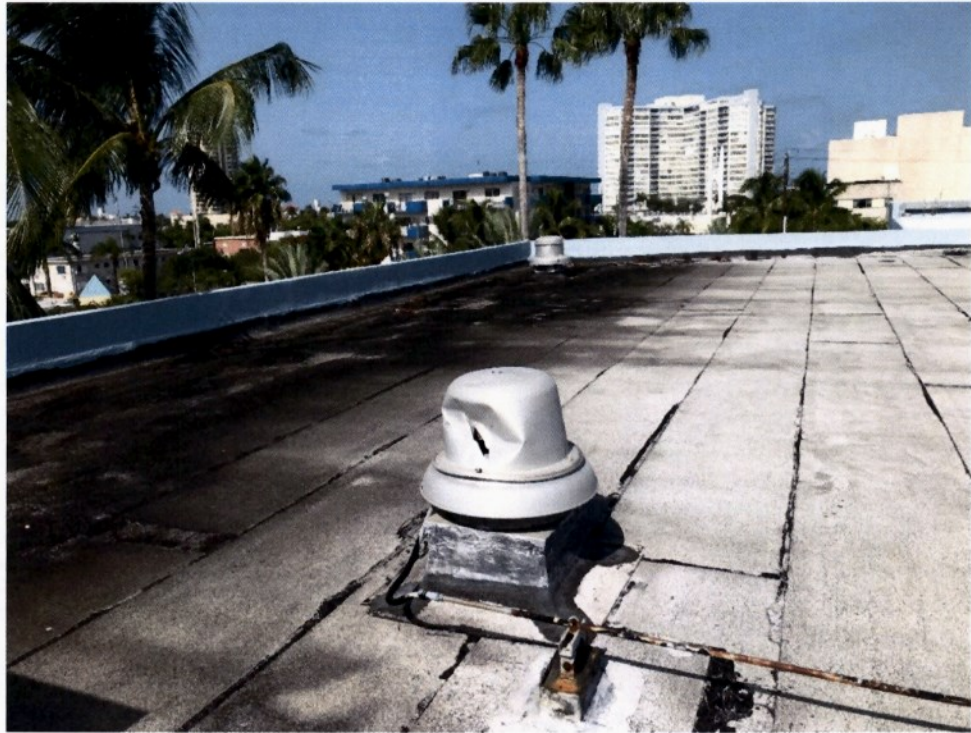
Photograph No. 25 – Deteriorated roofing at Western Upper Roof

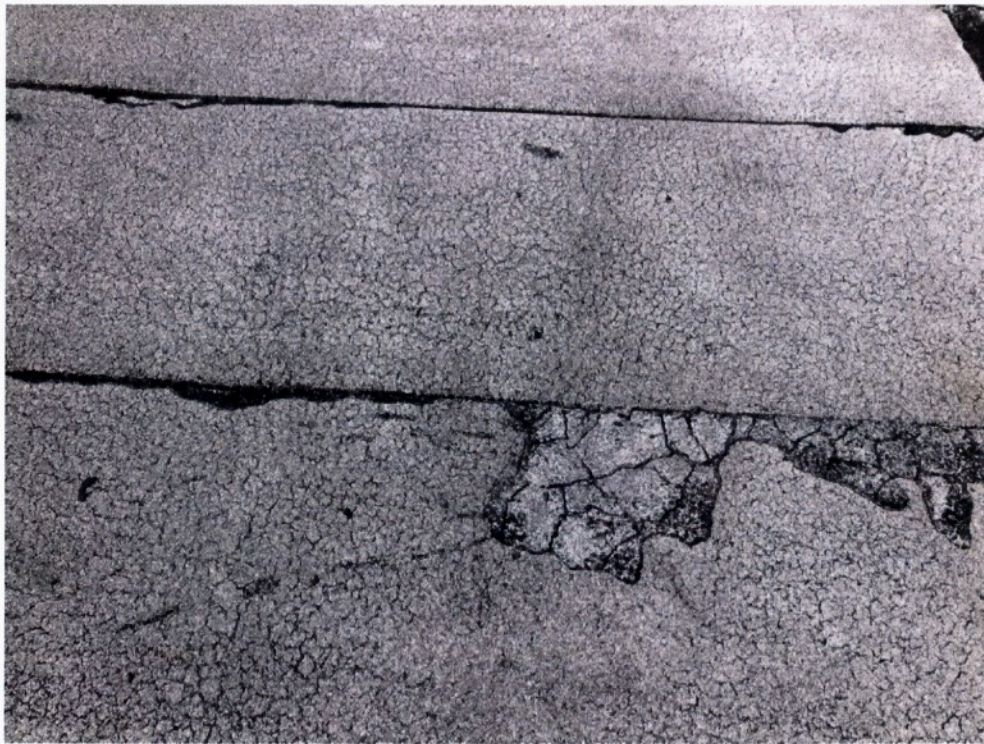
Photograph No. 26 – Deteriorated roofing at Western Upper Roof

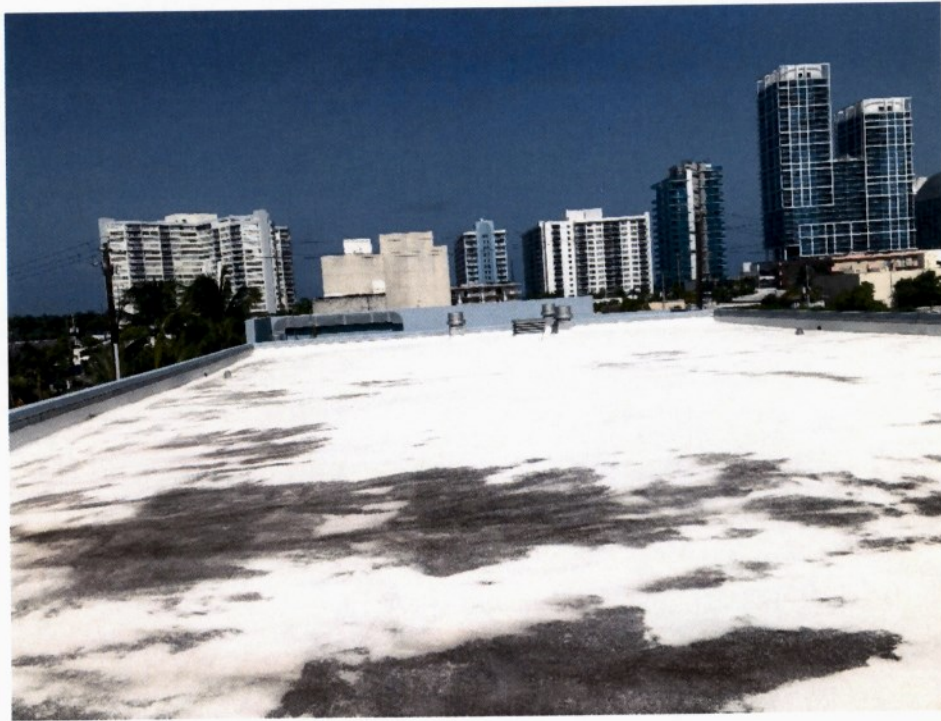
Photograph No. 27 – Deteriorated roofing at Western Upper Roof

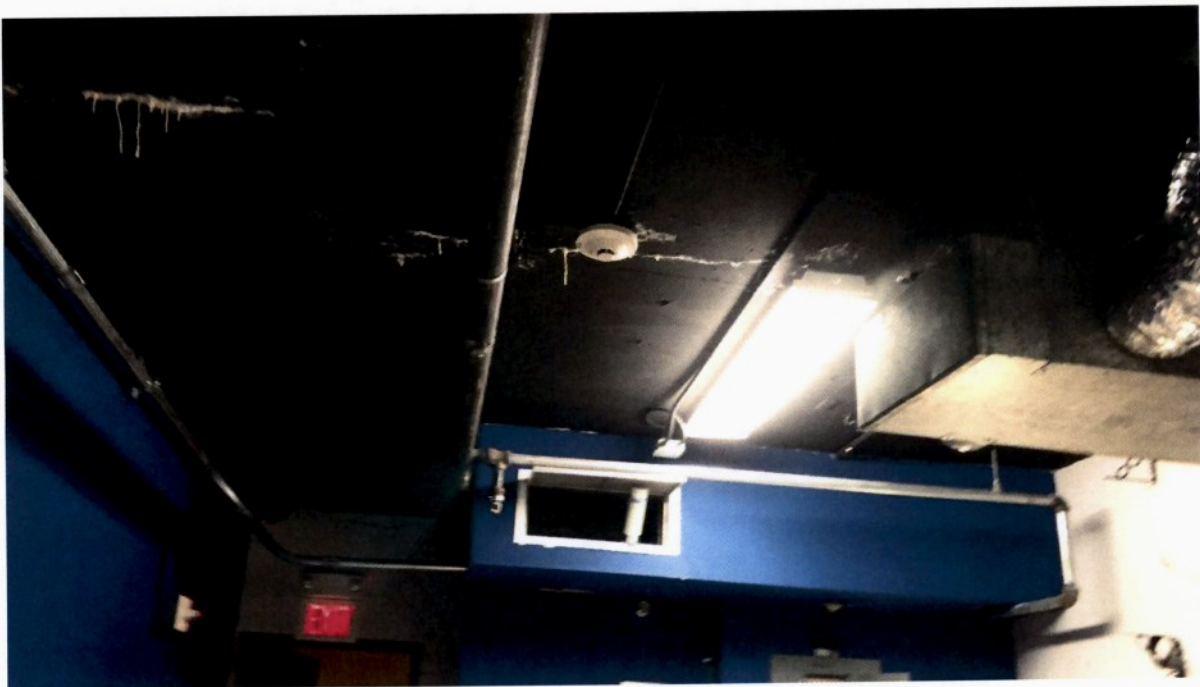
Photograph No. 28 – Efflorescence in Concrete Slab above Projection Room (East Side)

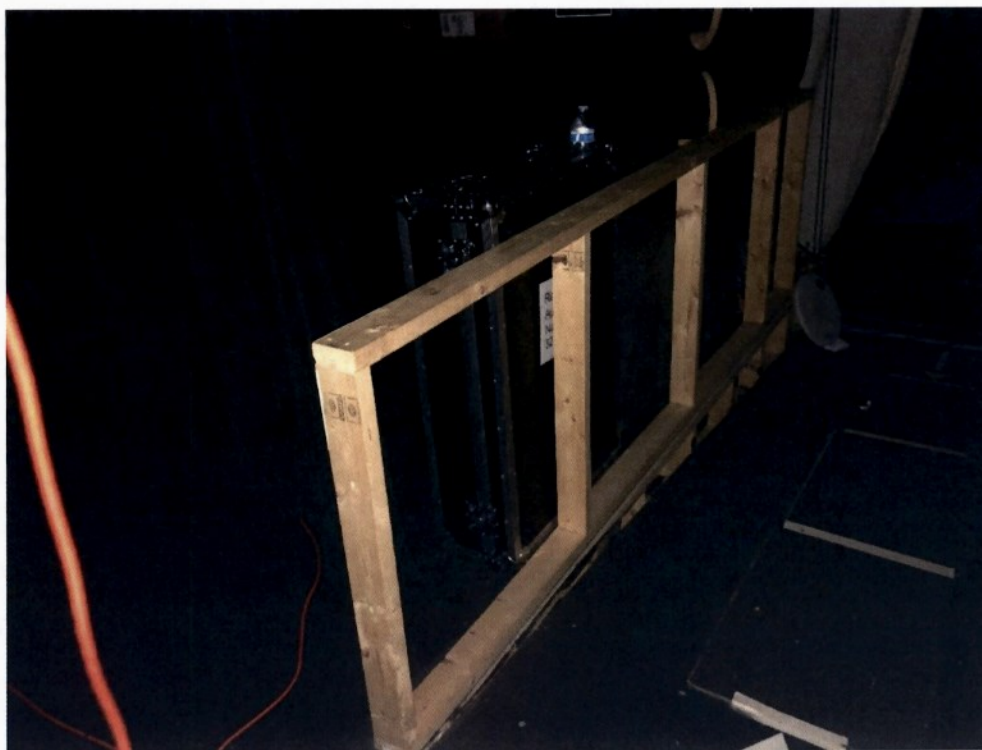
Photograph No. 37 – Loose Wooden Guardrail at East Cinema Theater

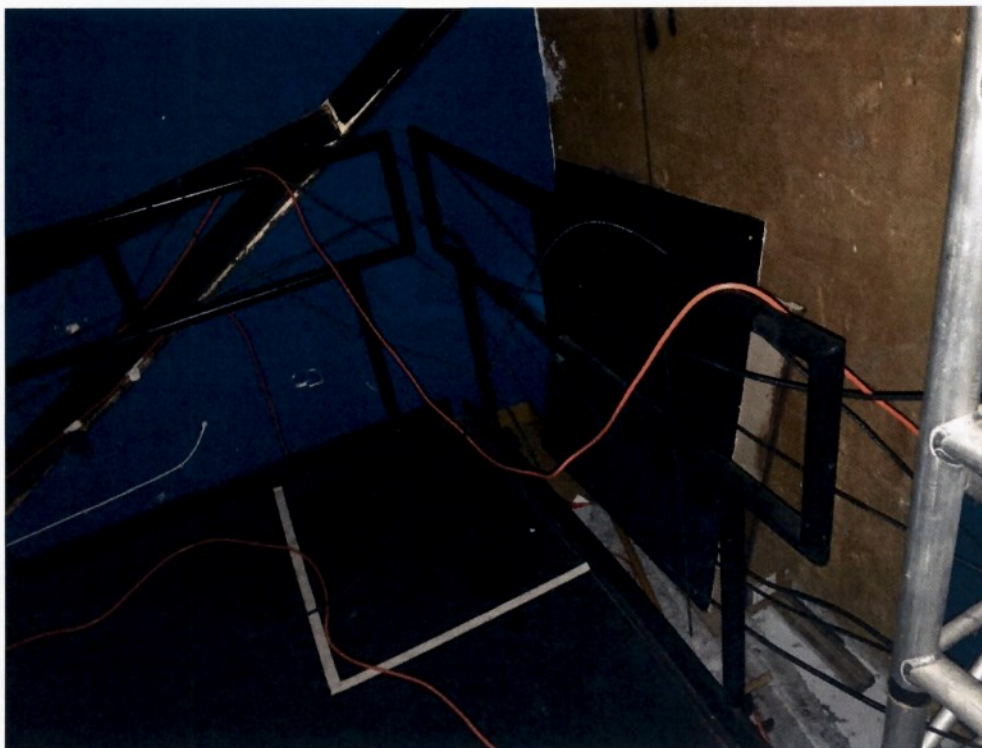
Photograph No. 38 – Loose Metal Guardrail at East Cinema Theater

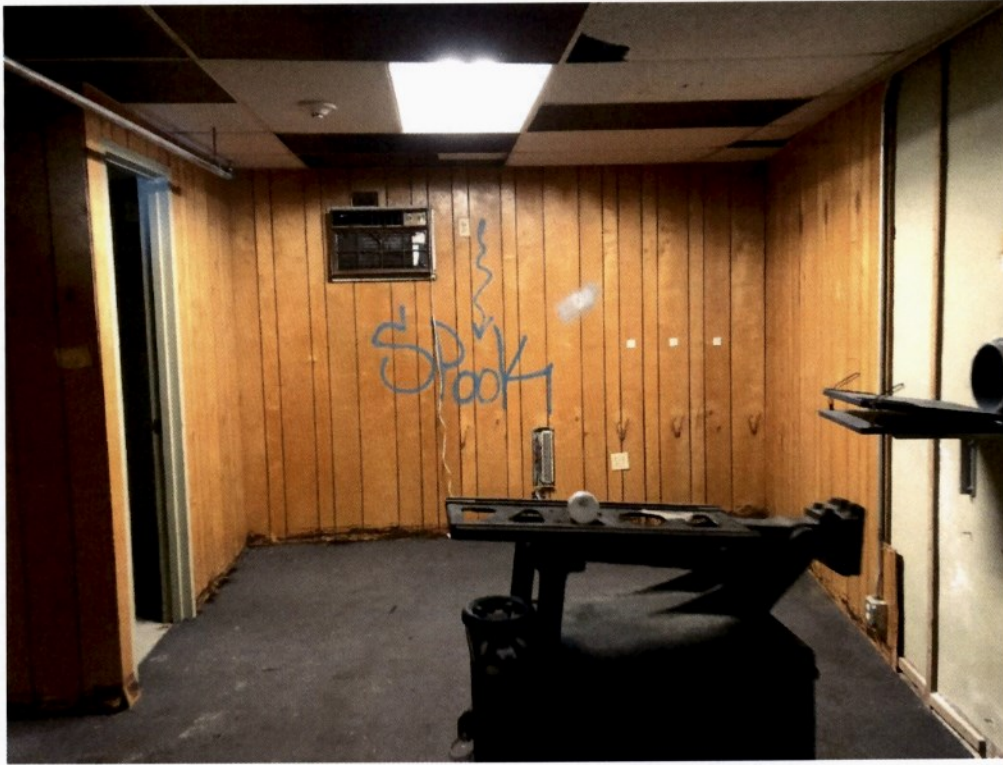
3. Paneling	Poor (see Photograph 39).
4. Paint only	Fair to poor
5. Other (describe)	N/A
i. Cracks	
1. Location – note beams, columns, other	Numerous narrow cracks throughout the exterior façades but not structurally significant.

Photograph No. 39 – Deteriorated Interior Wood Paneling in 2nd floor Room at the South End of Building (Between east and West Theaters).

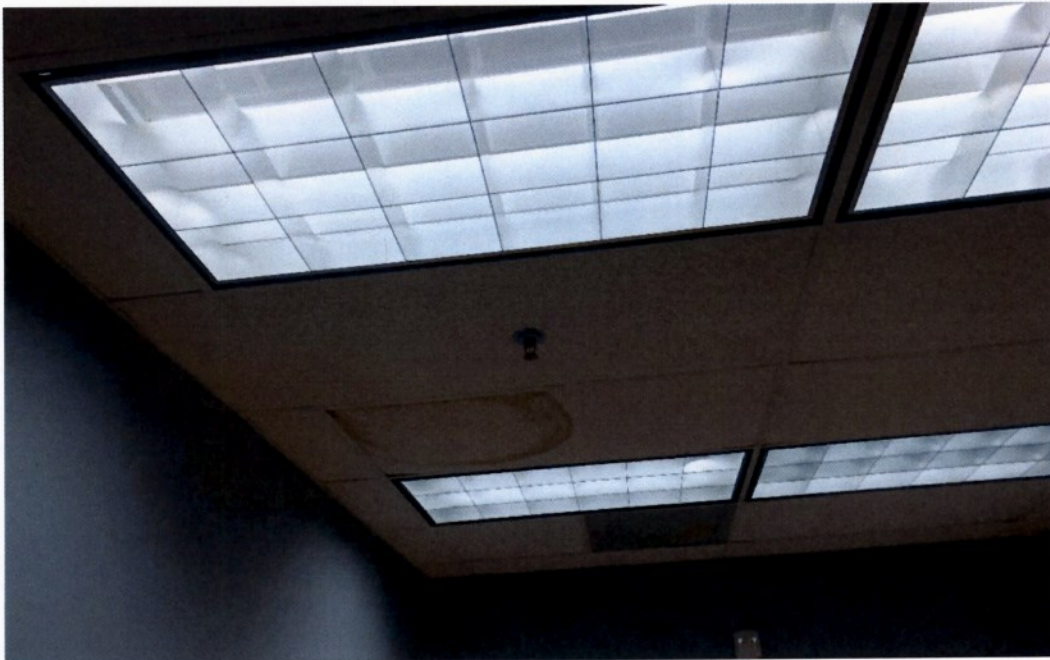
Photograph No. 40 – Stained Ceiling Tiles at Ceiling of First Level

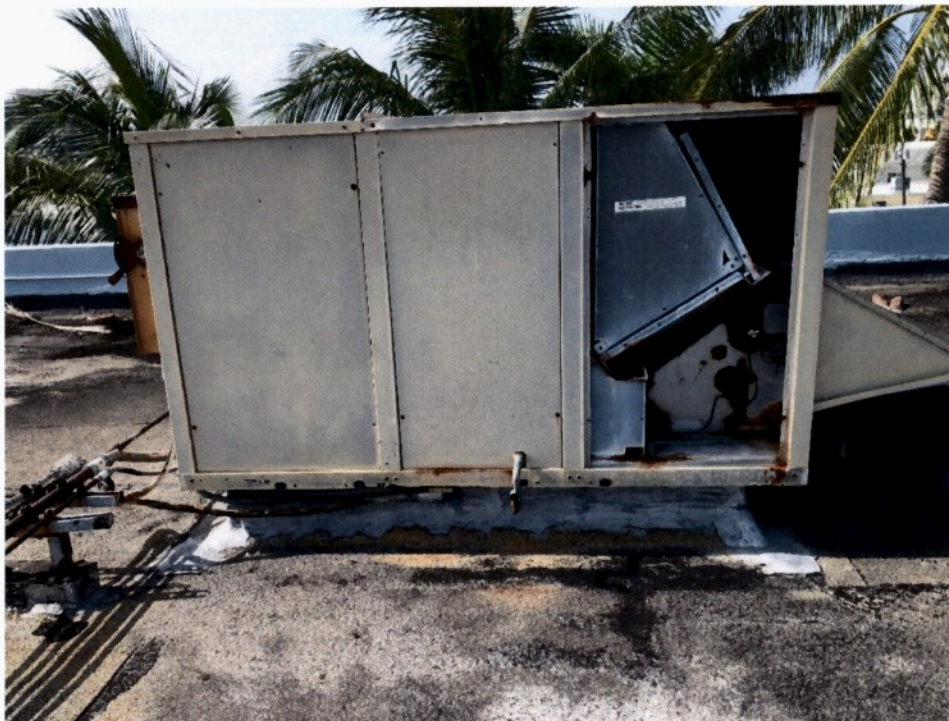
Photograph No. 64 – Package unit Unconnected to Roof Curb at Western Upper Roof

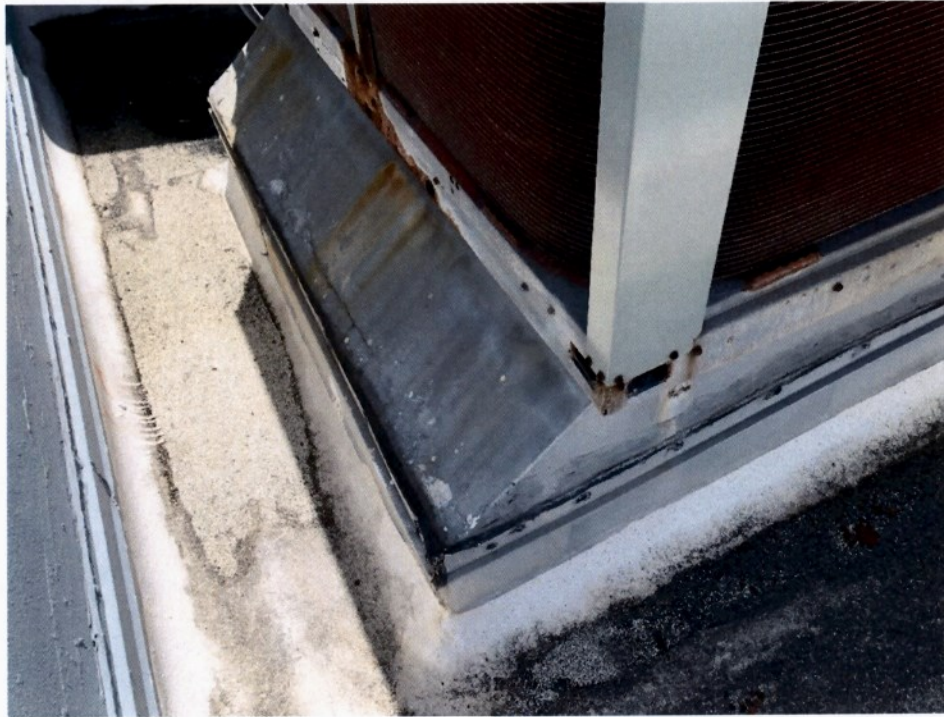
Photograph No. 65 – Package Unit Unconnected to Roof Curb at Low Roof between East and West Portions

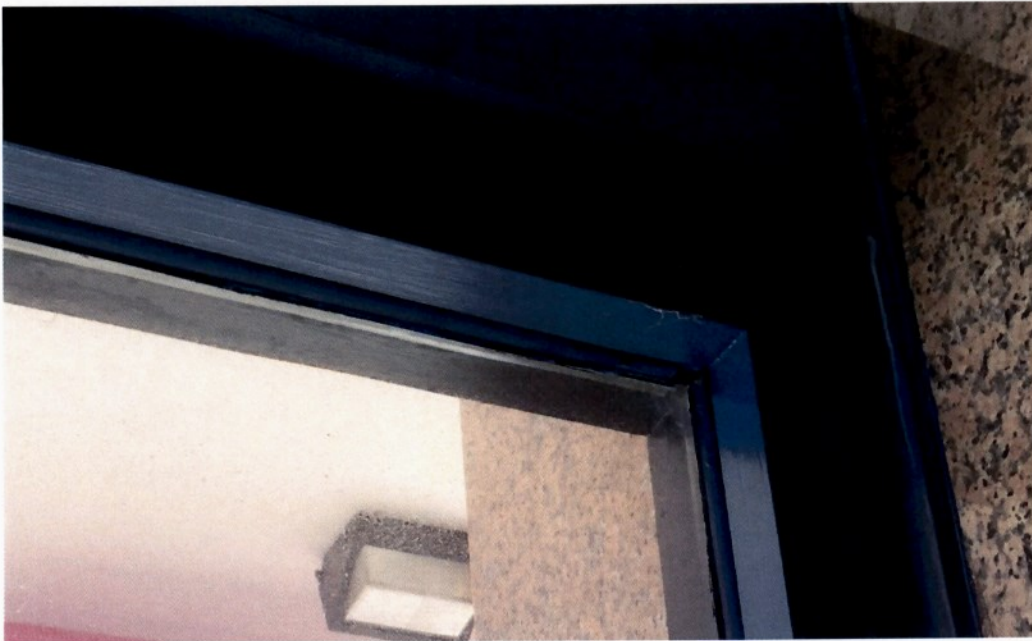
Photograph No. 74 – Missing Sealant at Corner of Fixed Window of North Façade

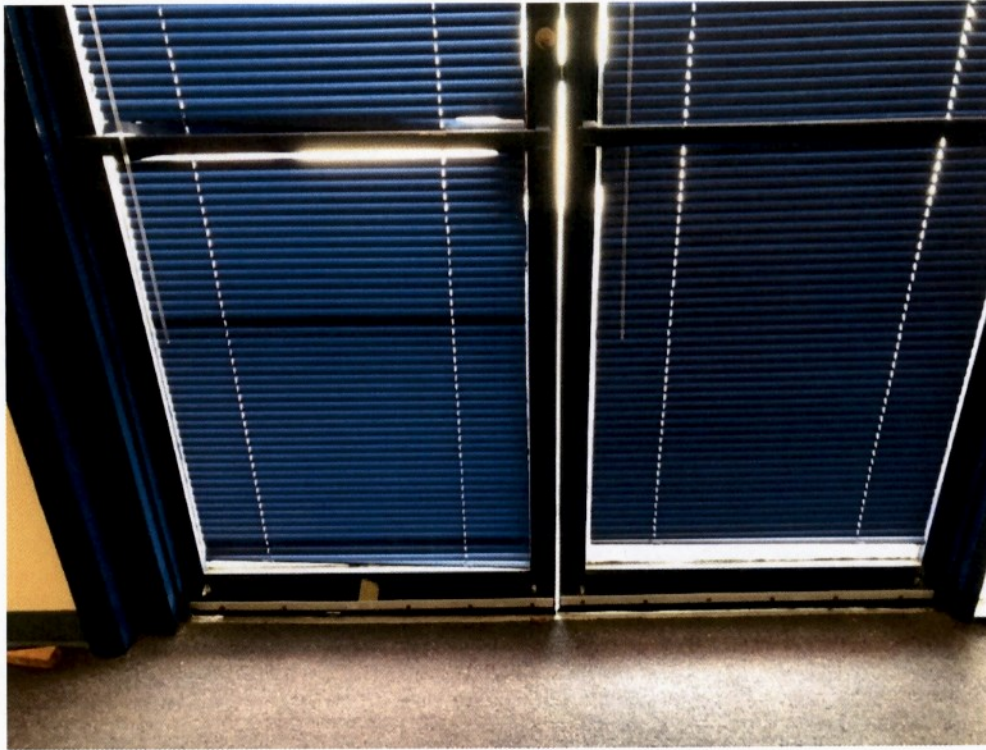
Photograph No. 75 – Considerable Gab between Pair of North Façade Doors

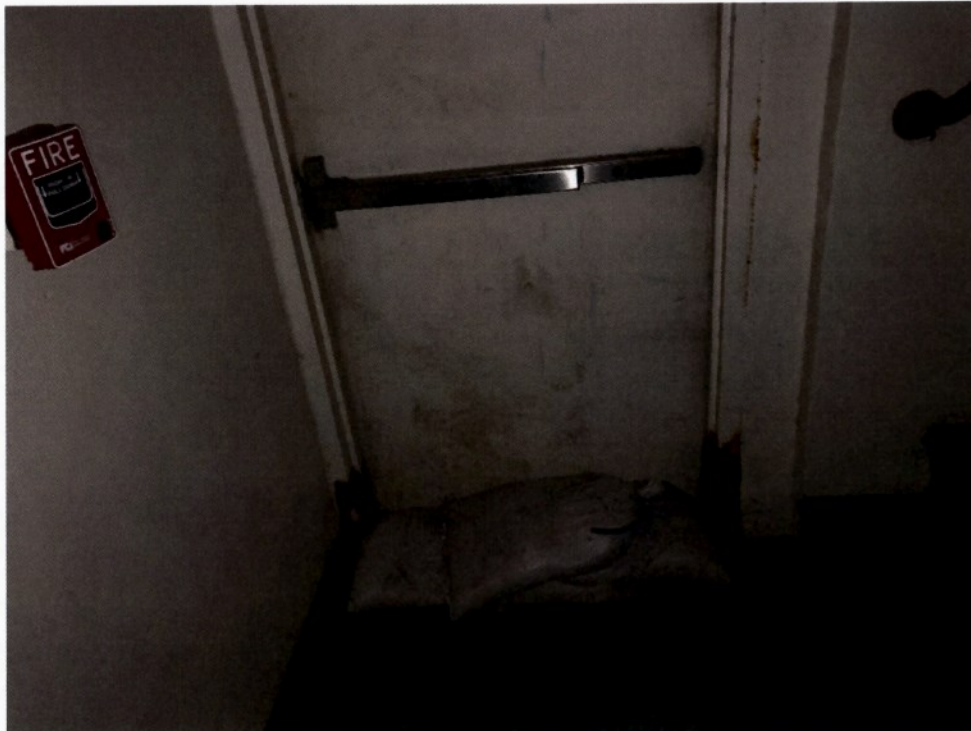
Photograph No. 76 – Corroded Exterior Door at Underground Electrical Room

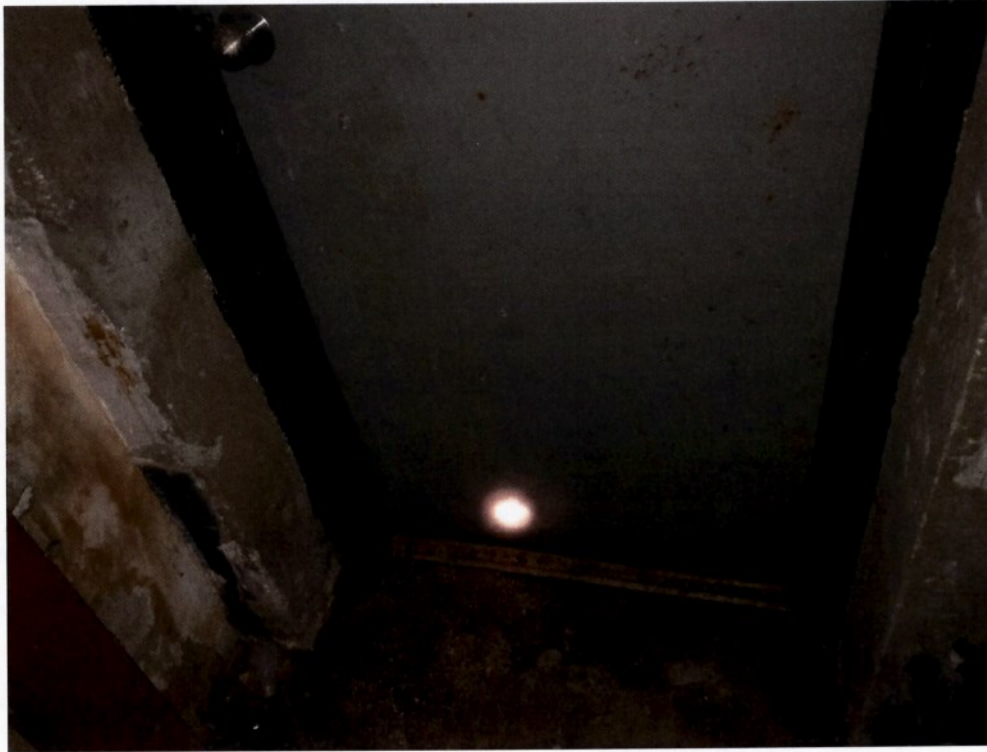
Photograph No. 77 – Lightly Corroded Exterior Door at Steel-framed Exit Staircase for Projection Room of West Cinema Theaters

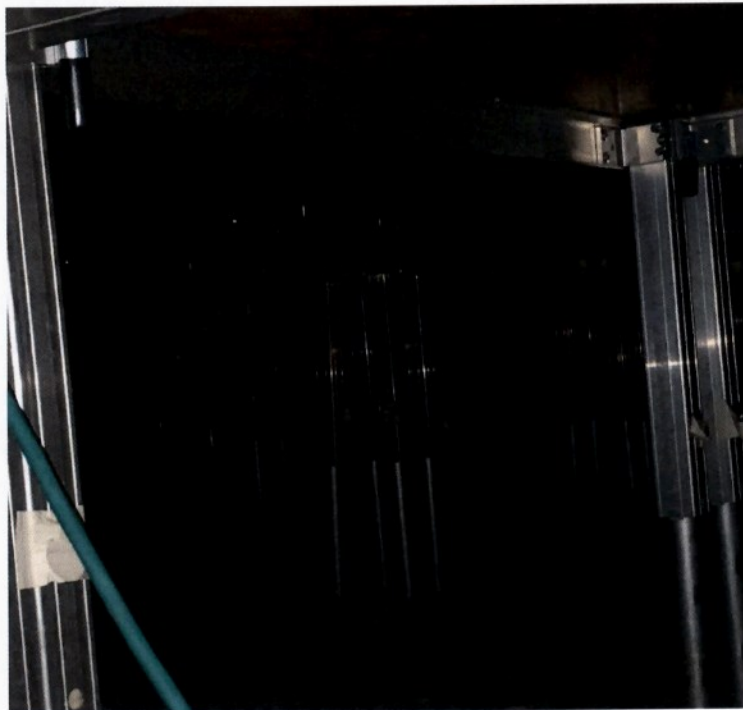
Photograph No. 78 – Crooked Leg of Stage's Aluminum-framed Platform

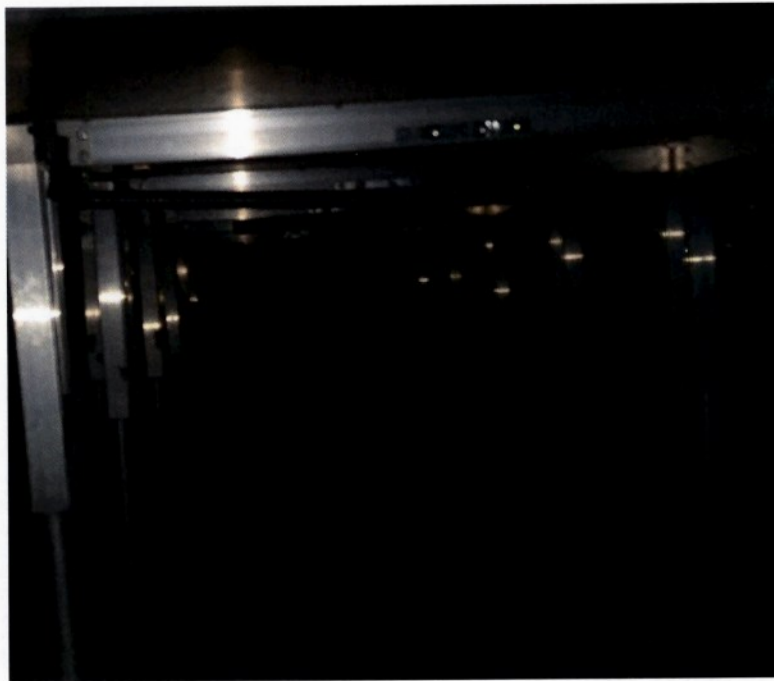
Photograph No. 83 – Loose C.M.U. blocks Supporting East Cinema Theater Platform
