**Reference: 50-Year Recertification
Byron Carlyle Theater
500 71 St., Miami Beach, Florida
Folio 02-3211-002-1070**

MINIMUM INSPECTION PROCEDURAL GUIDELINES FOR BUILDING RECERTIFICATION - STRUCTURAL

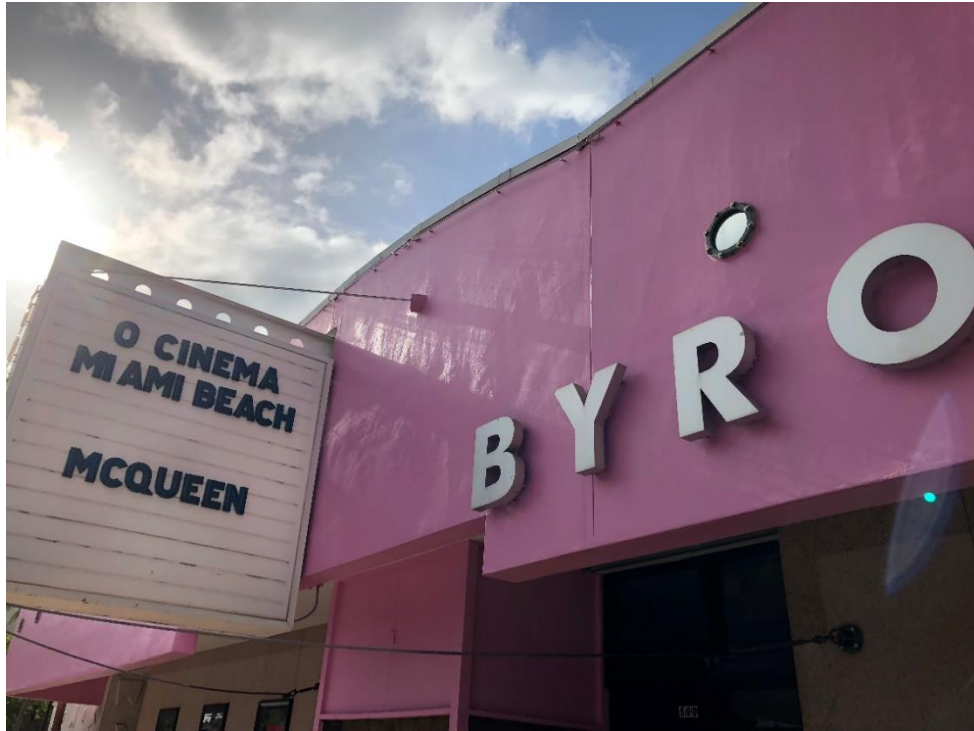
17) Cables providing lateral stability to the north façade's theater sign are loose (see Photograph 11).

Photograph No. 11 - Theater Sign at North Façade

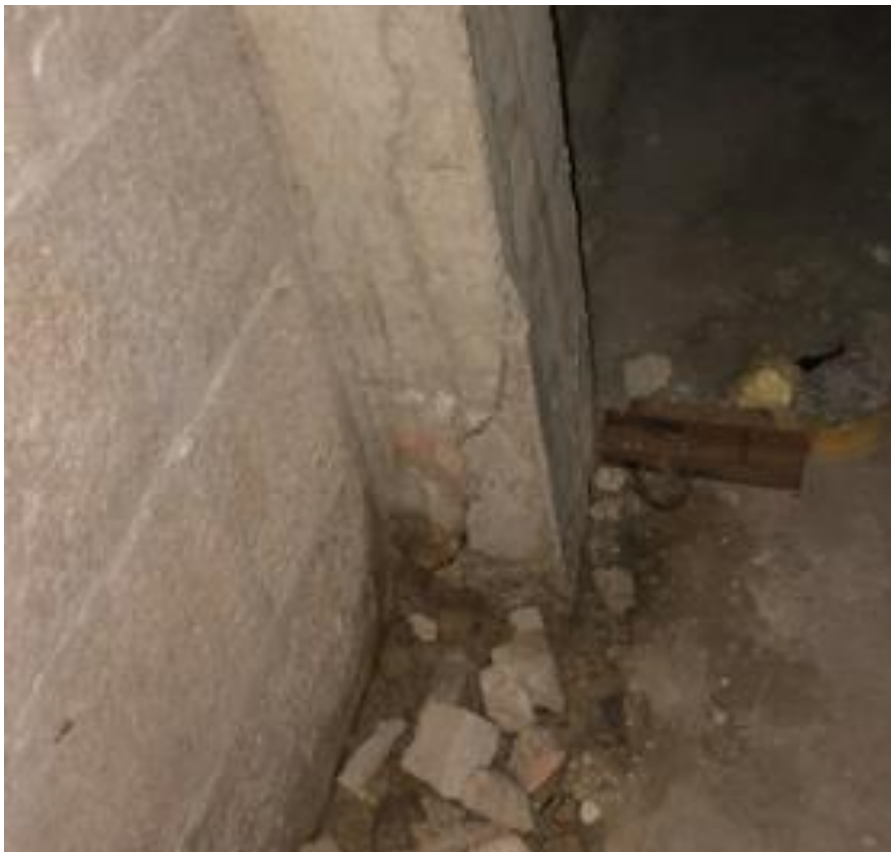
- 1) Concrete column located in hallway adjacent to the underground restrooms (at the west side) is spalled at the base (refer to Photograph 12).
- 2) Concrete slab above the electrical room at the ground floor (at corner of room, towards South facade) in between the east and west sides of the buildings is spalled (see Photograph 13).

Photograph No. 12 – Spalled Concrete Column at Underground Hall

- 2) Repair spall in concrete column located in hallway adjacent to the underground restrooms (at the west side) (refer to Section 2.b.1).
- 3) Repair spall in concrete slab above electrical room at the ground floor (refer to Section 2.b.2).

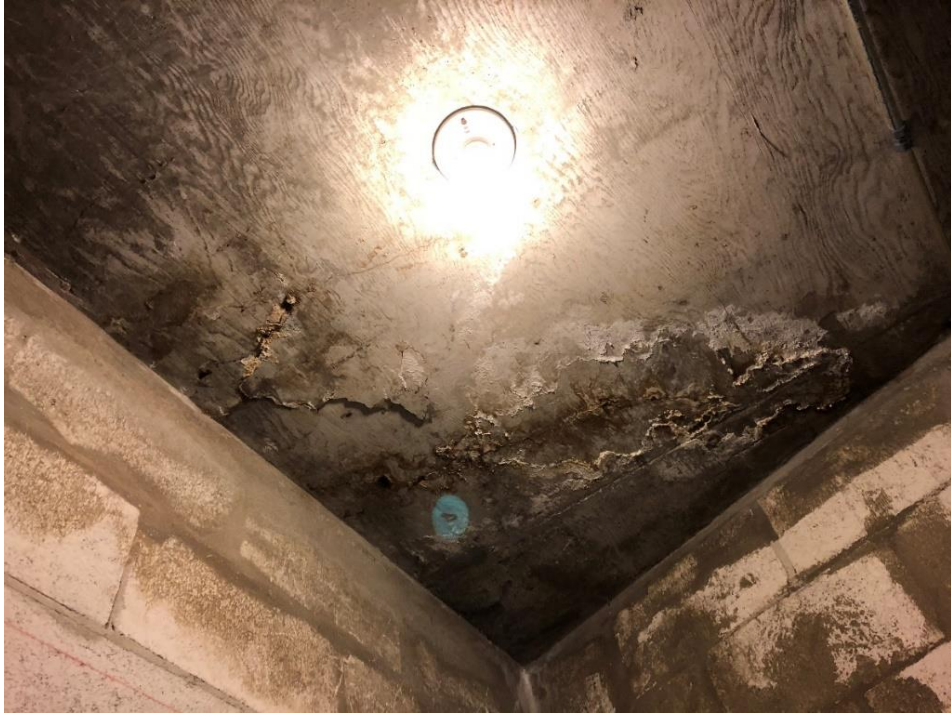
Photograph No. 13 – Spalled Concrete Slab above Electrical Room at Ground Floor

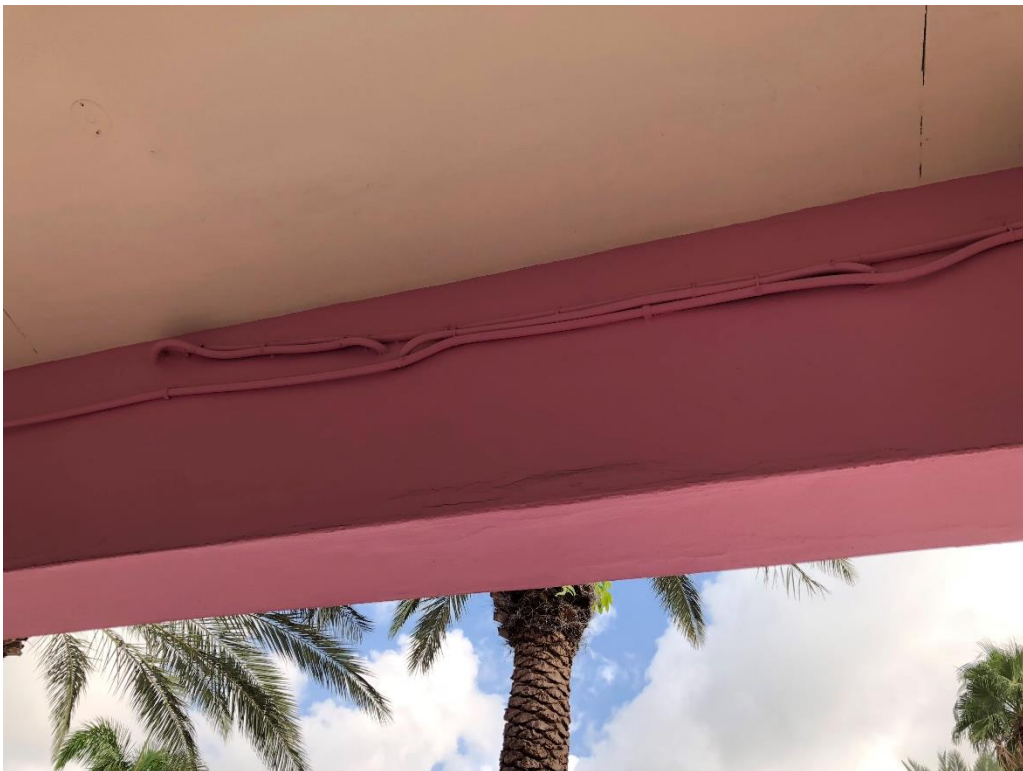
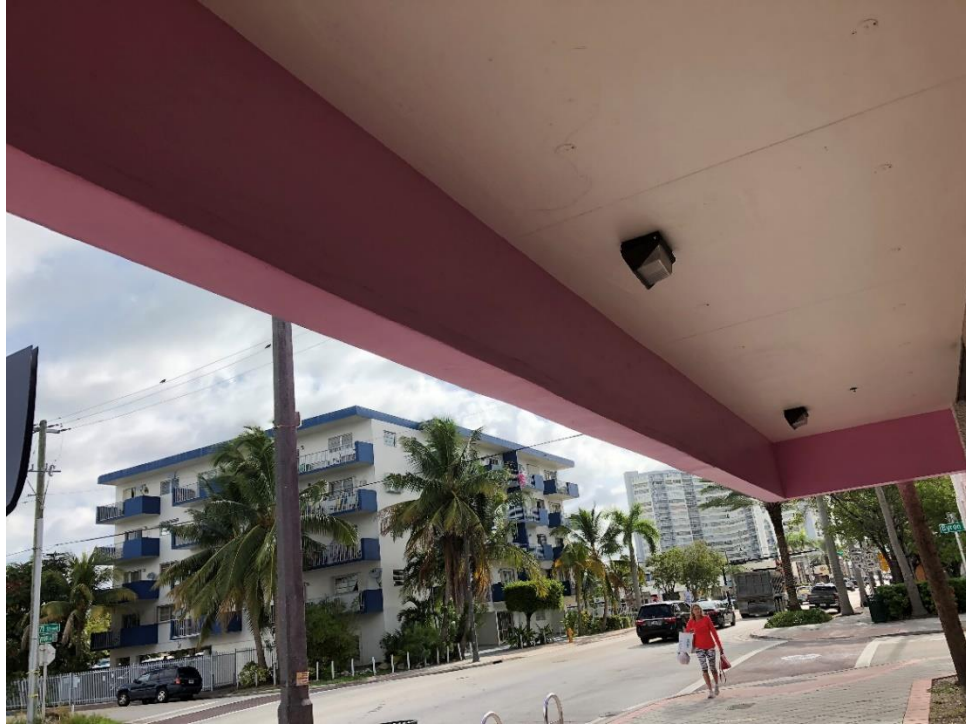
- 3) Exterior concrete beams at the north facade of the building are spalled at the bottom (see Photographs 14 and 15).
- 4) 2nd floor concrete slab in the south façade of the building (towards the center, above the men's restroom) has a large opening (about 9" in diameter) (refer to Photograph 16). Exposed reinforcement is observed at the perimeter of the opening as well as perpendicular narrow cracks. Additionally, a water tank seems to be bearing above this opening.

Photograph No. 14 – Spalled Exterior Concrete Beam at North Façade

Photograph No. 15 – Spalled Exterior Concrete Beam at North Façade

- 4) Repair spalled exterior concrete beams (refer to Section 2.b.3).
- 5) Reduce opening size in concrete slab above first floor men's restrooms (refer to Section 2.b.4) by drilling and setting dowels in epoxy and casting grout or concrete. Repair any existing cracks perpendicular to the opening.

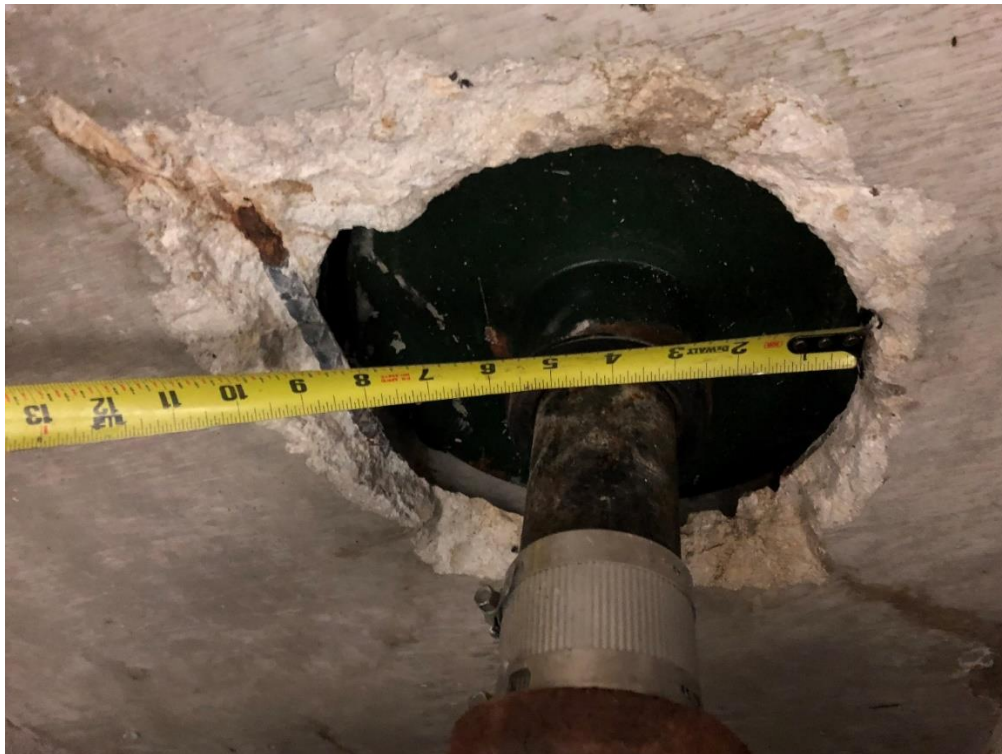
Photograph No. 16 – Opening in Slab above Men's Restroom (near South Façade)

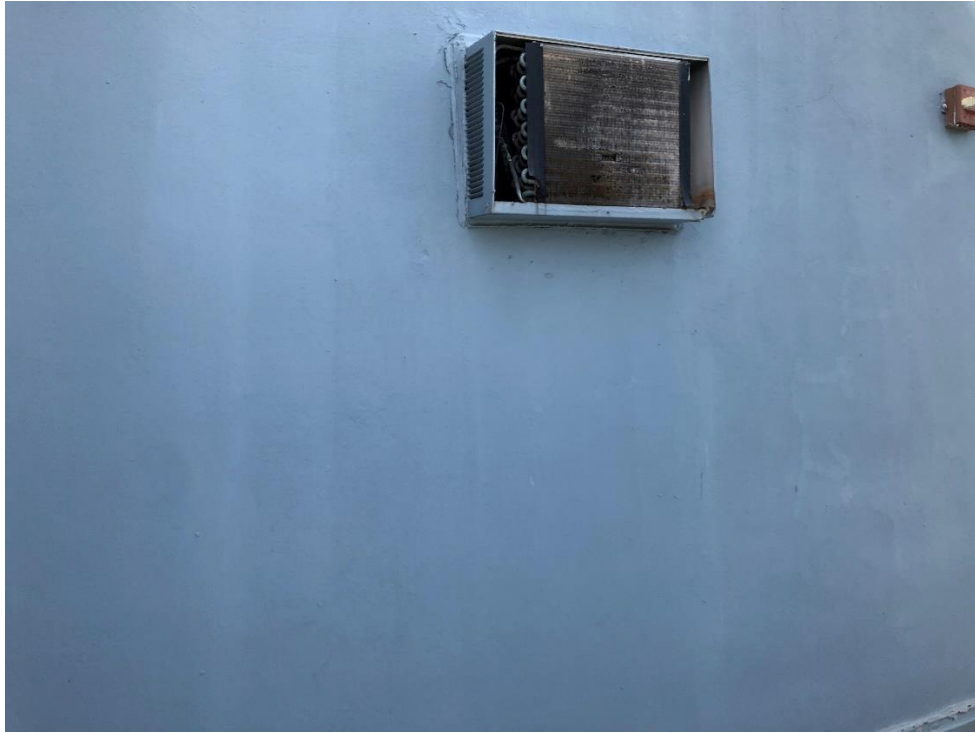
19) Air conditioning unit in 2nd floor room at south end of the building, in between the east and west theaters, lacks exterior cover (see Photograph 17). This can potentially allow water intrusion and accelerate deterioration of adjacent concrete members (i.e. concrete spalling and corrosion).

Photograph No. 17 – Uncovered Air Conditioning Unit in 2nd floor Room at the South End of Building (Between east and West Theaters).

- 23) Provide exterior cover to air conditioning unit in 2nd floor room at south end of the building, in between the east and west theaters, to prevent moisture intrusion (refer to Section 2.b.19.)

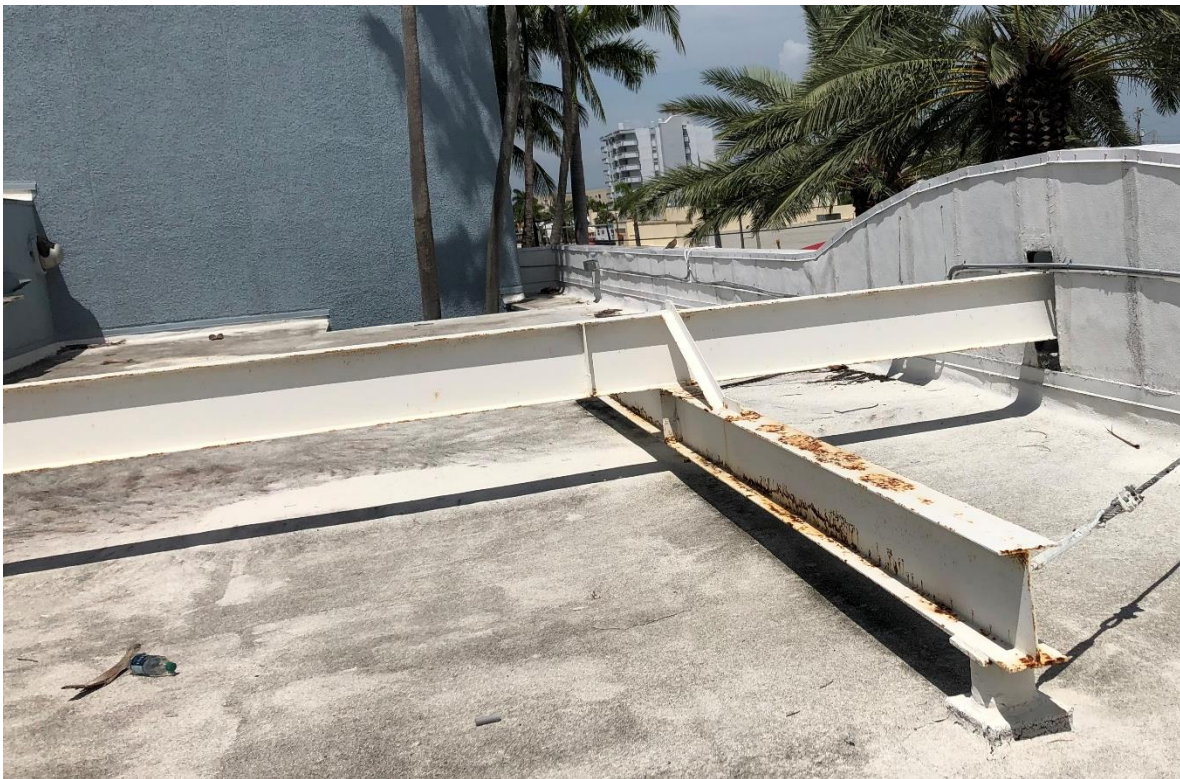
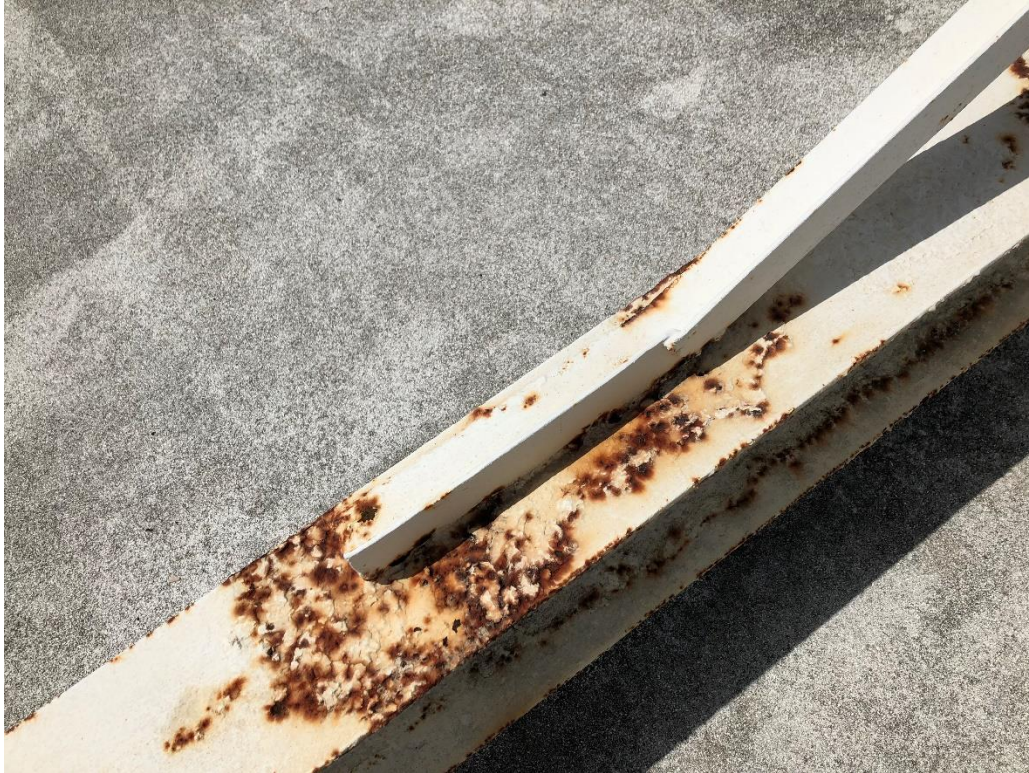
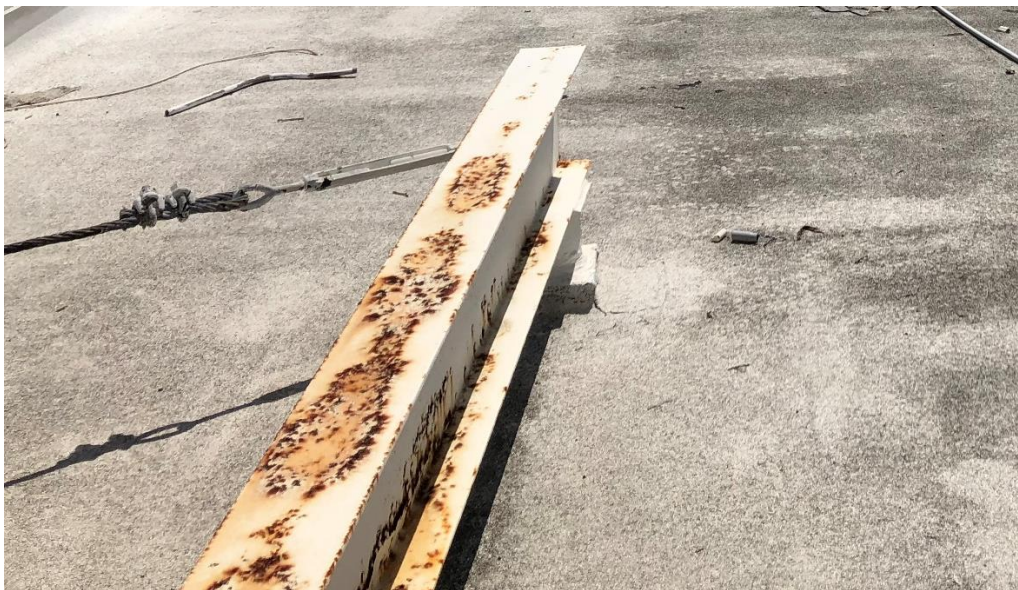
b. Exposed Steel- describe condition of paint and degree of corrosion
Structural steel assembly at the second level (at the north facade) is exposed to the elements and mildly corroded (see Photographs 18, 19, and 20). Due to the corrosion, paint has, of course, deteriorated.
c. Concrete or other fireproofing – note any cracking or spalling and note where any covering was removed for inspection
No fireproofing was observed in the structural steel framing.
d. Elevator sheave beams and connections, and machine floor beams – note condition:
There is no elevator in this building.

5) ... façade) is mildly corroded (see Photographs 18, 19, and 20).

Photograph No. 18 – Corroded Structural Steel Supporting Theater Sign

Photograph No. 19 – Corroded Structural Steel Supporting Theater Sign

Photograph No. 20– Corroded Structural Steel Supporting Theater Sign

- 6) Clean and remove all corrosion from structural steel supporting the theater sign (refer to Section 2.b.5). Afterwards, coat the steel with a corrosion inhibiting paint system.

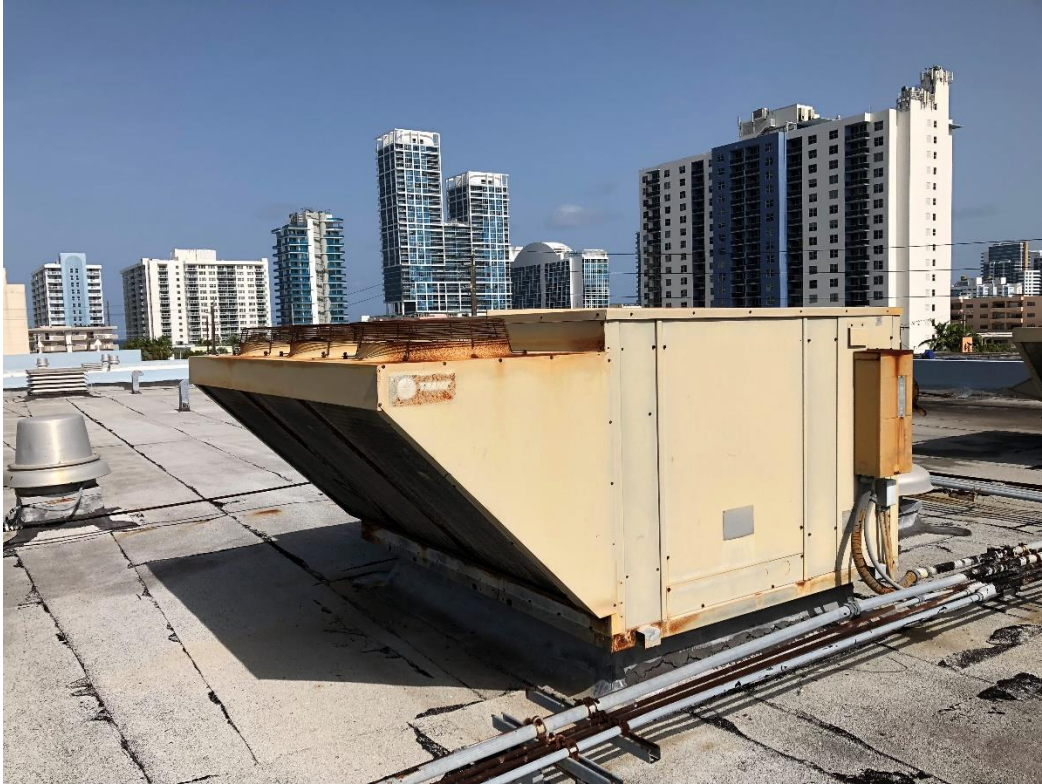
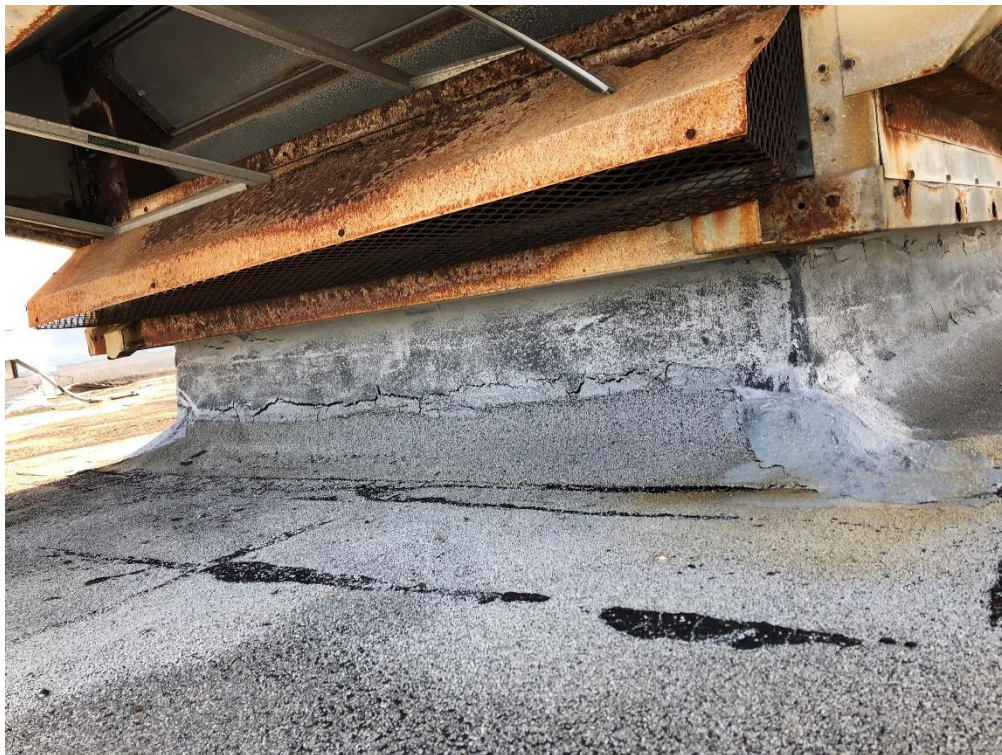
6) Rooftop A/C package units at western upper roof are mildly corroded (see Photographs 21 and 22).

Photograph No. 21 - Rooftop Package Unit at Western Upper Roof

Photograph No. 22 - Rooftop Package Unit at Western Upper Roof

- 7) If western upper roof A/C units will not be replaced, clean and remove all corrosion and coat with a corrosion-inhibiting paint system (refer to Section 2.b.6).

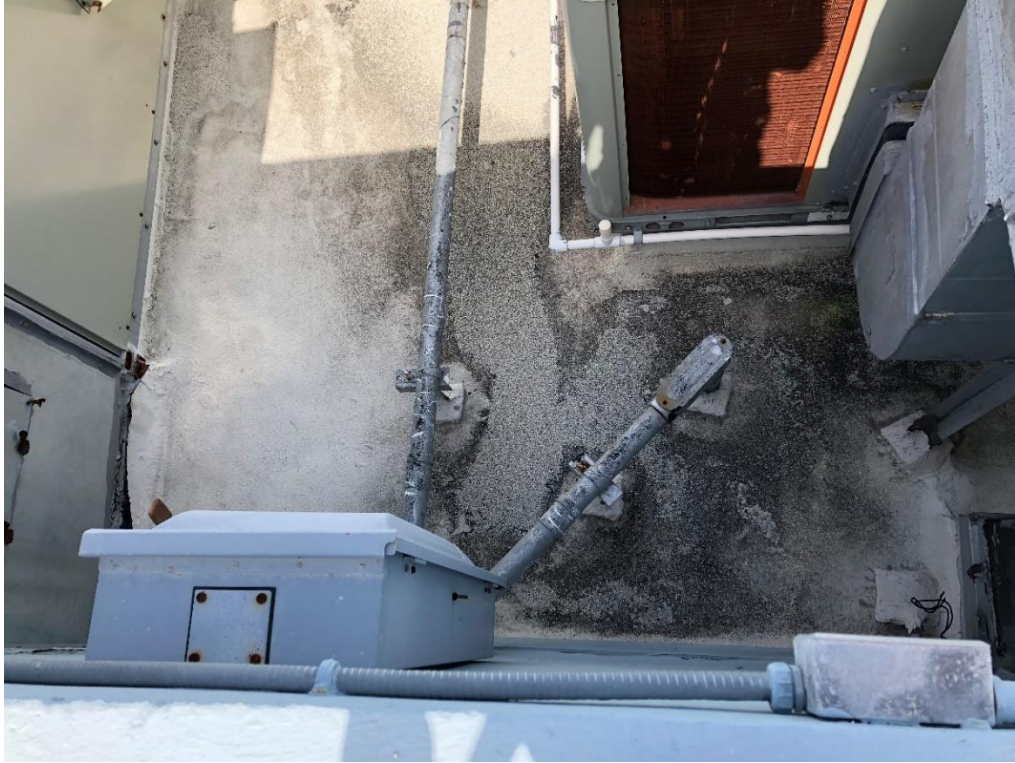
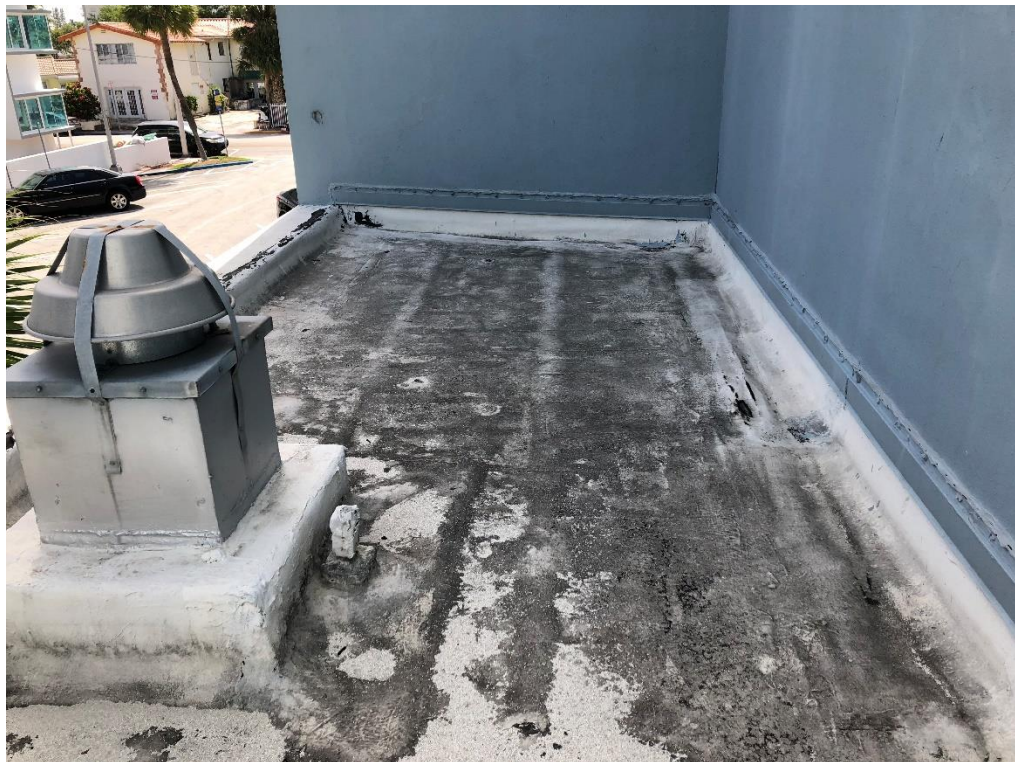
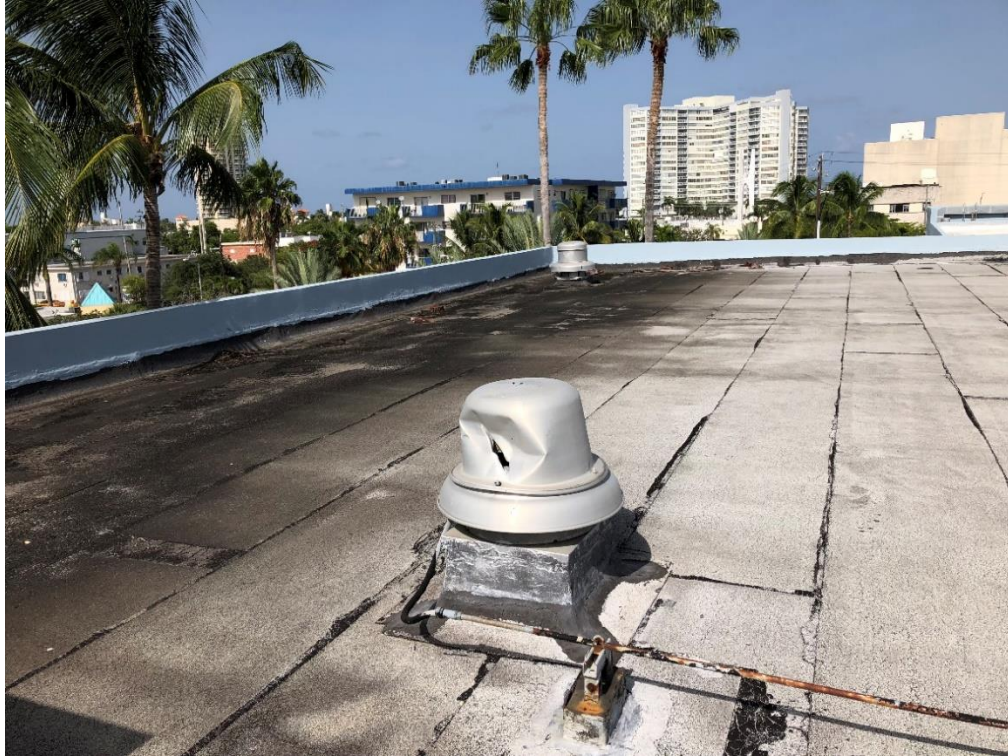
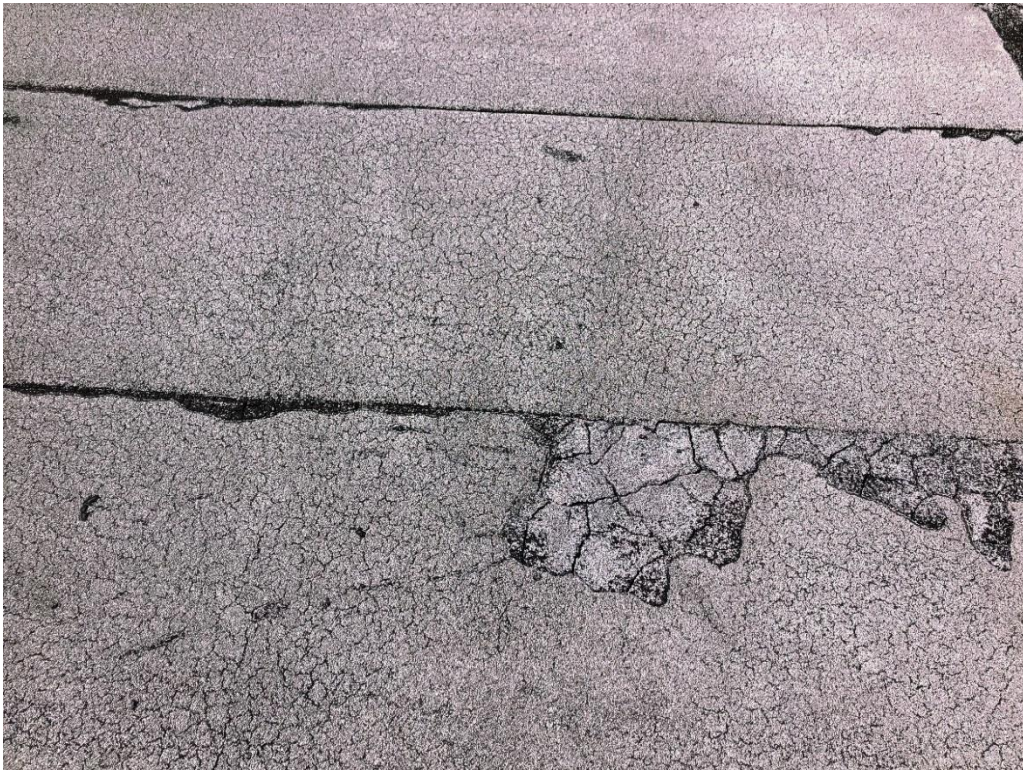
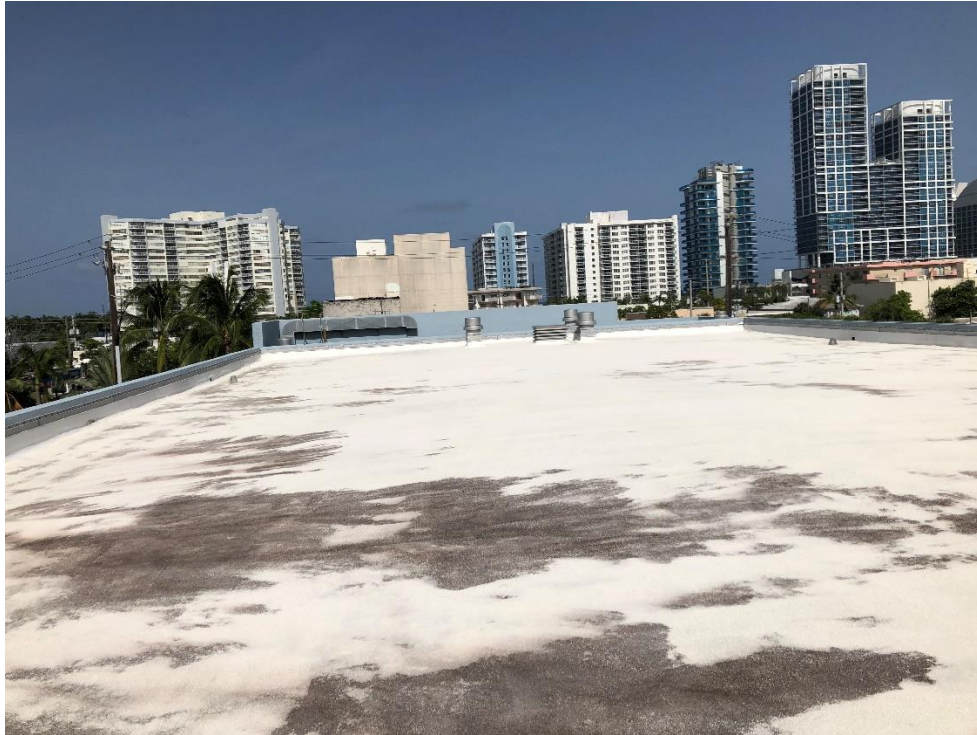
Photograph 56). The roofing over the two upper roofs and five lower roofs consists of built-up roofing systems. The roofing systems over all upper roofs and lower roofs are old and in need of maintenance (see photographs 23-27 and 57-59). No active water leaks were observed.

Photograph No. 23 – Deteriorated roofing at Eastern Lower Roof

Photograph No. 24 – Deteriorated roofing at Lower Roof at the 2nd Floor towards South Façade

Photograph No. 25 – Deteriorated roofing at Western Upper Roof

Photograph No. 26 – Deteriorated roofing at Western Upper Roof

Photograph No. 27 – Deteriorated roofing at Western Upper Roof

- 8) Provide maintenance to the roofing systems of the upper and lower roofs (refer to Section 2.b.7).
- 9) Remove efflorescence stains in concrete slab above projection room of cinema in eastern portion of the building and repair cracks (refer to Section 2.b.8).

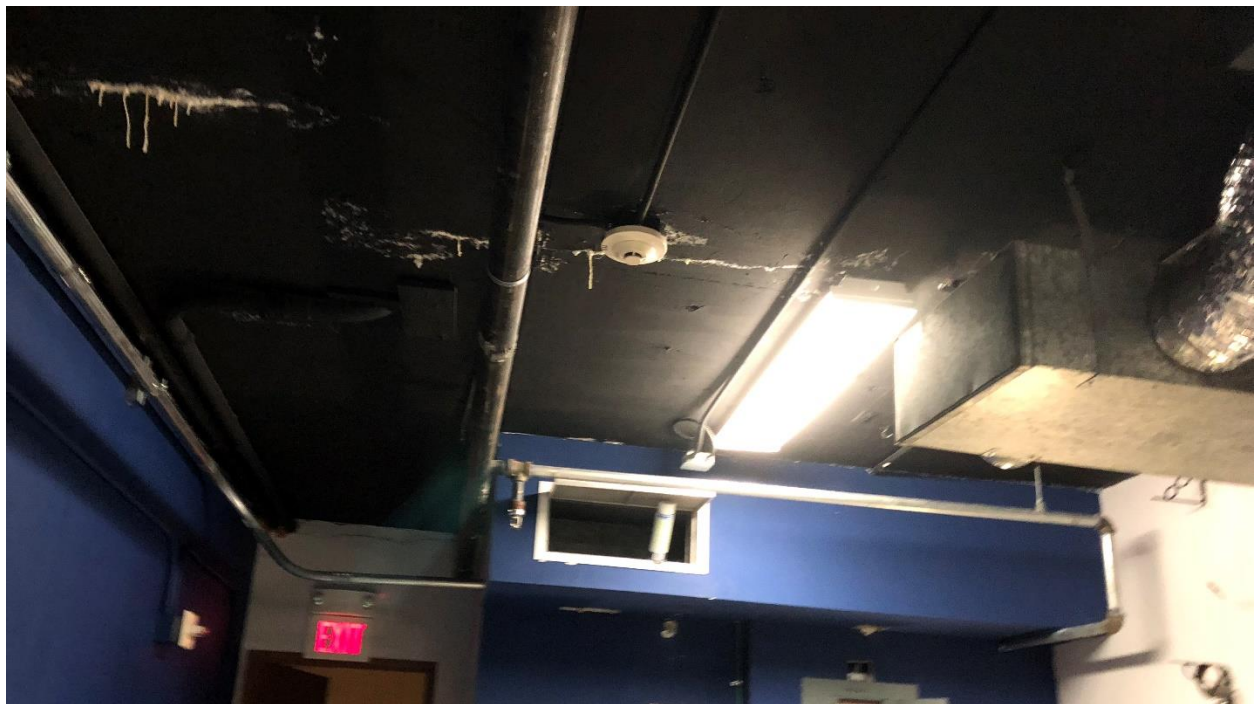
8) Efflorescence was observed below the low roof slab located above projection room of cinema theater in the eastern portion of the building through cracks in the slab (see Photograph 28). This is likely the consequence of roof leakage. This may have been a previous leak.

Photograph No. 28 – Efflorescence in Concrete Slab above Projection Room (East Side)

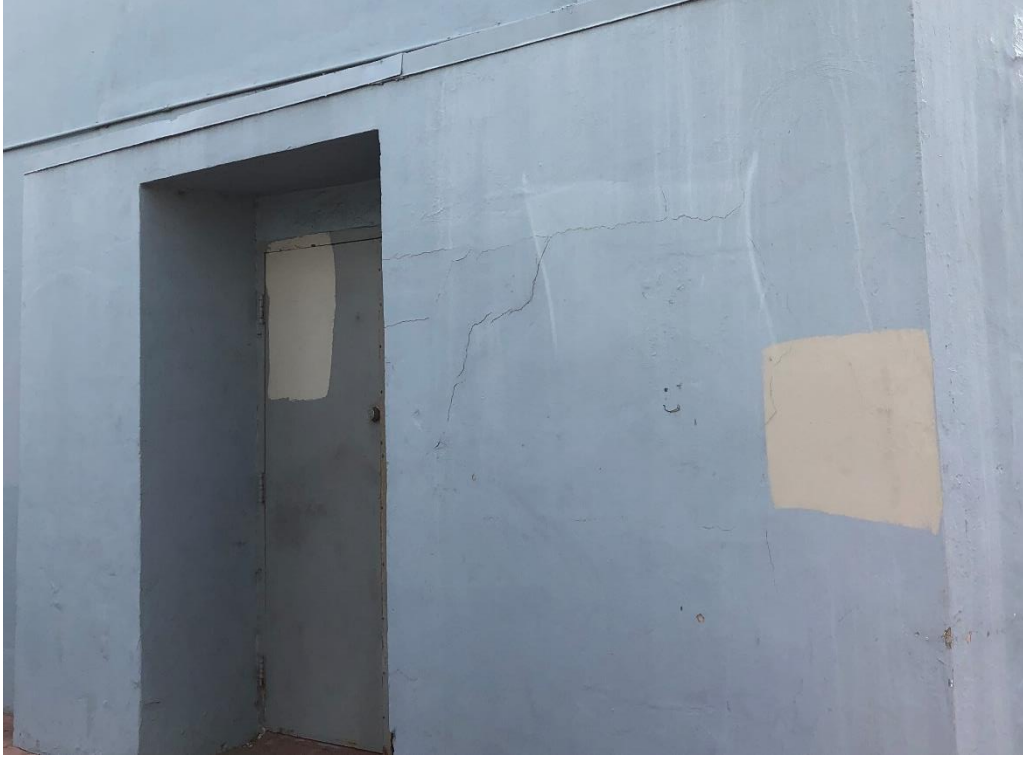
Photograph No. 31

12) Wall at northwest corner is cracked (see Photograph 31).

- 12) Seal gap between the exterior tile at the northeast corner of the building to prevent moisture intrusion (refer to Section 2.b.11).
- 13) Repair cracks in concrete wall at the northwest corner of the building (refer to Section 2.b.12).

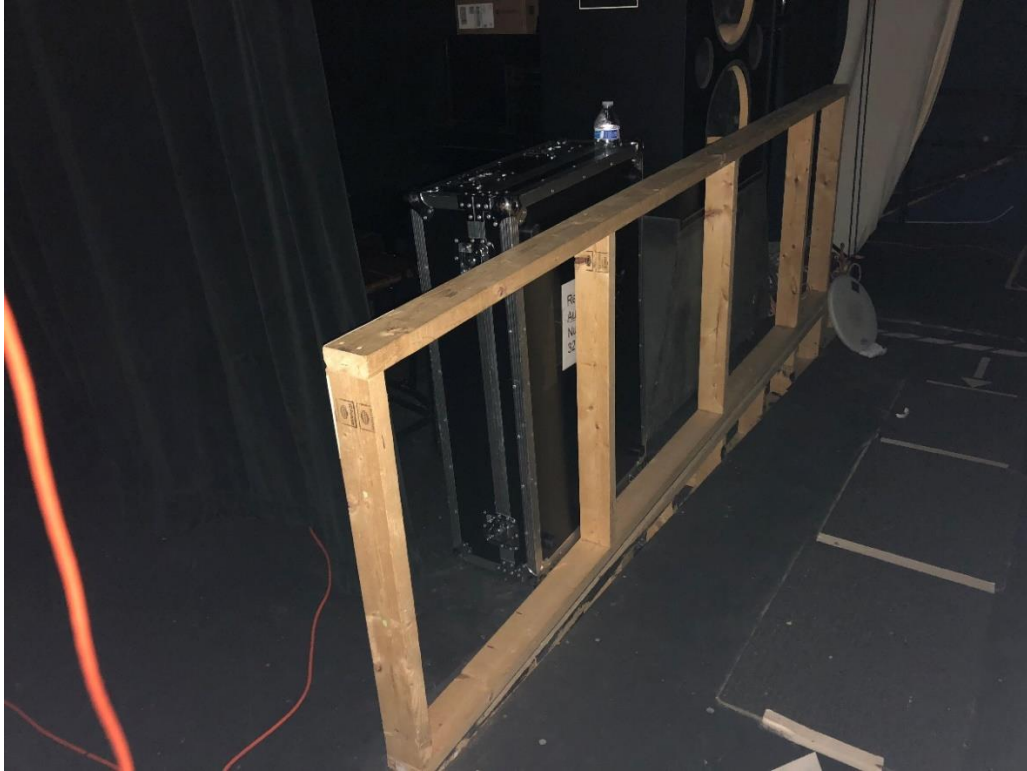
16) Existing wooden guardrail next to the access ramp in the northwest corner of the stage is loose (see Photograph 37). Existing metal railing at the northwest corner of the stage area (at the exit ramp to the dressing rooms) is also loose (see Photograph 38).

Photograph No. 37 – Loose Wooden Guardrail at East Cinema Theater

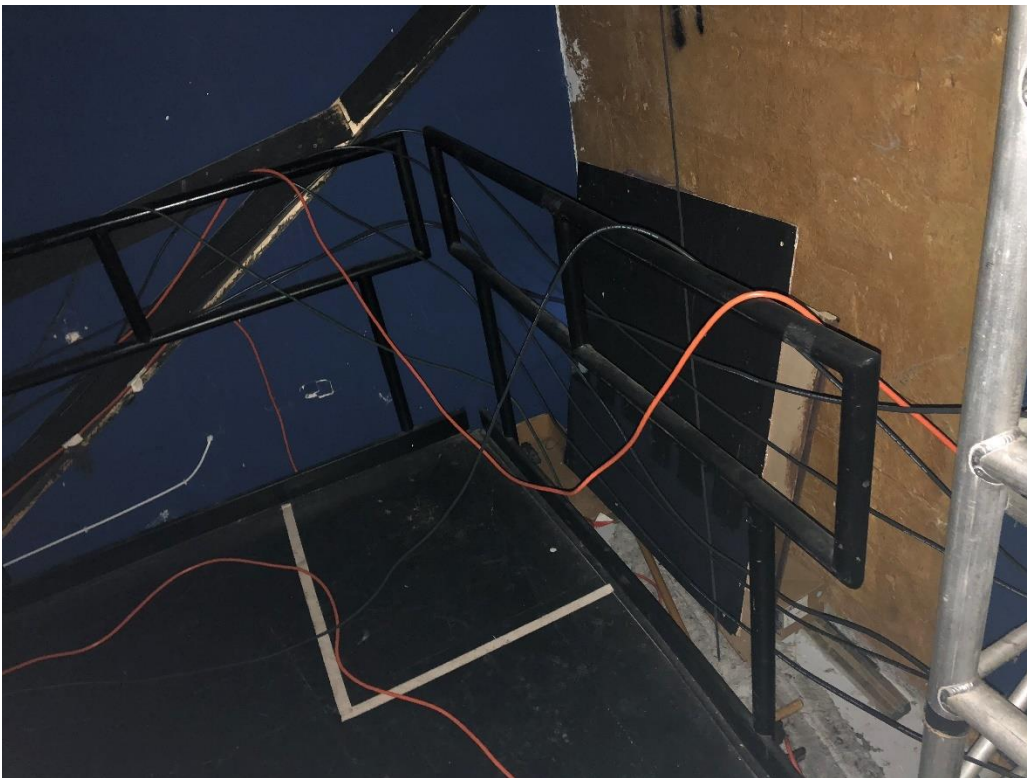
Photograph No. 38 – Loose Metal Guardrail at East Cinema Theater

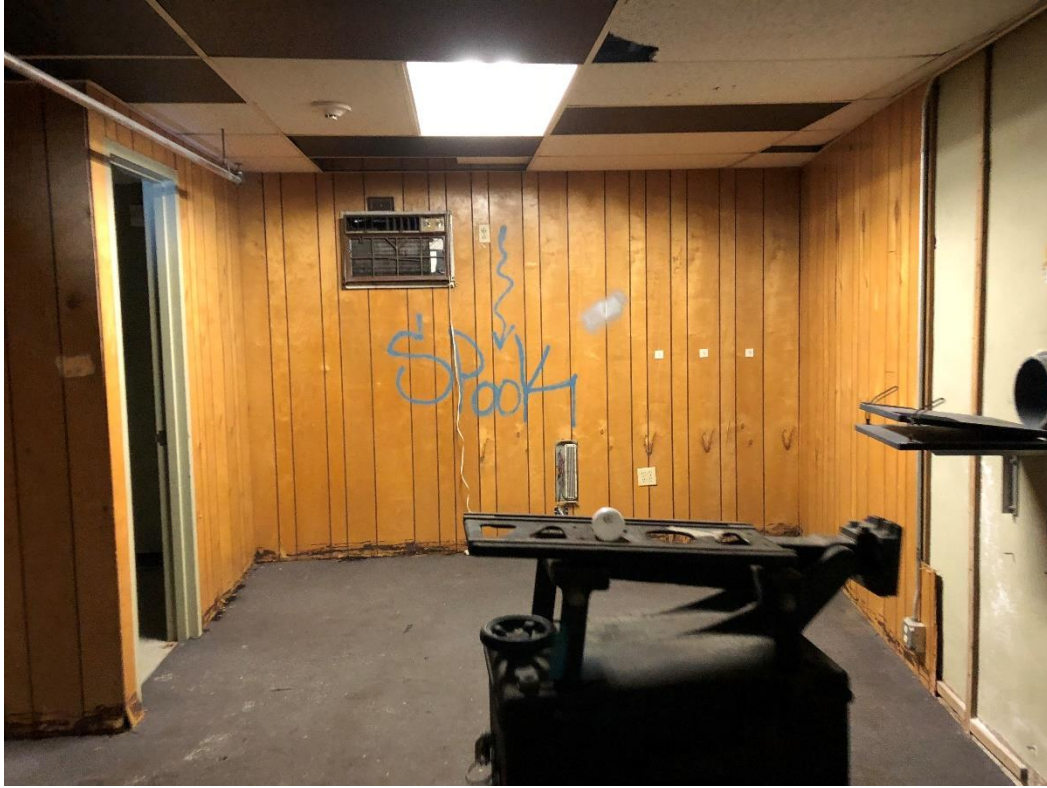
3. Paneling	Poor (see Photograph 39).
4. Paint only	Fair to poor
5. Other (describe)	N/A
i. Cracks	
1. Location – note beams, columns, other	Numerous narrow cracks throughout the exterior façades but not structurally significant.

Photograph No. 39 – Deteriorated Interior Wood Paneling in 2nd floor Room at the South End of Building (Between east and West Theaters).

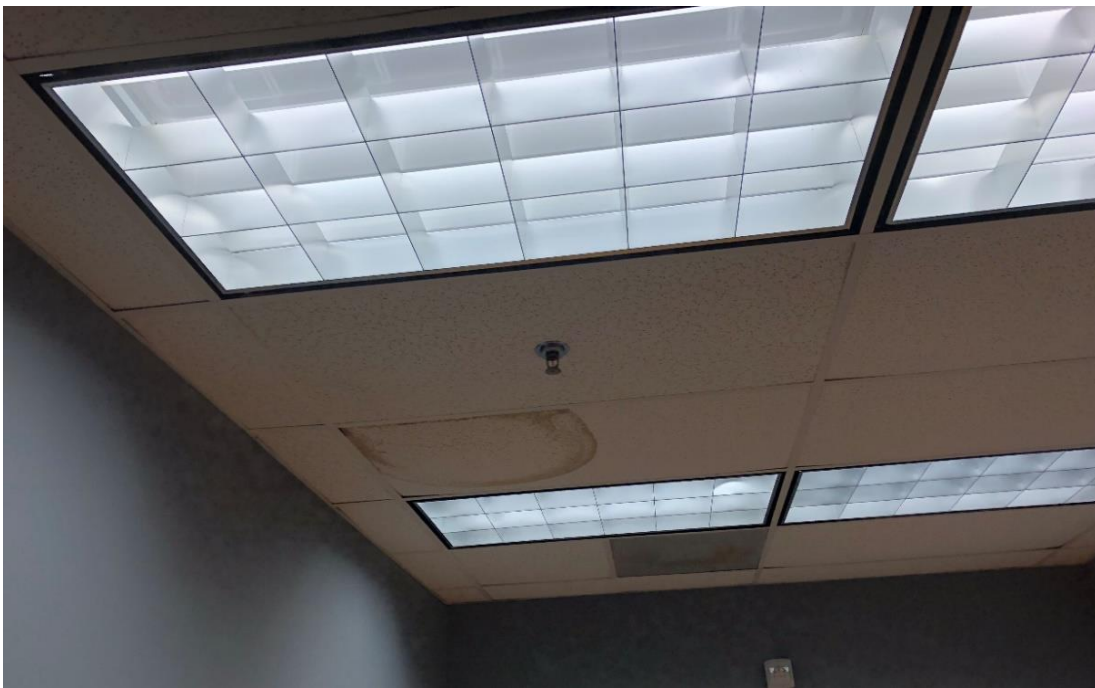
18) There were moisture stains in at least a couple of locations of the ceiling of the first-floor office area (towards the north façade) (see Photograph 40). This may be related to water intrusion from the low roof at the north façade. DWA, however, inspected the underside of the roof structure at this location and did not find signs of significant structural deterioration (see Photograph 41).

Photograph No. 40 – Stained Ceiling Tiles at Ceiling of First Level

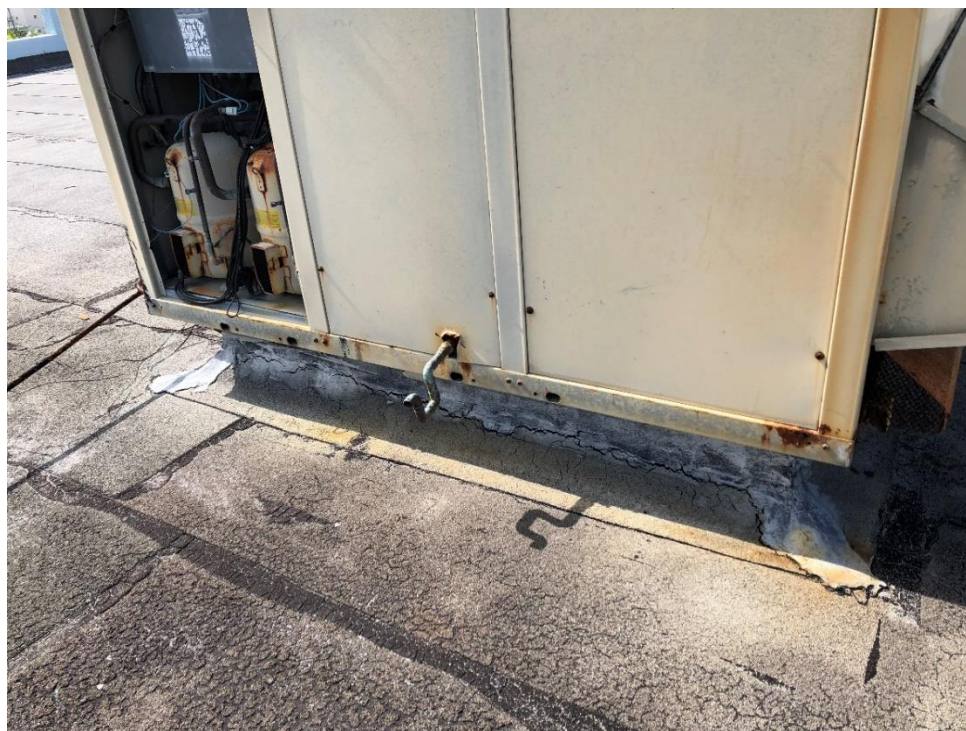
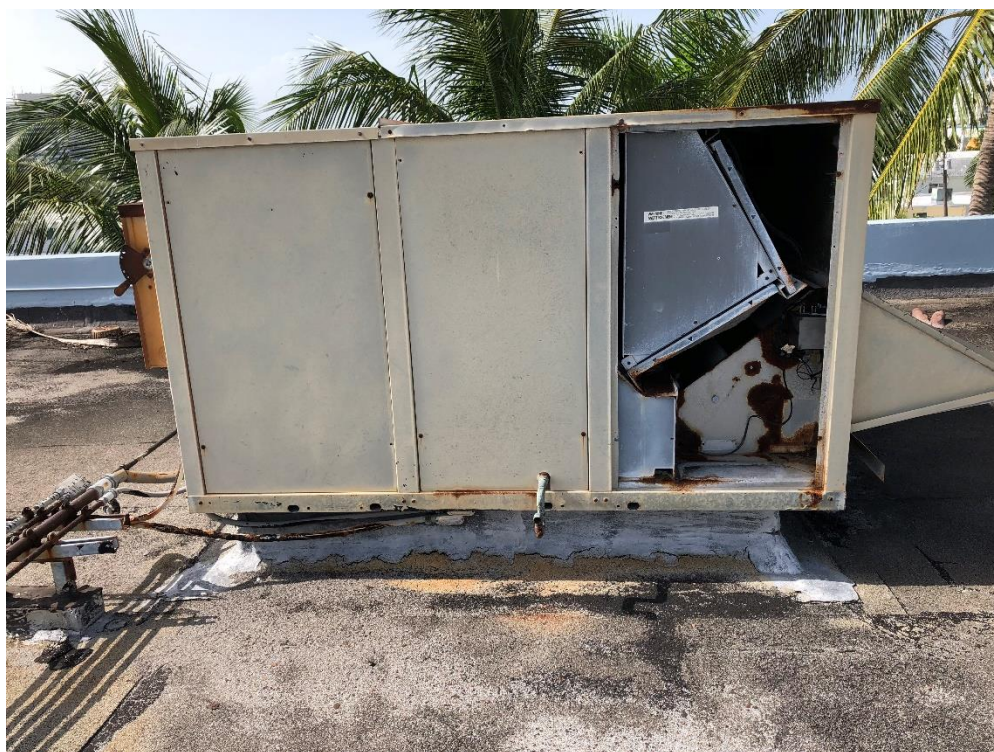
- 6.a.2 ... Condensing unit in lower roof at the east side of the building is supported on metal stands. One of the package units in the lower roof at the east side is being supported on a roof curb that is bigger than the unit (see Photograph 62). Several package units are not connected to their roof curbs, especially in the western upper roof and the lower roof between the east and west portions of the building (see Photographs 63, 64, and 65). Some units are missing enclosure panels (see Photographs 63 & 64).

Photograph No. 63 – Package unit Unconnected to Roof Curb at Western Upper Roof

Photograph No. 64 – Package unit Unconnected to Roof Curb at Western Upper Roof

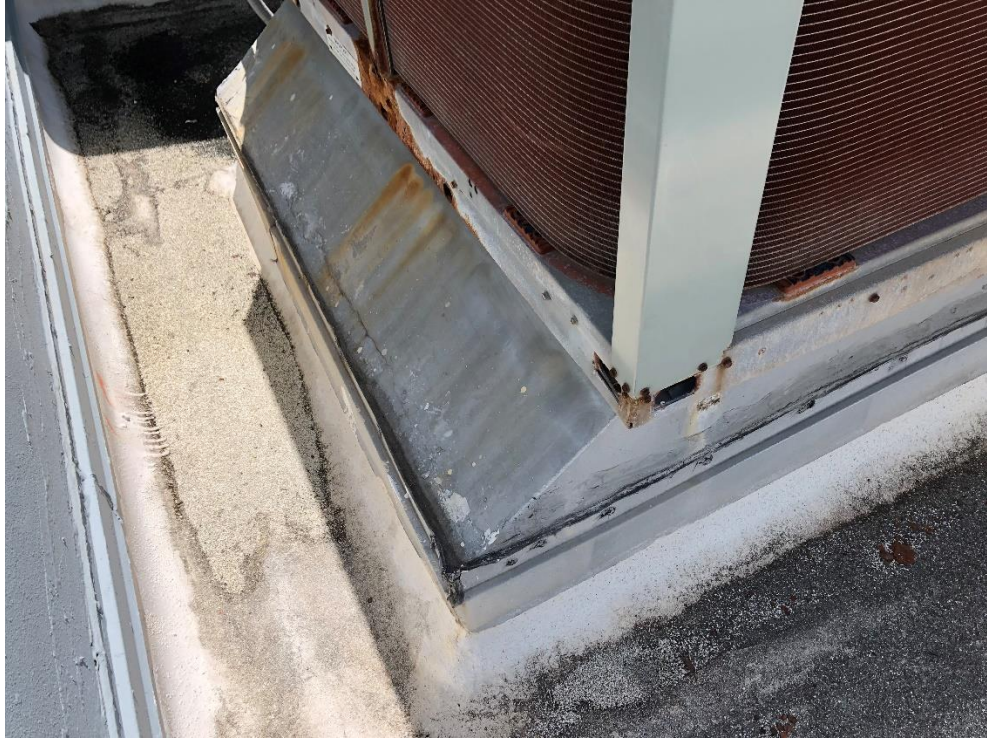
Photograph No. 65 – Package Unit Unconnected to Roof Curb at Low Roof between East and West Portions

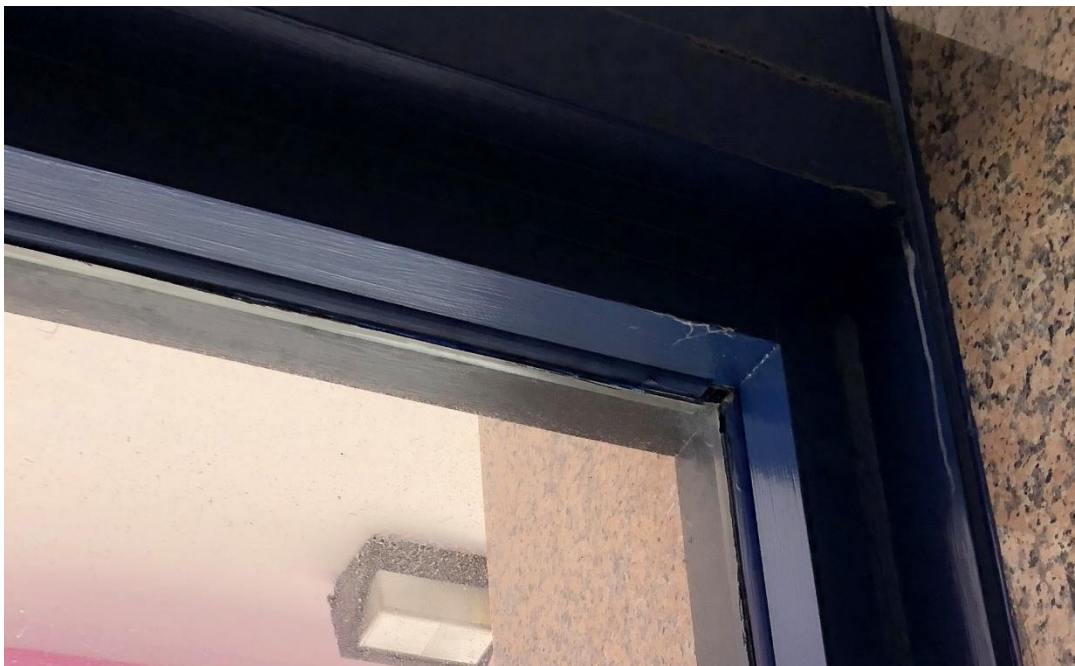
b. Anchorage- type and condition of fasteners and latches Not directly observed.
c. Sealant – type of condition of perimeter sealant and at mullions: Fair to poor condition. Perimeter sealant is missing or has deteriorated...CONTINUE ON ATTACHED SHEET

Photograph No. 74 – Missing Sealant at Corner of Fixed Window of North Façade
