**Reference: 50-Year Recertification
Byron Carlyle Theater
500 71 St., Miami Beach, Florida
Folio 02-3211-002-1070**

MINIMUM INSPECTION PROCEDURAL GUIDELINES FOR BUILDING RECERTIFICATION - STRUCTURAL

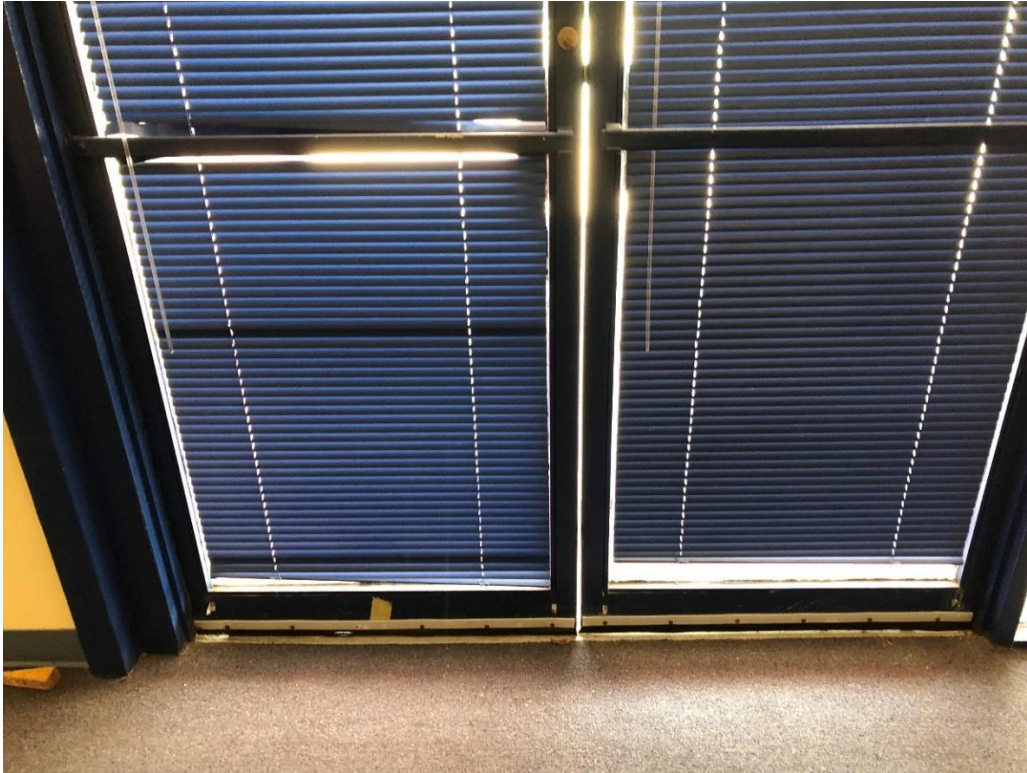
Photograph No. 75 – Considerable Gab between Pair of North Façade Doors

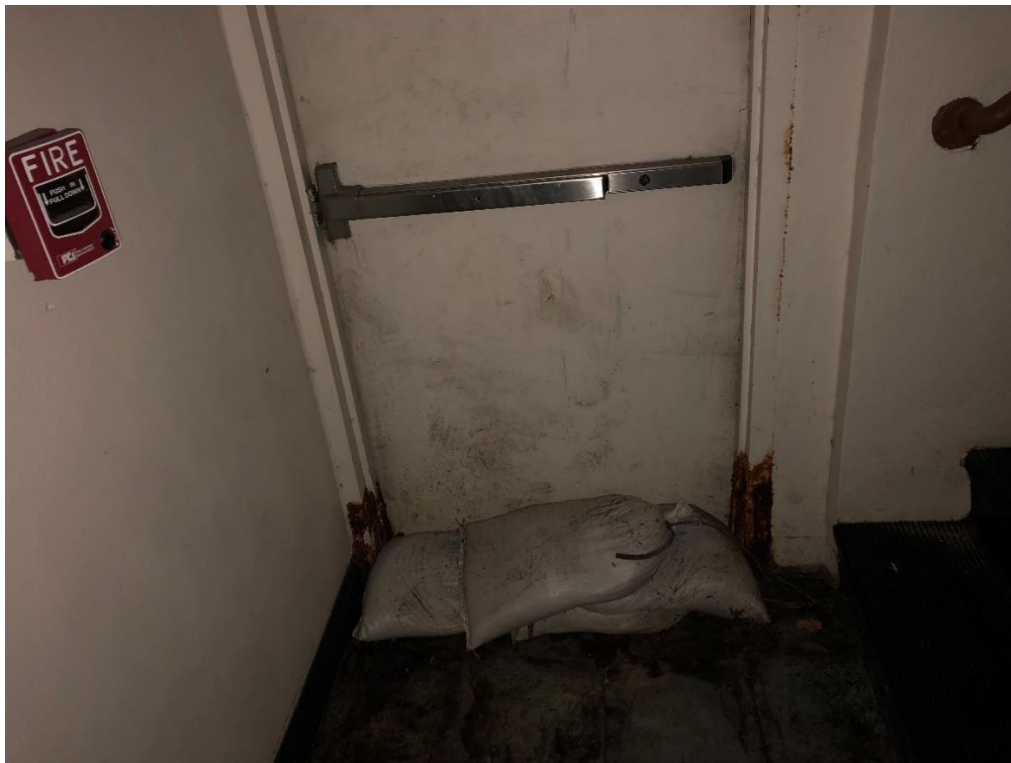
d. Interiors seals – type and condition at operable vents Not directly observed.
e. General condition: The exterior metal door and frame near the south end of the east façade are corroded at the base due to water intrusion (see Photograph 76). Metal door at other locations are lightly corroded (see Photograph 77).

Photograph No. 76 – Corroded Exterior Door at Underground Electrical Room

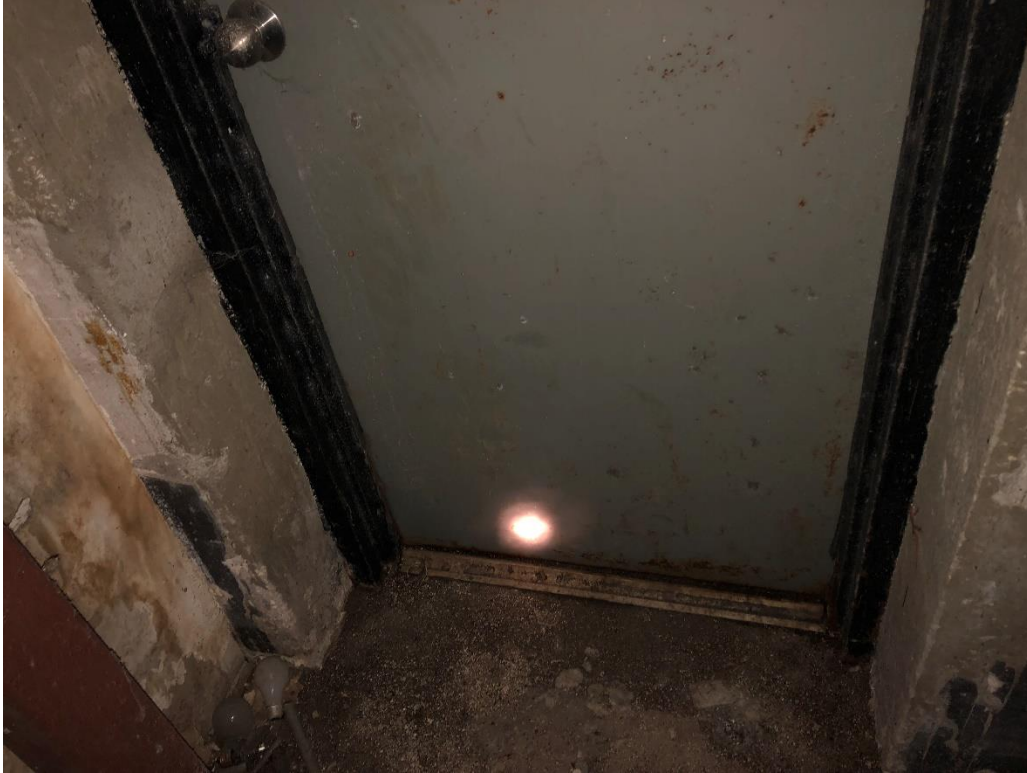
Photograph No. 77 – Lightly Corroded Exterior Door at Steel-framed Exit Staircase for Projection Room of West Cinema Theaters

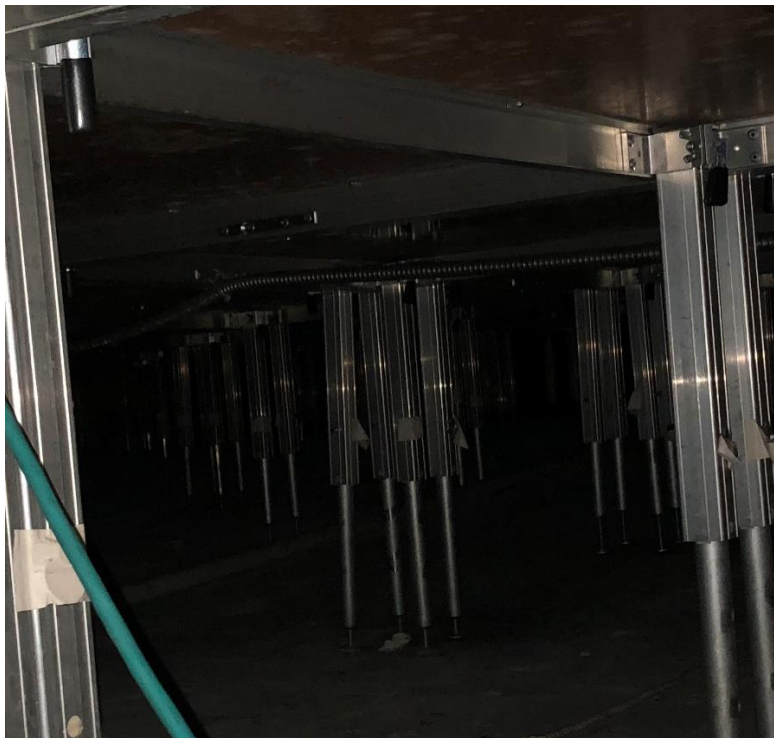
Photograph No. 78 – Crooked Leg of Stage's Aluminum-framed Platform

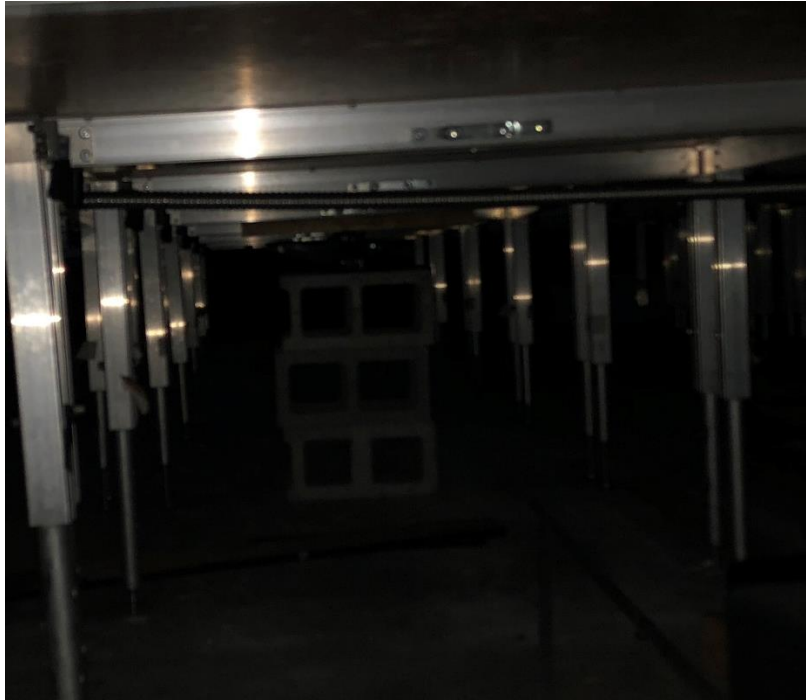
15) In an area towards the front of the stage of the east cinema theater, loose C.M.U. and what appears to be a car jack are supporting the versatile (i.e. removable) prefabricated aluminum-framed platform (see Photograph 83). It is unclear why this extra support is needed at this location.

Photograph No. 83 – Loose C.M.U. blocks Supporting East Cinema Theater Platform
