Tree Resource Evaluation for Proposed Miami Beach convention Center Hotel Site

January 6, 2019

Summary

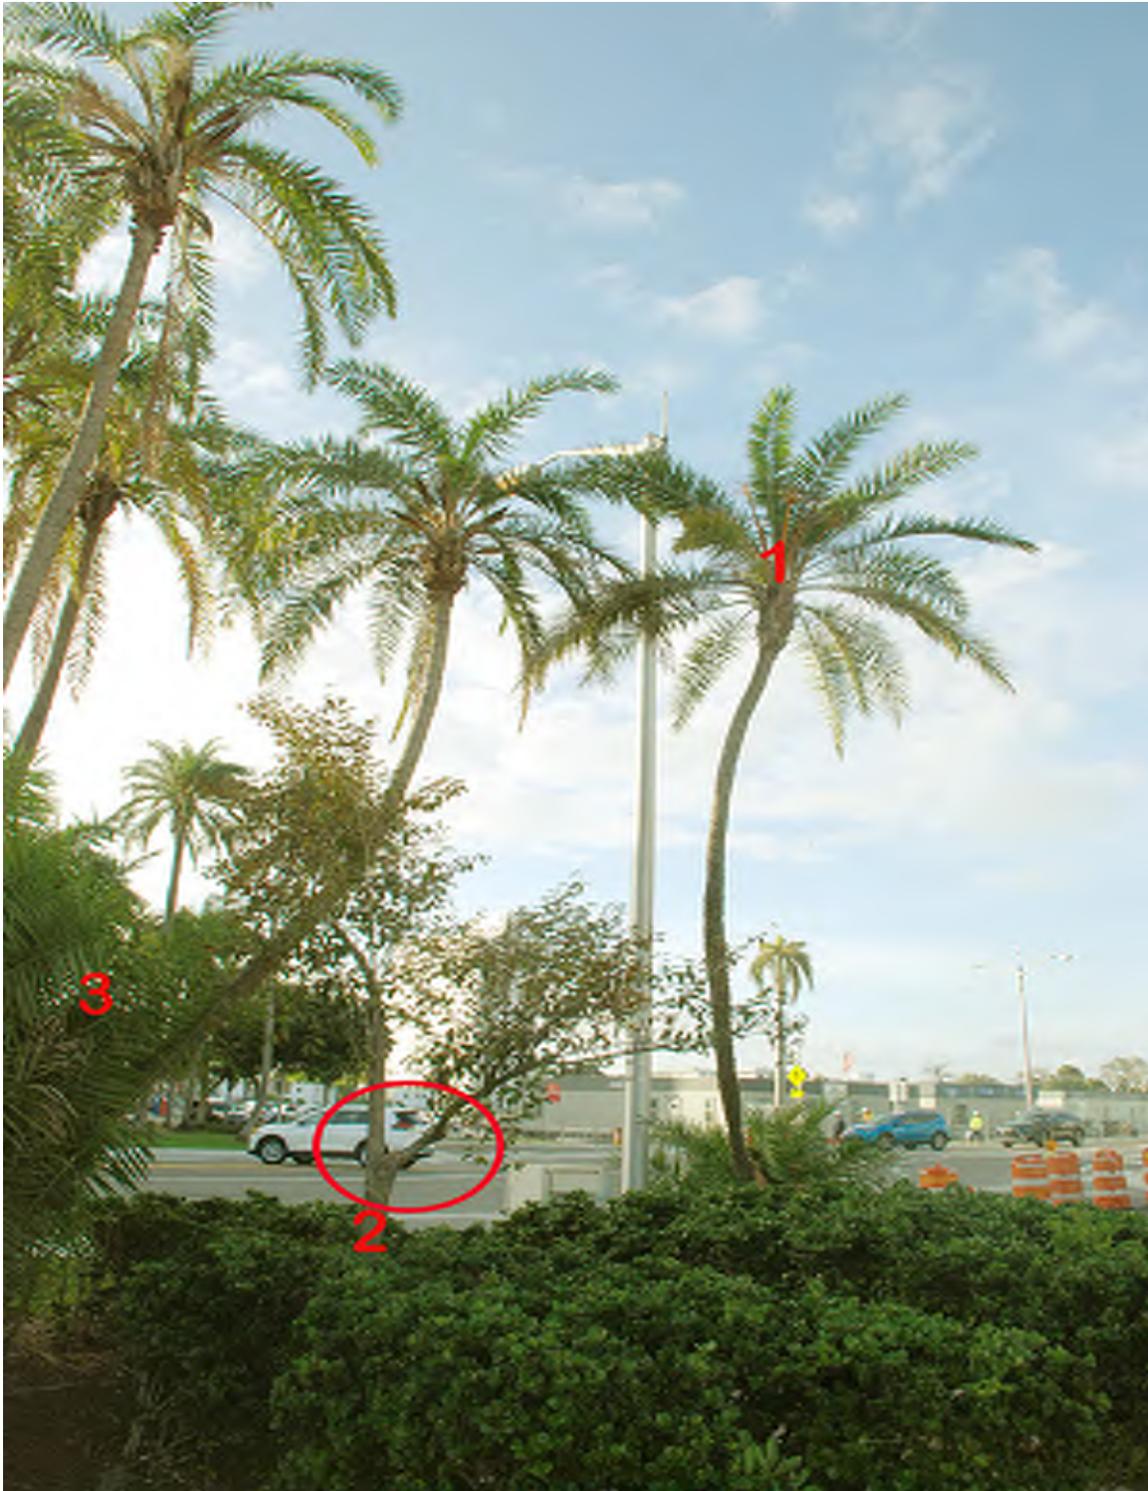
Photo 1 above is palm 1 and tree 2 viewed from the east. Palm 1 has only a single trunk. Tree 2 as indicated by the circle has a very weak trunk/main branch connection.

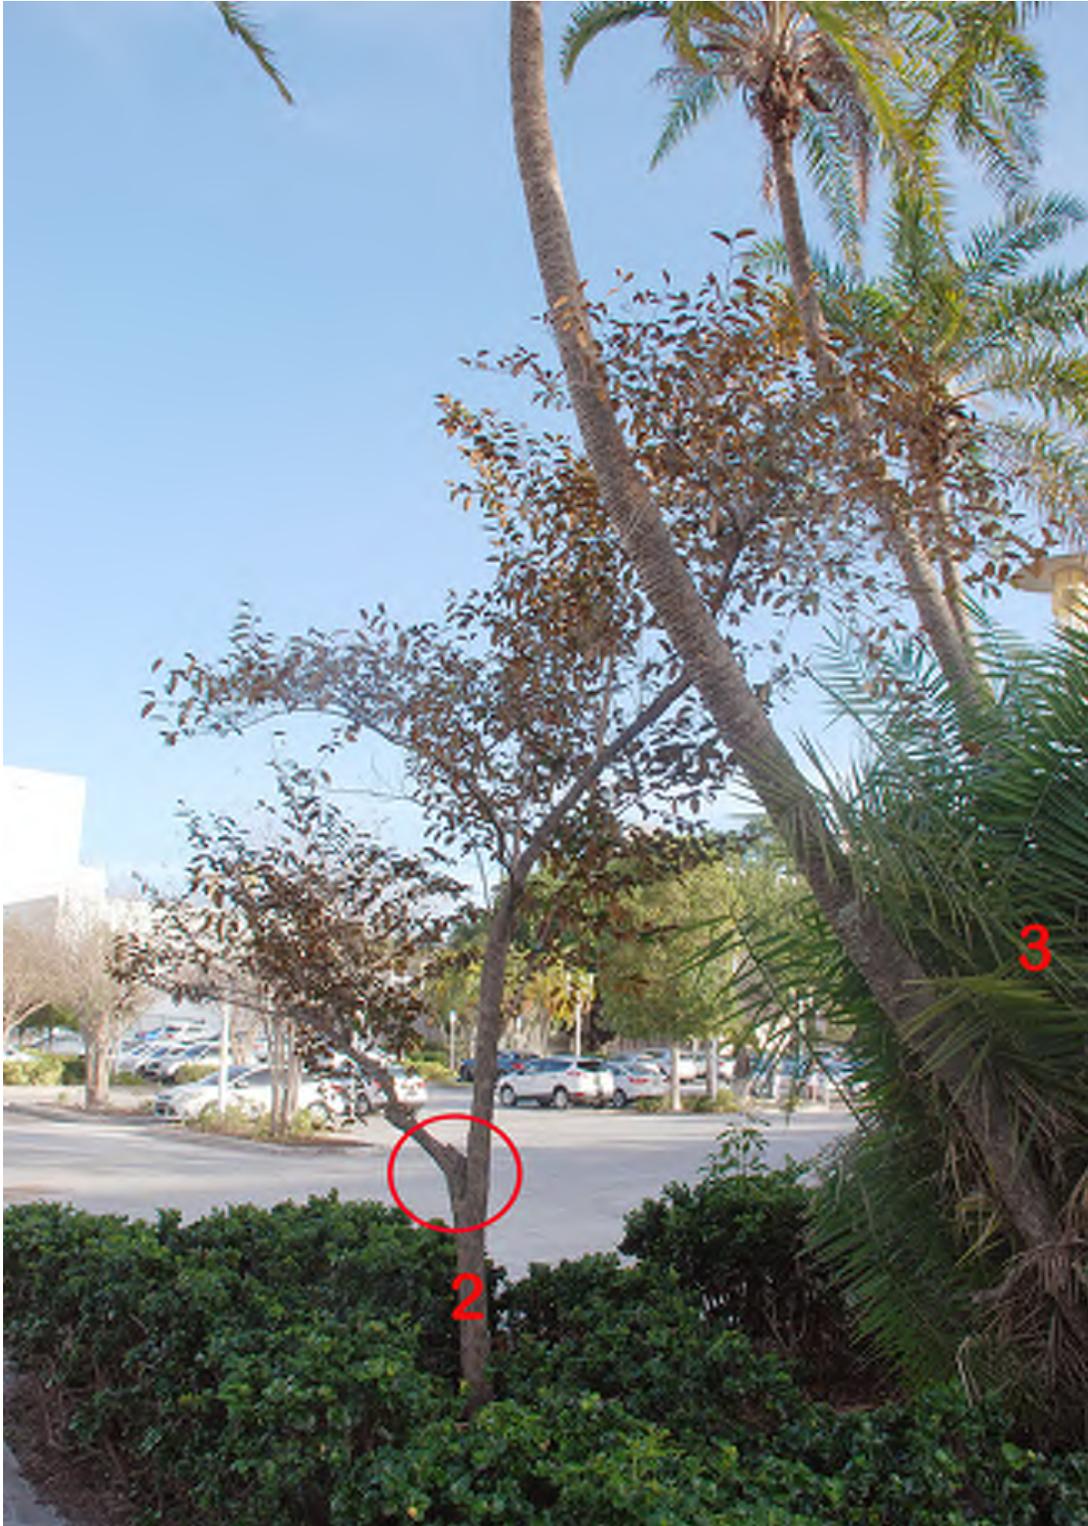
Photo 2 above is tree 2 and as indicated by the circle has a very weak trunk/main branch connection.

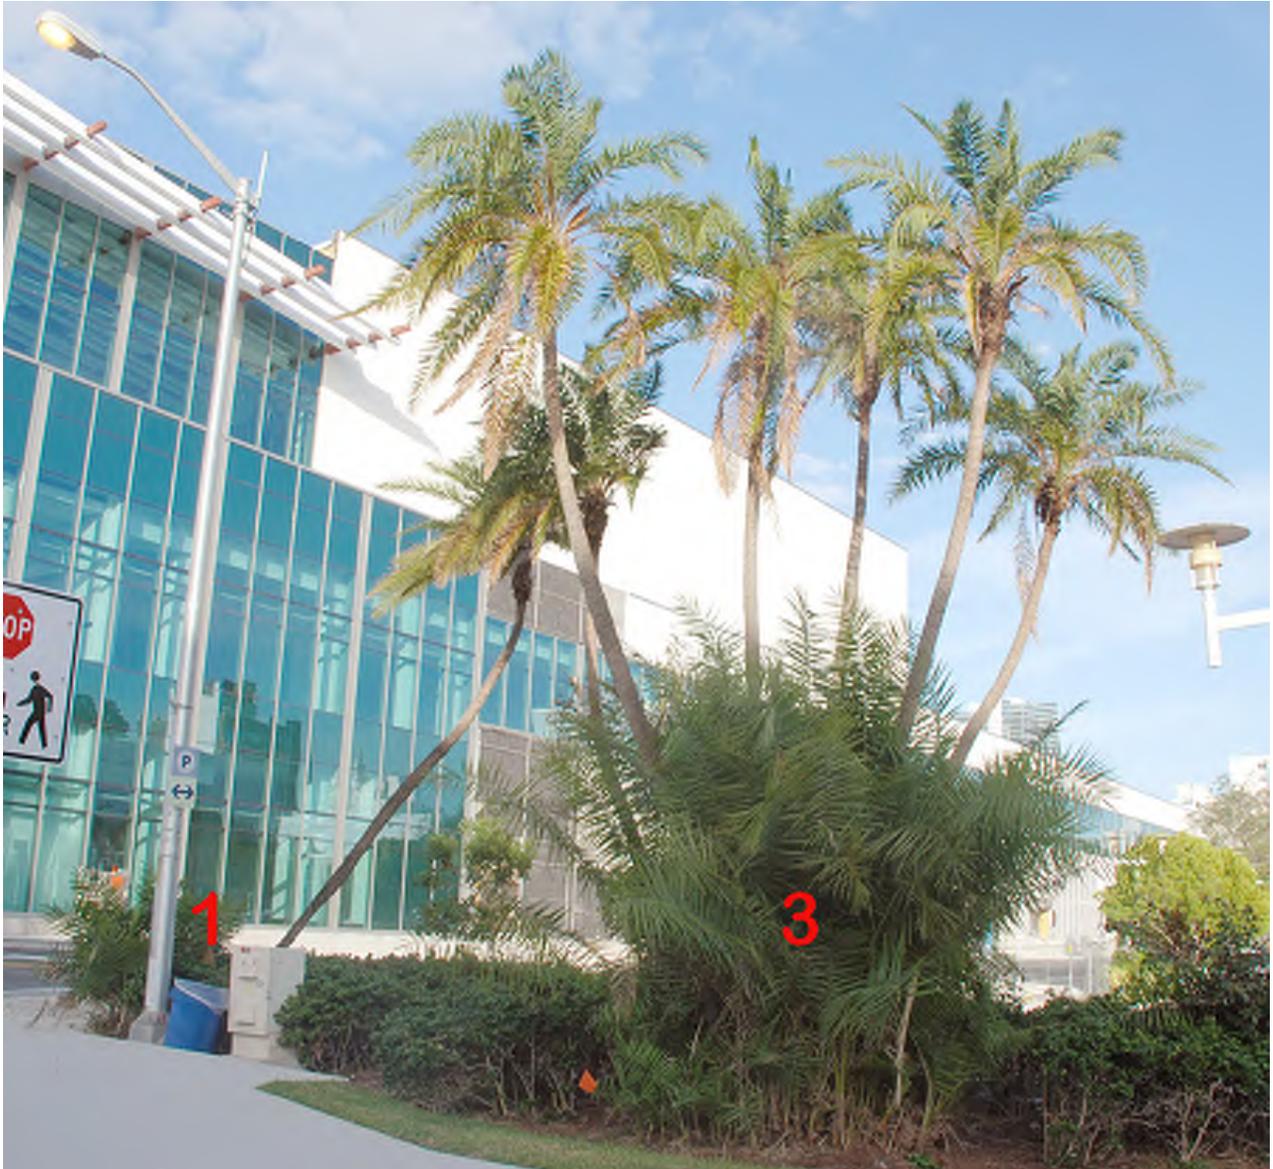
Photo 3 above is palm 3 viewed from the west. Palm 1 appears to have been damaged and had trunks removed.

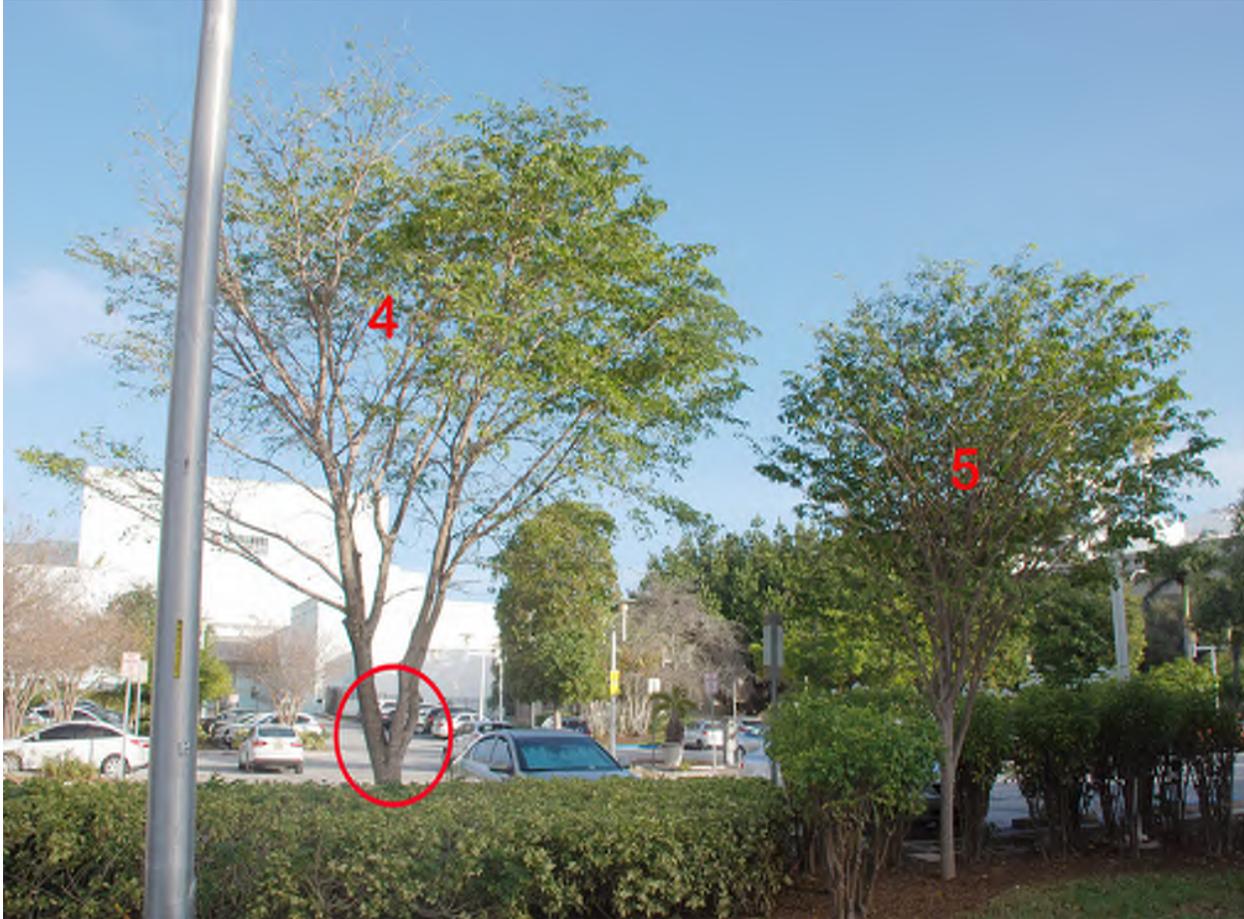
Photo 4 above is tree 4 with the circle indicating a very weak trunk/main branch connection, and tree 5 viewed from the west.

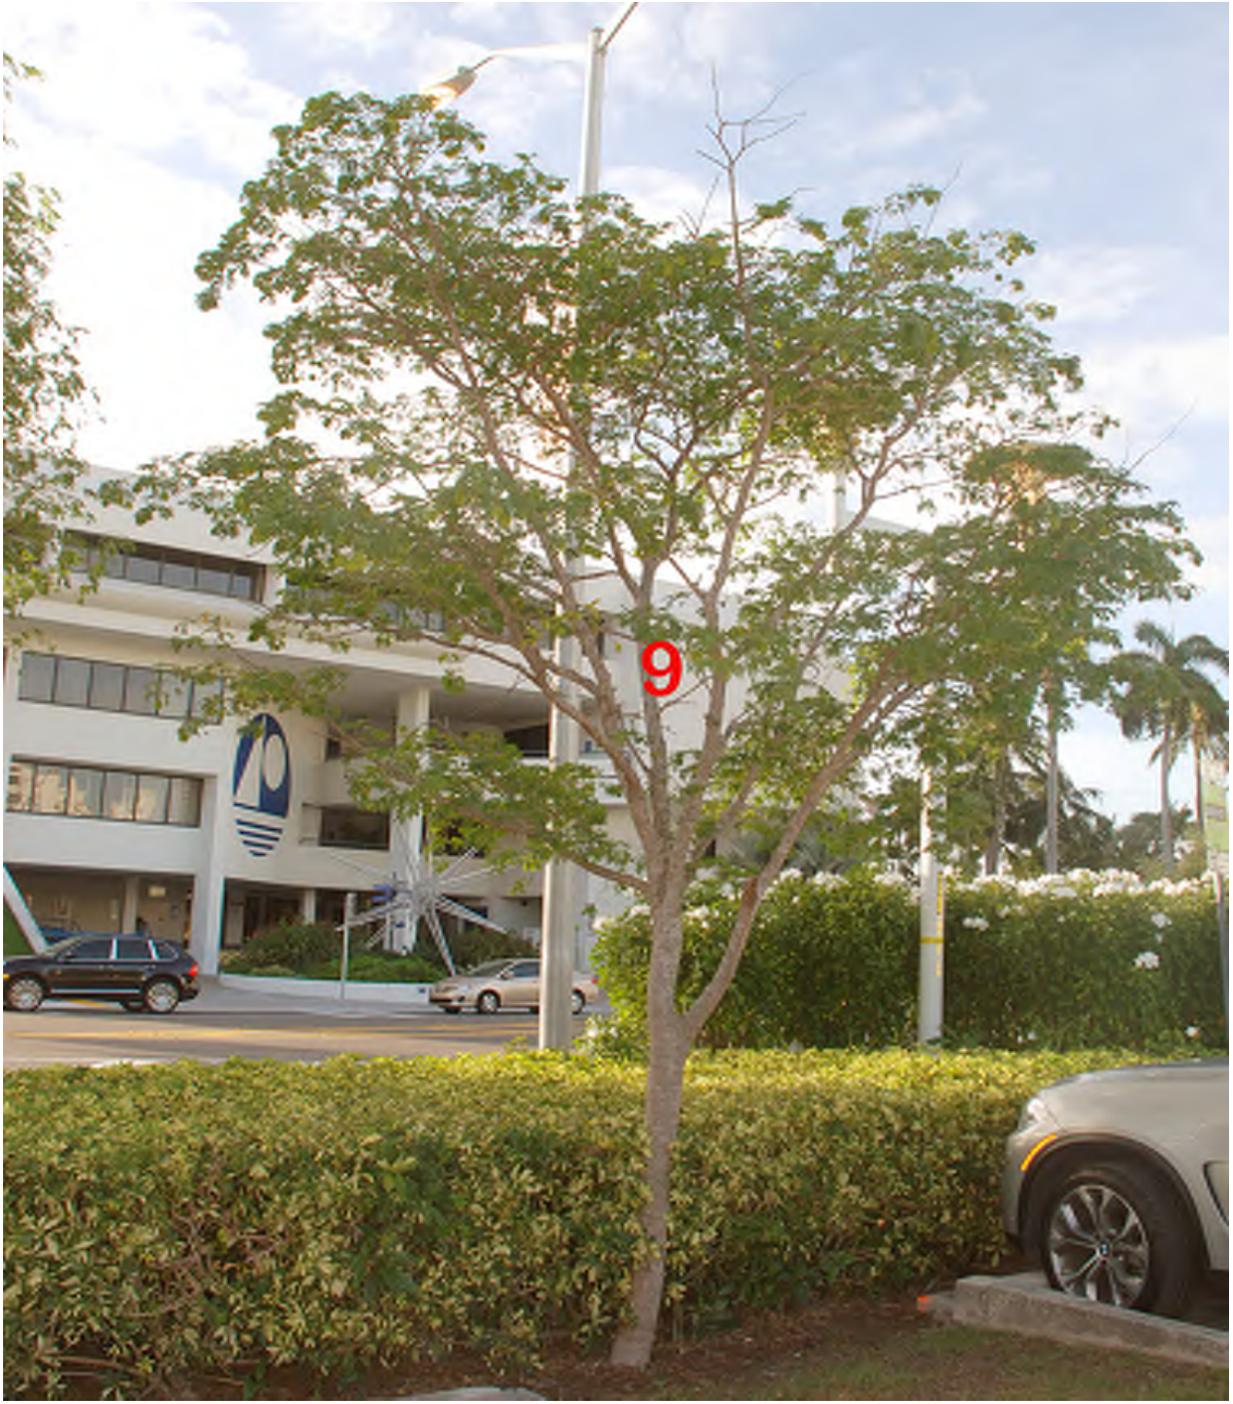
Photo 8 above is tree 9 viewed from the east. There is some small branch die-back in the canopy.

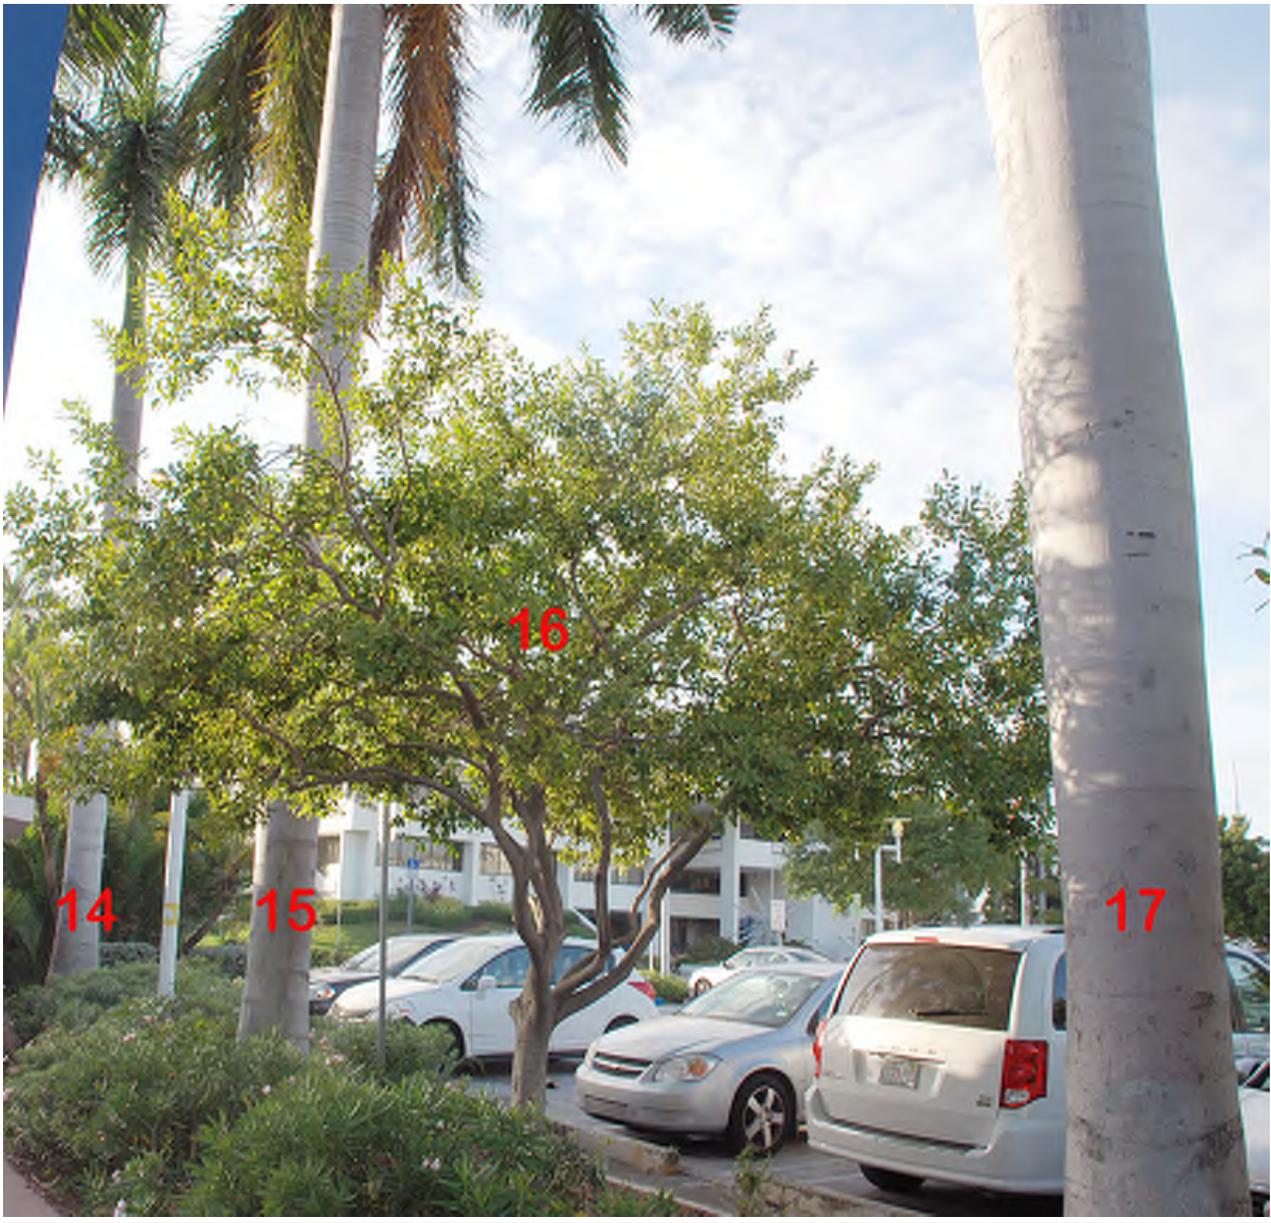
Photo 15 above is a closer view of tree 16 from the east. This tree is developing a severe nutrient deficiency.

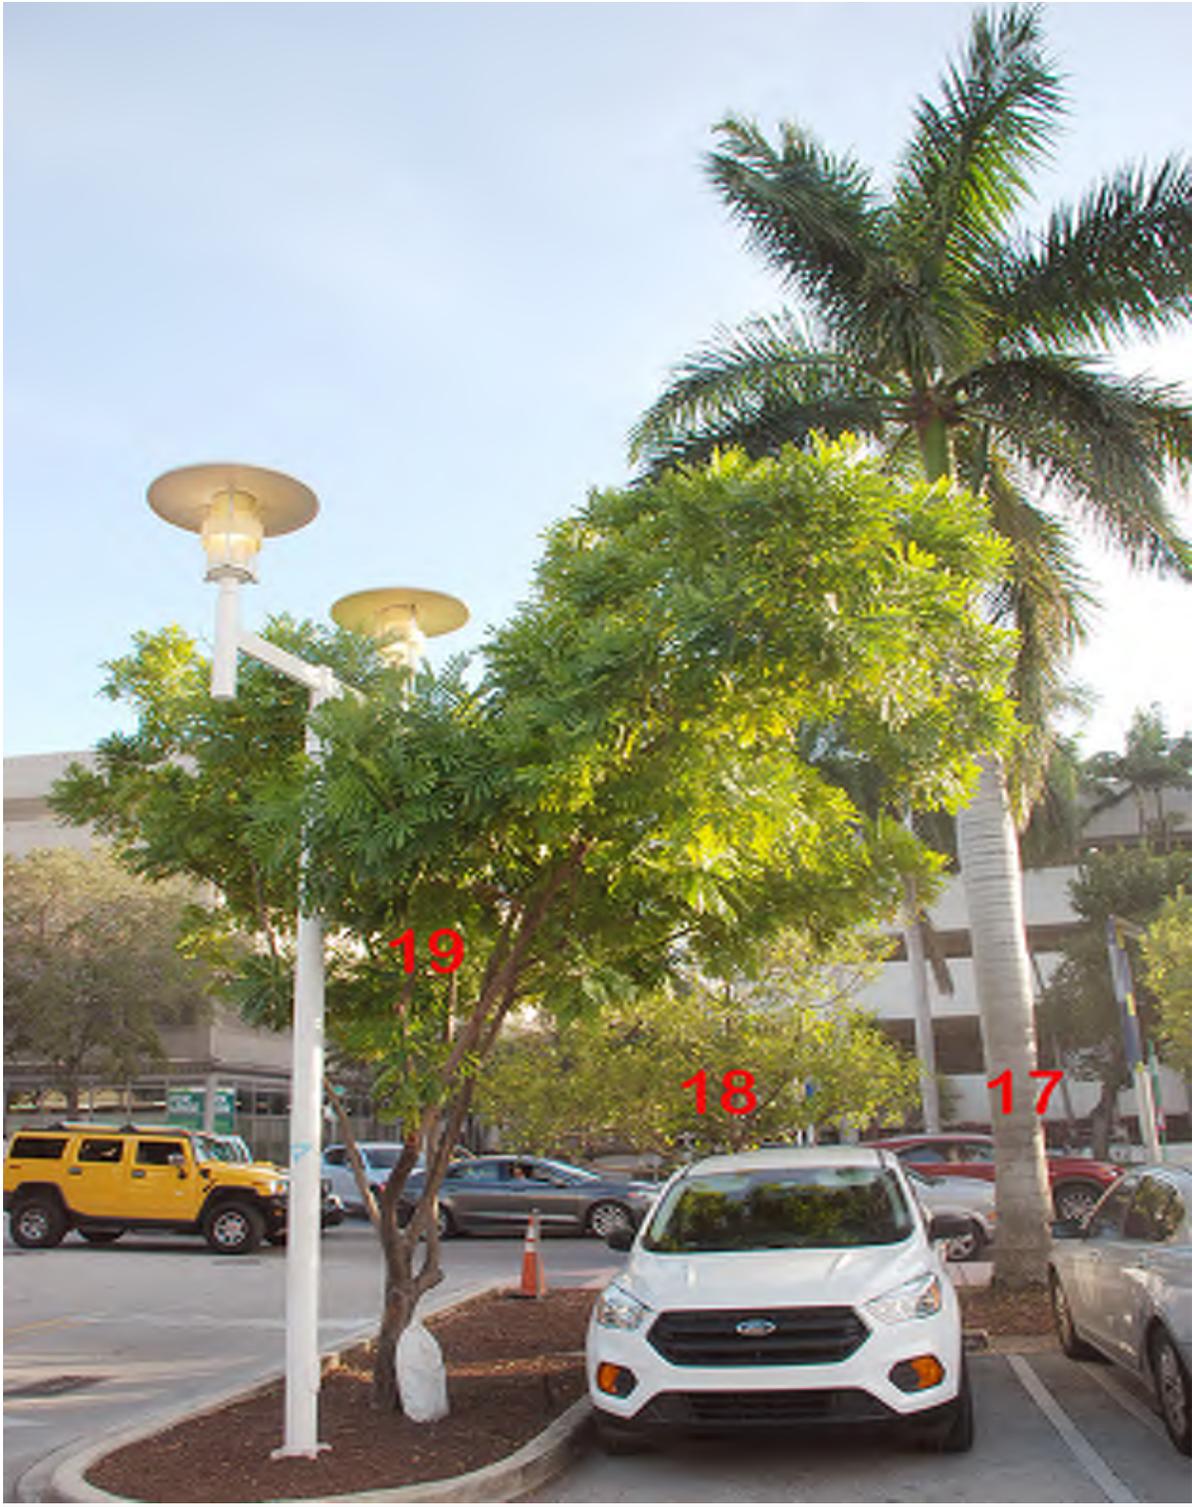
Photo 17 above is tree 19 viewed from the north. This tree has poor branch structure.

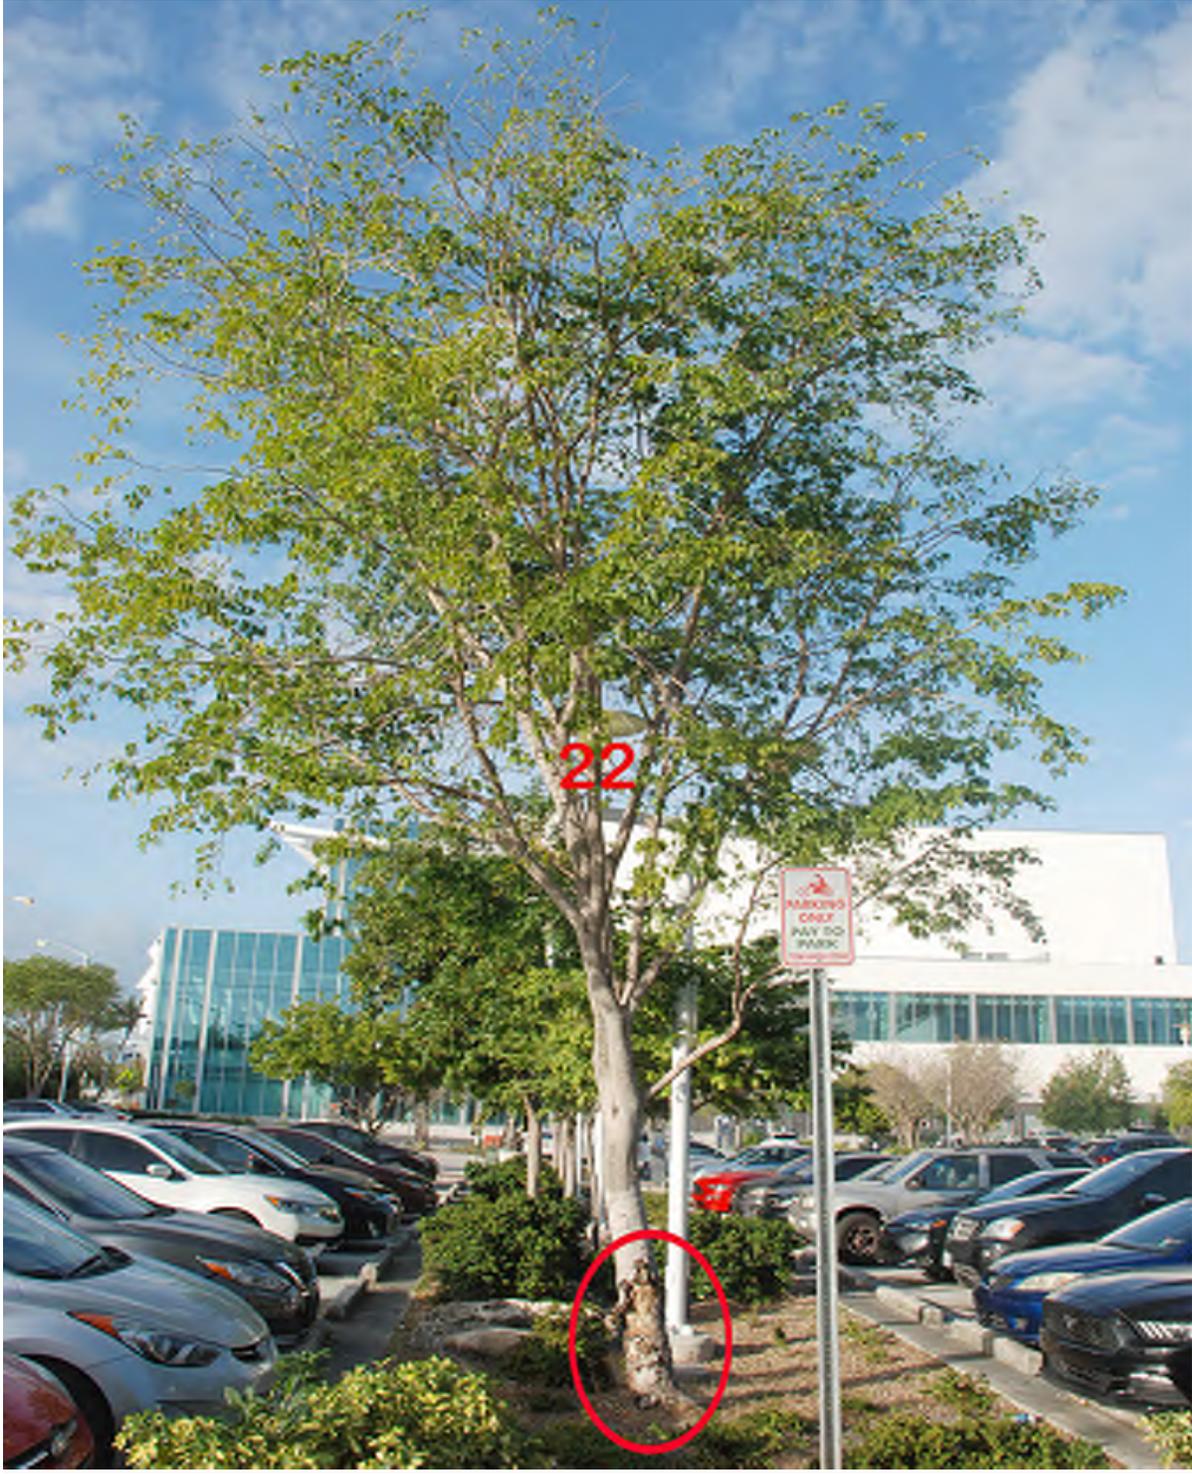
Photo 19 above is tree 22 viewed from the south. The circle indicates significant damage and decay to the trunk. See following photo. This tree should be removed immediately.

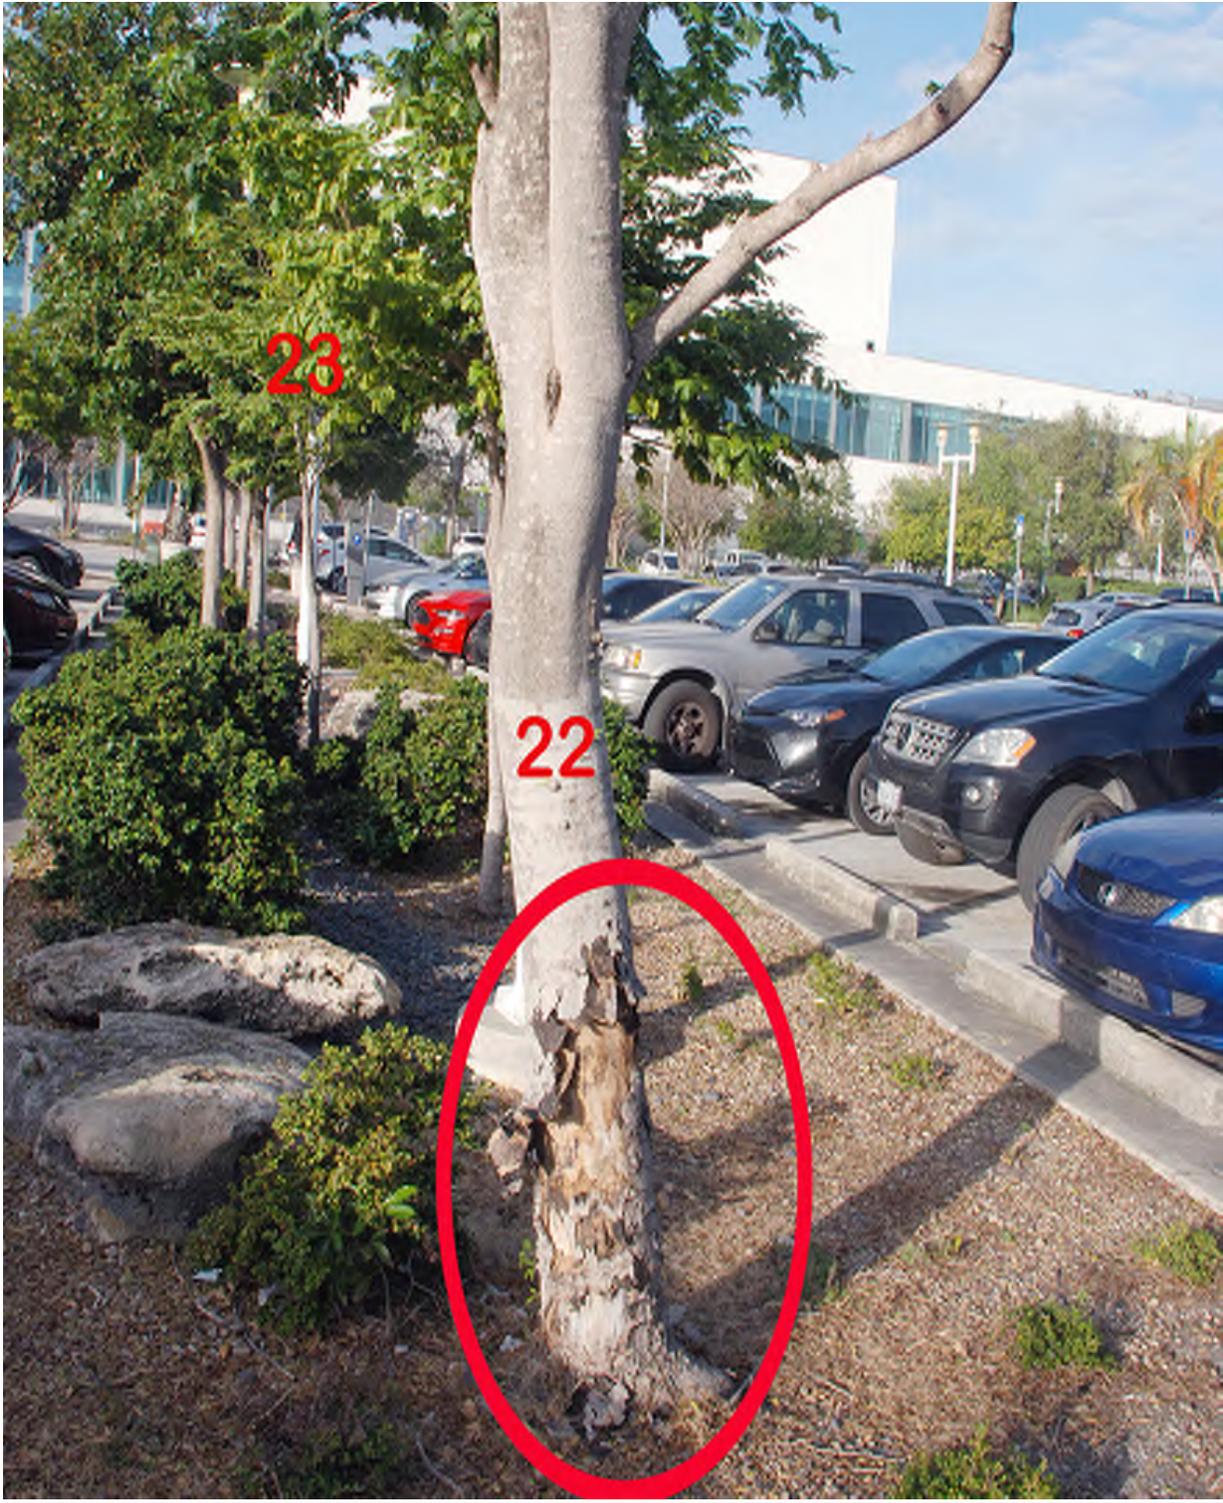
Photo 20 above is a closer view of the damaged and decaying trunk of tree 22. This tree should be removed immediately.

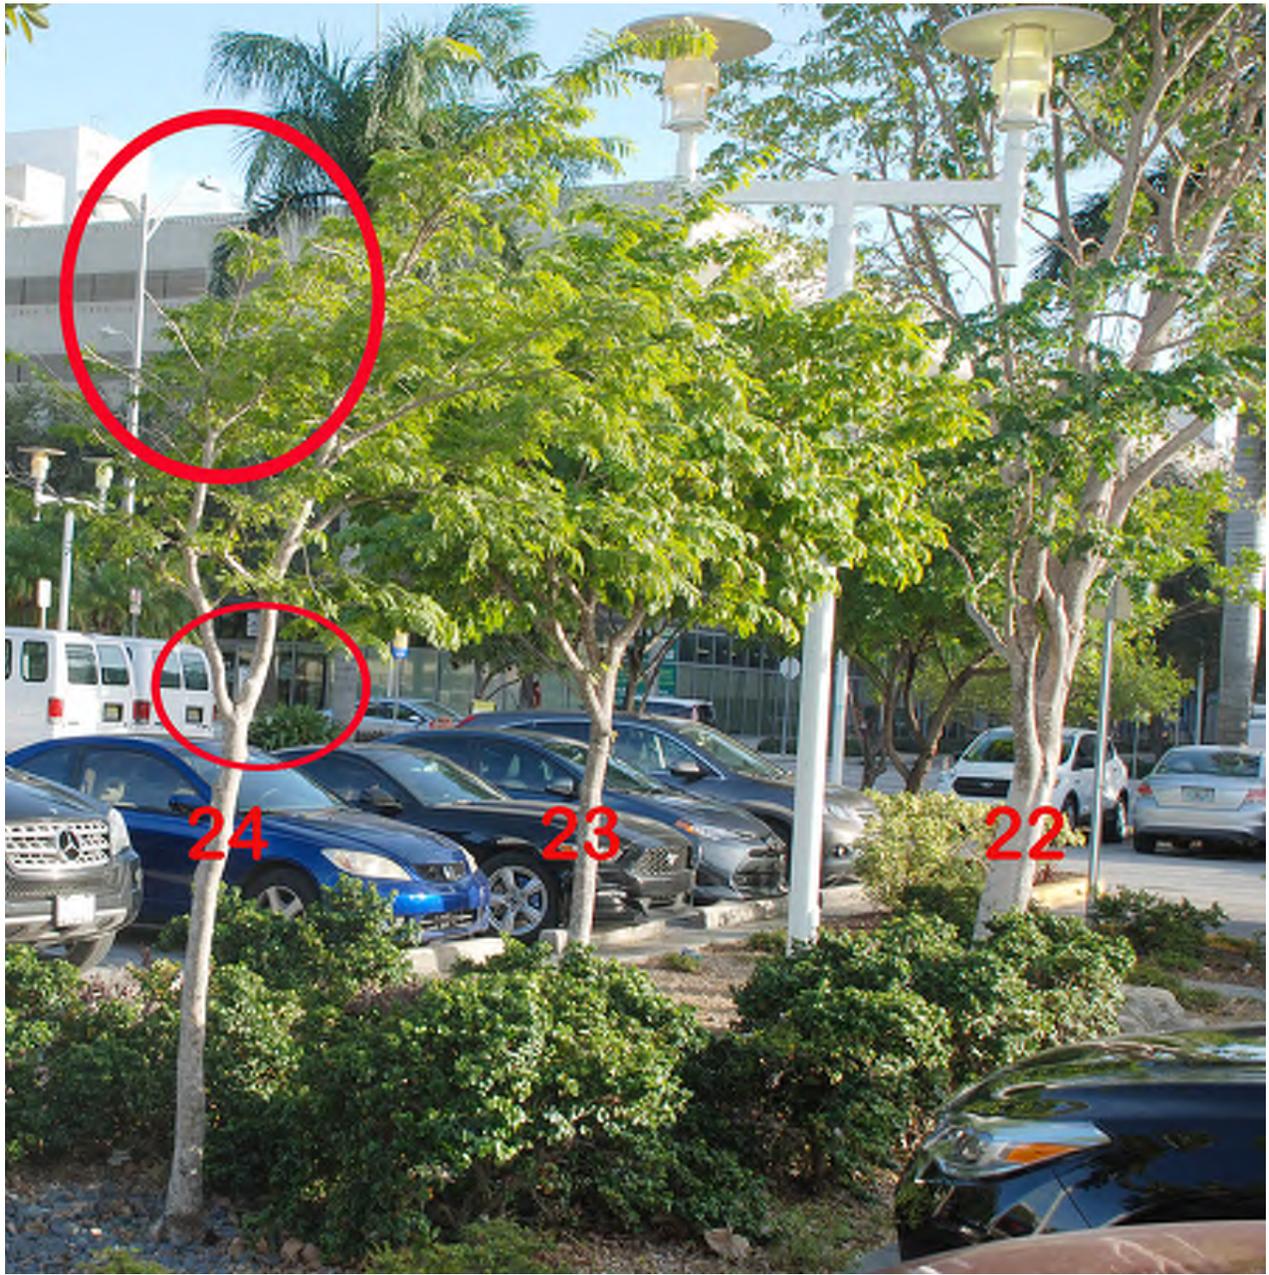
Photo 21 above is trees 22, 23 & 24 with small branch die-back and a weak trunk/main branch connection on tree 24.

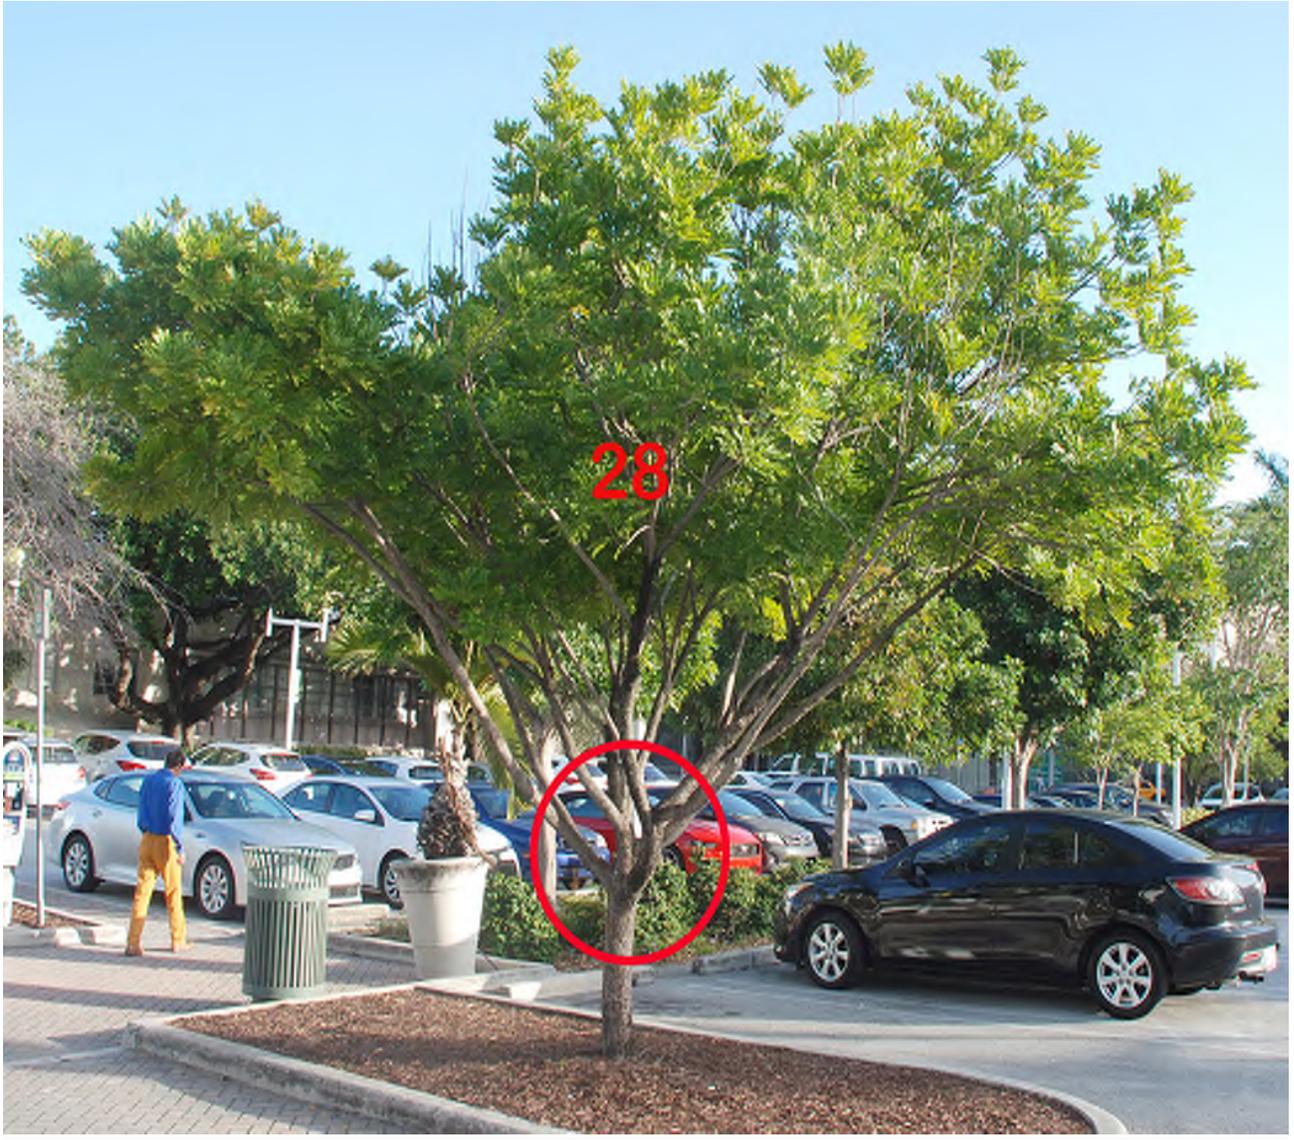
Photo 24 above is tree 28 with a weak trunk/main branch structure indicated via the circle. There is also small branch die-back in the canopy of this tree.

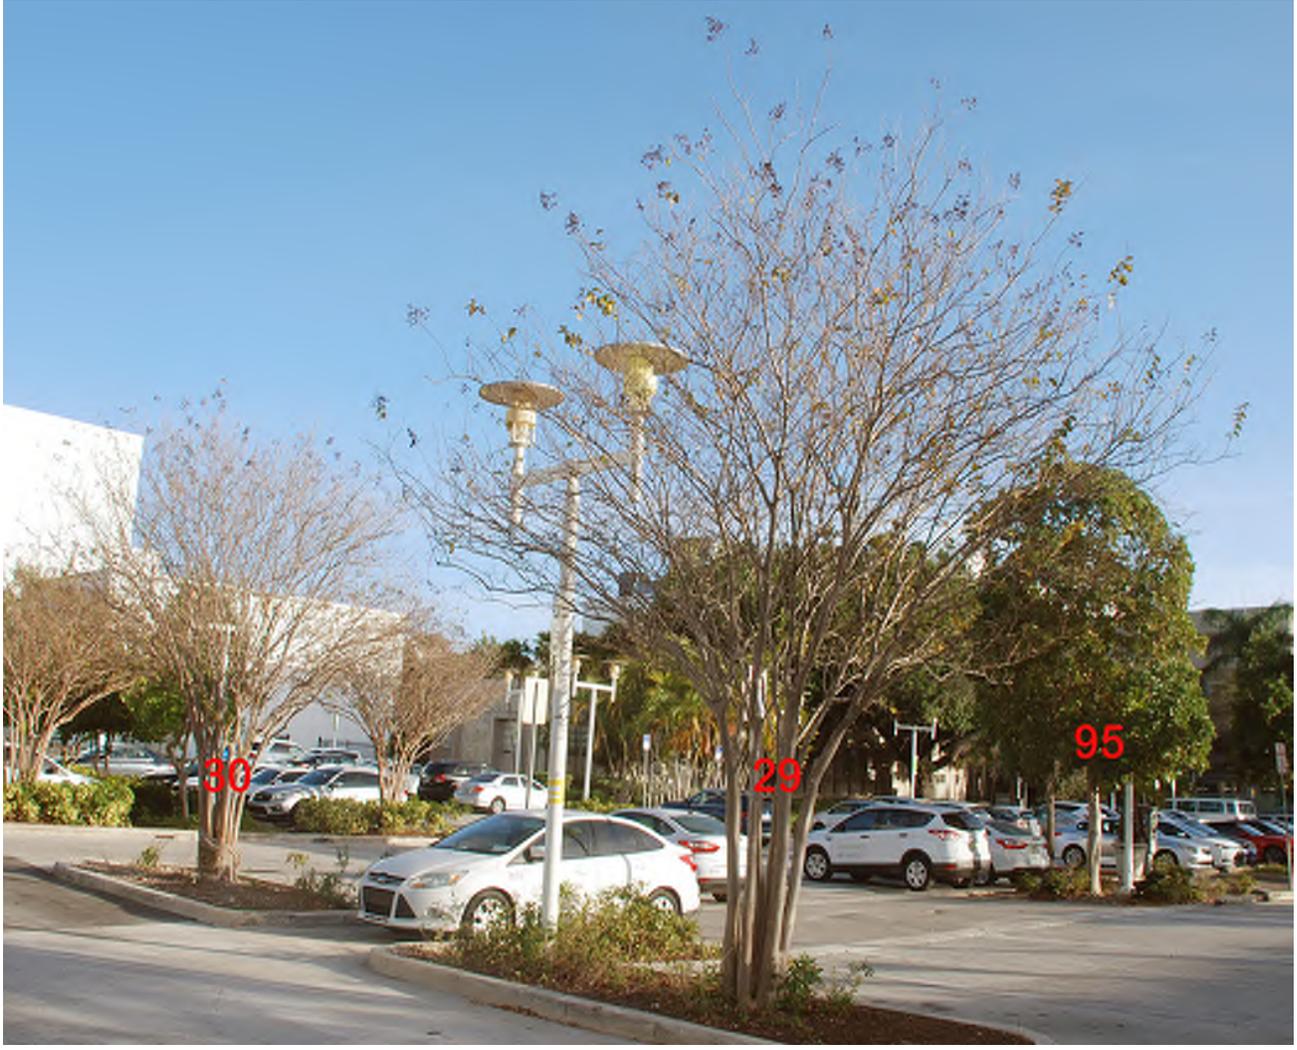
Photo 25 above is Crape myrtles 29 & 30. Both trees appear to have dropped their foliage although they are not dead. Tree 30 has its trunks wrapped with burlap. I rated these trees as moderate since they dropped their foliage but will most likely regrow new foliage.

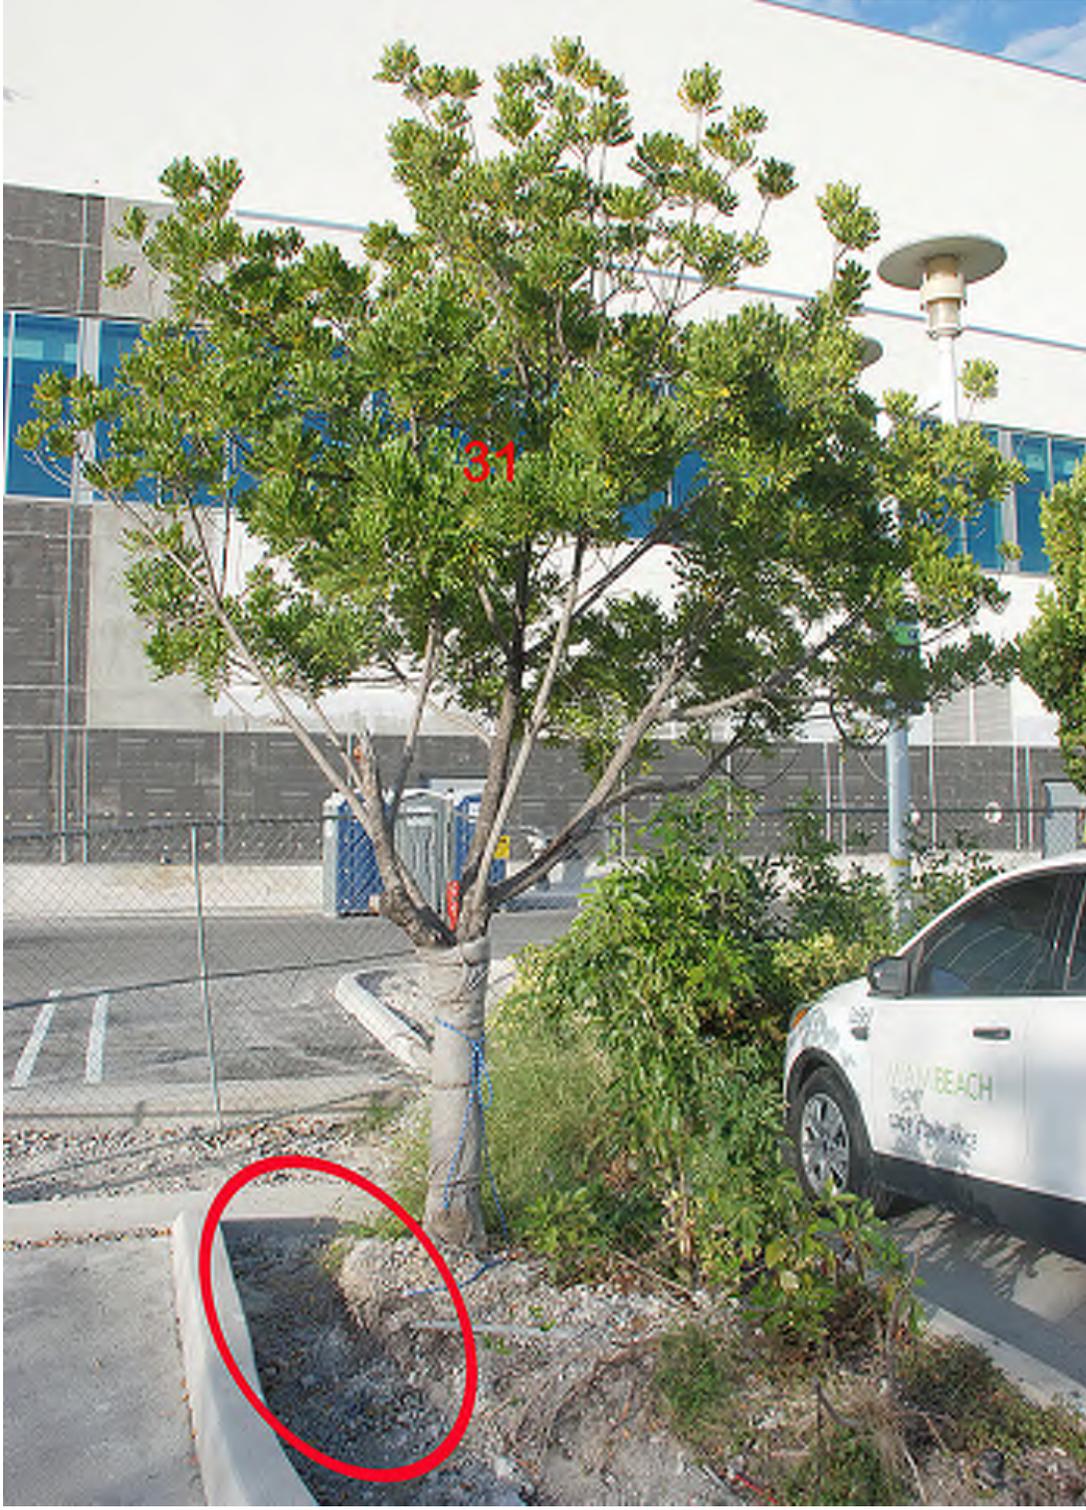
Photo 26 above is tree 31 viewed from south. A significant number of roots have been removed and left to dry-out.

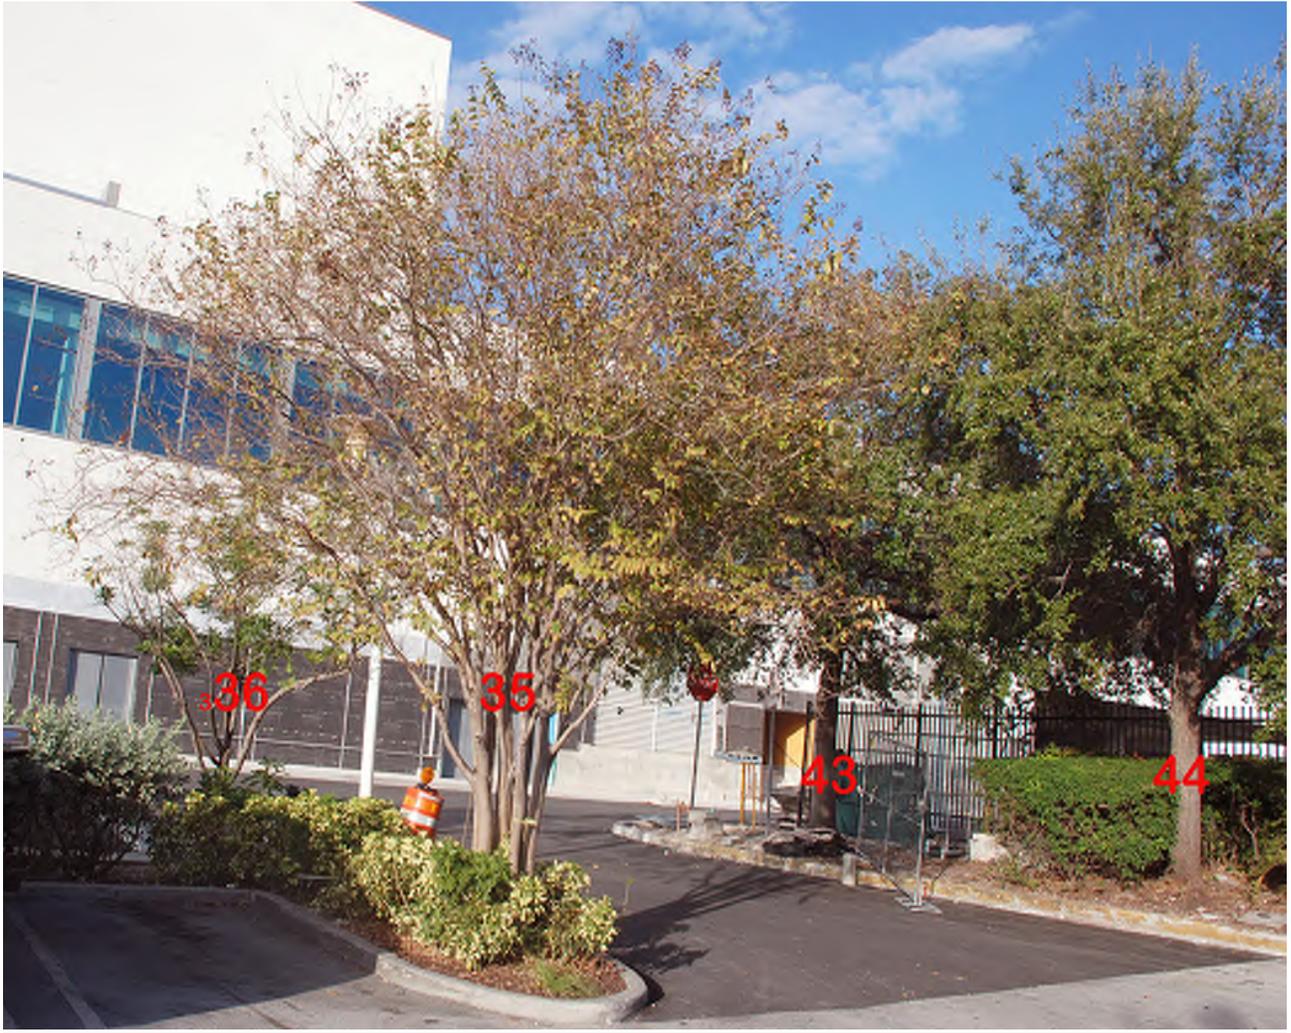
Photo 29 above is tree 35 with what appears to be normal seasonal canopy foliage loss.
